M42 Junction 6 Development Consent Order

Scheme Number TR010027

8.10(b) Statement of Common Ground with Natural England

October 2019

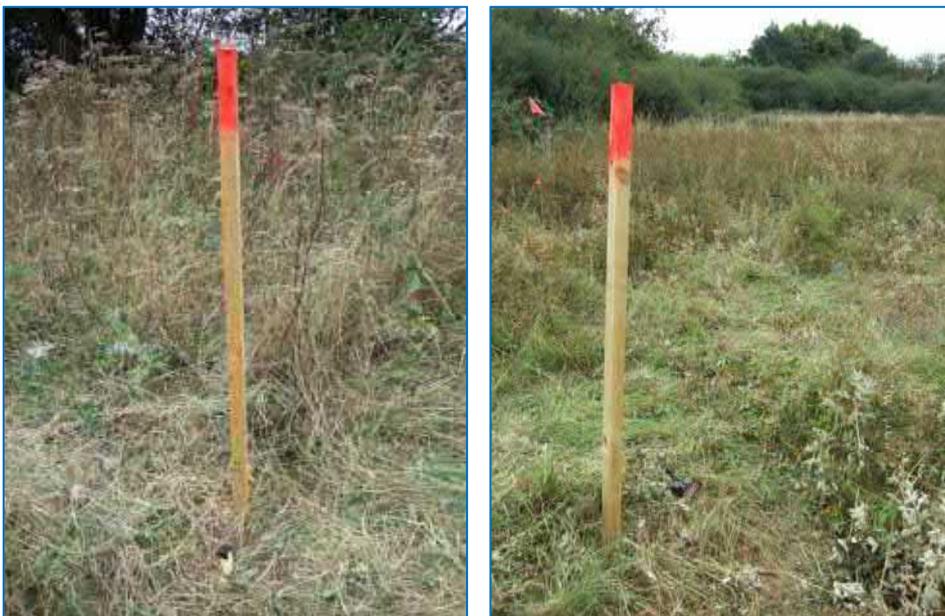
Photo 18 (left) Dipwell T2-D at the SE SSSI unit; and Photo 19 (right) Dipwell N2-B on the NW SSSI unit.

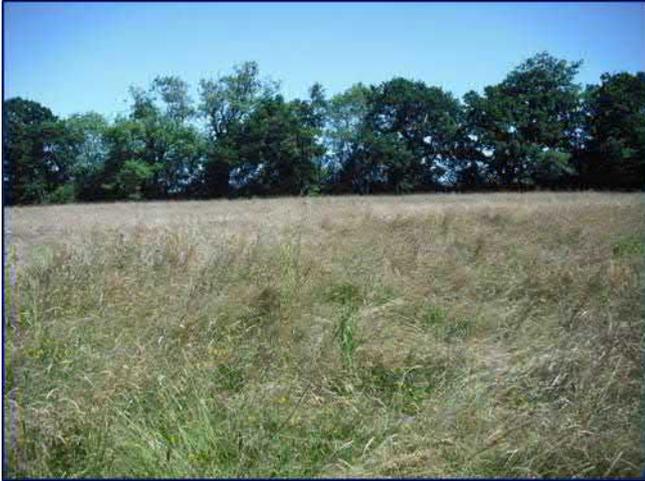
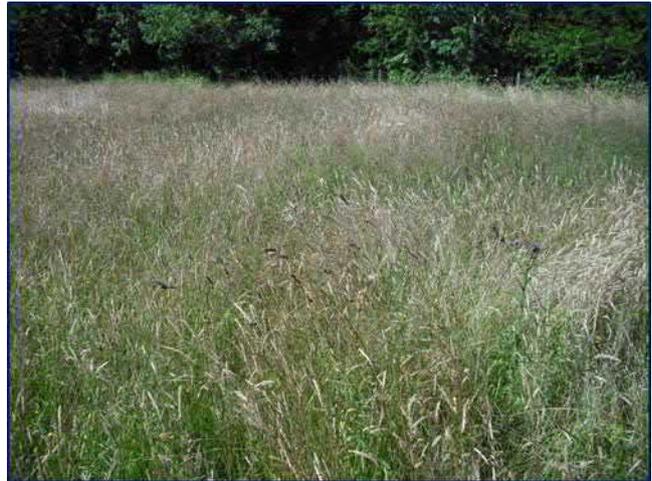
Photo 20 (left) and Photo 21 (right), typical vegetation in the SE SSSI unit eastern fields.

The two fields on the eastern side slope down to the watercourse and the vegetation on the day of the survey was grass dominated (tall and lodging in places) and dry (Photo 20 and 21). Yorkshire fog (*Holcus lanatus*) was abundant with other grasses such as cock's foot (*Dactylis glomerata*), common bent (*Agrostis capillaris*), red fescue (*Festuca rubra*), crested dog's tail (*Cynosurus cristatus*) and meadow fescue (*Schedonorus pratensis*). A range of generally common forbs were recorded and included ribwort plantain (*Plantago lanceolata*), common knapweed (*Centaurea nigra*), bird's foot trefoil (*Lotus corniculatus*) and red clover (*Trifolium pratense*). Less common species included yellow rattle (*Rhinanthus minor*) and tormentil (*Potentilla erecta*).

Seven quadrats were recorded in the two fields, as they were uniform in appearance and structure. The data obtained was run through TABLEFIT and the goodness of fit to the NVC community type MG5; *Cynosurus cristatus* - *Centaurea nigra* was at around 83% and classed as very good fit. The second best fit was to the MG5a *Lathyrus pratensis* sub-community type.

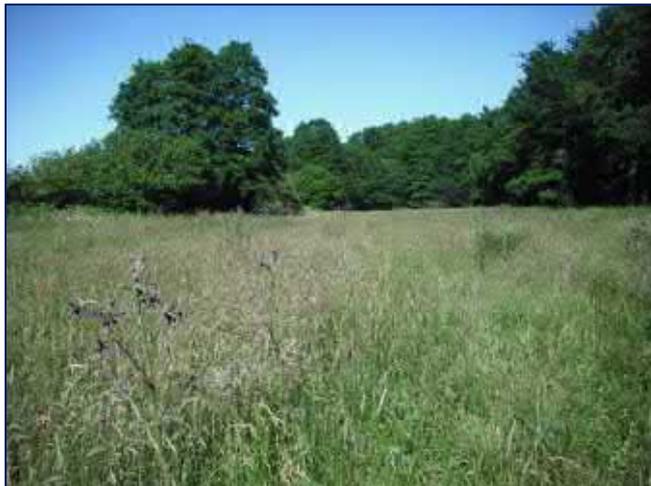
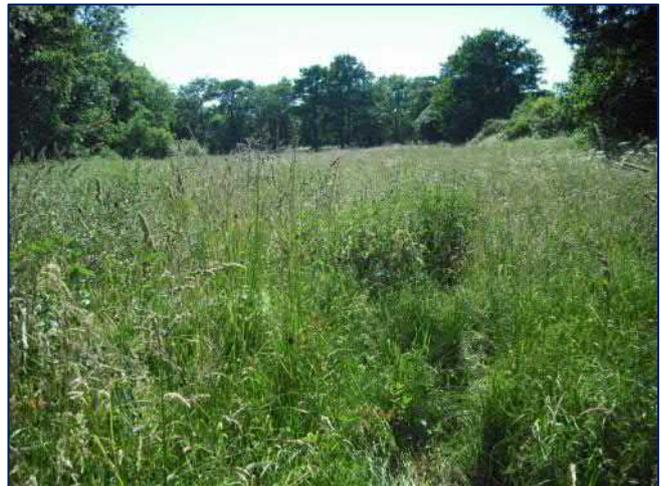
Photo 22 (left) and Photo 23 (right), typical vegetation in the SE SSSI unit wet meadow field.

The field within the SE SSSI unit on the west side of the watercourse was generally flat but with an apparent rise towards the northern boundary; the grasses did not dominate to the degree they did in the dry fields and there were patches of meadowsweet (*Filipendula ulmaria*) and great burnet (*Sanguisorba officinalis*) (Photo 22 and 23). Meadowsweet and other wetland species such as wild angelica (*Angelica sylvestris*) seemed to be more frequent towards the watercourse where the vegetation was taller and coarser. Interesting species recorded here were betony (*Stachys officinalis*) and tormentil (*Potentilla erecta*). It has been reported that meadow thistle (*Cirsium dissectum*) is also present but this was not found during the current survey.

Five quadrats were recorded in this western field and along with the data collected from similar vegetation recorded in the NW section of the SSSI (described below) were run through TABLEFIT. The goodness-of-fit to the NVC community type MG4; *Alopecurus pratensis* – *Sanguisorba officinalis* was around 63% and classed as a fair fit. Any variation in the vegetation from topographical variation was masked by the tall growth and a better understanding of this would be obtained once the field has been cut. This will provide information on the relationship of the community boundaries to topography, depth to water and ditch levels, and enable the communities to be tied with soils information to determine the mechanism whereby any vegetation changes are driven.

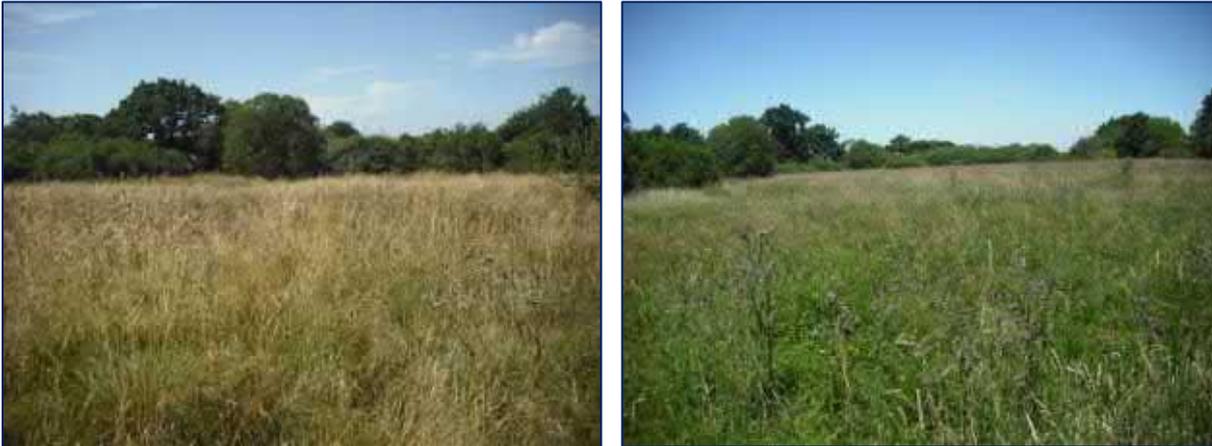
Photo 24 (left) and Photo 25 (right), typical vegetation in the NW SSSI unit western field.

The NW SSSI unit comprises two fields separated by a small, ephemeral watercourse, which was dry on the day of the survey. The western field appeared to be uniform in structure and was generally a mix of patches of larger forbs such as great burnet (*Sanguisorba officinalis*) and meadowsweet (*Filipendula ulmaria*), and grasses with a range of smaller forbs including several legumes scrambling through the vegetation (Photo 24 and Photo 25). This field appeared to be more diverse than the corresponding field in the SE SSSI unit and here saw-wort (*Serratula tinctoria*), quaking grass (*Briza media*) and devil's bit scabious (*Succisa pratensis*) were recorded in addition to the more typical and commoner forb species. When visited in August 2018, tufted hair grass (*Deschampsia cespitosa*) was the dominant species in this field.

Five quadrats were recorded in the field and along with the data collected from similar vegetation recorded in the SE SSSI unit were run through TABLEFIT. The goodness-of-fit to the NVC community type MG4; *Alopecurus pratensis* – *Sanguisorba officinalis* was around 63% and classed as a fair fit.

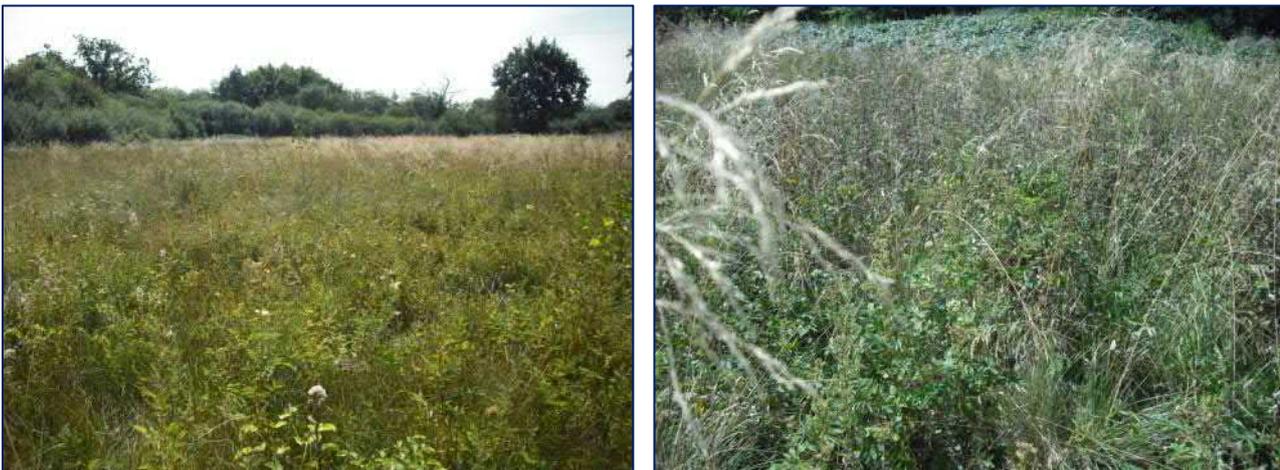
Photo 26 (left) and Photo 27 (right), typical vegetation in the NW SSSI unit eastern field.

The eastern field of the NW SSSI unit was only visited in August and had much coarser vegetation and the dominant grass across larger areas was tufted hair grass (*Deschampsia cespitosa*) but with meadowsweet and great burnet also frequent throughout the field. Sedges appeared to be more common in this field and included hairy sedge (*Carex hirta*), false fox sedge (*Carex otrubae*), common sedge (*Carex nigra*) and tufted sedge (*Carex acuta*). Otherwise it was very similar to the western field (Photos 26 and 27).

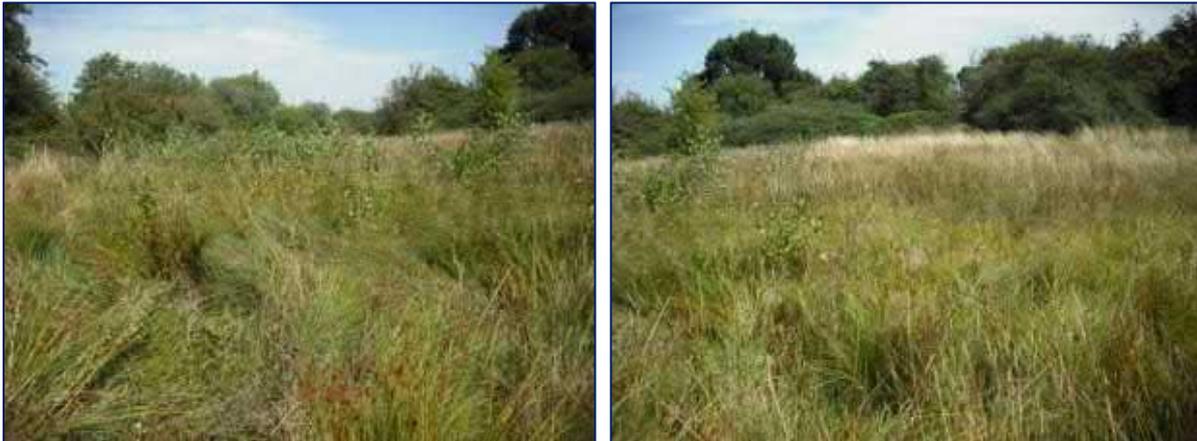
Photo 27 (left) and Photo 28 (right), typical vegetation in the distinct wetter area within the NW SSSI unit eastern field.

Part way along the western boundary of the field, there was a distinctive change in vegetation and whilst this will have to be shown by survey, it appeared to be delineated by a low spot, possibly linked to the ditch and was demarked by young alders (*Alnus glutinosa*). The vegetation here was dominated by tall rushes including soft rush (*Juncus effusus*), hard rush (*Juncus inflexus*) and sharp flowered rush (*Juncus*

acutiflorus), along with sedges with abundant great hairy willowherb (*Epilobium hirsutum*) and in the wettest areas patches of fool's watercress (*Apium nodiflorum*). This is the area considered to be a potential spring in the preceding discussion (Photo 27 and Photo 28).

Five quadrats were recorded in this area and the data was run through TABLEFIT. The goodness-of-fit to the NVC community type OV26; *Epilobium hirsutum* community was around 58% and classed as a fair fit. A similar fit was obtained from the MG9 community; *Holcus lanatus-Deschampsia cespitosa* grassland. This community is found in area where the ground is seasonally waterlogged and can be found in association with MG4 grassland but is not usually as species diverse and is tolerant of less free draining soils.

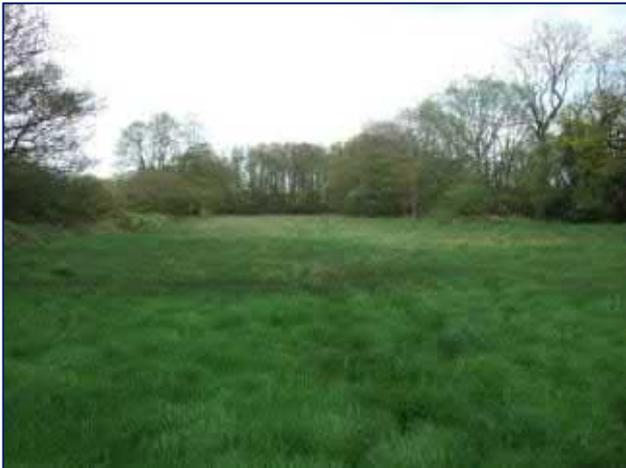
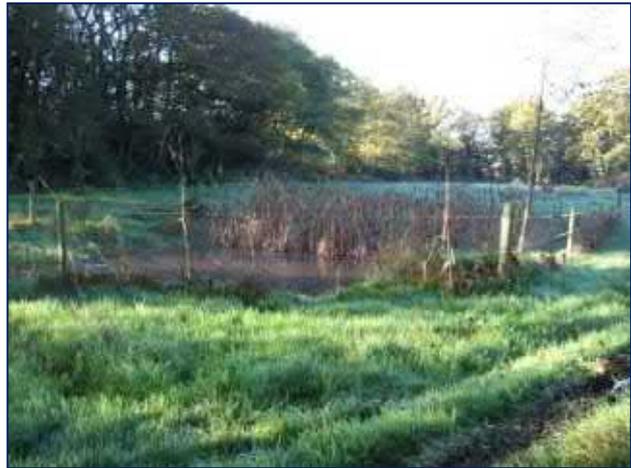
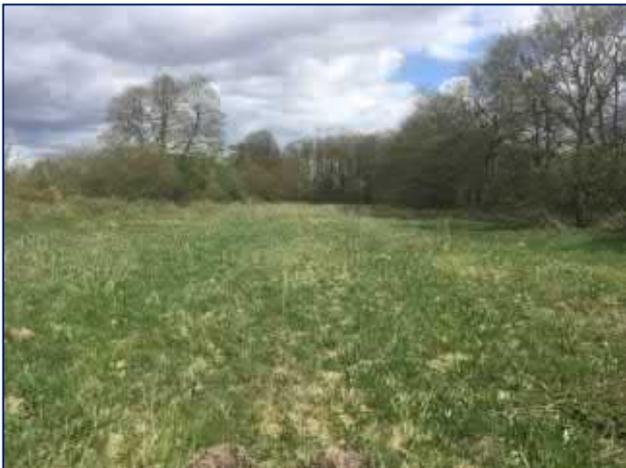
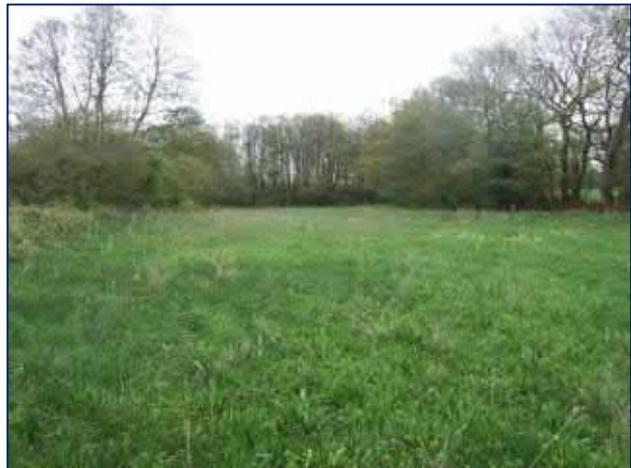
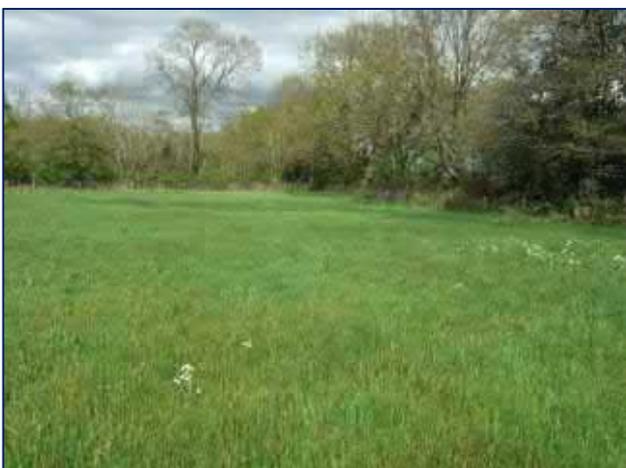
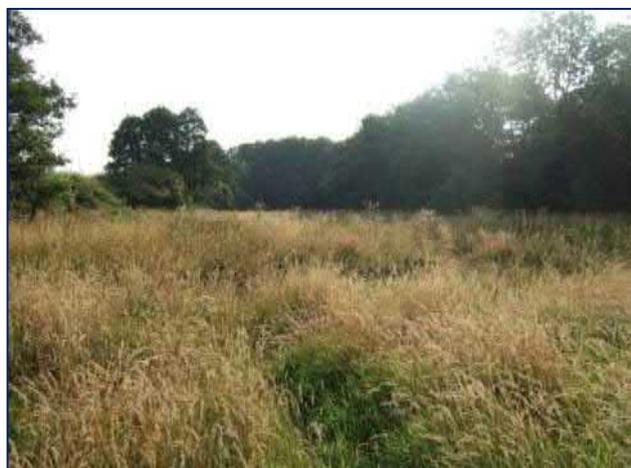
Photo 1 (top left) and Photo 2 (top right) Wet meadow fields at Bickenhill Meadows SSSI SE Unit / Shadowbrook Meadows LNR in cold/wet conditions; Photo 3 (middle left) Wet meadow fields at

Bickenhill Meadows SSSI SE Unit in warm/dry conditions; Photo 4 (middle right) and Photo 5 (bottom left) Bickenhill Meadows SSSI SE Unit in warm/dry conditions; Photo 6 (bottom right) Bickenhill Meadows SSSI unit southern field after a prolonged period of hot weather.

The southeastern unit consists of four fields and wet woodland at the far north of the site, and (along with the LNR) covers 4.4 hectares. The stream that flows through the centre of the site (from southwest to northeast) is a tributary of Shadow Brook. It meets Shadow Brook to the east of the M42 approximately 2 km downstream at NGR SP 20625 82231. The dry meadows are to the east of the site, and wet meadows are to the west. General views of the wet meadows are shown in Photos 1 to 6 under different conditions.

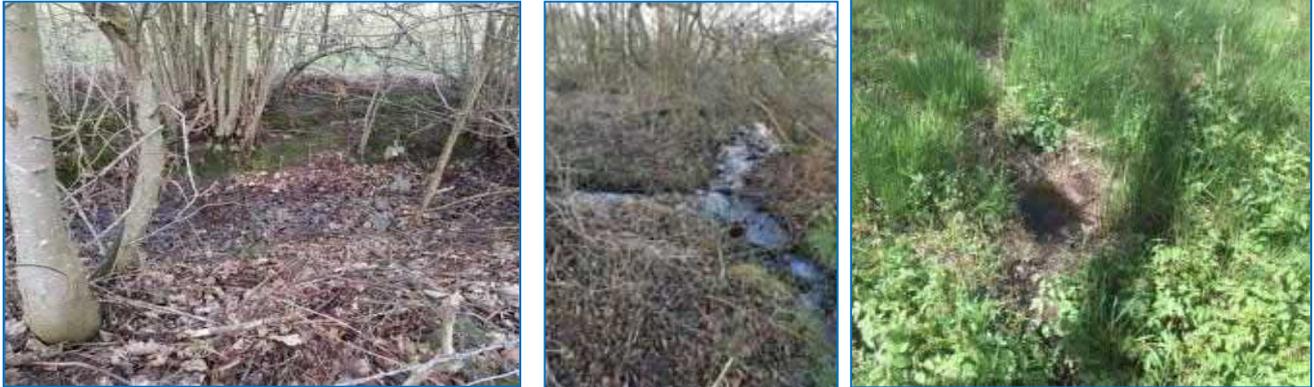
Photo 7 (left) Ponded water in agricultural drainage ditch at NW border of SE SSSI Unit; Photo 8 (right) confluence of the tributary of Shadow Brook and the drainage ditch within the alder woodland; Photo 9. Furrows and depressions saturated with water following rainfall in meadow field of SE SSSI Unit.

There is also an ephemeral drainage ditch bordering the northwest of the site (Photo 7), which varies between 1 and 1.5m wide. This was largely dry on the majority of site visits, with some ponded water in

places of 1-2 cm depth adjacent to the upper wet meadow. However, when observed after heavy rain there was obvious flow in the ditch, which presumably was sourced from runoff from the adjacent arable field which slopes significantly down to the SSSI. As the ditch enters the alder woodland at the northern extent of the SSSI there was a small amount of flow even during the drier site visits, which drains into the tributary of Shadow Brook (approximate NGR SP 18950 81743), see Photo 8.

When the SE SSSI unit was observed following heavy rainfall on 02/05/18 the entire site was extremely wet, with most grassland areas appearing to be fully saturated (Photo 9). All furrows and depressions that were observed during the visit contained surface water, including in the generally drier meadow fields.

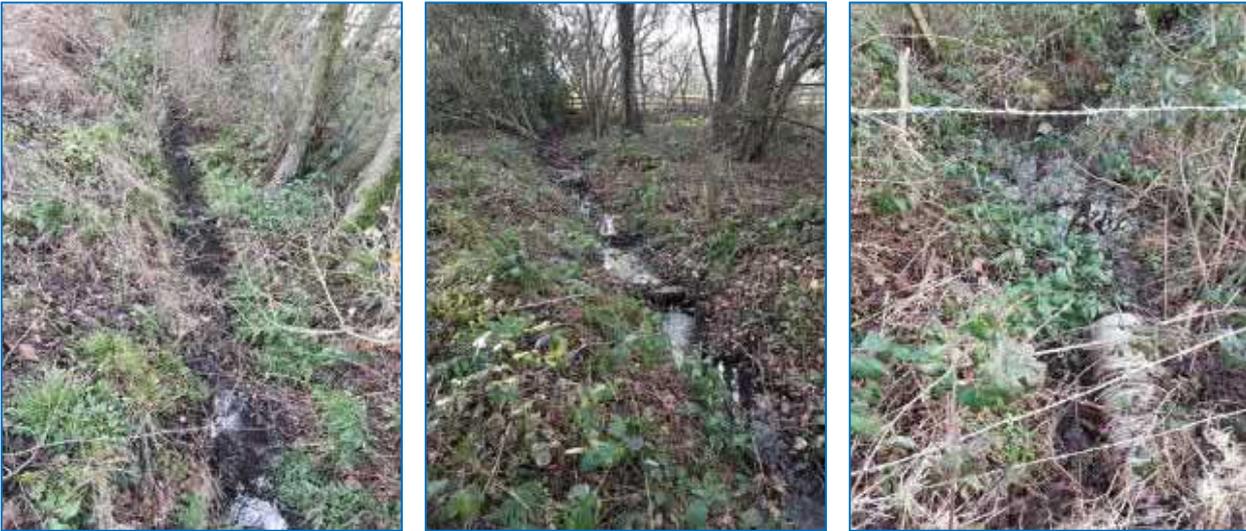
Photo 10 (left) and Photo 11 (centre): Tributary of Shadow Brook within the wet woodland. Photo 12: (right) Culvert exit downstream of the grassed land bridge.

Within the SE SSSI Unit the tributary of Shadow Brook is very straight and could have initially been an agricultural drainage ditch. It is around 0.5 m wide and water depth was in the region of 3-5 cm when observed on the site visits on the 02/05/18 (Photos 10 and 11). The bed was generally covered by accumulations of fine sediment (and leaf litter in the autumn), although some small accumulations of gravel of 4-5 mm in diameter were also evident.

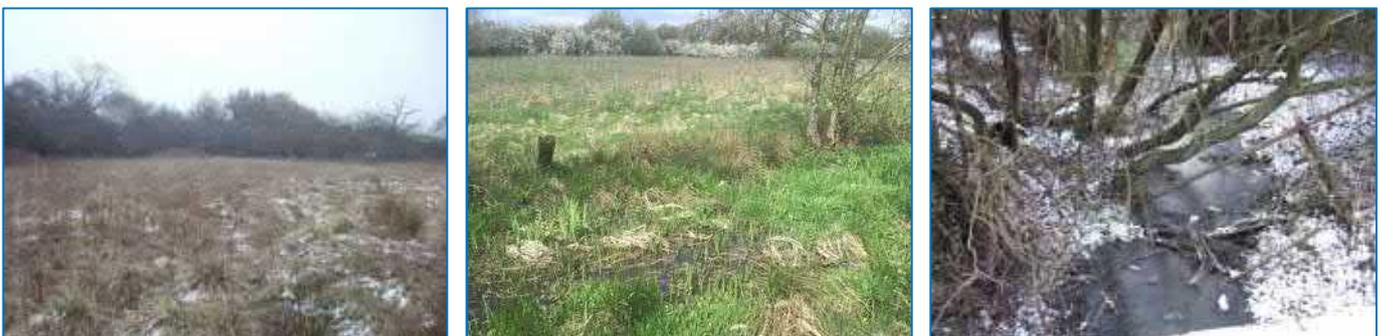
Photo 13 (left), Photo 14 (centre) and Photo 15 (right). Bickenhill Meadows SSSI NW Unit.

The NW SSSI unit is a small, roughly square grassland area of 2.7 ha, bordered on all sides by a scrub and woodland margin (Photo 13). A tributary of Low Brook flows from south to north and divides the field approximately in half, with the topography rising away from the tributary gently on both sides initially, becoming steeper further afield. The brook itself is surrounded by intermittent hedgerow vegetation. Immediately south of the site is a historic landfill site of raised elevation, from which groundwater (of unknown quality) may flow out towards the SSSI, as indicated by iron staining seeping from the embankment.

The watercourse appears to emanate from numerous ephemeral drainage ditches which flow around the elevated historic landfill area and coalesce at the south of the site to then flow north through the SSSI. A further drainage ditch flows north along the western boundary of the site. As the watercourse flows north through the SSSI unit it widens out into a very silted marshland area, with little discernable surface water flow (Photo 14), before reverting to a well-defined stream of up to 2.5m wide (Photo 15) which has generally good floodplain connectivity within the SSSI, and emergent macrophytic vegetation in places. The watercourse is not considered of sufficient size to cause significant flooding of the adjacent fields.

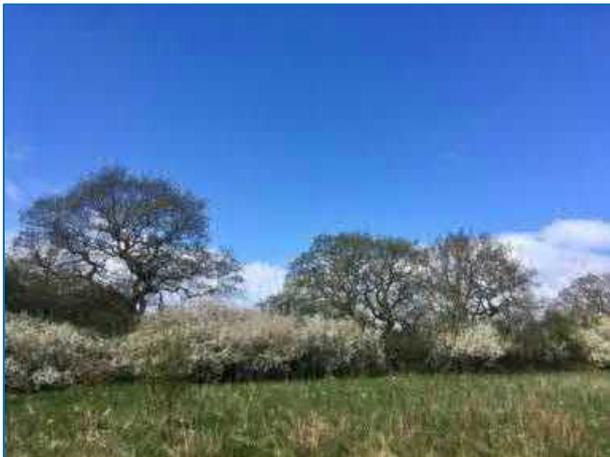
Photo 16 (left) – eastern field within the NW SSSI Unit showing the fringing blackthorn trees.

The western field has a generally drier and more uniform character than the eastern field (Photo 16), and is at a slightly greater elevation than the eastern field. The spatial distribution of the MG4 and MG5 grasslands across both fields is a likely consequence of local variability in moisture content in the upper 30-40 cm of soil, with tussocks and ridges across the site providing slightly drier conditions than localised depressions and troughs.

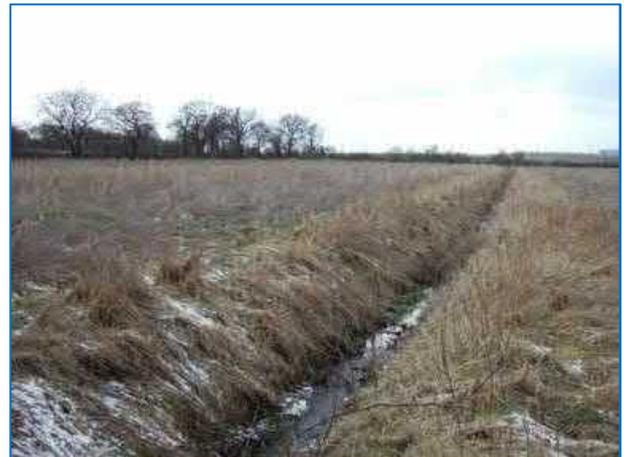
Photo 17 (right) tributary of Low Brook immediately north of the SE SSSI Unit boundary looking towards Birmingham International Airport.

As the tributary of Low Brook flows out of the SSSI to the north of the site, the watercourse becomes a perfectly straight (artificially straightened), deeply incised drainage channel with a width of around 1 m (see Photo 17). This flows north to Low Brook, which is then culverted beneath the Birmingham International Airport runway.

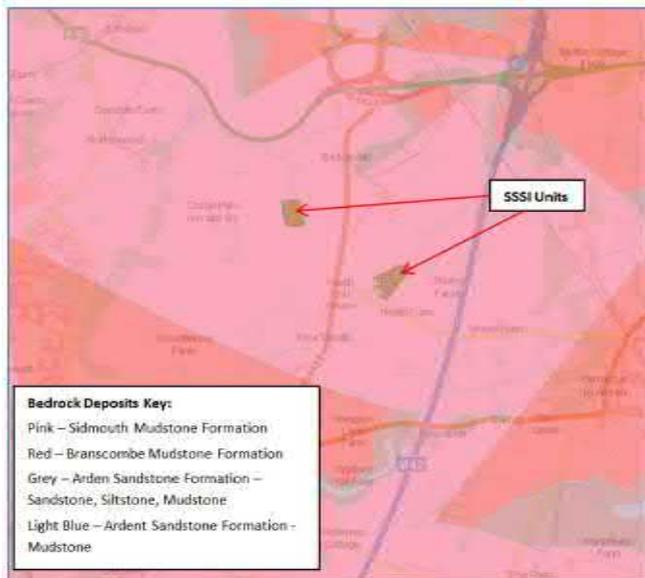
Figure 4. Bedrock deposits in the area around Bickenhill Meadows SSSI (source: British Geological Survey Geindex website, <http://www.bgs.ac.uk/geindex>).

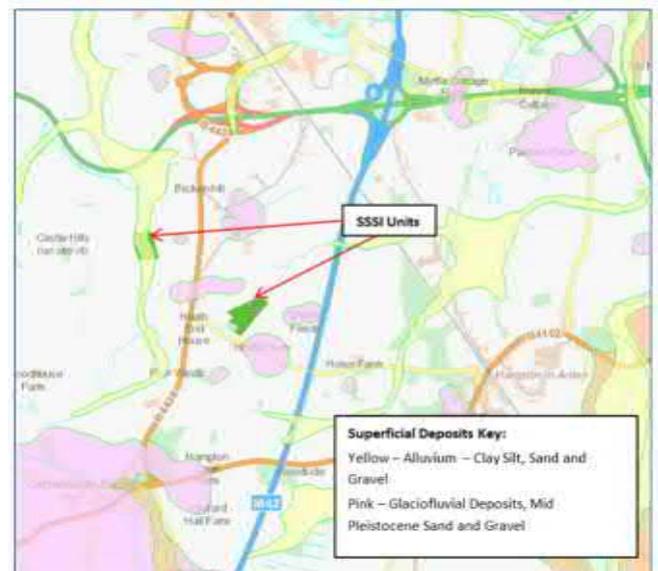
Figure 5. Superficial deposits in the area around Bickenhill Meadows SSSI (source: British Geological Survey Geindex website, <http://www.bgs.ac.uk/geindex>).

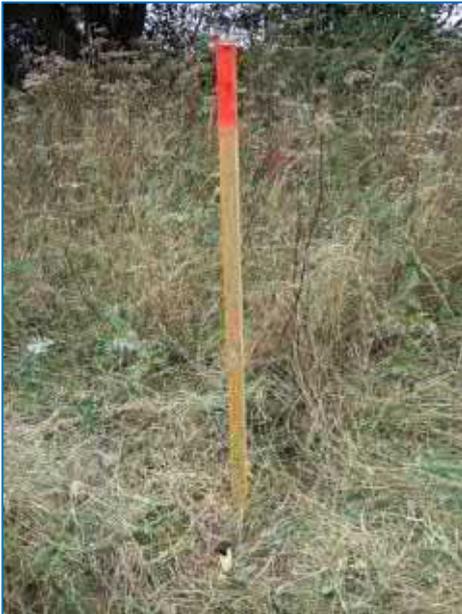
Dipwells were installed in the SE SSSI unit on 13-14th August 2018 (see Figure 12a for locations and Photo 18 for an example). A total of 10 dipwells were installed, covering MG4 grassland, MG5 grassland and transitional grassland areas. The dipwells were prefabricated from a perforated plastic pipe of 32 mm diameter. They are sealed above ground to prevent rainwater from filling the pipe. The plastic pipe is perforated at regular intervals along its length on all sides, to allow throughflow of soil water, and to allow equilibration to be achieved with the surrounding water table.

Photo 18. Dipwell T2-D at the SE SSSI unit.

- 9.4 Dipwells were installed in the SE Unit on 13-14 August 2018 (see Figure 12A for locations and Photo 18 for an example). A total of 10 dipwells were installed, covering MG4 grassland, MG5 grassland and transitional grassland areas. The dipwells were prefabricated from a perforated plastic pipe of 32 mm diameter. They were sealed above ground to prevent rainwater from filling the pipe. The plastic pipe is perforated at regular intervals along its length on all sides, to allow throughflow of soil water, and to allow equilibration to be achieved with the surrounding water table.

Photo 18. Dipwell T2-D at the SE SSSI unit.

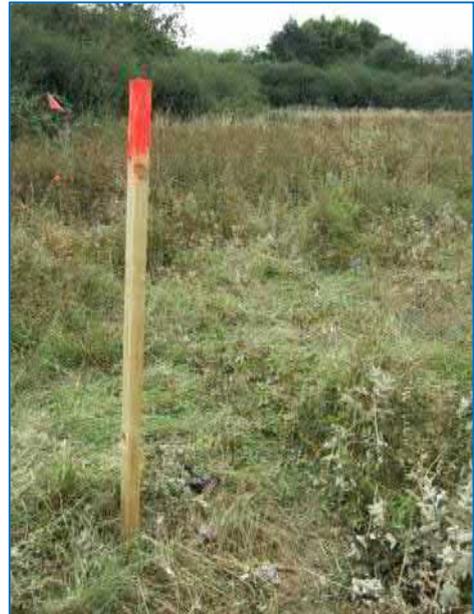
The dipwells in the NW SSSI unit were installed on 5th-6th September 2018 (see Figure 12b for locations, and an example in Photo 19). Despite sporadic rainfall in the period since the installation of the SE unit dipwells, the ground conditions at the NW unit remained extremely dry with no groundwater encountered during augering of any of the holes. In total, four dipwells were installed to 90 cm depth, two to 70 cm depth, and additional dipwells to 66 cm, 60 cm, 50 cm and 43 cm depth. The shallower depths of some dipwells are a result of impenetrable stiff clay layers being encountered. In general, the top soil at the NW SSSI unit was up to 20cm to 40 cm depth below ground, before trending to extremely stiff, dark grey clay to the base of the dipwells. The main exception were the two dipwells towards the centre of the eastern half of the SSSI (close to the wetter area potentially thought to be a spring), where sand and gravel layers were encountered at depths below 50 cm. Further details are described in Appendix B.

Photo 19. Dipwell N2-B on the NW SSSI unit.

- 9.6 The dipwells in the NW Unit were installed on 5-6 September 2018 (see Figure 12B for locations, and an example in Photo 19). Despite sporadic rainfall in the period since the installation of the SE unit dipwells, the ground conditions at the NW unit remained extremely dry with no groundwater encountered during augering of any of the holes. In total, 4 dipwells were installed to 90 cm depth, two to 70 cm depth, and additional dipwells to 66 cm, 60 cm, 50 cm and 43 cm depth. The shallower depths of some dipwells are a result of impenetrable stiff clay layers being encountered. In general, the top soil at the NW Unit was up to 20 cm to 40 cm depth below ground, before trending to extremely stiff, dark grey clay to the base of the dipwells. The main exceptions were the two dipwells towards the centre of the eastern half of the SSSI, where sand and gravel layers were encountered at depths below 50 cm. Further details are described in Annex B.

Photo 19. Dipwell N2-B on the NW SSSI unit.

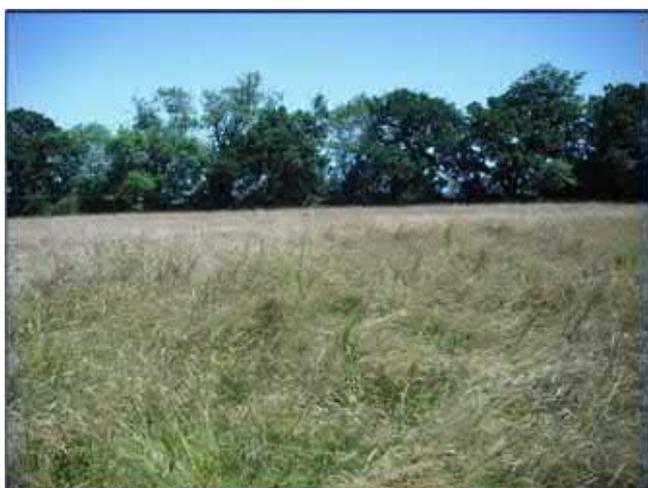
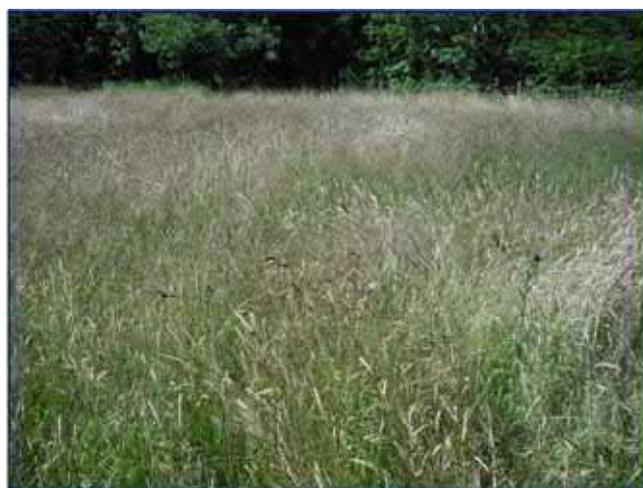
The two fields on the eastern side slope down to the watercourse and the vegetation on the day of the survey was grass dominated (tall and lodging in places) and dry (Photo 20 and 21). Yorkshire fog (*Holcus lanatus*) was abundant with other grasses such as cock's foot (*Dactylis glomerata*), common bent (*Agrostis capillaris*), red fescue (*Festuca rubra*), crested dog's tail (*Cynosurus cristatus*) and meadow fescue (*Schedonorus pratensis*). A range of generally common forbs were recorded and included ribwort plantain (*Plantago lanceolata*), common knapweed (*Centaurea nigra*), bird's foot trefoil (*Lotus corniculatus*) and red clover (*Trifolium pratense*). Less common species included yellow rattle (*Rhinanthus minor*) and tormentil (*Potentilla erecta*).

Photo 20 (left) and Photo 21 (right), typical vegetation in the SE SSSI unit eastern fields.

- 11.4 The two fields on the eastern side slope down to the watercourse and the vegetation on the day of the survey was grass dominated (tall and lodging in places) and dry (Photo 20 and 21). Yorkshire fog (*Holcus lanatus*) was abundant with other grasses such as cock's foot (*Dactylis glomerata*), common bent (*Agrostis capillaris*), red fescue (*Festuca rubra*), crested dog's tail (*Cynosurus cristatus*) and meadow fescue (*Schedonorus pratensis*). A range of generally common forbs were recorded and included ribwort plantain (*Plantago lanceolata*), common knapweed (*Centaurea nigra*), bird's foot trefoil (*Lotus corniculatus*) and red clover (*Trifolium pratense*). Less common species included yellow rattle (*Rhinanthus minor*) and tormentil (*Potentilla erecta*).

Photo 20 (left) and Photo 21 (right), typical vegetation in the SE SSSI unit eastern fields.

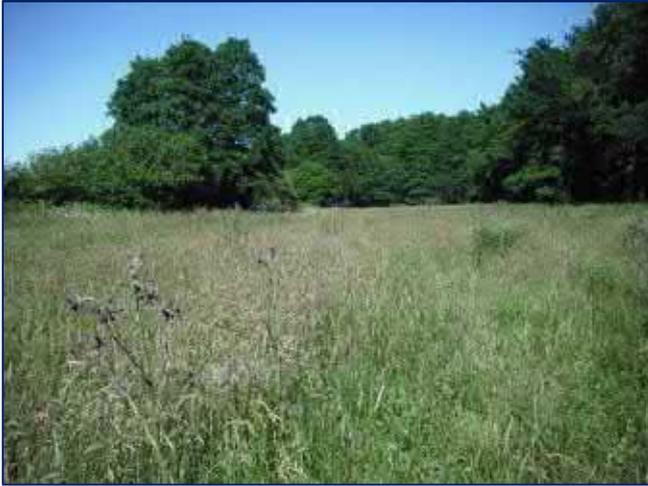
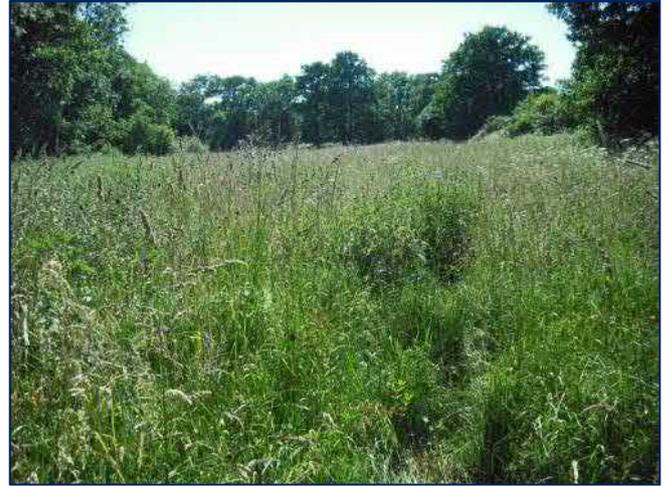
The field within the SE SSSI unit on the western side of the watercourse was generally flat but with an apparent rise towards the northern boundary; the grasses did not dominate to the degree they did in the dry fields and there were patches of meadowsweet (*Filipendula ulmaria*) and great burnet (*Sanguisorba officinalis*) (Photo 22 and 23). Meadowsweet and other wetland species such as wild angelica (*Angelica sylvestris*) seemed to be more frequent towards the watercourse where the vegetation was taller and coarser. Interesting species recorded here were betony (*Stachys officinalis*) and tormentil (*Potentilla erecta*). It has been reported that meadow thistle (*Cirsium dissectum*) is also present but this was not found during the current survey.

Photo 22 (left) and Photo 23 (right), typical vegetation in the SE SSSI unit wet meadow field.

in the dry fields and there were patches of meadowsweet (*Filipendula ulmaria*) and great burnet (*Sanguisorba officinalis*) (Photo 22 and 23). Meadowsweet and other wetland species such as wild angelica (*Angelica sylvestris*) seemed to be more frequent towards the watercourse where the vegetation was taller and coarser. Interesting species recorded here were betony (*Stachys officinalis*) and tormentil (*Potentilla erecta*). It has been reported that meadow thistle (*Cirsium dissectum*) is also present but this was not found during the current survey.

Photo 22 (left) and Photo 23 (right), typical vegetation in the SE SSSI unit wet meadow field.

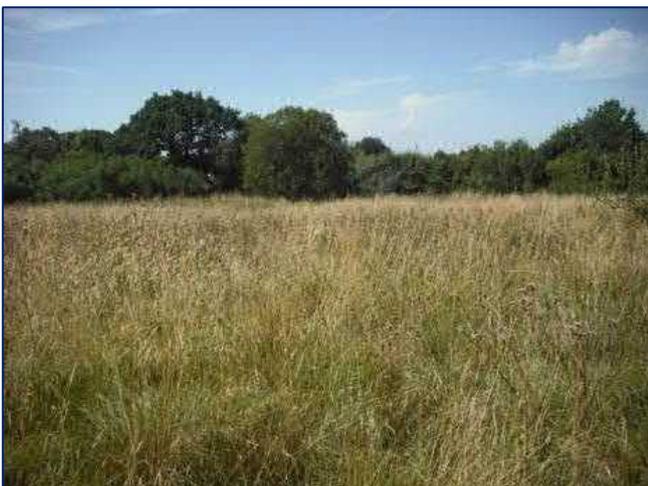
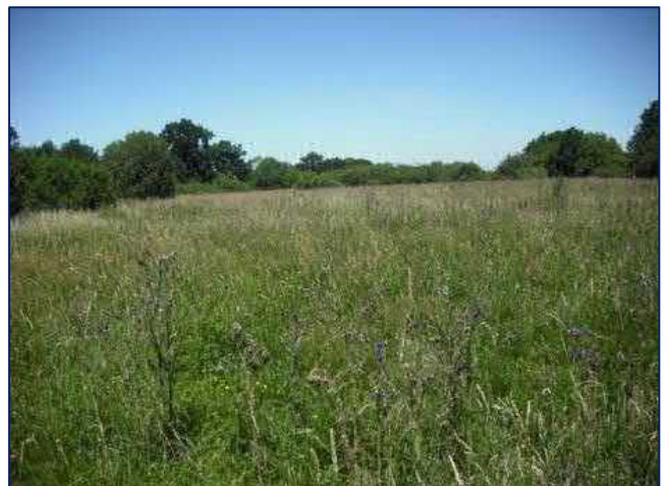
The NW SSSI unit comprises two fields separated by a small, ephemeral watercourse, which was dry on the day of the survey. The western field appeared to be uniform in structure and was generally a mix of patches of larger forbs such as great burnet (*Sanguisorba officinalis*) and meadowsweet (*Filipendula ulmaria*), and grasses with a range of smaller forbs including several legumes scrambling through the vegetation (Photo 24 and Photo 25). This field appeared to be more diverse than the corresponding field in the SI SSSI unit and here saw-wort (*Serratula tinctoria*), quaking grass (*Briza media*) and devil's bit scabious (*Succisa pratensis*) were recorded in addition to the more typical and commoner forb species. When visited in August 2018, tufted hair grass (*Deschampsia cespitosa*) was the dominant species in this field.

Photo 24 (left) and Photo 25 (right), typical vegetation in the NW SSSI unit western field.

- 11.8 The NW Unit comprises two fields separated by a small, ephemeral watercourse, which was dry on the day of the survey. The western field appeared to be uniform in structure and was generally a mix of patches of larger forbs such as great burnet (*Sanguisorba officinalis*) and meadowsweet (*Filipendula ulmaria*), and grasses with a range of smaller forbs including several legumes scrambling through the vegetation (Photo 24 and Photo 25). This field appeared to be more diverse than the corresponding field in the SE Unit and here saw-wort (*Serratula tinctoria*), quaking grass (*Briza media*) and devil's bit scabious (*Succisa pratensis*) were recorded in addition to the more typical and commoner forb species. When visited in August 2018, tufted hair grass (*Deschampsia cespitosa*) was the dominant species in this field.

Photo 24 (left) and Photo 25 (right), typical vegetation in the NW SSSI unit western field.

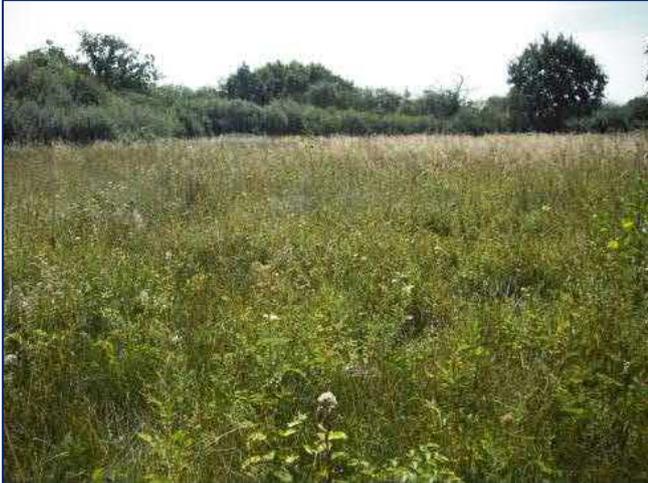
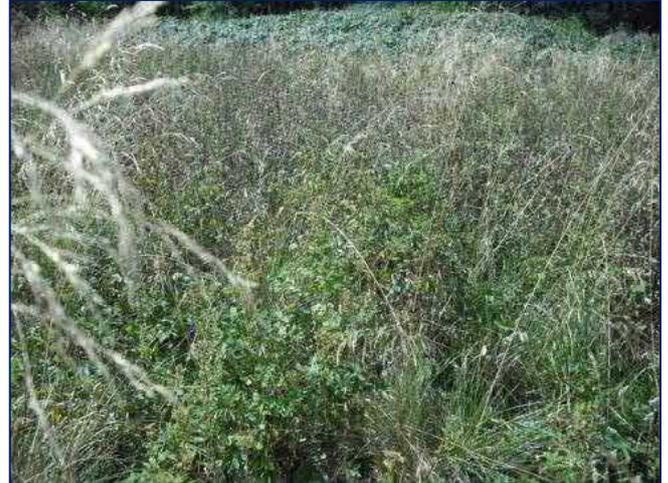
The eastern field of the NW SSSI unit was only visited in August and had much coarser vegetation and the dominant grass across large areas was tufted hair grass (*Deschampsia cespitosa*) but with meadowsweet and great burnet also frequent throughout the field. Sedges appeared to be more common in this field and included hairy sedge (*Carex hirta*), false fox sedge (*Carex otrubae*), common sedge (*Carex nigra*) and tufted sedge (*Carex acuta*). Otherwise it was very similar to the western field (Photos 26 and 27).

Photo 26 (left) and Photo 27 (right), typical vegetation in the NW SSSI unit eastern field.

- 11.9 Five quadrats were recorded in the field and along with the data collected from similar vegetation recorded in the SE SSSI unit were run through TABLEFIT. The goodness-of-fit to the NVC community type MG4; *Alopecurus pratensis* – *Sanguisorba officinalis* was around 63% and classed as a fair fit.
- 11.10 The eastern field of the NW Unit was only visited in August 2018 and had much coarser vegetation and the dominant grass across large areas was tufted hair grass (*Deschampsia cespitosa*) but with meadowsweet and great burnet also frequent throughout the field. Sedges appeared to be more common in this field and included hairy sedge (*Carex hirta*), false fox sedge (*Carex otrubae*), common sedge (*Carex nigra*) and tufted sedge (*Carex acuta*). Otherwise it was very similar to the western field (Photos 26 and 27).

Photo 26 (left) and Photo 27 (right), typical vegetation in the NW SSSI unit eastern field.

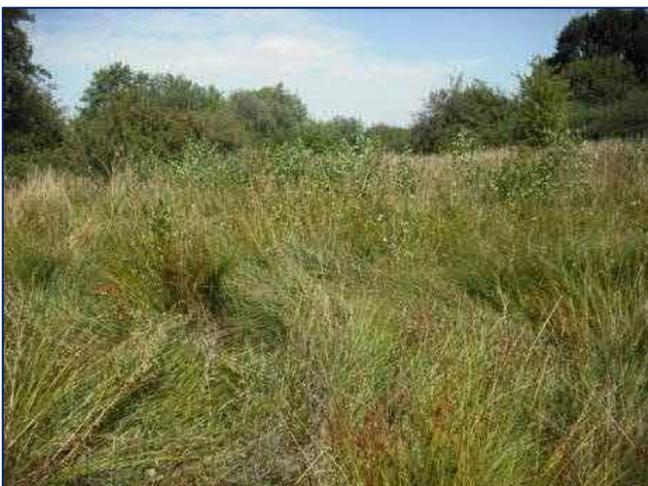
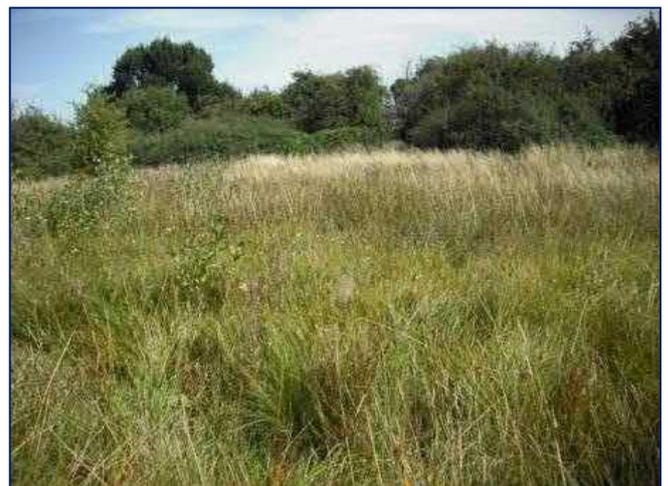
Part way along the western boundary of the field, there was a distinctive change in vegetation and whilst this will have to be shown by survey, it appeared to be delineated by a low spot, possibly linked to the ditch and was demarked by young alders (*Alnus glutinosa*). The vegetation here was dominated by tall rushes including soft rush (*Juncus effusus*), hard rush (*Juncus inflexus*) and sharp flowered rush (*Juncus acutiflorus*), along with sedges with abundant great hairy willowherb (*Epilobium hirsutum*) and in the wettest areas patches of fool's watercress (*Apium nodiflorum*). This is the area considered to be a potential spring in the preceding discussion (Photo 27 and Photo 28).

Photo 27 (left) and Photo 28 (right), typical vegetation in the distinct wetter area within the NW SSSI unit eastern field.

- 11.11 Part way along the western boundary of the field, there was a distinctive change in vegetation and whilst this will have to be shown by survey, it appeared to be delineated by a low spot, possibly linked to the ditch and was demarked by young alders (*Alnus glutinosa*). The vegetation here was dominated by tall rushes including soft rush (*Juncus effusus*), hard rush (*Juncus inflexus*) and sharp flowered rush (*Juncus acutiflorus*), along with sedges with abundant great hairy willowherb (*Epilobium hirsutum*) and in the wettest areas patches of fool's watercress (*Apium nodiflorum*). This is the area considered to be a potential spring in the preceding discussion (Photo 27 and Photo 28).

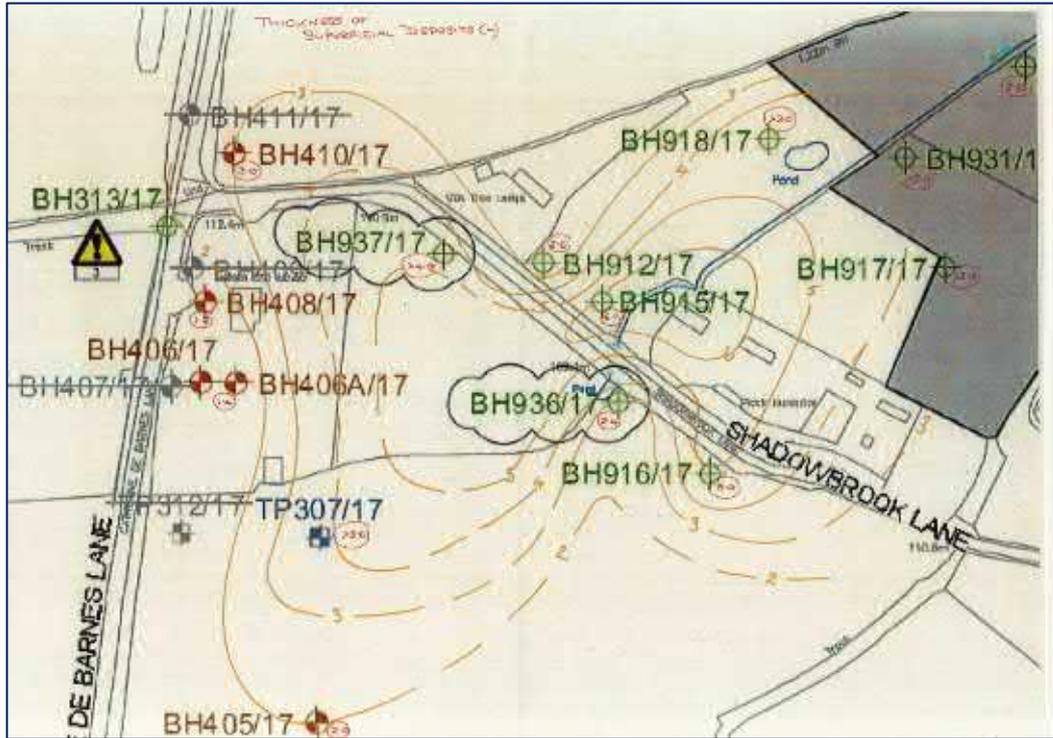
SE SSSI Unit – Further analysis (TN v8)

‘Bowl’ of superficial deposits centered on the WWT Nature Reserve / Shadowbrook Lane, where it is >6m thick and containing upper sand layers important for infiltration. At the proposed cutting superficial deposits only 1-2m thick and lacks upper sand layers (i.e. limited storage and infiltration potential). Thus, the cutting is unlikely to cut off a significant supply of groundwater.

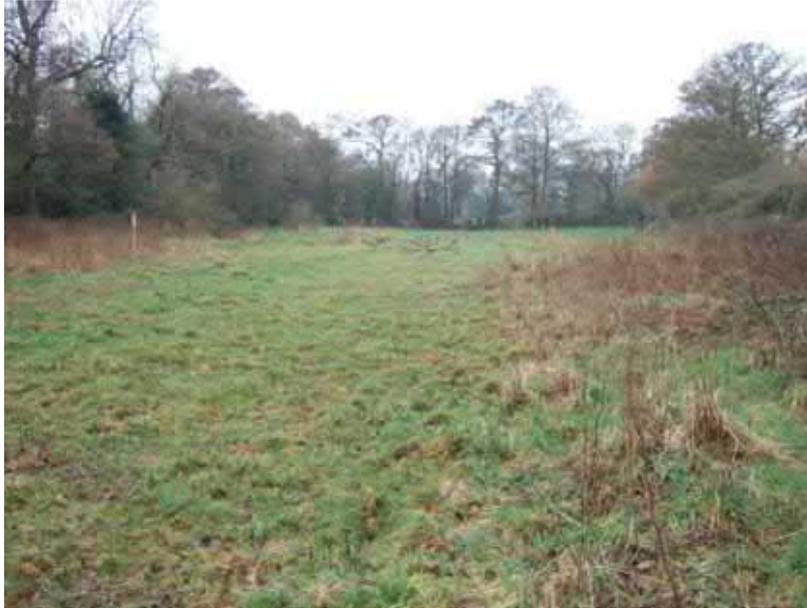
SE SSSI Unit – Further analysis summary (TNv8)

1. 21% total catchment loss. However, this includes only ~2% of the 'direct' catchment to SE Unit.
2. Groundwater recharge appears driven by rainfall events and likely completed prior to central stream flowing continuously.
3. Of the total catchment area lost, this is unlikely to be a significant source of groundwater due to thin superficial deposits and lack of sand layers important for infiltration.
4. Low risk of draw down into cutting due to lack of sand layers.

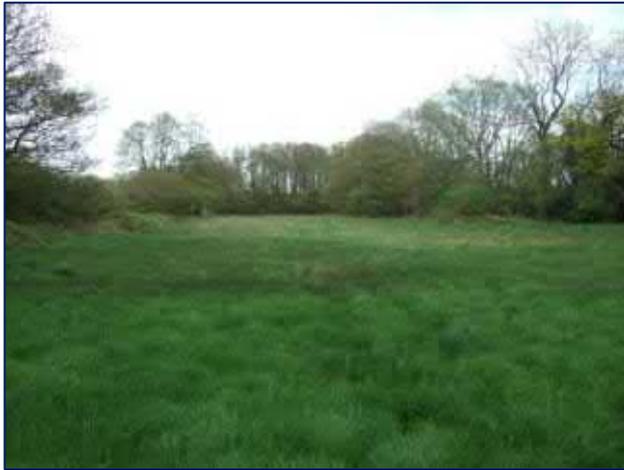
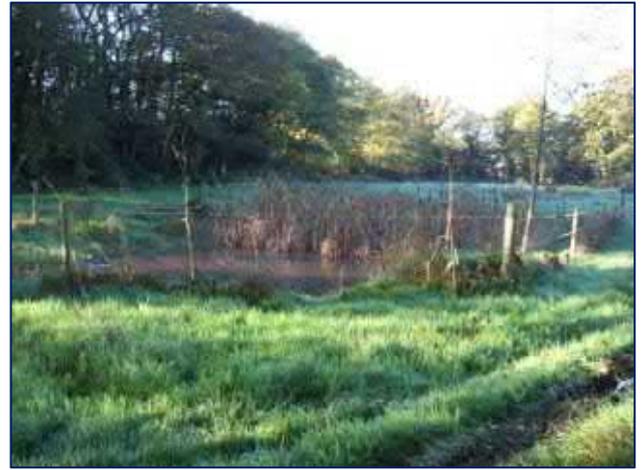
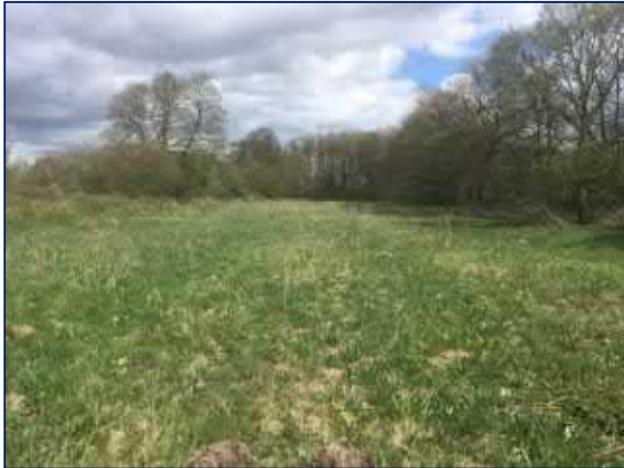
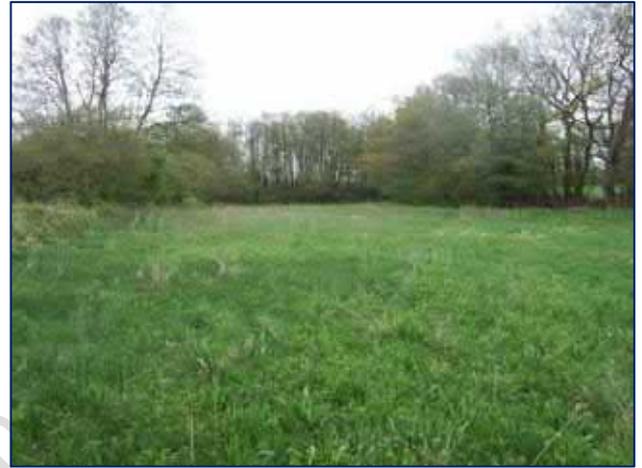
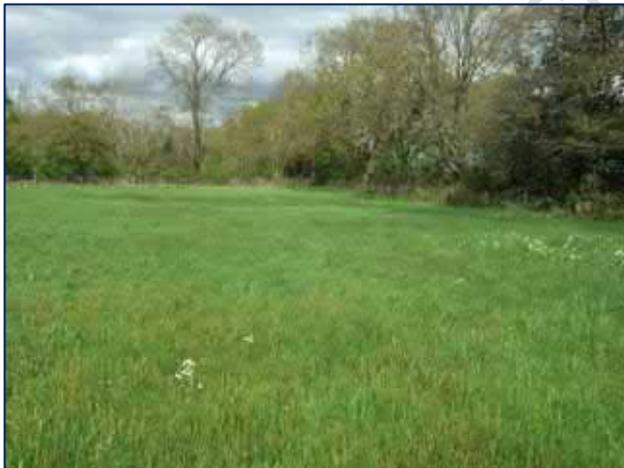
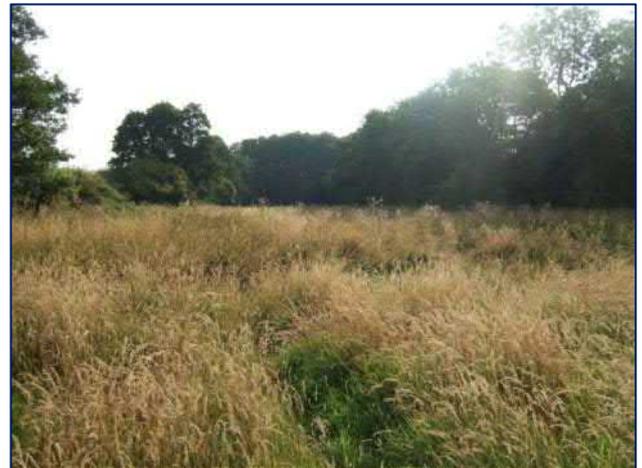
5.6 There is a small pond towards the centre of the southern field of the LNR site (but not within the SSSI) with emergent reed vegetation and which is surrounded by a stock proof fence (see Photo 2). The origins of the pond are not known, but when observed in very wet conditions a 'trickle' of water flowed from the pond and overland to the north to ultimately meet the tributary of Shadow Brook, possibly as a result of any undersoil drainage being blocked. During the late summer of 2018 this pond was completely dry.

Photo 1 (top left) and Photo 2 (top right) Wet meadow fields at Bickenhill Meadows SSSI SE Unit / Shadowbrook Meadows LNR in cold/wet conditions; Photo 3 (middle left) Wet meadow fields at Bickenhill Meadows SSSI SE Unit in warm/dry conditions; Photo 4 (middle right) and Photo 5 (bottom left) Bickenhill Meadows SSSI SE Unit in warm/dry conditions; Photo 6 (bottom right) Bickenhill Meadows SSSI SE unit southern field after a prolonged period of hot summer weather.
