M42 Junction 6 Development Consent Order

Scheme Number TR010027

8.10(b) Statement of Common Ground with Natural England

October 2019

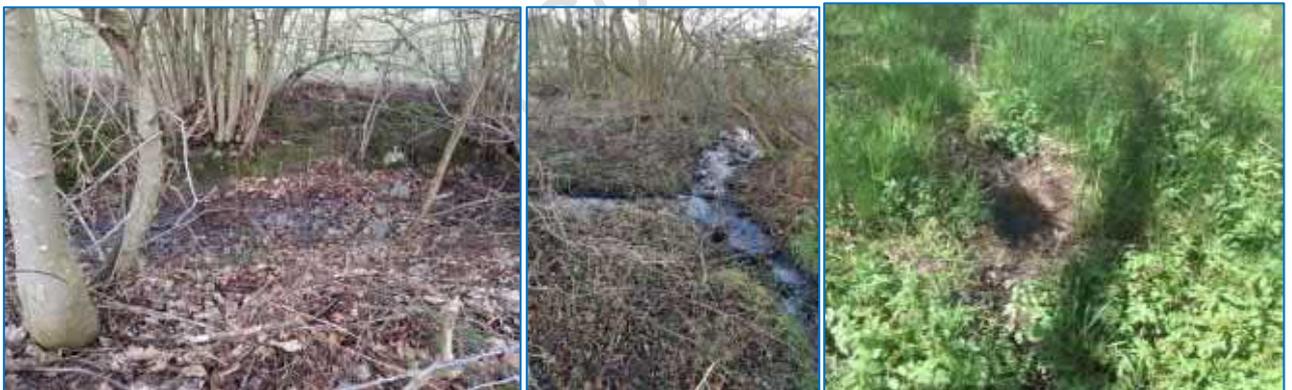
Photo 7 (left) Ponded water in agricultural drainage ditch at NW border of SE Unit; Photo 8 (right) confluence of the tributary of Shadow Brook and the drainage ditch within the alder woodland; Photo 9. Furrows and depressions saturated with water following rainfall in meadow field of SE Unit.

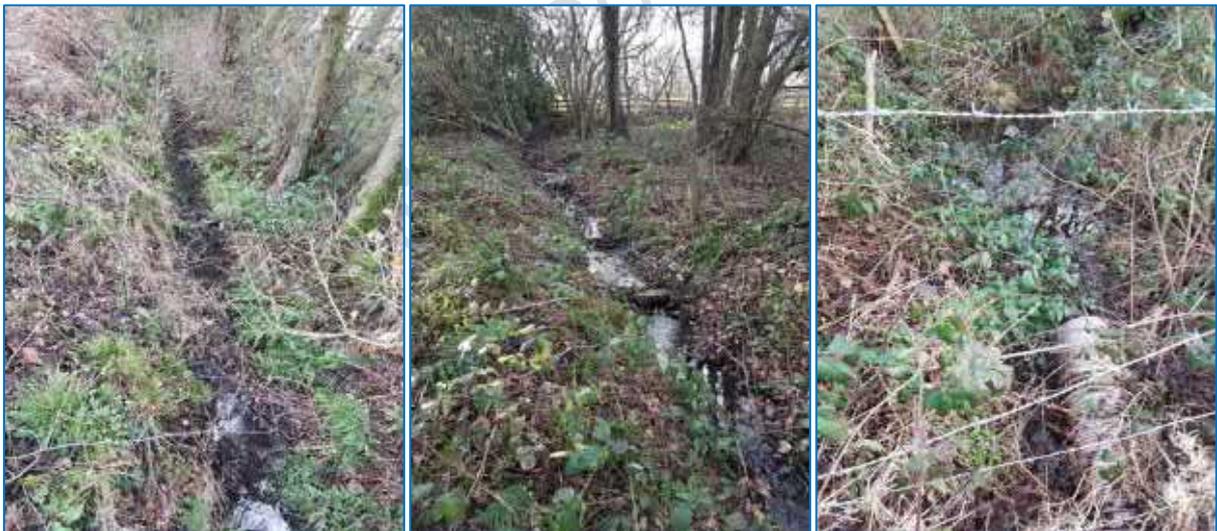
Photo 10 (left) and Photo 11 (centre): Tributary of Shadow Brook within the wet woodland. Photo 12: (right) Culvert exit downstream of the grassed land bridge.

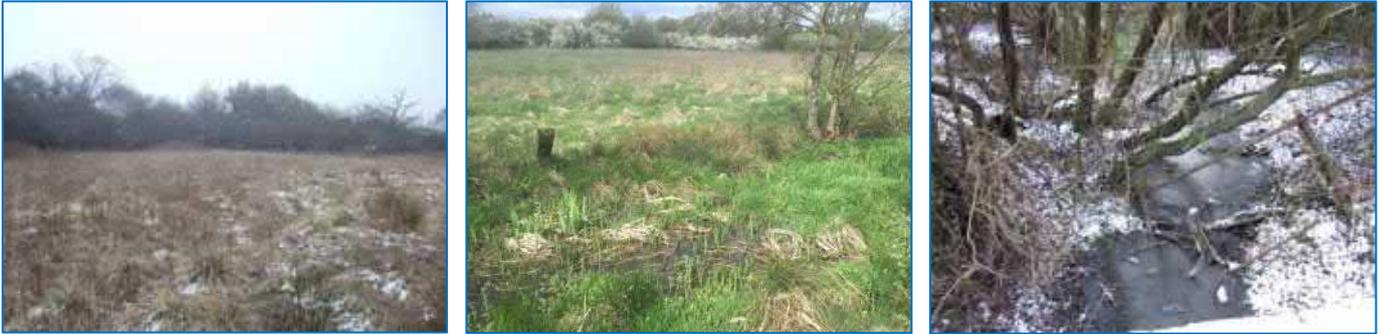
- 5.14 The NW Unit is a small, roughly square grassland area of 2.7ha, bordered on all sides by a scrub and woodland margin (Photo 13). A tributary of Low Brook flows from south to north and divides the field approximately in half, with the topography rising away from the tributary gently on both sides initially, becoming steeper further afield. The brook itself is surrounded by intermittent hedgerow vegetation. Immediately south of the site is a historic landfill site of raised elevation, from which groundwater (of unknown quality) may flow out towards the SSSI, as indicated by iron staining seeping from the embankment.

Photo 13 (left), Photo 14 (centre) and Photo 15 (right). Bickenhill Meadows SSSI NW Unit.

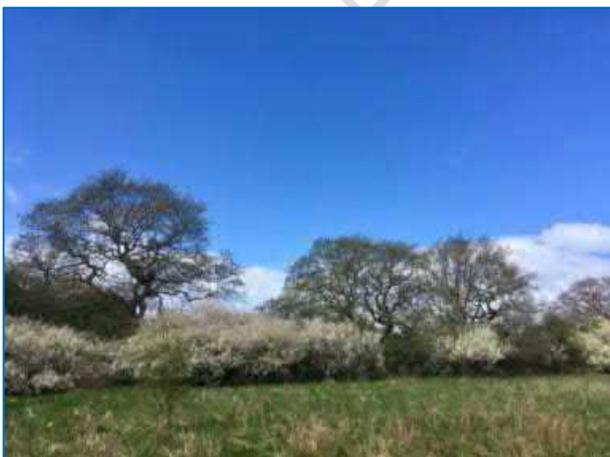
- 5.17 The western field has a generally drier and more uniform character than the eastern field (Photo 16), and is at a slightly greater elevation than the eastern field. The spatial distribution of the MG4 and MG5 grasslands across both fields is a likely consequence of local variability in moisture content in the upper 30-40 cm of soil, with tussocks and ridges across the site providing slightly drier conditions than localised depressions and troughs.

Photo 16 (left) – eastern field within the NW Unit showing the fringing blackthorn trees.

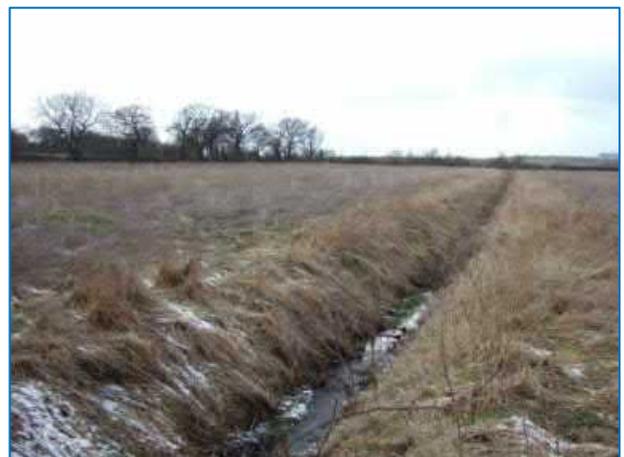
Photo 17 (right) tributary of Low Brook immediately north of the SE Unit boundary looking towards Birmingham Airport.

5.18 As the tributary of Low Brook flows out of the SSSI to the north of the site, the watercourse becomes a perfectly straight (artificially straightened), deeply incised drainage channel with a width of around 1m (see Photo 17). This flows north to Low Brook, which is then culverted beneath the Birmingham Airport runway.

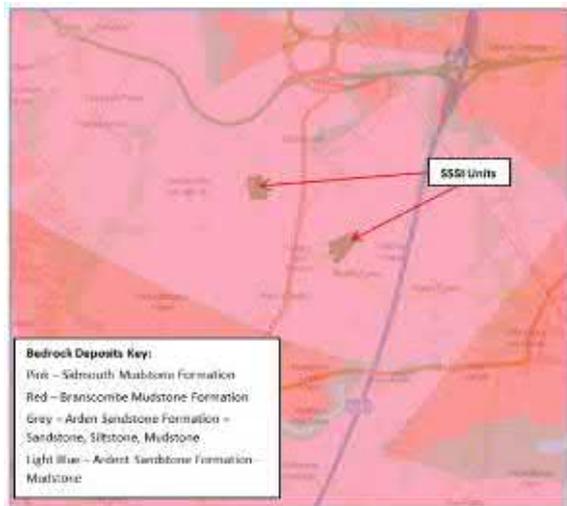
Figure 4. Bedrock deposits in the area around Bickenhill Meadows SSSI (source: British Geological Survey Geindex website, <http://www.bgs.ac.uk/geoindex>).

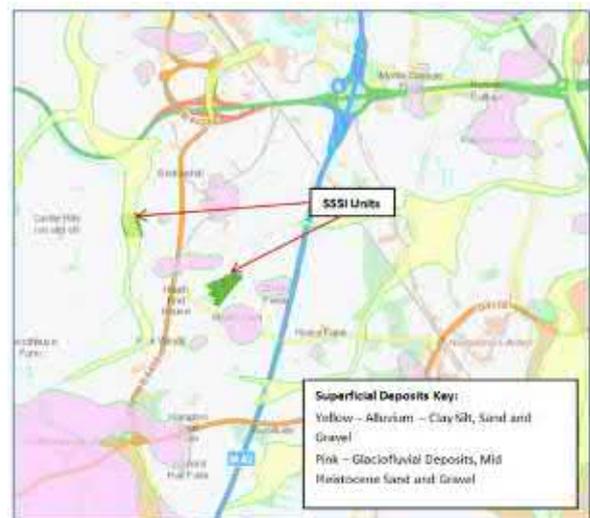
Figure 5. Superficial deposits in the area around Bickenhill Meadows SSSI (source: British Geological Survey Geindex website, <http://www.bgs.ac.uk/geoindex>).

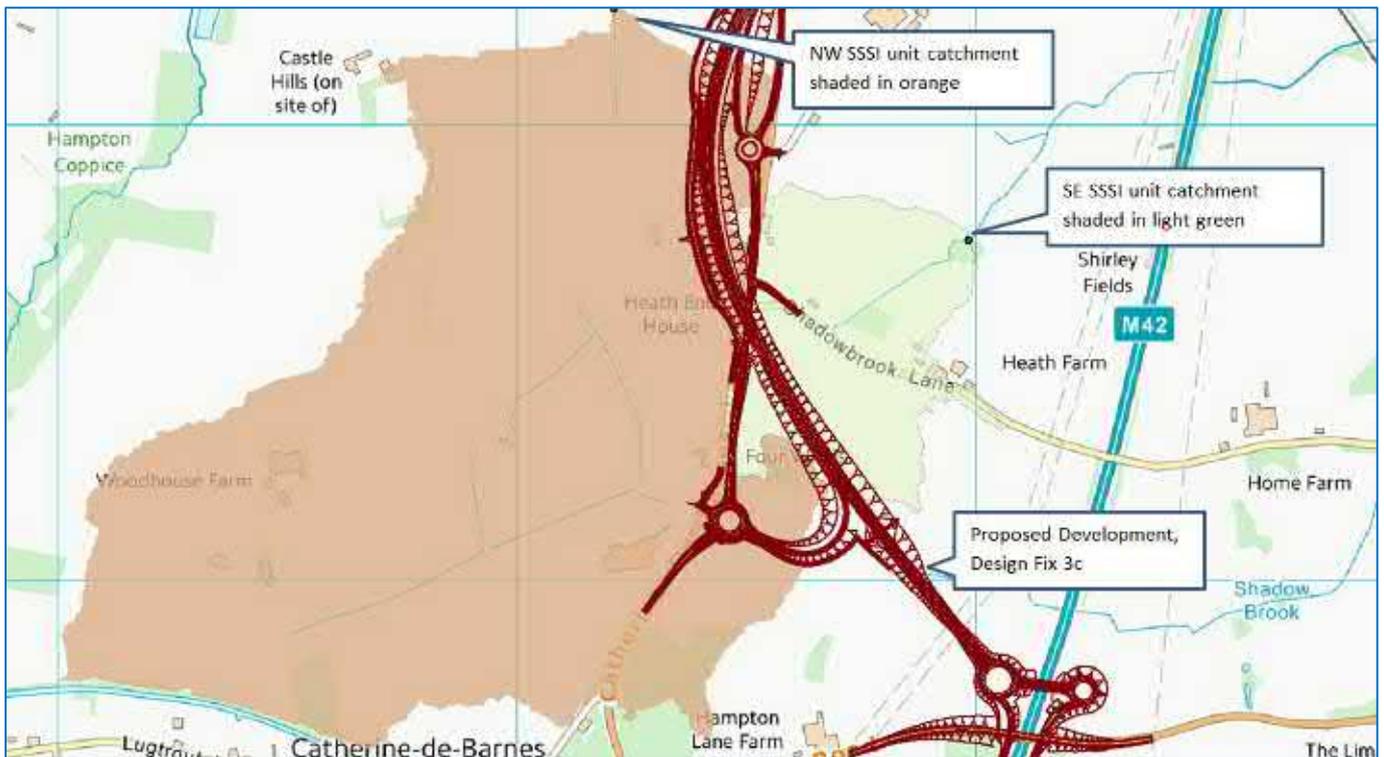
- 7.6 In Figure 8, the surface water catchments for each SSSI unit have been derived from the LiDAR data. The NW Unit has a noticeably larger catchment than the SE Unit, and extends a considerable distance to the southwest where it is interrupted by the Grand Union Canal near Catherine-de-Barnes. On the basis of the approximate road alignment shown in Figure 8, the proportion of the catchments that is lost below the footprint of the road and is cut off from the catchment due to the new mainline link road for each SSSI unit would be 4.7% for the NW Unit and 21.4% for the SE Unit, based on Design Fix 3C.

Figure 8. Catchment boundaries as determined from GIS catchment analysis, with the Design Fix 3C road alignment overlain in red.

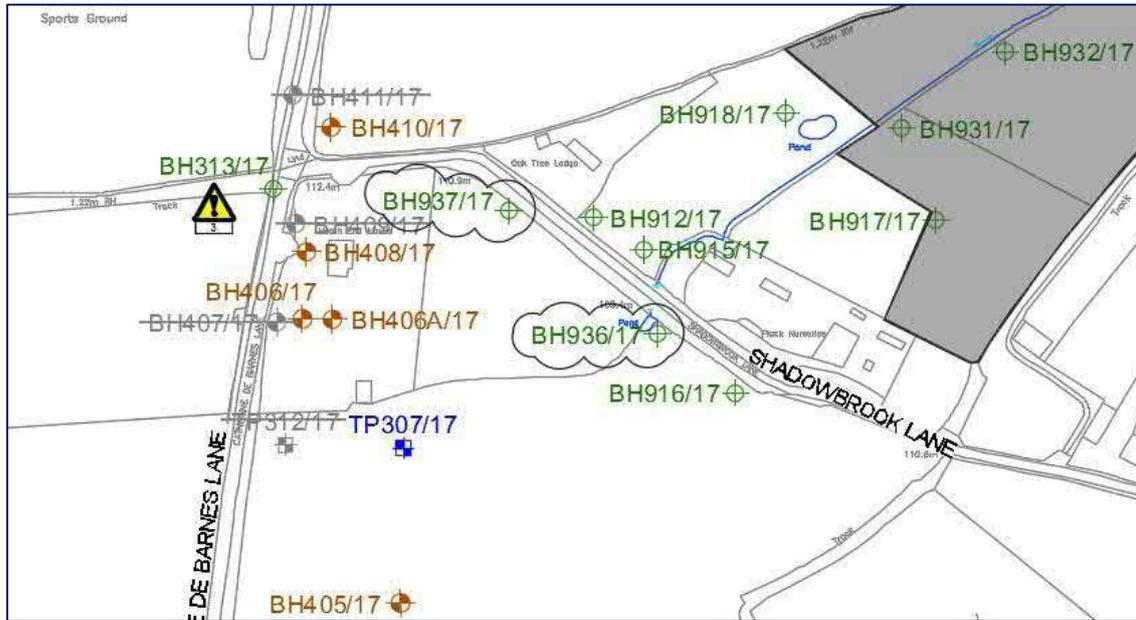
- 8.4 Figure 11A and 11B show the location of the Ground Investigation works in and around the SSSI units, which were completed in October 2018. The works now include boreholes around the periphery of both SSSI units and within the SSSI units. Those on the periphery of the units are window samples with a standpipe installation to allow monitoring of groundwater levels over time. The standpipes terminate on proving the surface of the Mercia Mudstone Formation. The boreholes within the SSSI units are not long-term installations for monitoring, but have been included to prove the underlying geology and provide a snapshot of groundwater conditions that can be related to the levels around the periphery of the sites.

Figure 11A (top) and 11B (bottom) Ground Investigation locations – extended to include the SSSI units. Red – cable percussion boreholes; orange – rotary coring boreholes; green – window sample; blue – trial pit.

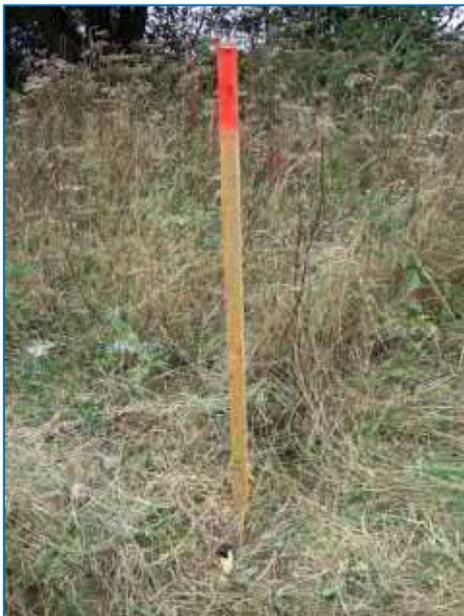
- 9.4 Dipwells were installed in the SE Unit on 13-14 August 2018 (see Figure 12A for locations and Photo 18 for an example). A total of 10 dipwells were installed, covering MG4 grassland, MG5 grassland and transitional grassland areas. The dipwells were prefabricated from a perforated plastic pipe of 32 mm diameter. They were sealed above ground to prevent rainwater from filling the pipe. The plastic pipe is perforated at regular intervals along its length on all sides, to allow throughflow of soil water, and to allow equilibration to be achieved with the surrounding water table.

Photo 18. Dipwell T2-D at the SE SSSI unit.

- 13.1 Ten dipwells were installed in the wet meadow at the SE SSSI unit on 13-14 August 2018 (see Figure 12A for locations and Photo 18 for an example), and ten dipwells were installed in the NW unit on 5-6 September 2018 (see Figure 12B for locations, and an example in Photo 19). Since the installation, a water level logger has been operational in one dipwell within each SSSI, recording water table depth at 15 minute intervals. The remaining dipwells have been monitored for water table depth, pH and conductivity on a fortnightly basis.

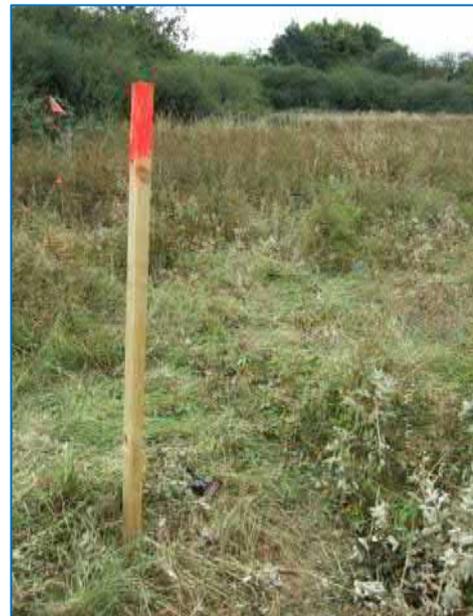
- 9.6 The dipwells in the NW Unit were installed on 5-6 September 2018 (see Figure 12B for locations, and an example in Photo 19). Despite sporadic rainfall in the period since the installation of the SE unit dipwells, the ground conditions at the NW unit remained extremely dry with no groundwater encountered during augering of any of the holes. In total, 4 dipwells were installed to 90 cm depth, two to 70 cm depth, and additional dipwells to 66 cm, 60 cm, 50 cm and 43 cm depth. The shallower depths of some dipwells are a result of impenetrable stiff clay layers being encountered. In general, the top soil at the NW Unit was up to 20 cm to 40 cm depth below ground, before trending to extremely stiff, dark grey clay to the base of the dipwells. The main exceptions were the two dipwells towards the centre of the eastern half of the SSSI, where sand and gravel layers were encountered at depths below 50 cm. Further details are described in Annex B.

Photo 19. Dipwell N2-B on the NW SSSI unit.

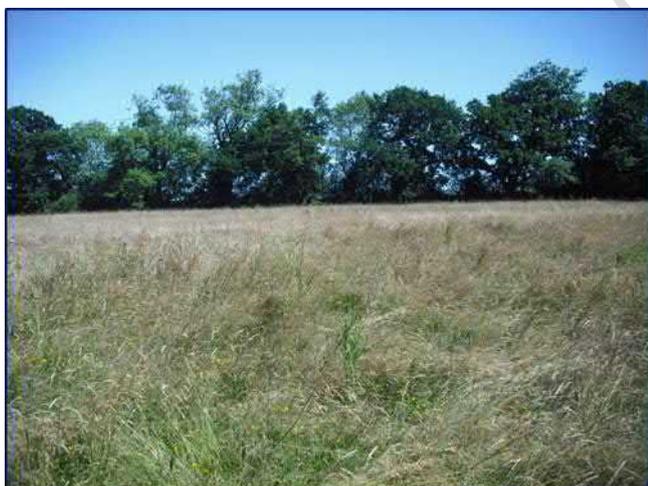
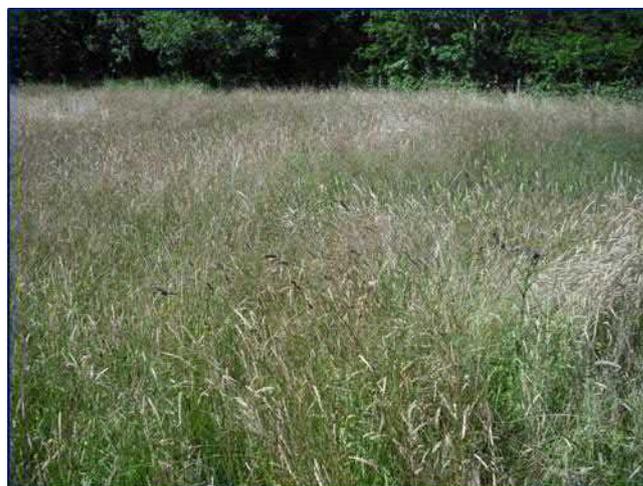
- 11.4 The two fields on the eastern side slope down to the watercourse and the vegetation on the day of the survey was grass dominated (tall and lodging in places) and dry (Photo 20 and 21). Yorkshire fog (*Holcus lanatus*) was abundant with other grasses such as cock's foot (*Dactylis glomerata*), common bent (*Agrostis capillaris*), red fescue (*Festuca rubra*), crested dog's tail (*Cynosurus cristatus*) and meadow fescue (*Schedonorus pratensis*). A range of generally common forbs were recorded and included ribwort plantain (*Plantago lanceolata*), common knapweed (*Centaurea nigra*), bird's foot trefoil (*Lotus corniculatus*) and red clover (*Trifolium pratense*). Less common species included yellow rattle (*Rhinanthus minor*) and tormentil (*Potentilla erecta*).

Photo 20 (left) and Photo 21 (right), typical vegetation in the SE SSSI unit eastern fields.

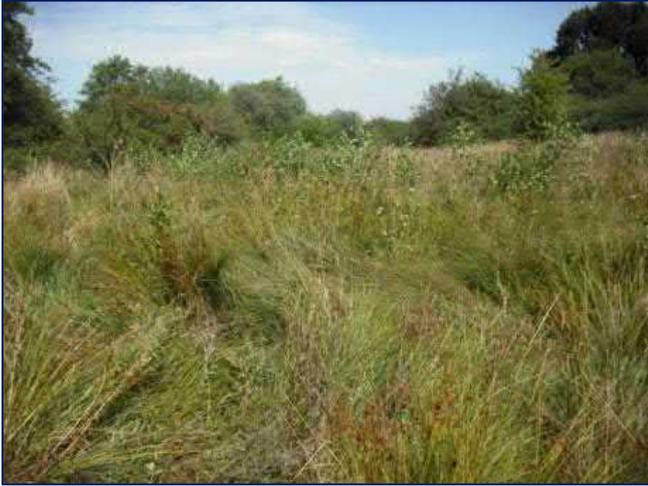
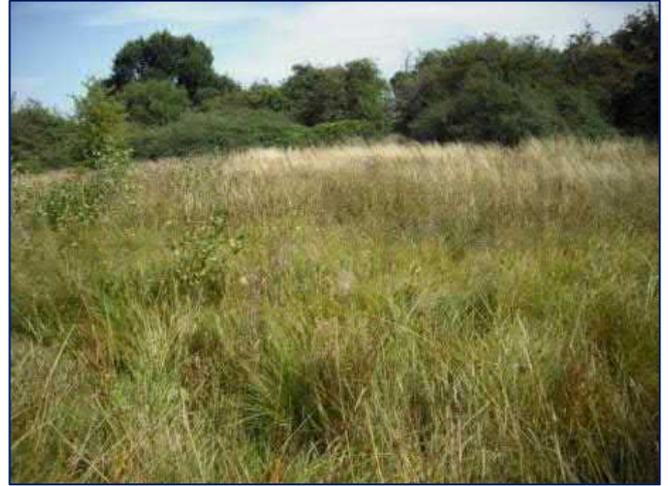
- 11.11 Part way along the western boundary of the field, there was a distinctive change in vegetation and whilst this will have to be shown by survey, it appeared to be delineated by a low spot, possibly linked to the ditch and was demarked by young alders (*Alnus glutinosa*). The vegetation here was dominated by tall rushes including soft rush (*Juncus effusus*), hard rush (*Juncus inflexus*) and sharp flowered rush (*Juncus acutiflorus*), along with sedges with abundant great hairy willowherb (*Epilobium hirsutum*) and in the wettest areas patches of fool's watercress (*Apium nodiflorum*). This is the area considered to be a potential spring in the preceding discussion (Photo 27 and Photo 28).

Photo 27 (left) and Photo 28 (right), typical vegetation in the distinct wetter area within the NW SSSI unit eastern field.

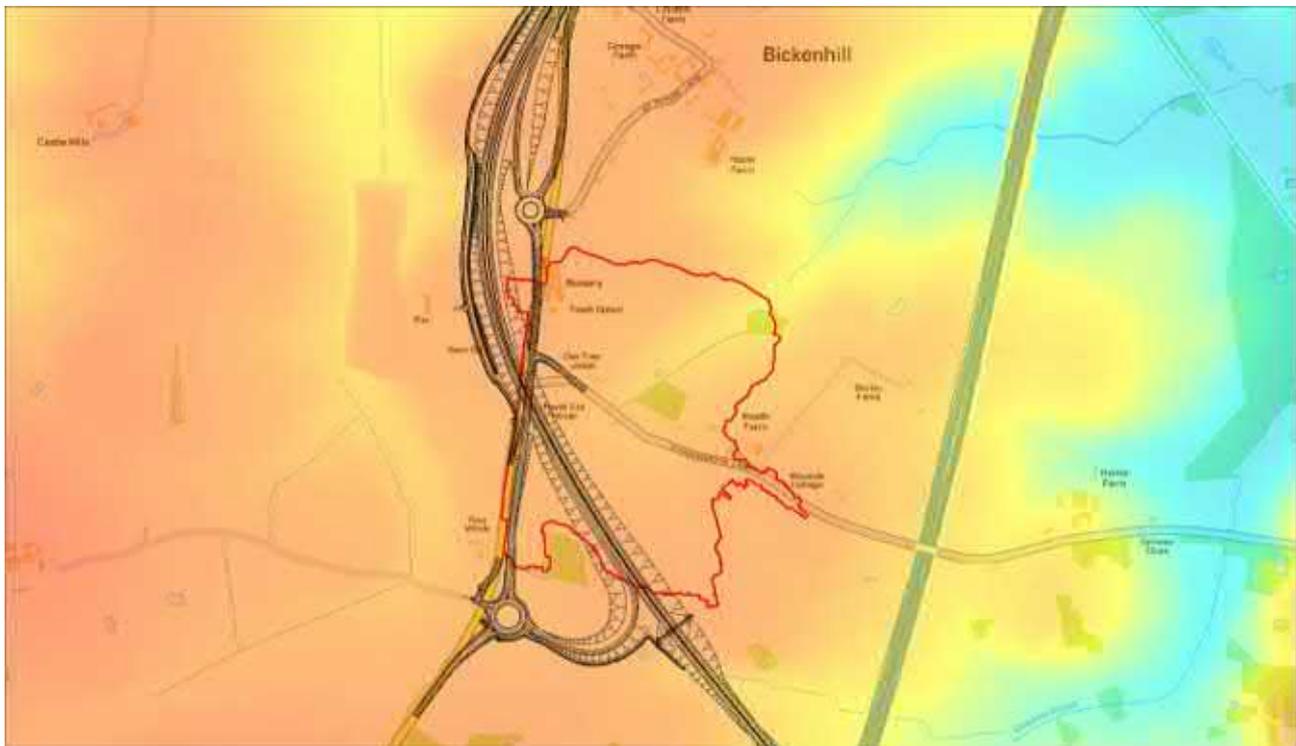
Analysis of the LiDAR data overlain with the catchment area of the SSSI indicates that the majority of the land surrounding the SSSI is relatively high, and the SSSI lies in a flat bottomed valley (Figure 2). The topography of the site is generally level, with a gentle rise in elevation away from the tributary of Shadow Brook, which flows through the approximate centre of the site. Therefore the total area of the catchment contributes flow to the SSSI through runoff from the surrounding hillslopes, and overland flow along the valley bottom, which then flows into the SSSI. The amount of water reaching the SSSI is maximised by the topography of the catchment surrounding the SSSI, therefore the reduction in the catchment area is going to have negligible impact on the SSSI.

Figure 2: LiDAR data showing the elevation of land in the catchment area contributing to the SSSI

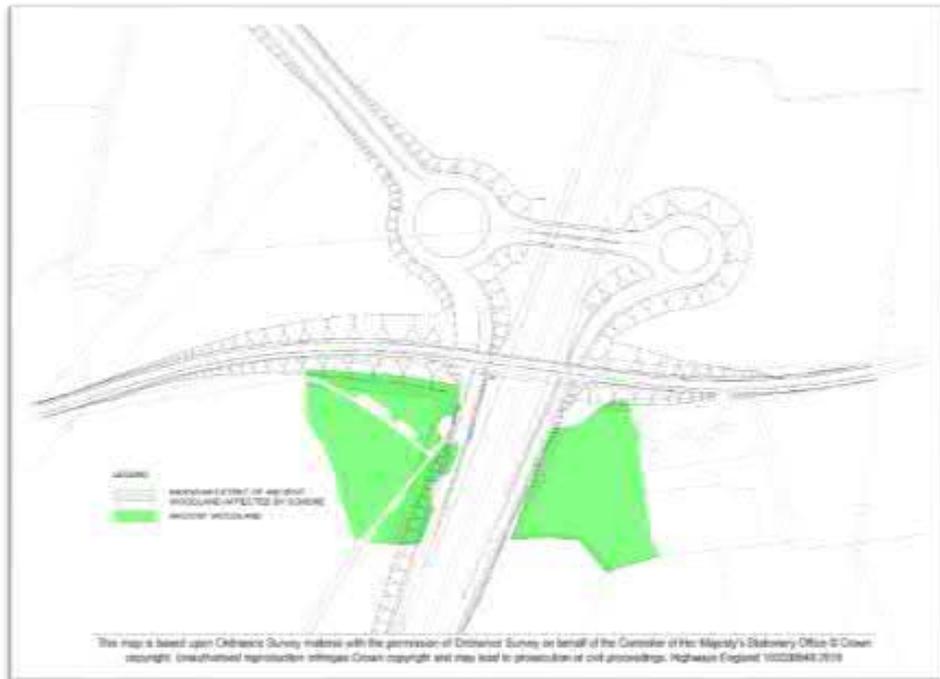
Figure 1-1: Maximum Extent of Ancient Woodland Affected by the Scheme

- 1.1.4 As set out in **Figure 1-1**, the impact on the ancient woodland from the Scheme would principally arise from the construction of a new overbridge (in respect of the associated embankments leading to the overbridge) on Solihull Road, and the proposed on- and off-slip roads at Junction 5A.
