M25 junction 10/A3 Wisley interchange TR010030

6.5 Environmental Statement: Appendix 7.10 Bat trapping

6.5 ENVIRONMENTAL STATEMENT: APPENDIX 7.10 BAT TRAPPING

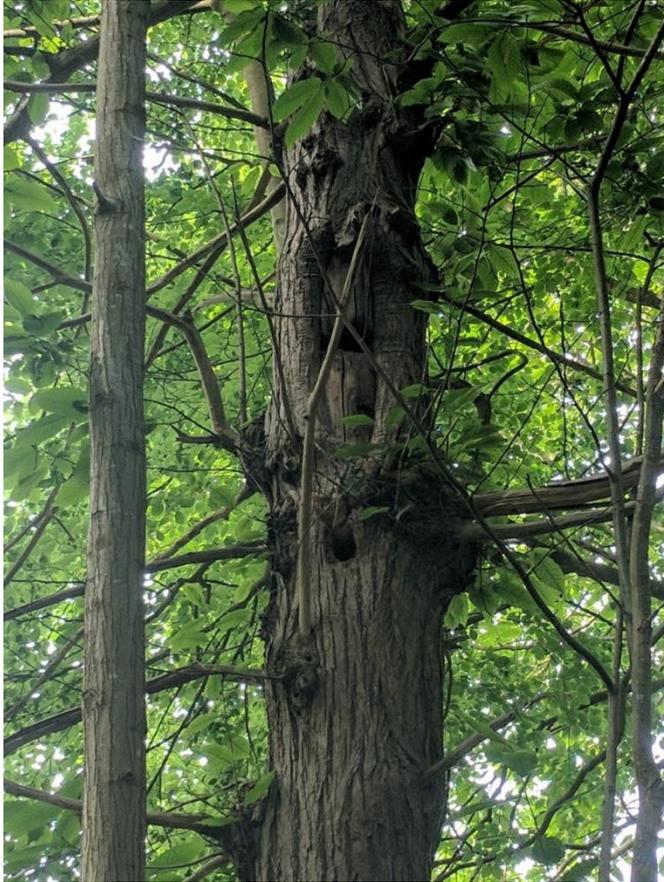
Plate 7.1 Roost tree used by brown long-eared bat in the north-east quadrant of junction 10 – TQ 0900 5845

7.1.5.22 This bat was caught in the south-east quadrant on the 16 July 2017. Following release, the bat's signal was checked periodically and identified in an easterly direction. On the 17 July 2017, the bat was radio tracked to a medium-sized sweet chestnut tree with scar damage and a number of holes present, which was considered likely to be a maternity roost (see Figure 7.14 and Annex B, Plate G.1). Following this, the tag was found dropped as the bat had moulted.

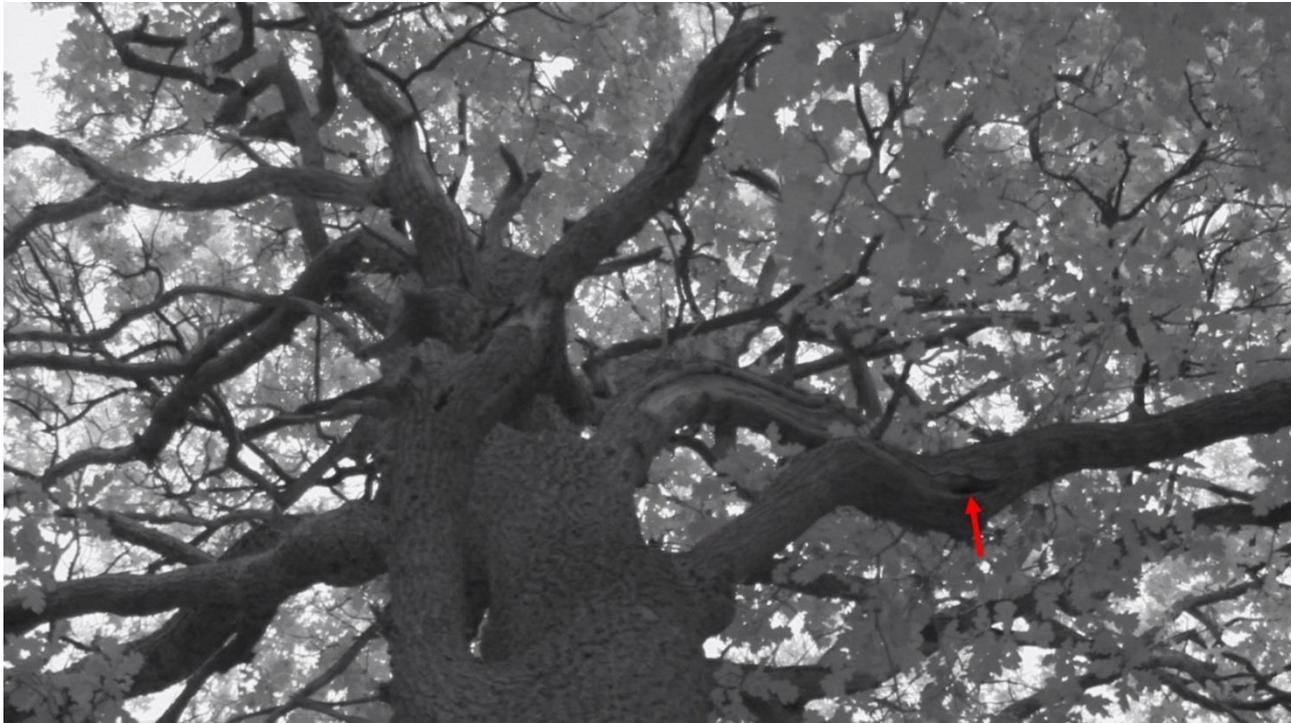
Plate 7.2 Natterers bat roosting in western area of junction 10 – TQ 07394 58531

7.1.5.24 The bat was radio tracked at dawn to locate the roost, which was identified in an oak tree at TQ 07394 58531 (see Figure 7.14). An emergence survey conducted on the 5 August 2017 identified 41 Natterer's bats emerge, which will have included adults and juveniles in the maternity roost. See Annex B, Plate G.2 for a photograph of the roost site.

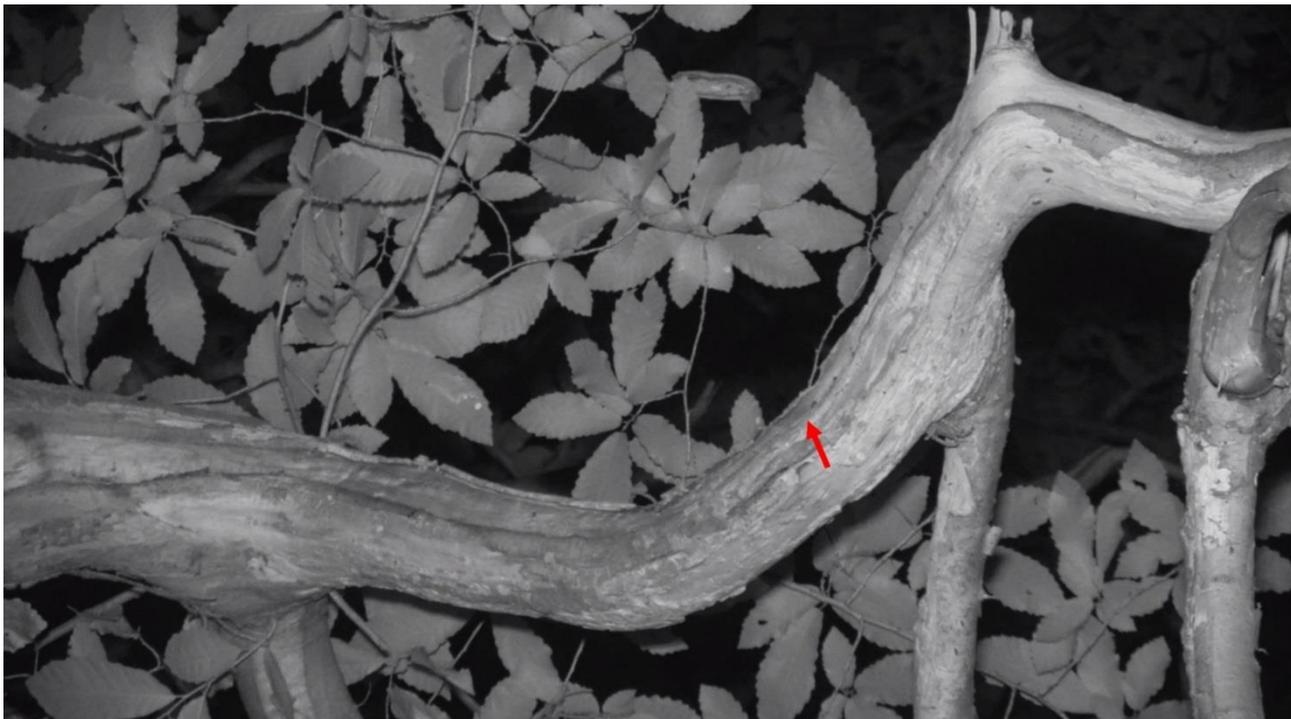
Plate 7.3 Bat 4, Natterers bat – first roost – TQ 09111 58477

7.1.5.30 On the 7 August 2017, the roost was located in a sweet chestnut tree at TQ 09111 58477, see roost 1 on Figure 7.14. An emergence survey was conducted on the 8 August 2017, which identified 46 Natterer's bats emerge. See Annex B, Plate G.3 for a photograph of the tree roost site.

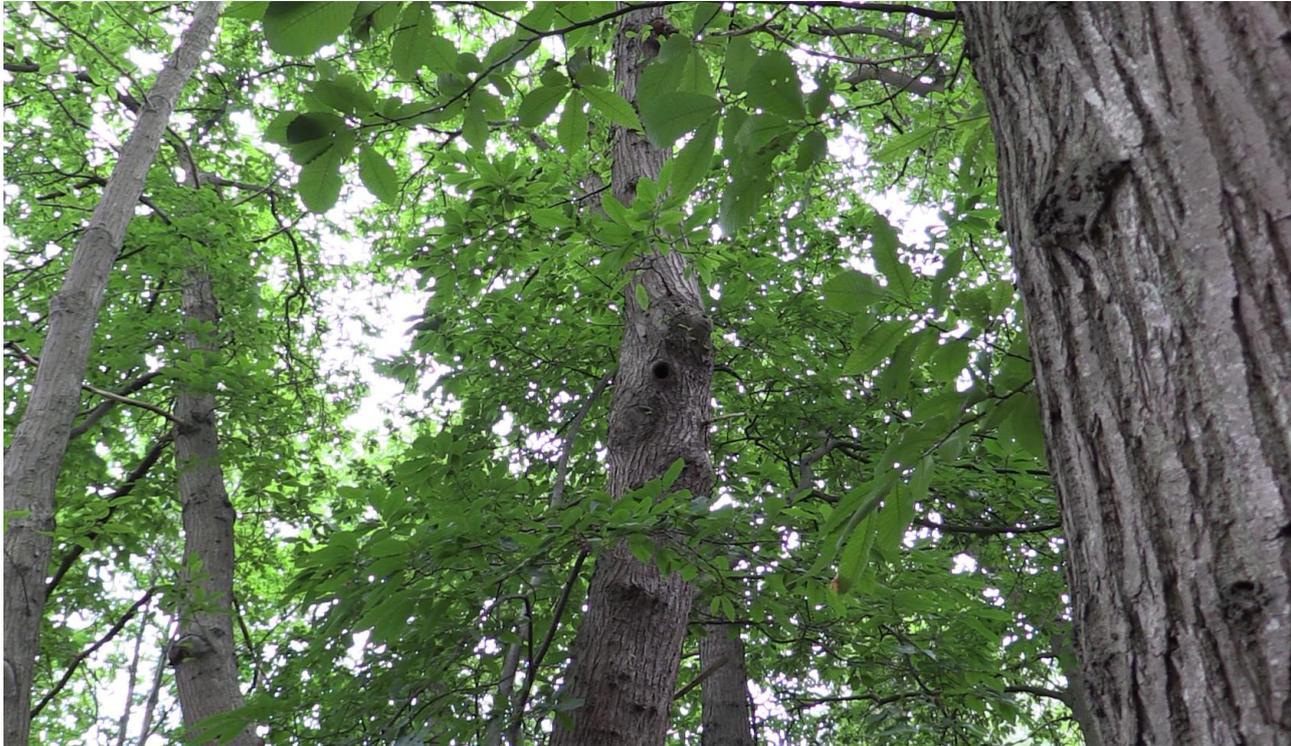
Plate 7.4 Bat 4, Natterers – second roost – TQ 08981 58466

7.1.5.31 On the 13 August 2017, the bat was identified as having moved roost to a sweet chestnut tree at TQ 08981 58466, see roost 2 on Figure 7.14. The bat was roosting in a lower hole and a dusk emergence survey identified 97 bats emerge. See Annex B, Plate G.4 for a photo of the tree roost site.
