Lower Thames Crossing

6.3 Environmental Statement Appendices Appendix 8.16 – Draft EPS mitigation licence application – bats

Licence Application Form

Mitigation Licensing - Bats

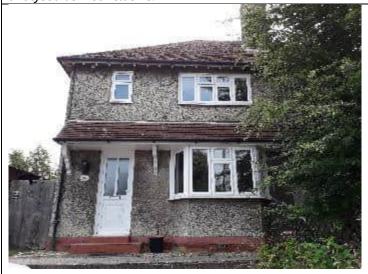
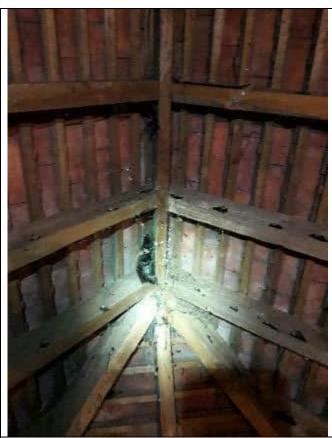
S2 1 Longview Cottage: Three common pipistrelle seen emerging. Suspected dropping was analysed as inconclusive.

The inconclusive droppings found at S2 have been assumed to be common pipistrelle following the peak emergence of three common pipistrelle from the building.

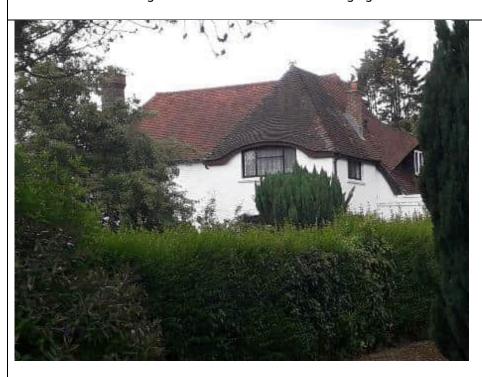
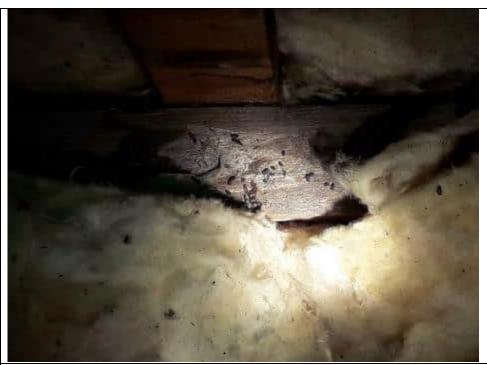
S14 Marling Manor: Pile of (after DNA analysis) brown long-eared bats droppings. No bats were seen within the building. Bats have since been seen emerging

Droppings were recovered from 13 structures that had DNA analysis undertaken on them. Six structures were found to support brown long-eared bat, one of which is within the Order Limits (S14). S14 will be retained although due to its close proximity to works (11 m) and significant severance to foraging habitat it is precautionarily assumed the roost will be abandoned and therefore lost. The remaining buildings outside of the Order Limits will not be impacted by the proposed work and are not included further within this licence.

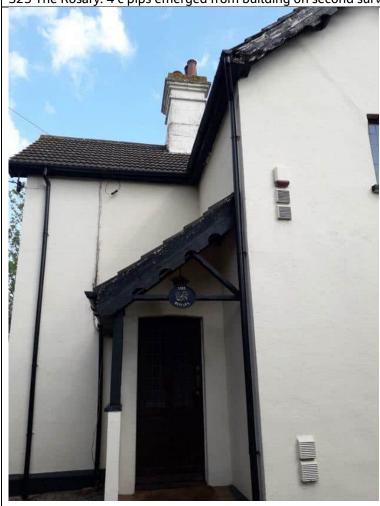
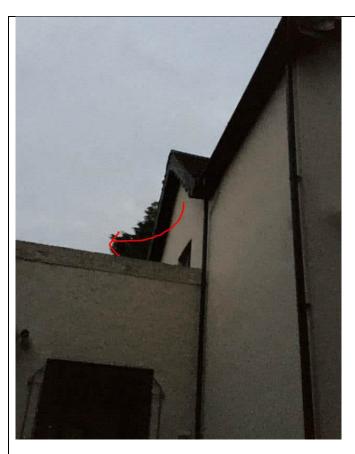
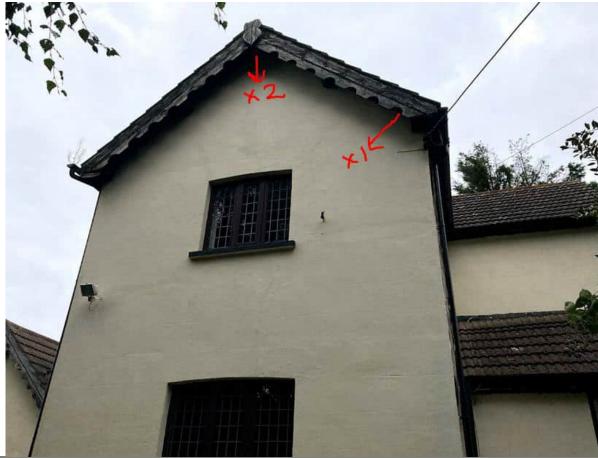
S25 The Rosary: 4 c pips emerged from building on second survey, see below.

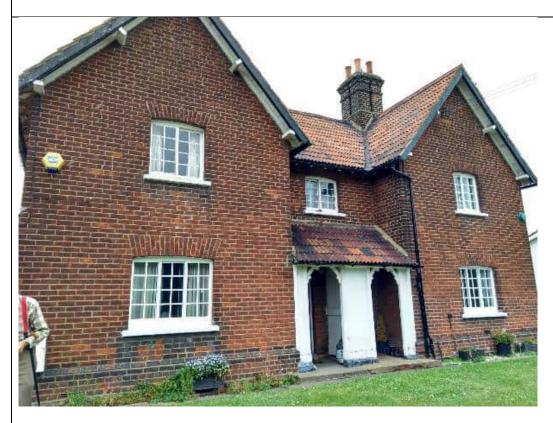
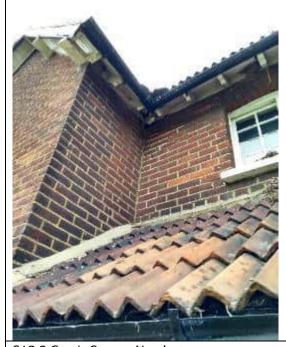
S29 1 + 2 Bridge Cottages: Emergence was identified under the gable end, fascia boards on the southwestern gable.

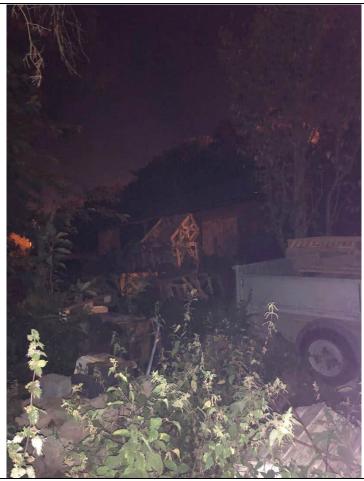
S356 Alde Cottage: 2 common pipistrelle emerged

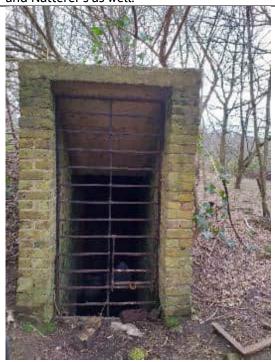
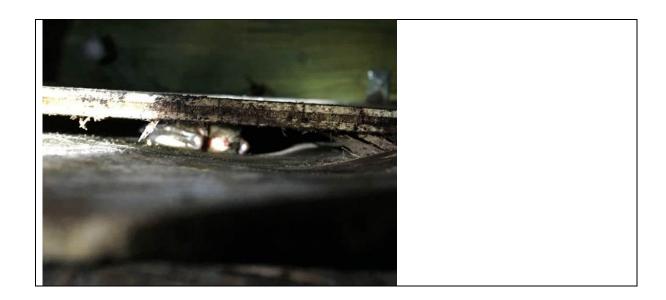
S328 Shorne Woods Air Raid Shelter Bunker 2: Internal inspection identified one hibernating Daubenton's bat. The local bat group have confirmed it as a hibernation roost for brown long-eared and Natterer's as well.

Data loggers were installed in S328 as part of the hibernation surveys to ensure similar conditions are recreated in the artificial roost.

Hibernation surveys have only been undertaken on the air raid shelters in Shorne Woods (S49 and S328) to confirm the presence of the roost and to measure baseline temperature and humidity conditions to inform future mitigation.
