Lower Thames Crossing

6.3 Environmental Statement Appendices Appendix 8.16 – Draft EPS mitigation licence application – bats (Tracked changes version)

Planning Inspectorate Scheme Ref: TR010032
Application Document Ref: TR010032/APP/6.3

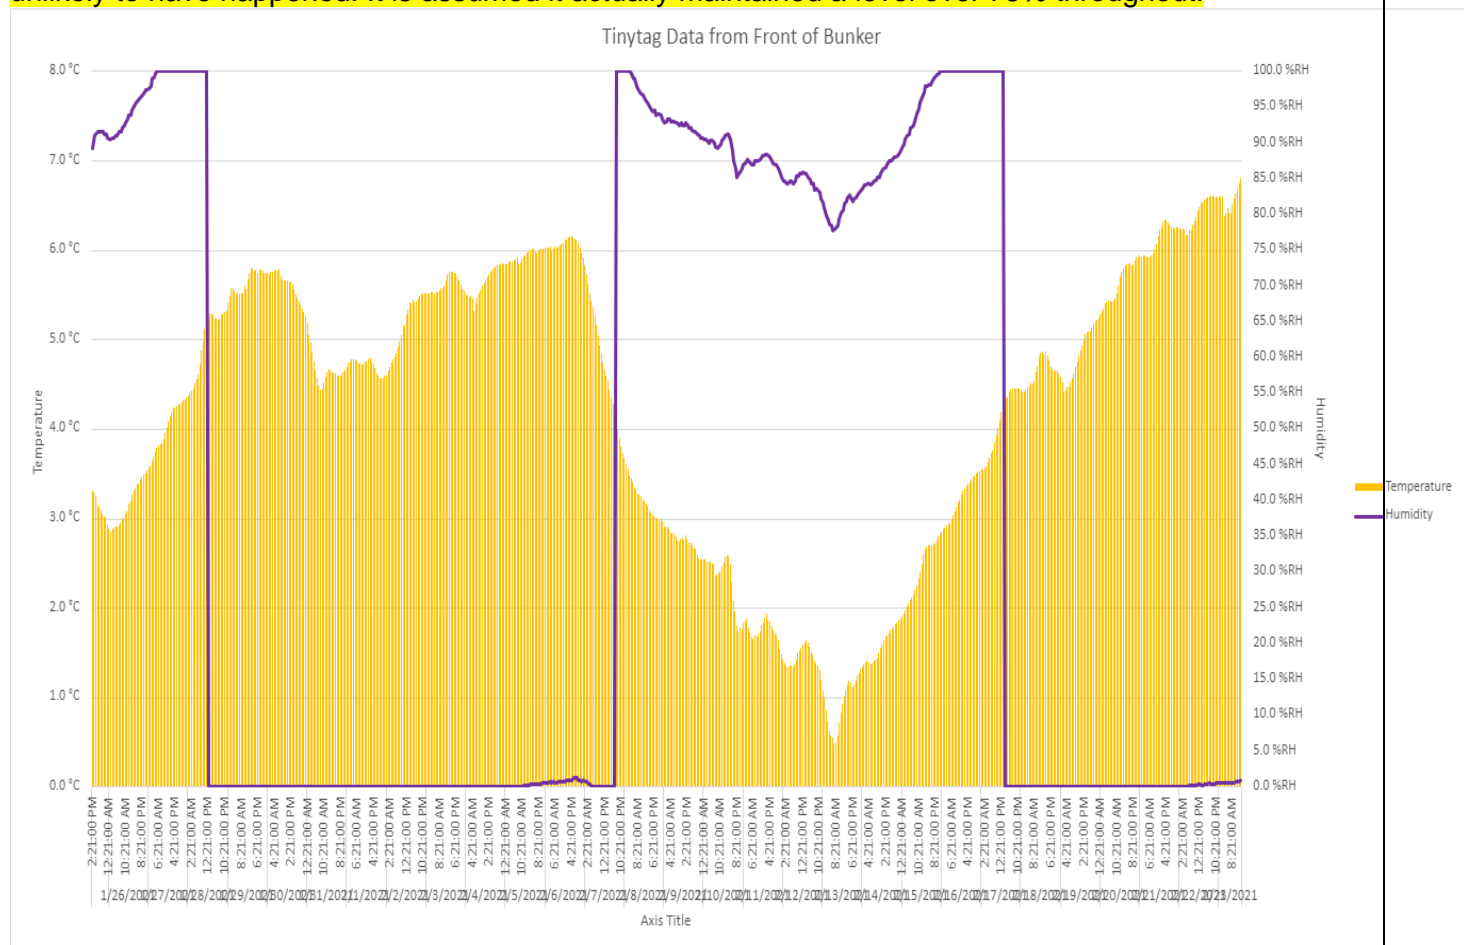
Temperature data from inside S368. Recorded using a tinytag located at the front of the bunker close to the entrance. The humidity recording appears compromised as the immediate drop from 100% to 0% is unlikely to have happened. It is assumed it actually maintained a level over 75% throughout.

The average temperature over the period was 4.2°C and average humidity (excluding the abrupt drops to zero) was 74.6%. The minimum temperature was 0.5°C and max was 6.5°C. No external recordings were collected at this time for comparison to see how stable the internal temperatures were, but a bat was recorded in the bunker when the temperature probe was collected in February.

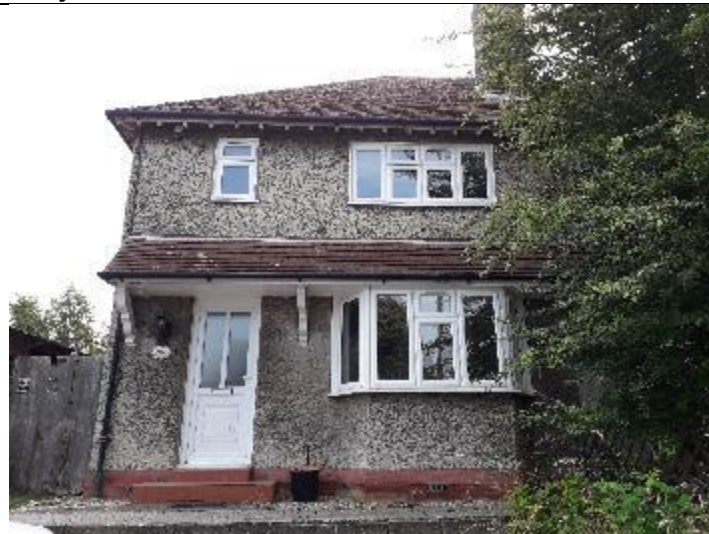
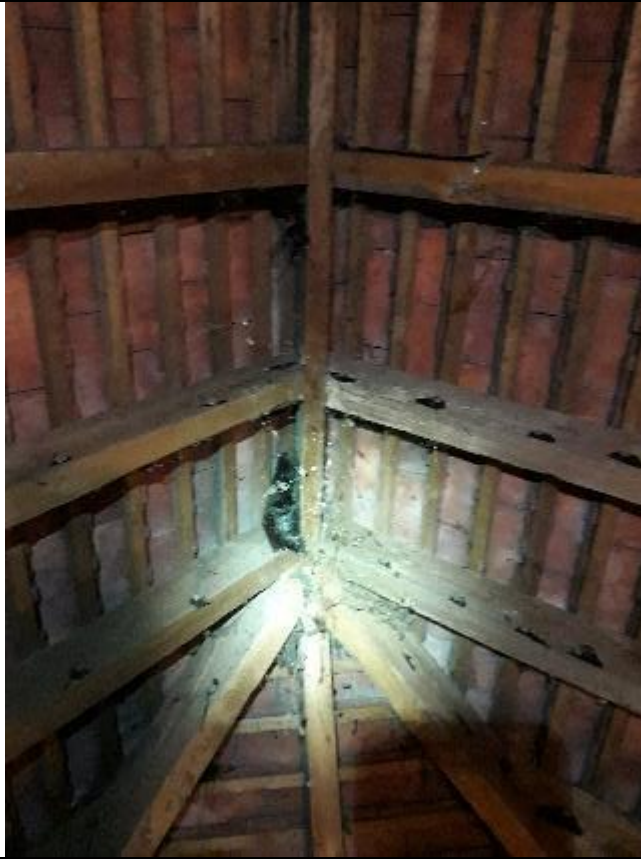
S2 1 Longview Cottage: Three common pipistrelle seen emerging. Suspected dropping was analysed as inconclusive.

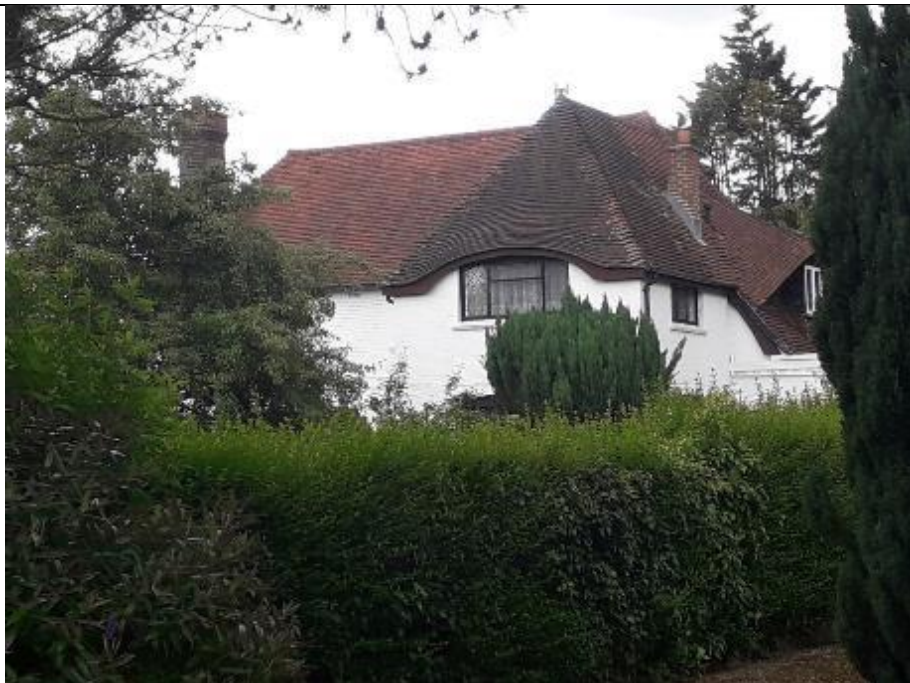
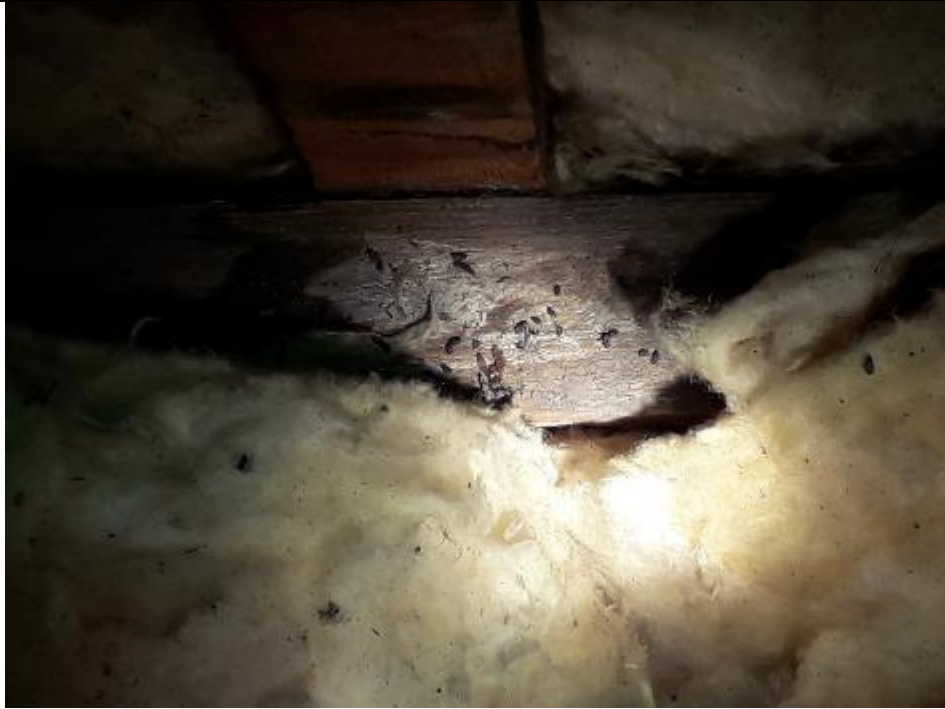
S14 Marling Manor: Pile of (after DNA analysis) brown long-eared bats droppings. No bats were seen within the building. Bats have since been seen emerging

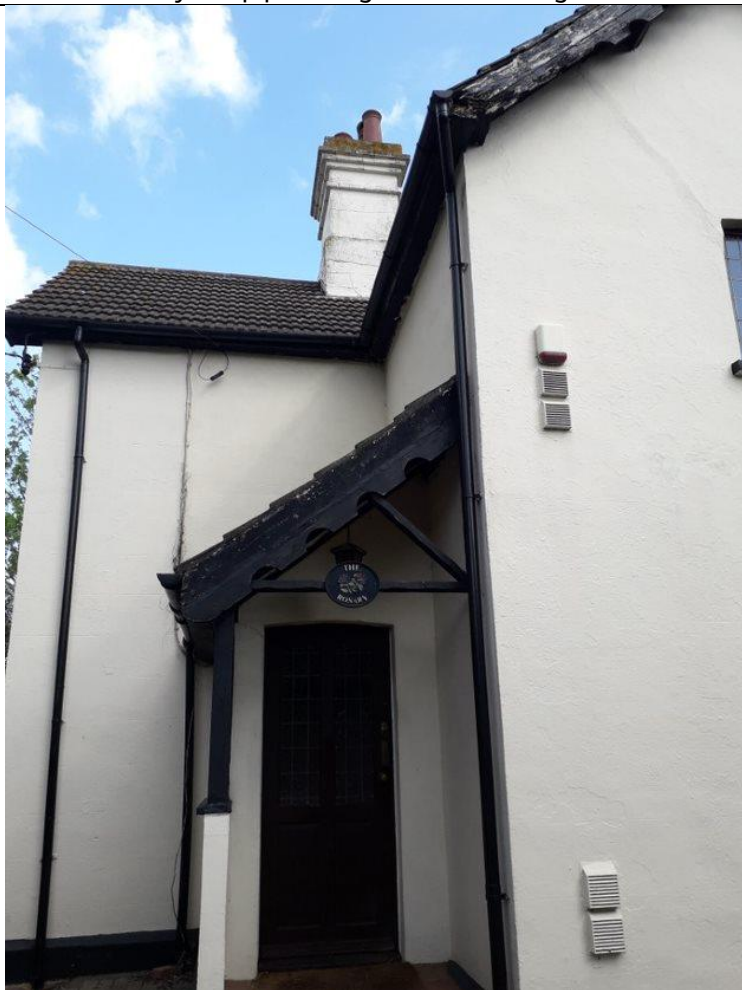
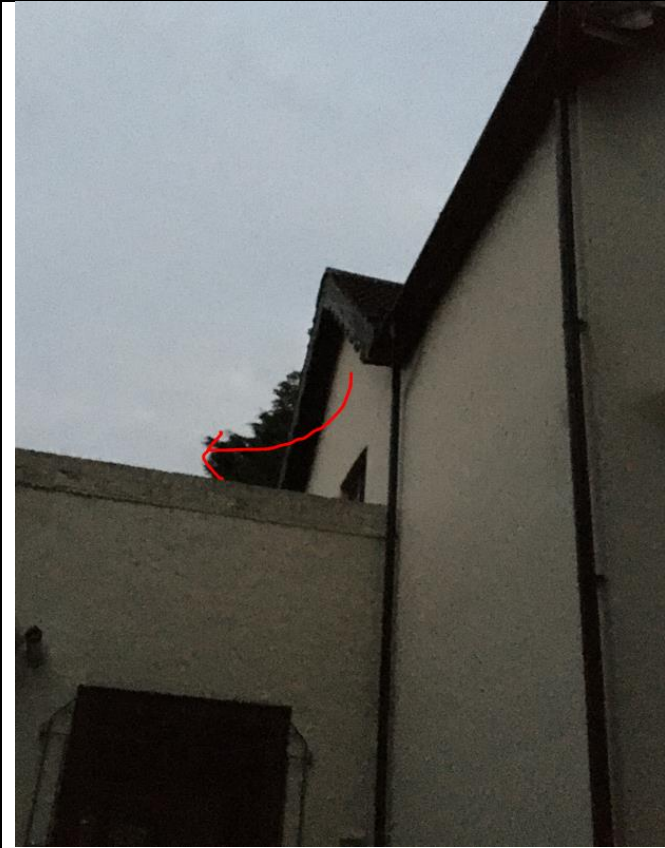
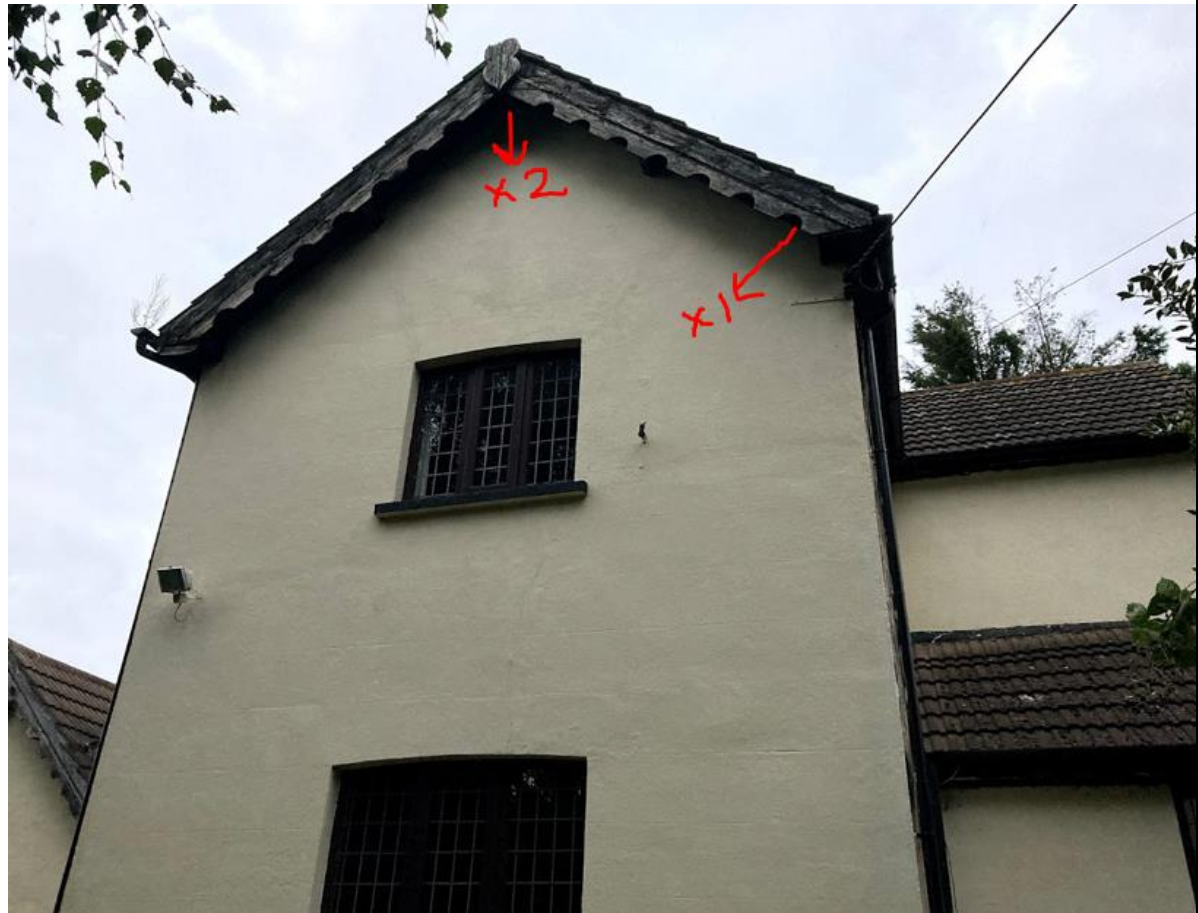
S25 The Rosary: 4 c pips emerged from building on second survey, see below.

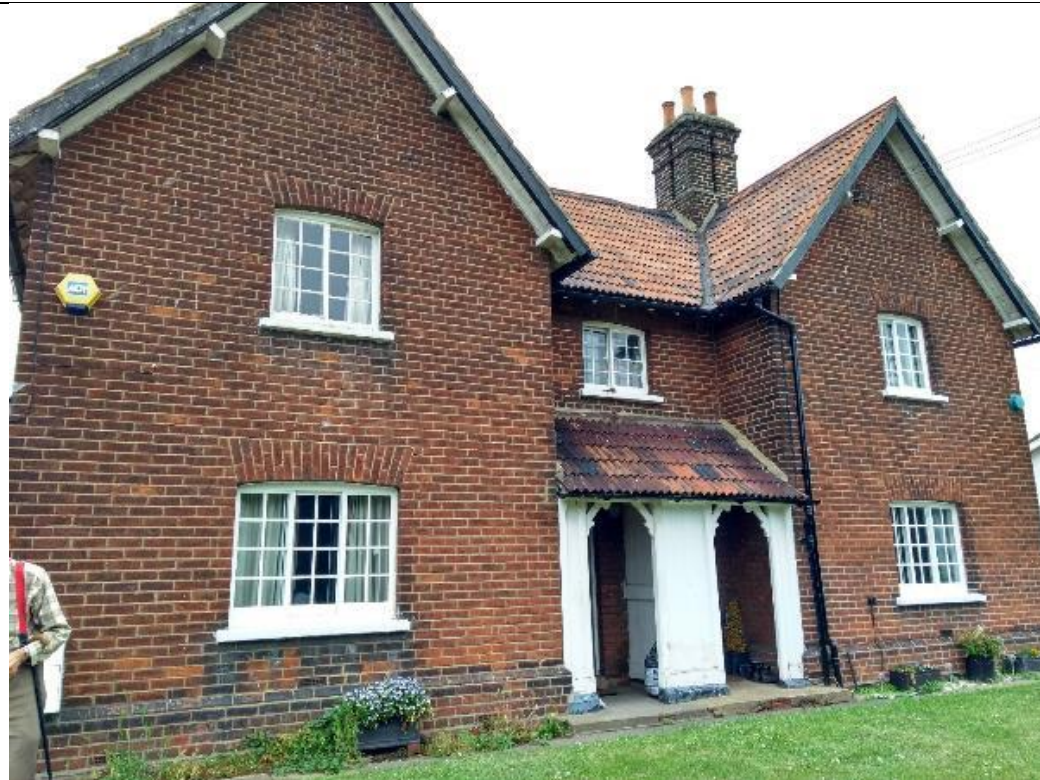
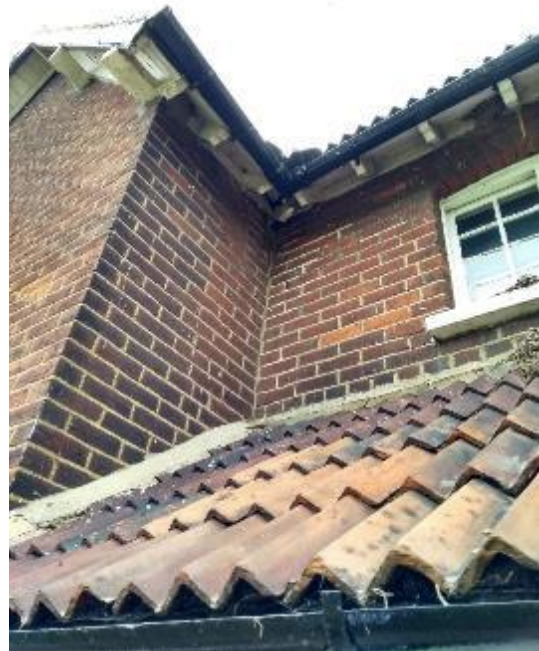
S29 1 + 2 Bridge Cottages: Emergence was identified under the gable end, fascia boards on the southwestern gable.

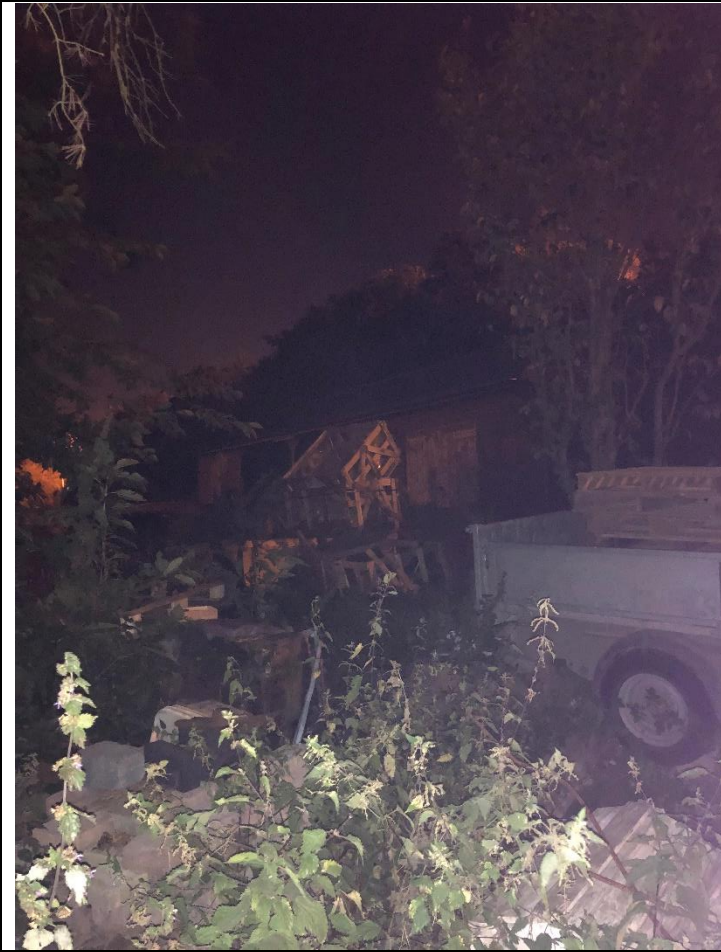
S356 Alde Cottage: 2 common pipistrelle emerged

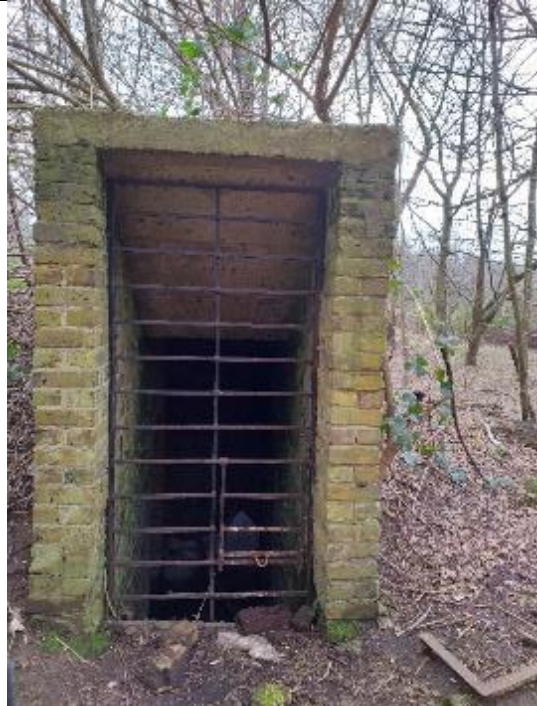
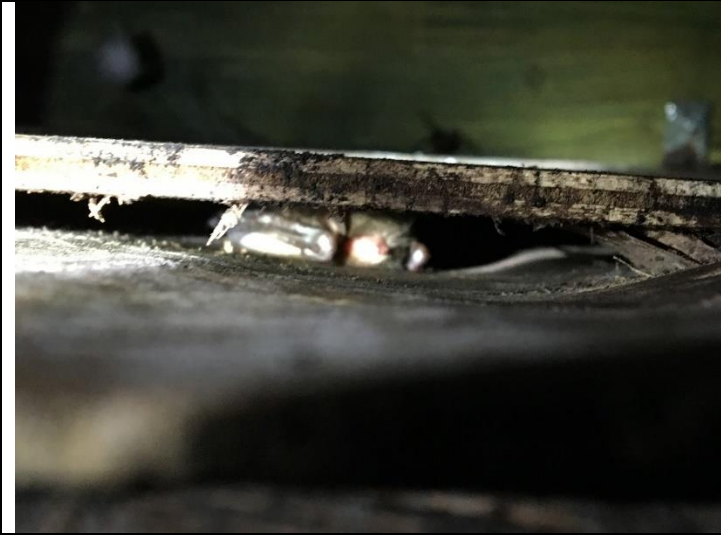
S328 Shorne Woods Air Raid Shelter Bunker 2: Internal inspection identified one hibernating Daubenton's bat. The local bat group have confirmed it as a hibernation roost for brown long-eared and Natterer's as well.
