A57 Link Roads

TR010034

9.41 Water Framework Directive (tracked)

9.41 WATER FRAMEWORK DIRECTIVE (TRACKED)

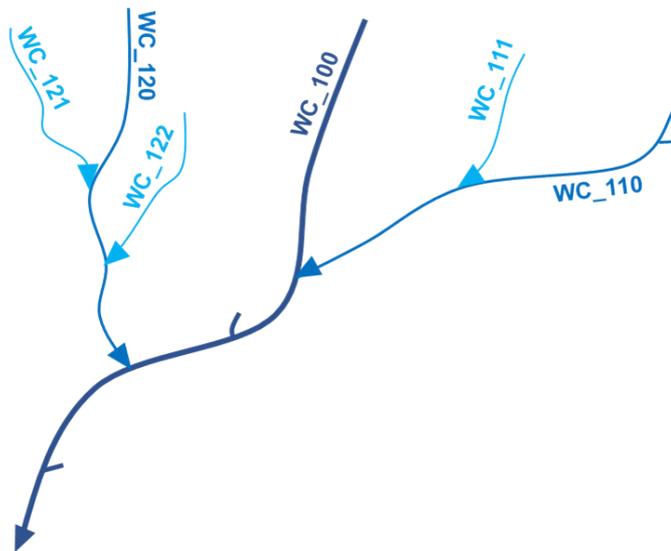
Insert 2-1 - Example watercourse numbering system

(e.g. WC_110 joins WC_100 upstream of WC_120). To avoid longer codes, where there are very short (< 100 m in length) tributaries of a watercourse, these are incorporated into the assessment for the watercourse they are joining. Watercourses which are located within the Zone of Influence (Zol), but flow into a major named watercourse outside of the Zol, are given the first digit 0 (i.e. "WC_0xx").
