# **A585 Windy Harbour to Skippool Improvement Scheme**

## **7.30 Draft Archaeological Mitigation Strategy and Preliminary WSI**

**DRAFT ARCHAEOLOGICAL MITIGATION STRATEGY AND PRELIMINARY  
WSI**

<b>Regulation Number:</b>	Regulation 5(2)(q)
<b>Planning Inspectorate Scheme Reference</b>	TR010035
<b>Application Document Reference</b>	TR010035/APP/7.30
<b>Author:</b>	A585 Windy Harbour to Skippool Improvement Scheme Project Team, Highways England

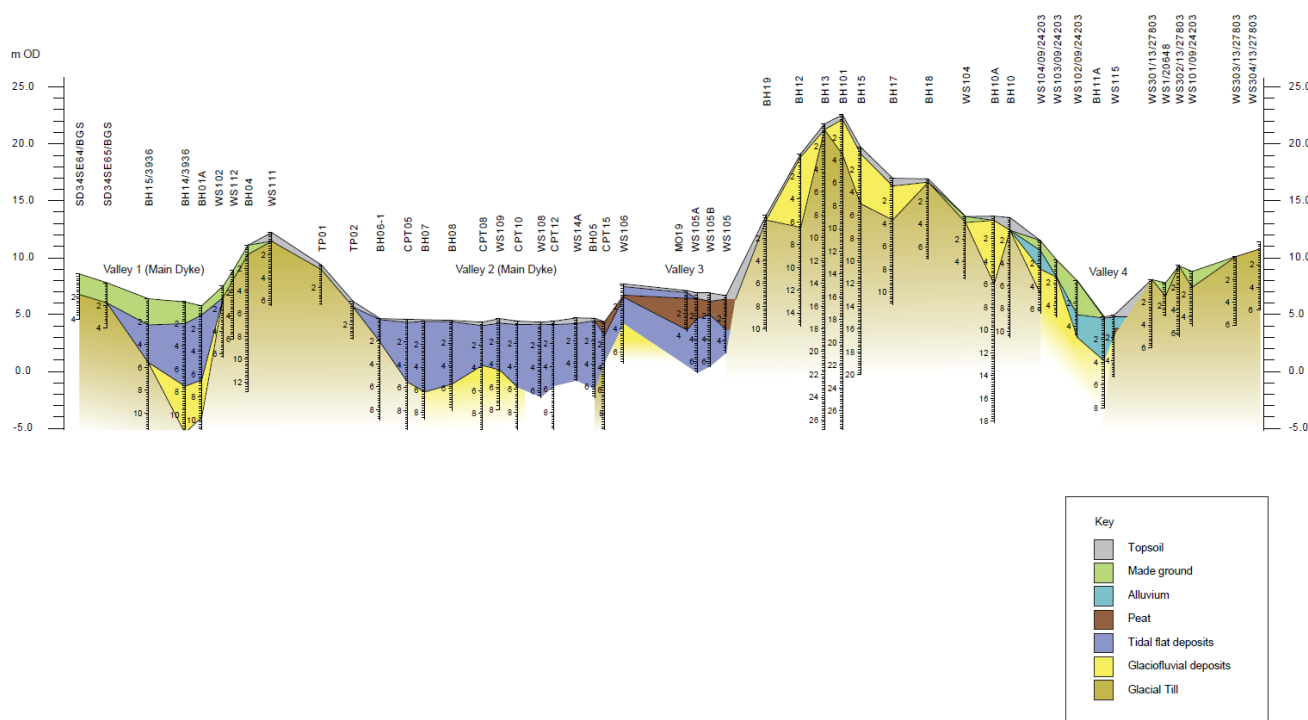
Plate 2: Valley locations as identified in the geoarchaeological deposit model. Image taken from the geoarchaeological assessment (document reference: TR010035/APP/6.7.3)

- 2.1.7 Oxford Archaeology North (OAN) conducted a geoarchaeological deposit model assessment of existing borehole data, drilled during Ground Investigations conducted as part of the Scheme's assessment (document reference TR010035/APP/6.7.3). The assessment further enhanced the understanding of the high archaeological interest and significance of the extensive peat deposits (**196**) known to be within the draft order limits (OAN, 2018).
- 2.1.8 The geoarchaeological assessment also identified the location of four valley margins (plate 2) present across the Scheme (OAN, 2018). These valley margins are considered to hold archaeological interest through the potential to yield evidence of early historic human activity (OAN, 2018).

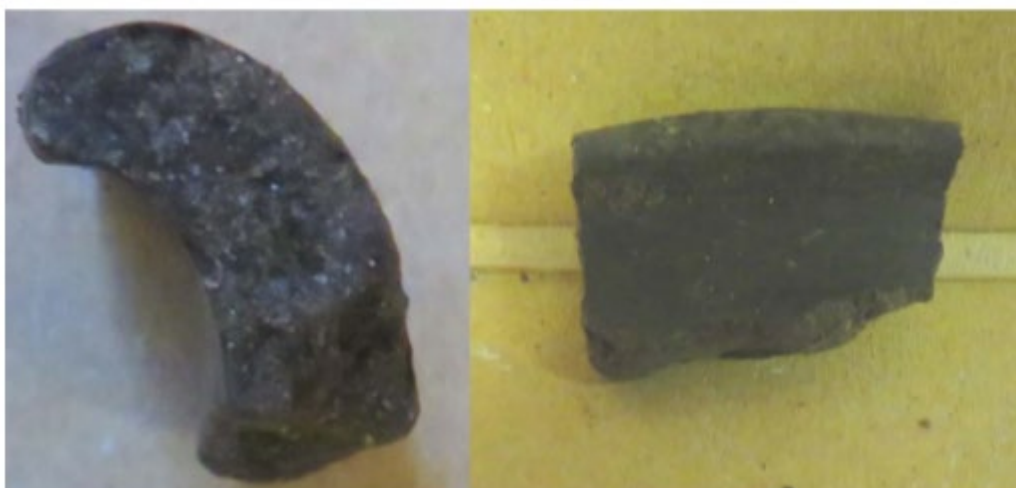
Plate 3: Image of Carinated Bowl rim, dated to the Early Neolithic (Image OAN, Appendix A).

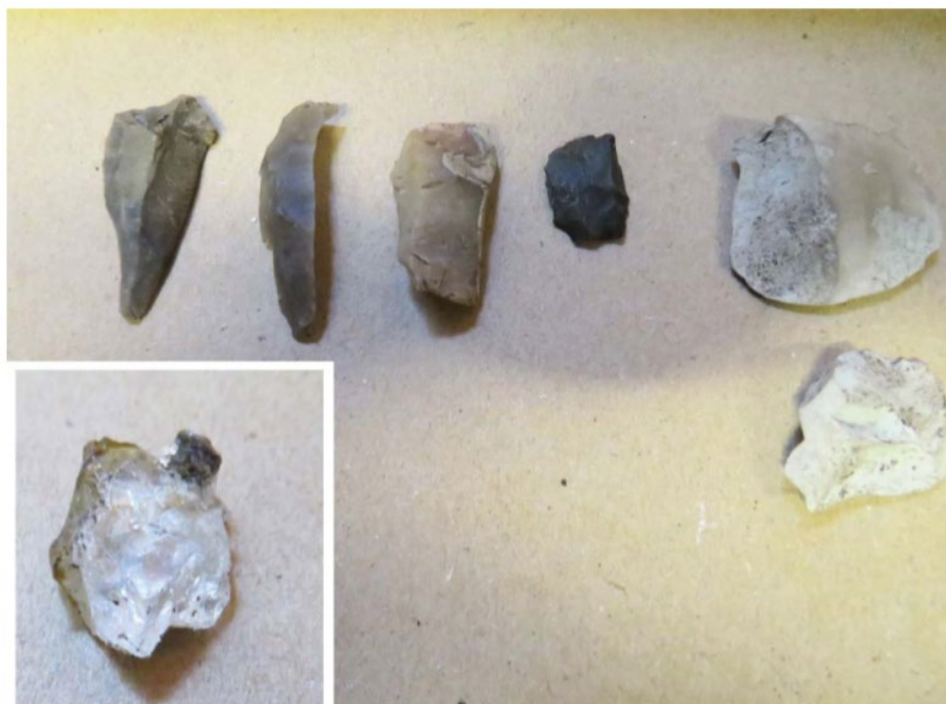
Plate 4: Range of flaked lithics recovered from the evaluation (Image OAN, Appendix A).

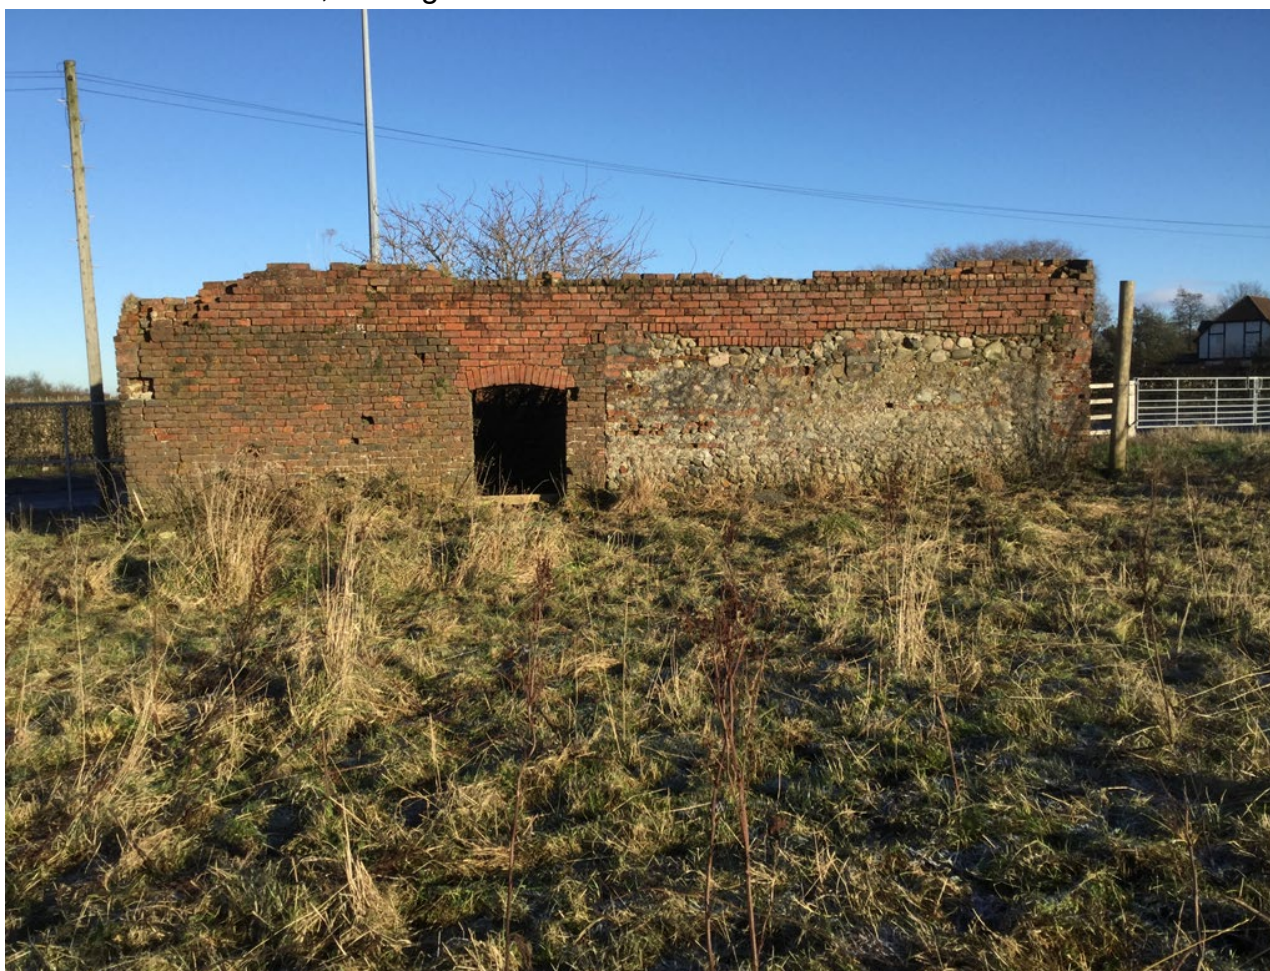
3.3.2 A derelict structure (**160**) (Plate 5) was identified on the southern edge of the A585 Mains Lane, during the desk study's walkover survey of the Scheme (document reference TR010035/APP/6.7.1 Rev 1). The structure would require demolition prior to construction, to allow for the new junction between the existing A585 and the proposed bypass.

Plate 5: Derelict Structure (160), identified during the desk study's walkover survey of the Scheme, looking North.

3.3.3 As detailed in section 7.6.15 of the ES Chapter 7: Cultural Heritage (document reference TR010035/APP/6.7 - Rev 1), the derelict structure will be preserved by

record prior to demolition. This recording will comprise a level 2 building survey, as defined by Historic England (Historic England, 2016a) and will meet the standards of CIFA (2019).

- 3.3.4 As outlined in section 3.5 of this report and section 7.6.15 of the ES Chapter 7: Cultural Heritage (document reference TR010036/APP/6.7 - Rev 1), the ground under the derelict structure (**160**) will be archaeological monitored by an archaeological watching brief during construction stripping, to also record any foundational remains and artefactual recovery; with the view to provide information on the structure's use during its operation and earliest date.

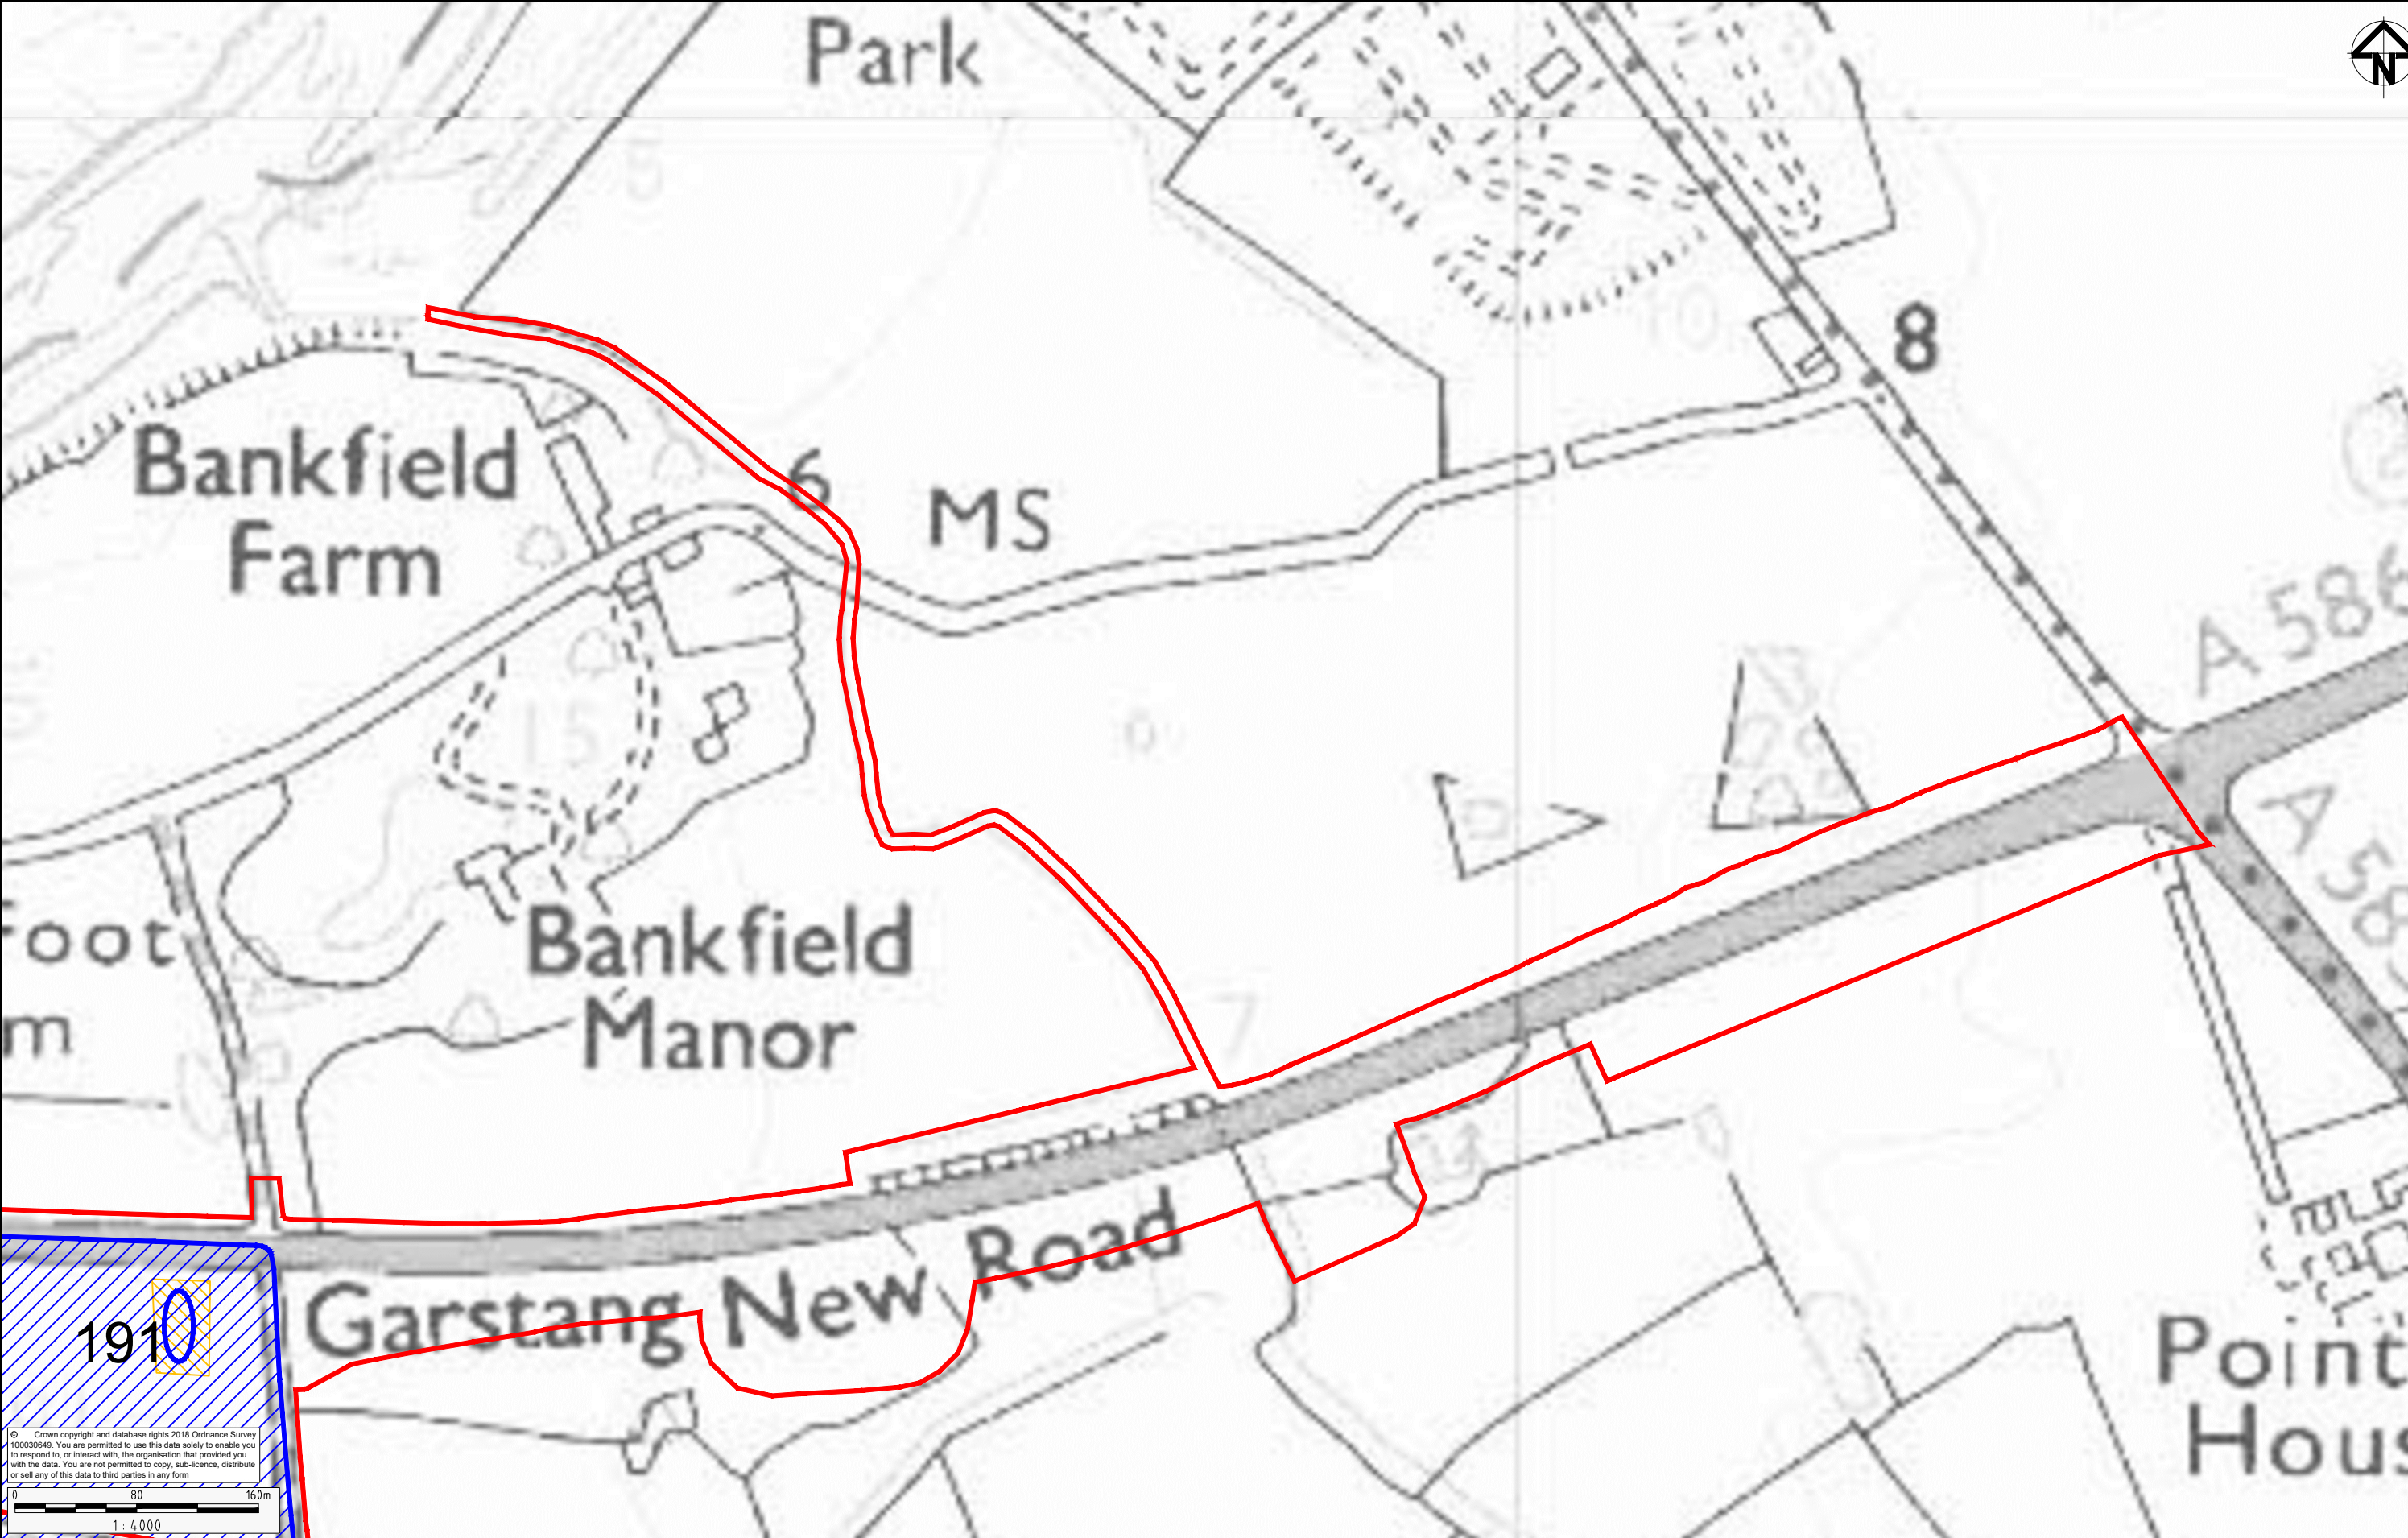
Figure 1: Proposed areas of archaeological mitigation and receptor locations

Project	A585 WINDY HARBOUR TO SKIPPOOL IMPROVEMENT SCHEME
Drawing Title	PROPOSED ARCHAEOLOGICAL MITTIGATION AREAS AND RECEPTOR LOCATIONS SHEET 3 OF 6

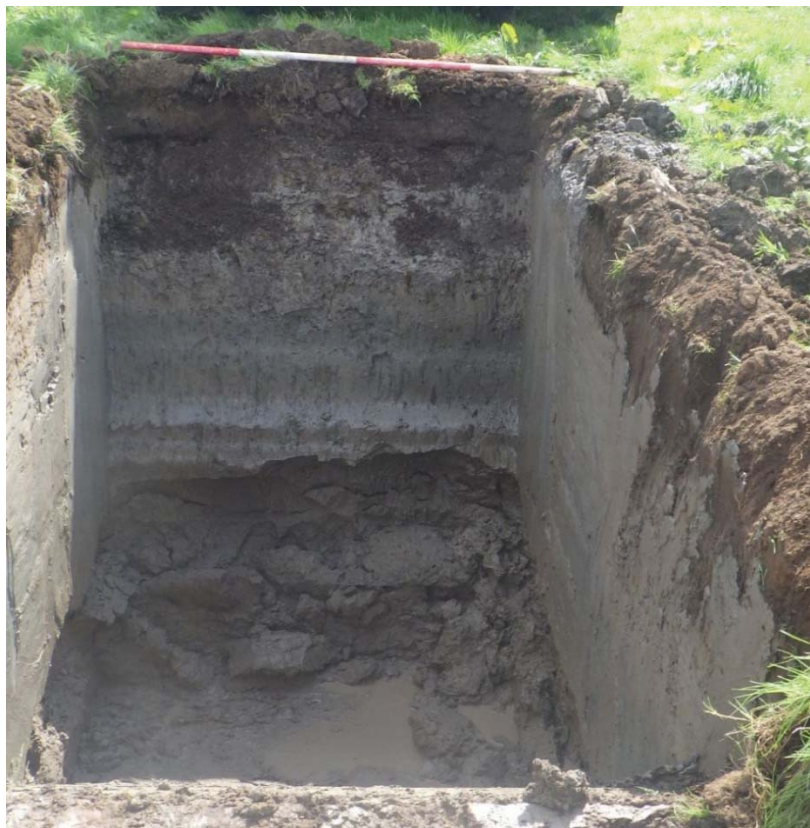
Plate 1: Topsoil over a thin layer of peat, sealing alluvium and tidal-flat deposits

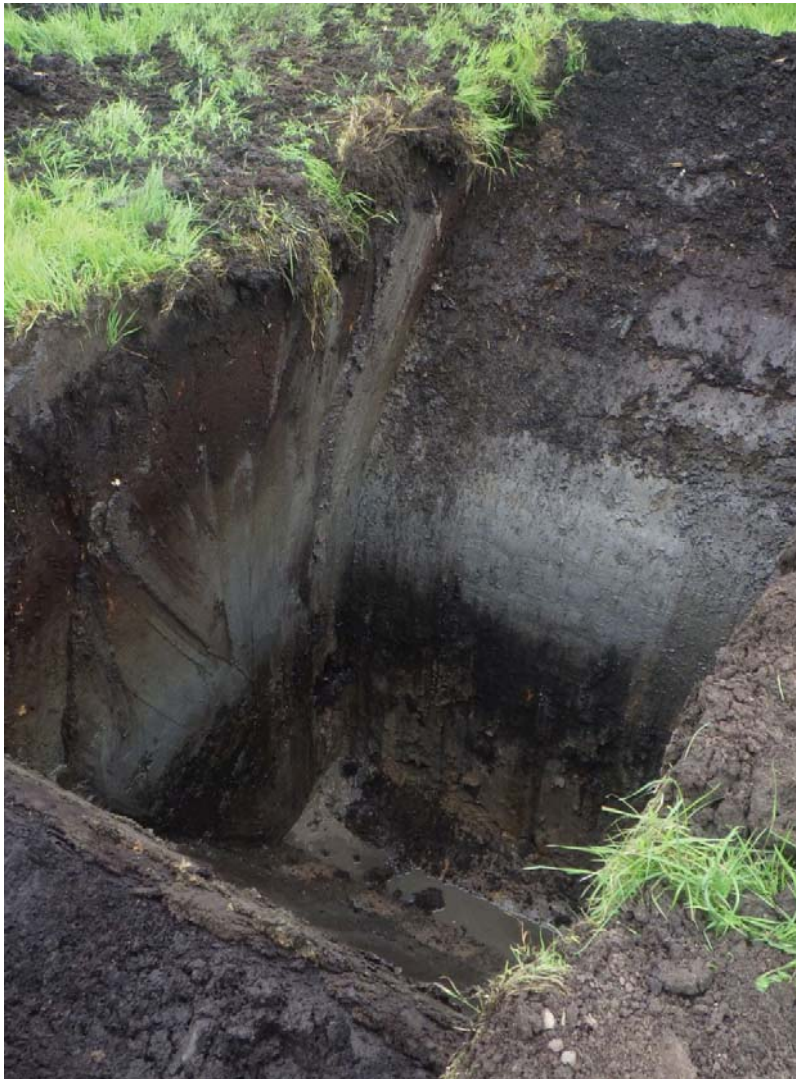
Plate 14: Trench 58 (western arm): shallow, concave feature with charcoal rich fills (1m scale)

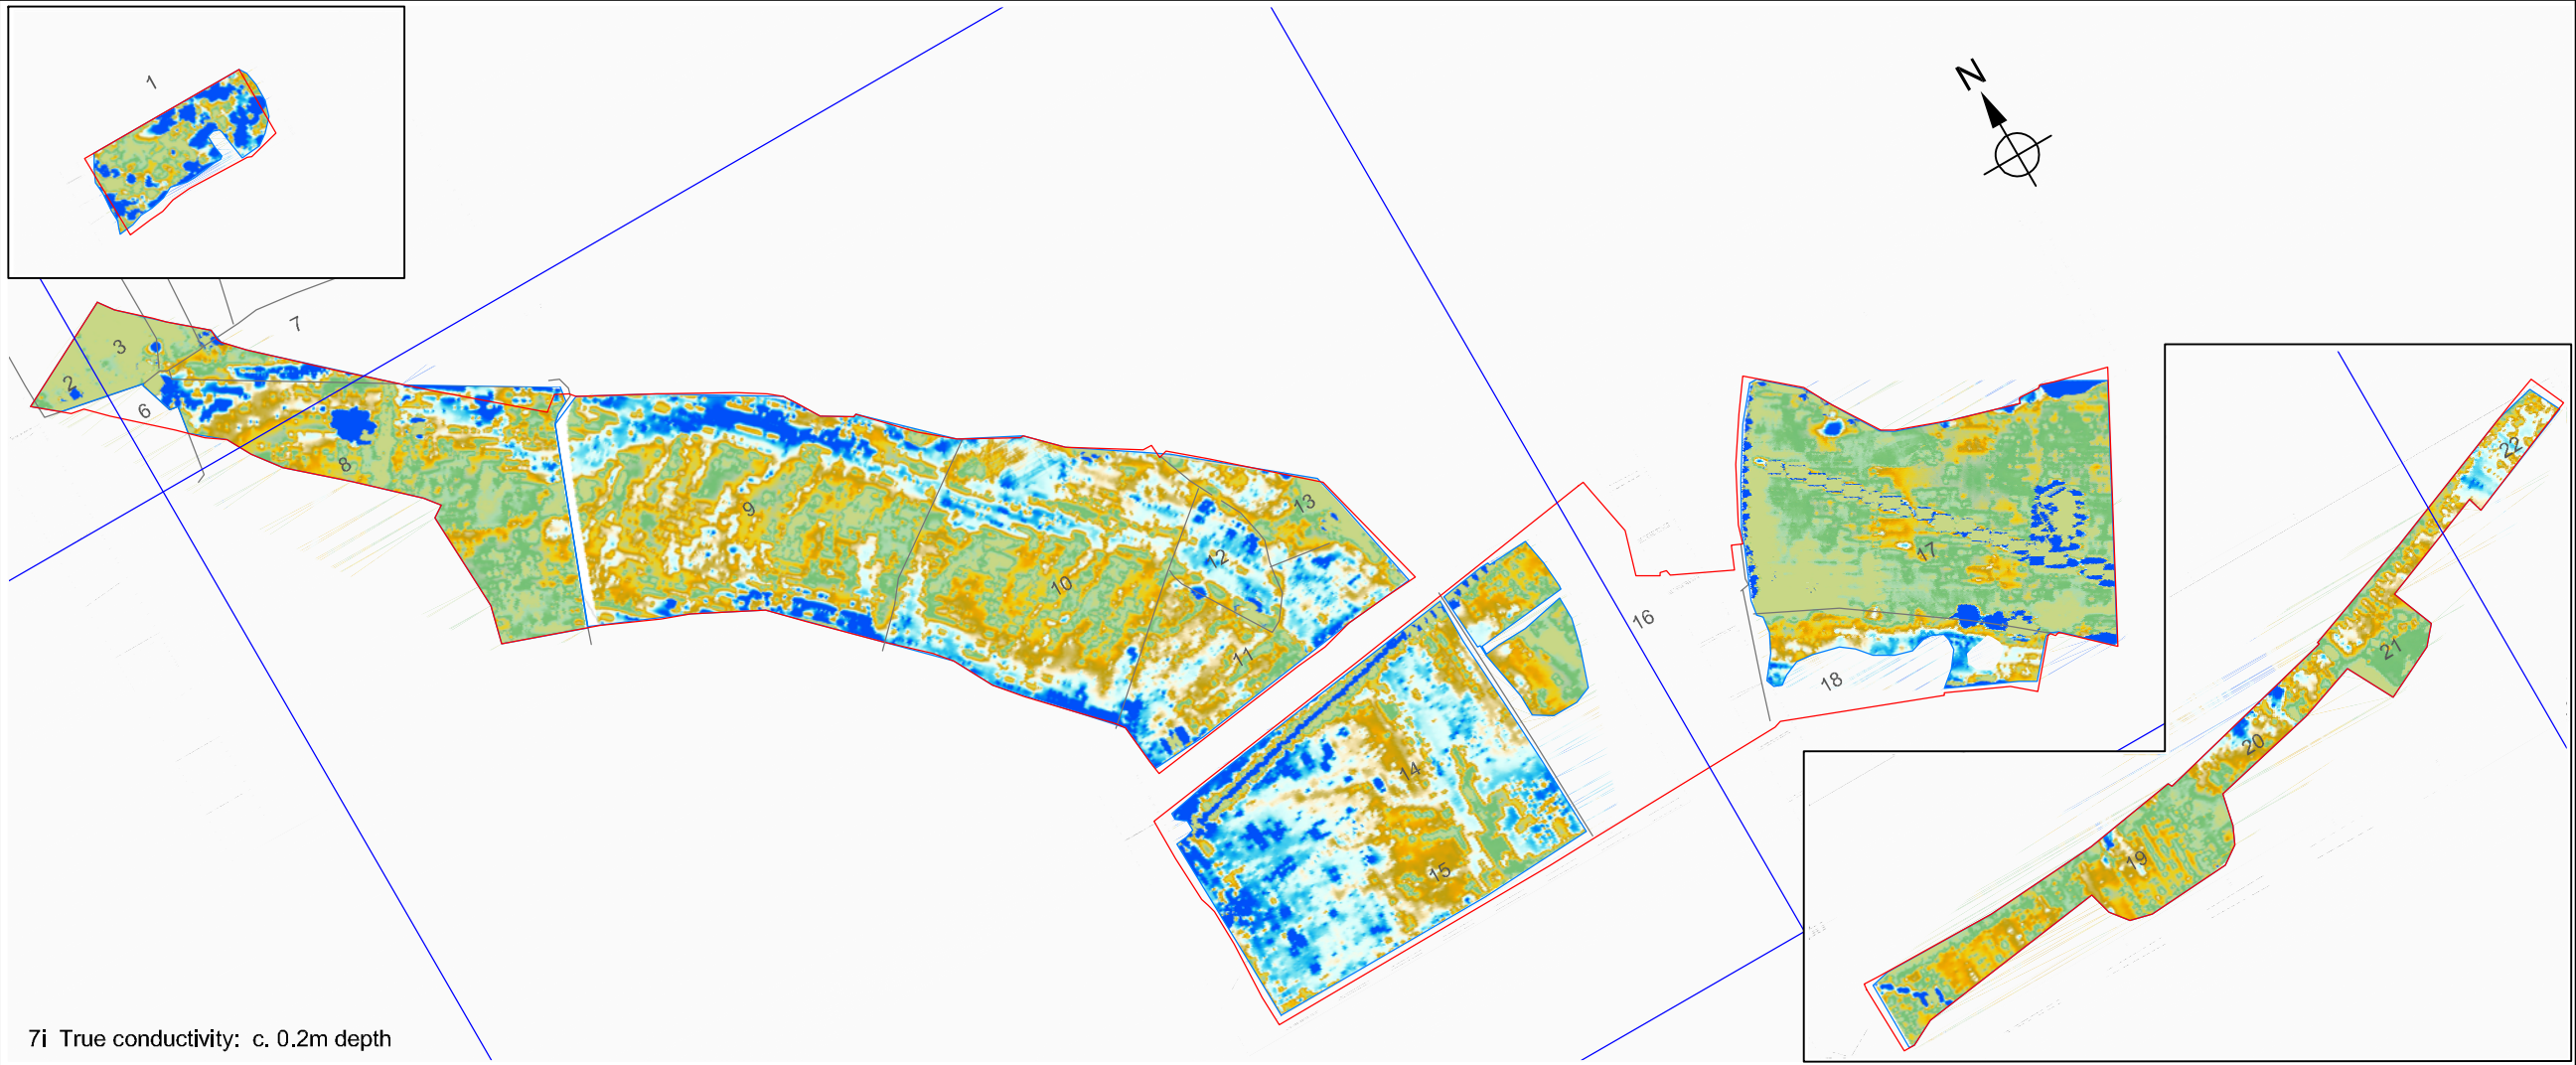
Figure 7

True conductivity  
(by numeric inversion:  
c. 0-2m and 4-6m depth)  
2/2
