M54 to M6 Link Road TR010054 Volume 6 6.3 Environmental Statement Appendices Appendix 7.1 Arboricultural Impact Assessment Report

6.3 Environmental Statement Appendices Appendix 7.1: Arboricultural Impact Assessment Report

Regulation Number	Regulation 5(2)(a)	
Planning Inspectorate Scheme	TR010054	
Reference		
Application Document Reference	6.3	
Author	M54 to M6 Link Road Project Team and	
	Highways England

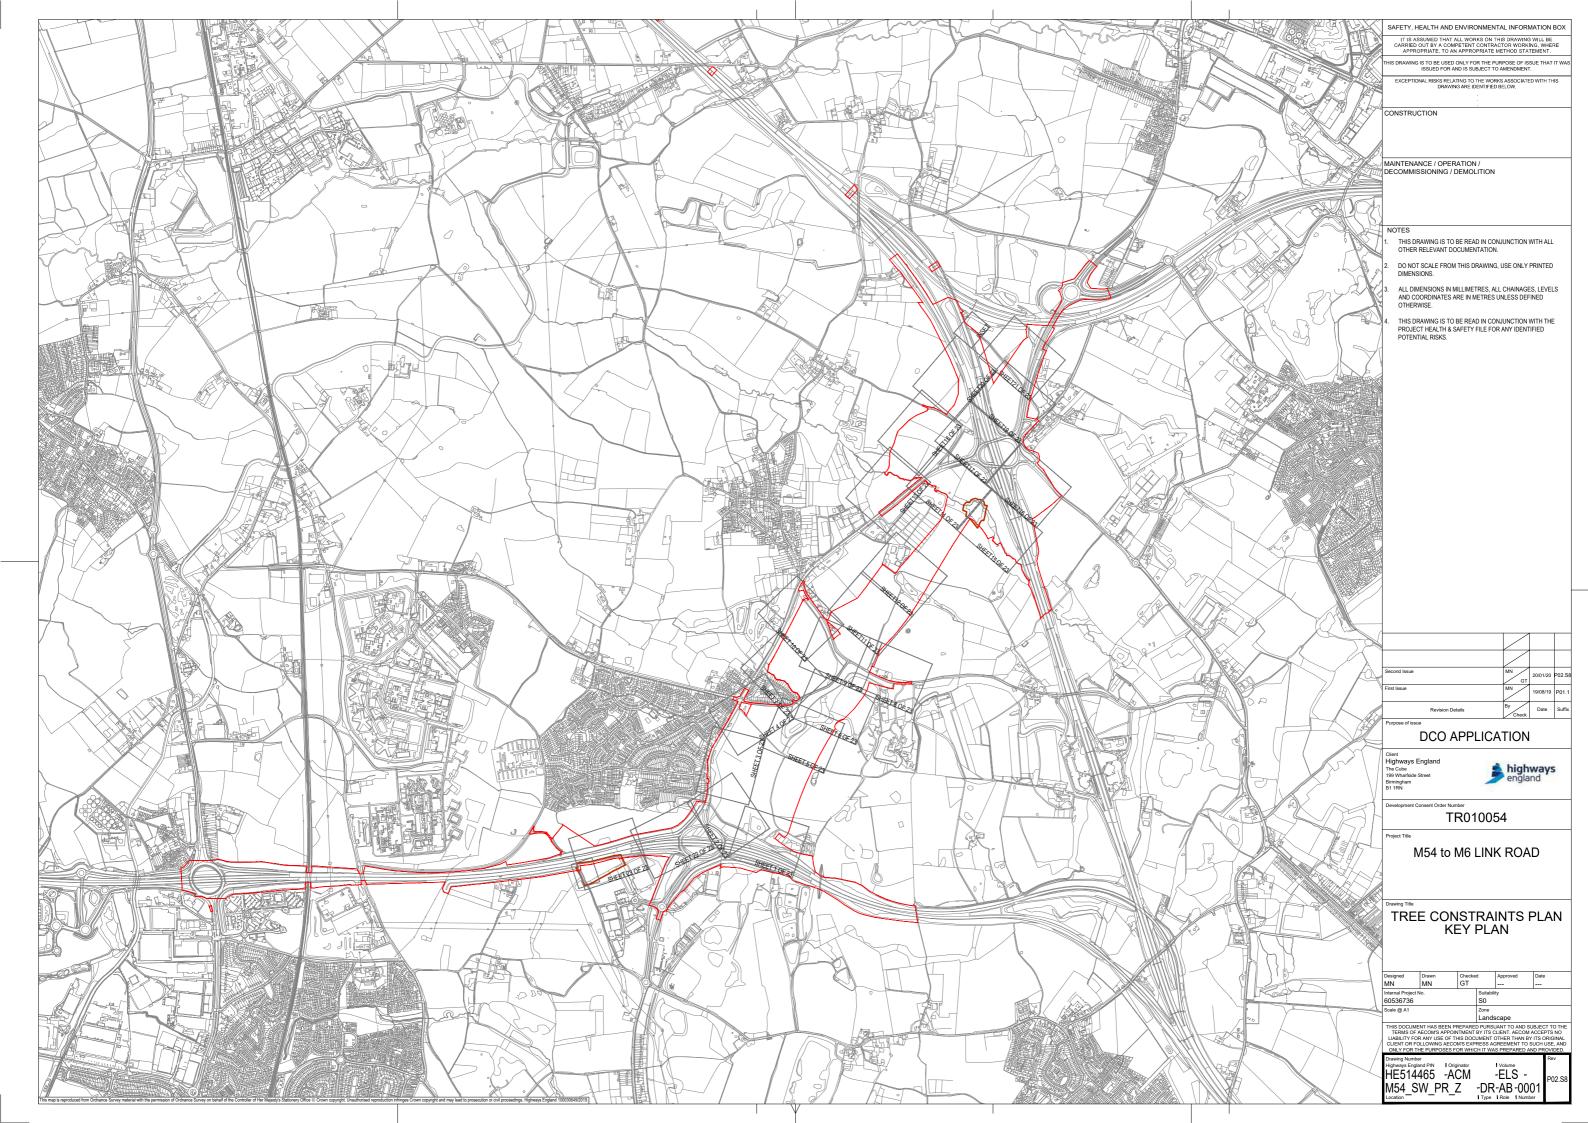
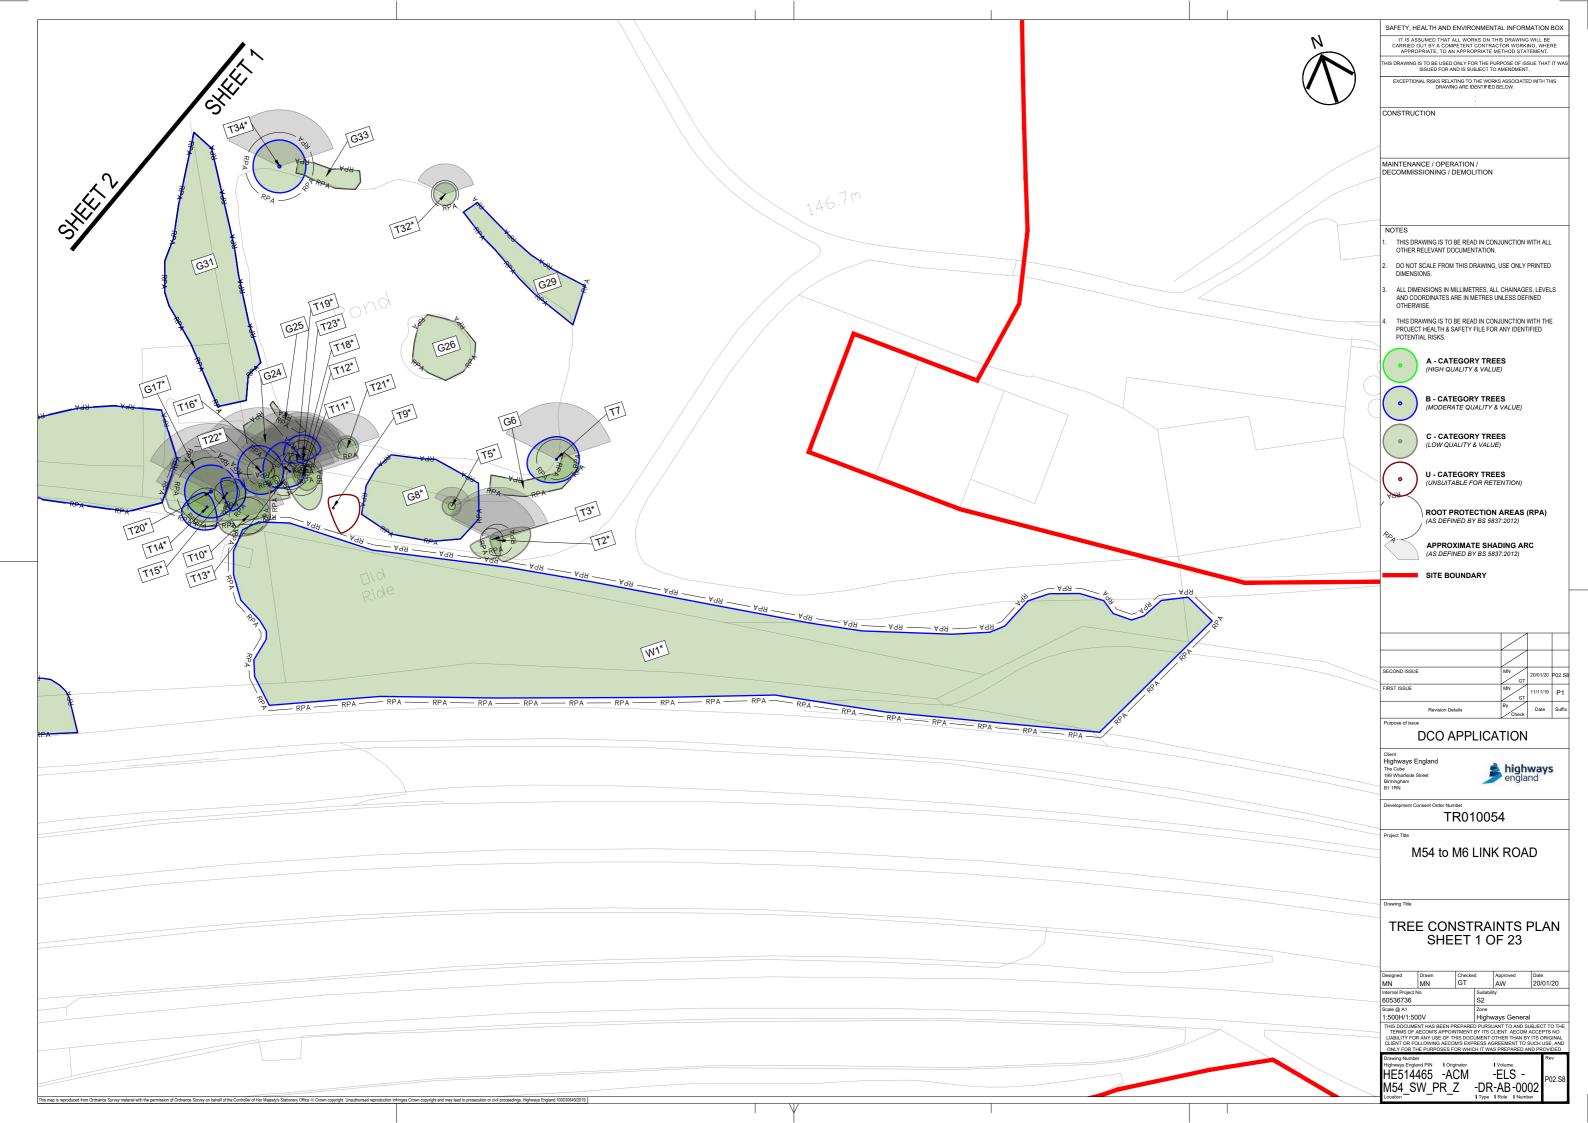
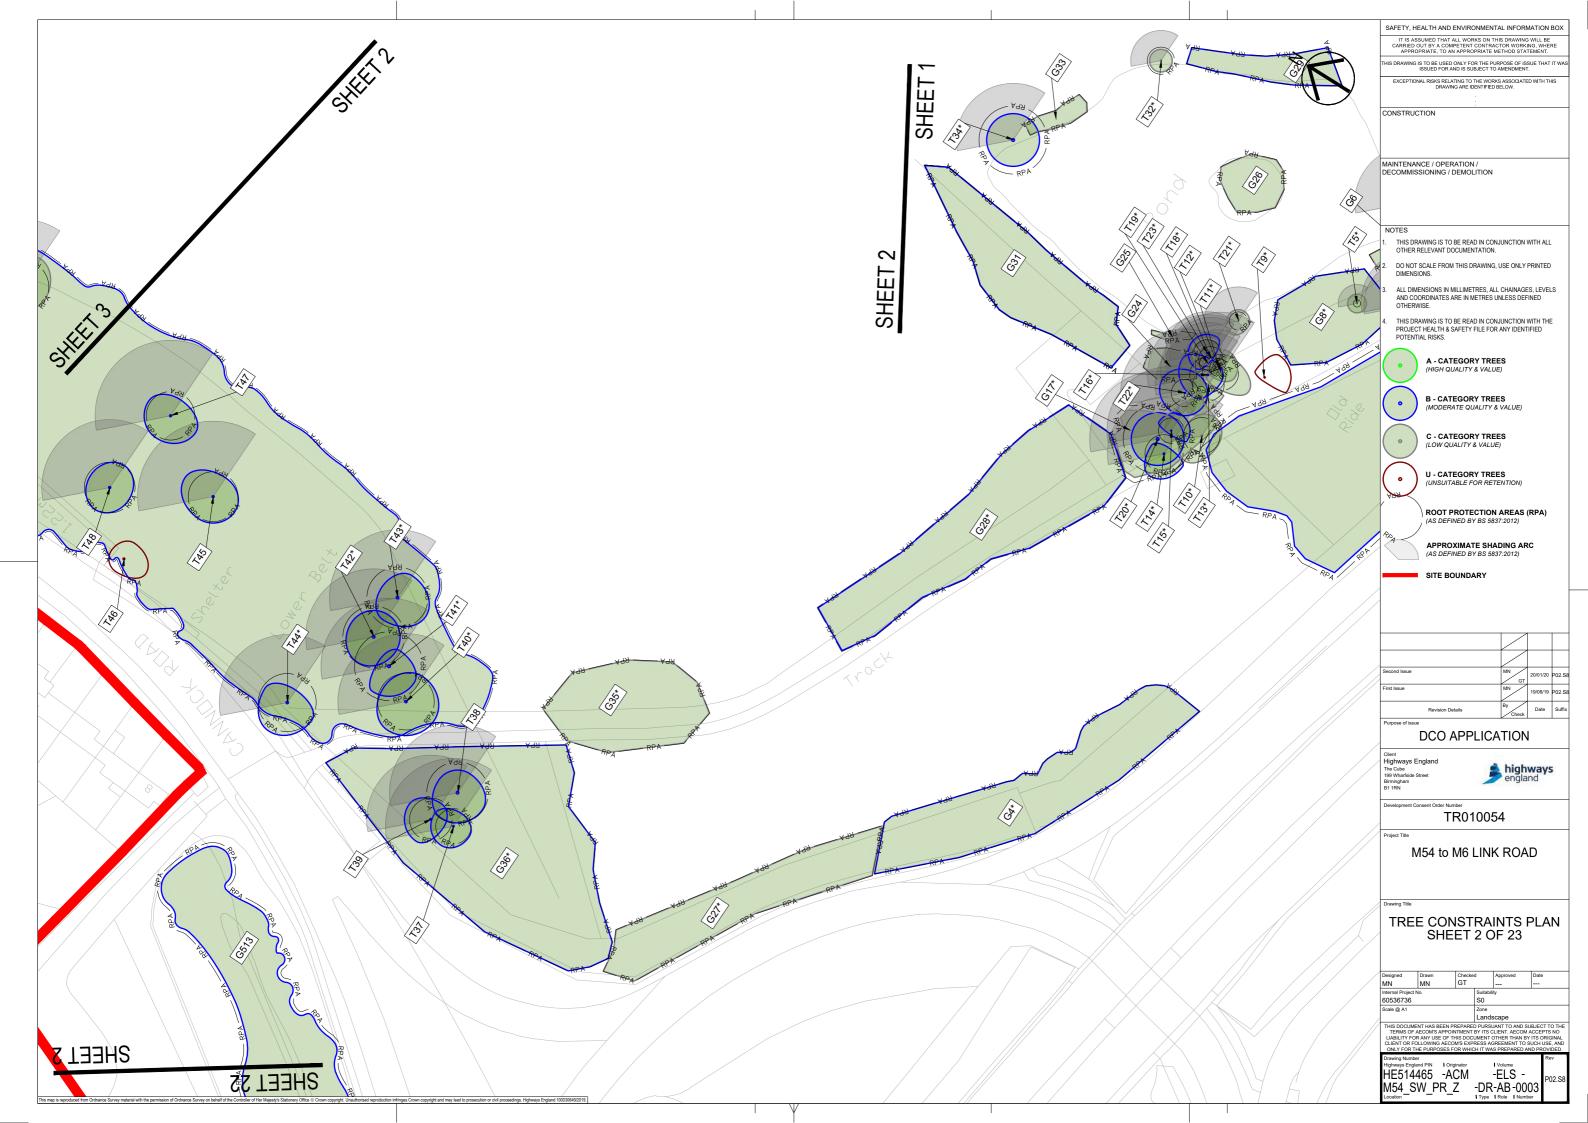
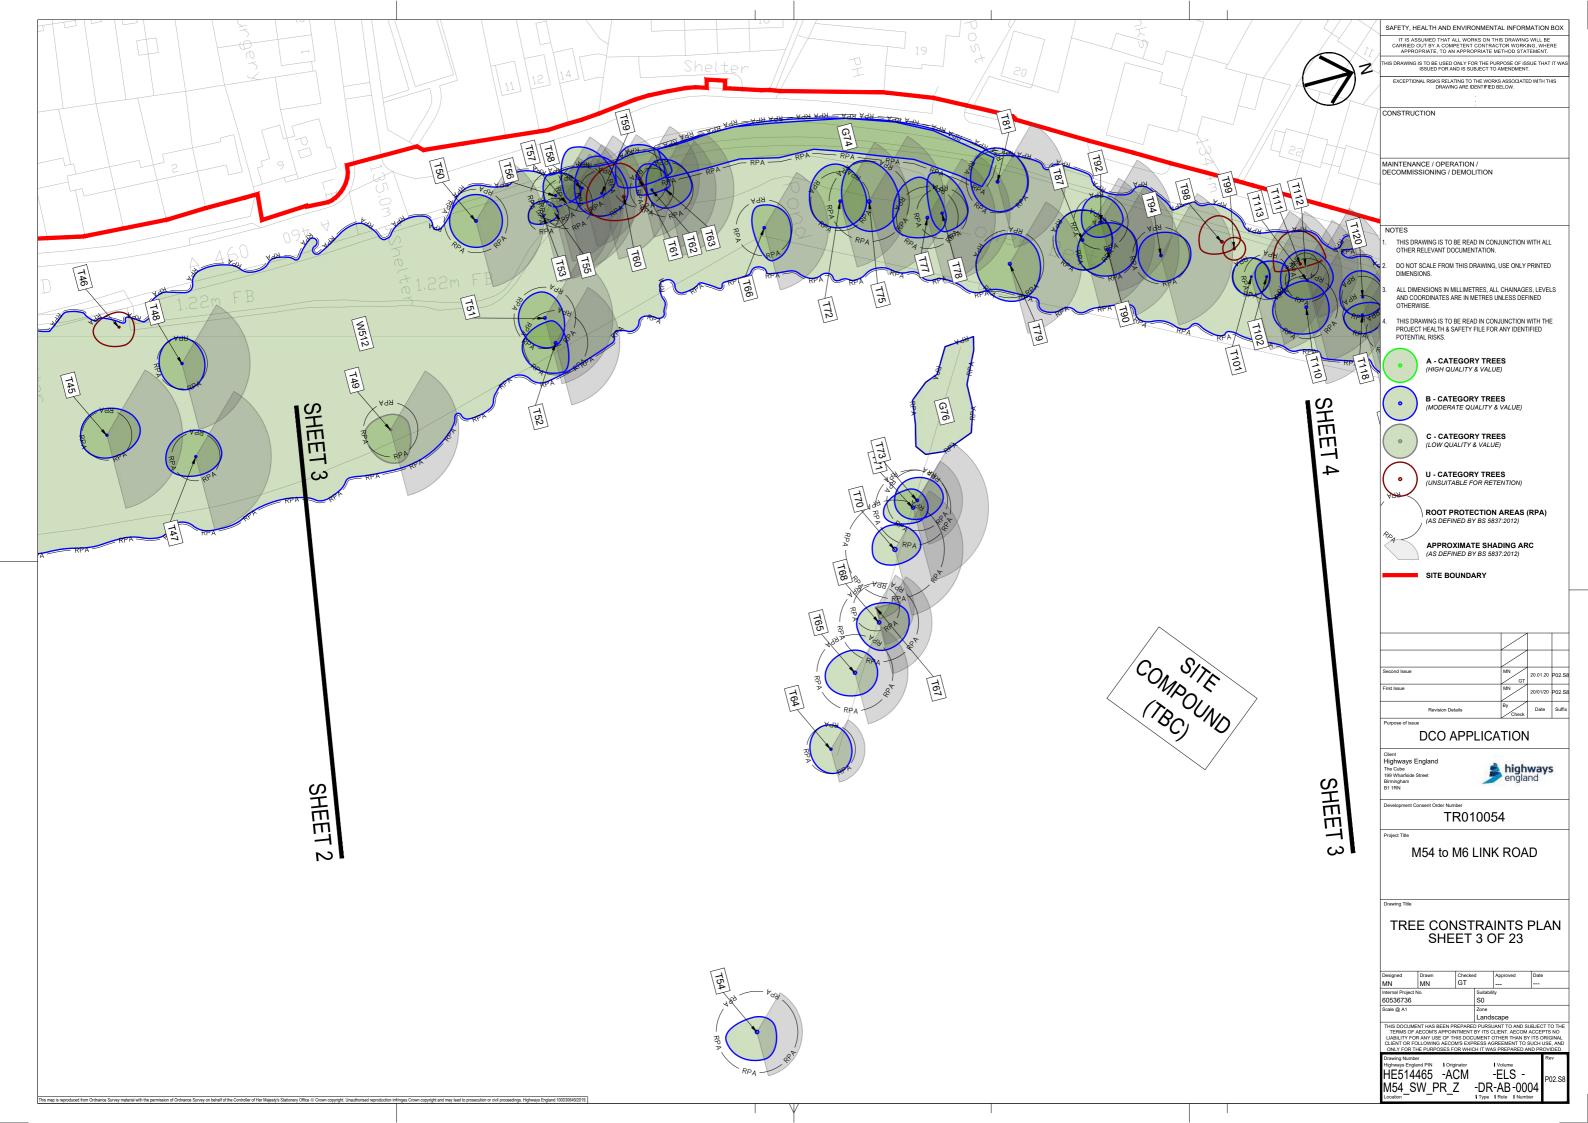
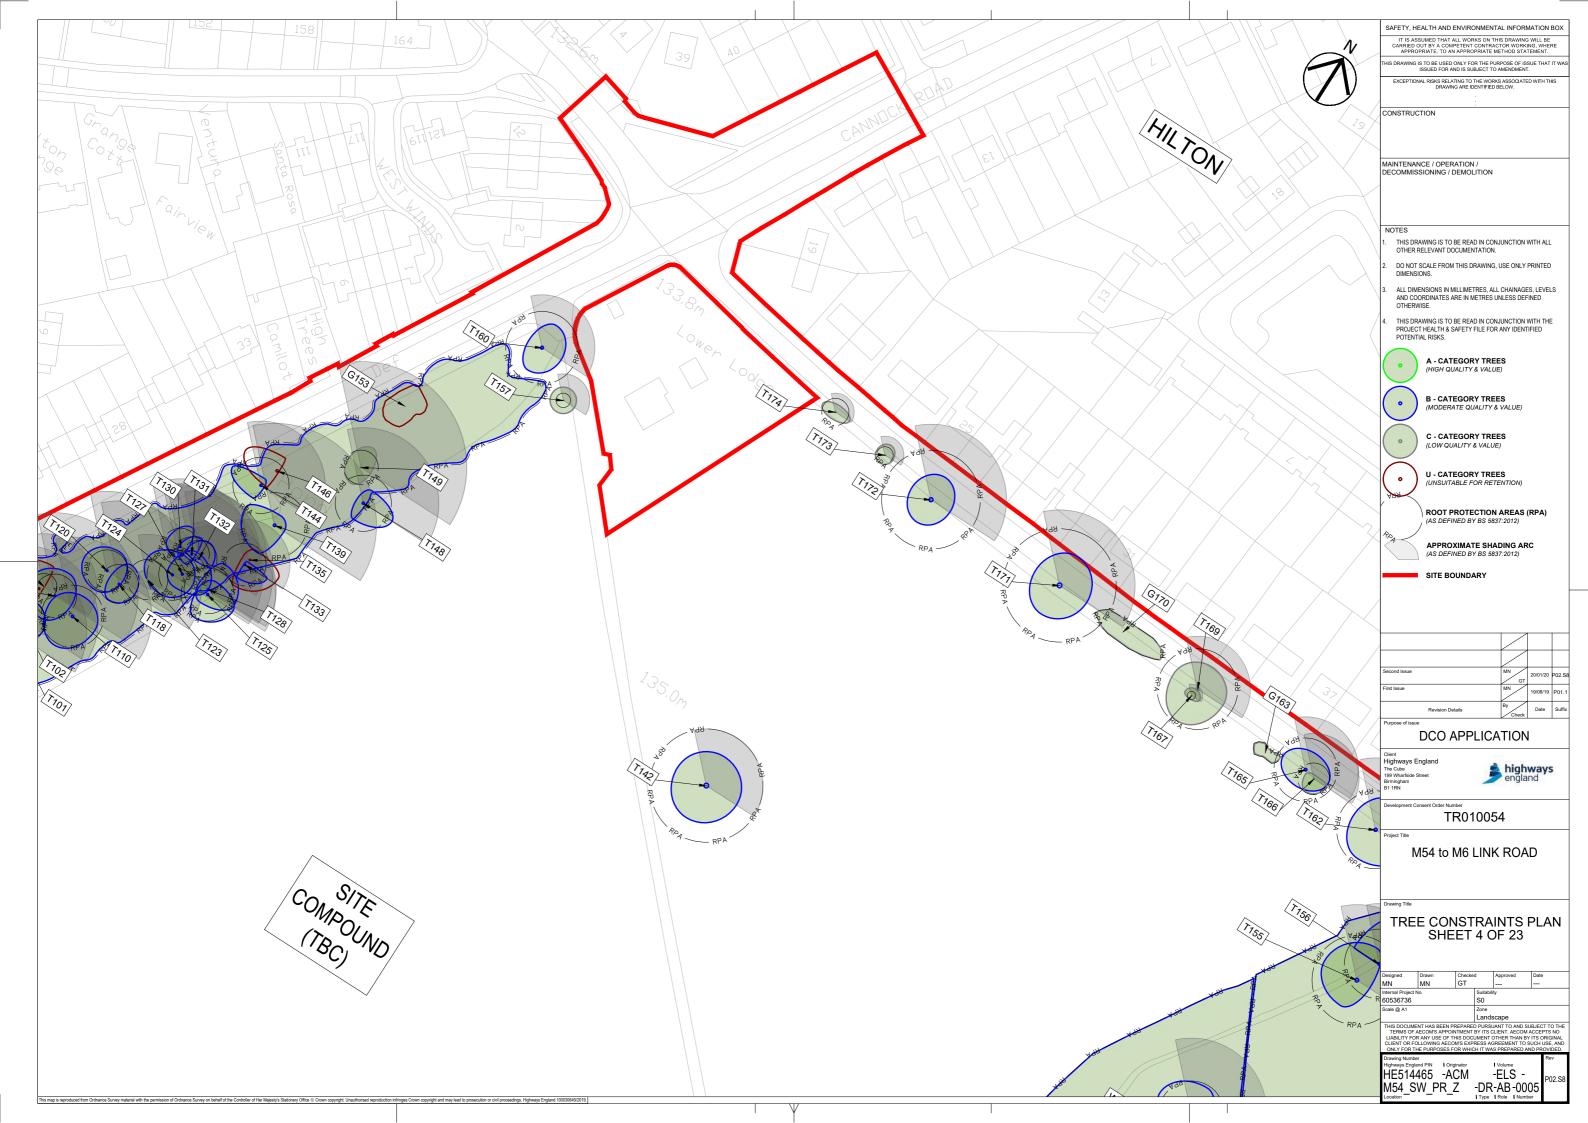
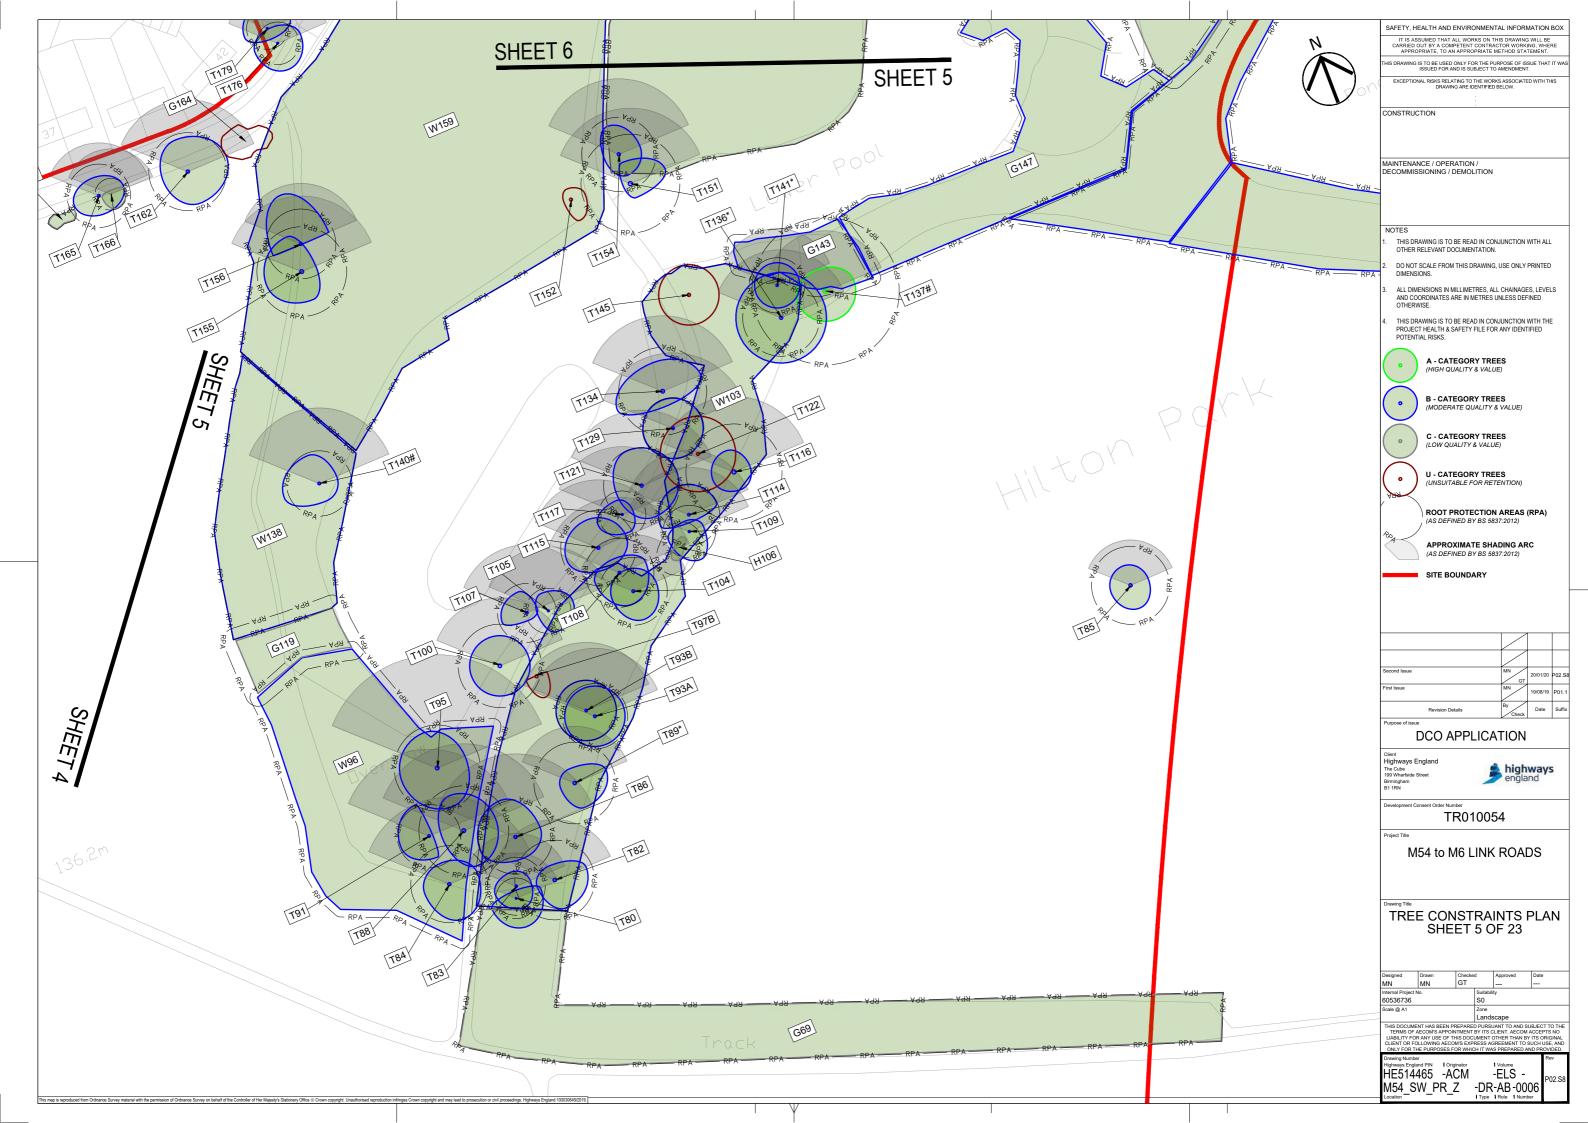
Annex A: Tree Constraints Plans (Key plan and Sheets 1 to 21

- 1.2.5. BS5837 recommends that a tree survey is undertaken to identify the quality and benefits of trees and the spatial constraints associated with them. This is then used to produce a Tree Constraints Plan showing the above and below ground constraints associated with trees. This drawing is used to inform the design process and to allow the retention of good quality trees where appropriate.

- a) the morphology and disposition of the roots, when influenced by past or existing site conditions (e.g. the presence of roads, structures and underground apparatus);
- b) topography and drainage;
- c) the soil type and structure;
- d) the likely tolerance of the tree to root disturbance or damage, based on factors such as species, age, condition and past management."
- 1.3.11. Where the RPA of trees have been adjusted these will be clearly illustrated on the TCP as being non-circular.

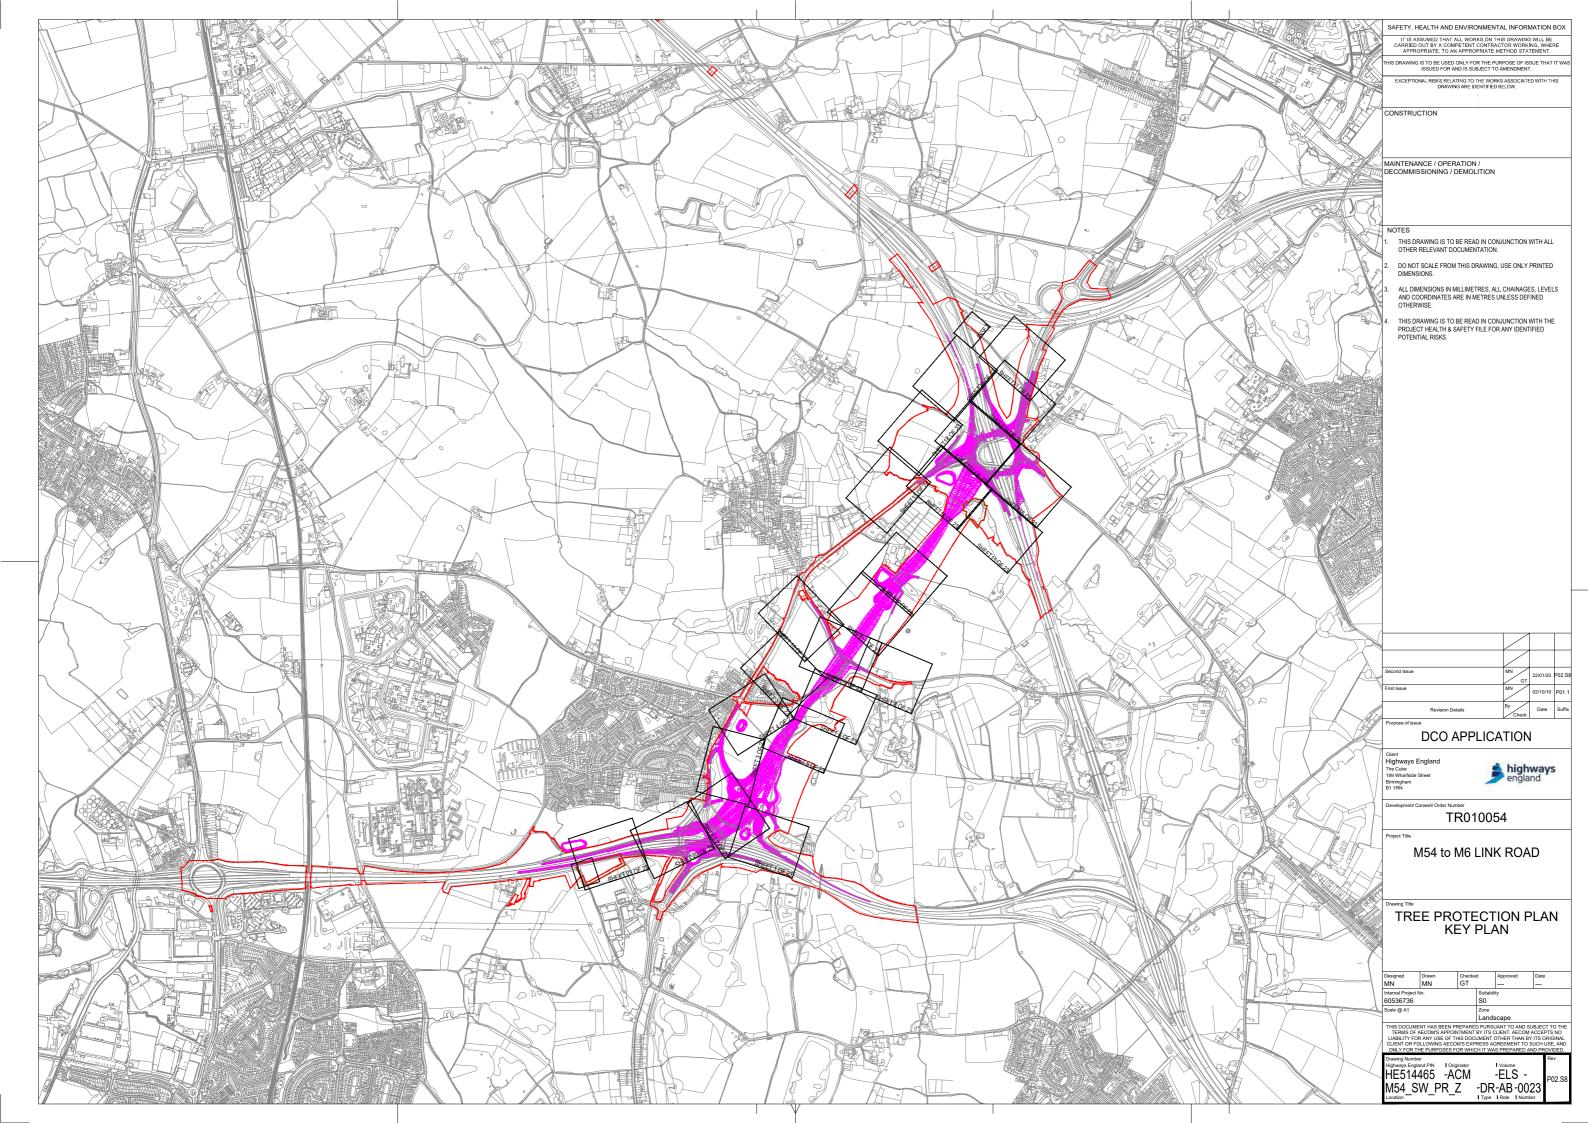
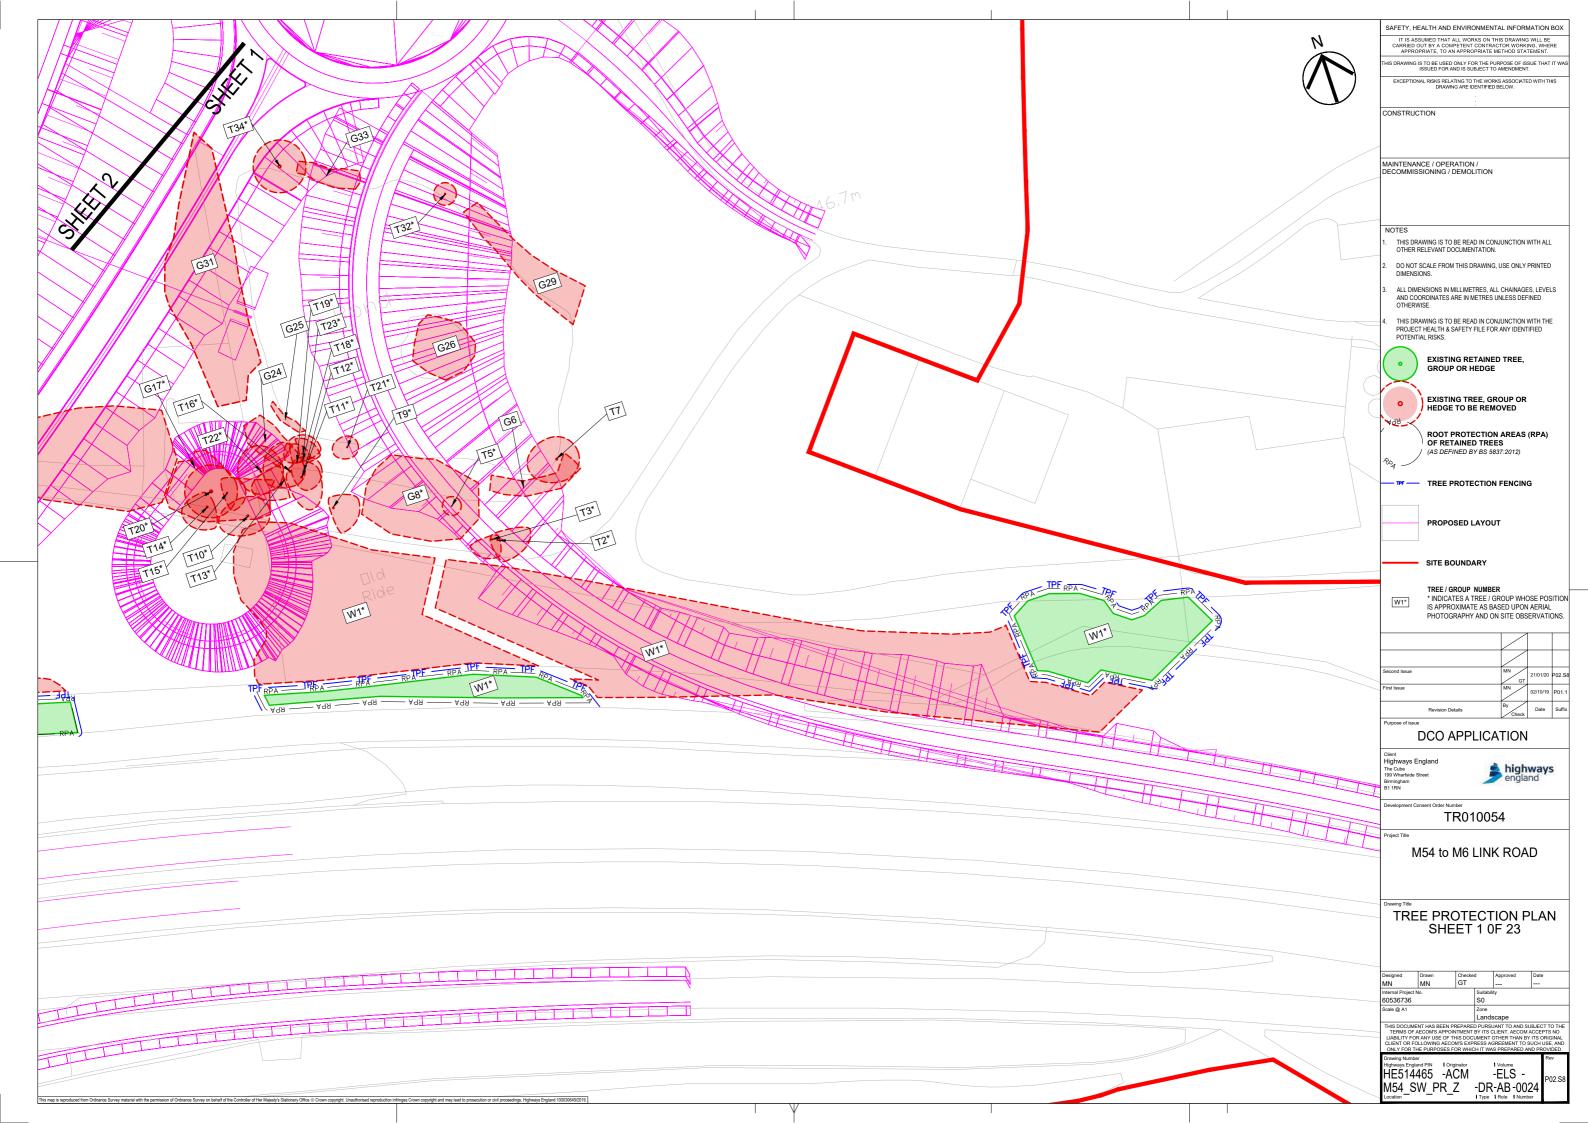
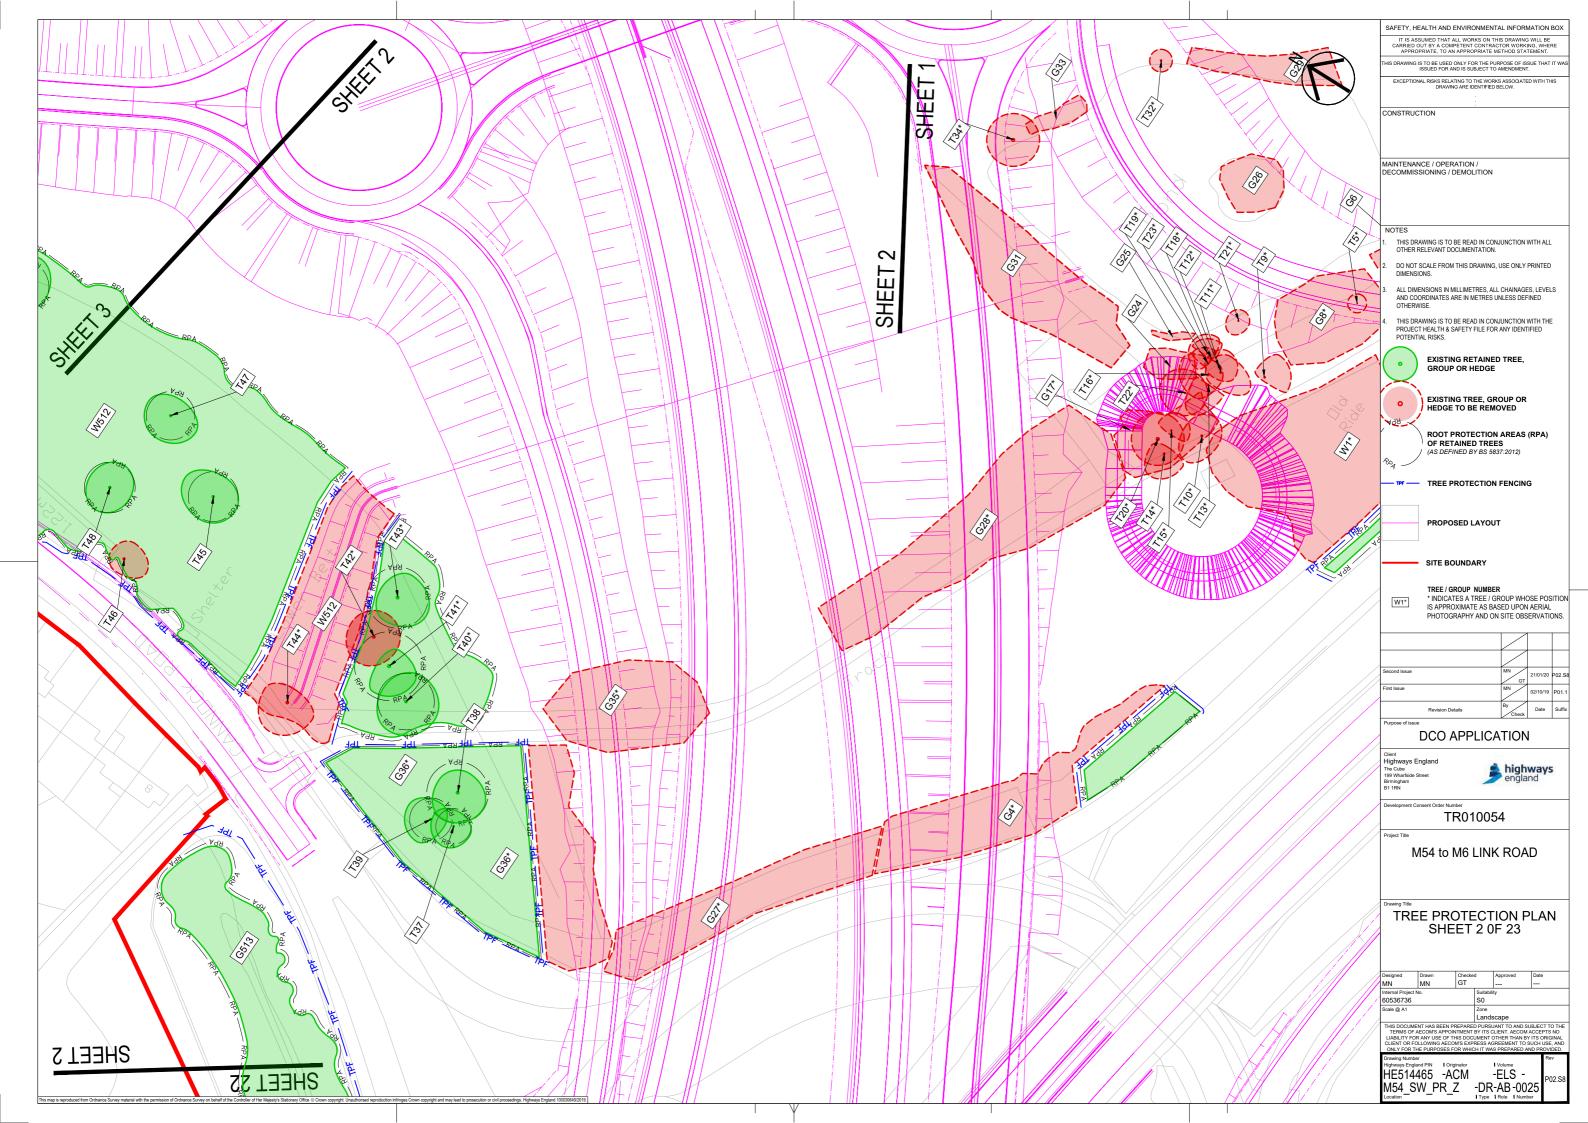
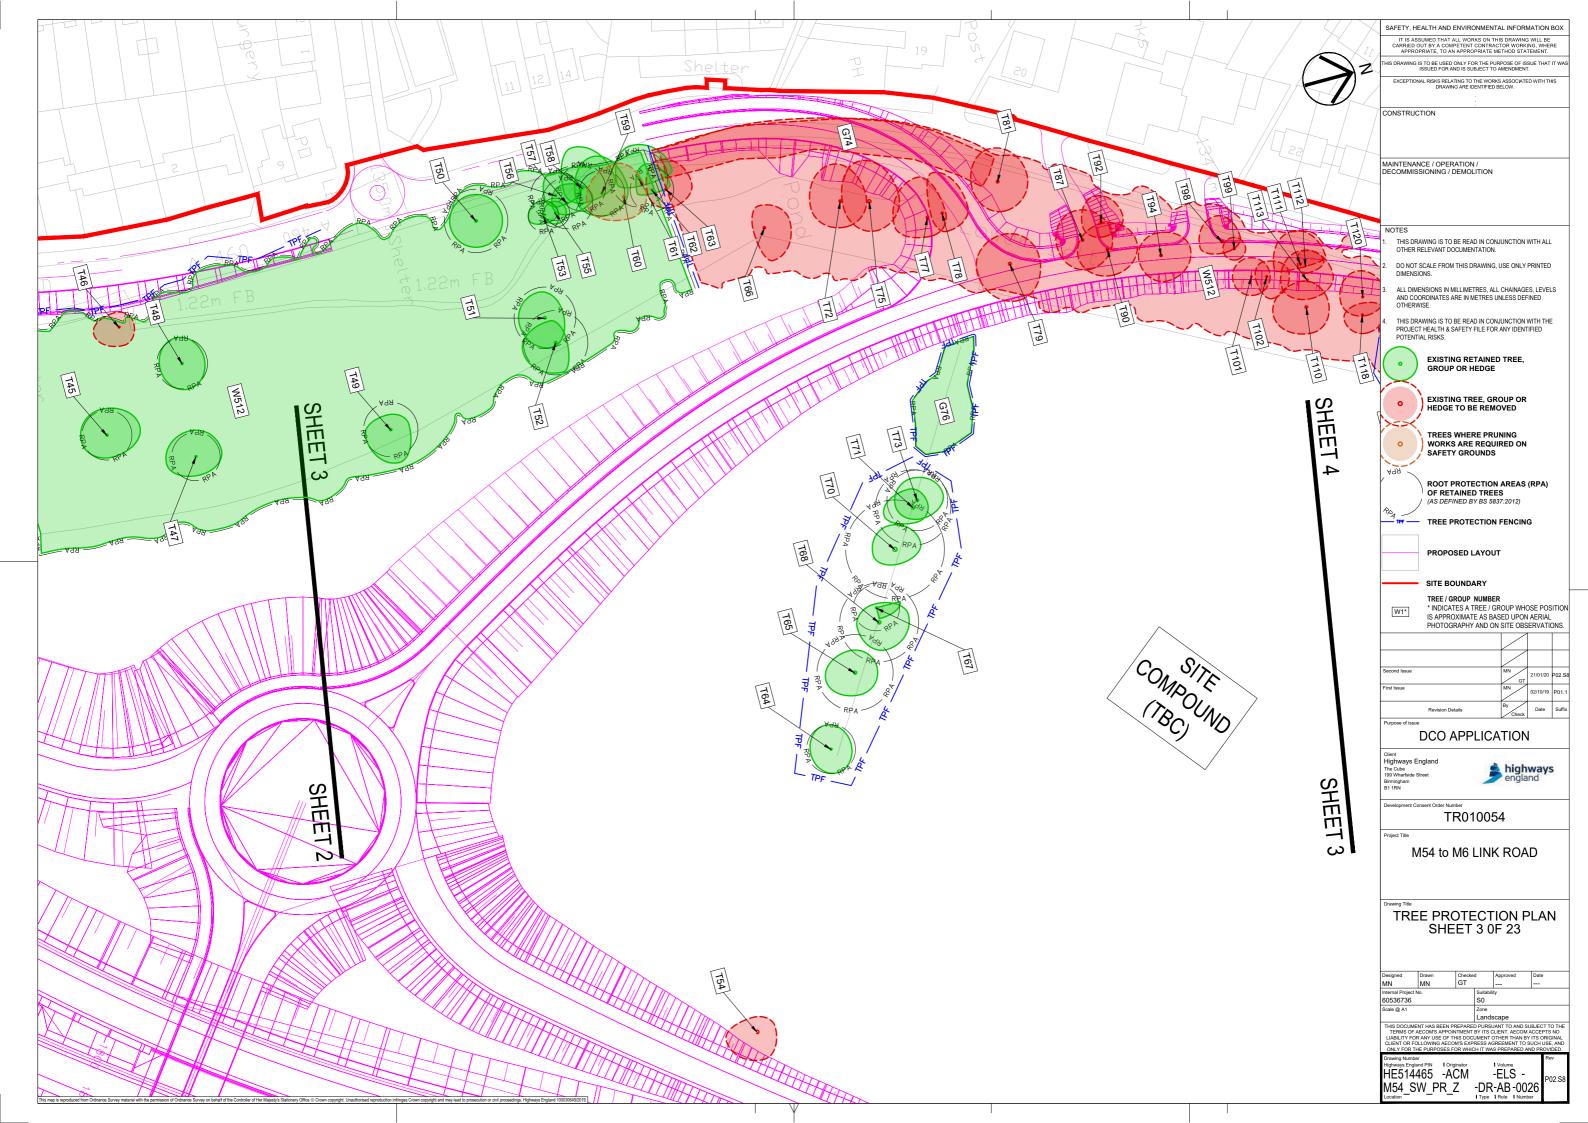
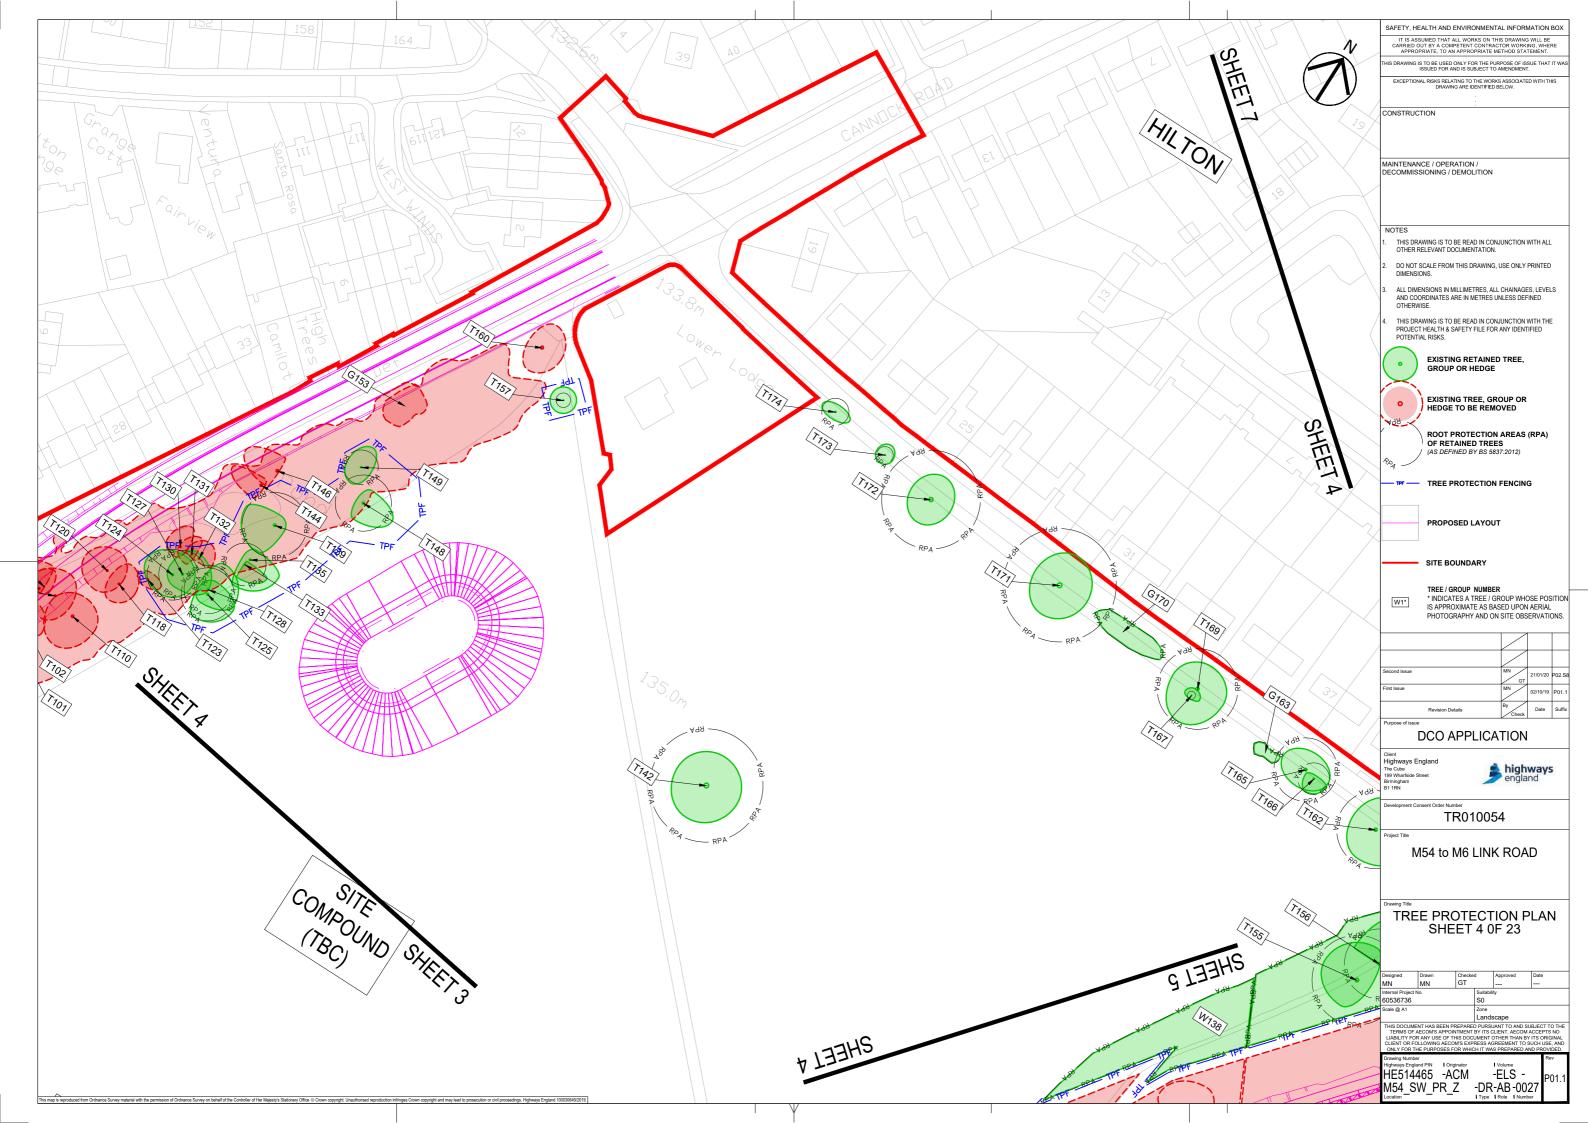
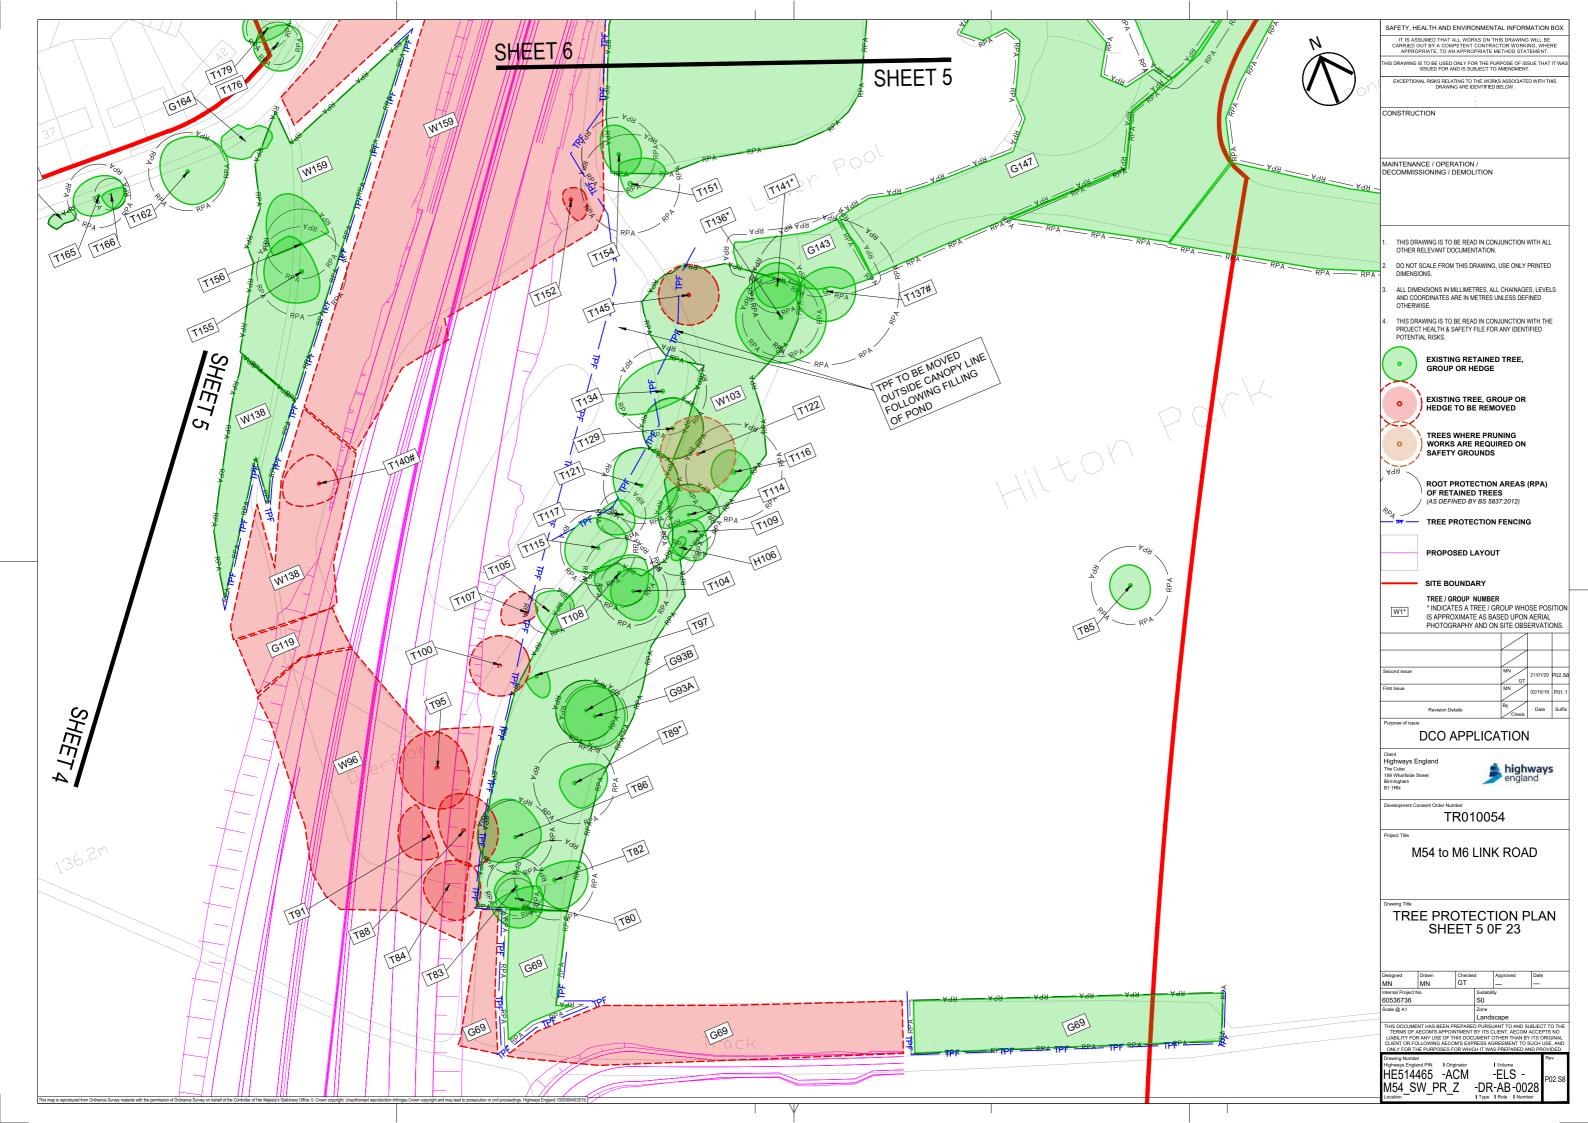
Annex C: Tree Protection Plans

- 1.2.6. An AIA is then developed to identify the likely direct and indirect impacts of the Proposed Development, and a Tree Protection Plan is prepared to identify trees to be removed or retained and to illustrate how retained trees are to be protected. An Arboricultural Method Statement is often required as a condition of planning consent to detail how sensitive operations are to be achieved in close proximity to retained trees. These elements are the minimum normally required for a planning application and are intended to ensure both a sustainable and harmonious relationship between trees and a new development.

5.6.1. Retained trees are vulnerable to damage from construction activities which can include physical damage to stems and branches following impacts with plant, root severance following trenching, root death or dysfunction following damage to soil structure, (caused by the movement of people or machinery on unsurfaced ground) or via the spillage of materials toxic to tree health. The default position is that the RPA and canopy spread of trees to be retained will form an effective Construction Exclusion Zone, secured with robust fencing where no access will be permitted. Where access is necessary within this area special measures, such as the use of ground protection and arboricultural supervision, are generally required. Positions of Tree Protection Fencing are shown on the Tree Protection Plans at Annex C.
