Project Title		A417 MISSING LINK	
Drawing Title			
FIGURE 7.11 ENVIRONMENTAL MASTERPLAN REG 5(2)(O) SHEET 8 OF 25			
Scale	1:1000	By	HS
Original Size	A1	Checked	AK
Date	21/05/21	Approved	SW
Date	21/05/21	Authorised	YB
Date	21/05/21	Revision	C01
Drawing Number	HE PIN	Originator	Volume
HE551505 - ARP	ARP	ELS	
X_XX_XXXX_X	-DR-LE-000063		
Location	Type	Role	Number

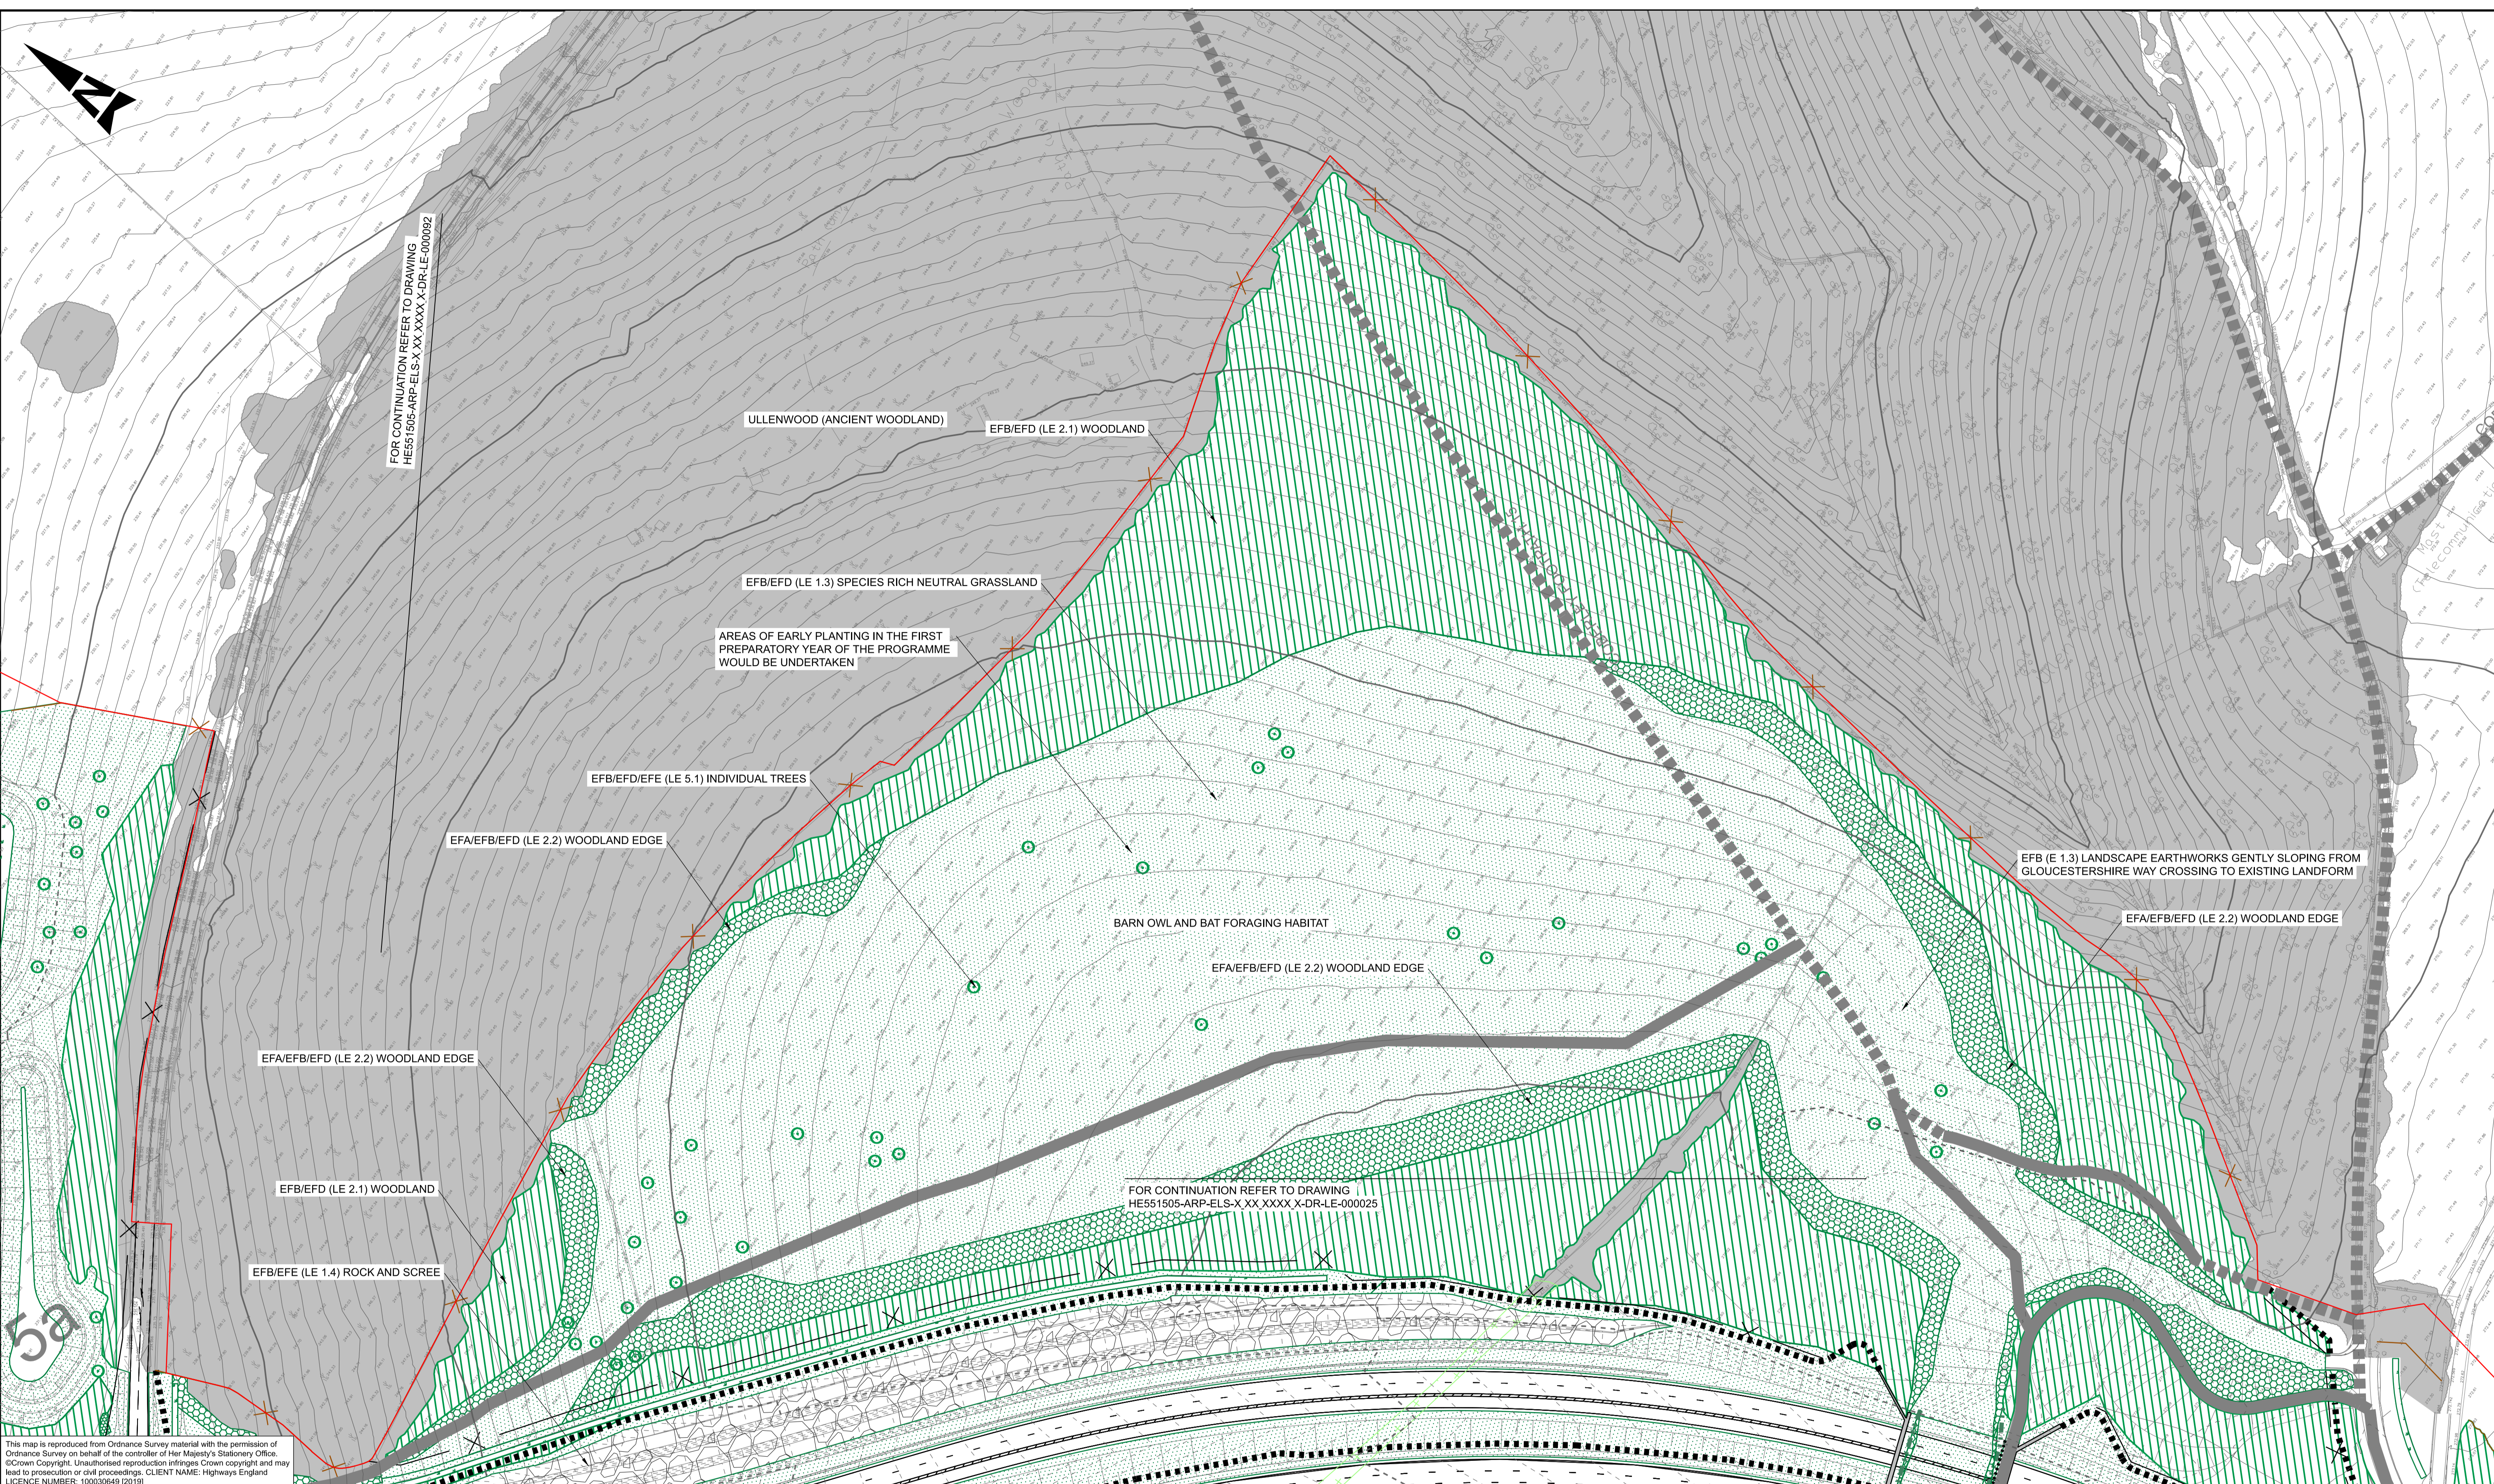
ULLENWOOD (ANCIENT WOODLAND) EFB/EFD (LE 2.1) WOODLAND

EFB/EFD (LE 1.3) SPECIES RICH NEUTRAL GRASSLAND

AREAS OF EARLY PLANTING IN THE FIRST
PREPARATORY YEAR OF THE PROGRAMME
WOULD BE UNDERTAKEN

EFB/EFD/EFE (LE 5.1) INDIVIDUAL TREES

EFA/EFB/EFD (LE 2.2) WOODLAND EDGE

EFB/EFD (LE 2.1) WOODLAND

EFB/EFE (LE 1.4) ROCK AND SCREE

BARN OWL AND BAT FORAGING HABITAT

EFB (E 1.3) LANDSCAPE EARTHWORKS GENTLY SLOPING FROM
GLOUCESTERSHIRE WAY CROSSING TO EXISTING LANDFORM
