A417 Missing Link  
TR010056

6.4 Environmental Statement  
Appendix 6.5 Trial Trenching Report  
Part 2 of 4

**6.4 Environmental Statement  
Appendix 6.5 Trial Trenching Report  
Part 2 of 4**

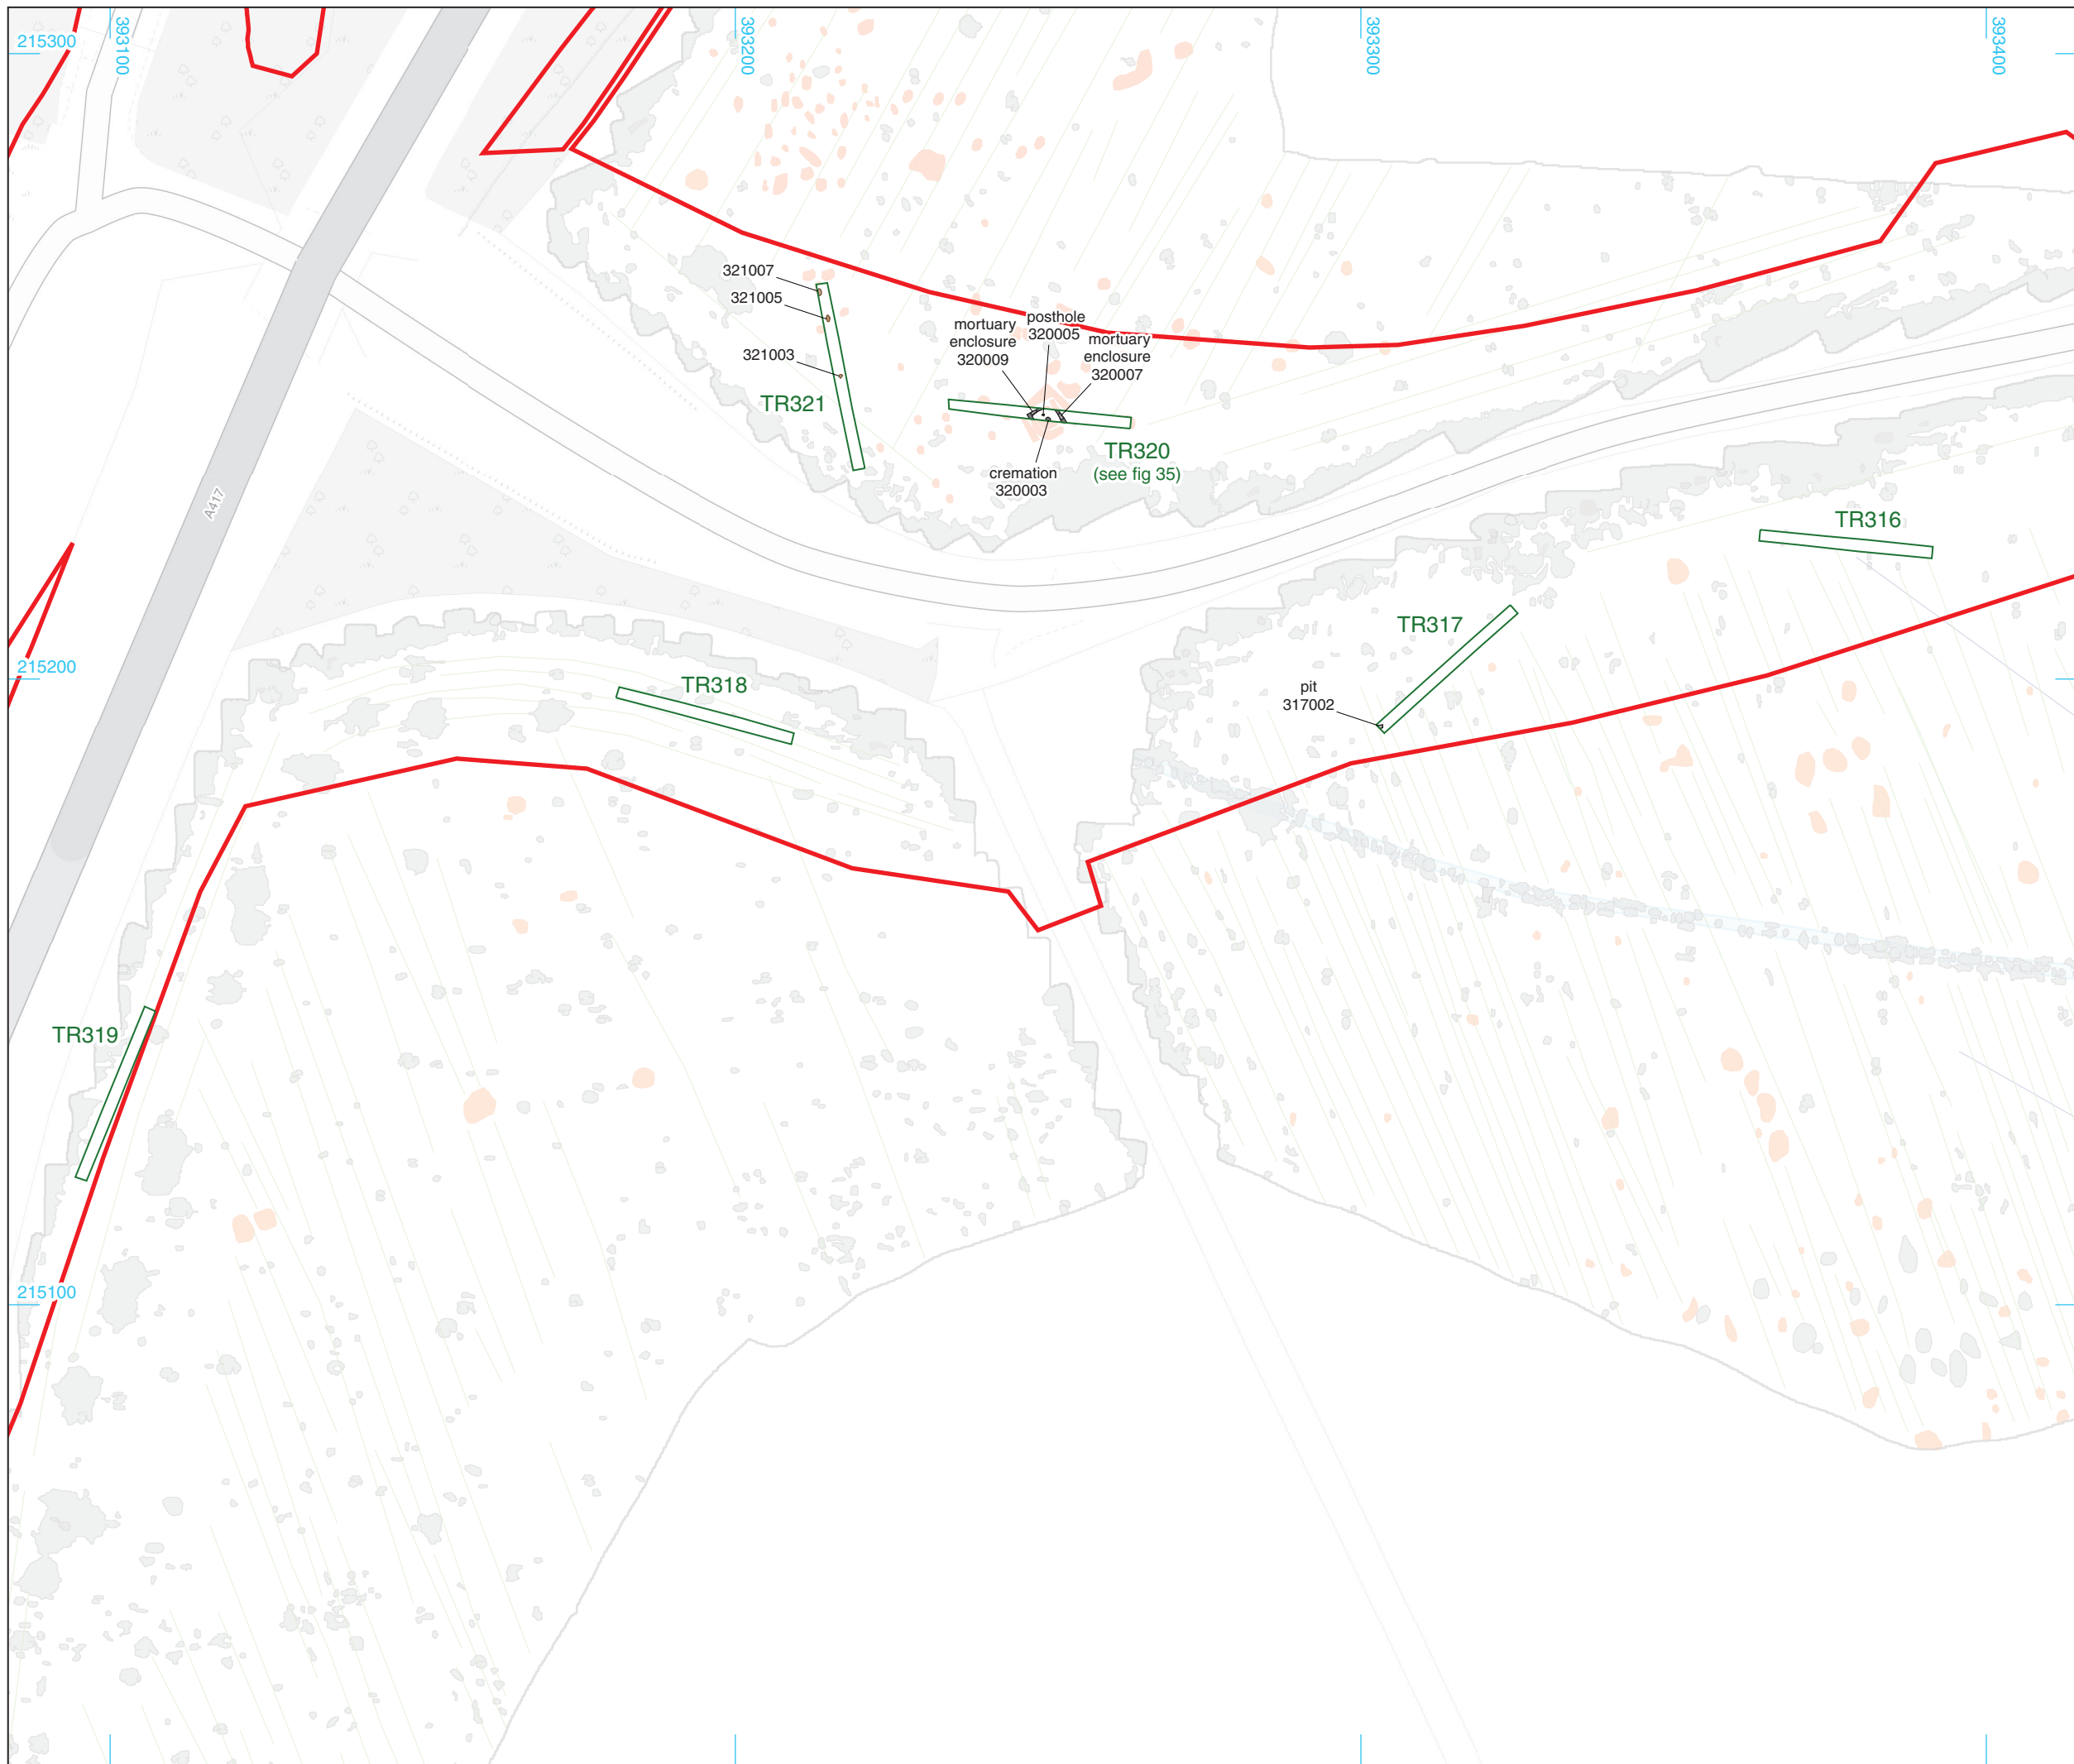
<small>DRAWN BY</small> RW	<small>PROJECT NO.</small> CR0463	<small>FIGURE NO.</small>
<small>CHECKED BY</small> DJB	<small>DATE</small> 03/02/2021	<b>13</b>
<small>APPROVED BY</small> DS	<small>SCALE@A3</small> 1:1000

**FIGURE TITLE**  
 Area 2 Field A, and trenches 316 to 319:  
 trench location plan showing archaeological  
 features and geophysical survey results

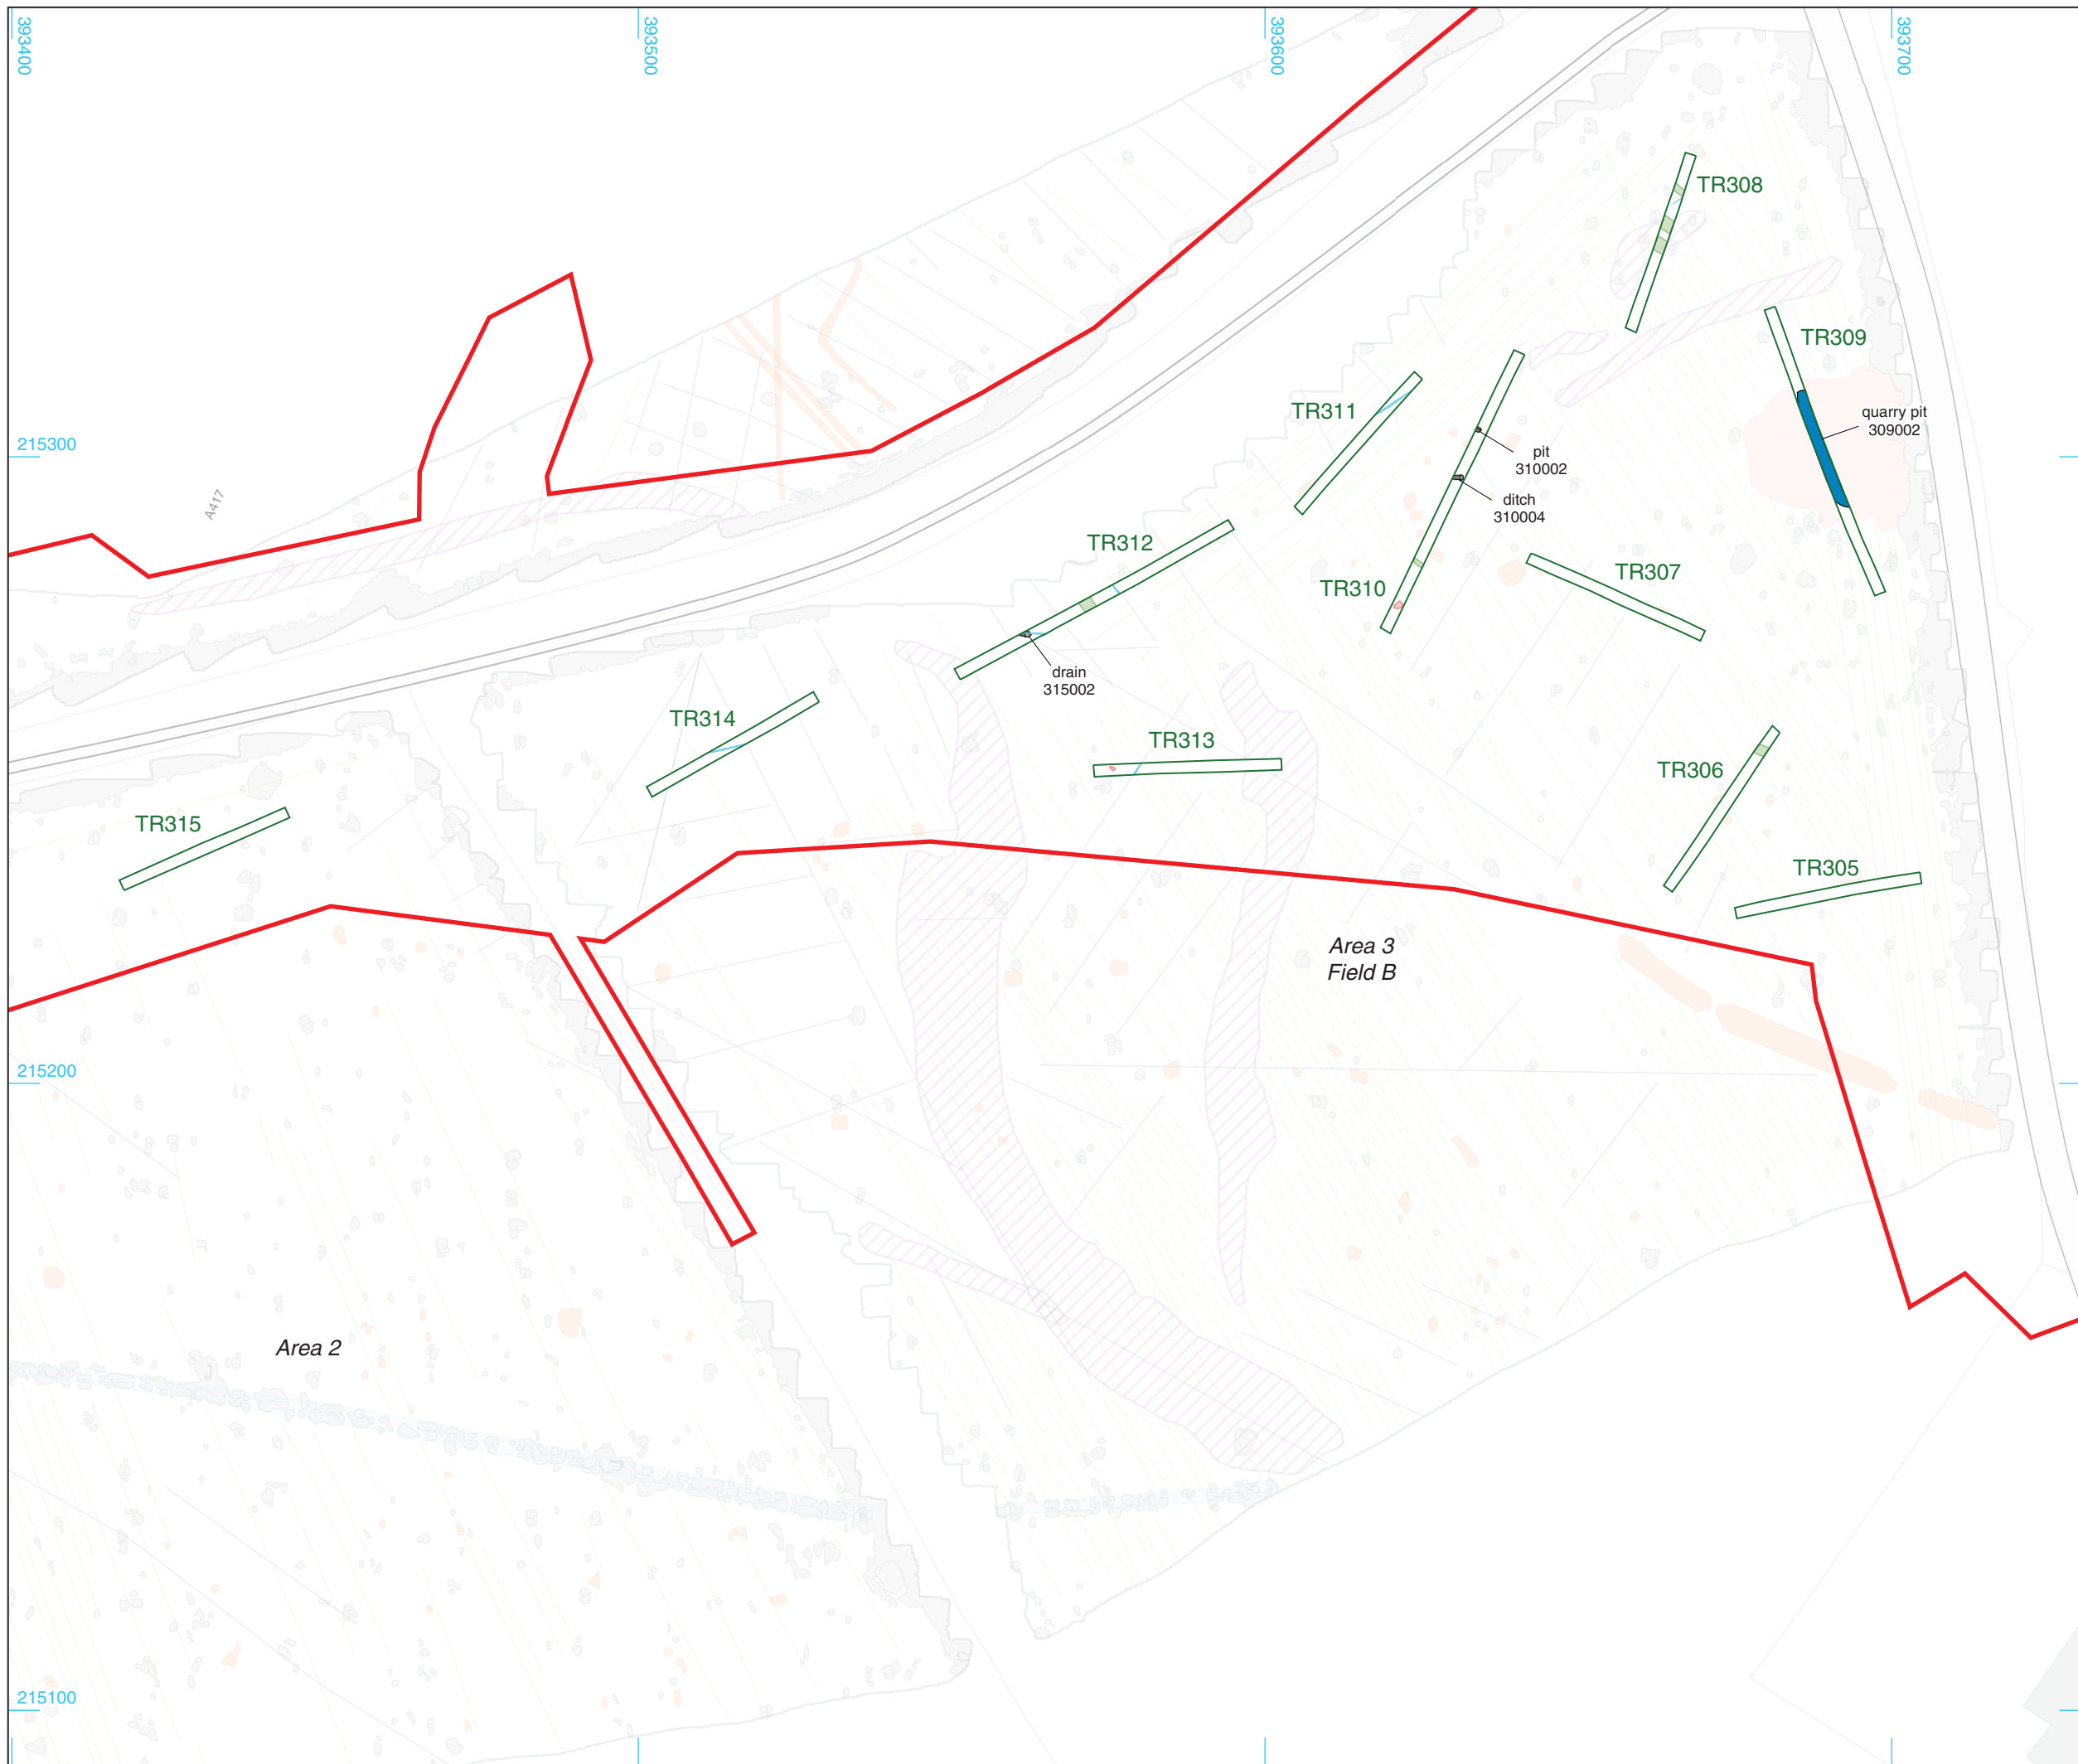
<small>DRAWN BY</small> RW	<small>PROJECT NO.</small> CR0463	<small>FIGURE NO.</small> 14
<small>CHECKED BY</small> DJB	<small>DATE</small> 03/02/2021	
<small>APPROVED BY</small> DS	<small>SCALE@A3</small> 1:1000

**FIGURE TITLE**  
 Area 3 Field B and trench 315: trench  
 location plan showing archaeological  
 features and geophysical survey results

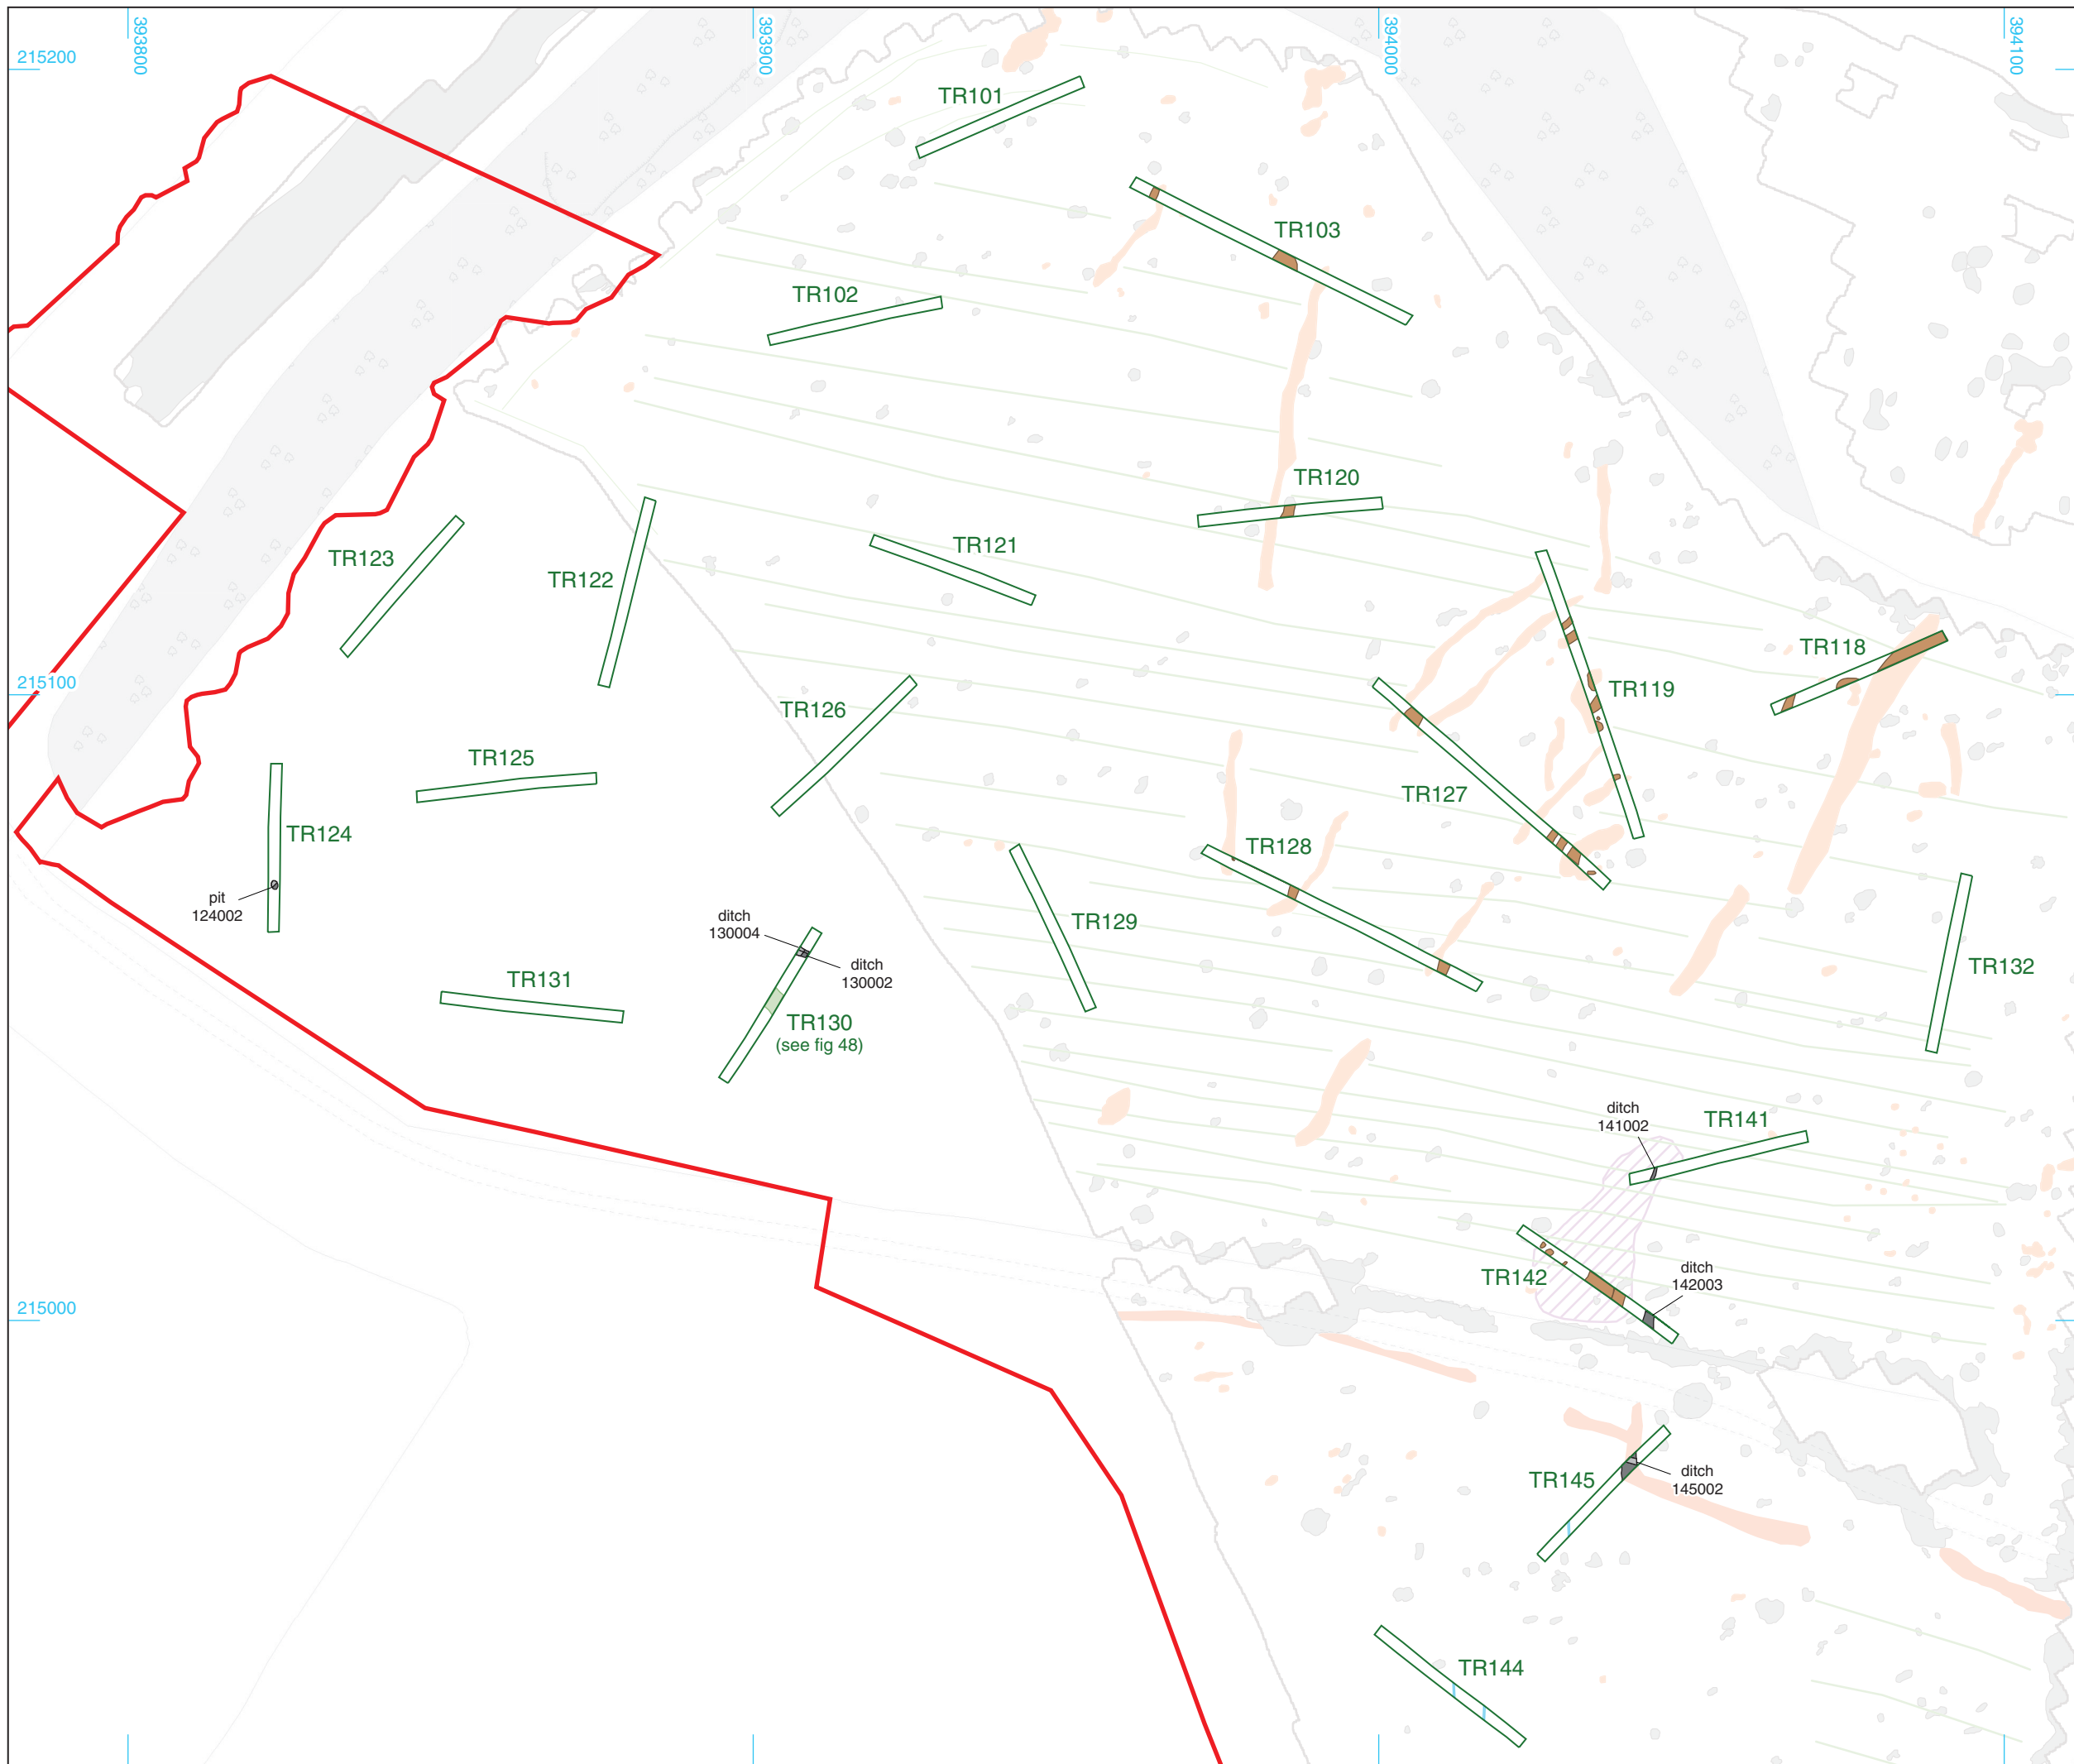
<b>DRAWN BY</b> RW	<b>PROJECT NO.</b> CR0463	<b>FIGURE NO.</b>
<b>CHECKED BY</b> DJB	<b>DATE</b> 03/02/2021	<b>15</b>
<b>APPROVED BY</b> DS	<b>SCALE@A3</b> 1:1000

**FIGURE TITLE**  
 Area 3 Field A: trench location plan showing  
 archaeological features and geophysical  
 survey results

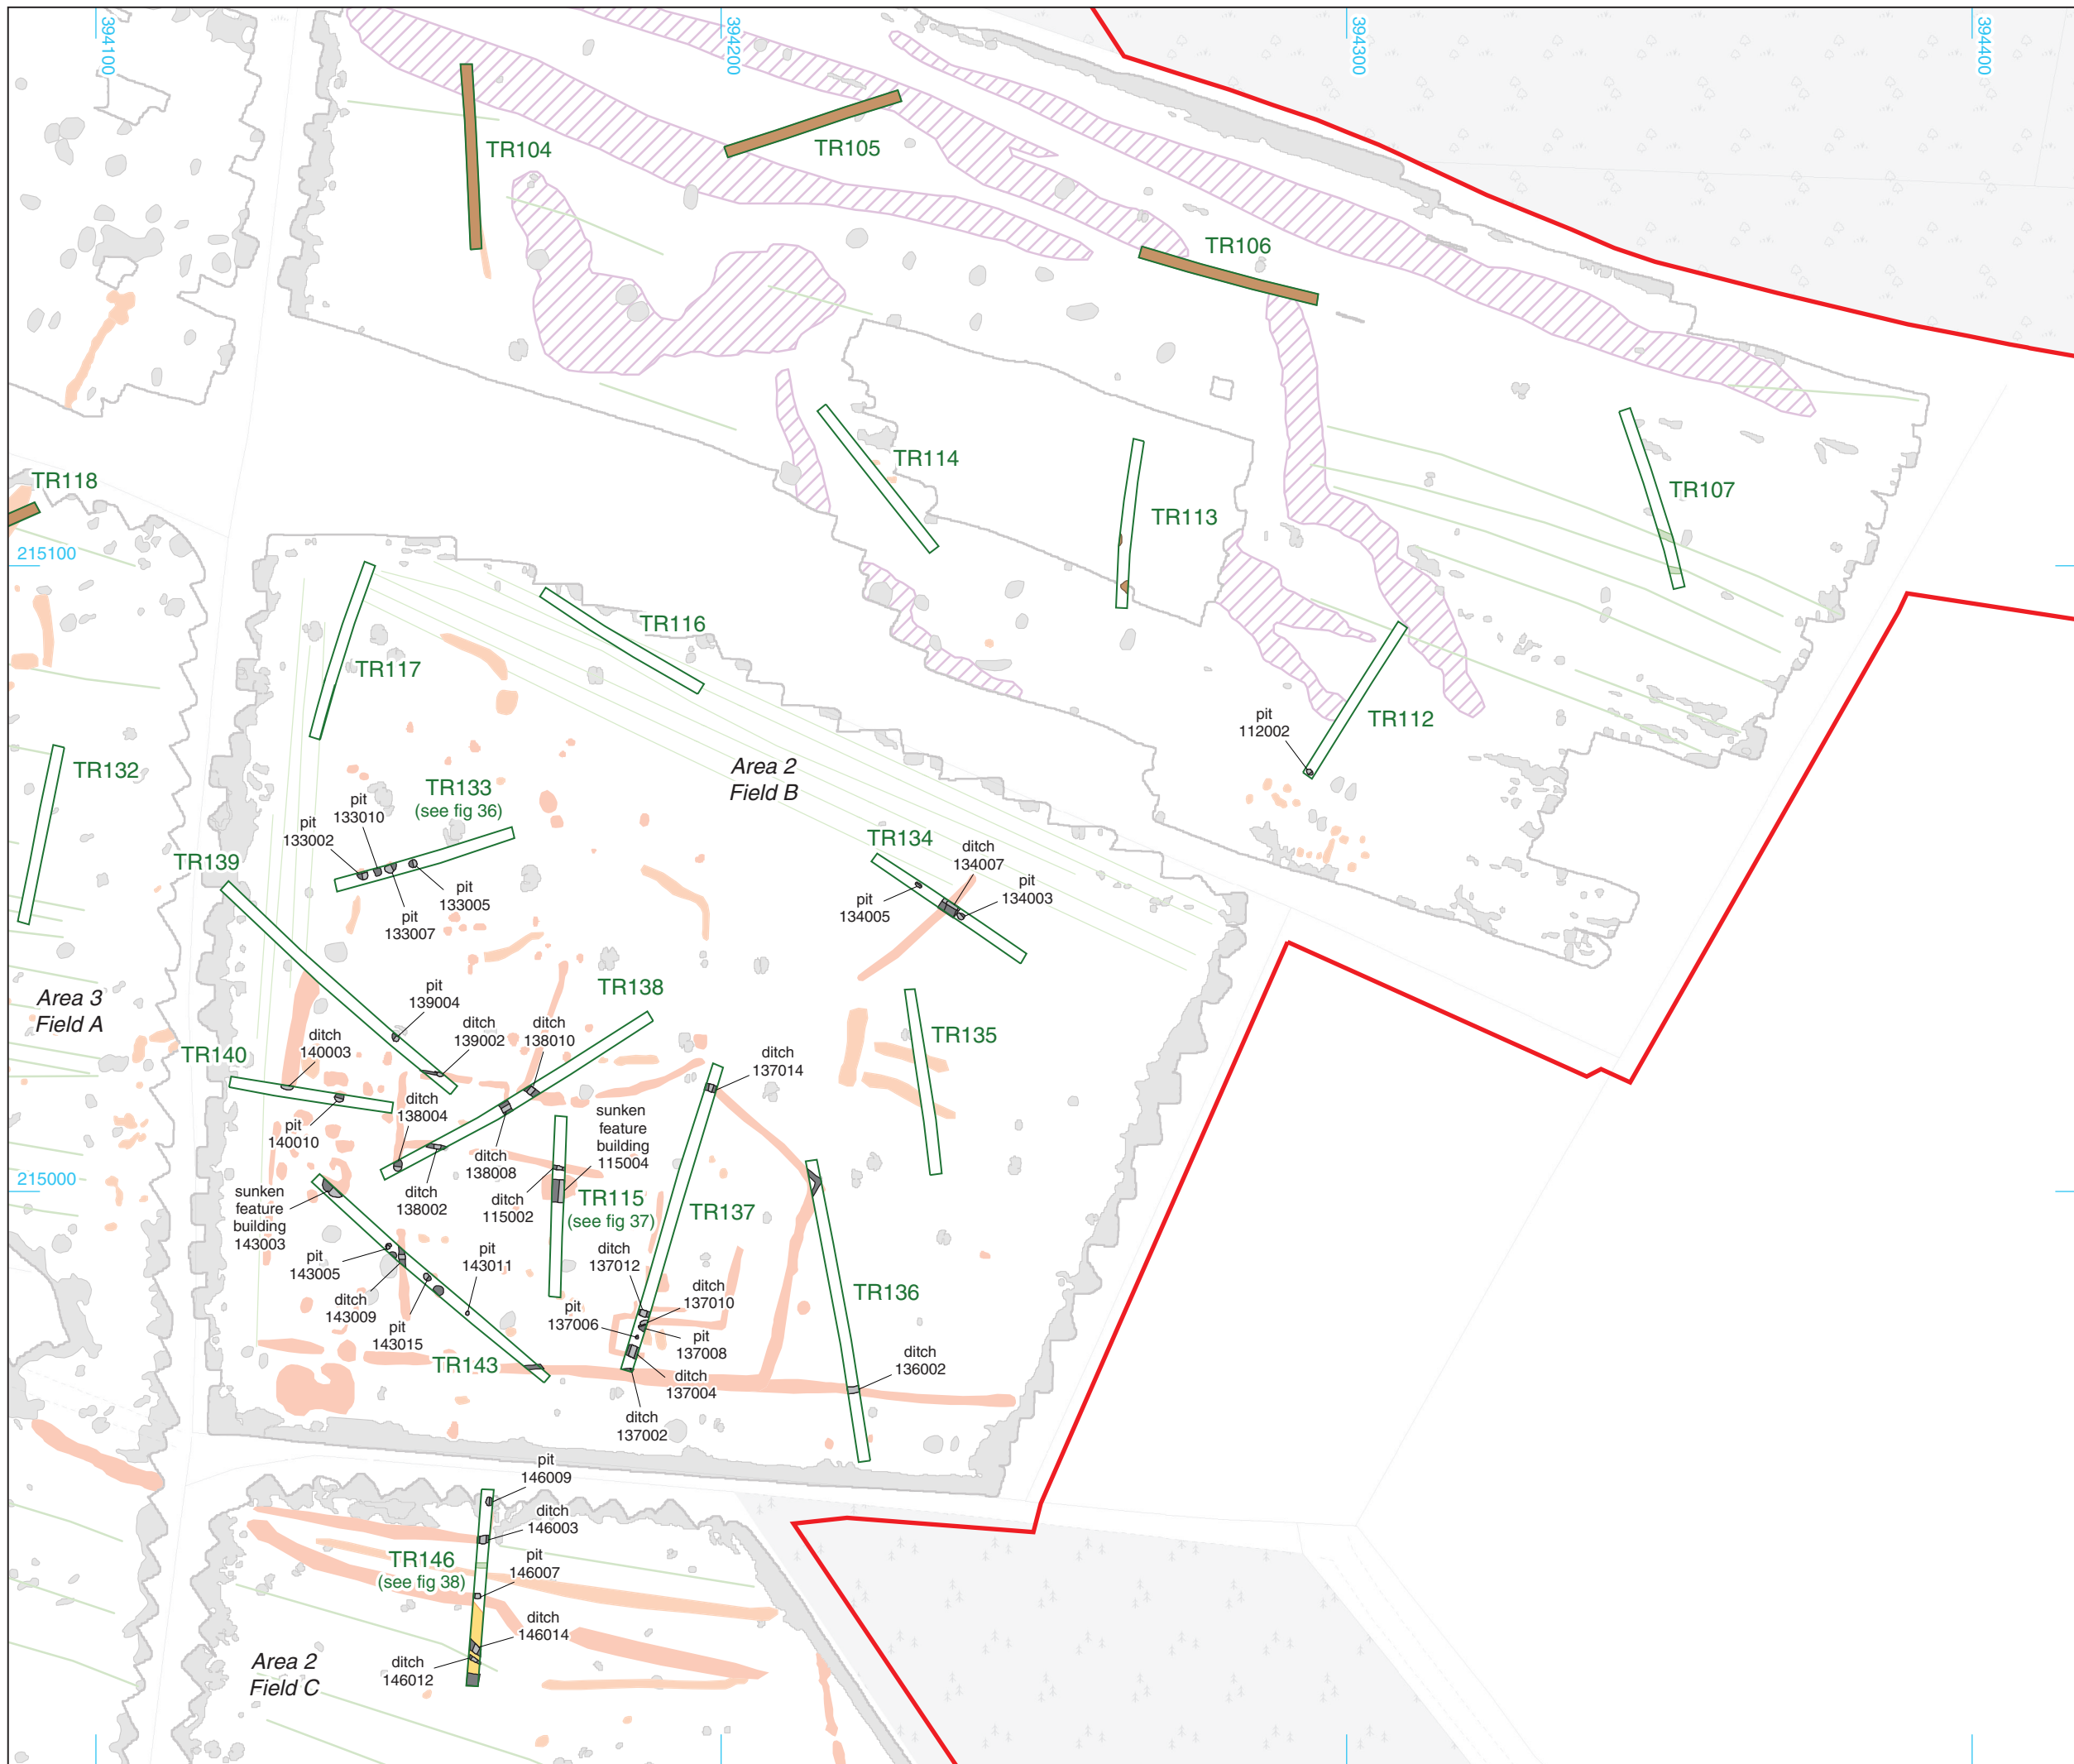
DRAWN BY	RW	PROJECT NO.	CR0463	FIGURE NO.
CHECKED BY	DJB	DATE	03/02/2021	16
APPROVED BY	DS	SCALE@A3	1:1000

**FIGURE TITLE**  
 Area 2 Fields B and C, and Area 3 Field A: trench location plan showing archaeological features and geophysical survey results

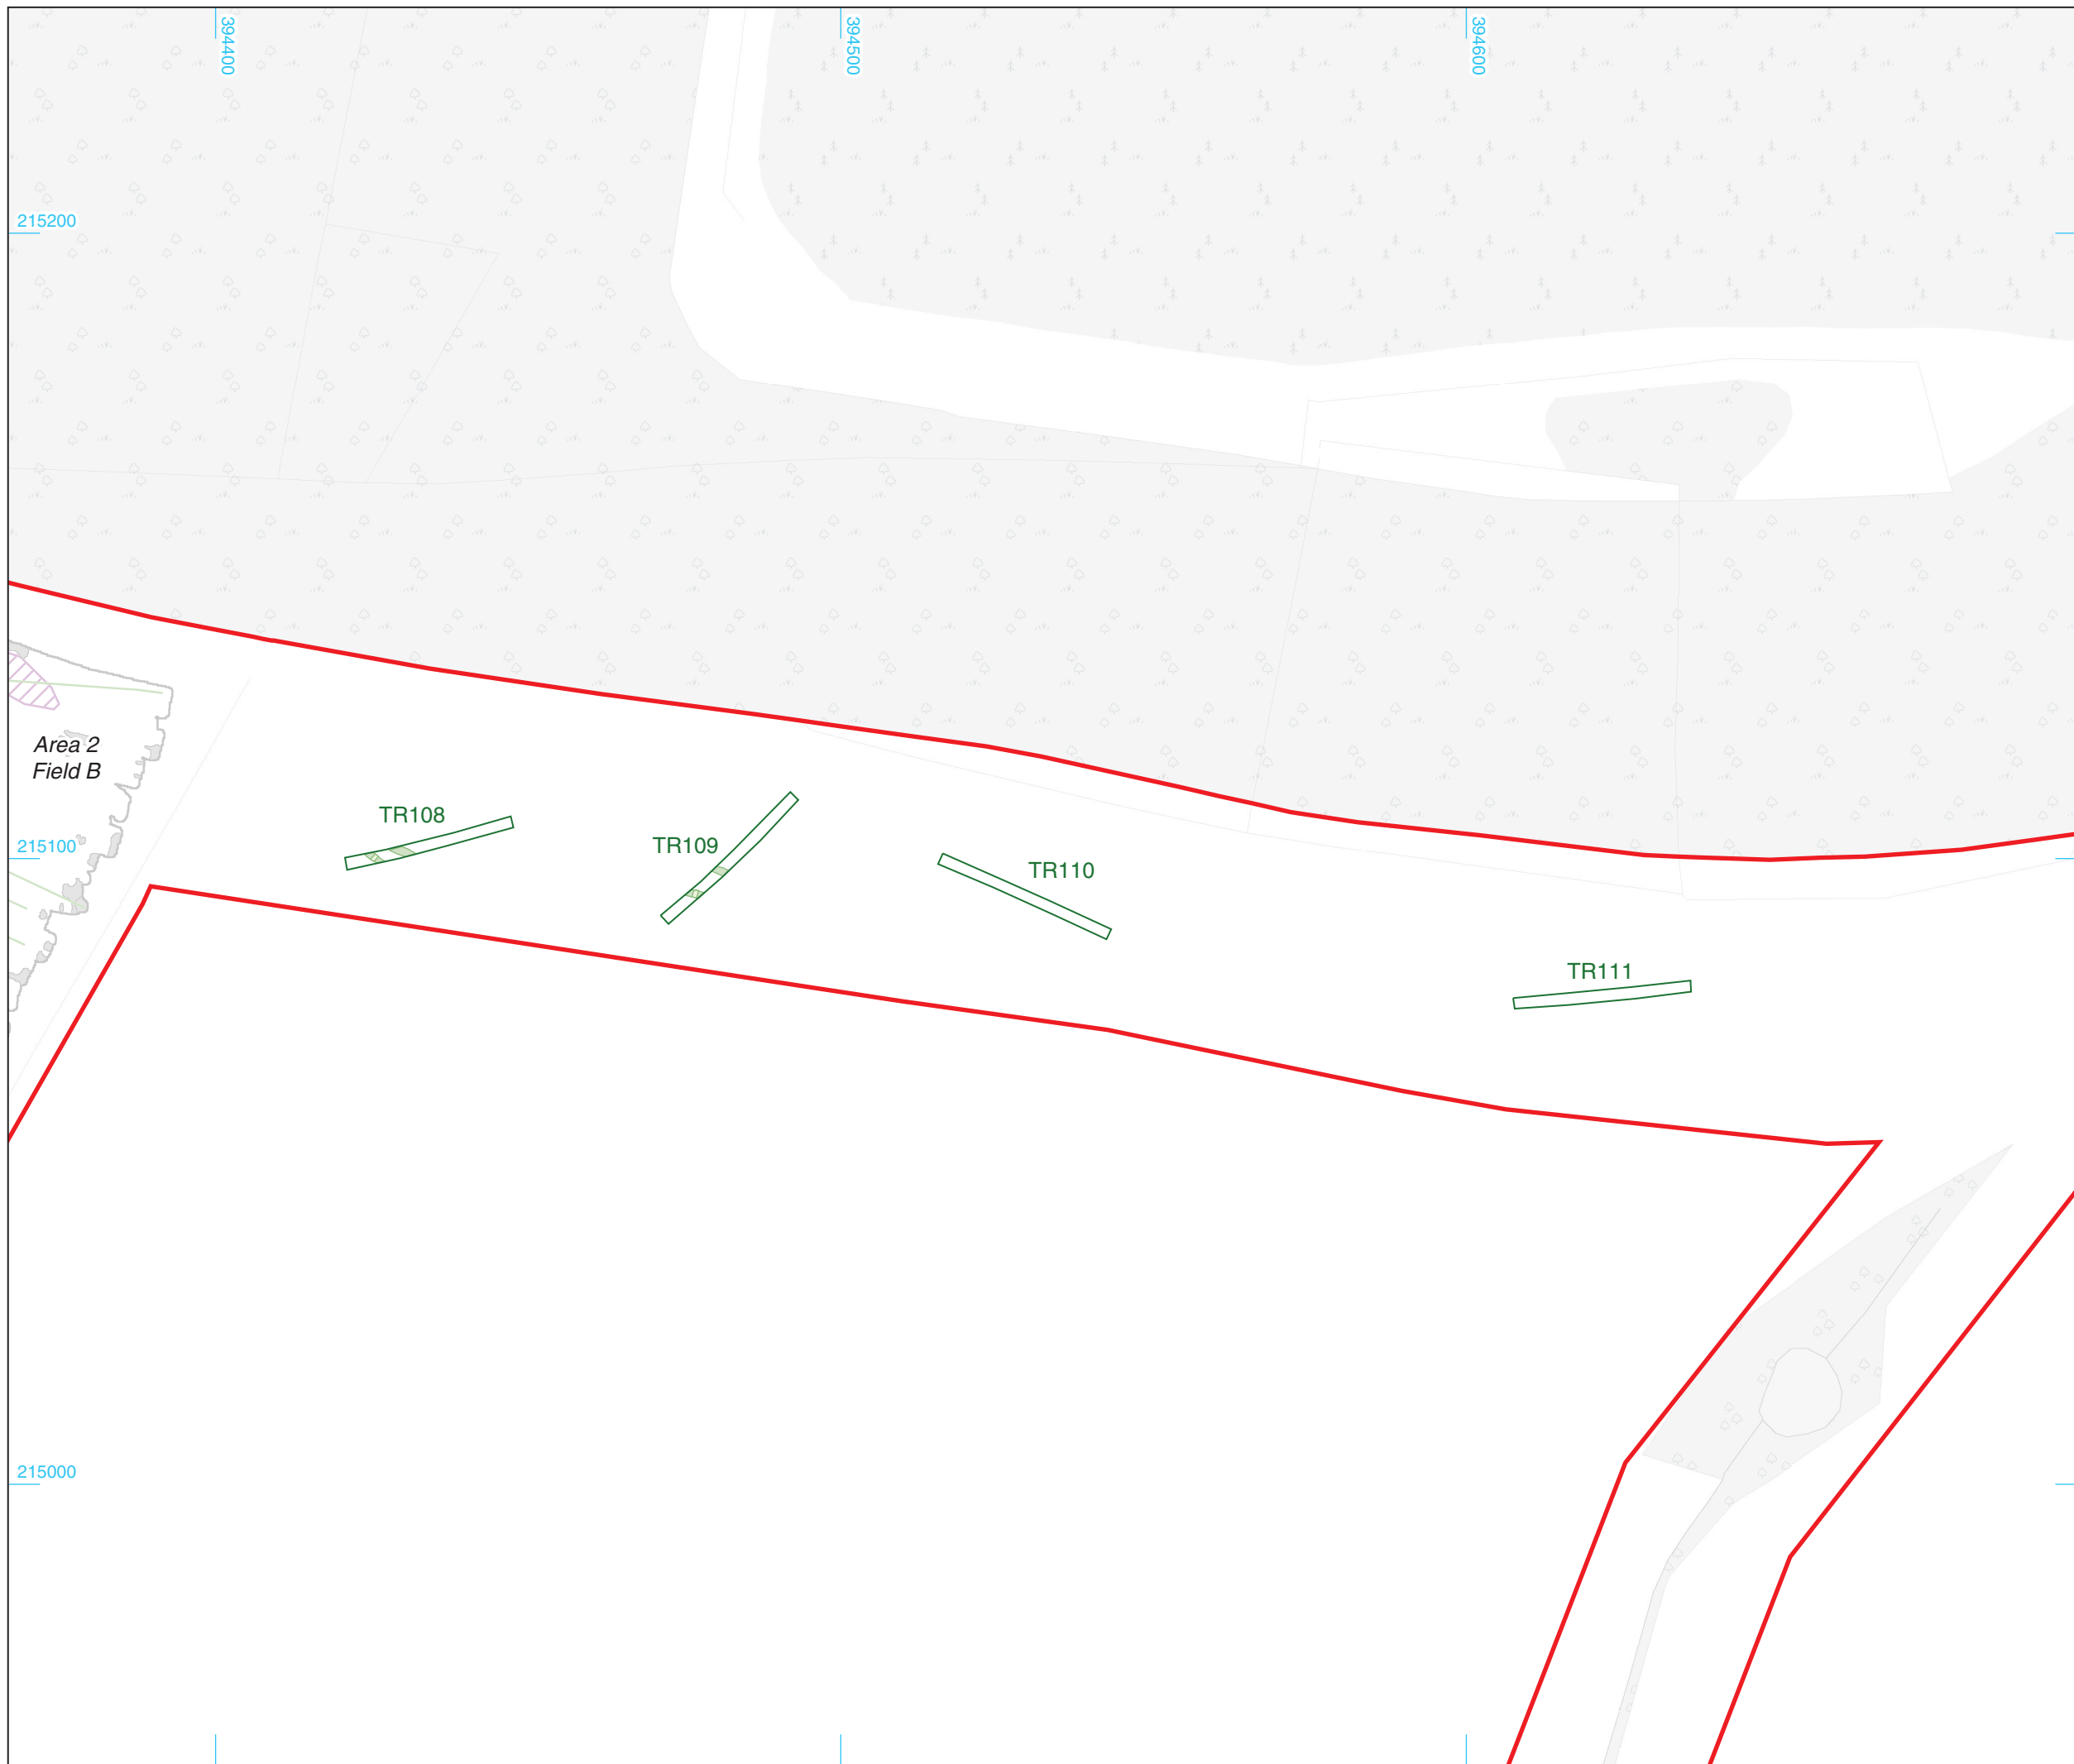
<small>DRAWN BY</small> RW	<small>PROJECT NO.</small> CR0463	<small>FIGURE NO.</small>
<small>CHECKED BY</small> DJB	<small>DATE</small> 03/02/2021	<b>17</b>
<small>APPROVED BY</small> DS	<small>SCALE@A3</small> 1:1000

**FIGURE TITLE**  
 Area 2 Trenches 108-111: trench location\ plan showing archaeological features and geophysical survey results

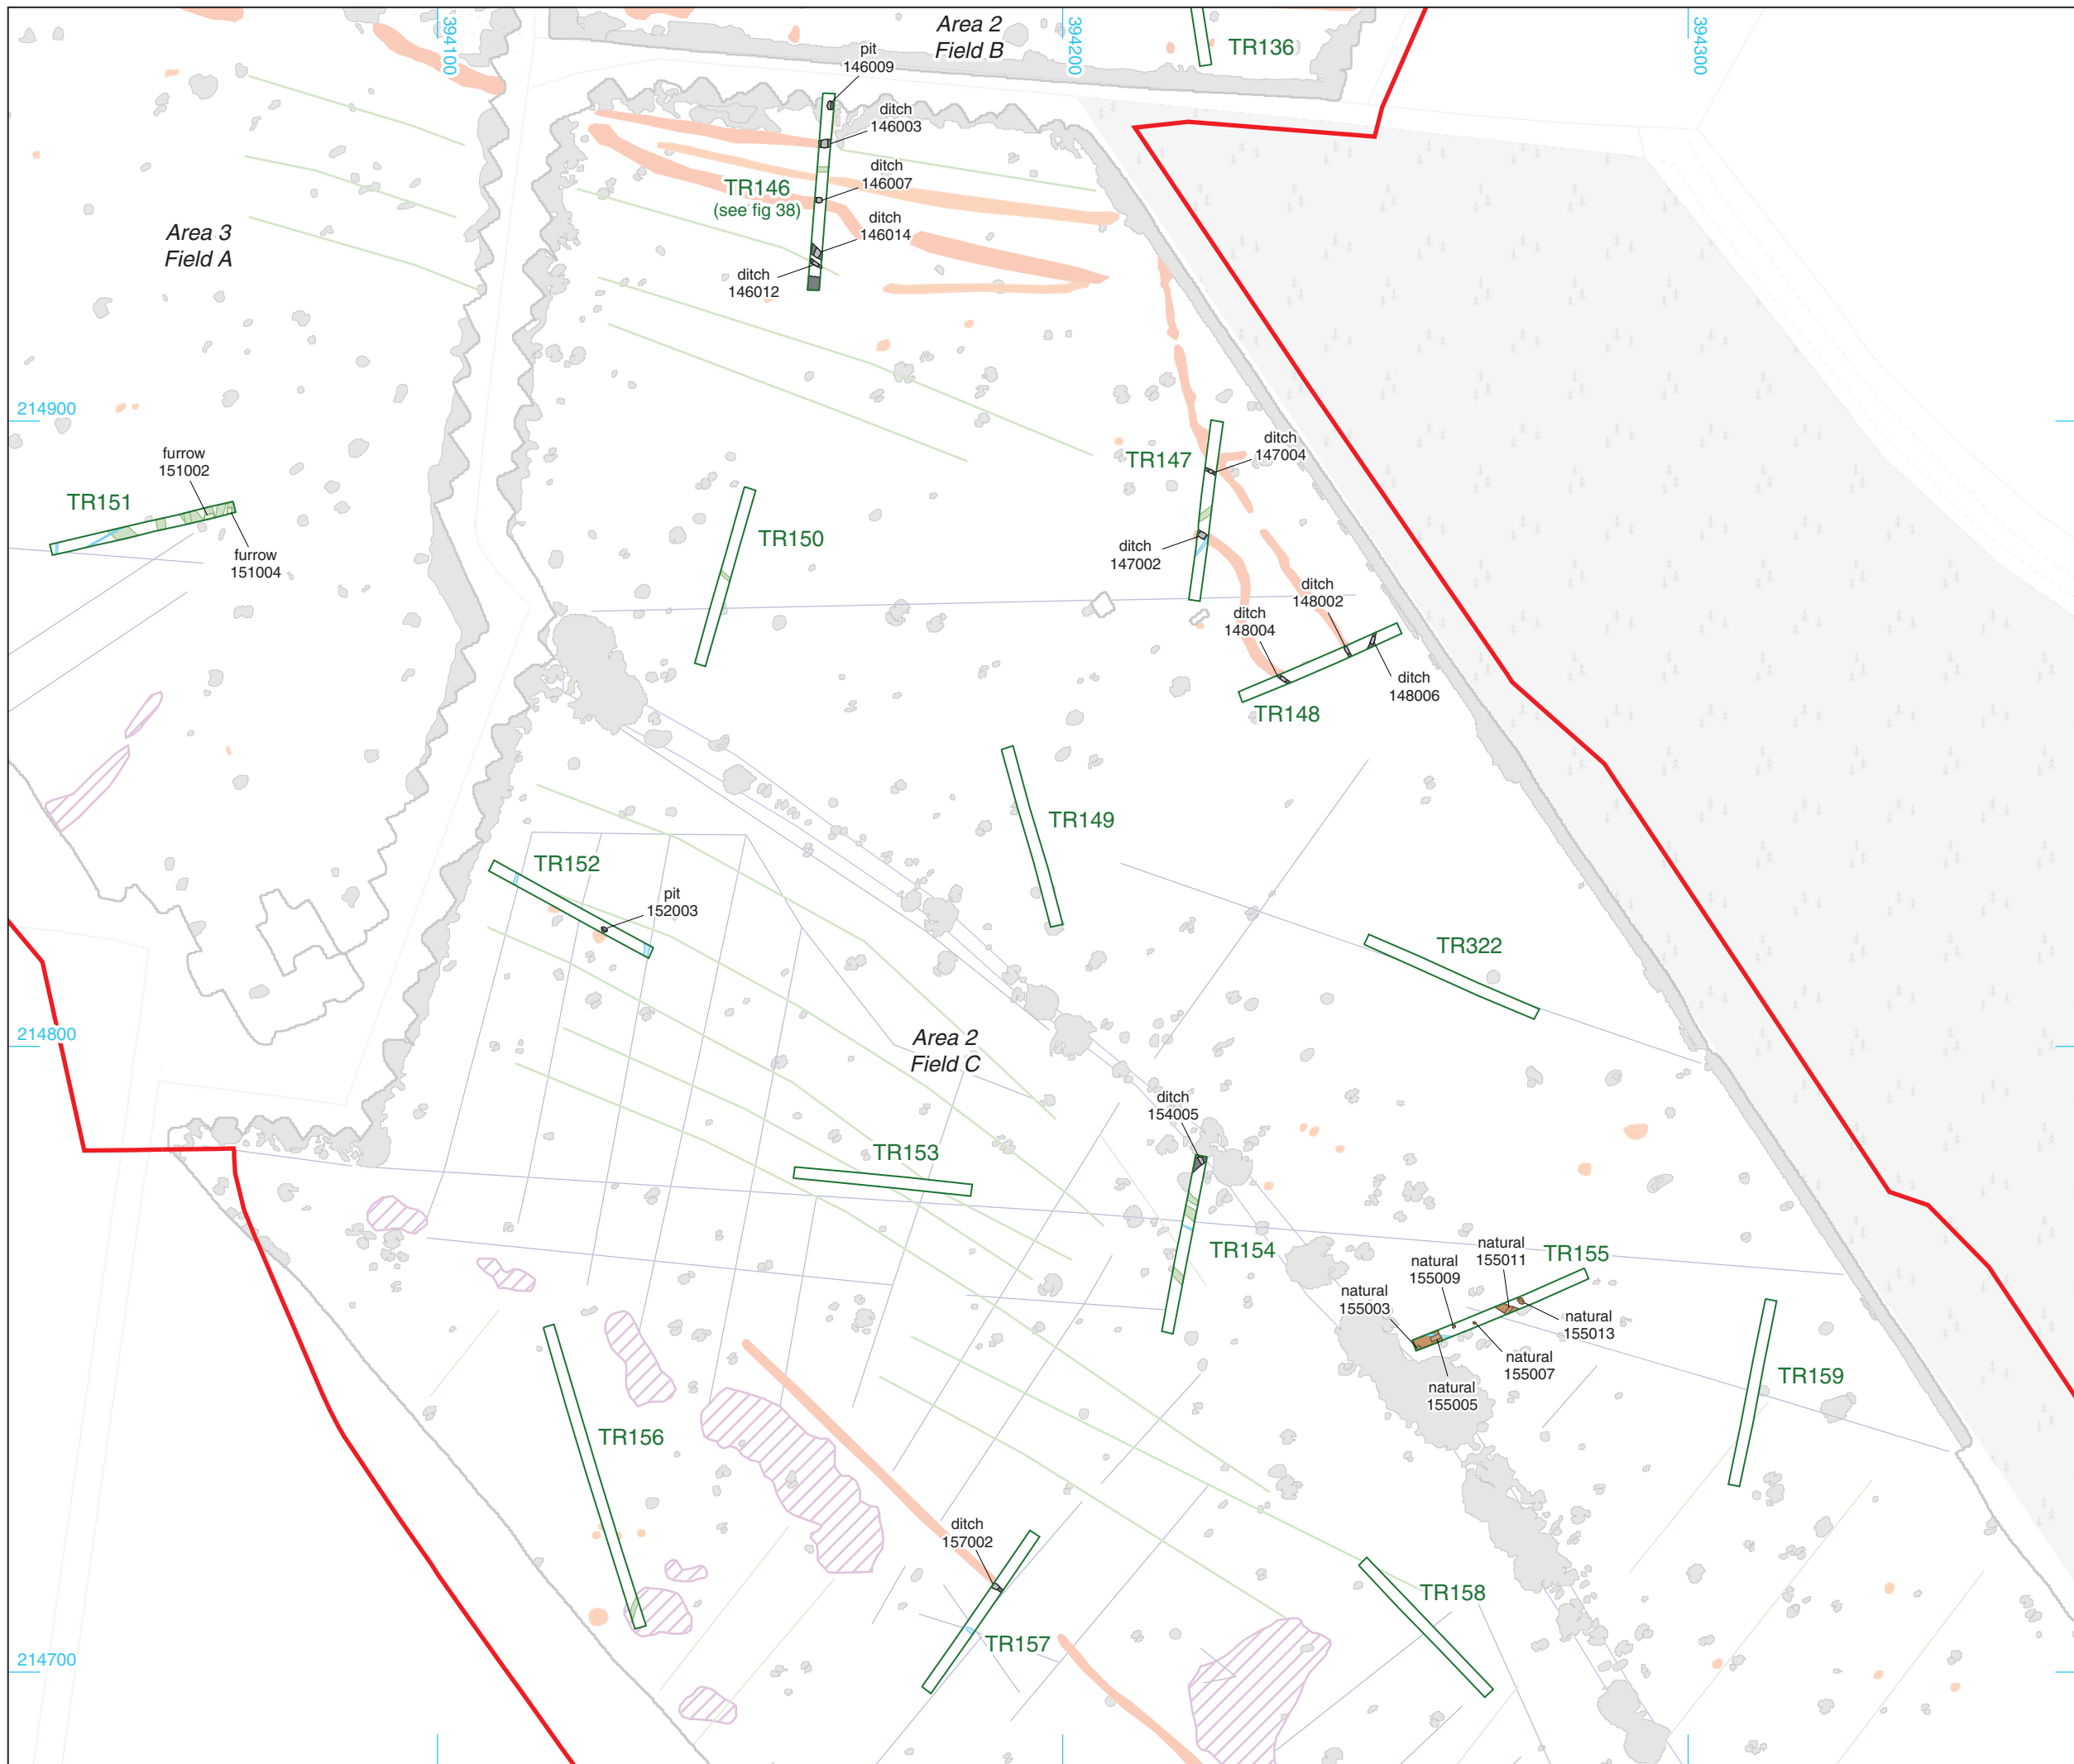
<small>DRAWN BY</small> RW	<small>PROJECT NO.</small> CR0463	<small>FIGURE NO.</small> 18
<small>CHECKED BY</small> DJB	<small>DATE</small> 03/02/2021	
<small>APPROVED BY</small> DS	<small>SCALE@A3</small> 1:1000

**FIGURE TITLE**  
 Area 2 Field C, and Area 3 Field A: trench  
 location plan showing archaeological  
 features and geophysical survey results
