A417 Missing Link  
TR010056

6.4 Environmental Statement  
Appendix 6.5 Trial Trenching Report  
Part 2 of 4

**6.4 Environmental Statement  
Appendix 6.5 Trial Trenching Report  
Part 2 of 4**

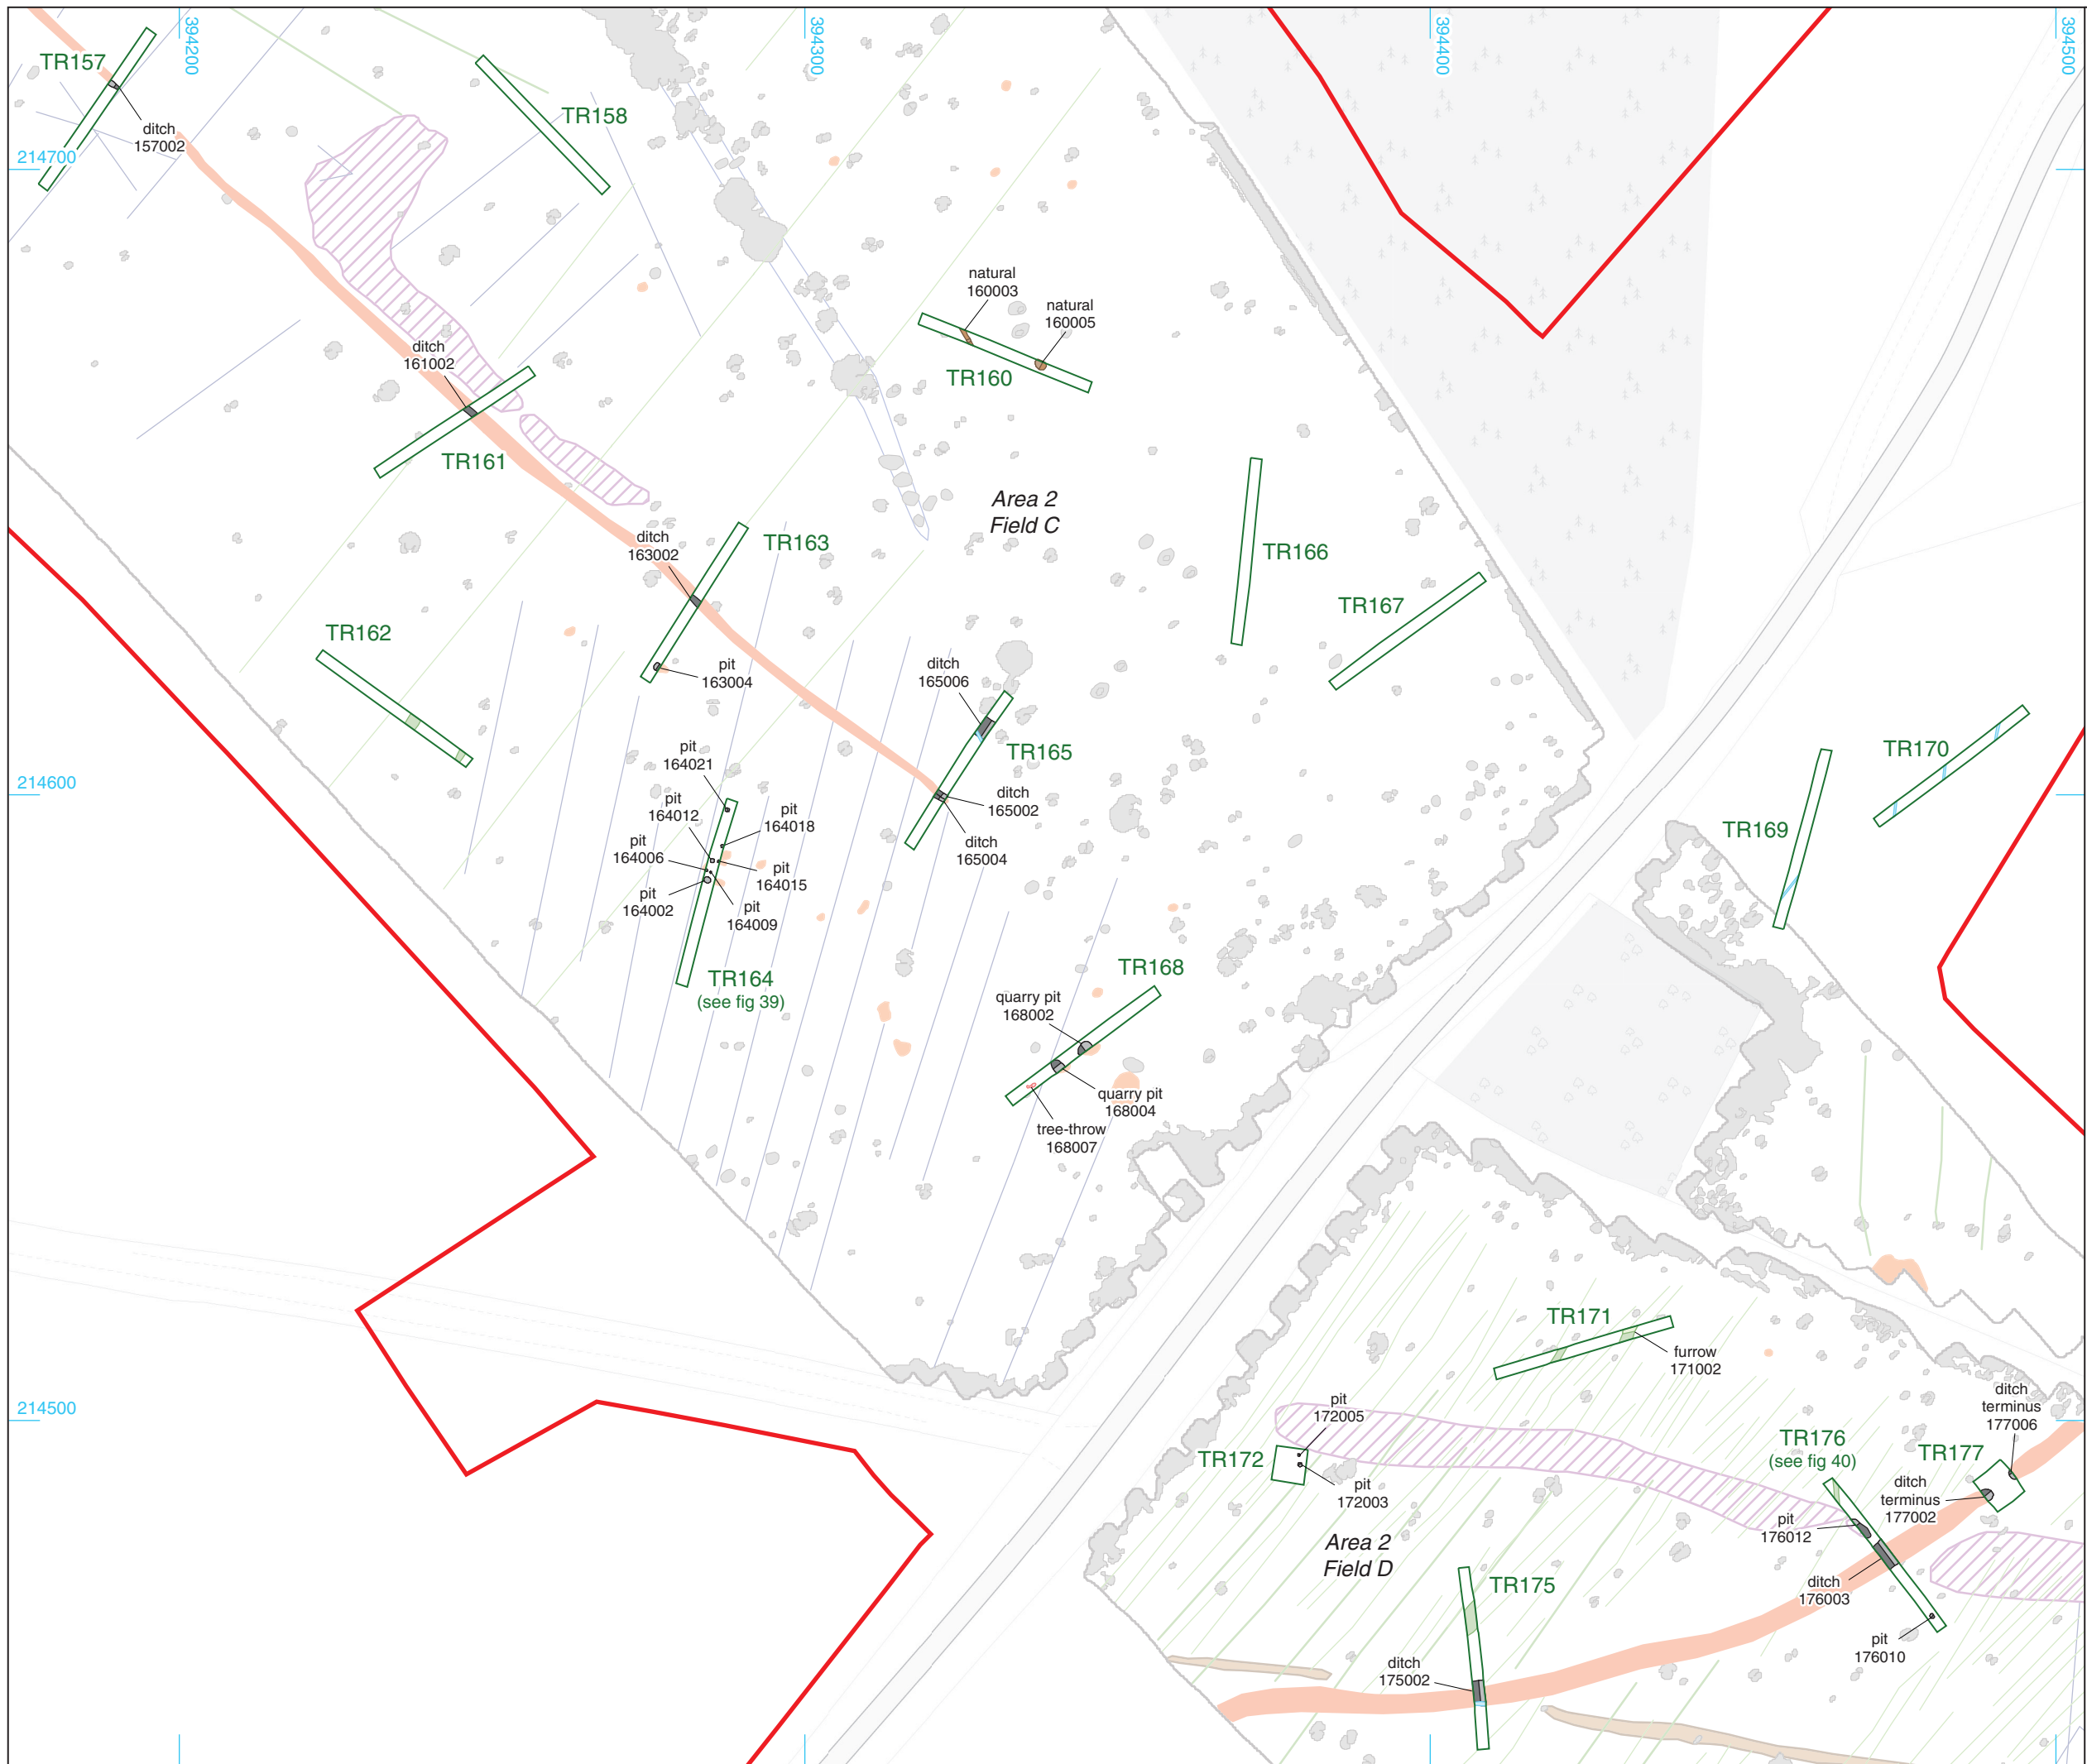
<small>DRAWN BY</small> RW	<small>PROJECT NO.</small> CR0463	<small>FIGURE NO.</small> 19
<small>CHECKED BY</small> DJB	<small>DATE</small> 03/02/2021	
<small>APPROVED BY</small> DS	<small>SCALE@A3</small> 1:1000

**FIGURE TITLE**  
 Area 2 Fields C and D: trench location plan showing archaeological features and geophysical survey results

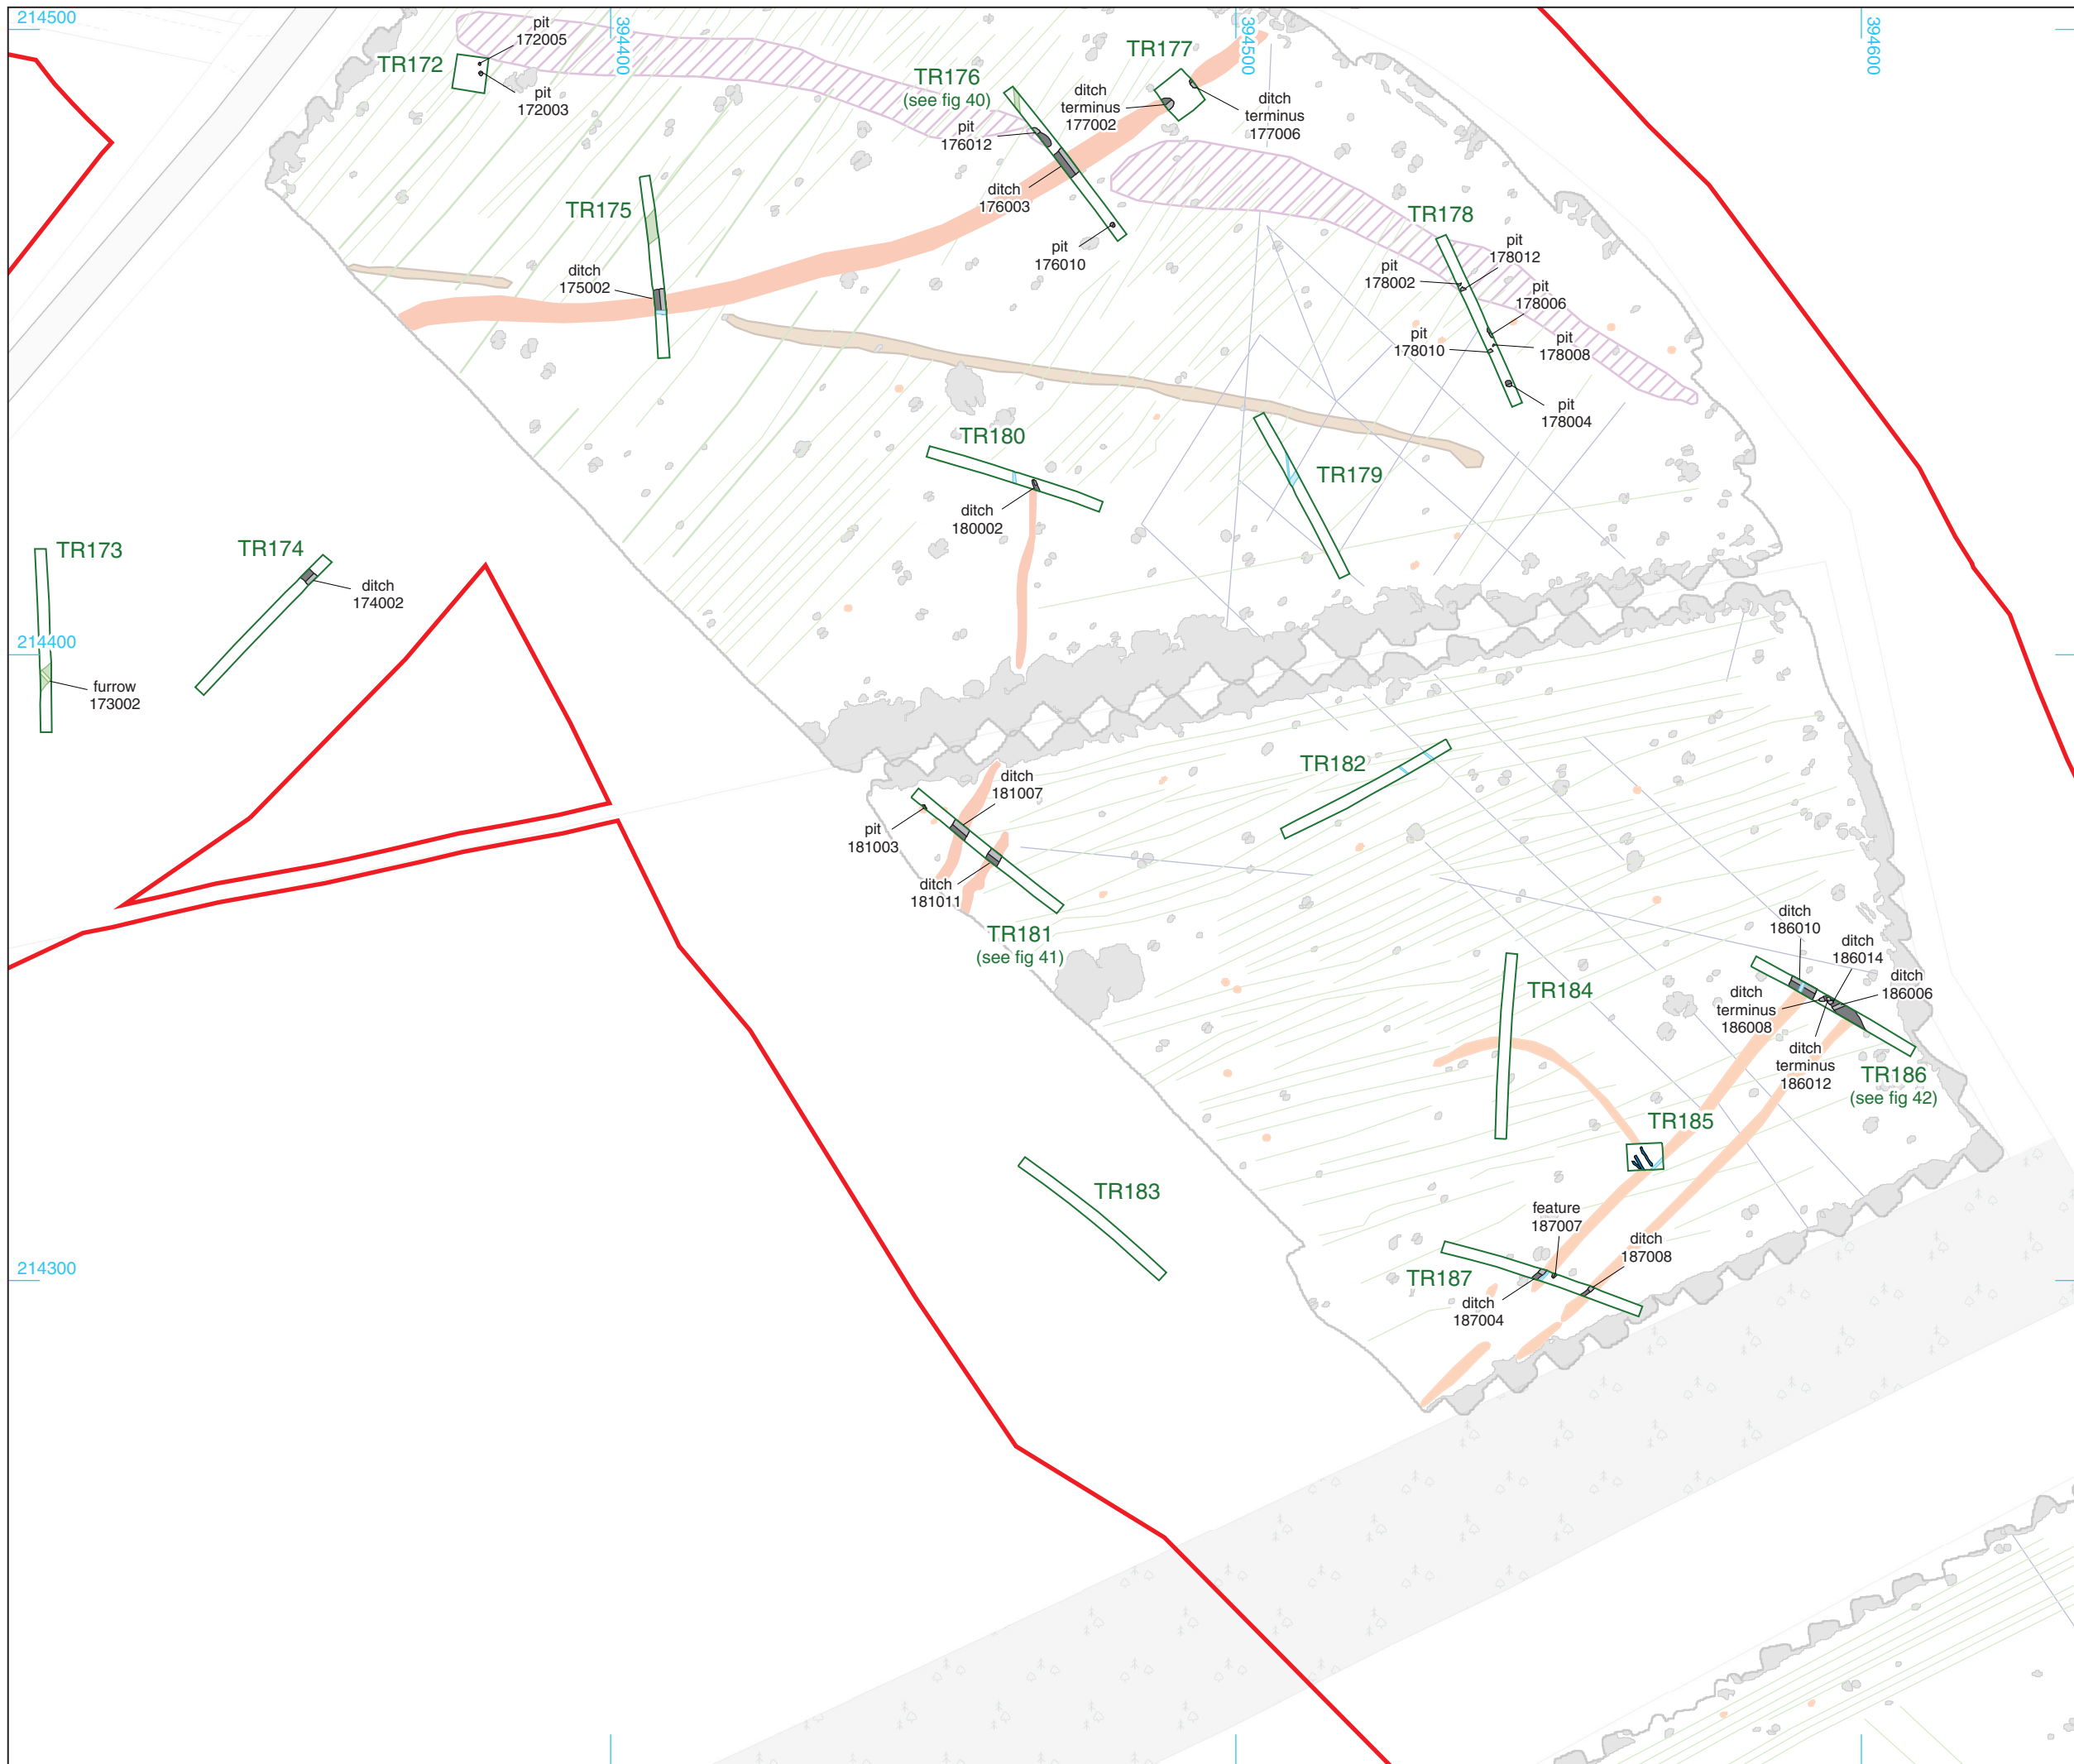
DRAWN BY	RW	PROJECT NO.	CR0463	FIGURE NO.
CHECKED BY	DJB	DATE	03/02/2021	20
APPROVED BY	DS	SCALE@A3	1:1000

**FIGURE TITLE**  
 Area 2 Field D: trench location plan showing  
 archaeological features and geophysical  
 survey results

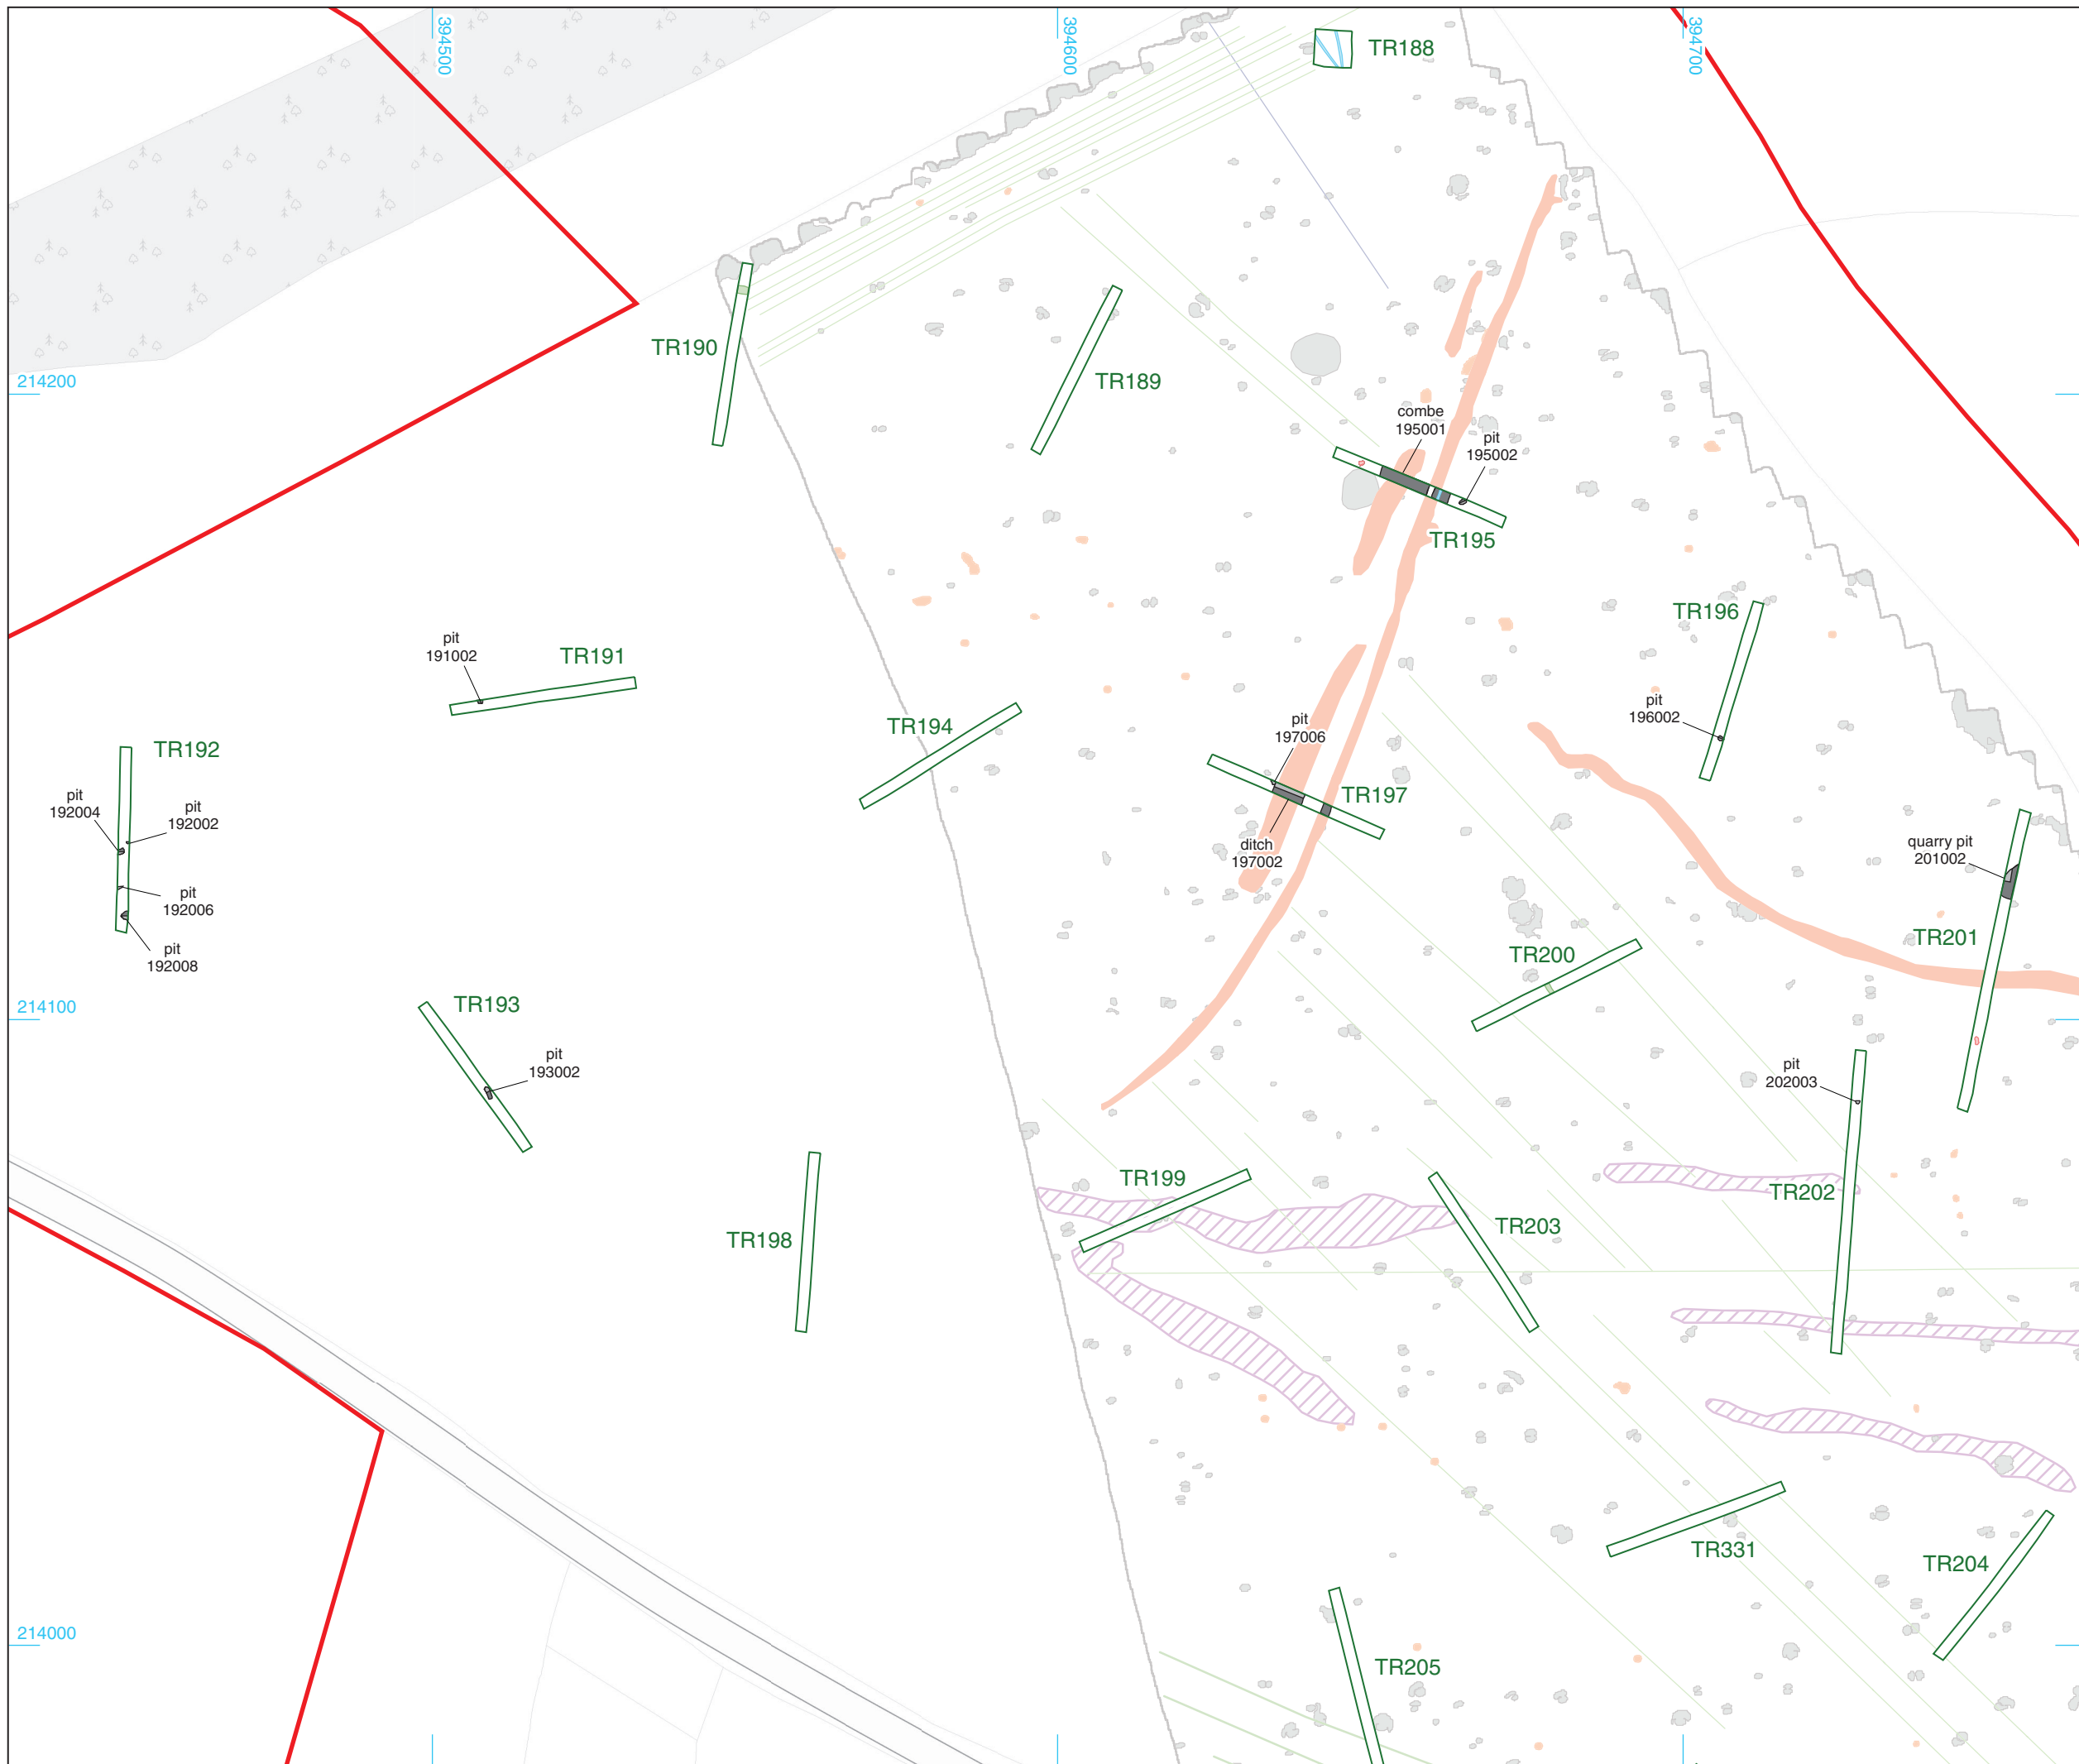
DRAWN BY	RW	PROJECT NO.	CR0463	FIGURE NO.
CHECKED BY	DJB	DATE	03/02/2021	
APPROVED BY	DS	SCALE@A3	1:1000	<b>21</b>

**FIGURE TITLE**  
 Area 2 Field E: trench location plan showing  
 archaeological features and geophysical  
 survey results
