M5 Junction 10 Improvements Scheme

Environmental Statement Appendix 8.2 WFD Compliance Assessment TR010063 – APP 6.15

Appendix 8.2 WFD Compliance Assessment

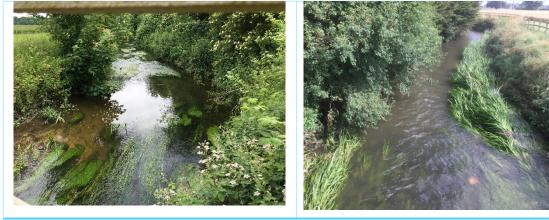
Table 4-5 - Water body photographs Chelt – M5 to conf. R. Severn

Photo 9 (2022): Upstream view of the River Chelt approximately 0.6 km downstream of the M5 crossing. Aquatic plants can be seen within the channel with thick vegetation growth on both banks. Photo 10 (2019): Downstream view of the River Chelt with more vegetation growth on both banks. Continuous tree cover on the left bank provides shade.

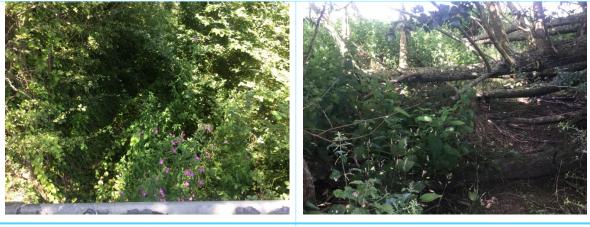
Table 4-8 - Representative photographs ordinary watercourses

Photo 15 (2019): Image of Drain 10 form public footpath over bridge. The channel was overgrown and over deepened. Himalayan

Photo 16 (2019): Drain 12 upstream of Withybridge Lane. There was no flow within the
