Gatwick Airport Northern Runway Project

Environmental Statement

Appendix 5.3.2: Code of Construction Practice Annex 6 – Outline Arboricultural and Vegetation Method Statement – Part 3 - Tracked Version

Airport Preliminary Tree Removal & Protection Plans Appendix 5.3.2 Annex 6 Sheet 6 of 13

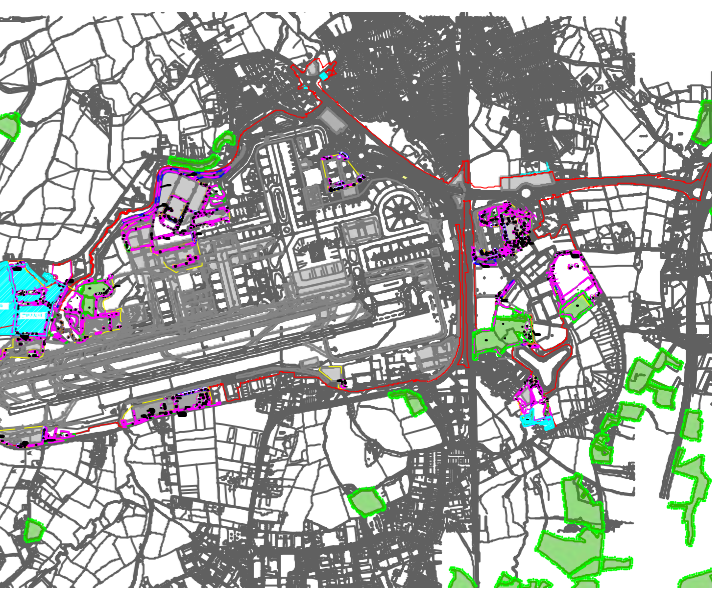
DRAWING TITLE
 Airport Preliminary Tree Removal & Protection Plans
 Appendix 5.3.2 Annex 6
 Sheet 7 of 13

A section of HSD approximately 12m long will require removal to enable access for soil deposition at Penning Field. Trees and shrubs will be planted to re-establish the hedgerow. Exact location of vegetation removal required will be assessed during detail design.

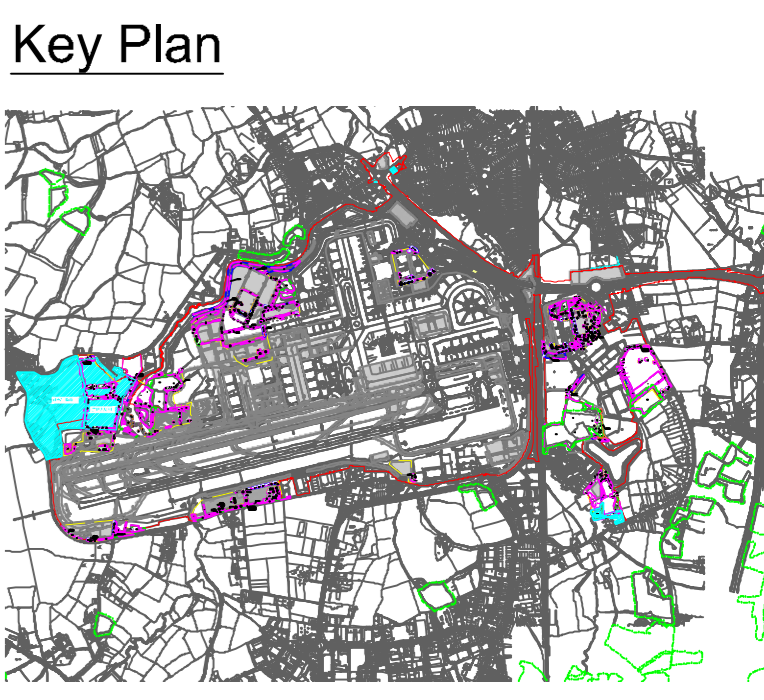
DRAWING TITLE
Airport Preliminary Tree Removal & Protection Plans
 Appendix 5.3.2 Annex 6
 Sheet 10 of 13

Existing Fence to be retained and used as TPF

T272
T273
T274
T275
T276
