Gatwick Airport Northern Runway Project

Environmental Statement

Appendix 8.10.1: Tree Survey Report and Arboricultural Impact Assessment – Part 4 – Clean Version

DRAWING TITLE
M23 & A23 Preliminary Tree Removal Plans
 Appendix 8.10.1
 Sheet 2 of 9

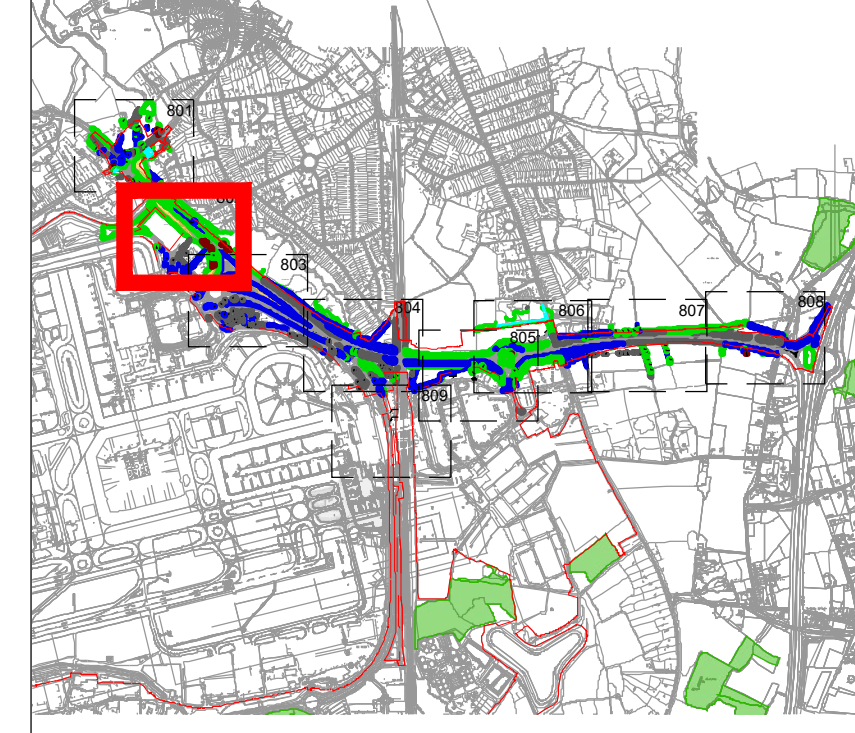
- Site Boundary
 - Survey Boundary / Boundary of M23/A23 construction activity
 - Projected Tree loss required for construction (Worst Case Scenario)
 - Tree with numbered reference. Canopy spread and coloured BS5837:2012 tree quality category as shown below.

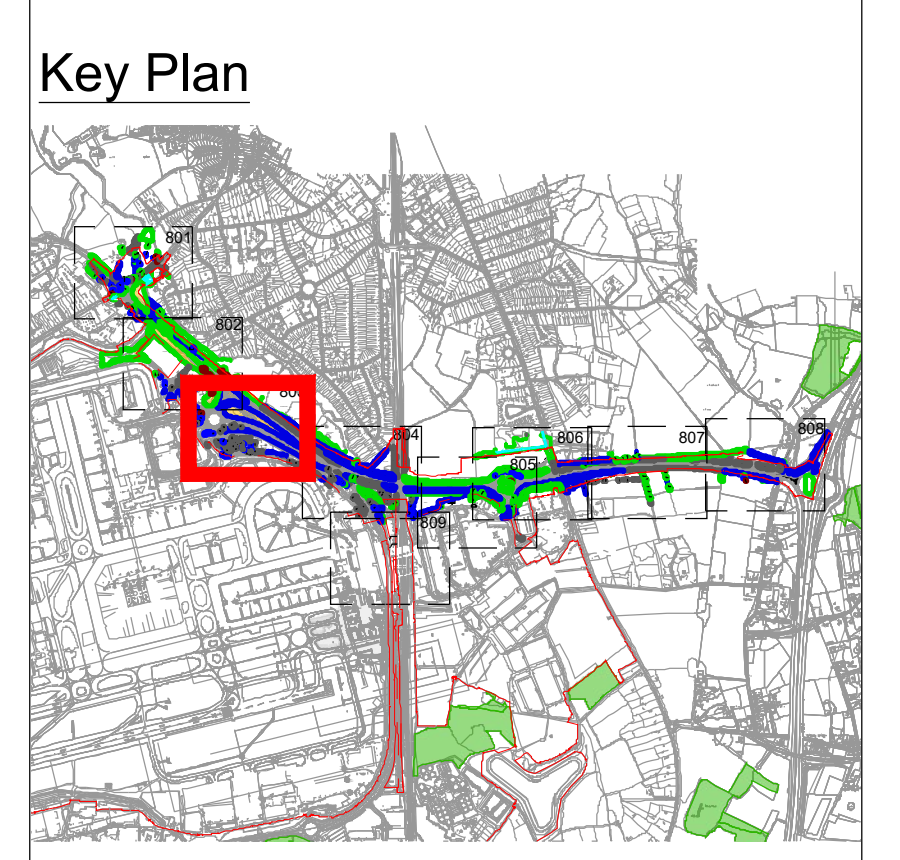
DRAWING TITLE
M23 & A23 Preliminary Tree Removal Plans
 Appendix 8.10.1
 Sheet 3 of 9

- Site Boundary
- Survey Boundary / Boundary of M23/A23 construction activity
- Projected Tree loss required for construction (Worst Case Scenario)
- Tree with numbered reference. Canopy spread and coloured BS5837:2012 tree quality category as shown below.
= Tree details estimate (inaccessible tree)
• = Tree in off site location
- G1 Vegetation group with numbered reference. Canopy extents and BS5837:2012 tree quality category as shown below.
- H1 Hedge with numbered reference. Width and BS5837:2012 tree quality category as shown below.

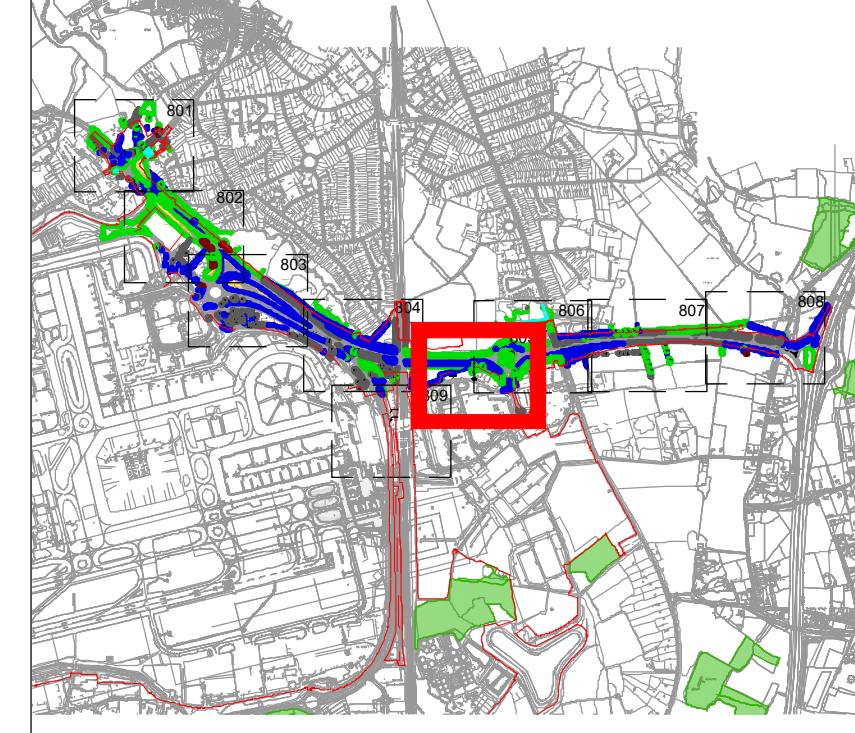
DRAWING TITLE
 M23 & A23 Preliminary Tree Removal Plans
 Appendix 8.10.1
 Sheet 5 of 9

Projected Tree loss required for construction (Worst Case Scenario)
 -

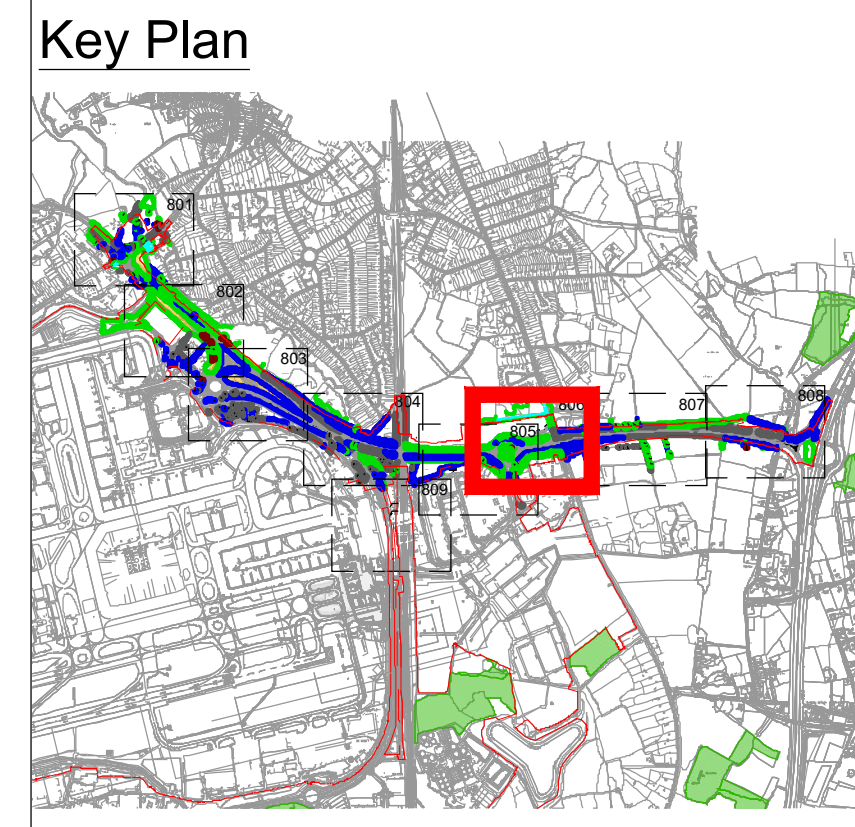
DRAWING TITLE
M23 & A23 Preliminary Tree Removal Plans
 Appendix 8.10.1
 Sheet 6 of 9

Projected Tree loss required for construction (Worst Case Scenario)
-

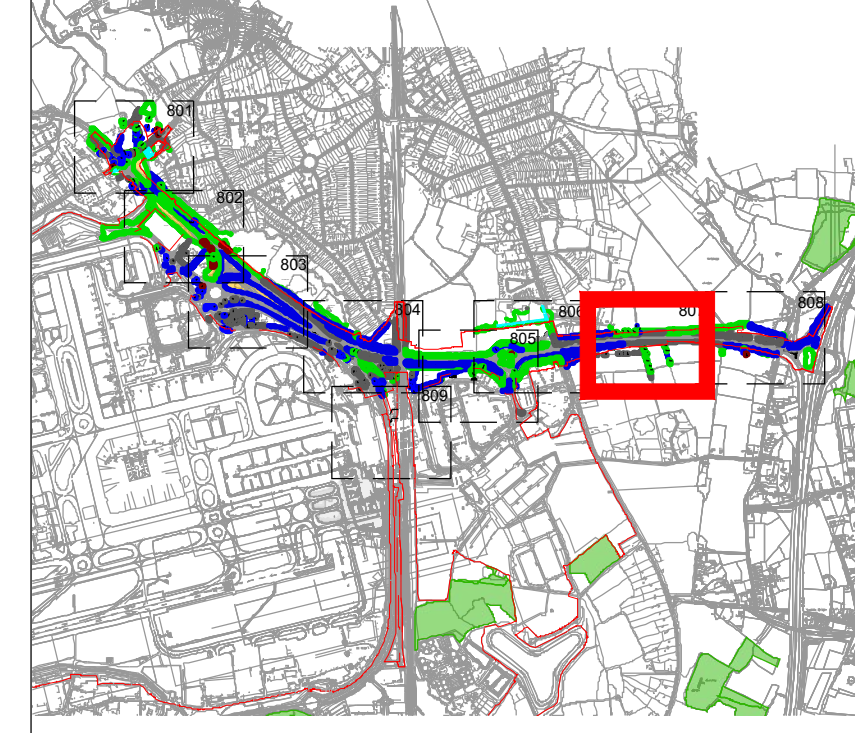
DRAWING TITLE
 M23 & A23 Preliminary Tree Removal Plans
 Appendix 8.10.1
 Sheet 7 of 9

Projected Tree loss required for construction (Worst Case Scenario)

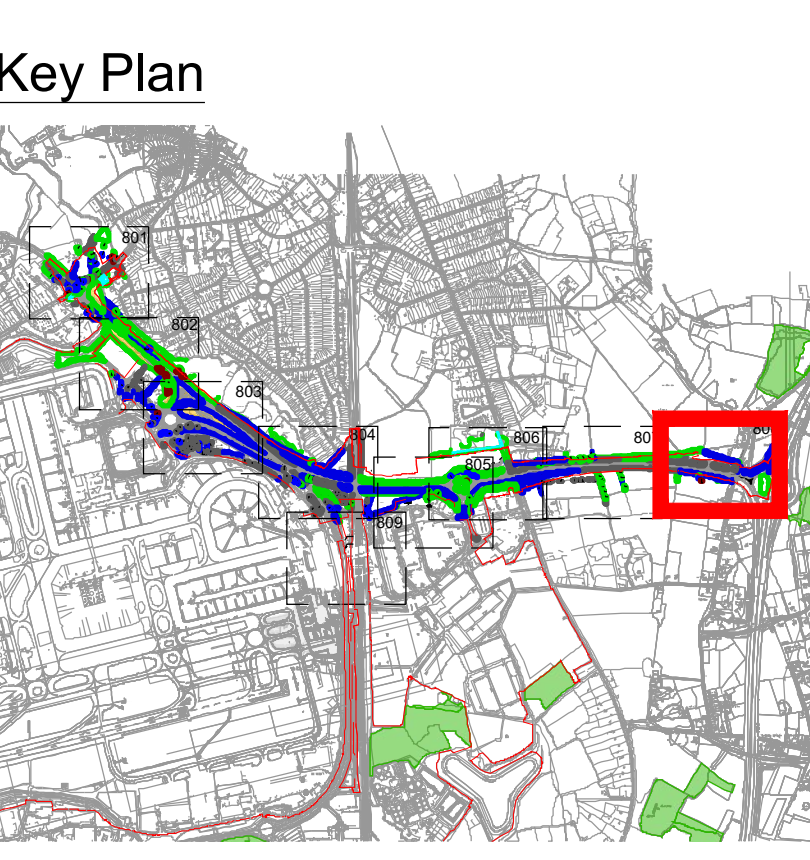
DRAWING TITLE
M23 & A23 Preliminary Tree Removal Plans
 Appendix 8.10.1
 Sheet 8 of 9

- Site Boundary
- Survey Boundary / Boundary of M23/A23 construction activity
- Projected Tree loss required for construction (Worst Case Scenario)
- Tree with numbered reference. Canopy spread and coloured BS5837:2012 tree quality category as shown below.
 - = Tree details estimate (accessible tree)
 - = Tree in off site location
- G1 Vegetation group with numbered reference. Canopy extents and BS5837:2012 tree quality category as shown below.
- H1 Hedge with numbered reference. Width and BS5837:2012 tree quality category as shown below.

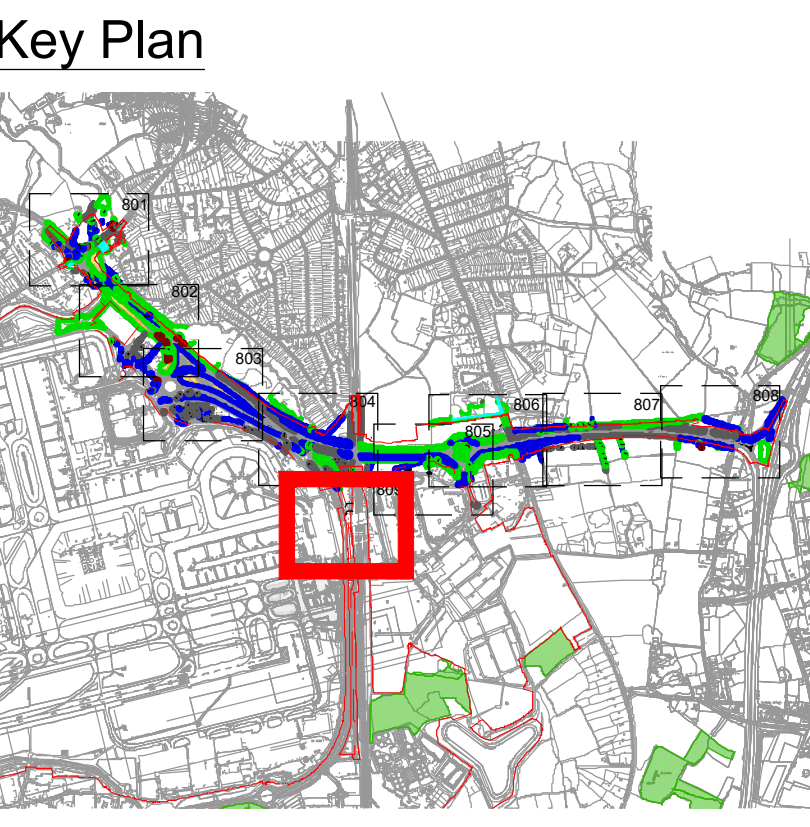
DRAWING TITLE
M23 & A23 Preliminary Tree Removal Plans
 Appendix 8.10.1
 Sheet 9 of 9

- Site Boundary
- Survey Boundary / Boundary of M23/A23 construction activity
- Projected Tree loss required for construction (Worst Case Scenario)
- Tree with numbered reference. Canopy spread and coloured BS5837:2012 tree quality category as shown below.
 - = Tree details estimate (inaccessible tree)
 - = Tree in off site location
- G1 Vegetation group with numbered reference. Canopy extents and BS5837:2012 tree quality category as shown below.
- H1 Hedge with numbered reference. Width and BS5837:2012 tree quality category as shown below.

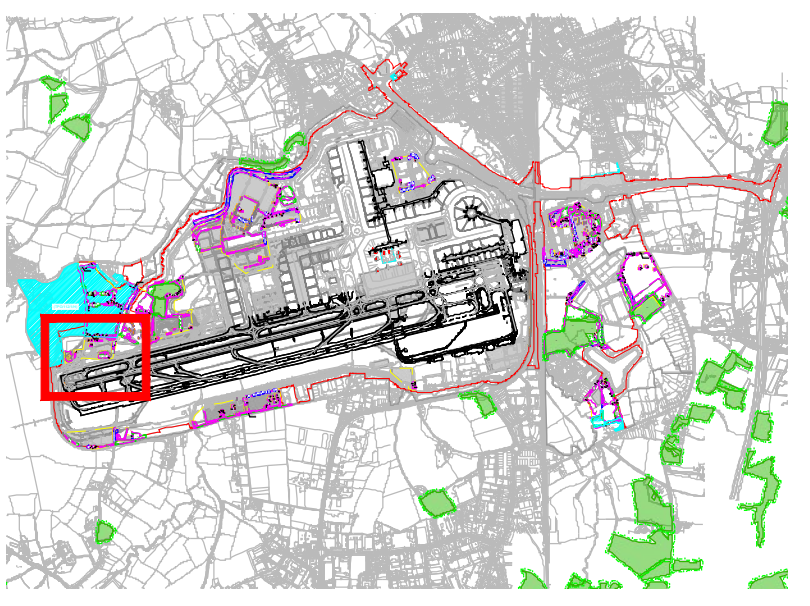
**Airport Preliminary Tree Removal Plans
Appendix 8.10.1
Sheet 1 of 13**

A section of approximately 12m long will require removal to enable access for new road to land east of Muscovy Field. Trees and shrubs will be planted to reinstate the field boundary. Exact location of vegetation removal required will be assessed during detail design.

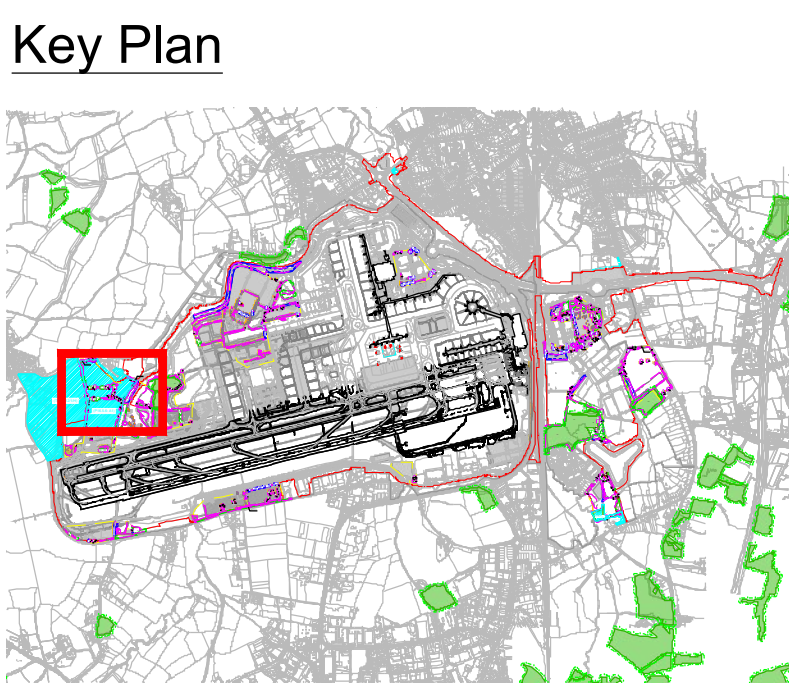
Airport Preliminary Tree Removal Plans Appendix 8.10.1 Sheet 2 of 13

- Direction of first significant branch
- Root protection area (RPA) Calculated in accordance with Section 4.6 - BS5837:2012
- Veteran tree buffer (15 x stem Ø) (as per standing advice produced by Forestry England and Natural England)
- Tree protected by Tree Preservation Order. Bracketed number relates to the TPO reference.
- Designated Ancient Woodland (as per Natural England ancient woodland inventory, via open data publication)
- Ancient Woodland tree buffer (15m offset) (as per standing advice produced by Forestry England and Natural England)
- Projected tree loss required for construction of the Project (worst case scenario)
- Indicative Scheme Layout

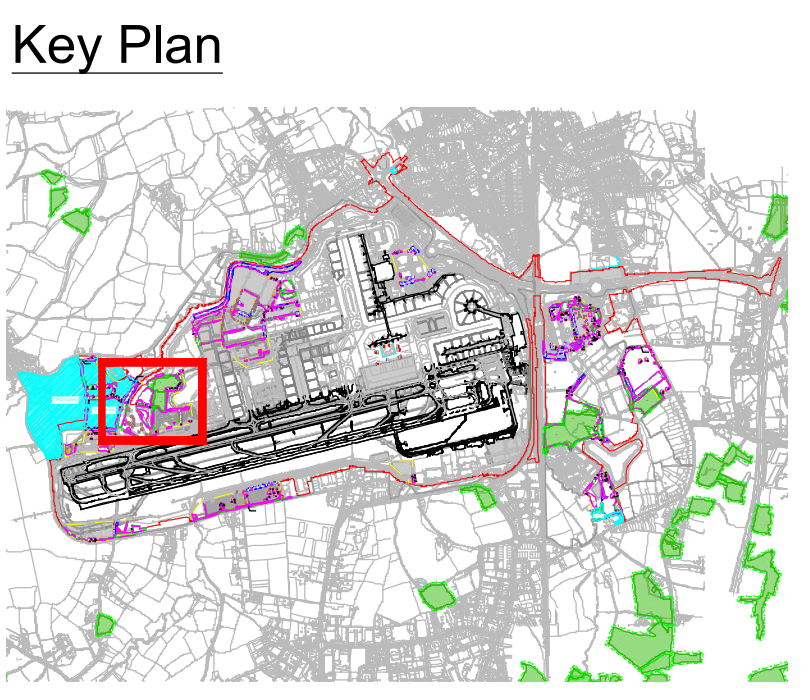
Airport Preliminary Tree Removal Plans Appendix 8.10.1 Sheet 3 of 13

- Direction of first significant branch
- Root protection area (RPA) Calculated in accordance with Section 4.6 - BS5837:2012
- Veteran tree buffer (15 x stem Ø) (as per standing advice produced by Forestry England and Natural England)
- Tree protected by Tree Preservation Order. Bracketted number relates to the TPO reference.
- Designated Ancient Woodland (as per Natural England ancient woodland inventory, via open data publication)
- Ancient Woodland tree buffer (15m offset) (as per standing advice produced by Forestry England and Natural England)
- Projected tree loss required for construction of the Project (worst case scenario)
- Indicative Scheme Layout

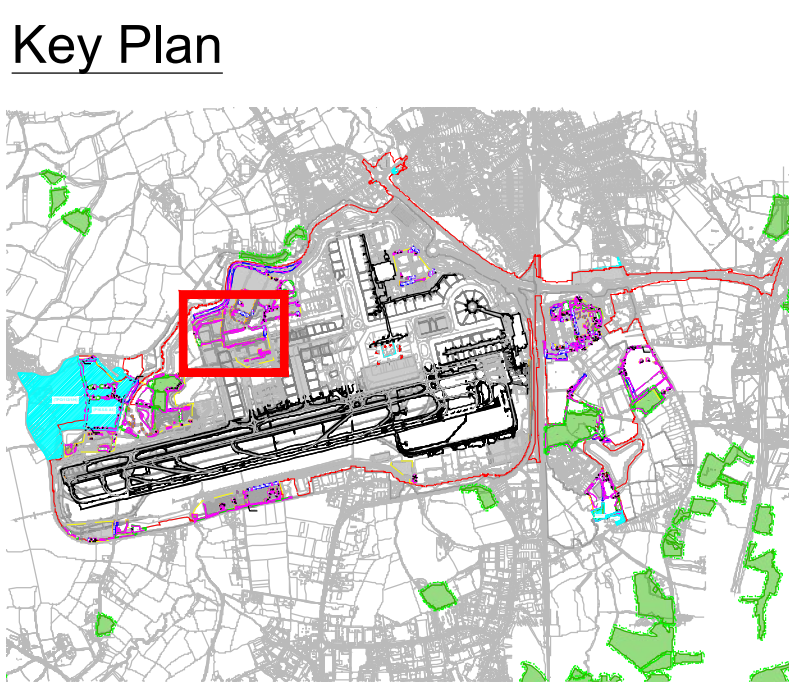
**Airport Preliminary Tree Removal Plans
Appendix 8.10.1
Sheet 4 of 13**

- Direction of first significant branch
- Root protection area (RPA). Calculated in accordance with Section 4.6 - BS5837:2012
- Veteran tree buffer (15 x stem Ø) (as per standing advice produced by Forestry England and Natural England)
- Tree protected by Tree Preservation Order. Bracketted number relates to the TPO reference.
- Designated Ancient Woodland (as per Natural England ancient woodland inventory, via open data publication)
- Ancient Woodland tree buffer (15m offset) (as per standing advice produced by Forestry England and Natural England)
- Projected tree loss required for construction of the Project (worst case scenario)
- Indicative Scheme Layout
