Portishead Branch Line (MetroWest Phase 1)

9.47 ExA.FI.D6.V1 – Agreement with Forestry Commission

Agreement relating to rights at Leigh Woods, Abbots Leigh Road, Abbots Leigh, BS8 3QB

The AGVMP

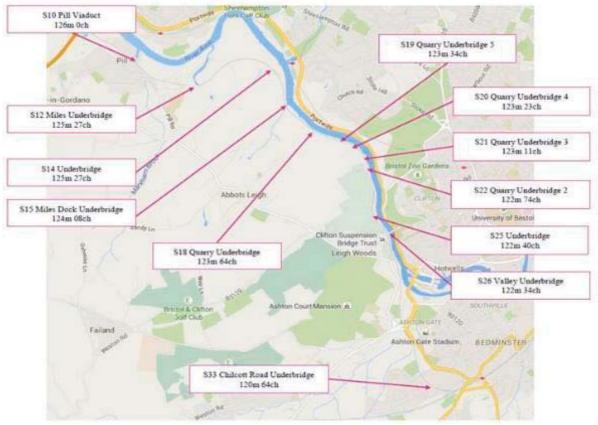
Figure 1: Location of bridges in the Avon Gorge

Structures within the Avon Gorge SAC/SSSI are S15, S18, S19, S20, S21, S22, S25 and S26

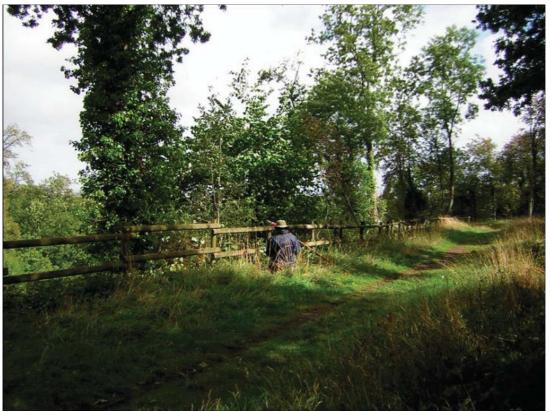
Photograph 1. Grey-leaved whitebeams planted on far side of fence, Leigh Woods Camp, 2004.

- 7.1.8. A series of grey-leaved whitebeams *S. porrigentiformis* were planted out along the north side of Leigh Woods camp (ST559733; Photograph 1).

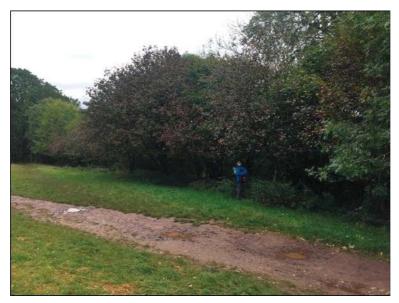
Photograph 2. Whitebeams planted in a row along the edge of The Plain over c. 50 m, photo taken 8/10/19

7.1.9. The planted whitebeams were surveyed by Dr Rich and Ms Libby Houston on 8th October 2019 to gather current information on the condition of the planted whitebeams. The information is provided in Table 12 and photograph 2 and 3. The location of the trees surveyed are shown on Figure 5.

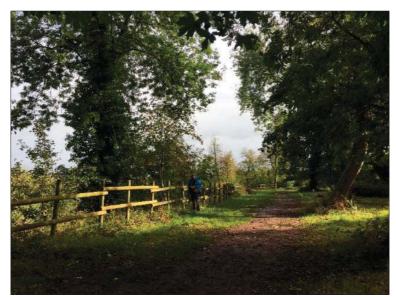
Photograph 3. Whitebeams planted behind the safety fence in the edge of Leigh Woods Camp, photo taken 8/10/19

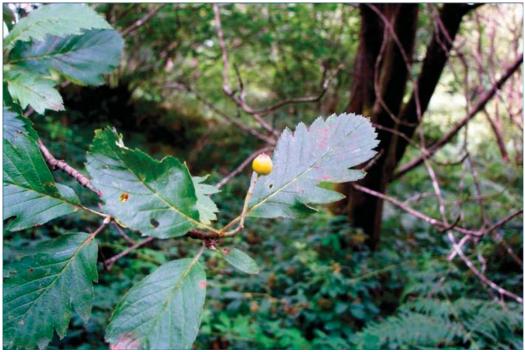
Photograph 5. One of the planted trees of Ley's whitebeam fruiting at Penmoelallt in August 2010 (planted in 1963).

7.1.10. Following discovery of a second population of the very rare Ley's whitebeam *Sorbus leyana* at Penmoelallt, Powys by J. Evans in 1958, the FC collected seed from them in 1959 and grew on saplings (presumably in a forestry nursery). In April 1963, seven 2-year-old saplings were planted in three separate fenced enclosures on level ground above the cliffs adjacent to the wild plants. Six of these trees survived to the following year and by 1968 had grown to between 1.7 and 2.7 m tall. The fences around the enclosures were removed in the early 1990s. All six remaining trees survive to 2004 and 2010 (Photographs 4 and 5) and had a mean estimated height of 10 m and mean girth at 1.3 m of 58 cm and all have fruited (Rich et al. 2005). These trees were still present in 2018 (T. Rich personal observation). Deer and sheep graze these woodlands but have not affected the mature trees.

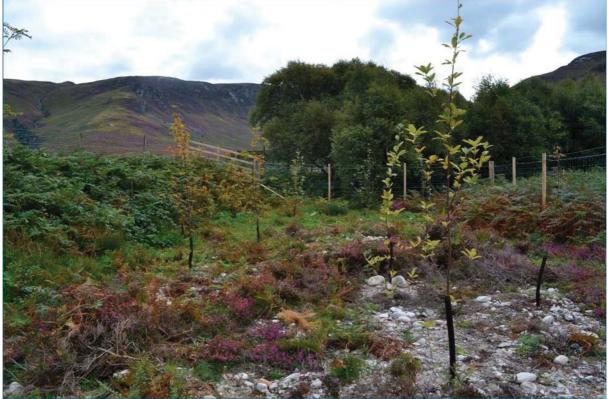
Photograph 7. Arran Sorbus planting enclosure at mouth of Glen Catacol. September 2014.

7.1.12. Royal Botanic Gardens Edinburgh and Scottish Natural Heritage (and its predecessors) and have studied the whitebeams of Arran since the 1970s. As part of a recent conservation project, three endemic species grown from seed from Arran origin have been planted out in an enclosure at the mouth of Glen Catacol and when visited in 2014 were growing well (Photograph 7).

The saplings of Arran whitebeam *S. arranensis* and Arran service-tree *S. pseudofennica* were most likely grown from seed; the sapling of the false rowan *S. pseudomeinichii* may have been grown from cuttings (Dr Rich collected seed of it for the Royal Botanic Gardens Edinburgh to grow during his 2014 visit). The saplings were quite large when originally planted and have to be protected from the high red deer grazing pressure on Arran.

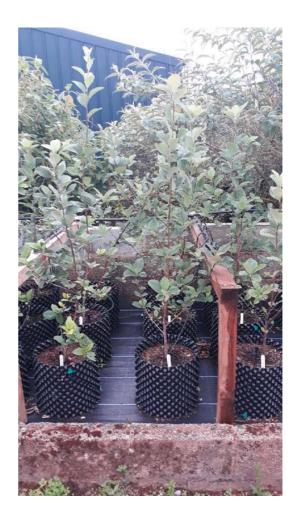
Above- Sorbus leighensis most recent photo Left- Sorbus bristolensis most recent photo

Current height of trees in centimetres	
avonensis	130>160
leighensis	80>160
bristoliensis	90>130
eminens	100>150
