Appendix 9.3 - Model Verification

Northampton AQMA No.1 and NSSUE, Collingtree

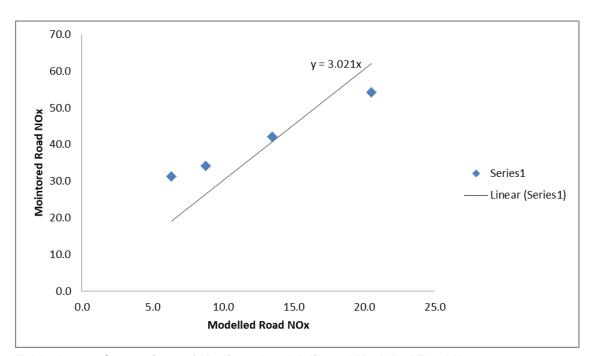
Figure A9.3.1: Monitored vs Modelled NO_x

- Year(s) of verification: 2016
- Verification factor(s):
 - 0 3.02

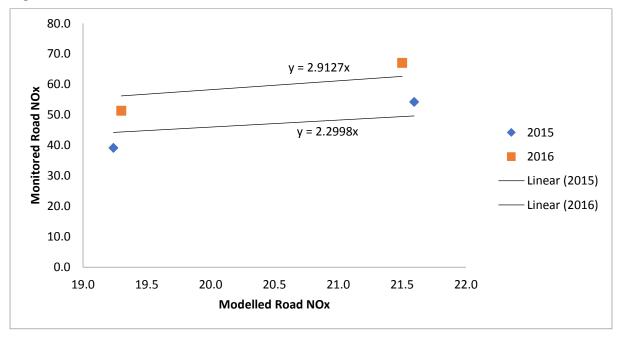
Figure A9.3.2: Monitored vs Modelled NO_x

• Year(s) of verification: 2015 & 2016

2015: 2.302016: 2.91

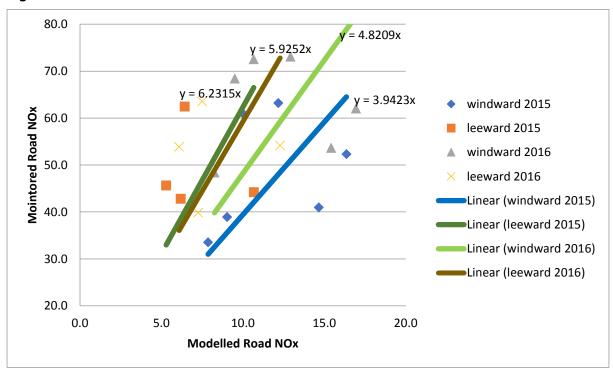
Figure A9.3.3: Monitored vs Modelled NO_x

Leeward: 6.23Windward: 3.94

Leeward: 5.92Windward: 4.82

• Harborough Road scoped out of MV as adjacent to bus stop and suspected limited air flow around DT.

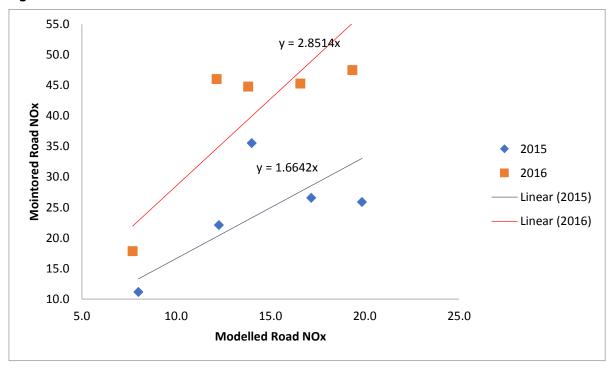
Figure A9.3.4: Monitored vs Modelled NO_x

Verification factor(s):
 2015: 1.66
 2016: 2.85

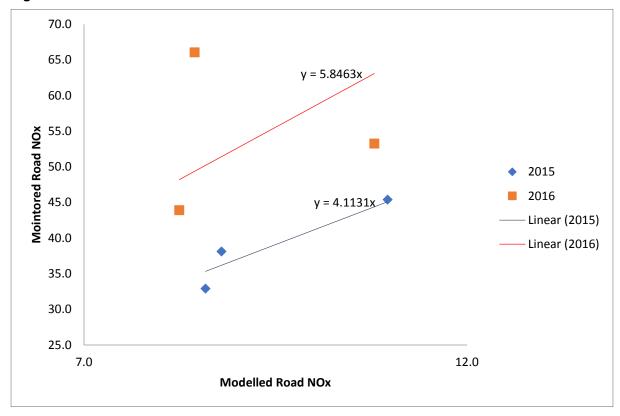
Figure A9.3.5: Monitored vs Modelled NO_x

Verification factor(s):2015: 4.11

o 2016: 5.85

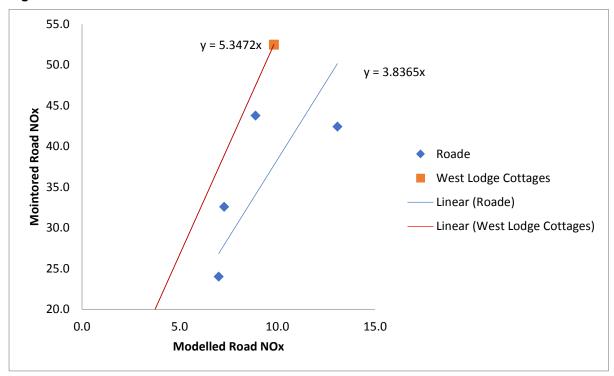
Figure A9.3.6: Monitored vs Modelled NO_x

o Roade: 3.84

o West Lodge Cottages: 5.35

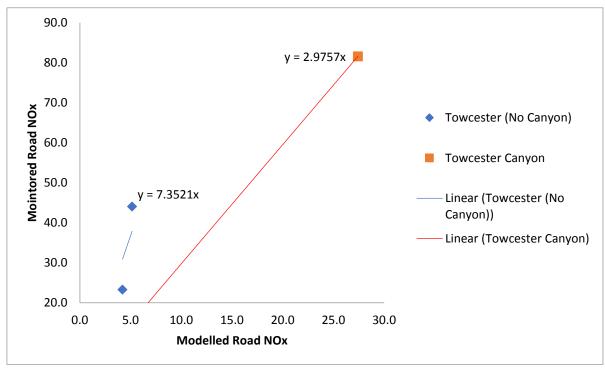
Figure A9.3.7: Monitored vs Modelled NO_x

- Year(s) of verification: 2015
- Parts of Towcester modelled as a simple Canyon.
- A number of DT not considered in verification as not considered representative of residential
 use
- Verification factor(s):
 - o 2015: 2.97 (Canyon), 7.35 (Not Canyon)
