## **HINCKLEY NATIONAL RAIL FREIGHT INTERCHANGE**

### **The Hinckley National Rail Freight Interchange Development Consent Order**

### **ES Appendix 11.4: Arboricultural Impact Assessment**

Document reference: 6.2.11.4

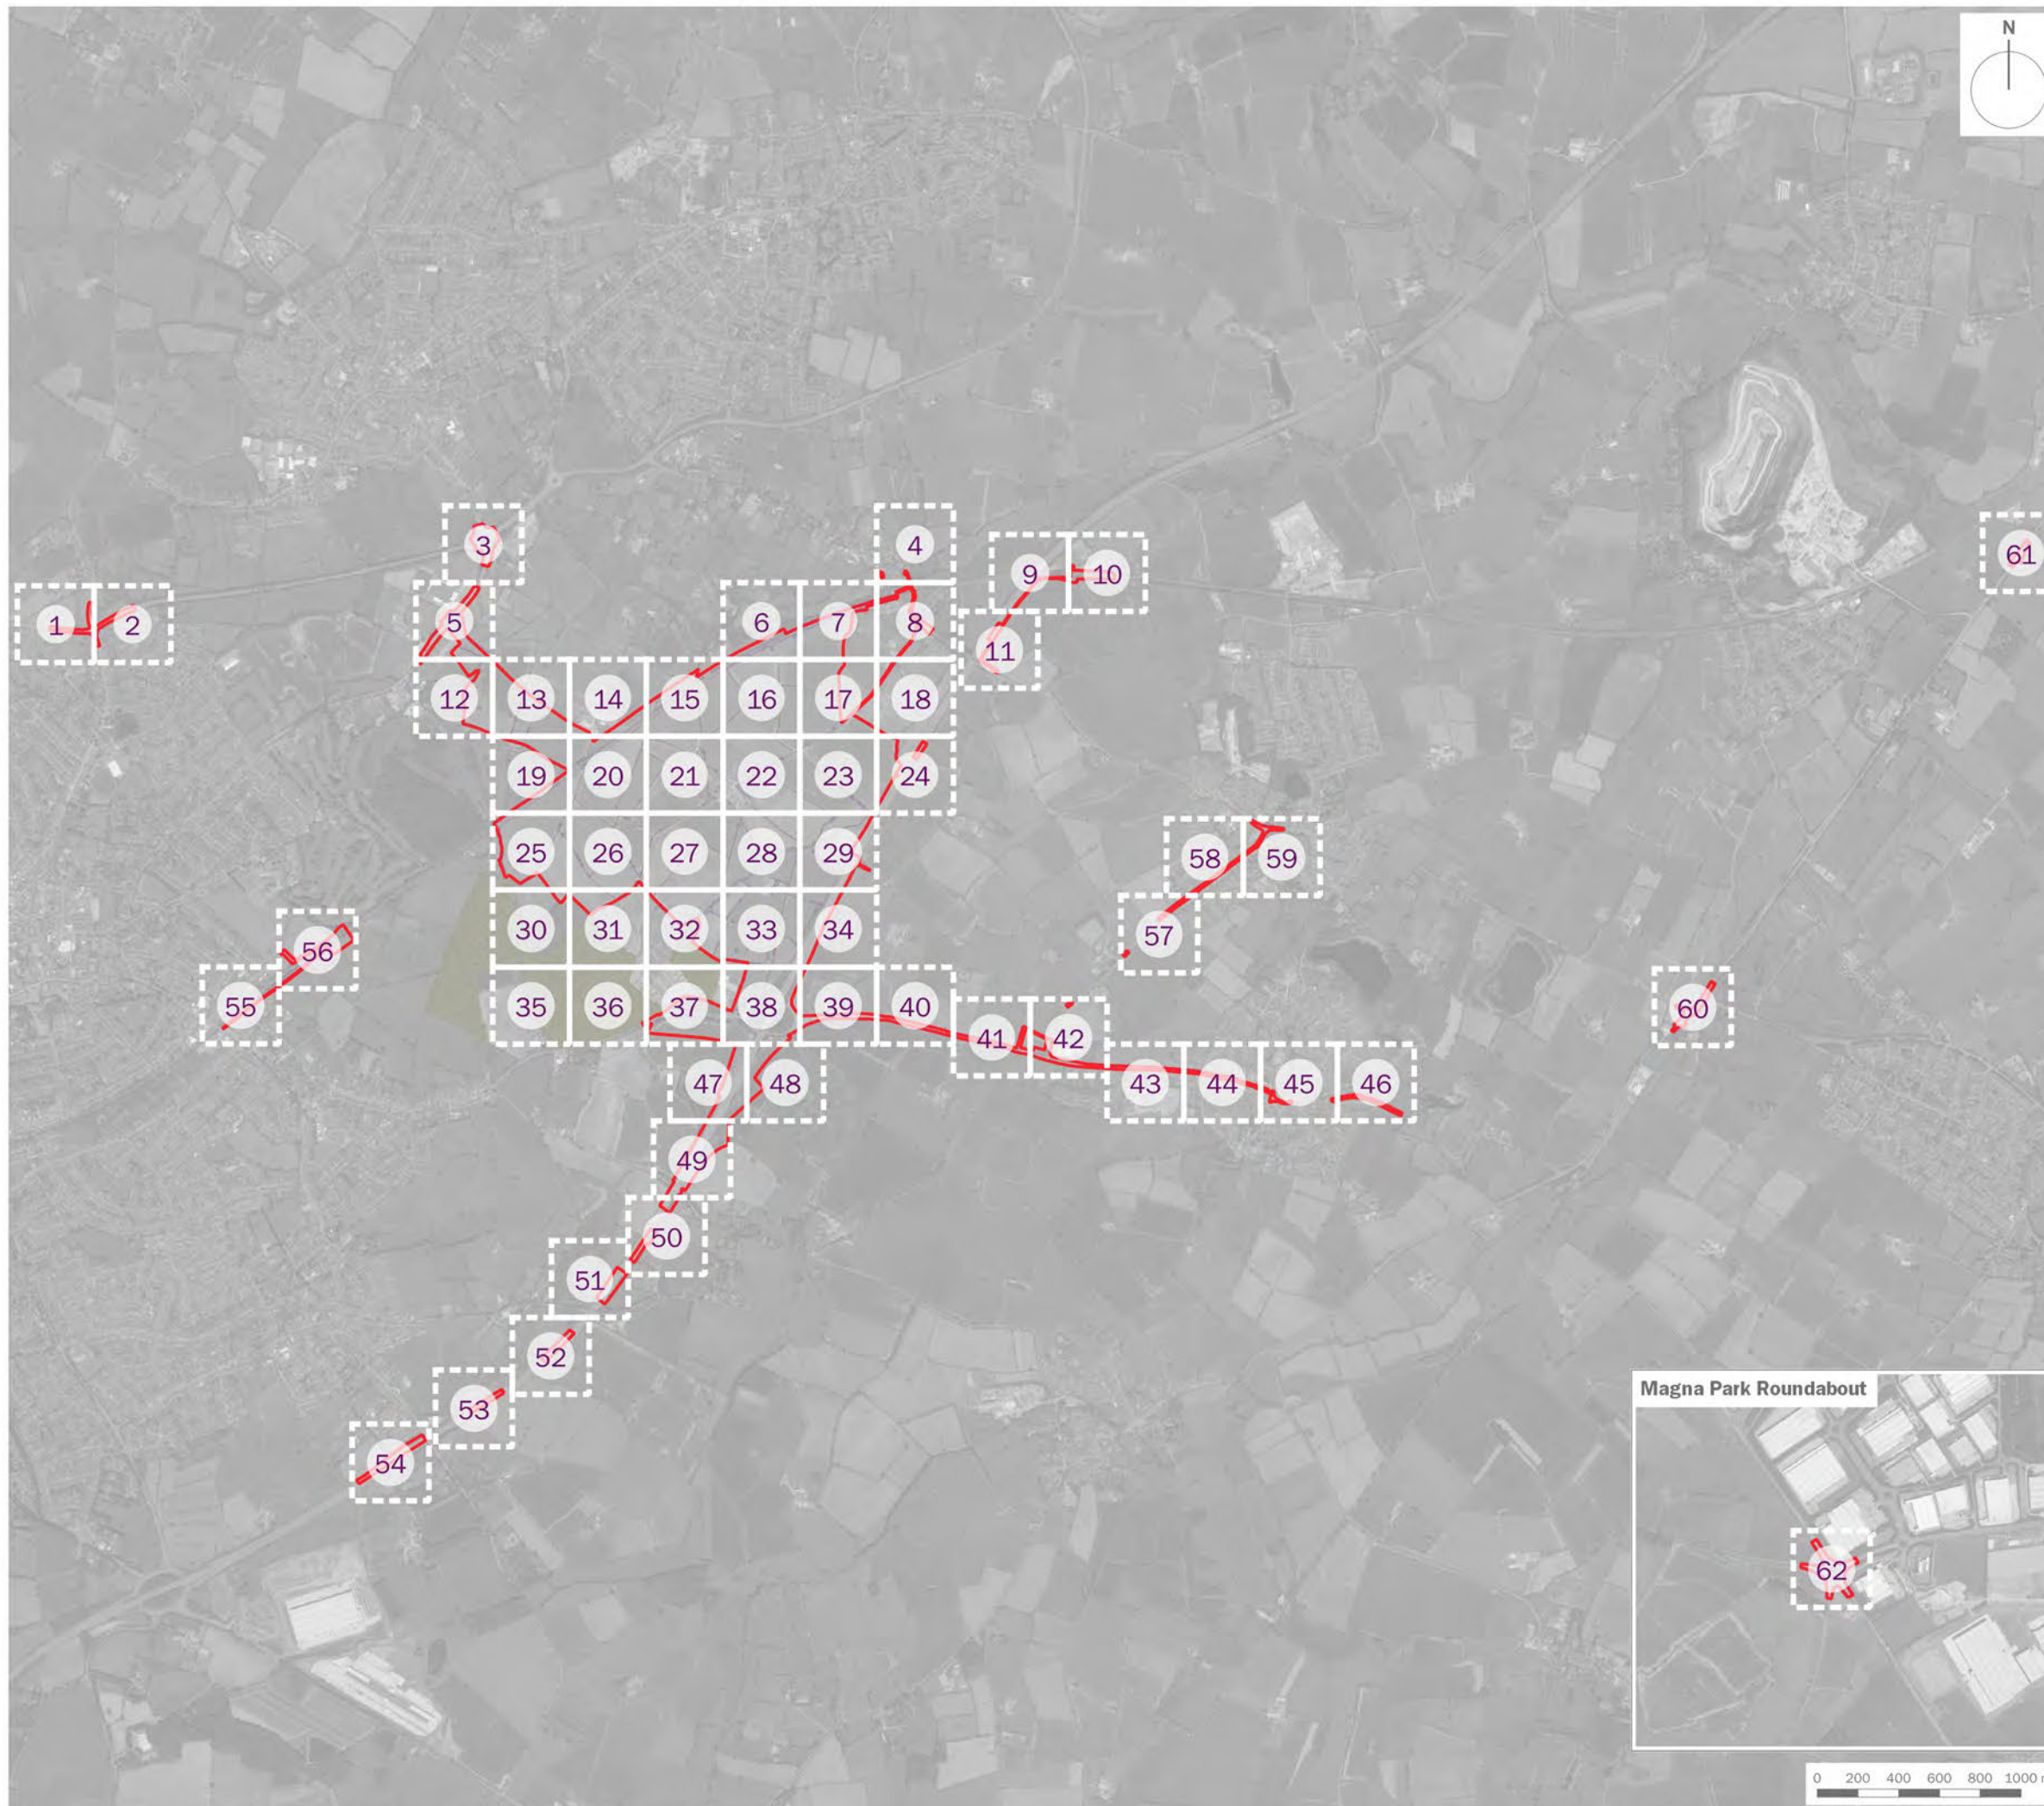
client	<b>Tritax Symmetry (Hinckley) Limited</b>		
project title	<b>Hinckley National Rail Freight Interchange</b>		
drawing title	<b>Tree Constraints Plan (Overview)</b>		
date	31 OCTOBER 2022	drawn by	GYo
drawing number	edp3267_d037h	checked	BWa
scale	1:32,000 @ A3	QA	RBa

Annex 1 ◆ Tree Constraints Plan  
(edp3267\_d037h 31 October 2022 GYo/BWa)

- 3.11 The required RPA for each item is described in the Tree Survey Schedule (Annex 2) and depicted on the Tree Constraints Plan within Annex 1. To ensure appropriate protection is afforded to the roots, the extent of the RPA shall be defined by means of the installation of protective barriers in accordance with the recommendations given in Section 6.2 of BS 5837:2012, the specification for which is enclosed as Annex 7.

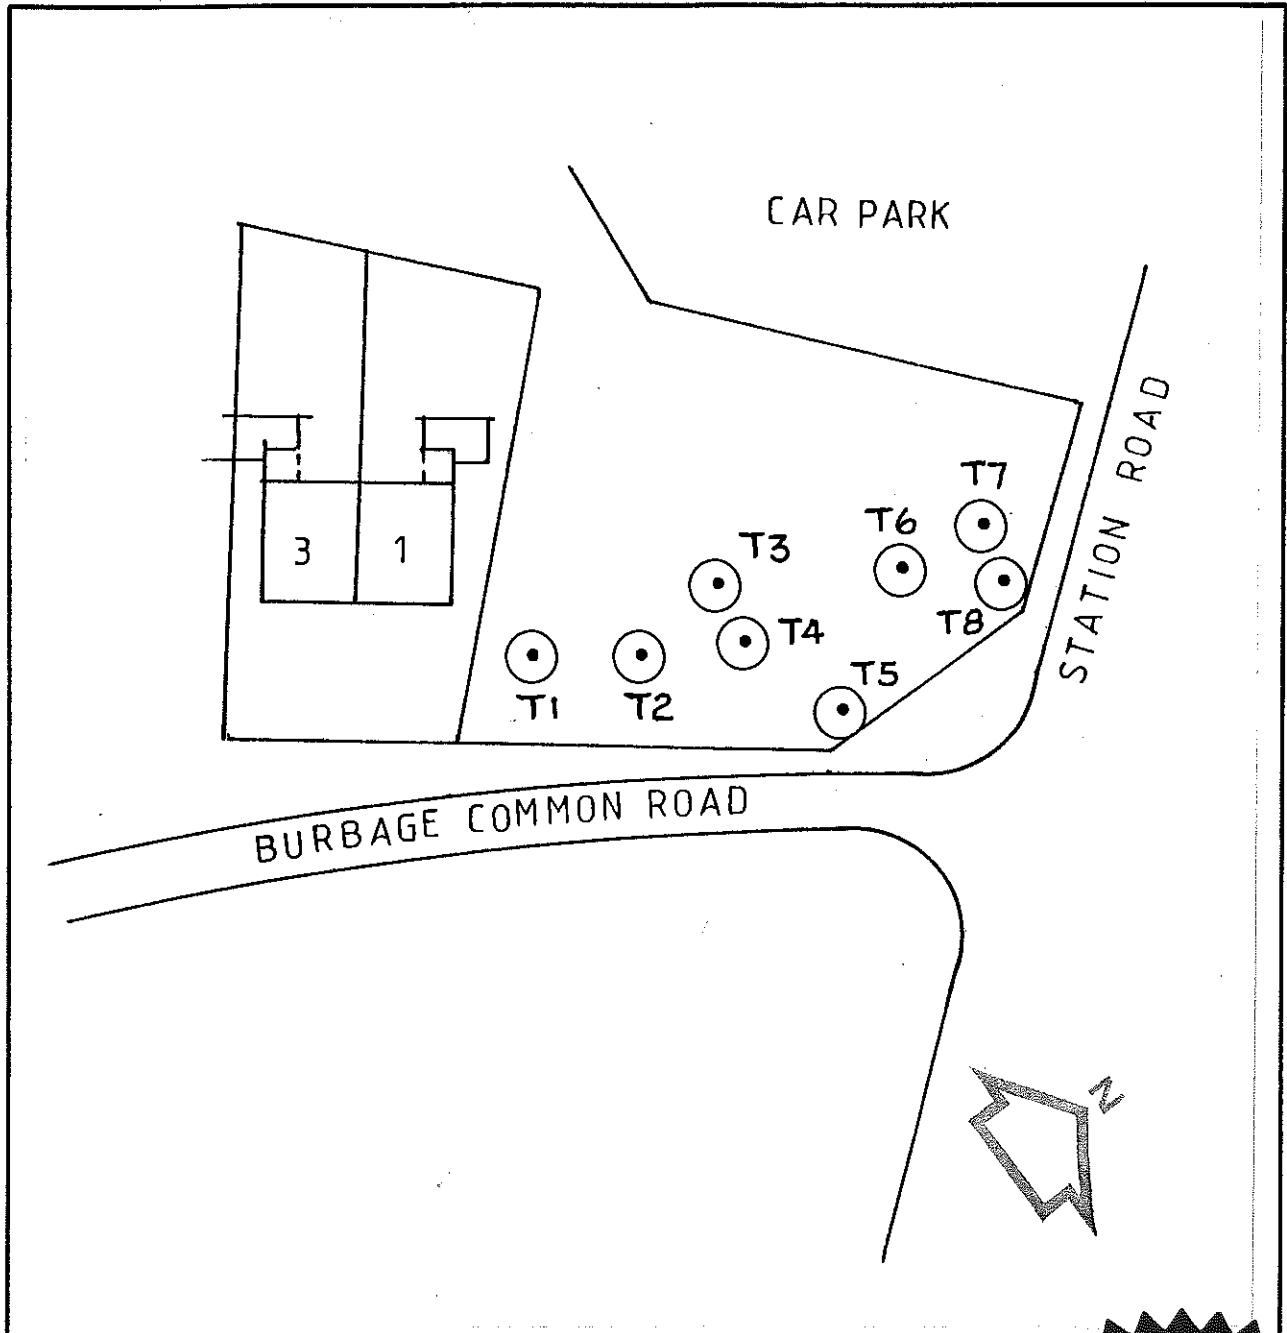
Junction of Burbage Common Road & Station Road, Elvesthorpe.

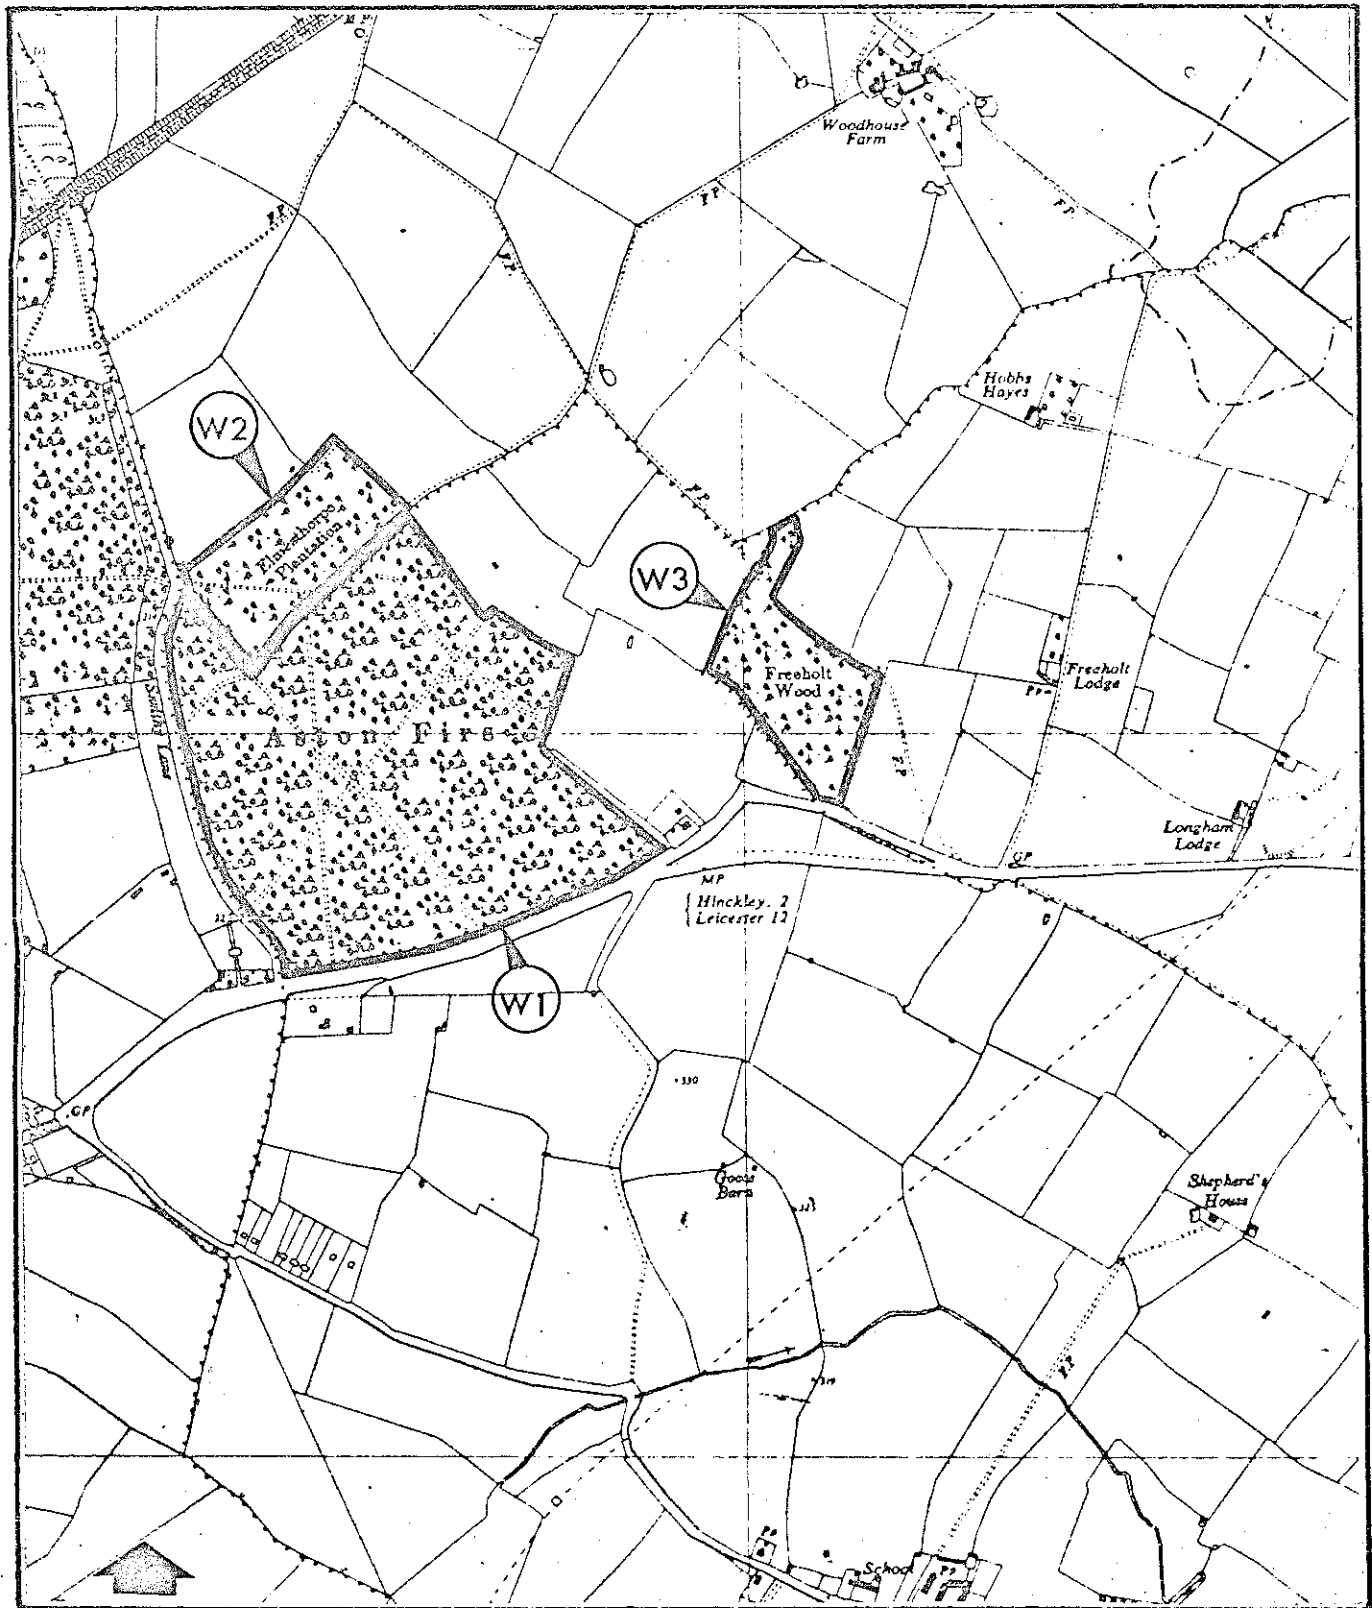
## Aston Firs, Elmesthorpe Plantation and Freeholt Wood. Tree Preservation Order 1967

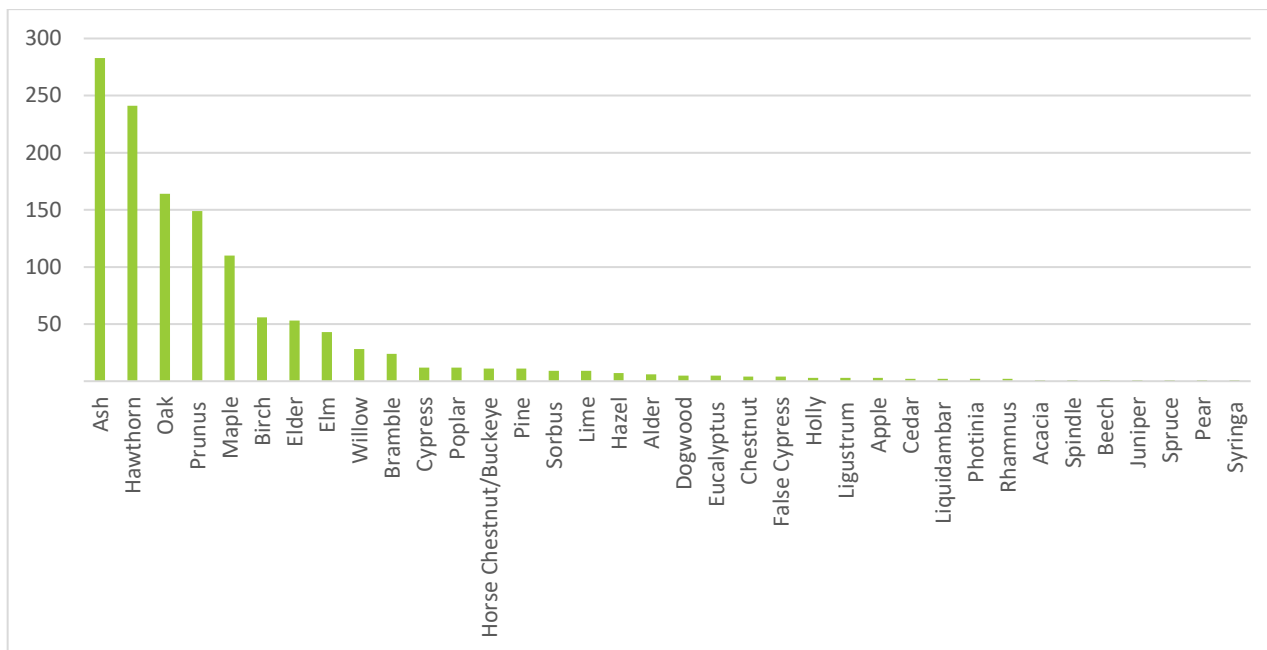
Figure A4.1: Species Diversity.

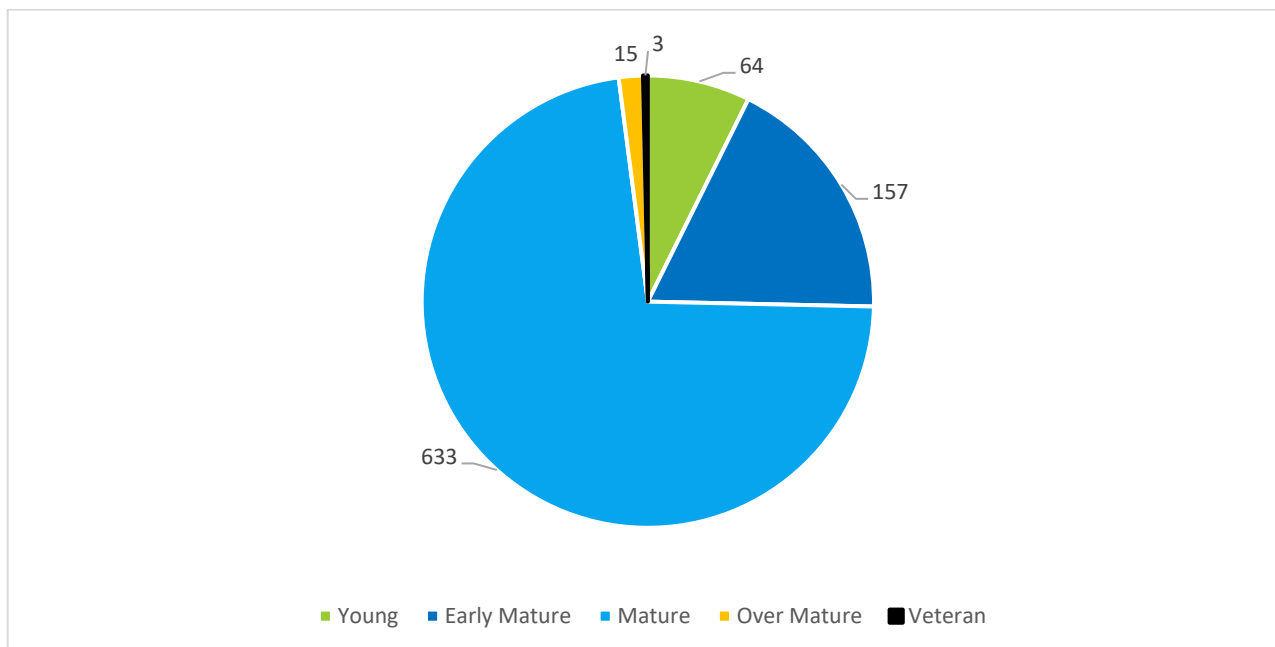
Figure A4.2: Age Distribution.

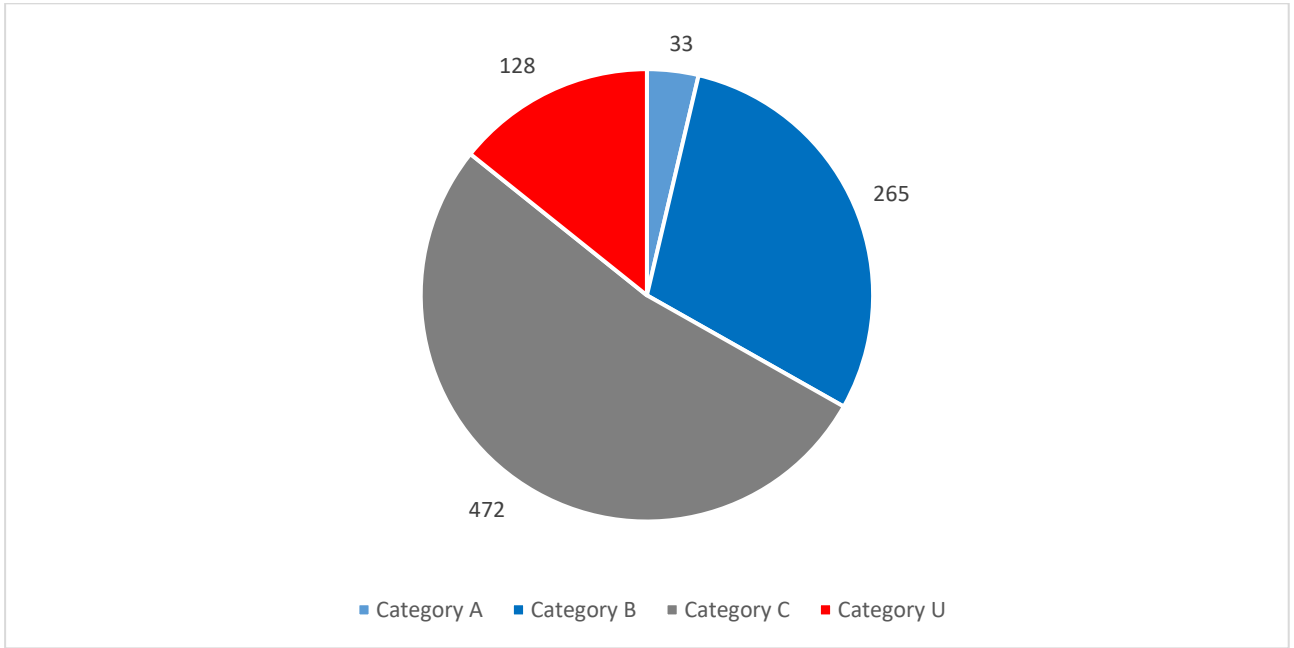
**Figure A4.3: Category Grading.**

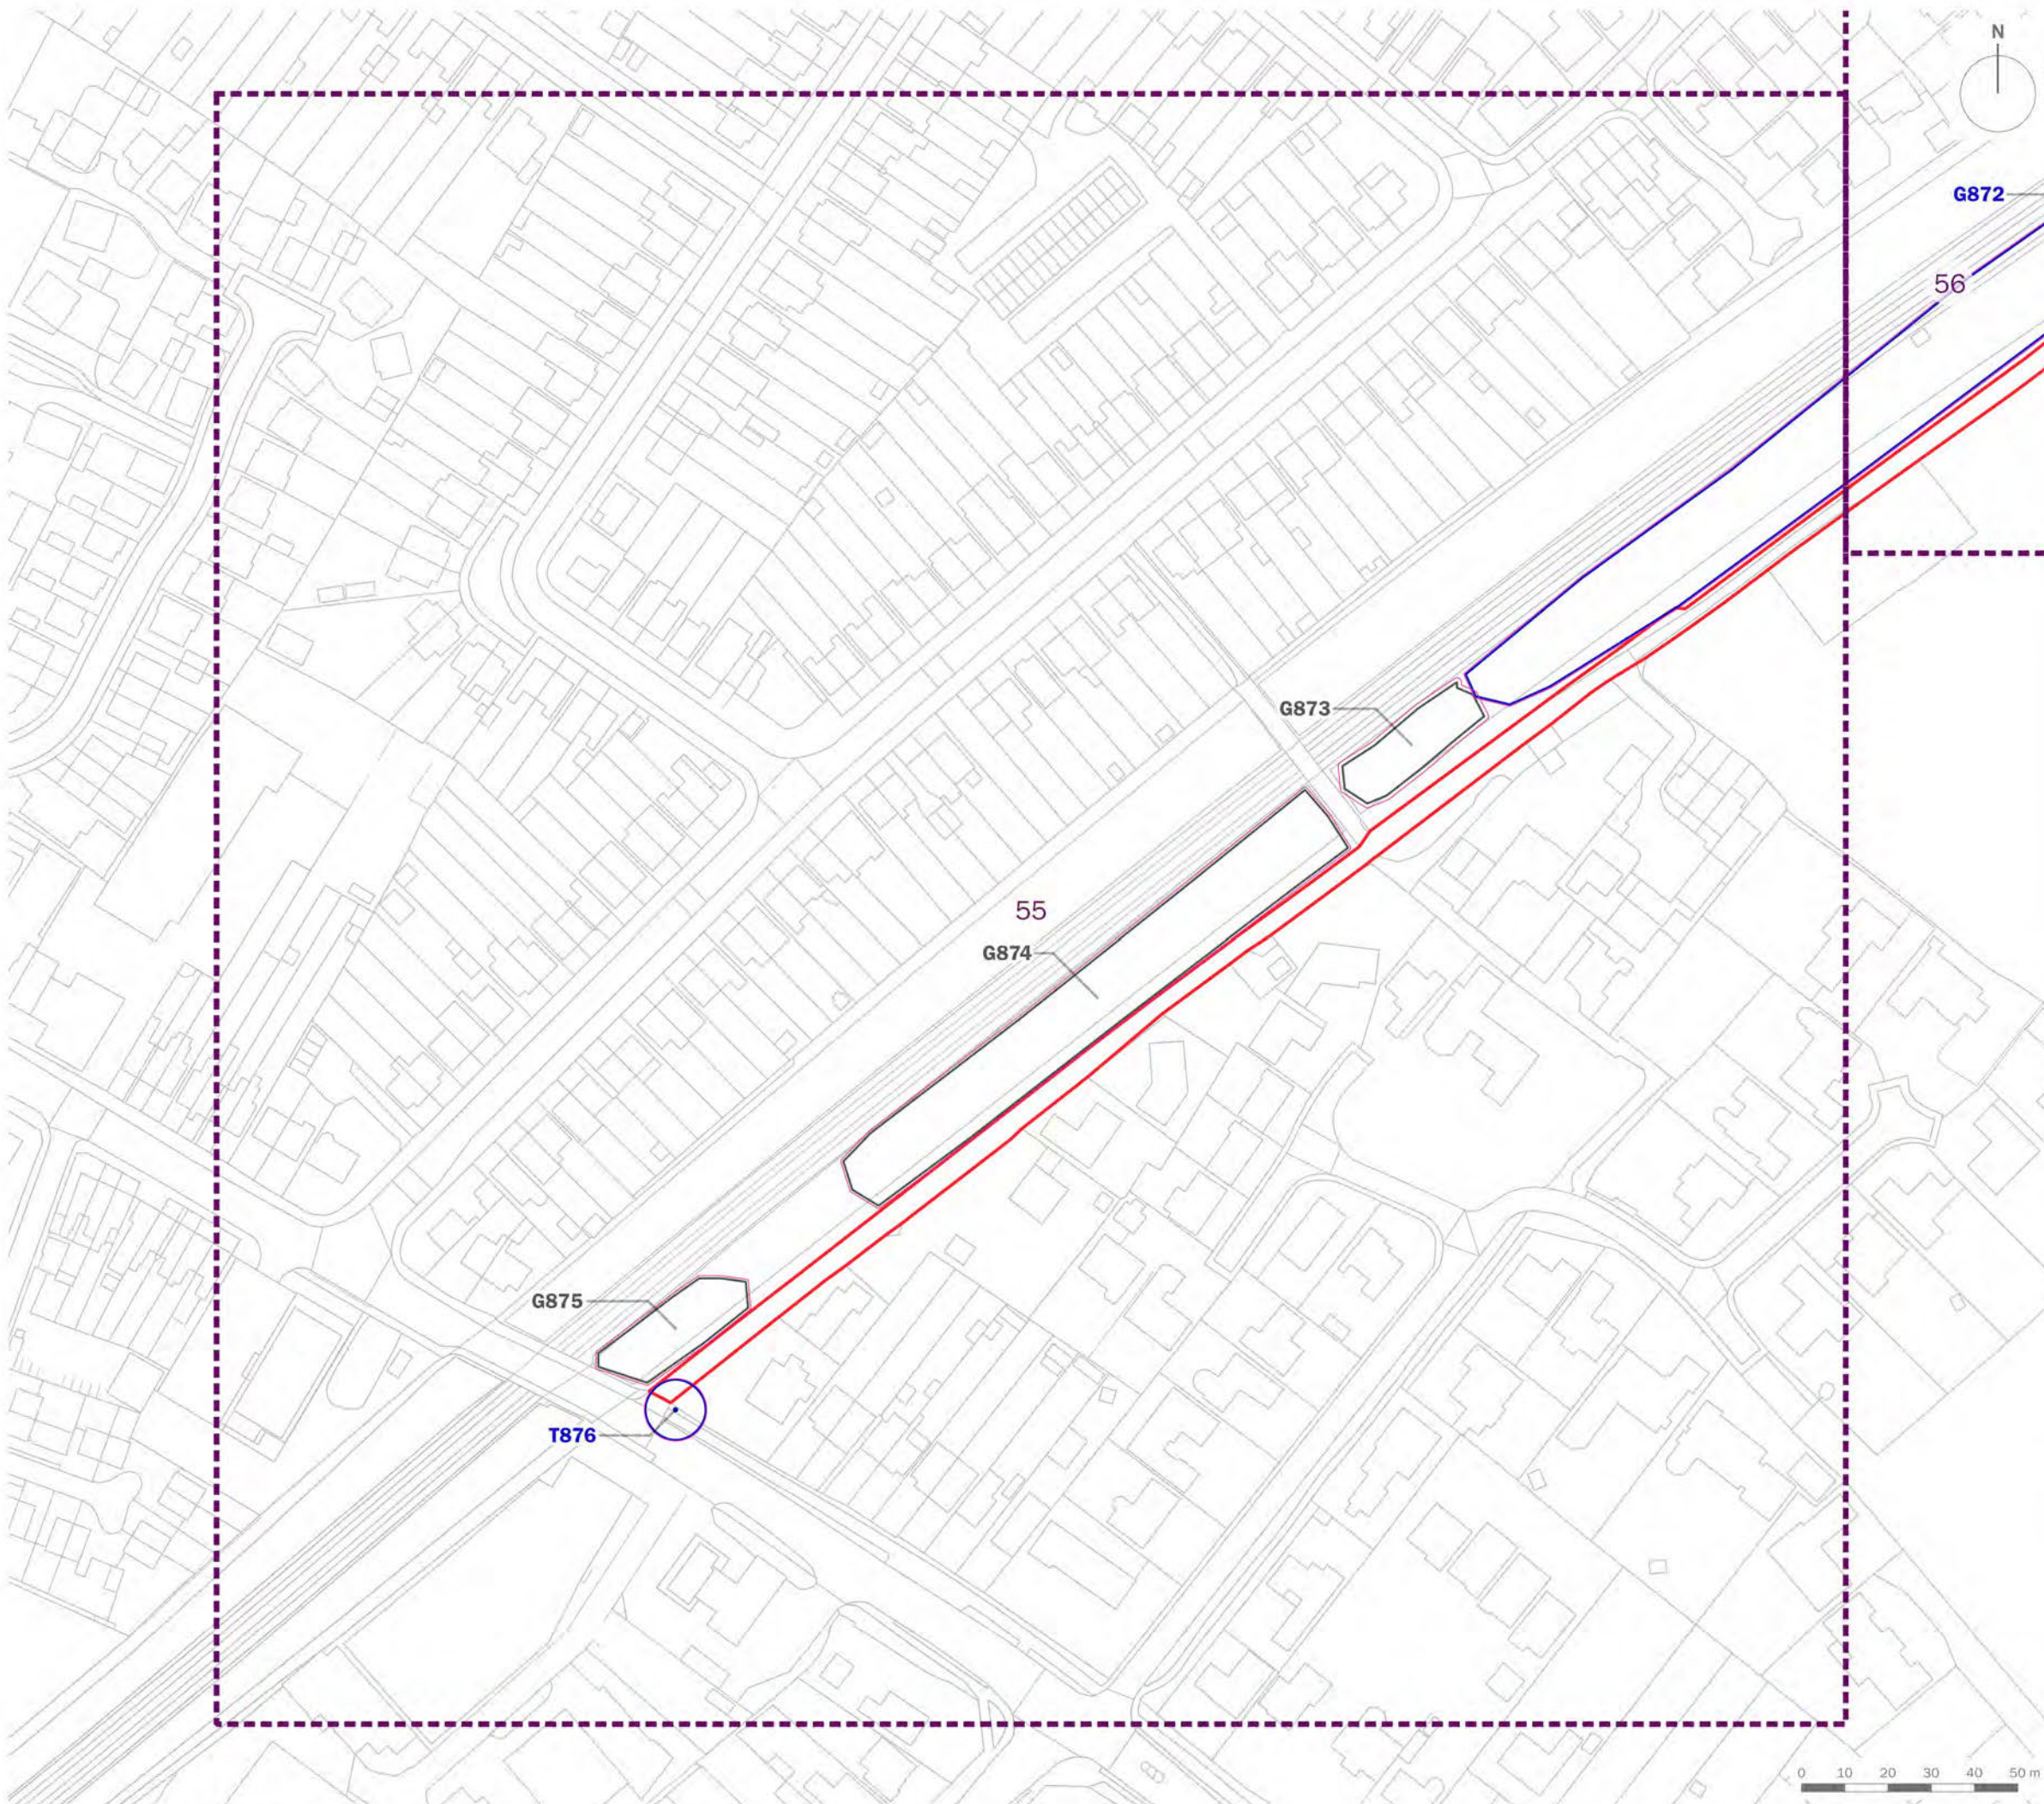
date	30 SEPTEMBER 2022	drawn by	GYo
drawing number	edp3267_d041e	checked	BWa
scale	1:1,500 @ A3	QA	RBa

Trees to be Removed

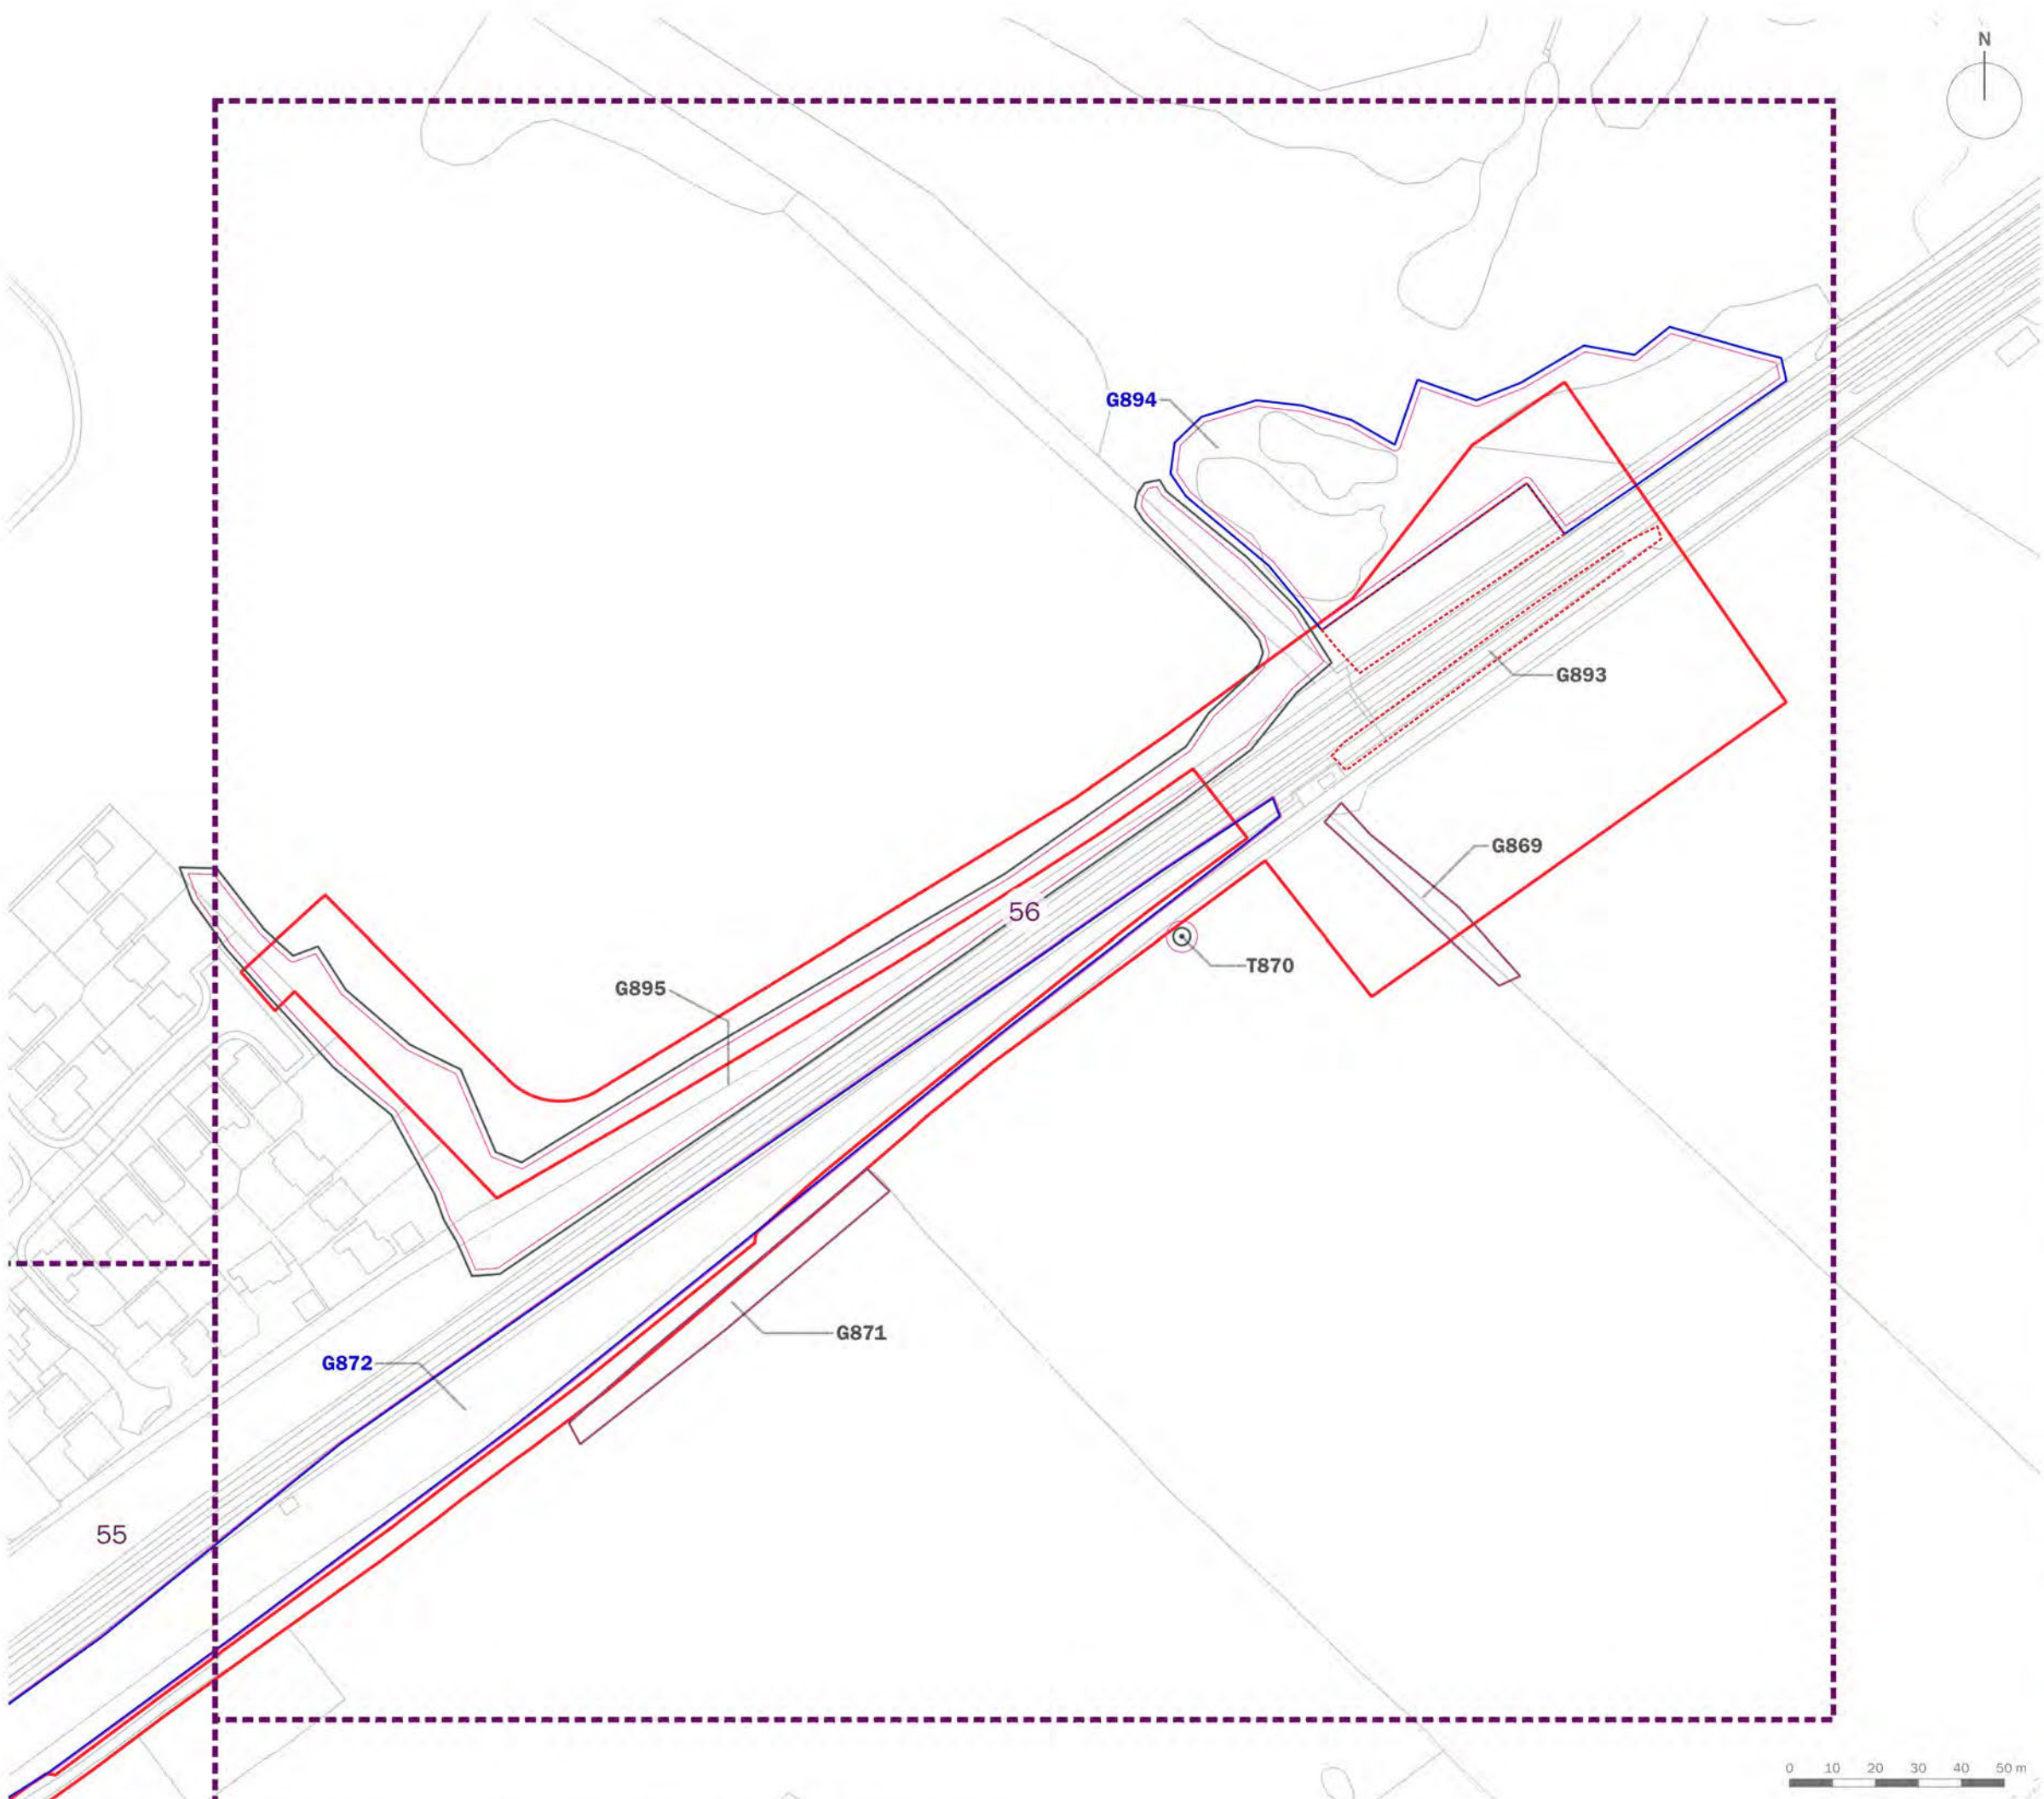
date	30 SEPTEMBER 2022	drawn by	GYo
drawing number	edp3267_d041e	checked	BWa
scale	1:1,500 @ A3	QA	RBa

Trees to be Removed

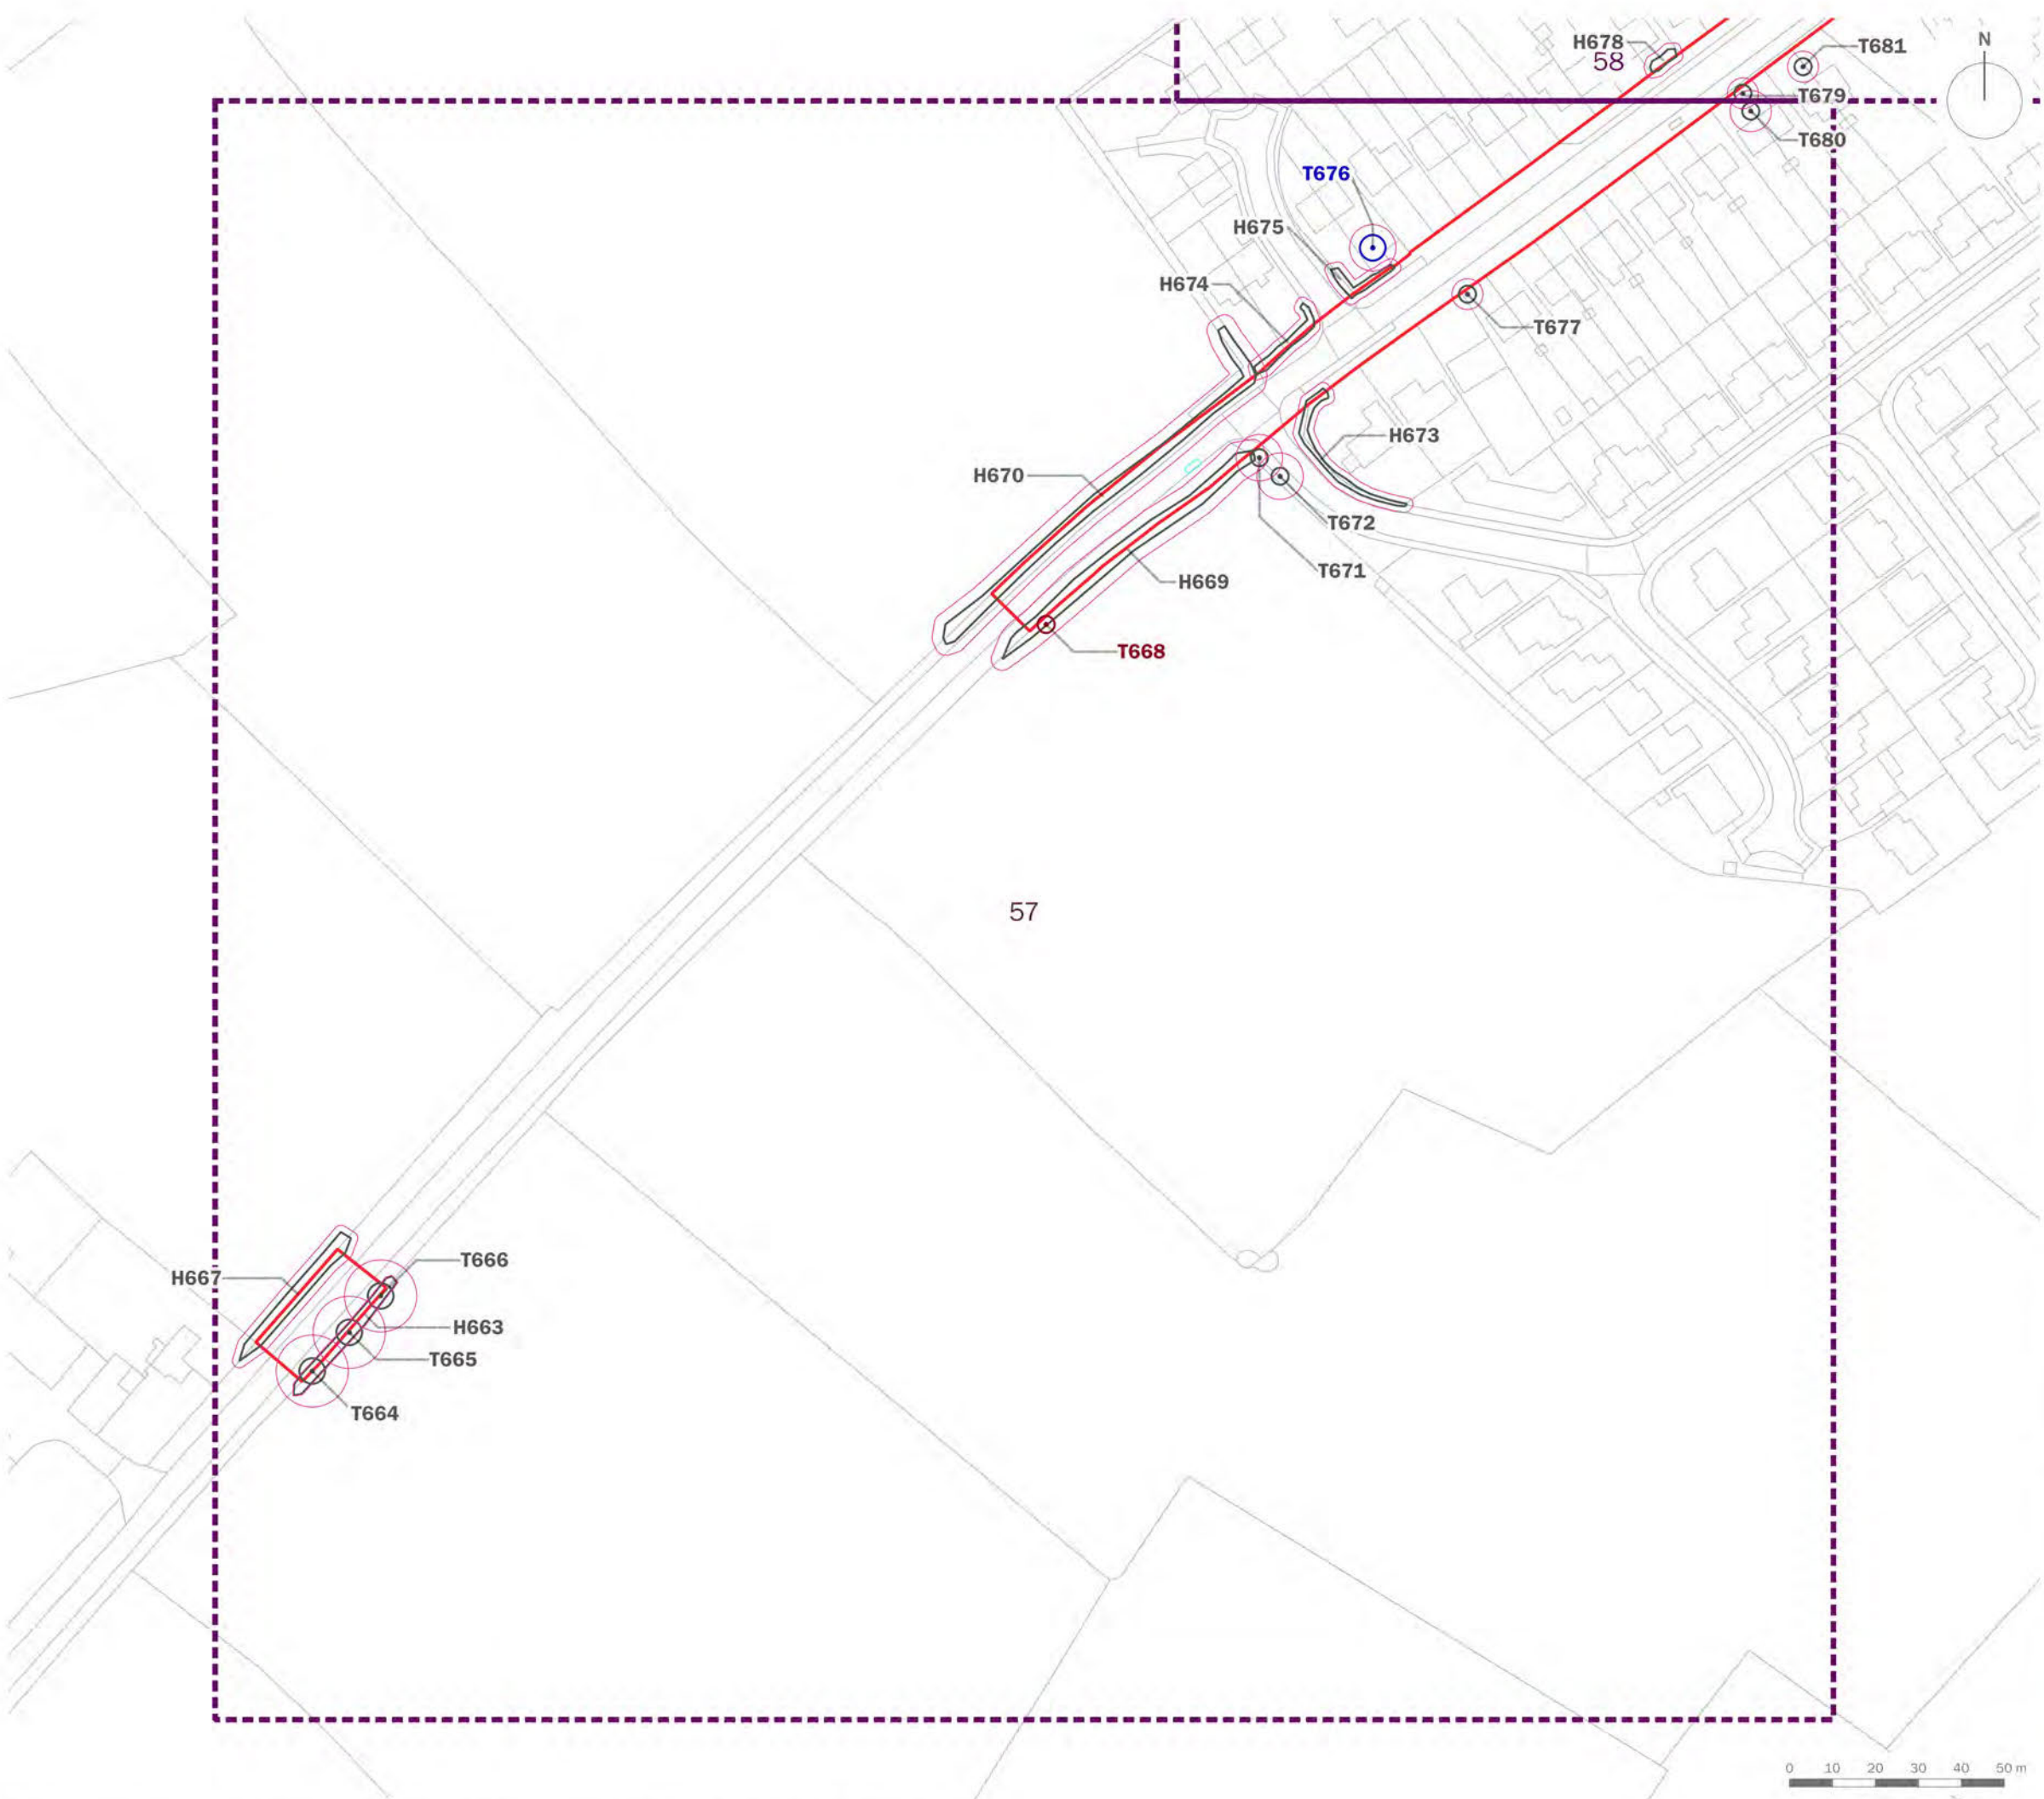
date	30 SEPTEMBER 2022	drawn by	GYo
drawing number	edp3267_d041e	checked	BWa
scale	1:1,500 @ A3	QA	RBa

Tree Preservation Order
-   Trees to be Removed
