## **HINCKLEY NATIONAL RAIL FREIGHT INTERCHANGE**

### **The Hinckley National Rail Freight Interchange Development Consent Order**

### **ES Appendix 11.4: Arboricultural Impact Assessment**

Document reference: 6.2.11.4

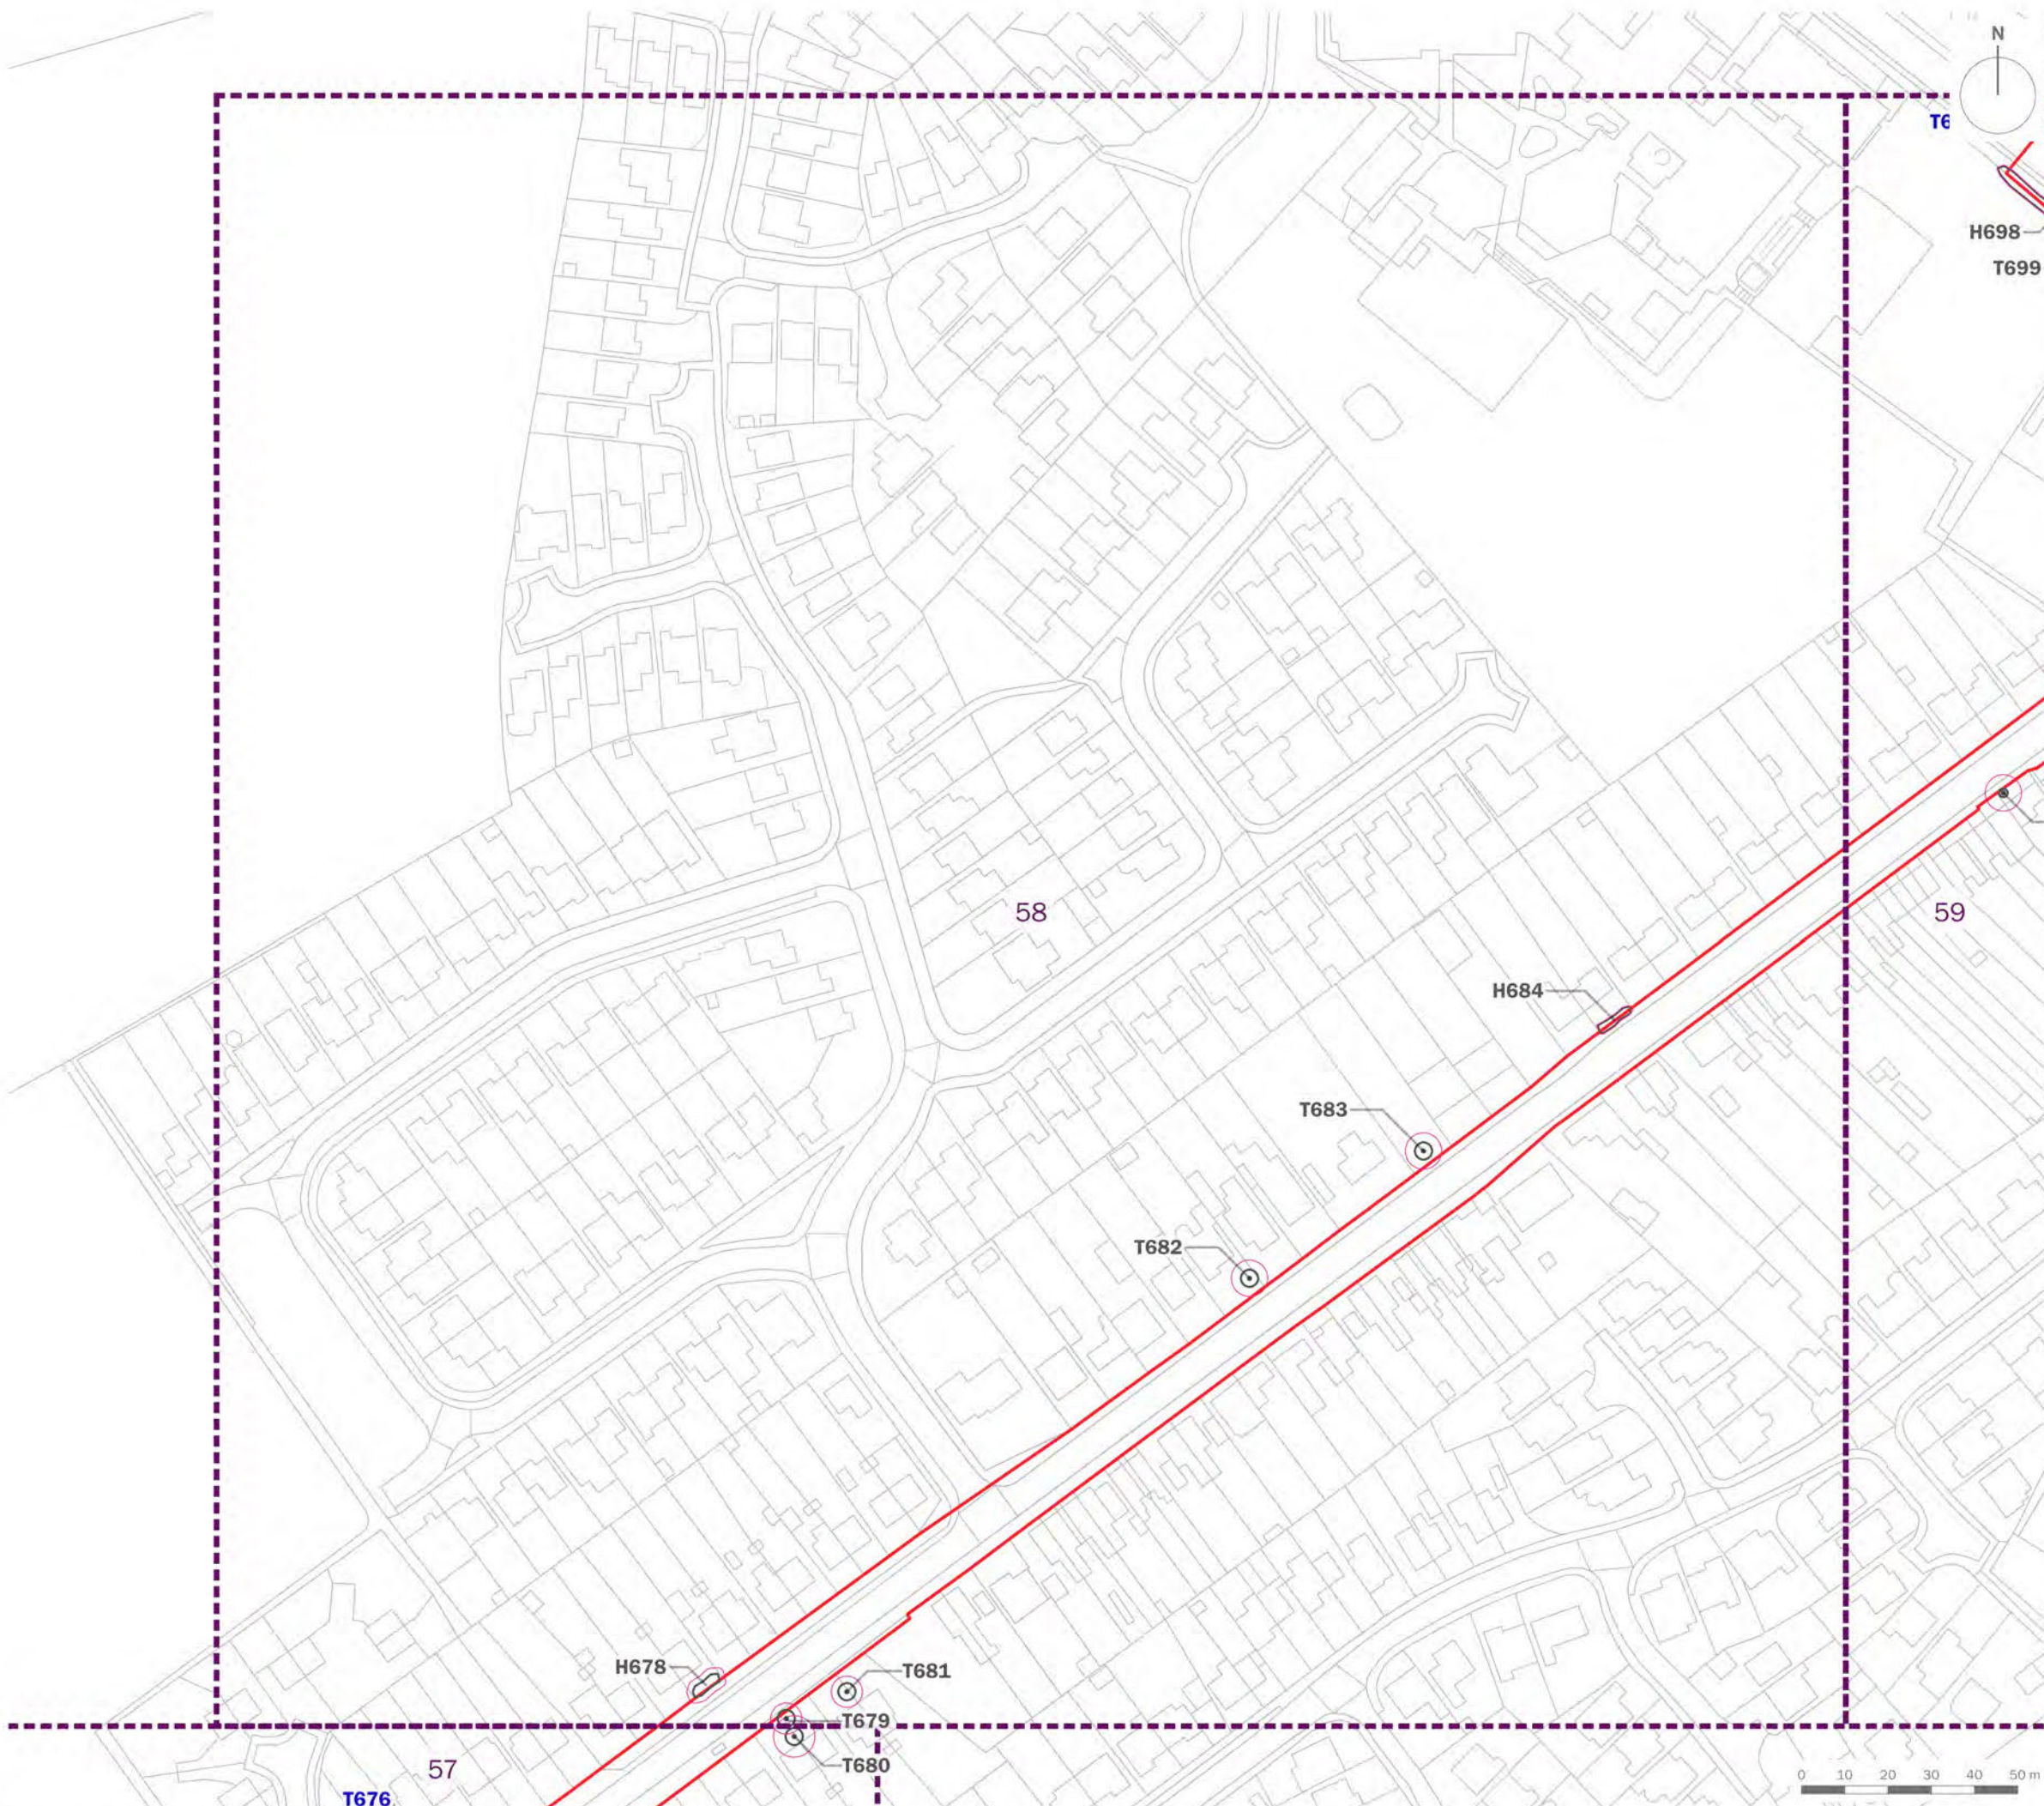
date	30 SEPTEMBER 2022	drawn by	GYo
drawing number	edp3267_d041e	checked	BWa
scale	1:1,500 @ A3	QA	RBa

Trees to be Removed

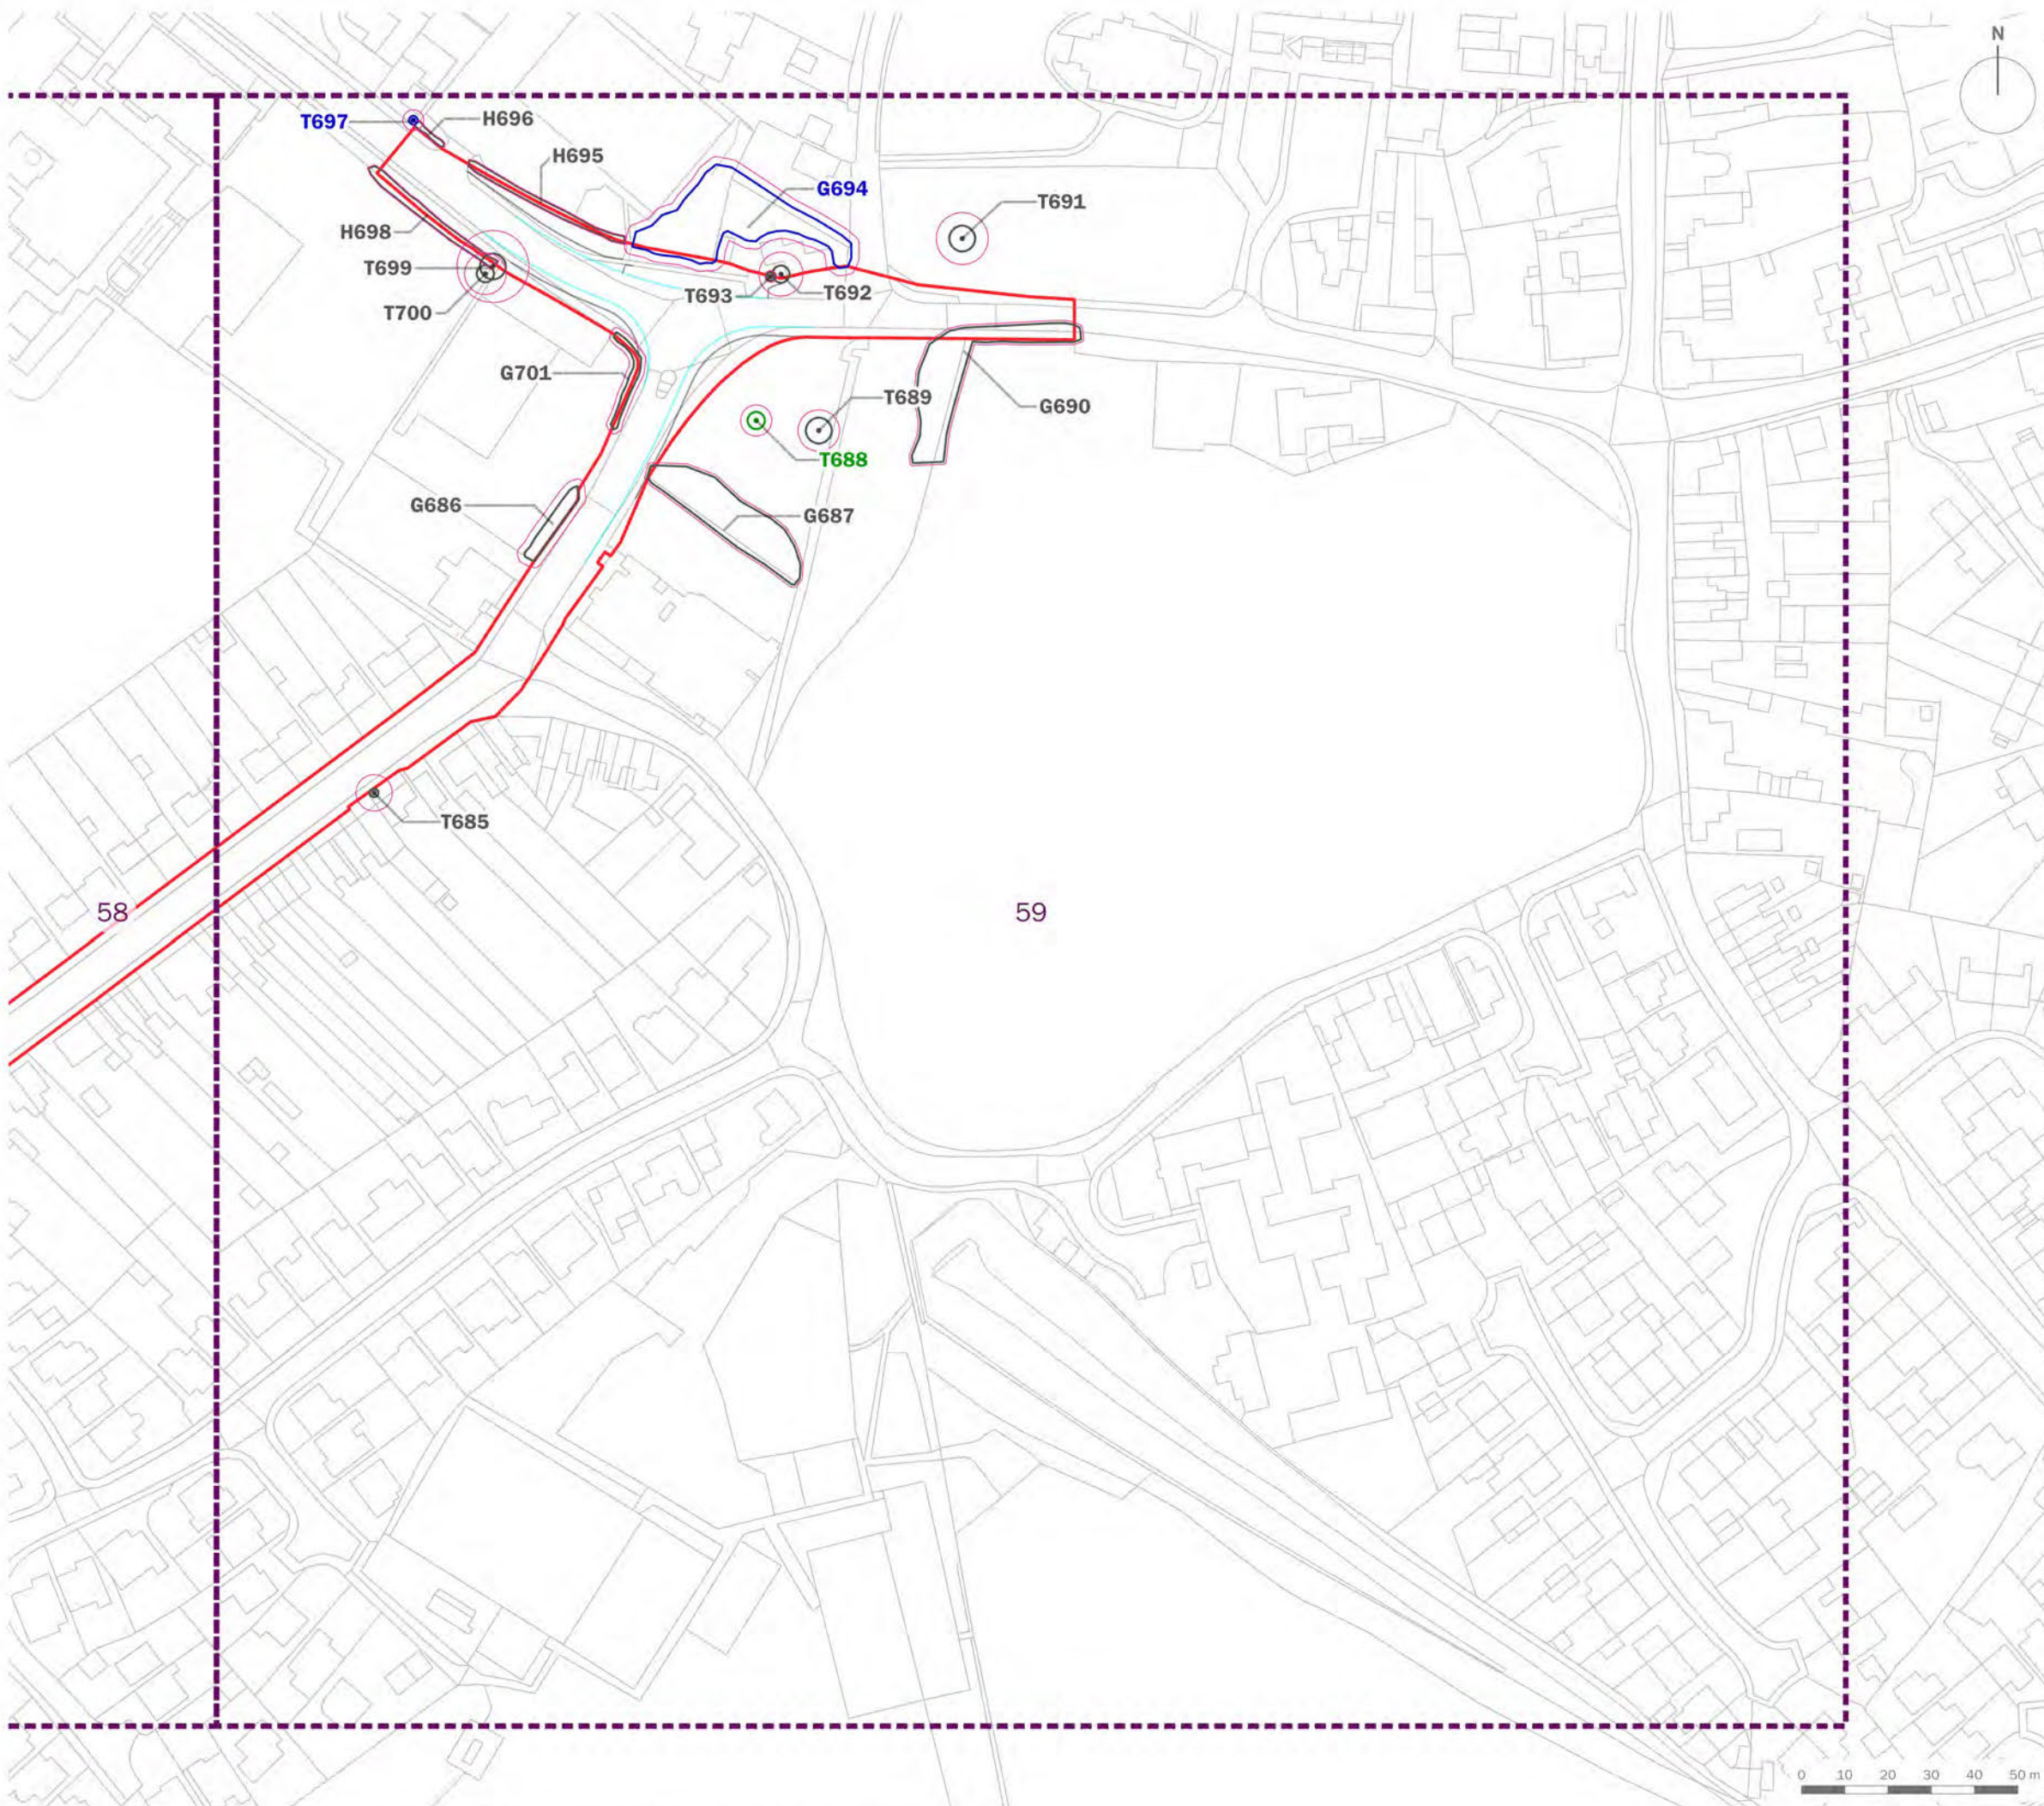
date	30 SEPTEMBER 2022	drawn by	GYo
drawing number	edp3267_d041e	checked	BWa
scale	1:1,500 @ A3	QA	RBa

Trees to be Removed

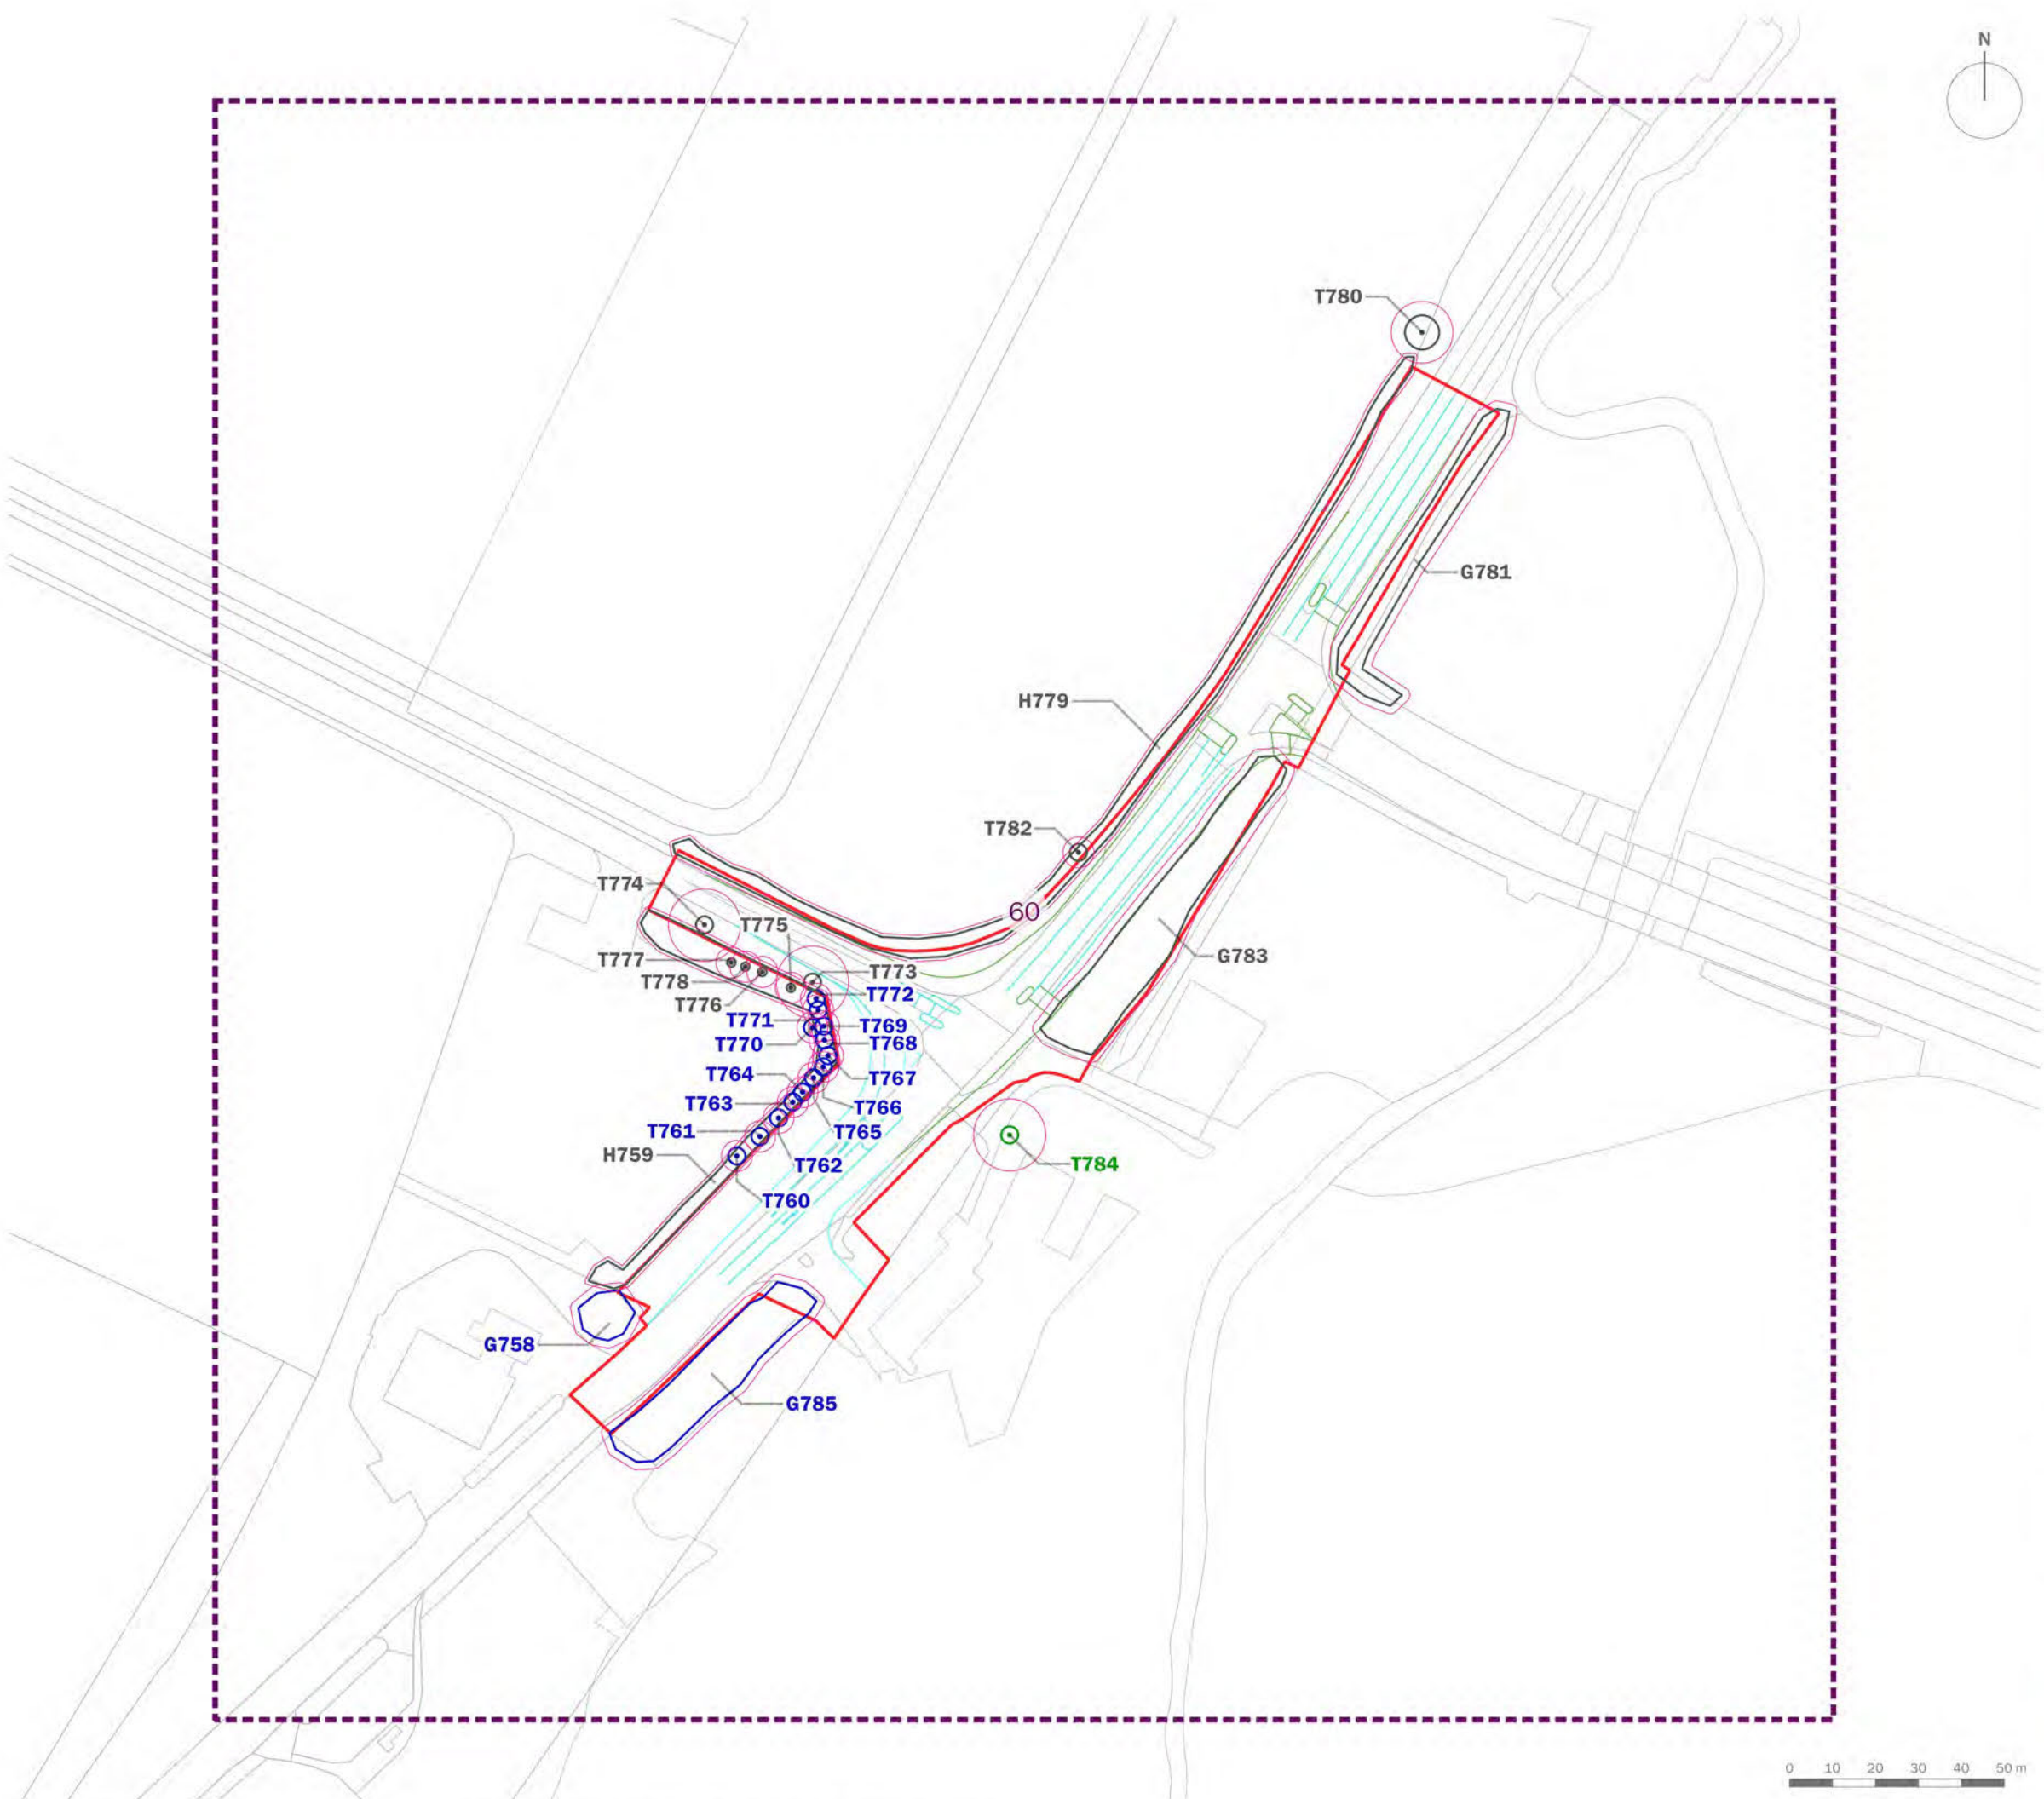
date	30 SEPTEMBER 2022	drawn by	GYo
drawing number	edp3267_d041e	checked	BWa
scale	1:1,500 @ A3	QA	RBa

Trees to be Removed

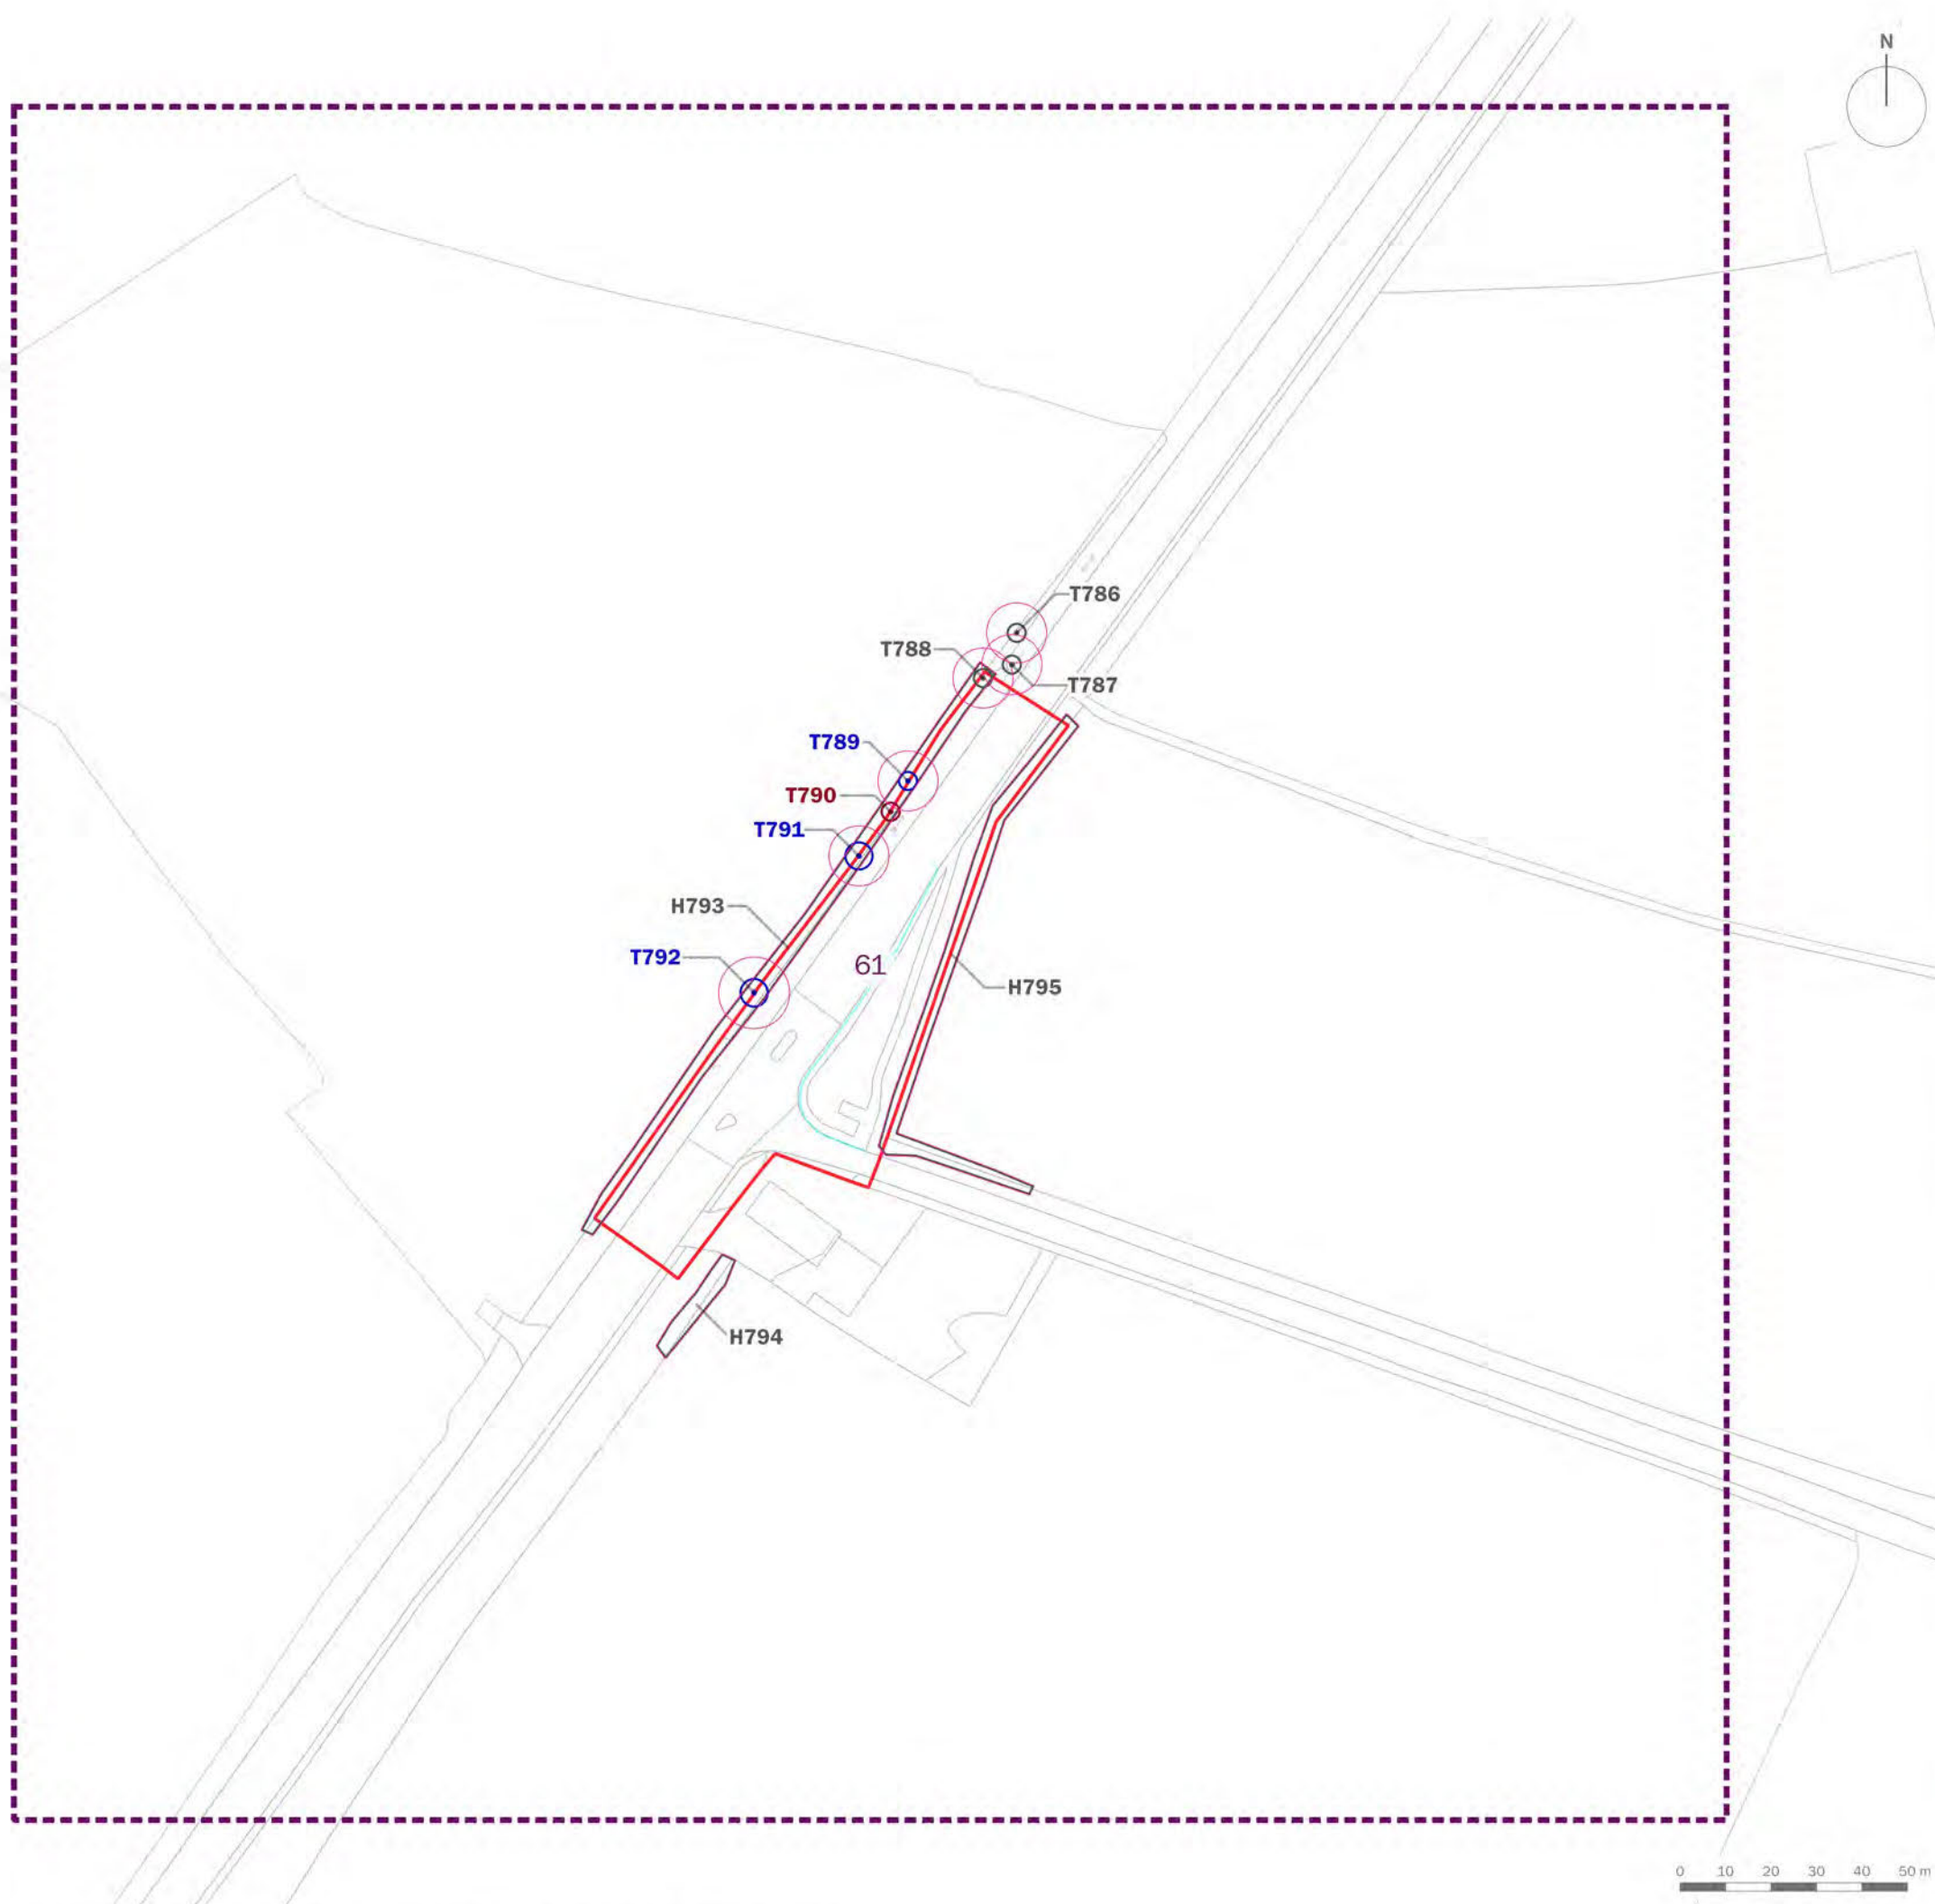
date	30 SEPTEMBER 2022	drawn by	GYo
drawing number	edp3267_d041e	checked	BWa
scale	1:1,500 @ A3	QA	RBa

- Order Limits
- T1 Tree/Group Number
- Tree/Group Canopy
- Tree Stem
- Root Protection Area
- Category A: Trees of high quality and value
- Category B: Trees of moderate quality and value
- Category C: Trees of low quality and value
- Category U: Trees of poor quality and value
- Ancient Semi-natural Woodland
- 15m Ancient Woodland Buffer Zone and Veteran Tree Buffer
- ★ Veteran Tree
- Tree Preservation Order
- Trees to be Removed

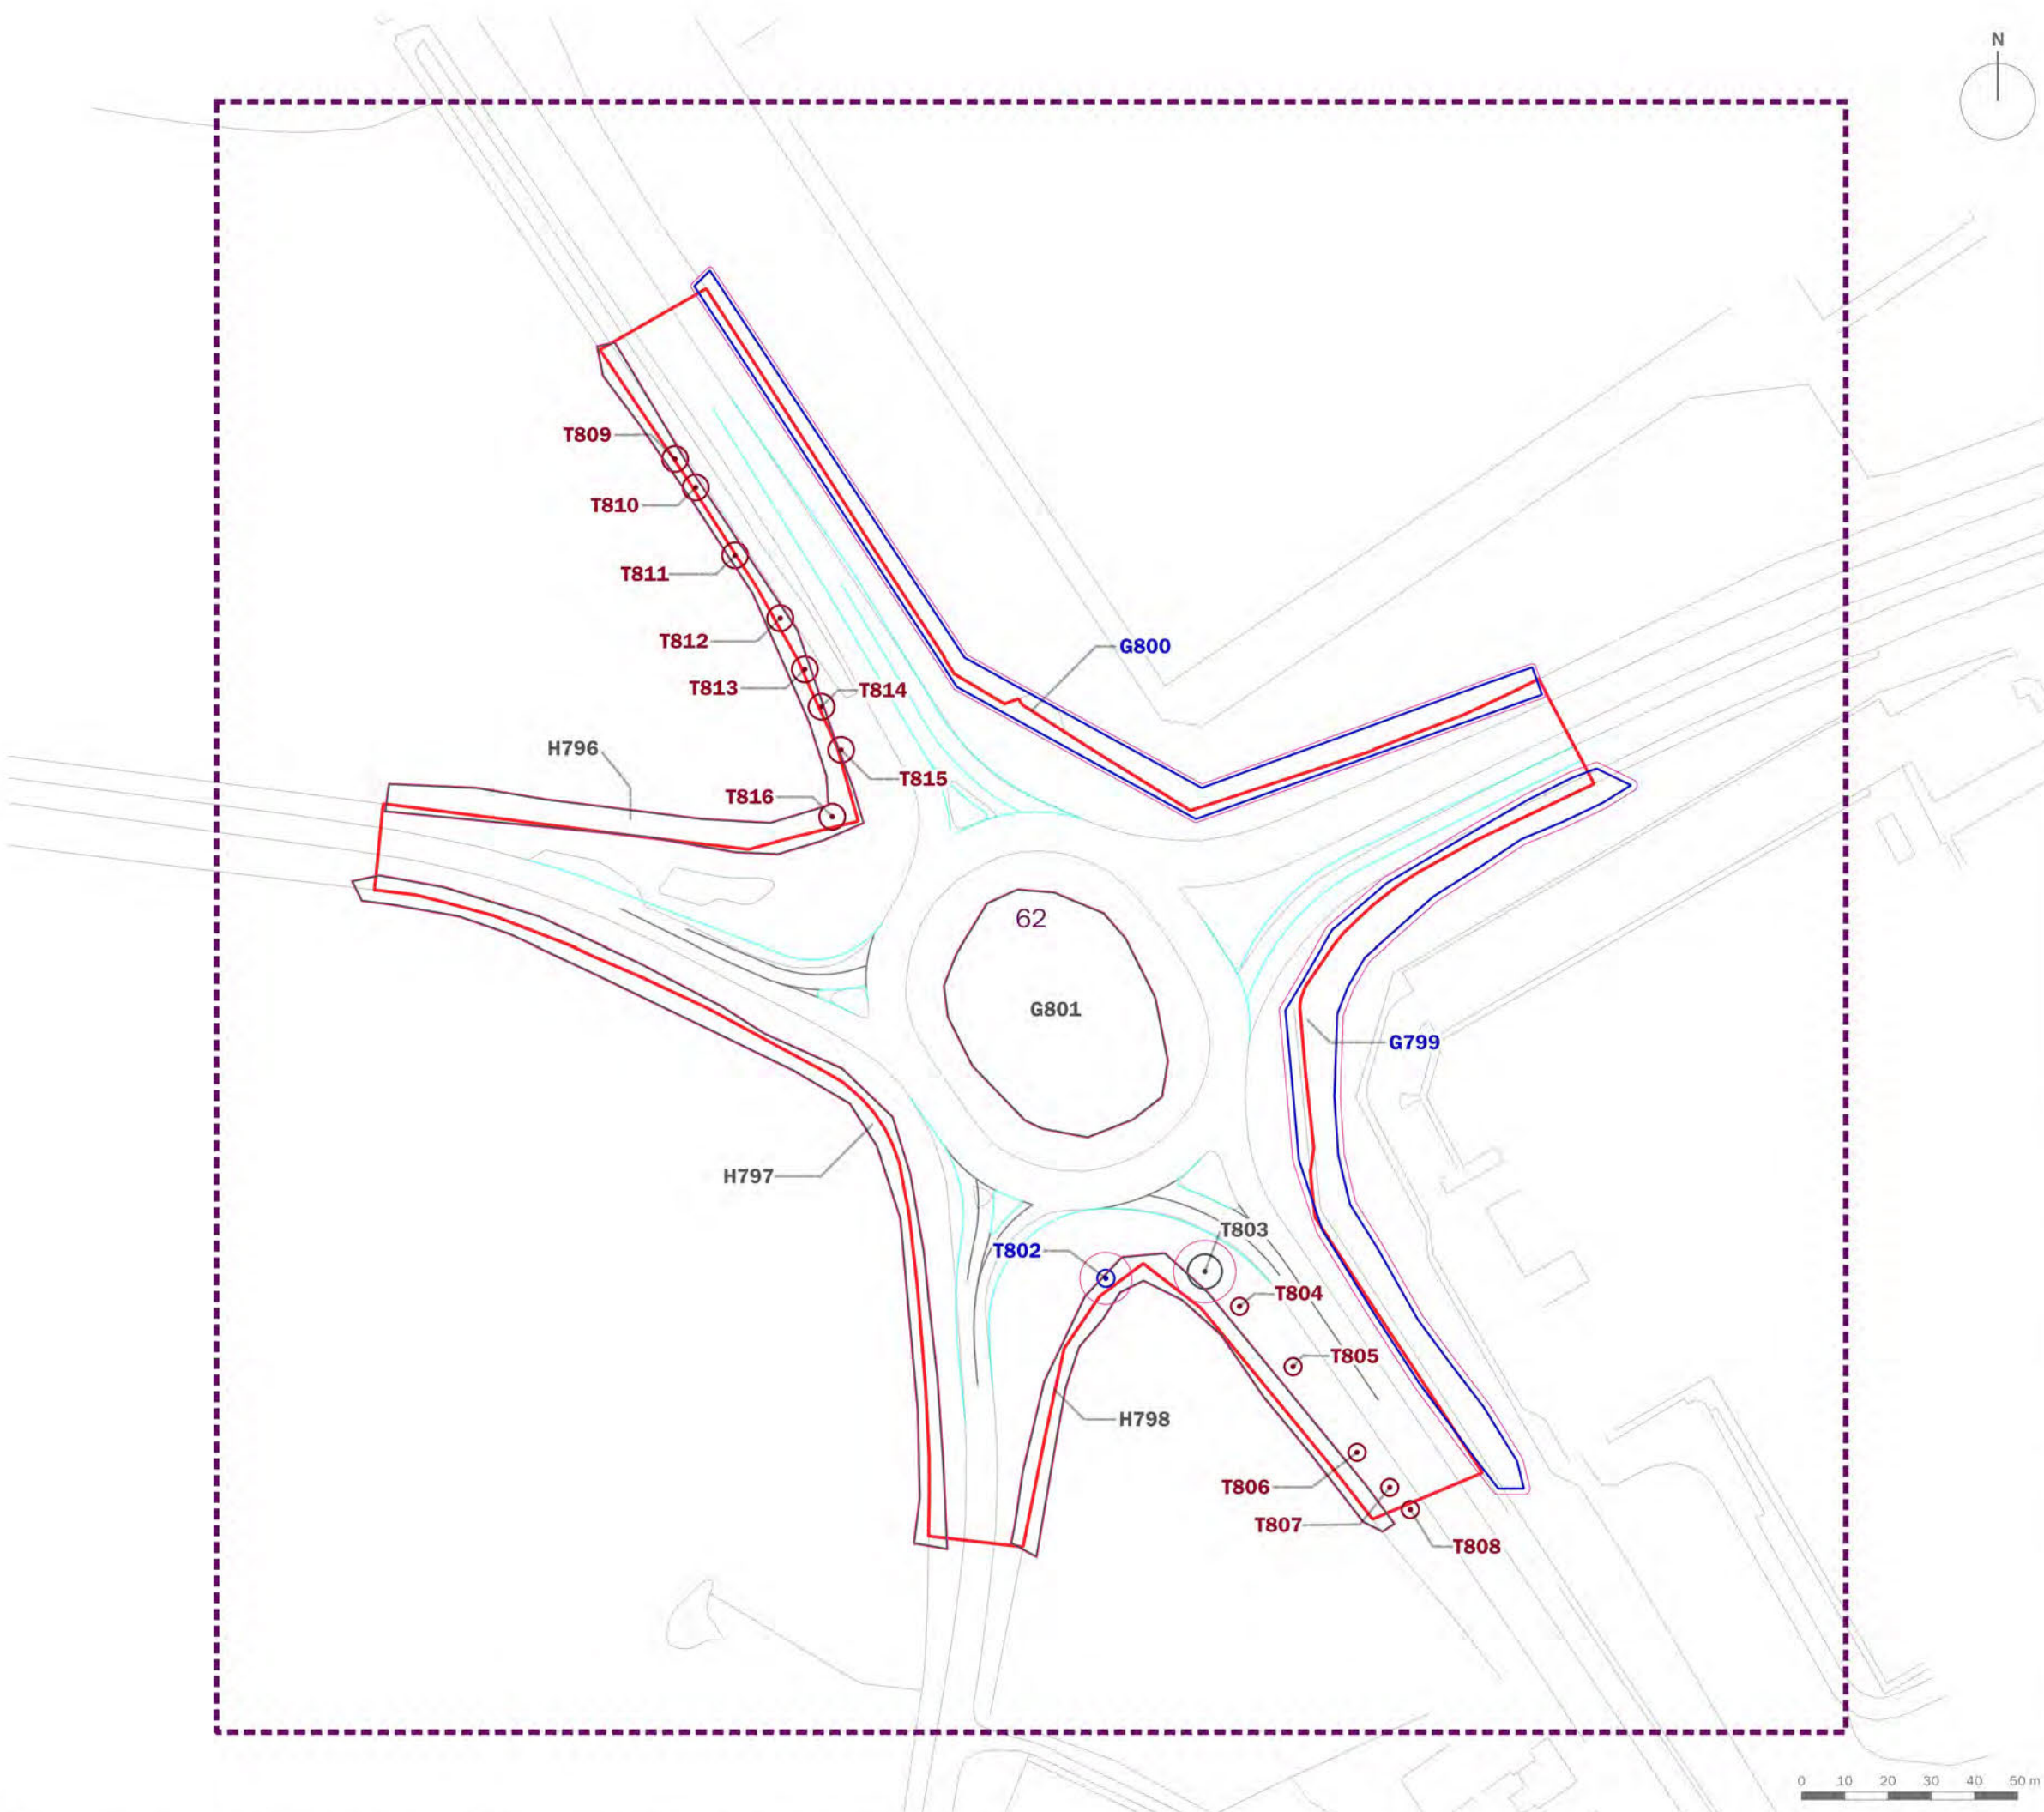
date	30 SEPTEMBER 2022	drawn by	GYo
drawing number	edp3267_d041e	checked	BWa
scale	1:1,500 @ A3	QA	RBa

Trees to be Removed
