## **HINCKLEY NATIONAL RAIL FREIGHT INTERCHANGE**

### **Applicant's Comments on Local Impact Reports [Appendix C - Technical Note Collision Data Review 2020- 2023]**

Document reference: 18.4.3

PROJECT NAME	<b>Hinckley National Rail Freight Interchange, Leicestershire</b>		
DOCUMENT NUMBER	HNRFI-BWB-GEN-XX-RP-TR-0032	BWB REF	NTT 2814
AUTHOR	AJ Oakes	STATUS	S2
CHECKED	Shirley Dumigan	REVISION	P01
APPROVED	Malcolm Ash	DATE	24/10/2023

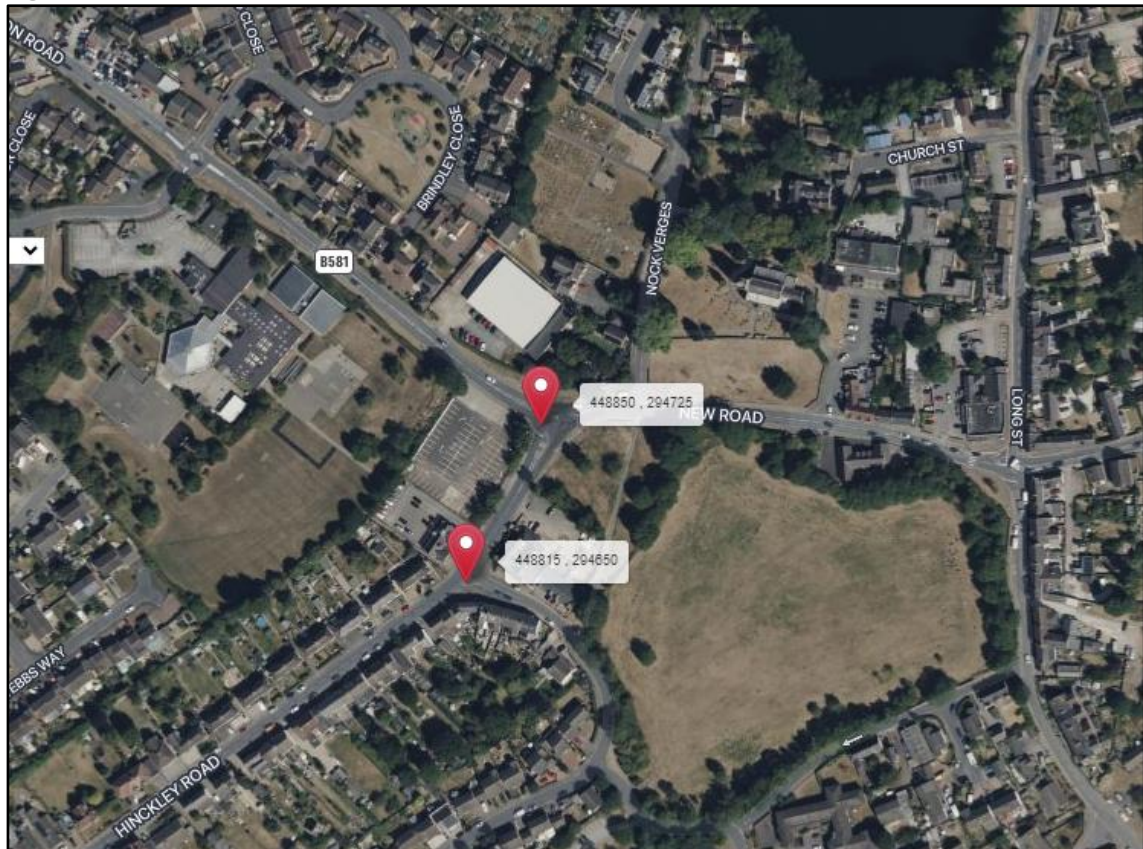
**Figure 2.1: B581 Station Road/New Road/Hinckley Road Junction**

2.7 Figure 2.1 shows that a total of two collisions have occurred at the B581 Station Road / New Road / Hinckley Road junction. Table 2.1 provides a breakdown of the collision severity at the junction.

2.8 Over the three-year period 2 PICs occurred in the vicinity of the B581 Station Road / New Road / Hinckley Road junction. One of the collisions occurred at the actual junction and the other collisions approximately 70 metres to the south of the junction on Hinckley Road.

2.9 Having reviewed the PIC data for both collisions, there does not appear to be any common causal factors attributable to the highway layout present within the data recorded.

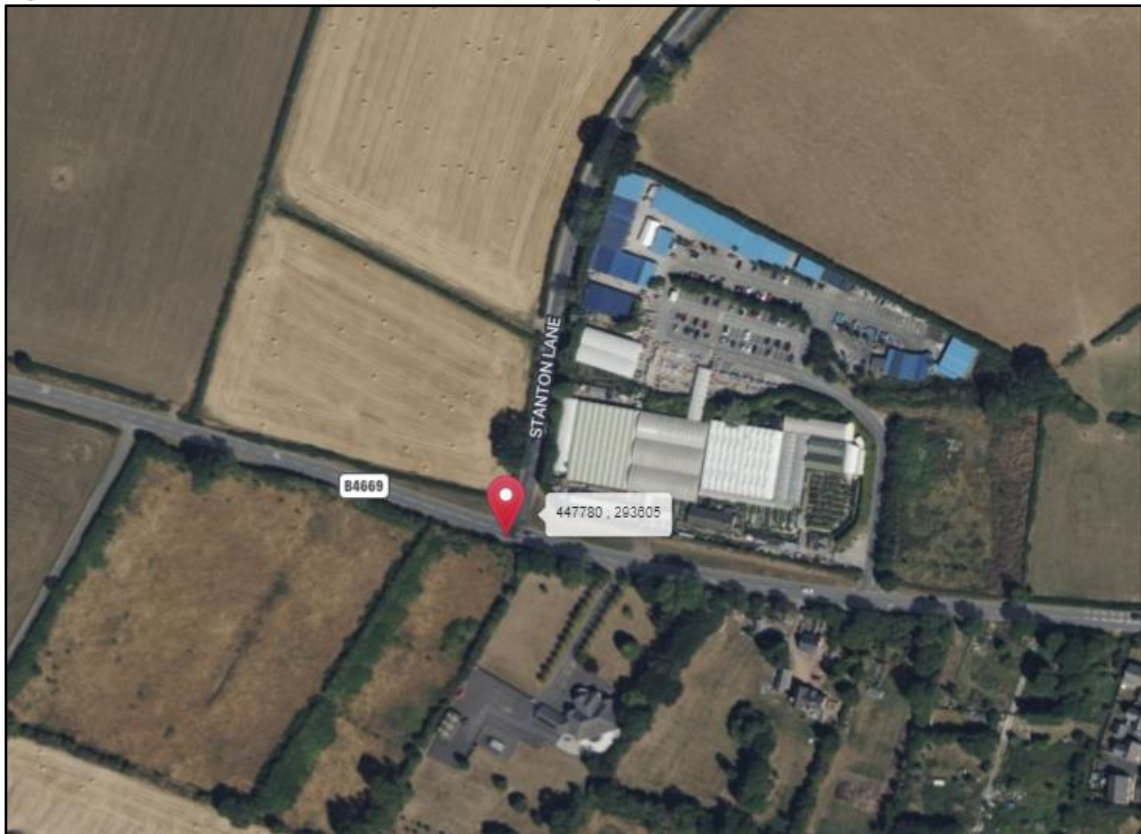
Figure 2.2: B4669 Hinckley Road/Stanton Lane junction

2.10 Figure 2.2 shows that there was one collision recorded at the B4669 Hinckley Road Junction. Table 2.2 provides a breakdown of the collision severity at the junction.

2.11 The collision that was recorded occurred between two cars in the middle of the junction on a rainy day when the road surface was wet. The collision was recorded as a slight injury accident.

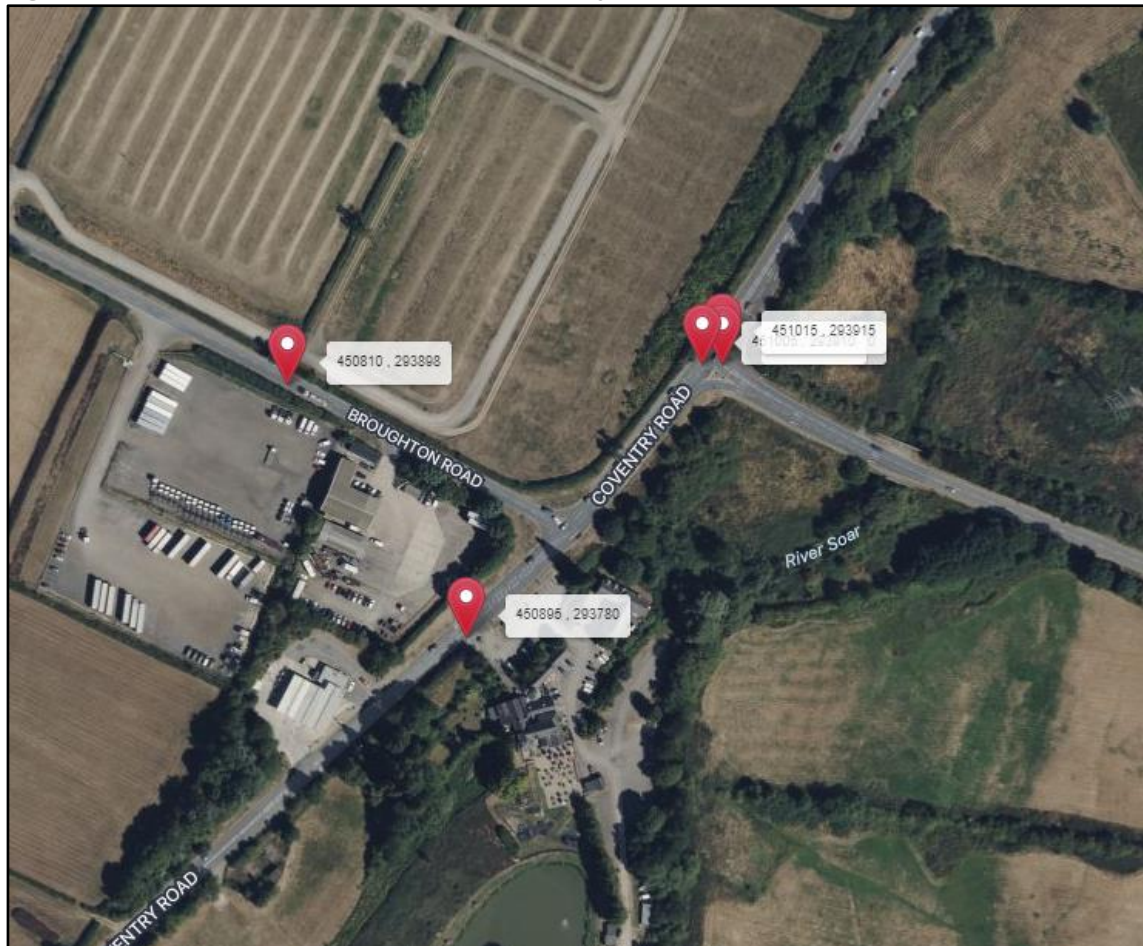
Figure 2.3: B4669 Hinckley Road/Stanton Lane junction

2.12 Figure 2.3 shows that a total of five collisions have occurred at the B4114 Coventry Road / B581 Broughton Road junction. Table 2.3 provides a breakdown of the collision severity at the junction.

2.13 Over the three-year period, three PICs were classified as being slight severity, two of serious severity and no fatalities. However, the serious collisions all occurred at different locations at the junction.

- 2.14 Three of the collisions at the junction involved right turning vehicles, one at the access to the Mill on the Soar car park which resulted in a slight injury and the other two occurred at the B4114/Coventry Road junction both involving right turners into Coventry Road, during the hours of darkness and in wet weather. One in 2020 resulting in slight injury the other in 2023 resulting in serious injury.
- 2.15 The remaining collisions included a slight injury PIC involving a car and an HGV which appears to be a shunt type collision on the northbound through movement at the B4114/Coventry Road junction, and the other PIC was classified as a serious injury collision and involved a motorcycle travelling west on Broughton Road away from the junction and no other vehicles were involved.

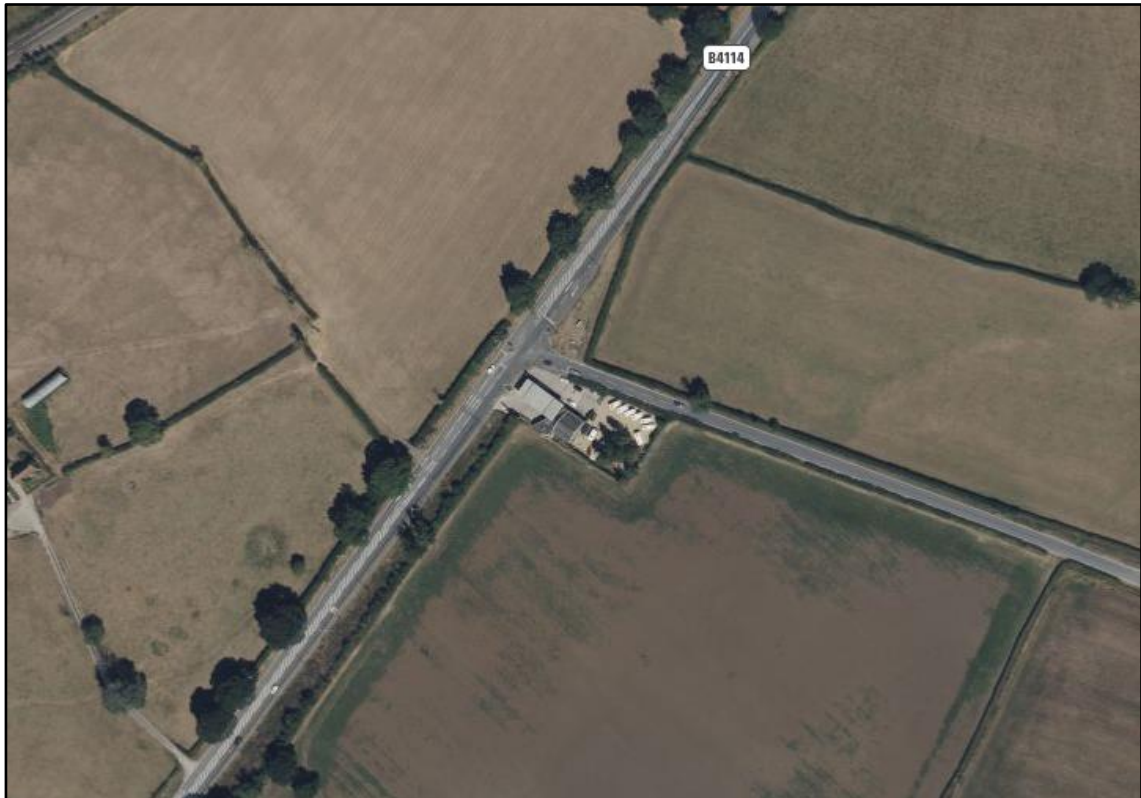
**Figure 2.4: B4669 Coventry Road / Croft Road junction**

- 2.16 Figure 2.4 shows that there were no collisions recorded at the B4114 Coventry Road / Croft Road Junction between January 2020 and July 2023. As a result, no further investigation was required at this junction.

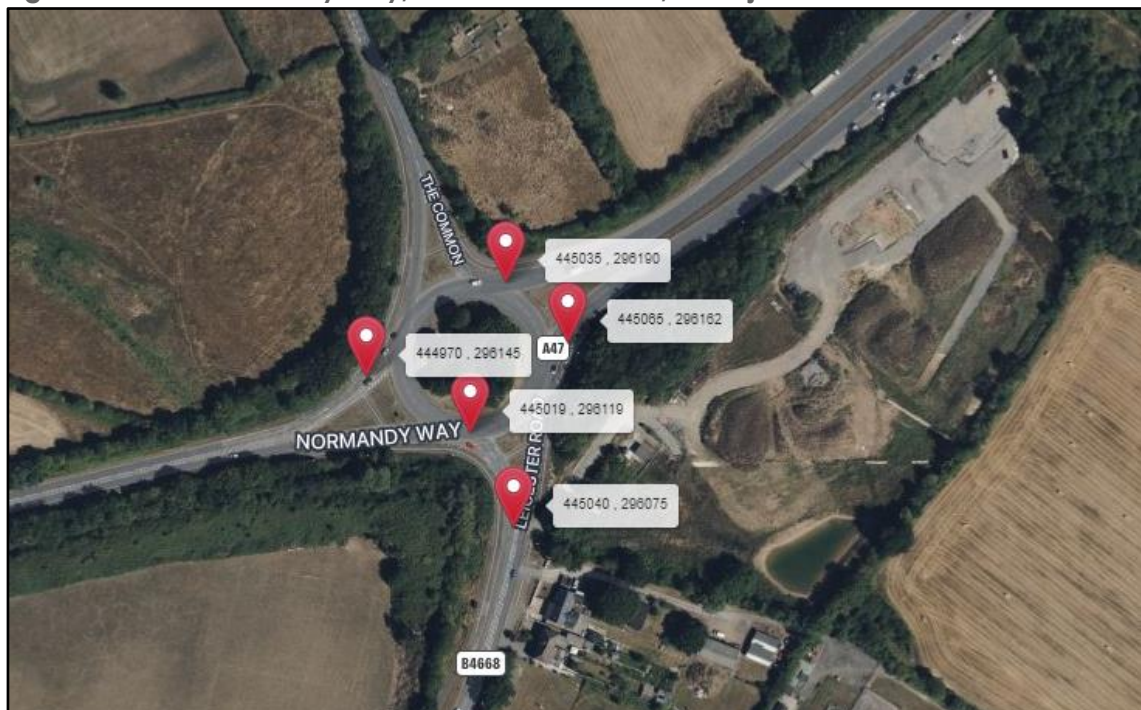
**Figure 2.6: A47 Normandy Way/A47 Leicester Road/Road junction**

- 2.23 Figure 2.6 shows that a total of 5 collisions have occurred at the A47 Normandy Way / A47 Leicester Road / B4668 Leicester Road / The Common Junction. Table 2.5 provides a breakdown of the collision severity at the junction.

2.24 Over the three-year period 4 PICs were classified as being slight severity, one of serious severity and no fatalities.

2.25 Three of the recorded collisions were shunt type collisions, two of which occurred on each of the A47 entries to the roundabout, and one on the A47(E) exit. The remaining two collisions involved motorcycles; one on the circulatory which was classed as a slight injury accident and one on the B4668 northbound approach to the roundabout which involved a car switching lanes and colliding with a motorcyclist, resulting in serious injuries.

2.26 Whilst there were five collisions recorded at the junction, all of the collisions occurred at different locations around the roundabout, and no real trends or patterns have been identified. The number of collisions has dropped from three in 2021 to just one in 2022 and there have been no recorded collisions so far this year.

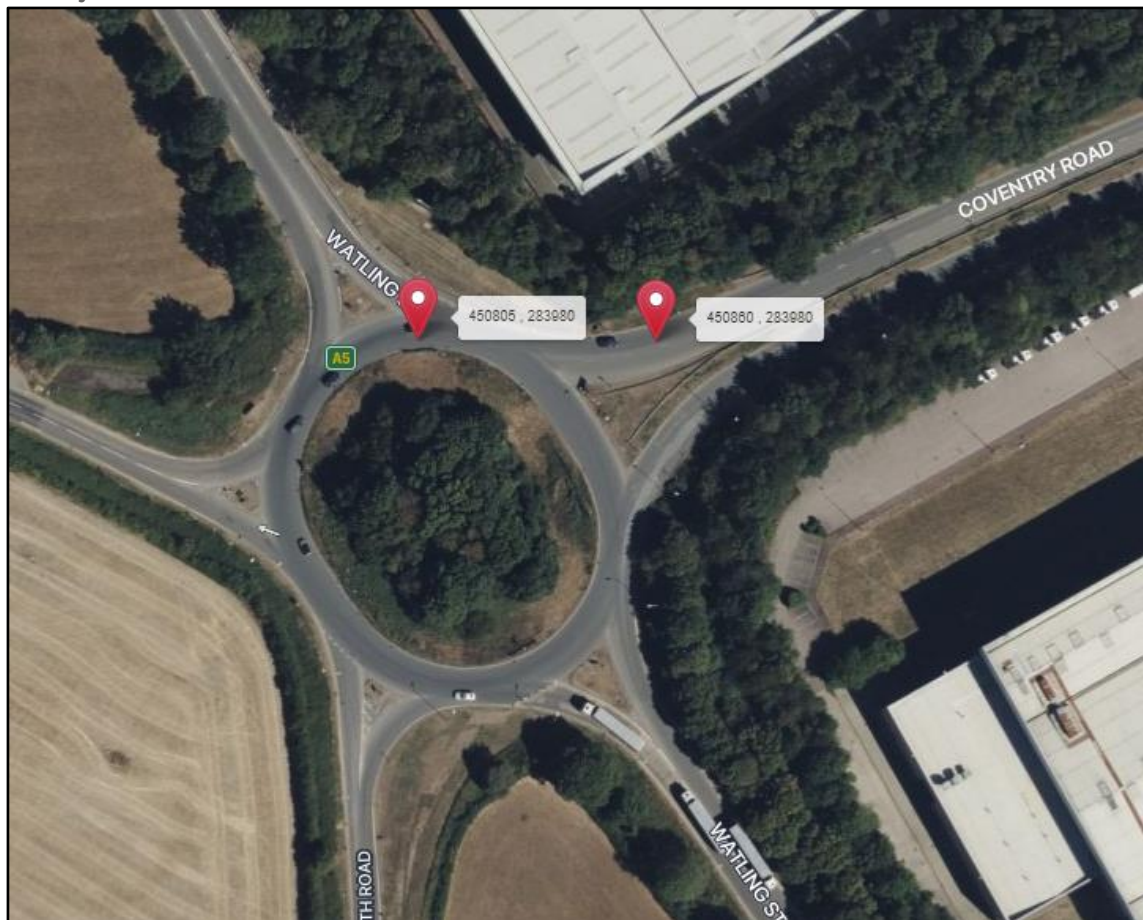
**Figure 2.7: Cross in Hand Roundabout (A5 Watling Street/A4303/B4027/Coal Pit Lane) Road junction**

2.27 Figure 2.7 shows that 2 collisions have occurred at the Cross in Hand Roundabout Junction over the three-year period. Table 2.6 provides a breakdown of the collision severity at the junction.

2.28 Of the two collisions, one PIC was classified as being slight severity and the other was classified as serious severity. No fatalities were recorded at the Cross in Hand Roundabout.

2.29 The slight injury collision occurred when a car and a van collided on the circulatory as the vehicles entered and exited the roundabout simultaneously. The serious injury collision occurred on the A4303 when 4 cars collided leaving the roundabout.

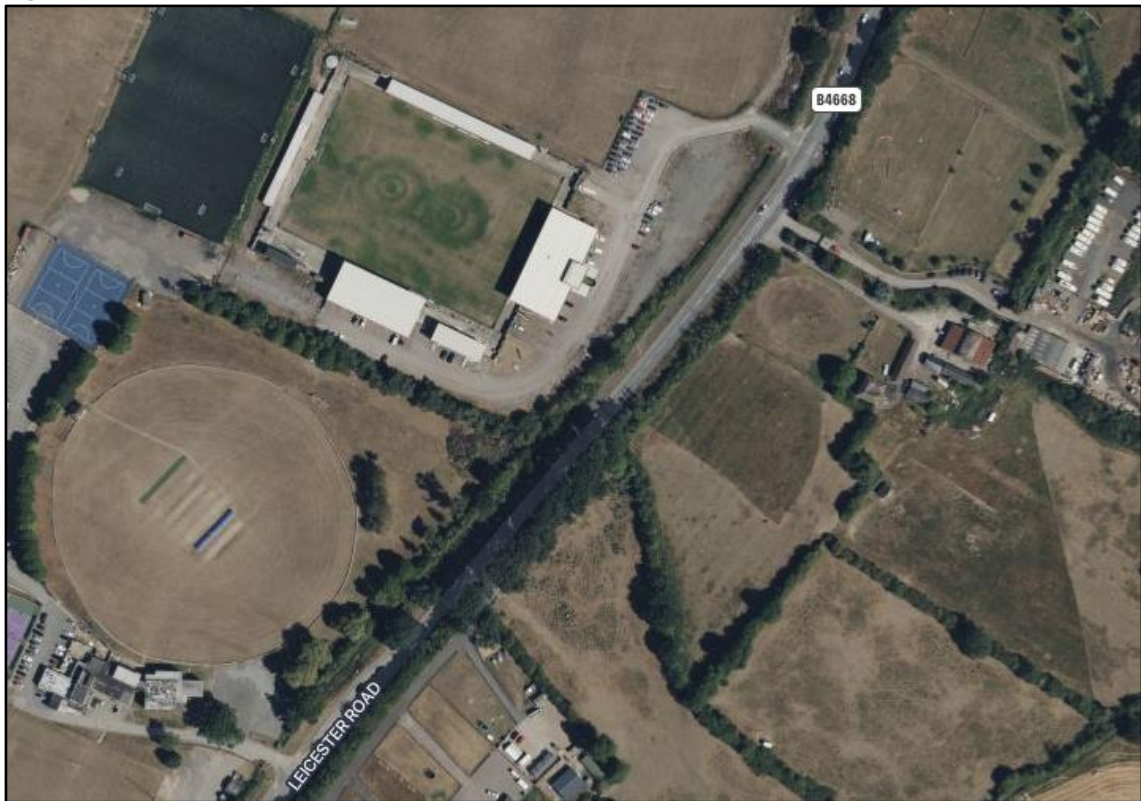
**Figure 2.9: B4668 Leicester Road**

- 2.33 Figure 2.9 shows that there were no collisions recorded at the B4668 in the vicinity of the proposed site access junction between January 2020 and July 2023. As a result, no further investigation was required at this junction.

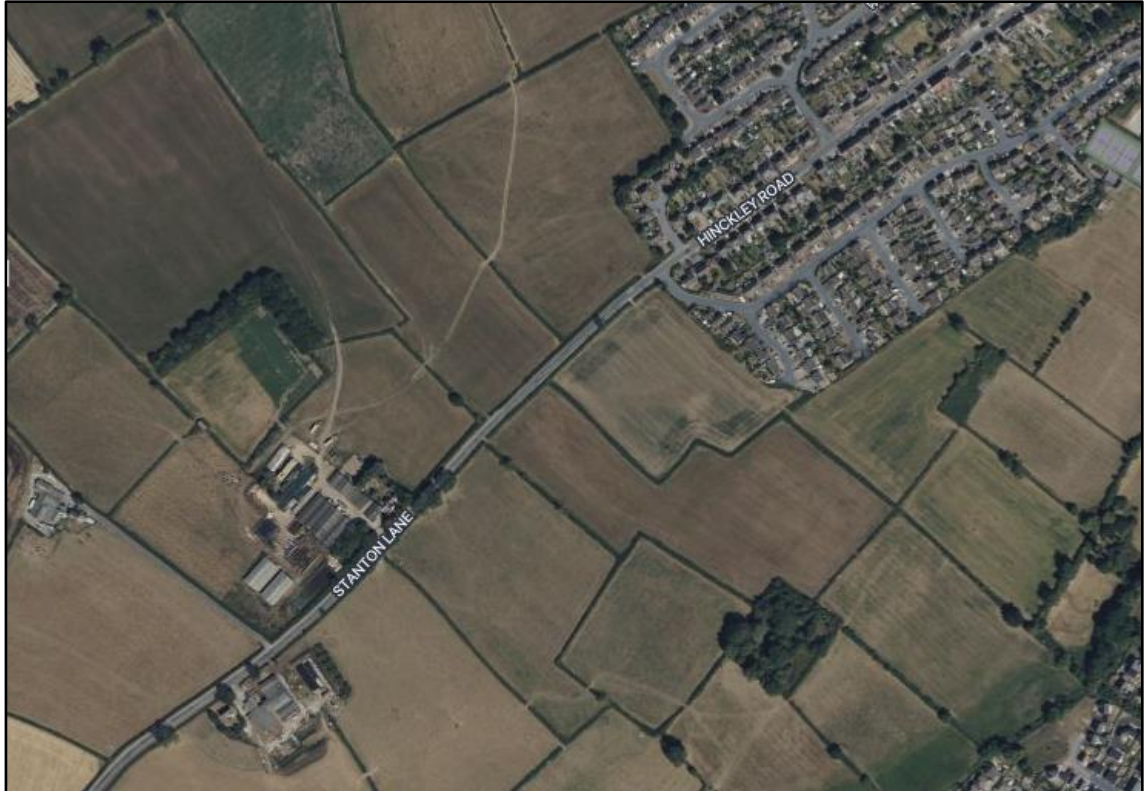
Figure 2.10: Stanton Lane south of Stoney Stanton

- 2.34 Figure 2.10 shows that there were no collisions recorded on Stanton Lane to the south of Stoney Stanton between January 2020 and July 2023. As a result, no further investigation was required along this stretch of road.

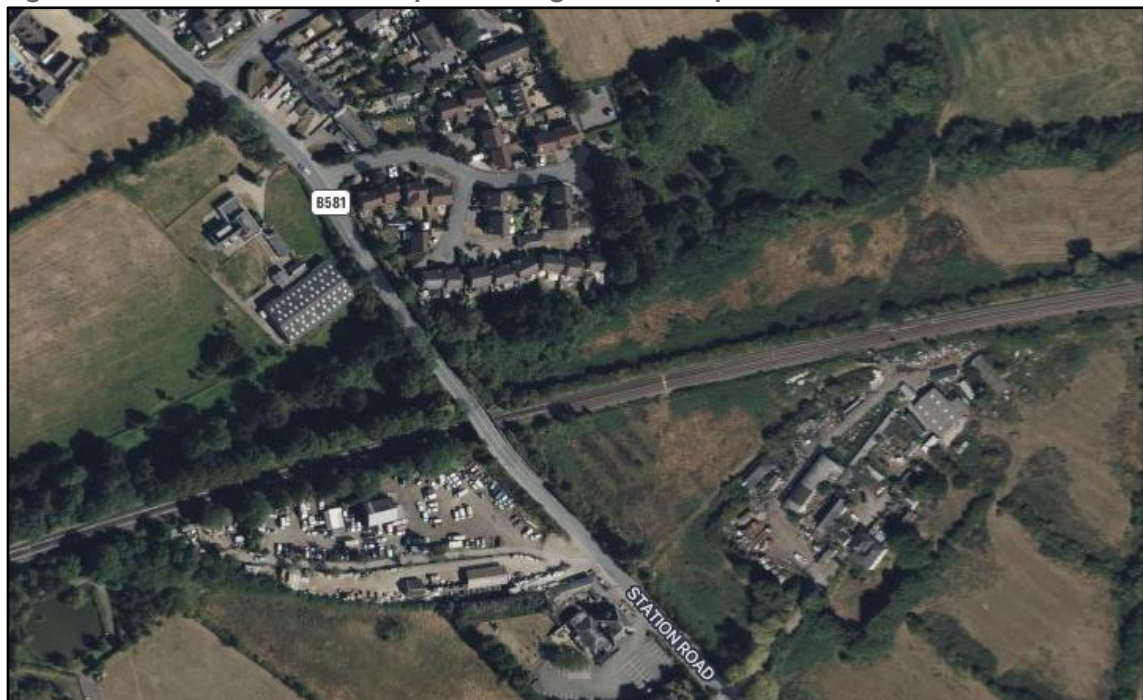
**Figure 2.12. Station Road Railway Overbridge Elmesthorpe**

2.37 Figure 2.12 shows that there were no collisions recorded on Station Road in the vicinity of the railway overbridge, just to the south of Elmesthorpe between January 2020 and July 2023. As a result, no further investigation was required along this stretch of road.

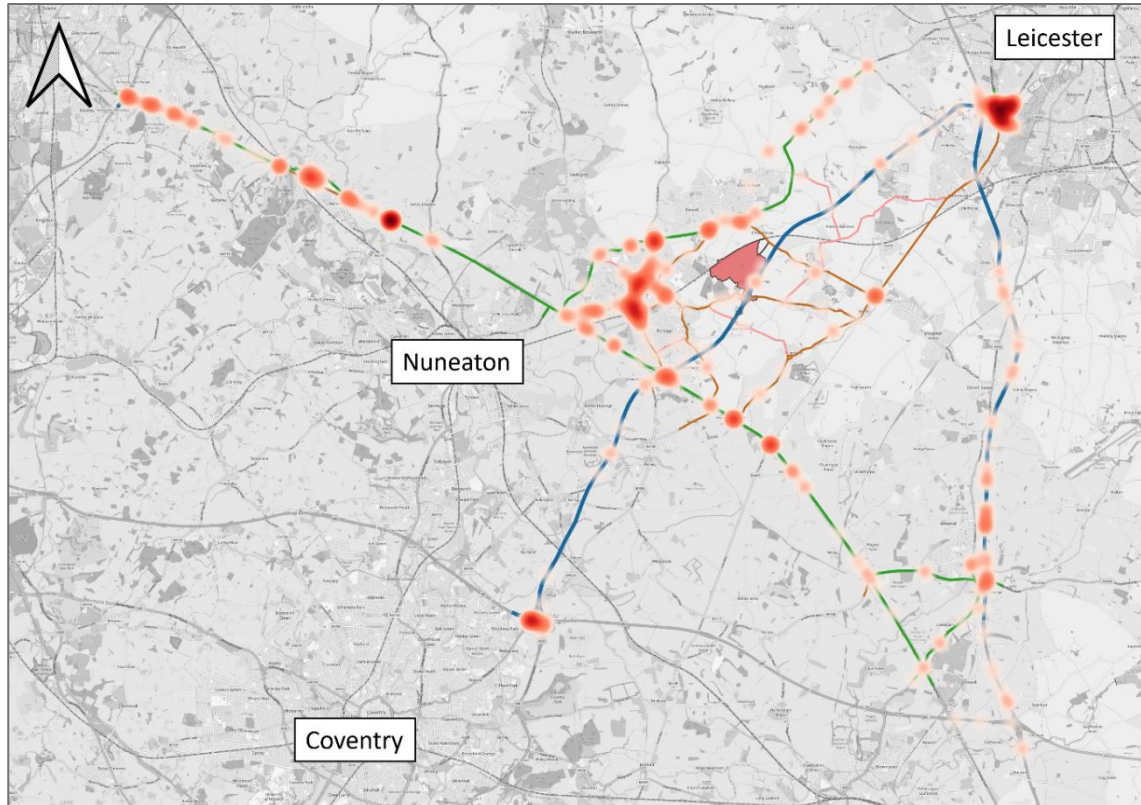
Figure 3.2: Collision Heatmap (2020 – 2023)

- A5 Watling St / Woodford Lane;
  - M6 Junction 2 Roundabout;
  - M1 Junction 21 Roundabout;
- 3.17 The hotspots for the latest three year period have also been reviewed and is presented below in Figure 3.2. The collision heatmap for the most recent data (2020-2023) mirrors that of the previous collision heatmap (2015-2019) with the exception of an additional hotspot identified on the A5 at the B4114 Coventry Road Junction.

3.18 As a result of the above, the same five locations listed from the previous review were examined again with the most recent (2020 – 2023) data in further detail. The A5/B4114 junction has been added to the list of locations due to it being identified as having an increased number of collisions over the latest 3 year period, as shown in the most recent heatmap .

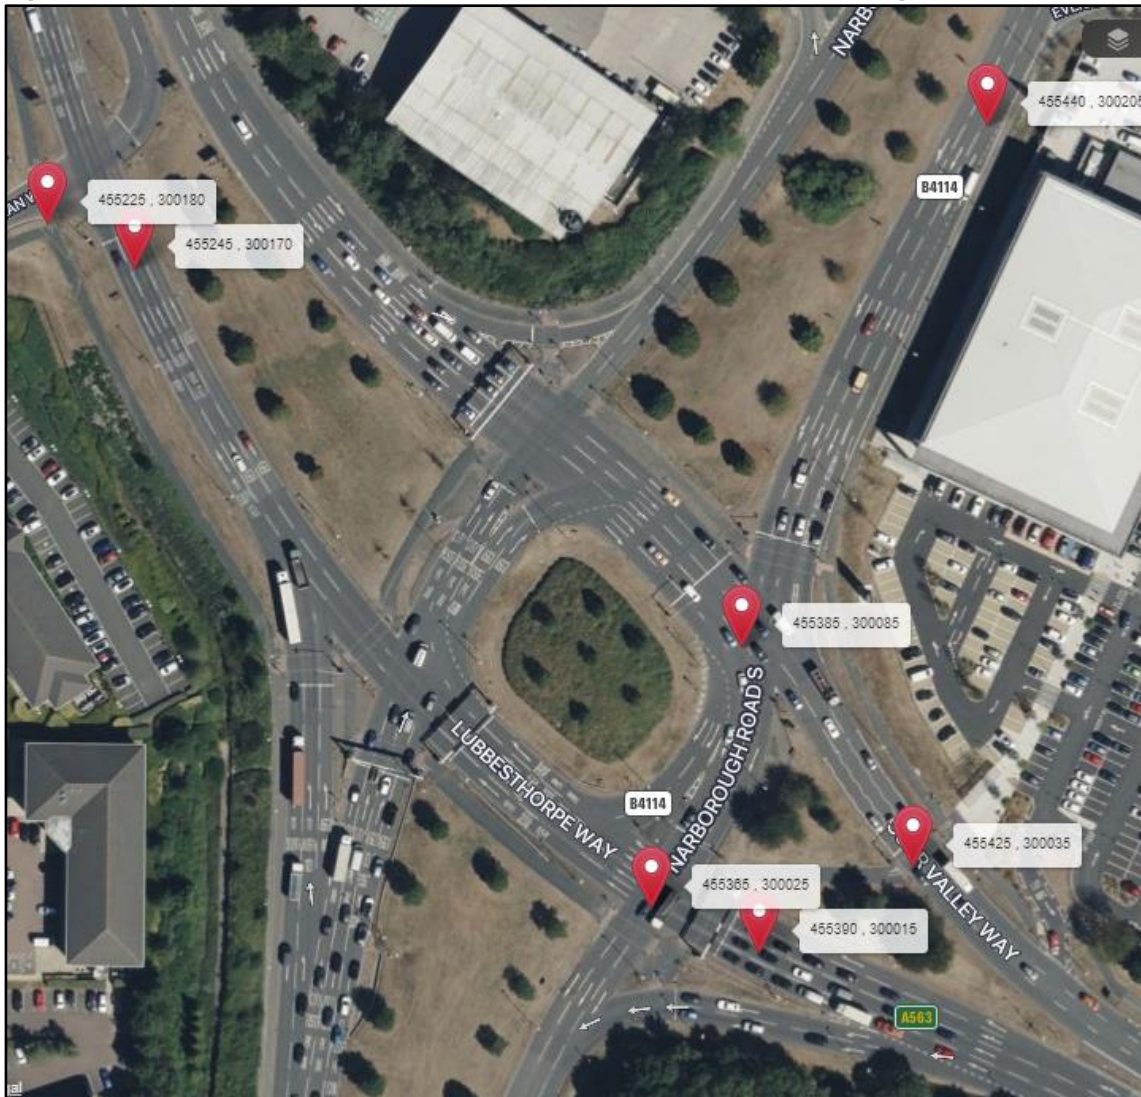
Figure 3.3: A563 Lubbesthorpe Way/Soar Valley Way/B4114 Narborough Rd Junction

3.19 Figure 3.3 shows that a total of seven collisions have occurred at the A563 Lubbesthorpe Way / Soar Valley Way / B4114 Narborough Road South Junction over the latest 3 year period. Table 3.2 provides a breakdown of the collision severity at the junction.

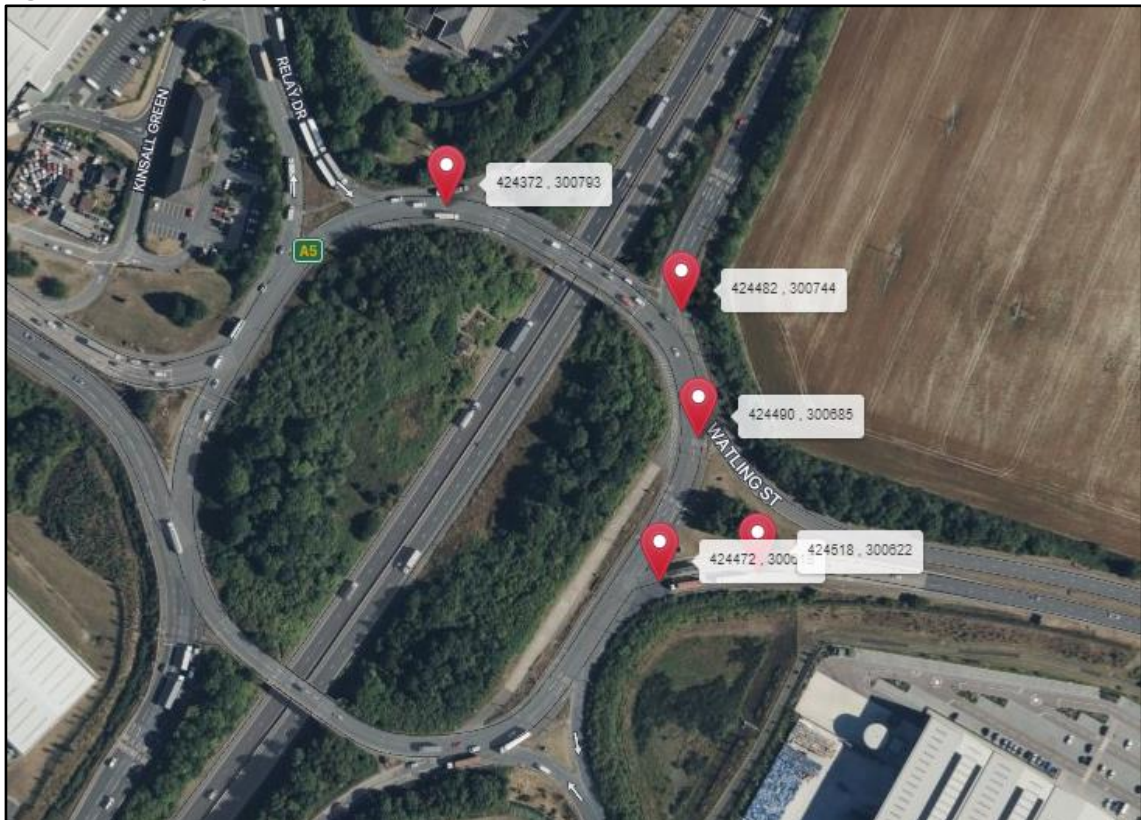
Figure 3.4: M42 junction 10

- 3.24 Figure 3.4 shows that a total of five collisions have occurred at the M42 Junction 10. Table 3.3 provides a breakdown of the collision severity at the junction.

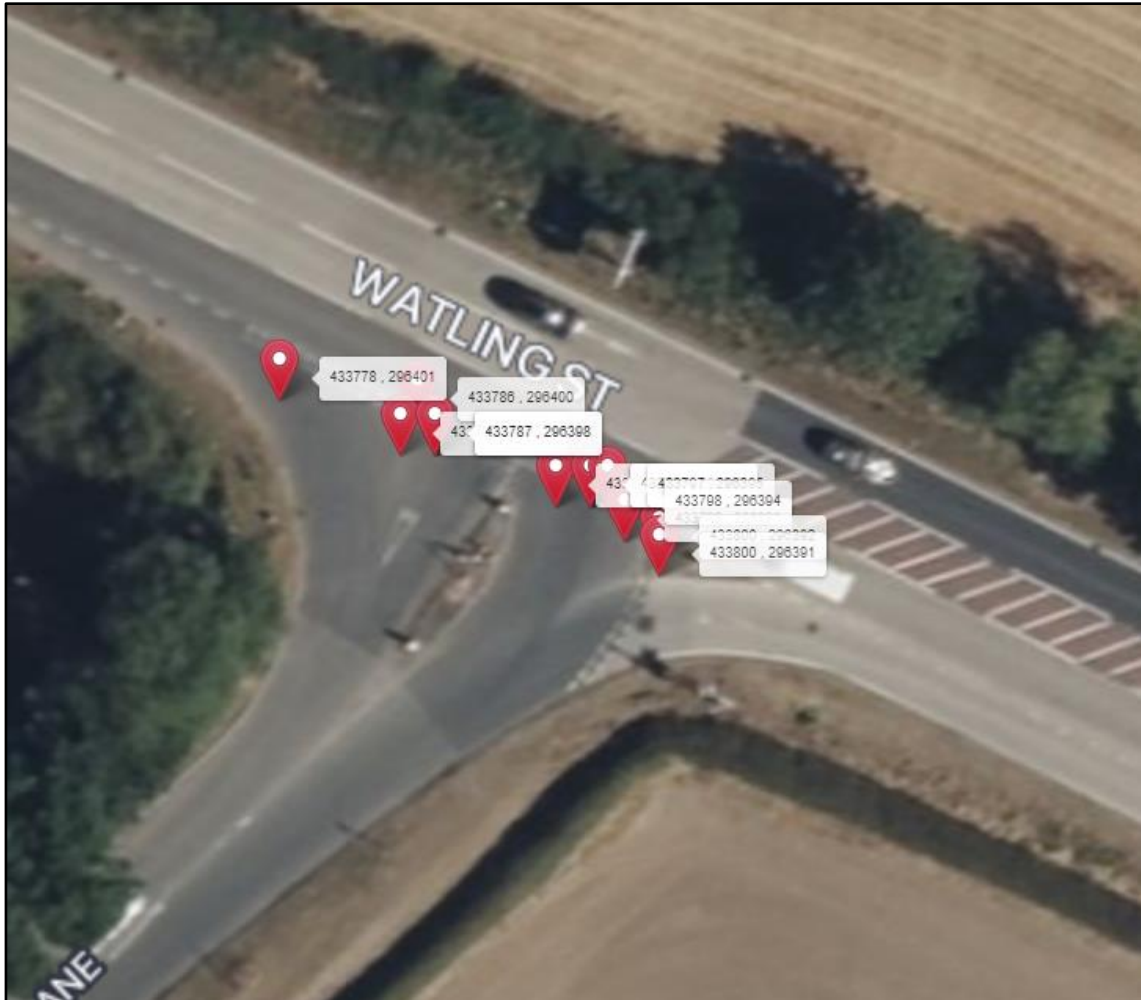
Figure 3.5: A5 Watling Street / Woodford Lane Junction

- 3.28 Figure 3.5 shows that a total of 11 collisions have occurred at the A5 Watling Street / Woodford Lane junction. Table 3.4 provides a breakdown of the collision severity at the junction.

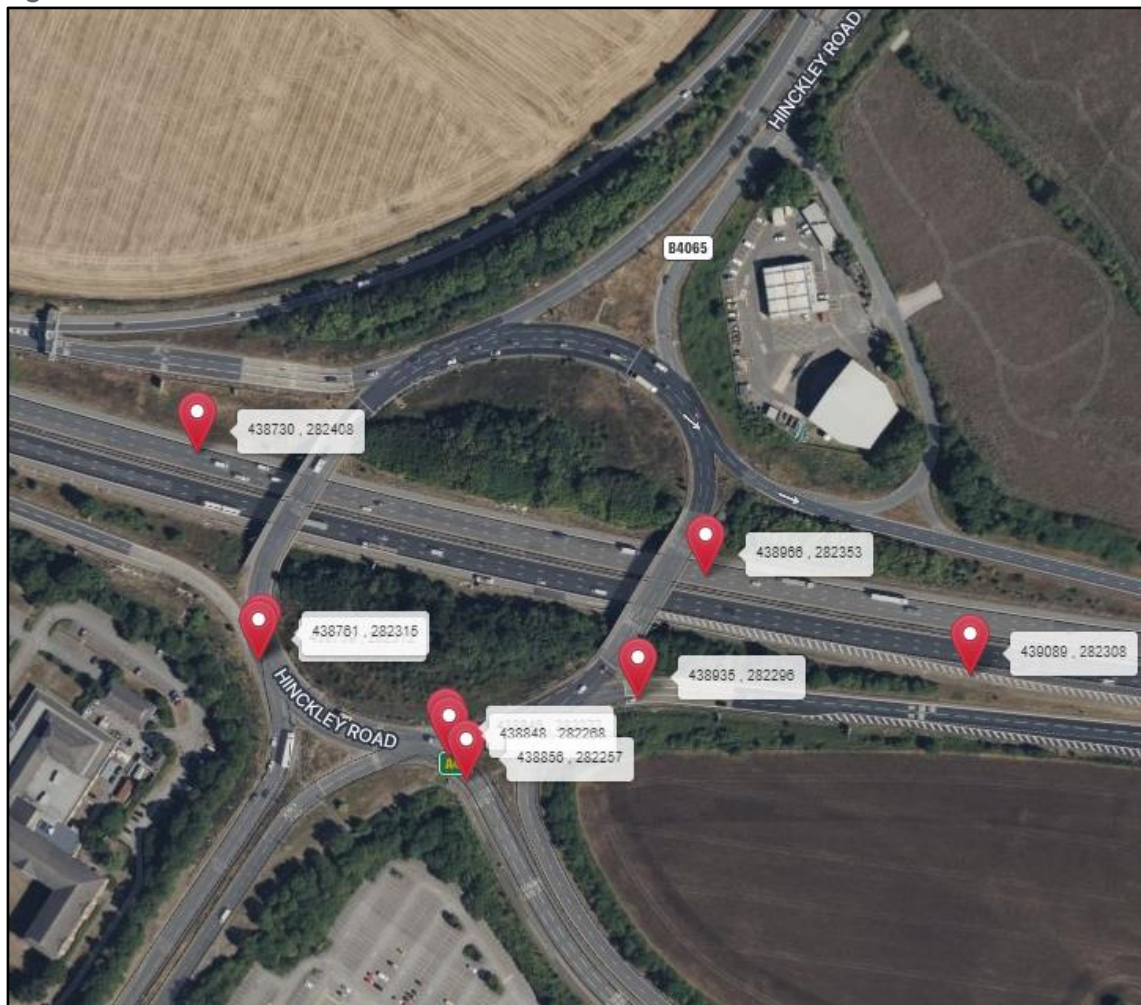
Figure 3.6: M6 Junction 2 Roundabout

- 3.33 Figure 3.6 shows that a total of nine collisions have occurred at the M6 Junction 2 roundabout. Table 3.5 provides a breakdown of the collision severity at the junction.

- 3.36 Having reviewed the PIC data for the remaining six collisions recorded at the junction, it appears that the majority of the collisions were caused by vehicles changing lane at the last minute, or being in the incorrect lane as they circulated the junction. There were also a couple of shunt type collisions recorded too.

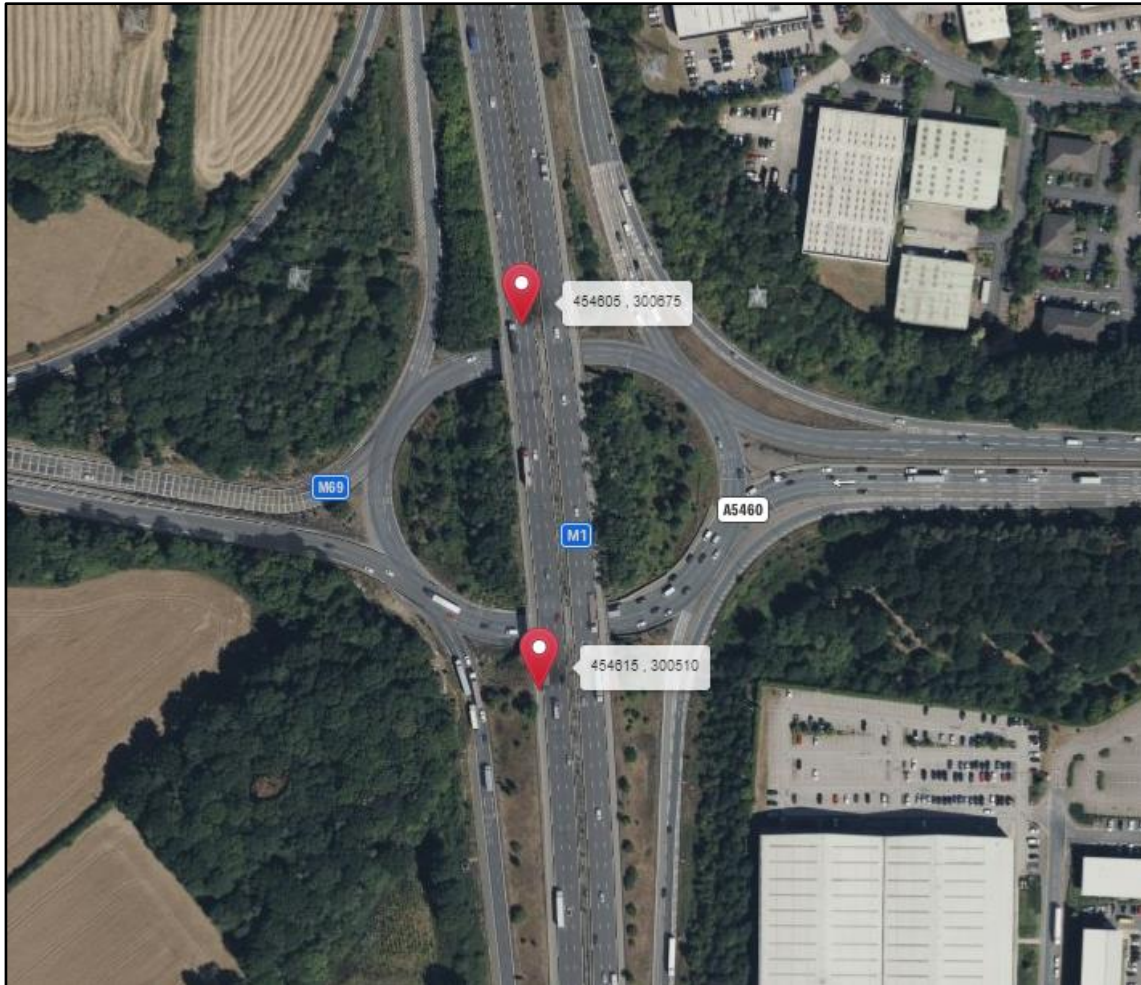
Figure 3.7: M1 Junction 21 Roundabout

- 3.39 Figure 3.7 shows that a total of two collisions have occurred at the M1 Junction 21 roundabout. Table 3.6 provides a breakdown of the collision severity at the junction.

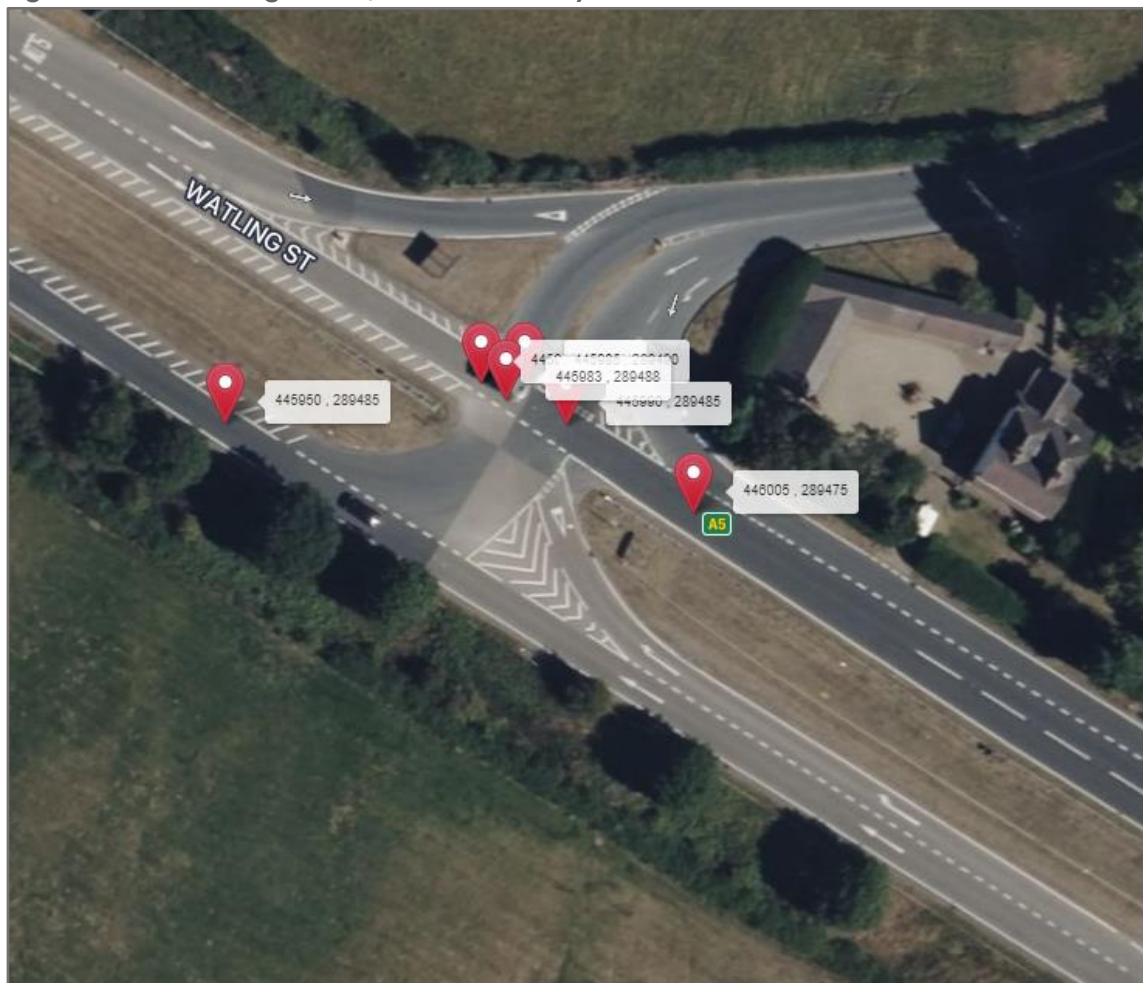
Figure 3.8: A5 Watling Street / B4114 Coventry Road

- 3.43 Figure 3.8 shows that a total of six collisions have occurred at the A5 Watling Street/B4114 Coventry Road junction. Table 3.7 provides a breakdown of the collision severity at the junction.
