HINCKLEY NATIONAL RAIL FREIGHT INTERCHANGE

Project reference TR050007

Hinckley NRFI Technical Note Collision Data Review ~~Applicant's Comments on Local Impact Reports~~ ~~[Appendix C – Technical Note Collision Data Review 2020–~~ ~~2023]~~

Document reference: 18.4.3A

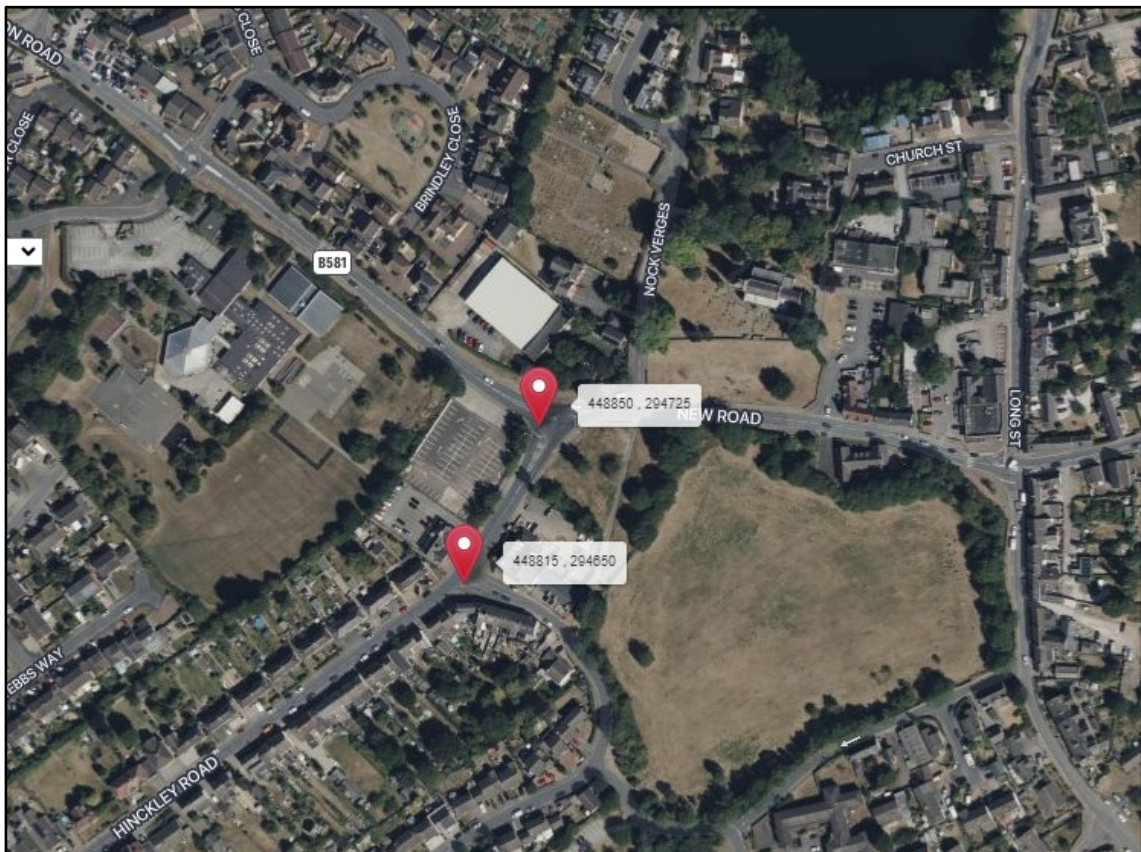
Figure 2.1: B581 Station Road/New Road/Hinckley Road Junction

2.7 Figure 2.1 shows that a total of two collisions have occurred at the B581 Station Road / New Road / Hinckley Road junction. Table 2.1 provides a breakdown of the collision severity at the junction.

2.8 Over the three-year period 2 PICs occurred in the vicinity of the B581 Station Road / New Road / Hinckley Road junction. One of the collisions occurred at the actual junction and the other collisions approximately 70 metres to the south of the junction on Hinckley Road.

2.9 Having reviewed the PIC data for both collisions, there does not appear to be any common causal factors attributable to the highway layout present within the data recorded.

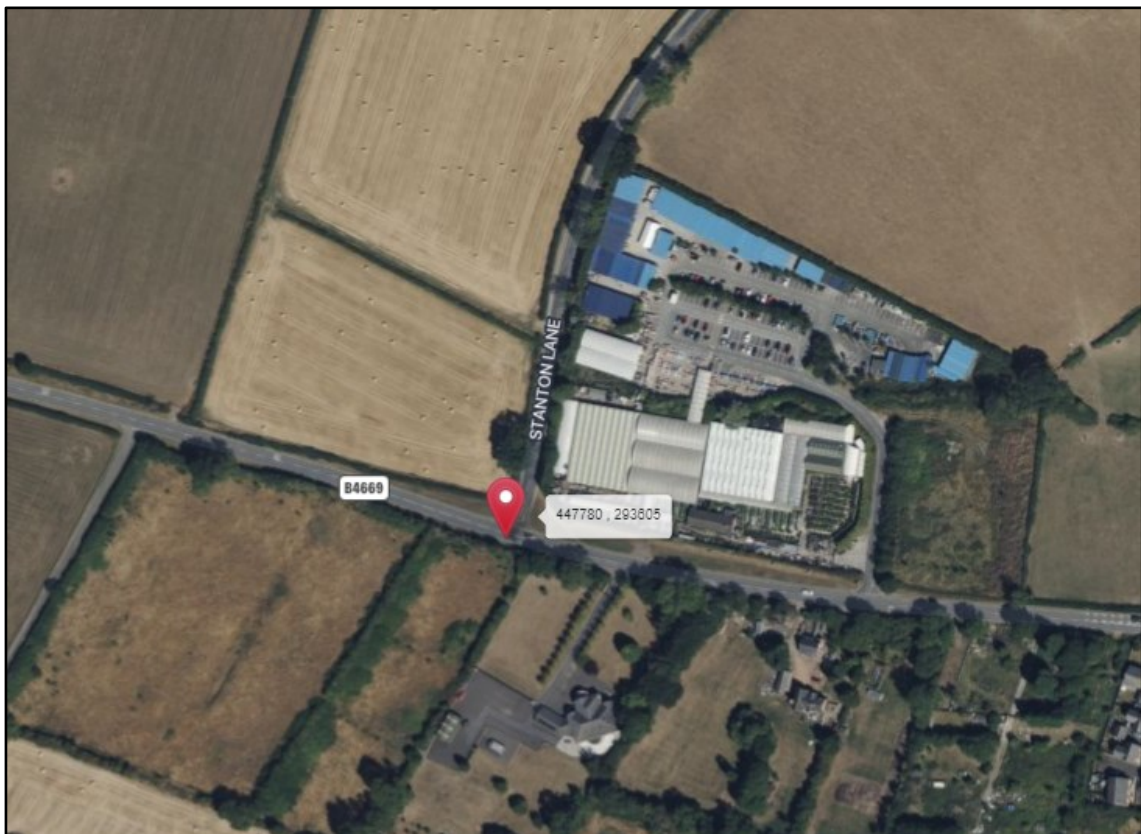
Figure 2.2: B4669 Hinckley Road/Stanton Lane junction

2.10 Figure 2.2 shows that there was one collision recorded at the B4669 Hinckley Road Junction. Table 2.2 provides a breakdown of the collision severity at the junction.

2.11 The collision that was recorded occurred between two cars in the middle of the junction on a rainy day when the road surface was wet. The collision was recorded as a slight injury accident.

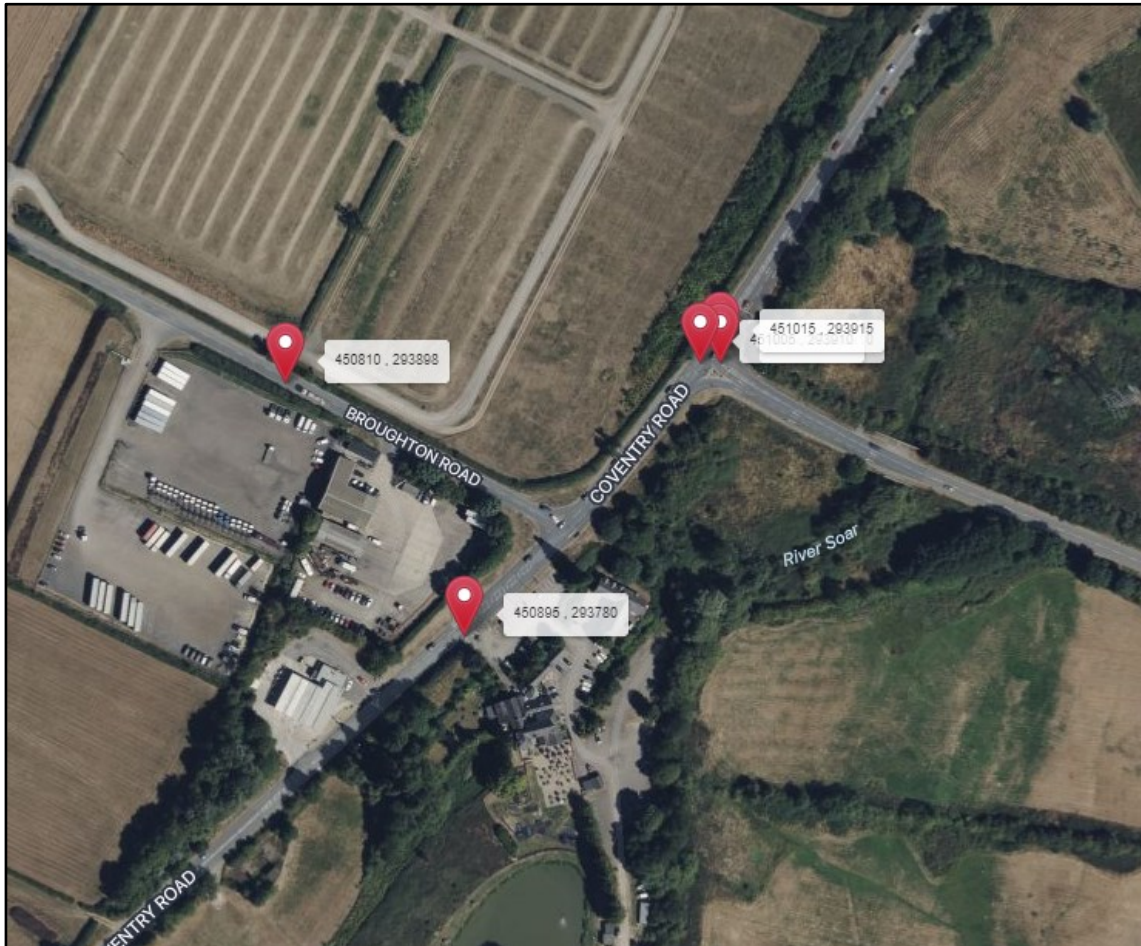
Figure 2.3: B4669 Hinckley Road/Stanton Lane junction

2.12 Figure 2.3 shows that a total of five collisions have occurred at the B4114 Coventry Road / B581 Broughton Road junction. Table 2.3 provides a breakdown of the collision severity at the junction.

2.13 Over the three-year period, three PICs were classified as being slight severity, two of serious severity and no fatalities. However, the serious collisions all occurred at different locations at the junction.

- 2.14 Three of the collisions at the junction involved right turning vehicles, one at the access to the Mill on the Soar car park which resulted in a slight injury and the other two occurred at the B4114/Coventry Road junction both involving right turners into Coventry Road, during the hours of darkness and in wet weather. One in 2020 resulting in slight injury the other in 2023 resulting in serious injury.
- 2.15 The remaining collisions included a slight injury PIC involving a car and an HGV which appears to be a shunt type collision on the northbound through movement at the B4114/Coventry Road junction, and the other PIC was classified as a serious injury collision and involved a motorcycle travelling west on Broughton Road away from the junction and no other vehicles were involved.

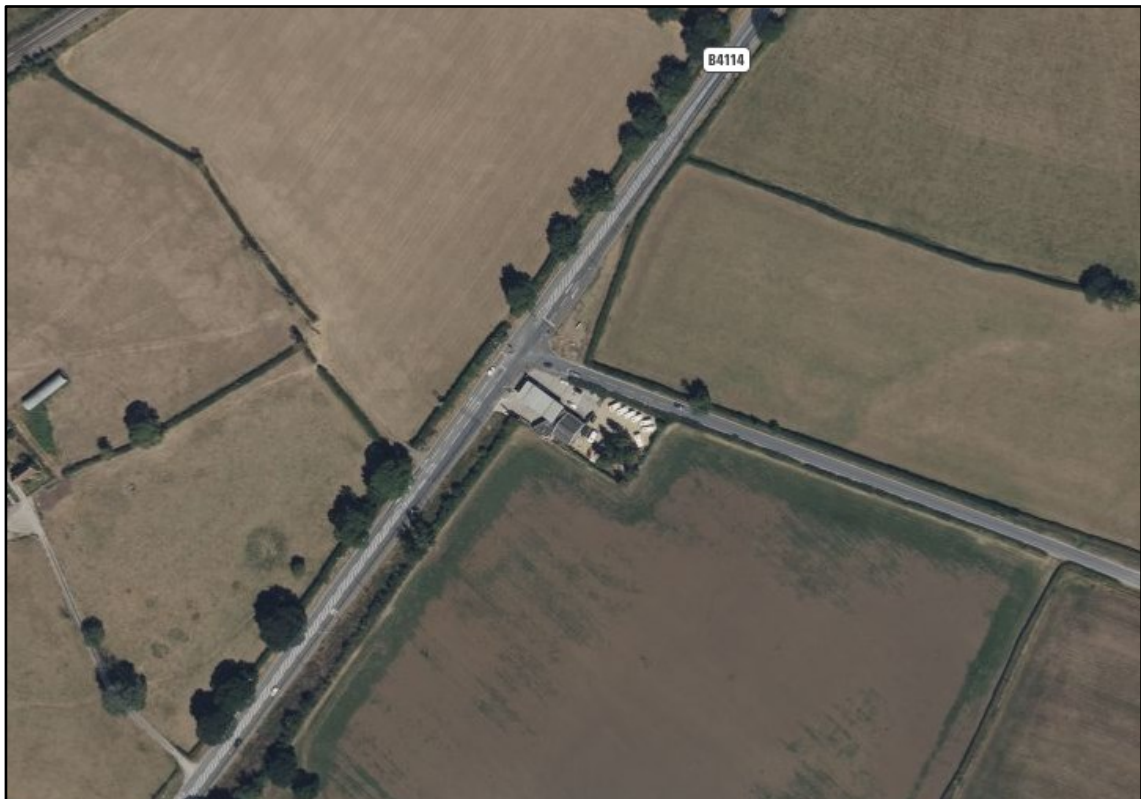
Figure 2.4: B4669 Coventry Road / Croft Road junction

- 2.16 Figure 2.4 shows that there were no collisions recorded at the B4114 Coventry Road / Croft Road Junction between January 2020 and July 2023. As a result, no further investigation was required at this junction.

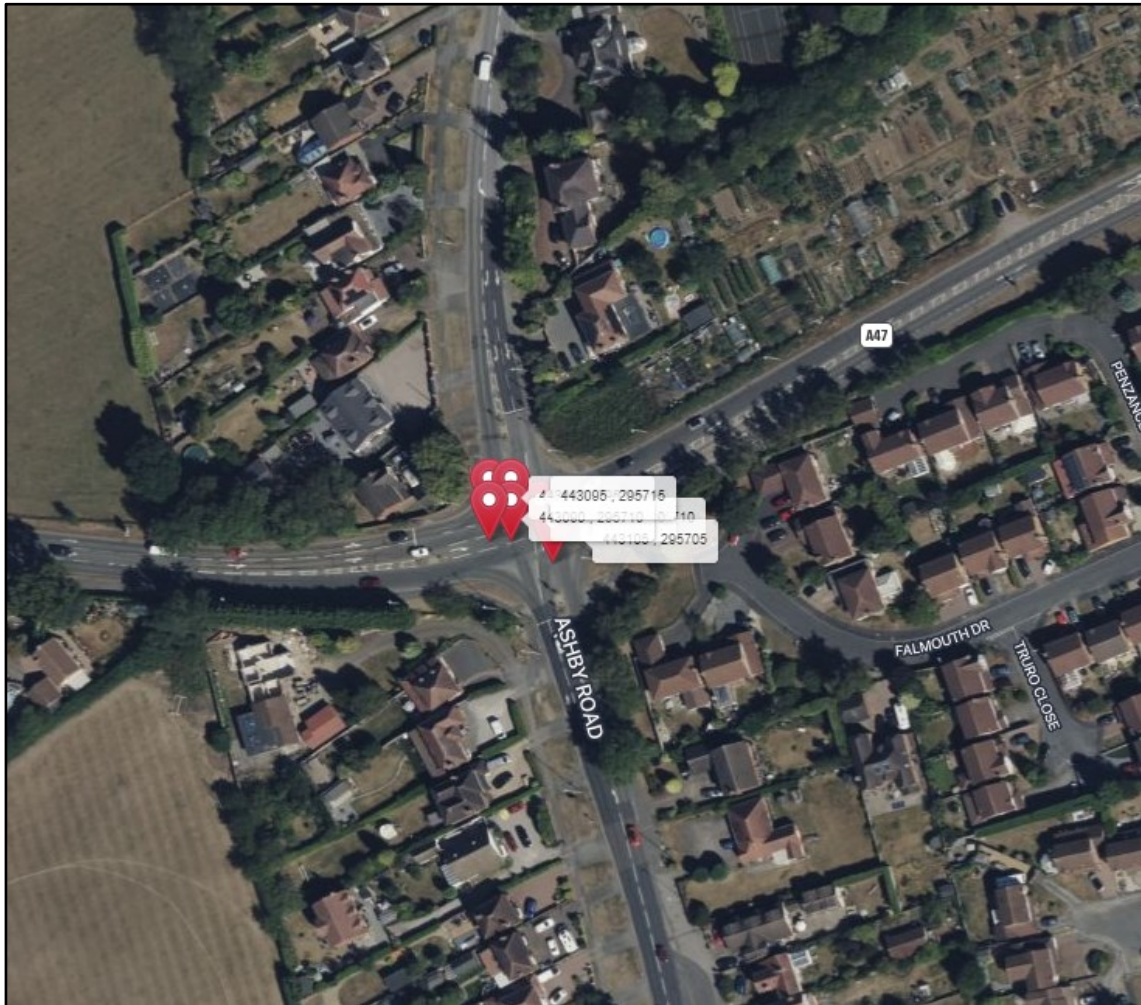
Figure 2.5: A47 Normandy Way / A447 Ashby Road junction

2.17 Figure 2.5 shows that a total of six collisions have occurred at the A47 Normandy Way / A447 Ashby Road Junction. Table 2.4 provides a breakdown of the collision severity at the junction.

2.18 Over the three-year period and of the six recorded PICS, five PICs were classified as being slight severity and one PIC was classed as serious severity. No fatalities were recorded.

- 2.19 The serious collision only involved one vehicle, a car travelling eastbound through the junction during a January evening when the road surface was wet/damp.

- 2.20 The remaining five slight injury collisions all occurred in the centre of the junction. All of the collisions involved two cars and they all involved vehicles turning right across the path of another vehicle although the right turn movements were into different arms of the junction. Of the five slight injury collisions, four of them happened in the wet weather and they all happened in the hours of darkness during the winter months.

- 2.21 As a result, there are trends identified at this junction, with right turners, wet weather and the hours of darkness. The collision trend is generally reduced from four collisions in 2020 to only two in 2022 and none recorded so far during 2023.

- 2.22 It should be noted that the proposed mitigation scheme restages the existing junction to provide right turners from the A47 into Ashby Road south with an indicative green arrow to provide them with an unopposed turning stage to improve capacity and safety.

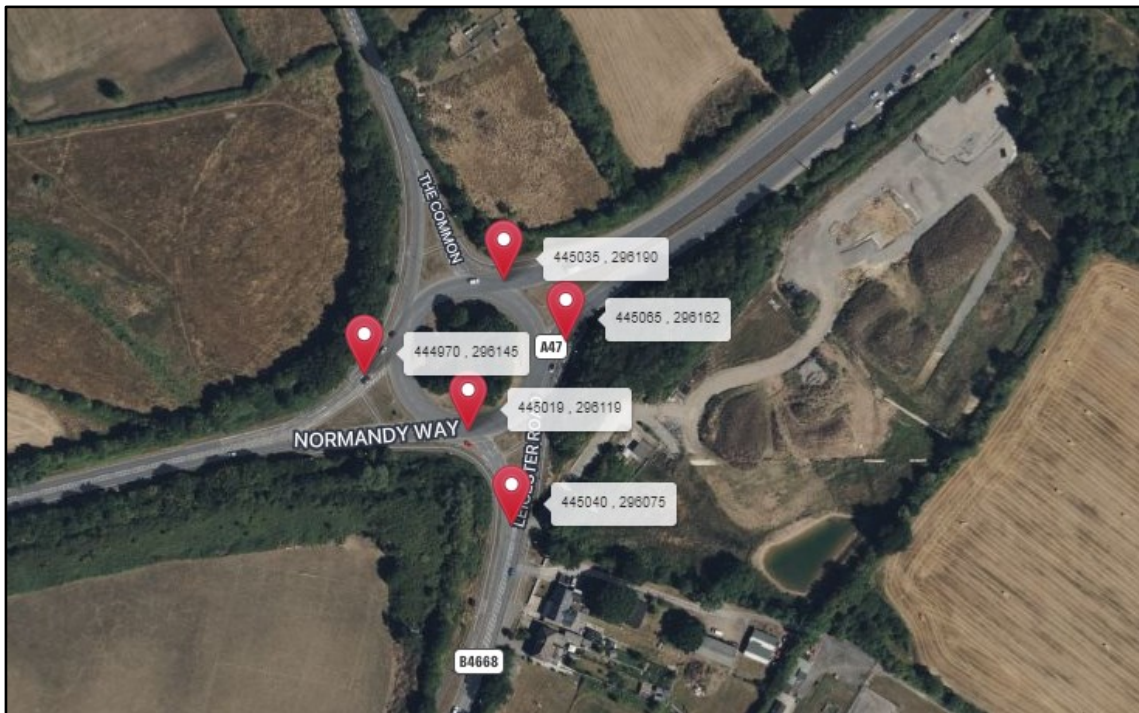
Figure 2.6: A47 Normandy Way/A47 Leicester Road/Road junction

- 2.23 Figure 2.6 shows that a total of 5 collisions have occurred at the A47 Normandy Way / A47 Leicester Road / B4668 Leicester Road / The Common Junction. Table 2.5 provides a breakdown of the collision severity at the junction.

2.24 Over the three-year period 4 PICs were classified as being slight severity, one of serious severity and no fatalities.

2.25 Three of the recorded collisions were shunt type collisions, two of which occurred on each of the A47 entries to the roundabout, and one on the A47(E) exit. The remaining two collisions involved motorcycles; one on the circulatory which was classed as a slight injury accident and one on the B4668 northbound approach to the roundabout which involved a car switching lanes and colliding with a motorcyclist, resulting in serious injuries.

2.26 Whilst there were five collisions recorded at the junction, all of the collisions occurred at different locations around the roundabout, and no real trends or patterns have been identified. The number of collisions has dropped from three in 2021 to just one in 2022 and there have been no recorded collisions so far this year.

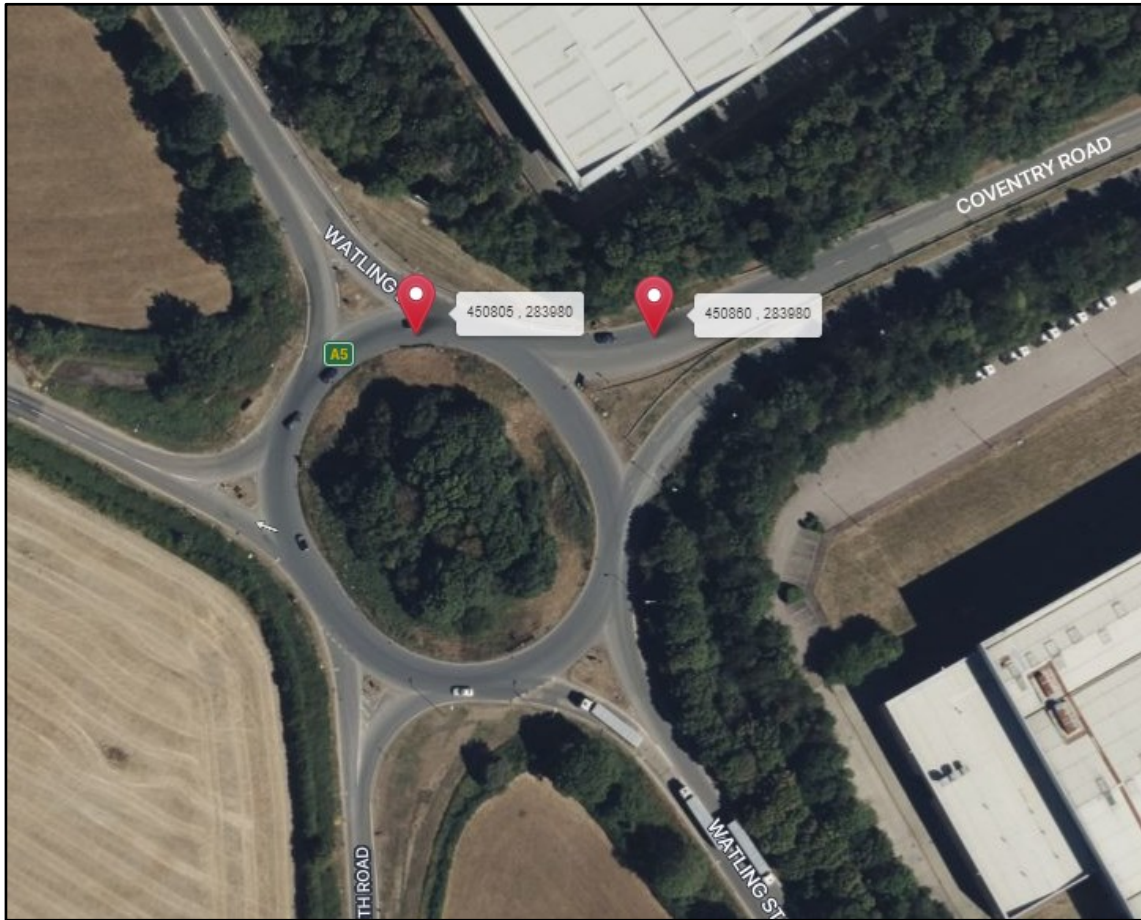
Figure 2.7: Cross in Hand Roundabout (A5 Watling Street/A4303/B4027/Coal Pit Lane) Road junction

2.27 Figure 2.7 shows that 2 collisions have occurred at the Cross in Hand Roundabout Junction over the three-year period. Table 2.6 provides a breakdown of the collision severity at the junction.

- 2.28 Of the two collisions, one PIC was classified as being slight severity and the other was classified as serious severity. No fatalities were recorded at the Cross in Hand Roundabout.
- 2.29 The slight injury collision occurred when a car and a van collided on the circulatory as the vehicles entered and exited the roundabout simultaneously. The serious injury collision occurred on the A4303 when 4 cars collided leaving the roundabout.

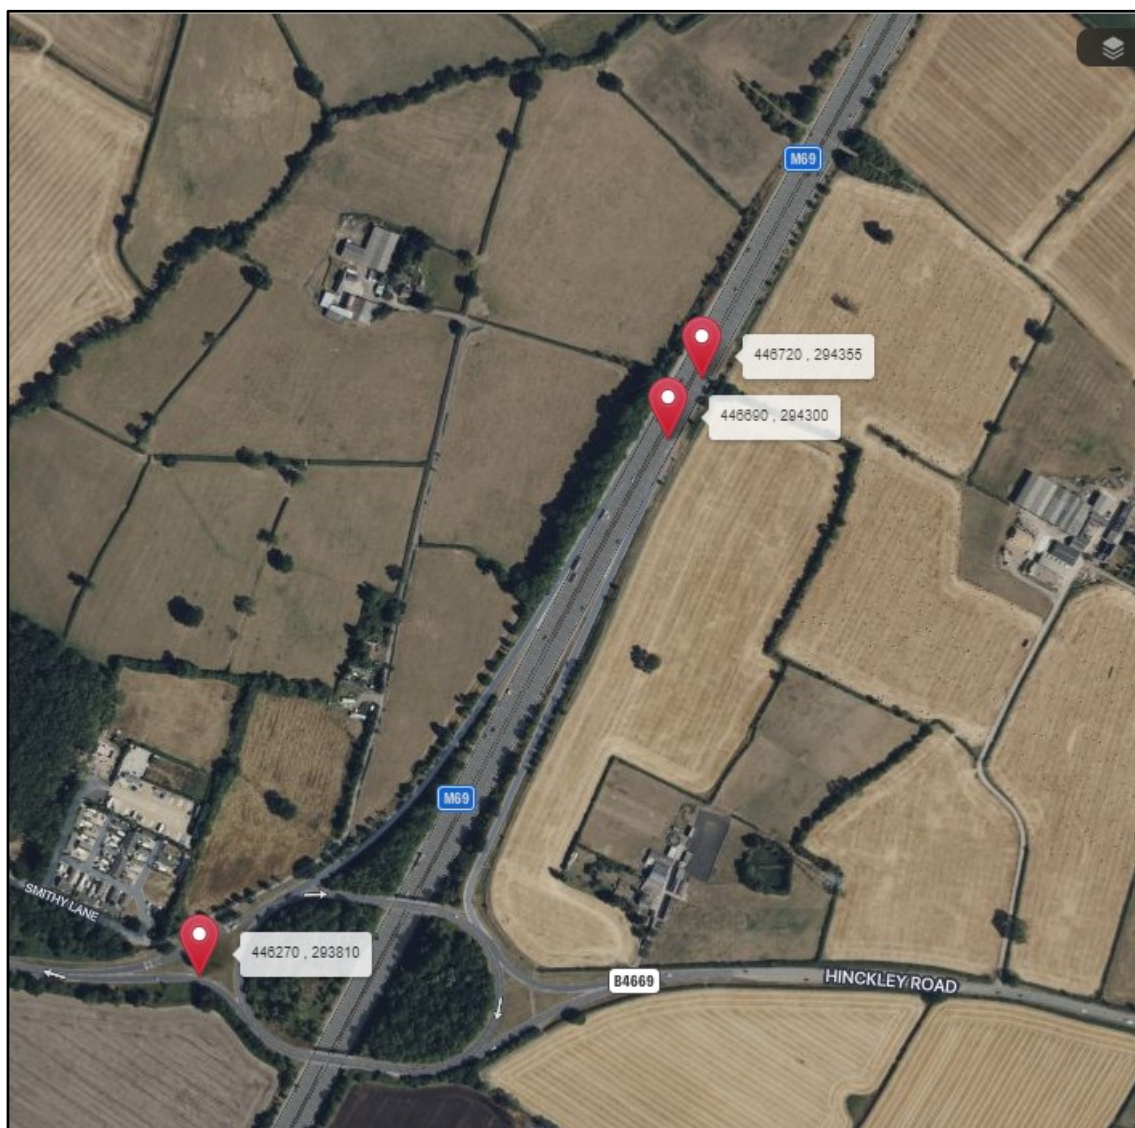
Figure 2.8: M69 Junction 2

2.30 Figure 2.8 shows that three collisions have occurred in the vicinity of the M69 Junction 2 over the three-year period. Table 2.7 provides a breakdown of the collision severity at the junction.

- 2.31 Of the three collisions, one PIC occurred on the B4669 Hinckley Road to the west of Junction 2 and was classified as being slight severity. The other two collisions occurred on the M69 itself, to the north of the southbound off-slip and were both also classed as slight severity.
- 2.32 The slight injury collision on the B4669 occurred when a car leaving the roundabout in a westbound direction as involved in a collision, but no other vehicles were implicated. The two slight injury collisions recorded on the M69 both happened on the southbound carriageway and involved vehicles changing lanes.

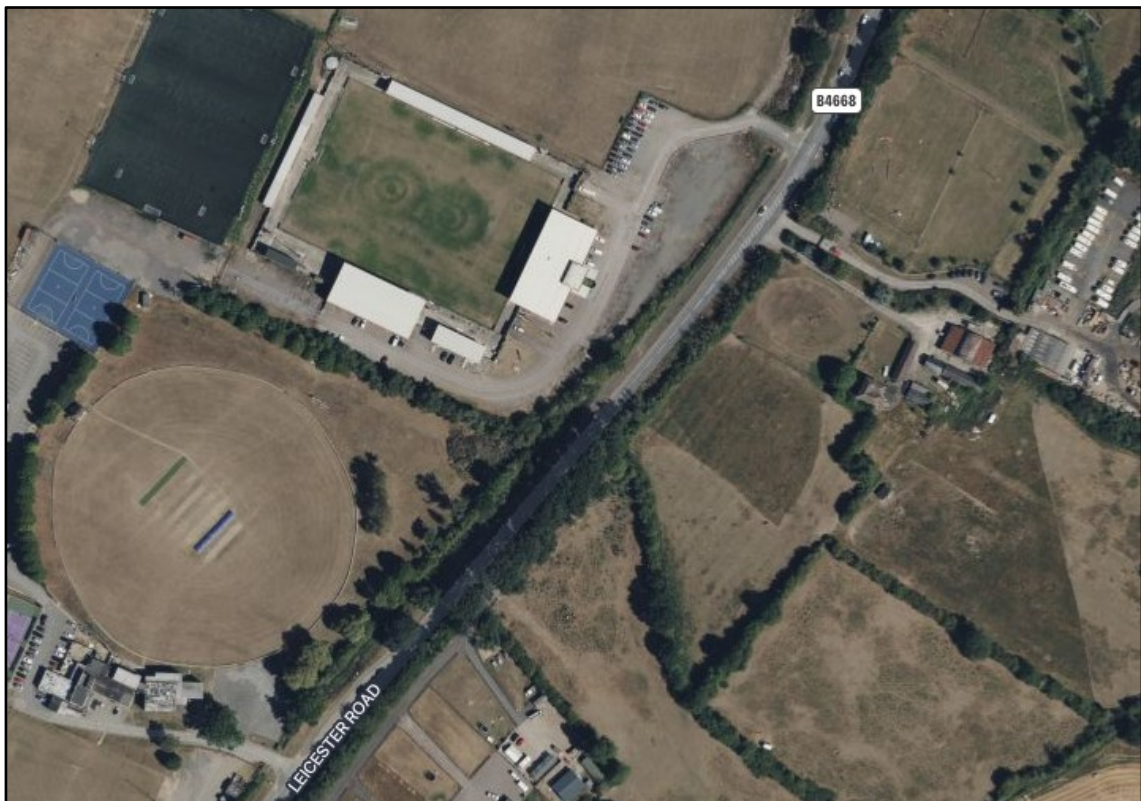
Figure 2.9: B4668 Leicester Road

- 2.33 Figure 2.9 shows that there were no collisions recorded at the B4668 in the vicinity of the proposed site access junction between January 2020 and July 2023. As a result, no further investigation was required at this junction.

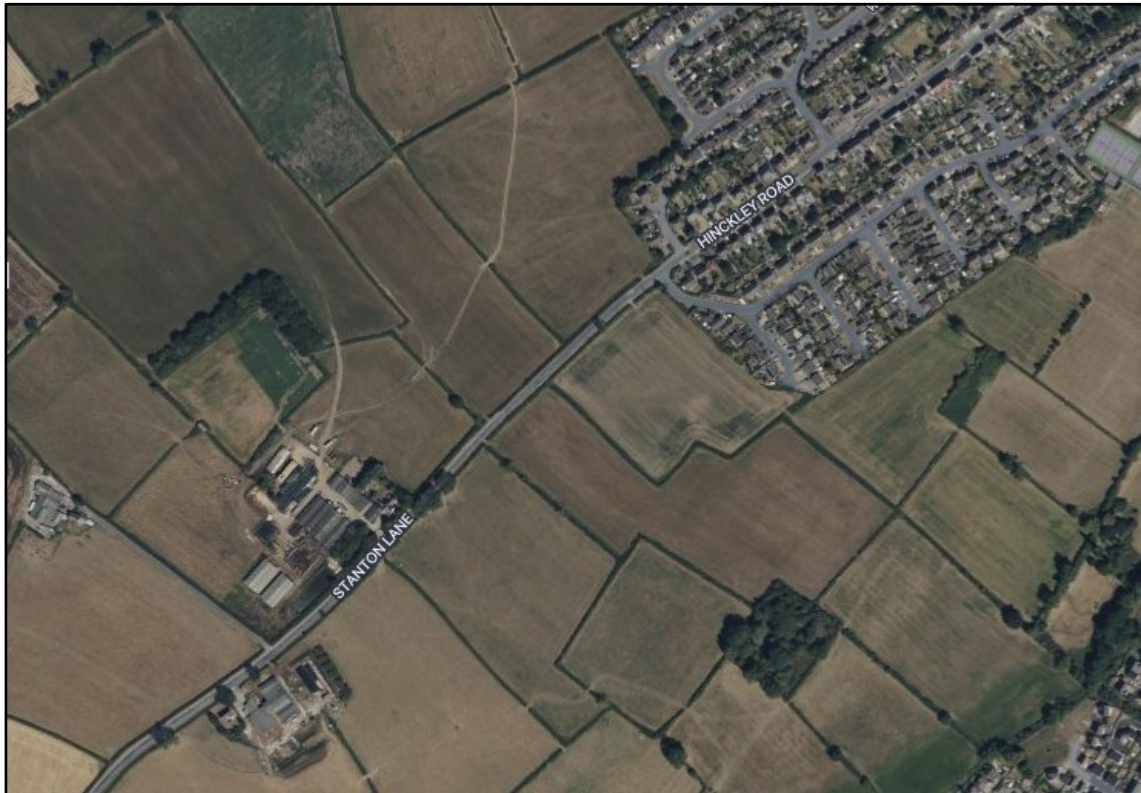
Figure 2.10: Stanton Lane south of Stoney Stanton

- 2.34 Figure 2.10 shows that there were no collisions recorded on Stanton Lane to the south of Stoney Stanton between January 2020 and July 2023. As a result, no further investigation was required along this stretch of road.

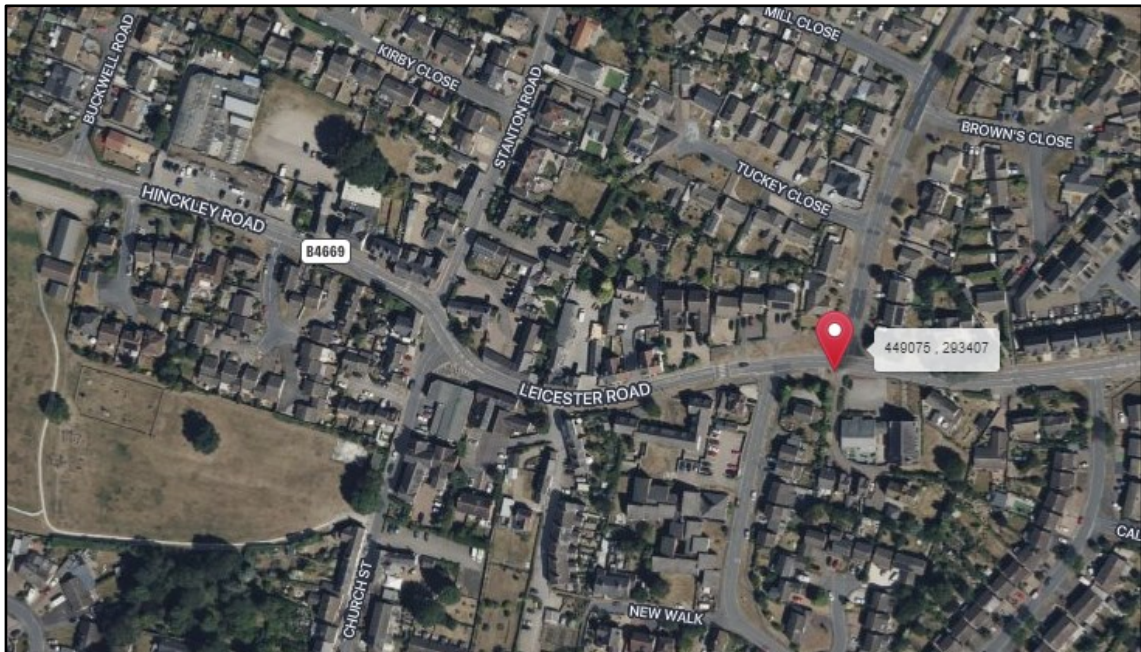
Figure 2.11: Leicester Road through the centre of Sapcote

- 2.35 Figure 2.11 shows that there was one collision recorded at the B4669 Leicester Road through the centre of Sapcote. Table 2.8 provides a breakdown of the collision severity at this section of carriageway.

2.36 The collision that was recorded occurred at the junction of Leicester Road and Grace Road. The collision occurred during the hours of darkness and the road surface was wet. The collision only involved one car and was recorded as a serious injury accident.

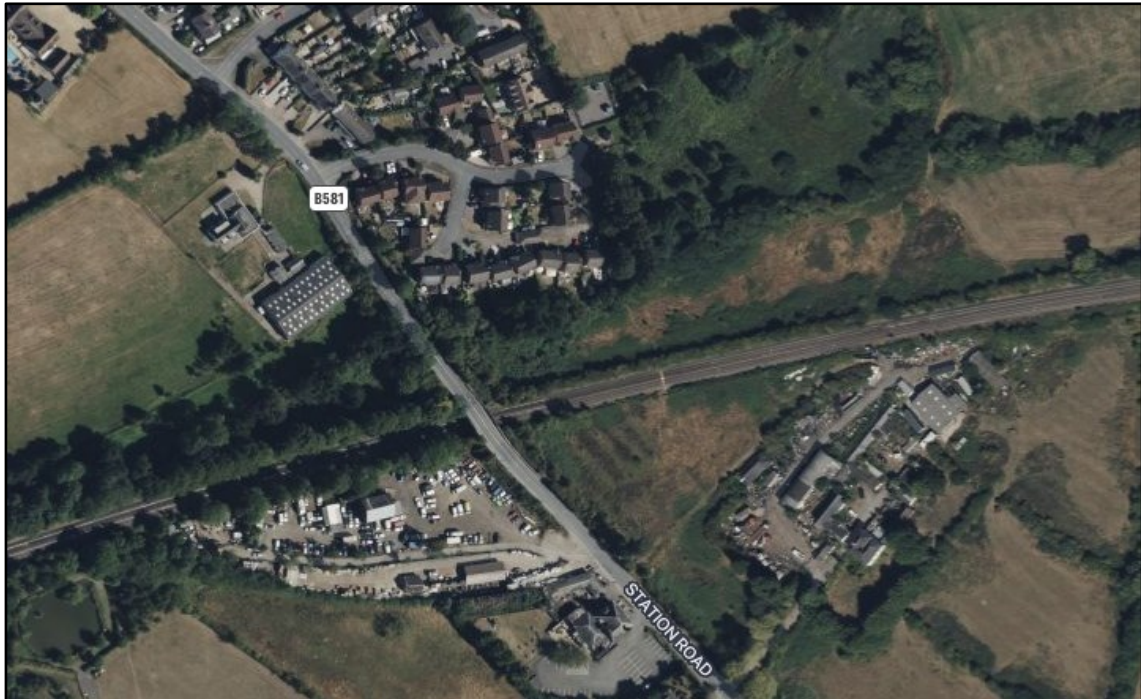
Figure 2.12. Station Road Railway Overbridge Elmesthorpe

2.37 Figure 2.12 shows that there were no collisions recorded on Station Road in the vicinity of the railway overbridge, just to the south of Elmesthorpe between January 2020 and July 2023. As a result, no further investigation was required along this stretch of road.

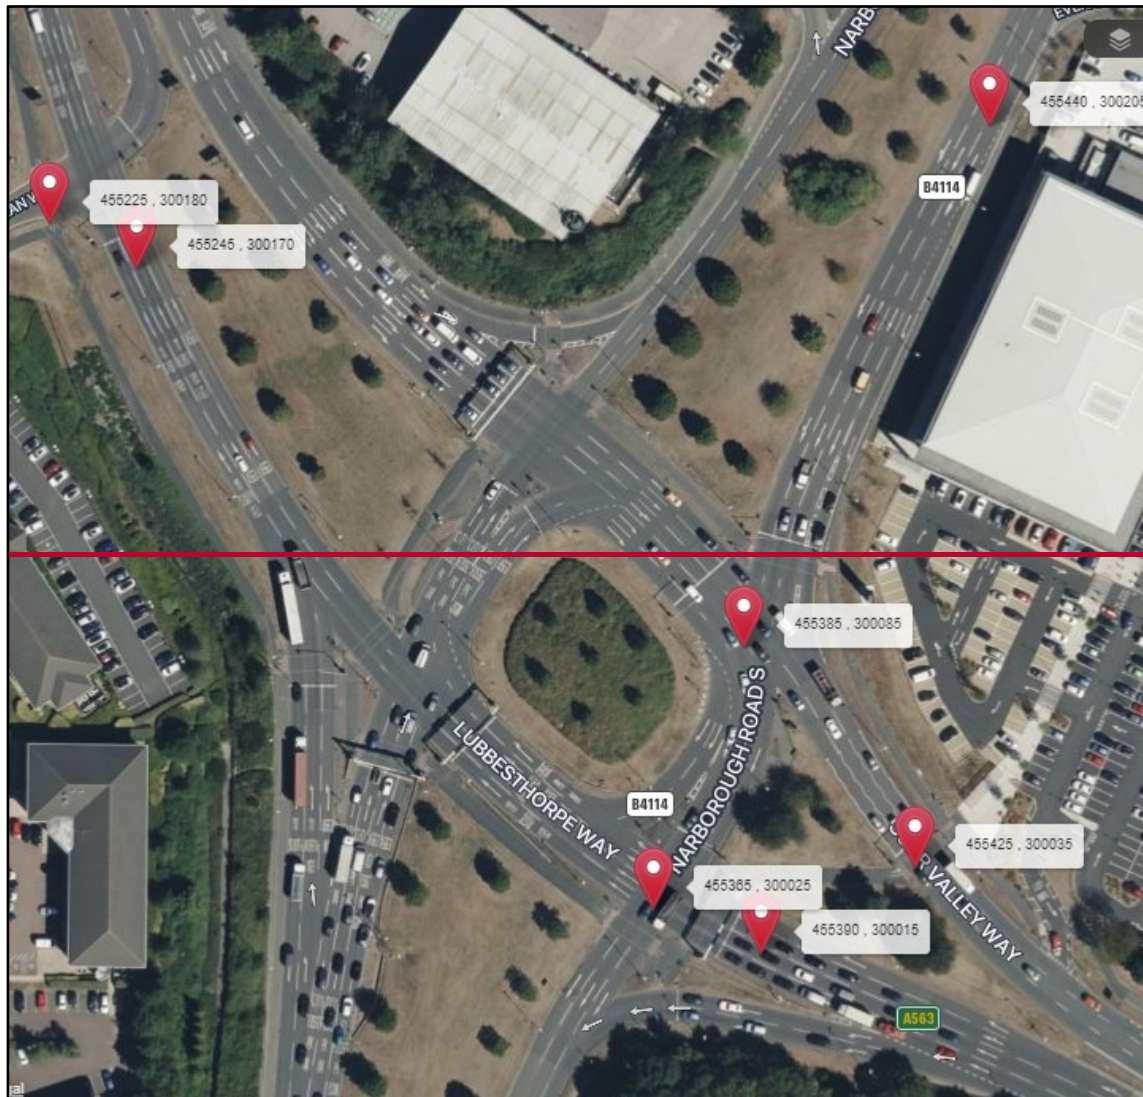
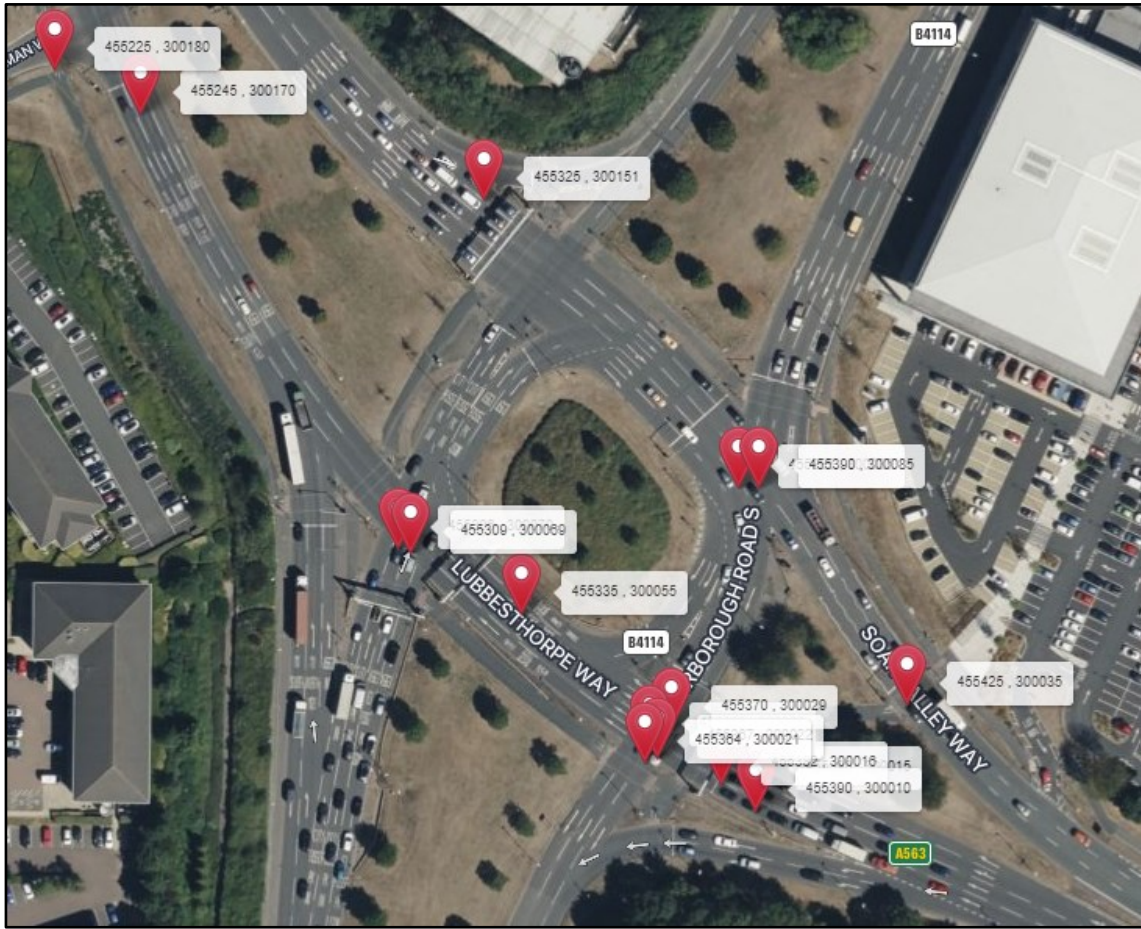
Figure 3.3: A563 Lubbesthorpe Way/Soar Valley Way/B4114 Narborough Rd Junction

3.30 Figure 3.3 shows that a total of ~~seven~~¹⁷ collisions have occurred at the A563 Lubbesthorpe Way / Soar Valley Way / B4114 Narborough Road South Junction over the latest ~~3~~⁵ year period. Table 3.2 provides a breakdown of the collision severity at the junction.

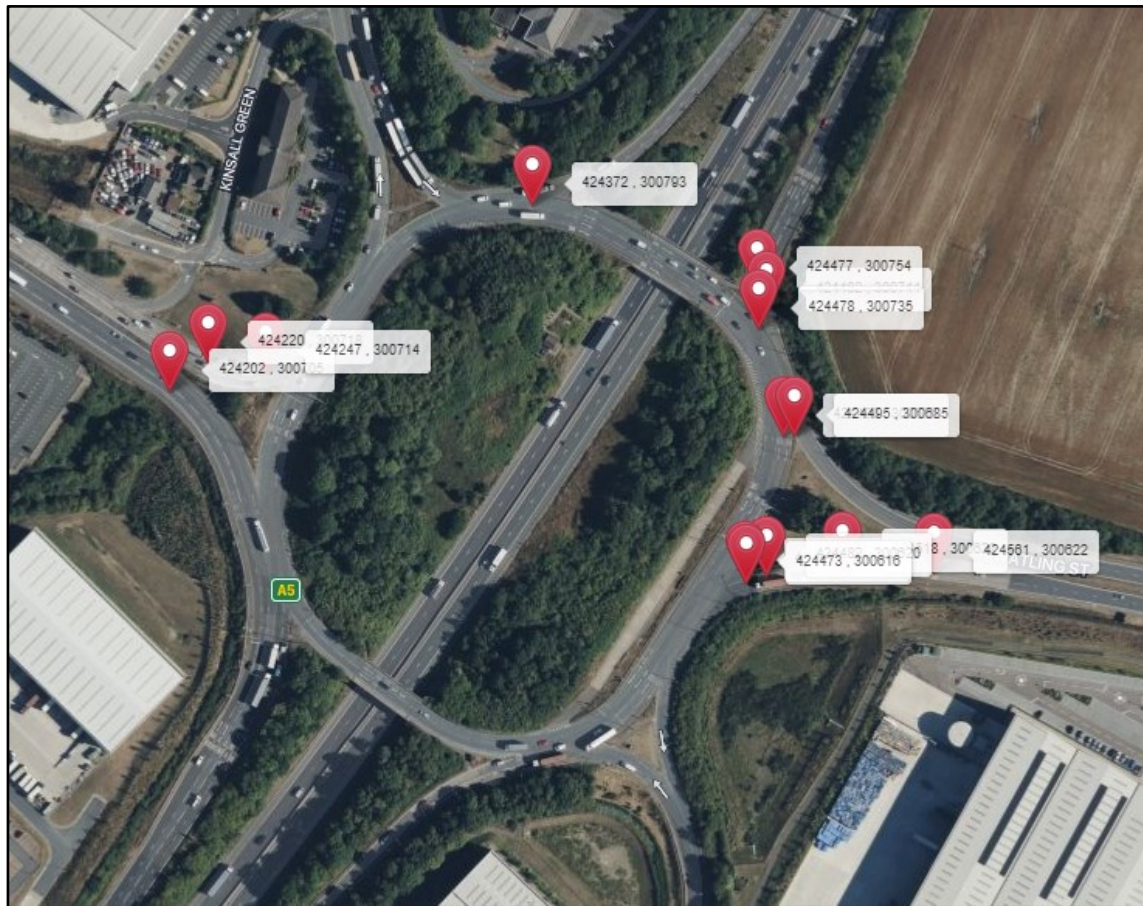
Figure 3.4: M42 junction 10

3.243.35 Figure 3.4 shows that a total of ~~five~~15 collisions have occurred at the M42 Junction 10. Table 3.3 provides a breakdown of the collision severity at the junction.

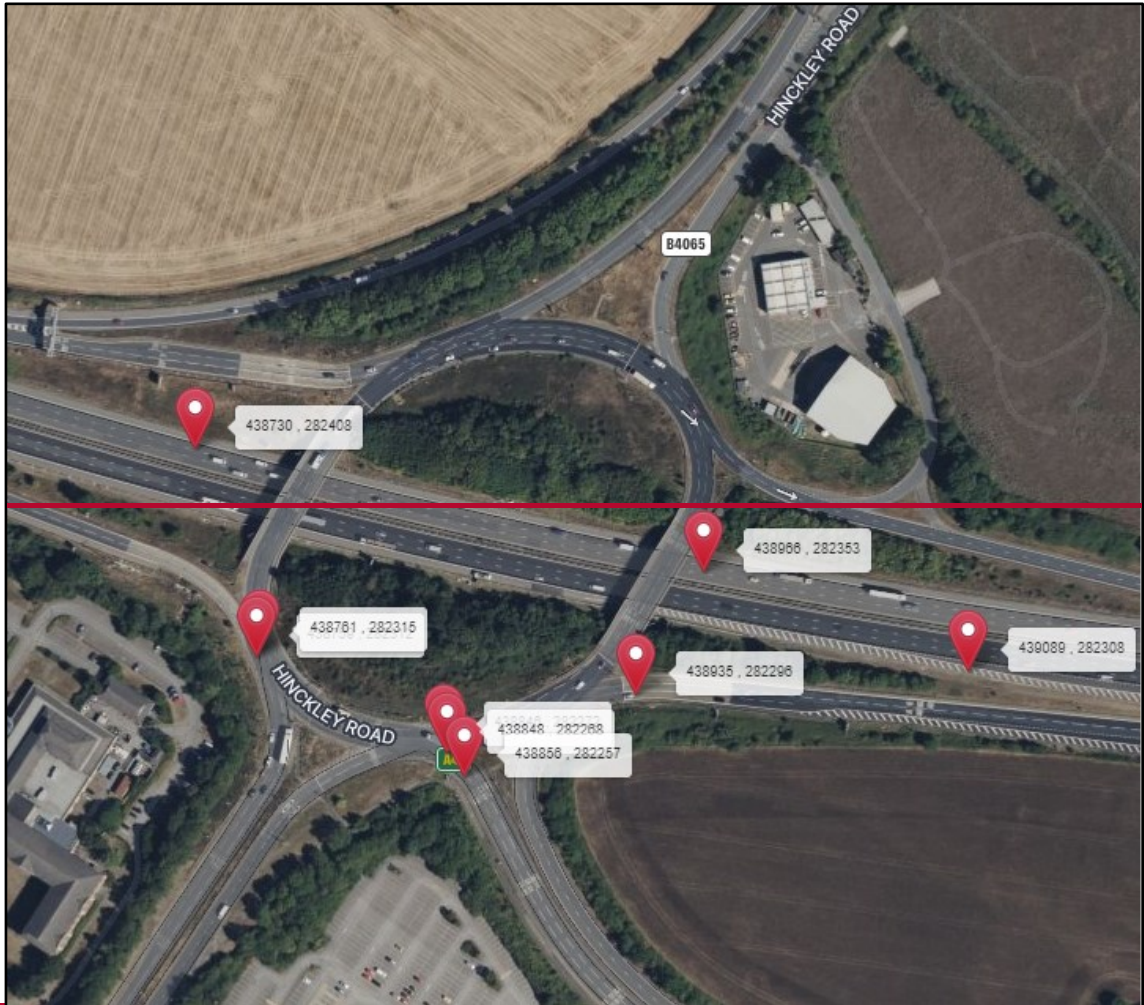
Figure 3.6: M6 Junction 2 Roundabout

3.46 Figure 3.6 shows that a total of ~~nine~~18 collisions have occurred at the M6 Junction 2 roundabout. Table 3.5 provides a breakdown of the collision severity at the junction.

3.51 It appears that the majority of the collisions were caused by vehicles changing lane at the last minute, or being in the incorrect lane as they circulated the junction or approached the junction. There were also some shunt type collisions recorded too.

5-23.52 Compared to the previous summary of data from 2015 to 2019, the number of collisions each year has remained at a similar rate. A slight peak was recorded in 2019, but the number of collisions has since reduced considerably since since. Whilst it is unfortunate that a fatal collision has occurred at this junction, it appears ~~2019. The previous data presented 20 collisions over a five year period, which averages to four collisions a year. The latest data has an average have been a unique occurrence which was not caused by the layout of 2.5 collisions a year over the 3.5 year period examined.~~ the highway.

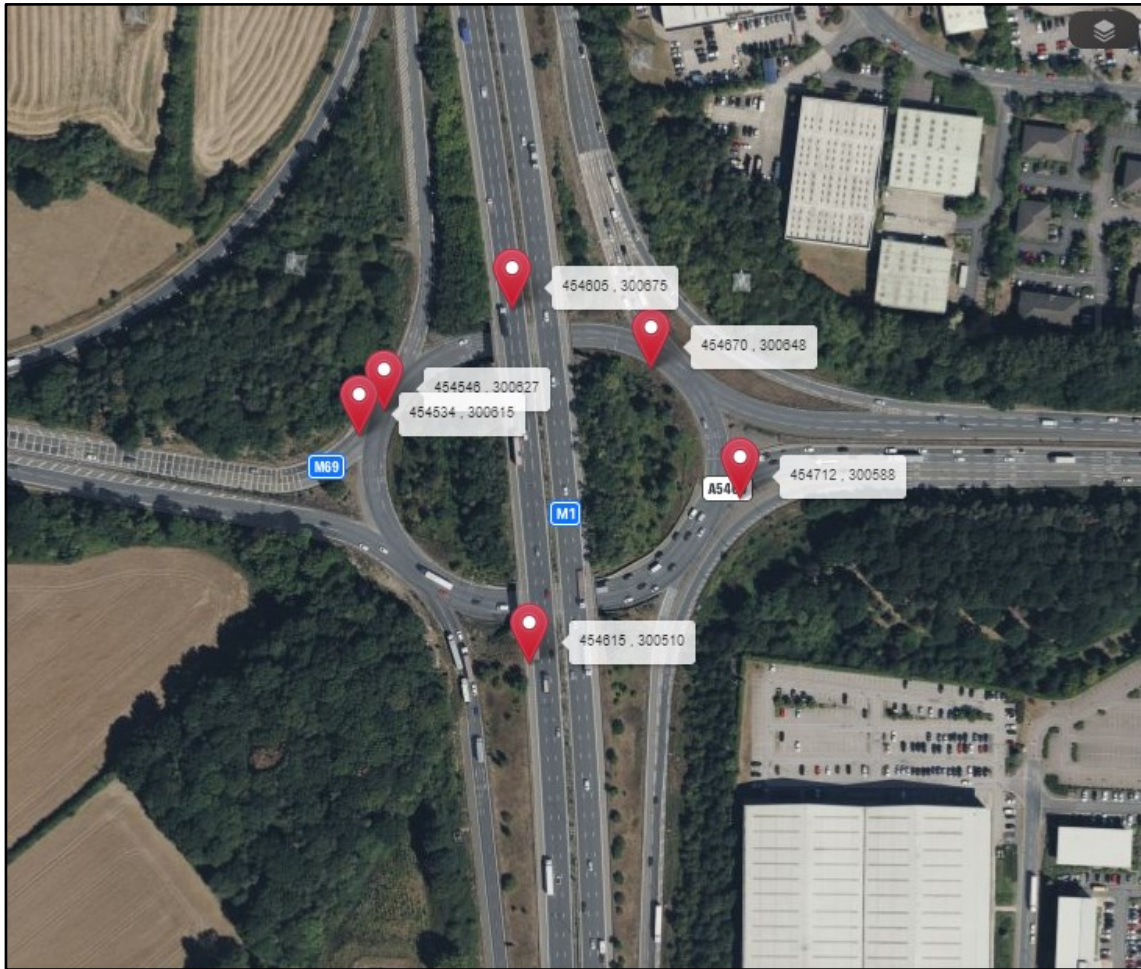
Figure 3.7: M1 Junction 21 Roundabout

3.53 Figure 3.7 shows that a total of ~~two~~six collisions have occurred at the M1 Junction 21 roundabout. Table 3.6 provides a breakdown of the collision severity at the junction.
