**Road Line Marking Assessment Report Covering Darlington
Borough Council Road Infrastructure Surrounding Bishopton
Parish Council Area.
Document Reference BPC/1/24/001**

This report has been written with reference to **CS 126 Inspection and assessment of road markings and road studs (formerly TD 26/17) Version 0.1.0**

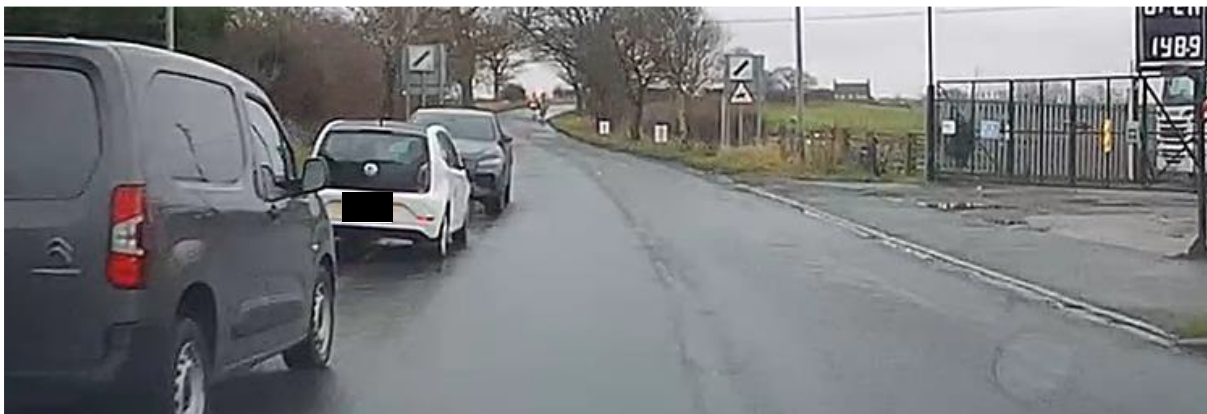
R1.4 – Condition score 0

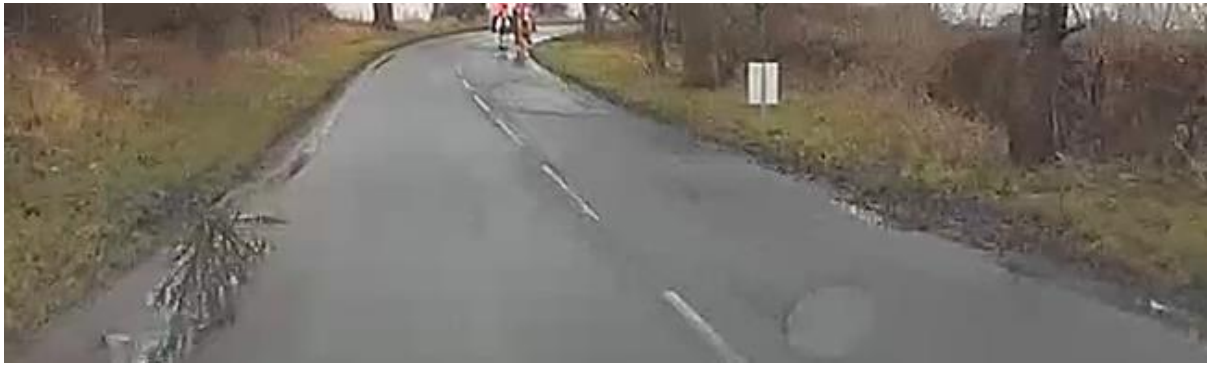
R1.5 – Condition score 10

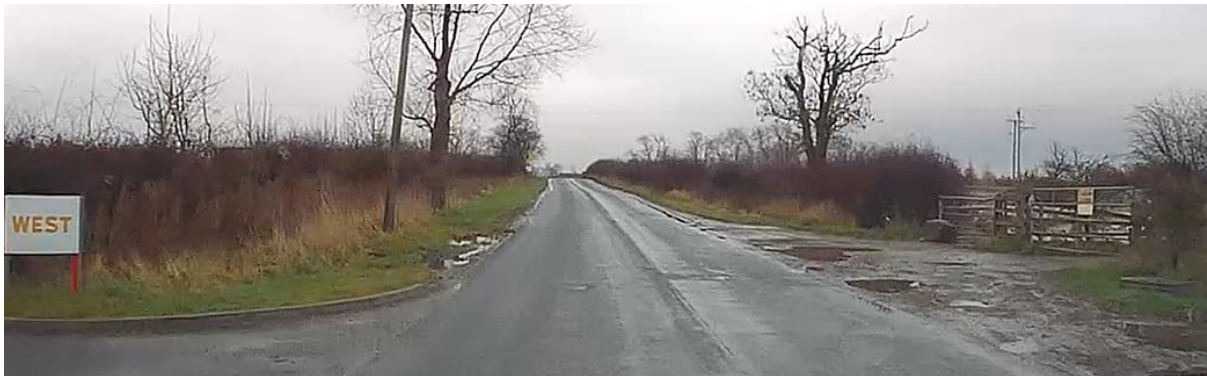
R1.14 – Condition score 0

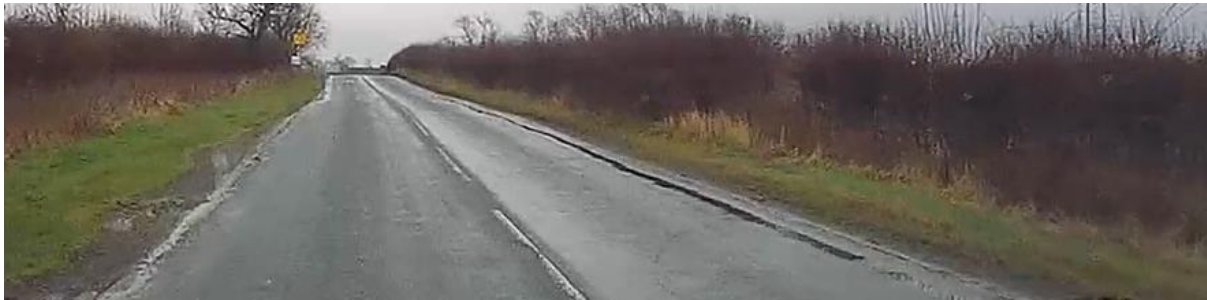
R1.15 – Condition score 10

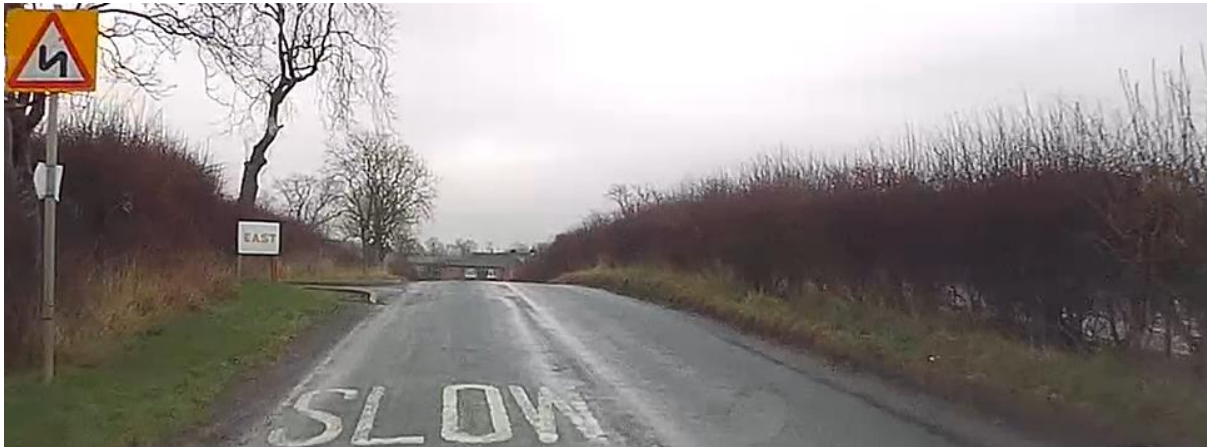
R1.16 – Condition score 0

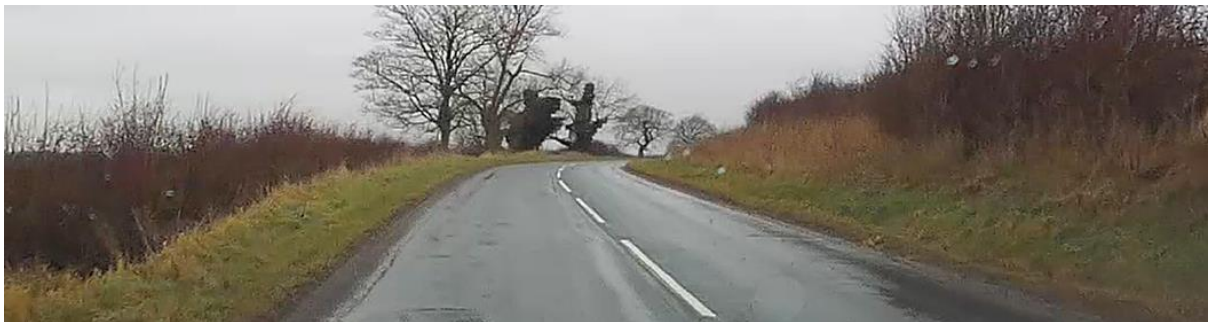
R2.8– Condition score 40

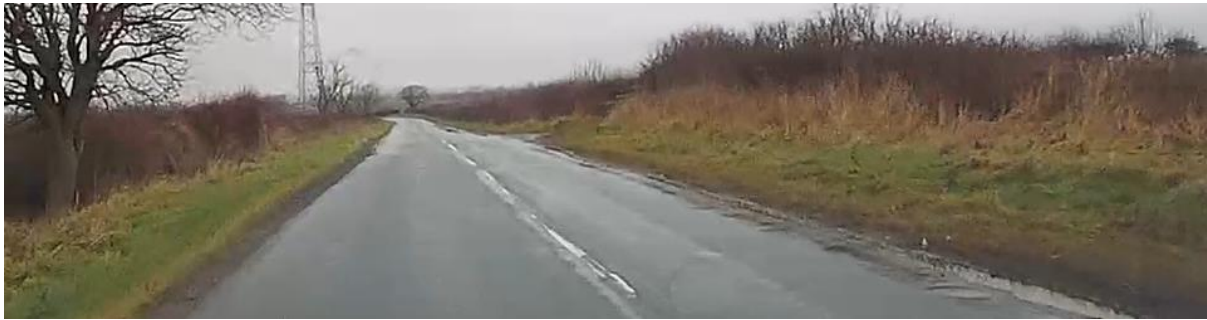
R2.9– Condition score 10

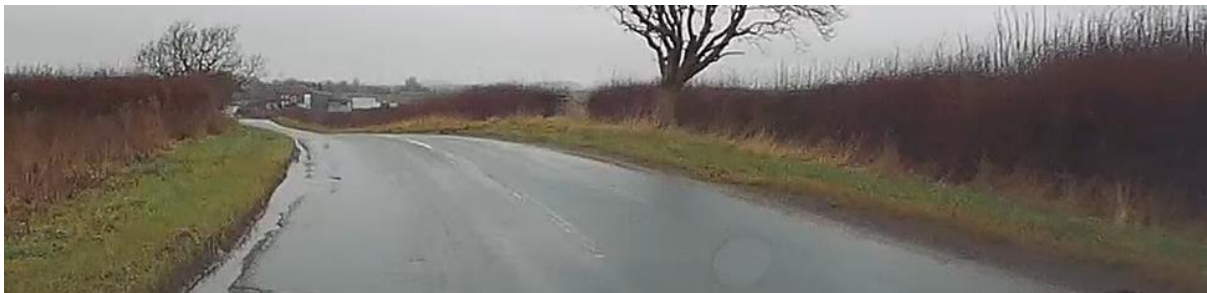
R2.10 - Condition score 0

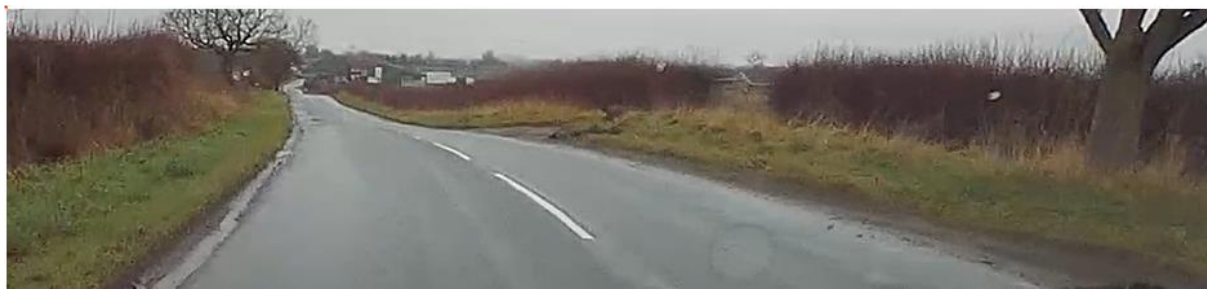
R2.11 - Condition score 0

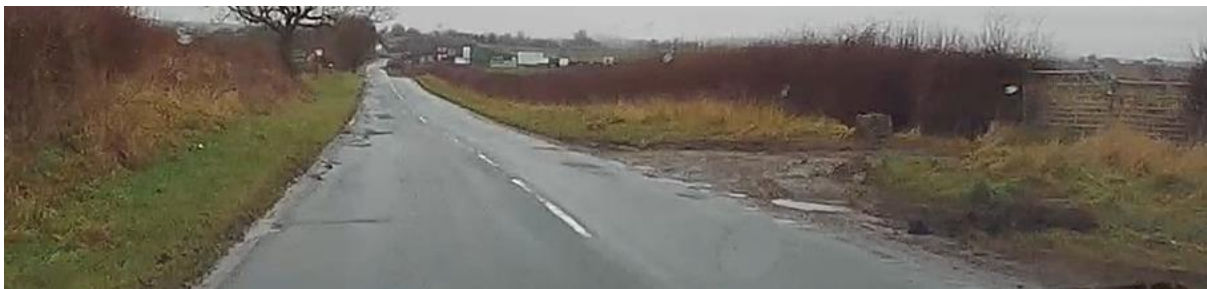
R2.12 - Condition score 10

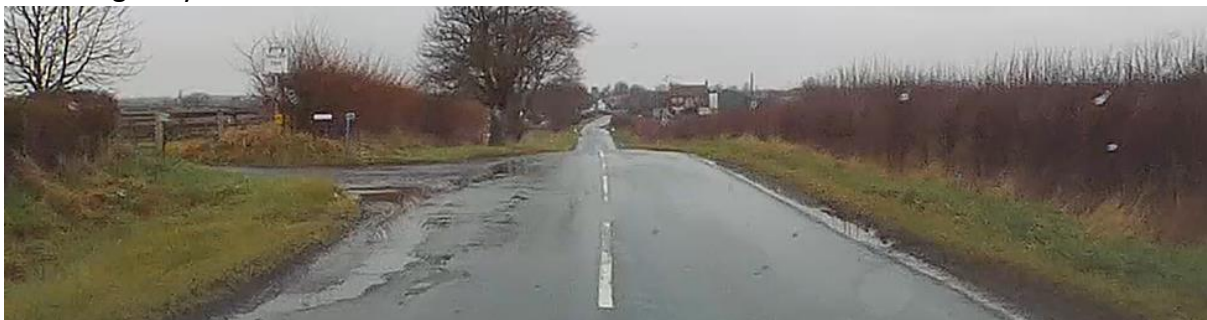
R2.13 - Condition score 10 (Note Lane surface extreme poor condition) forced to use centre of carriageway!

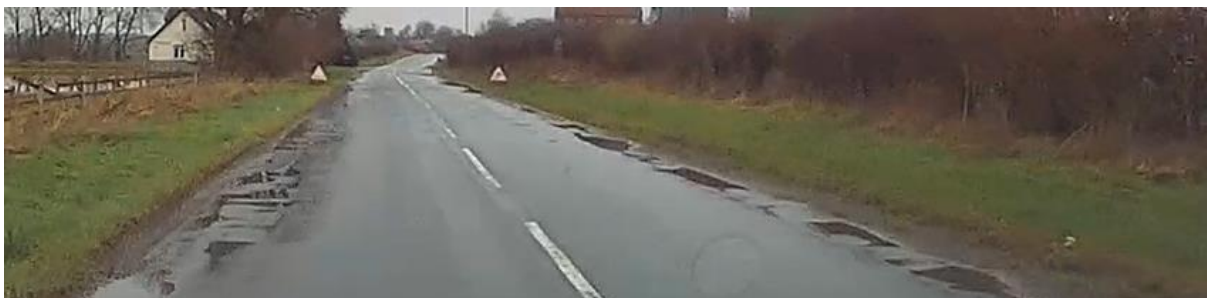
R2.17 - Condition score 10

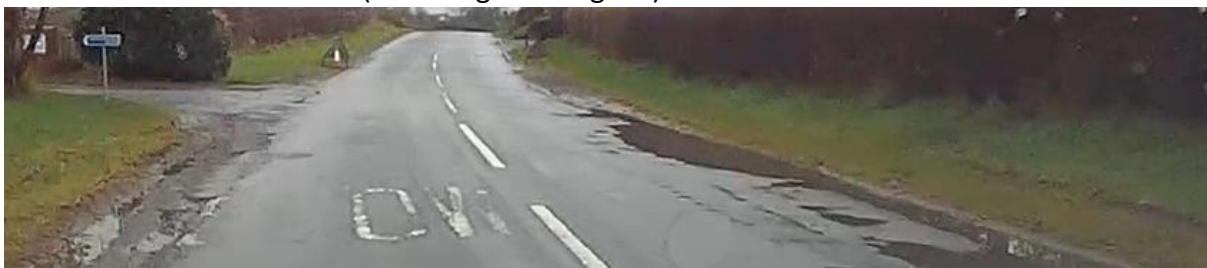
R2.18 - Condition score 10. (SLOW sign not legible)

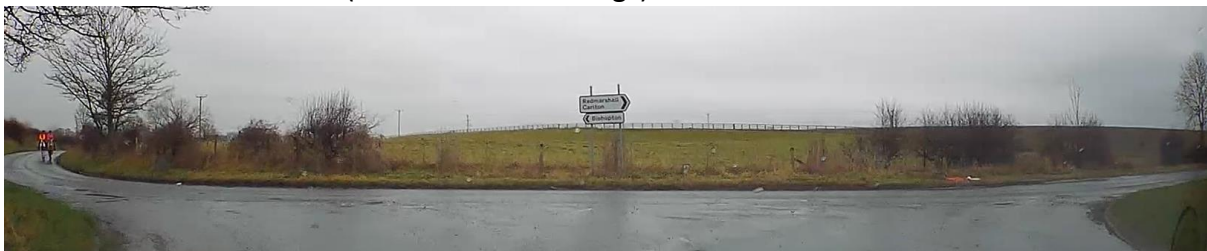
R2.22 - Condition score 0. (For Junction markings)

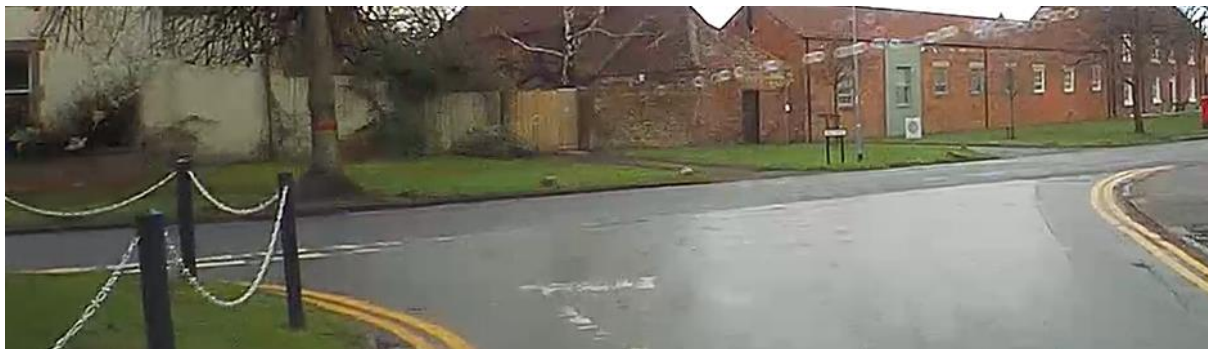
R3.1 - Condition score 0. Junction lines

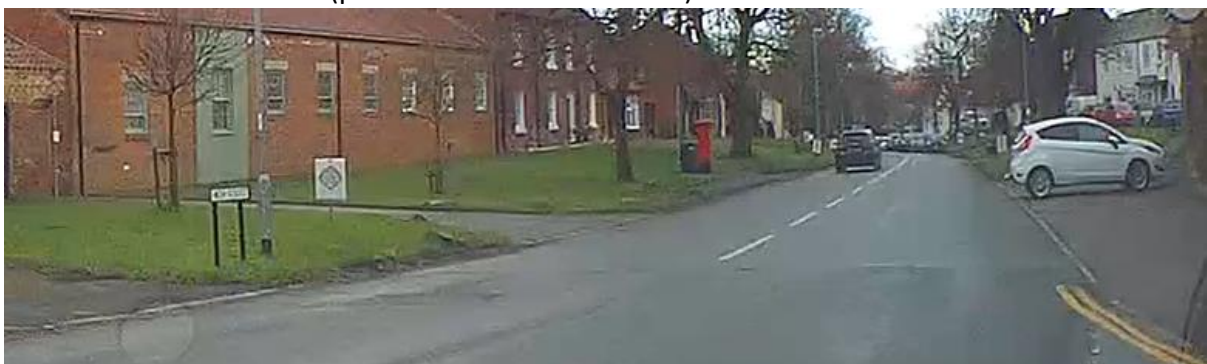
R3.3 - Condition score 0. (prior to resurfaced section)

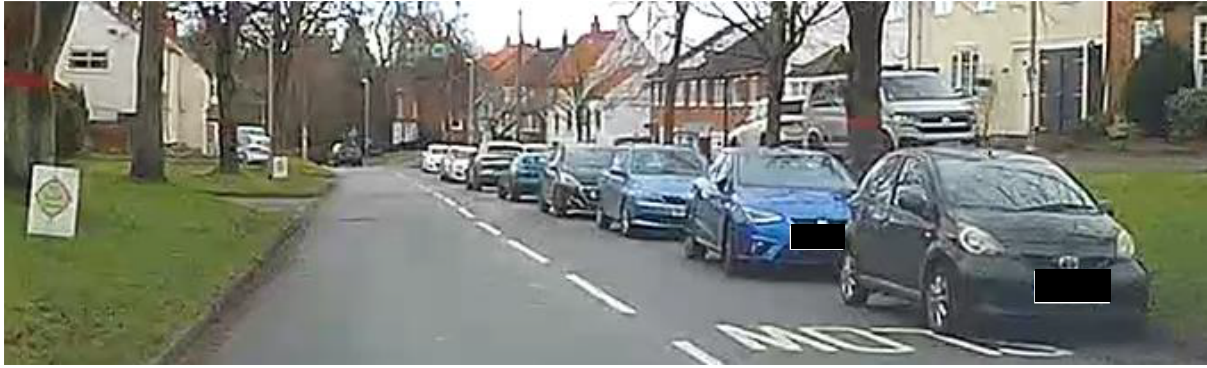
R3.5 - Condition score 40

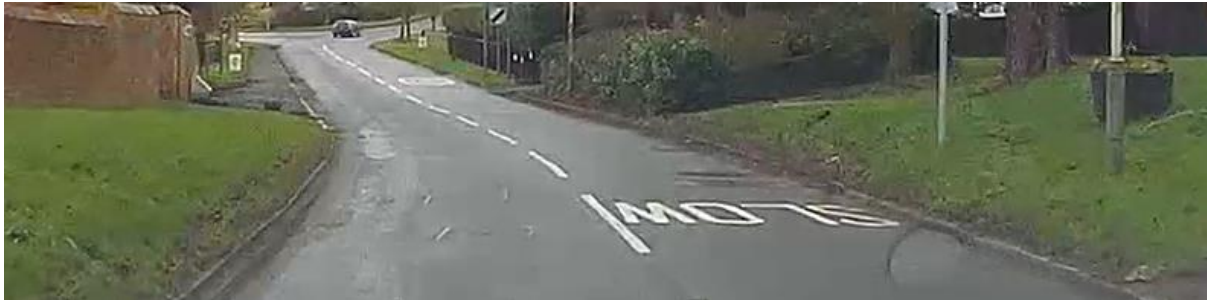
R3.6 - Condition score 40

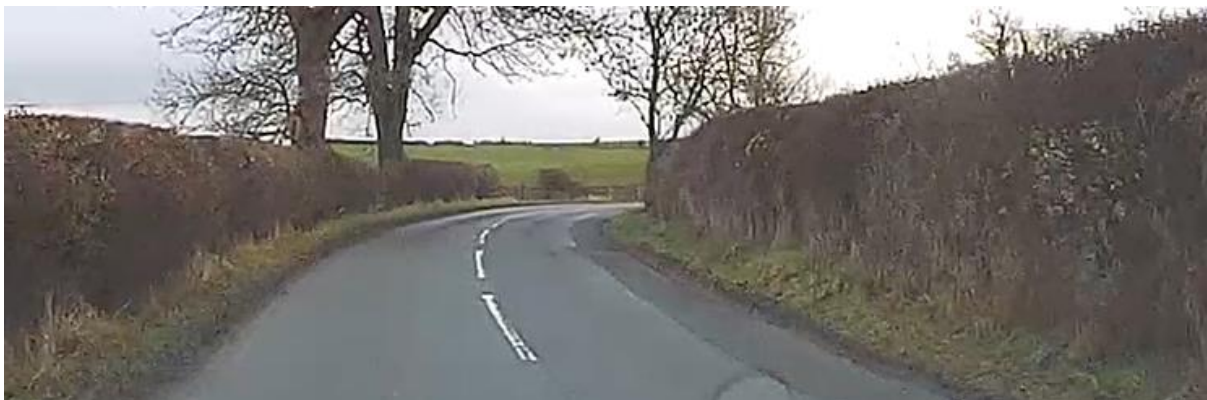
R3.10 Condition score 10

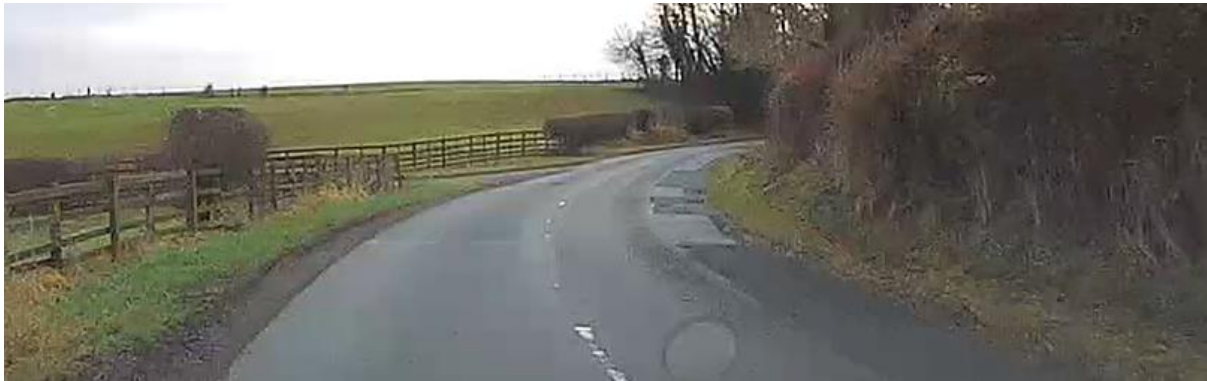
R3.11 Condition score 0 (very Poor road surface inside of bend)

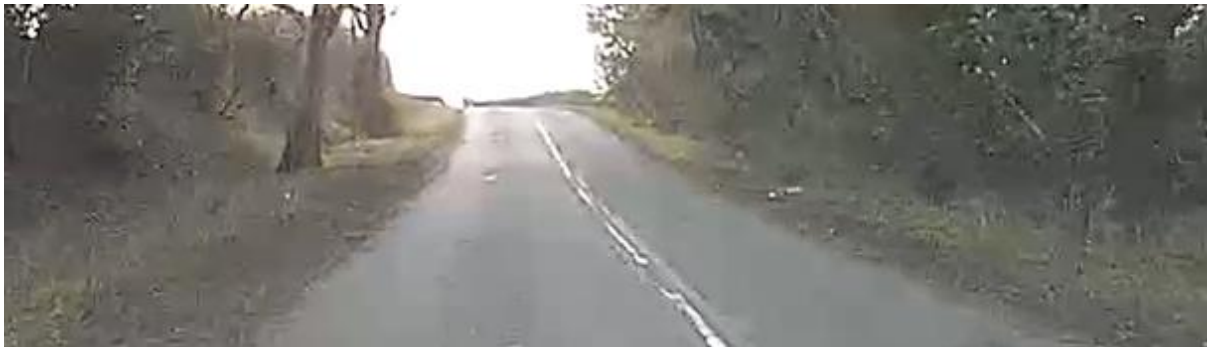
R3.12 Condition score 10

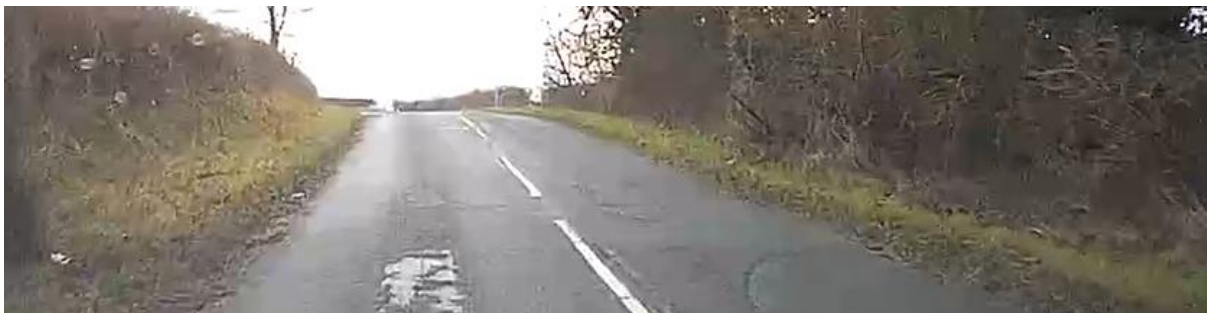
R3.13 Condition score 20

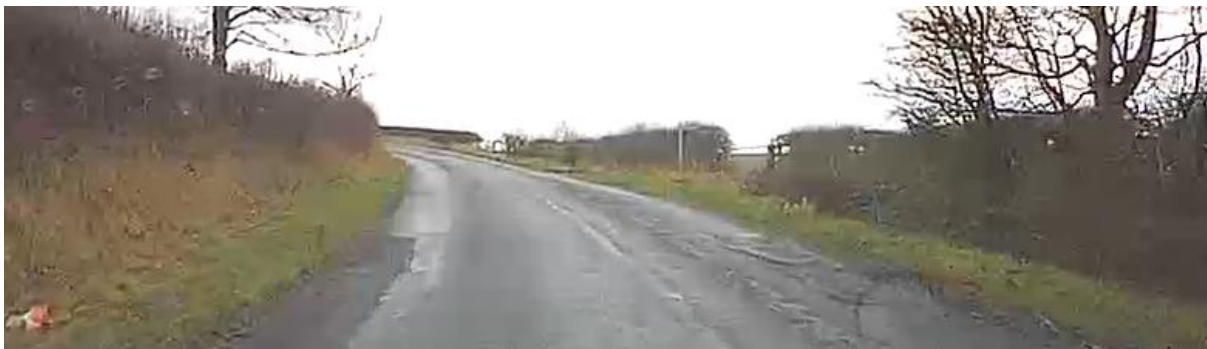
R3.14 Condition score 0

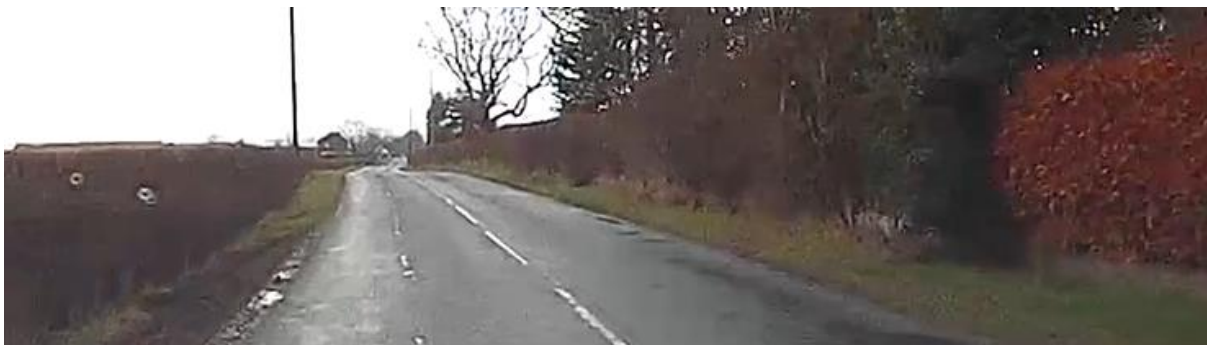
R3.18 Condition score 10

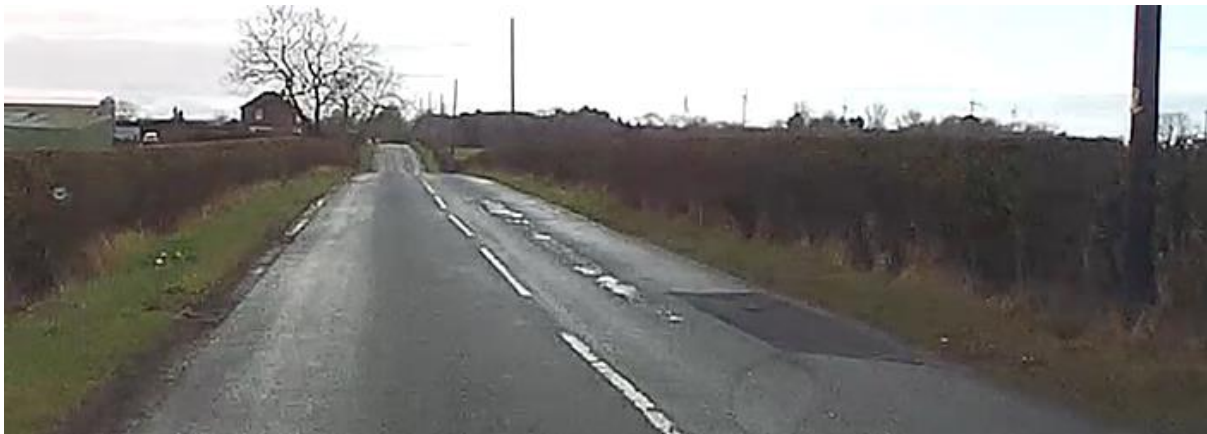
R3.20 Condition score 20

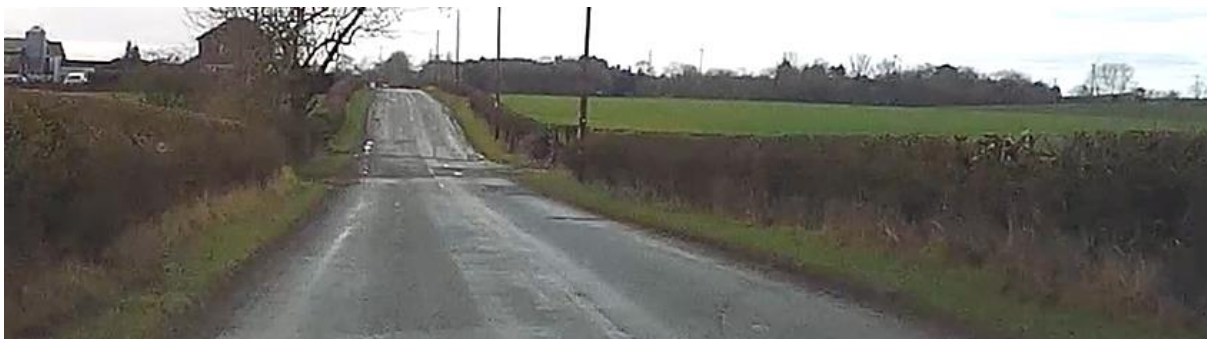
R3.21 Condition score 0

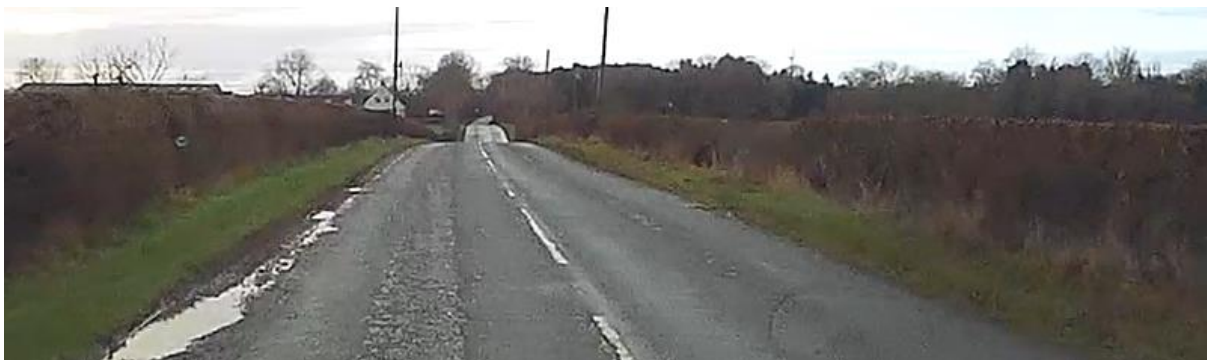
R3.22 Condition score 10

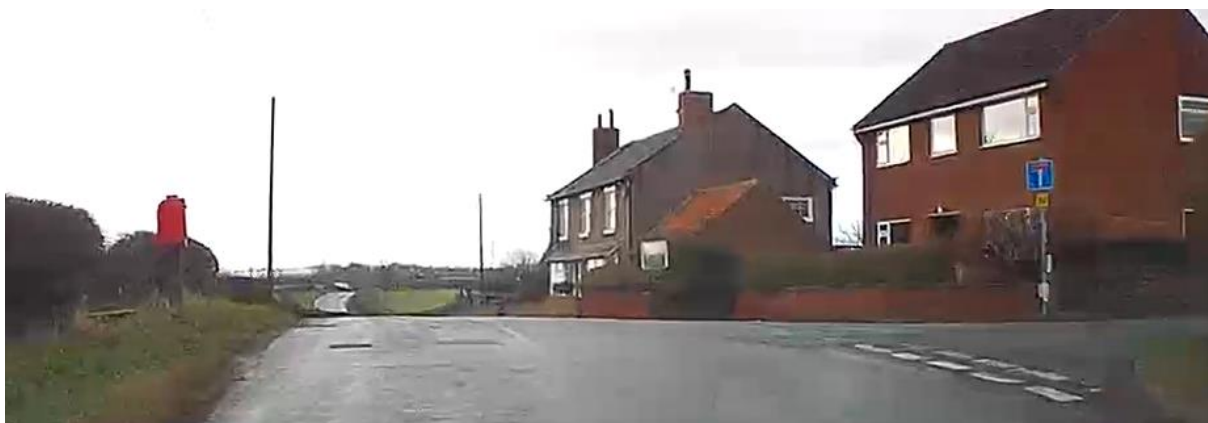
R3.27 Condition score 0

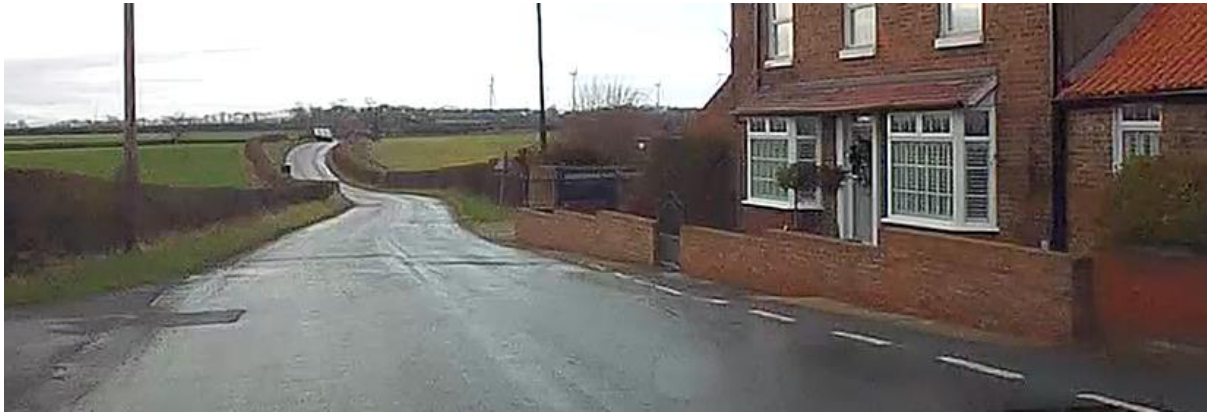
R3.28 Condition score 0

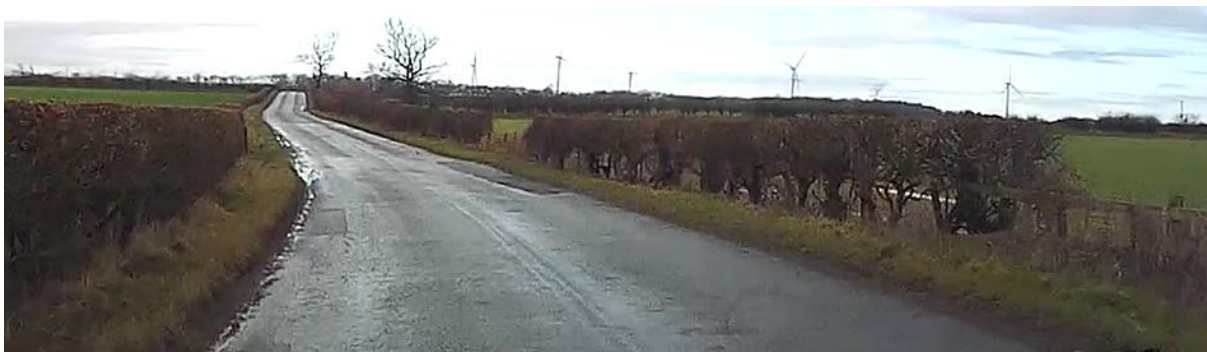
R3.29 Condition score 0

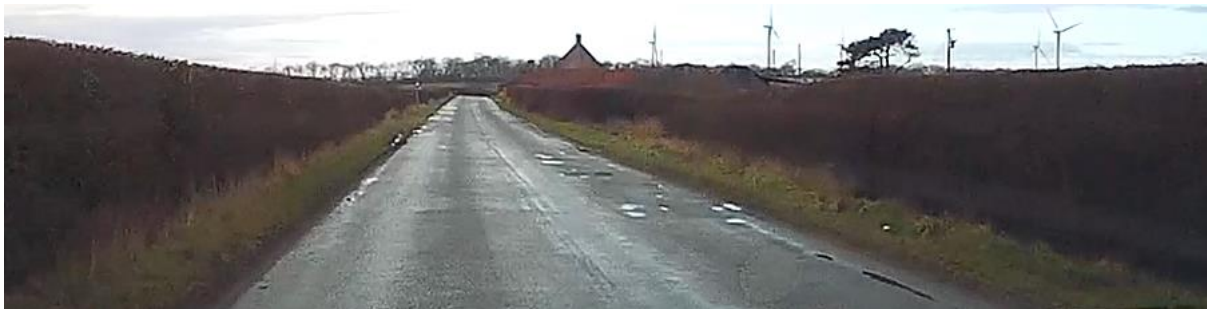
R3.30 Condition score 0

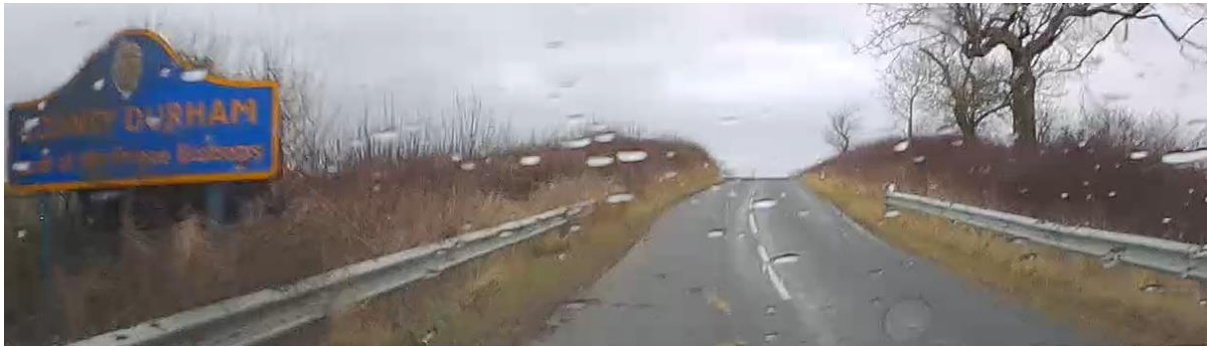
R4.11 Condition Score 30 (Crossing into Co Durham)

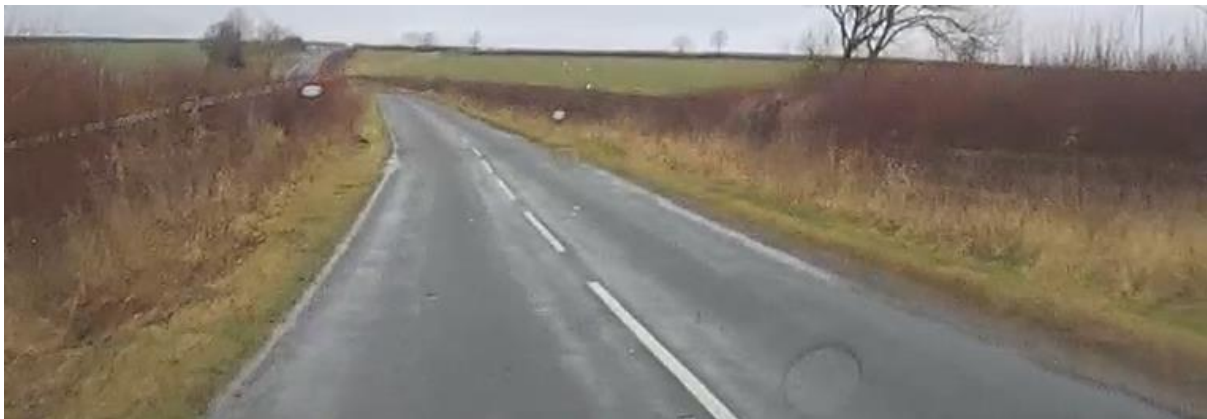
R4.13 Condition Score 40

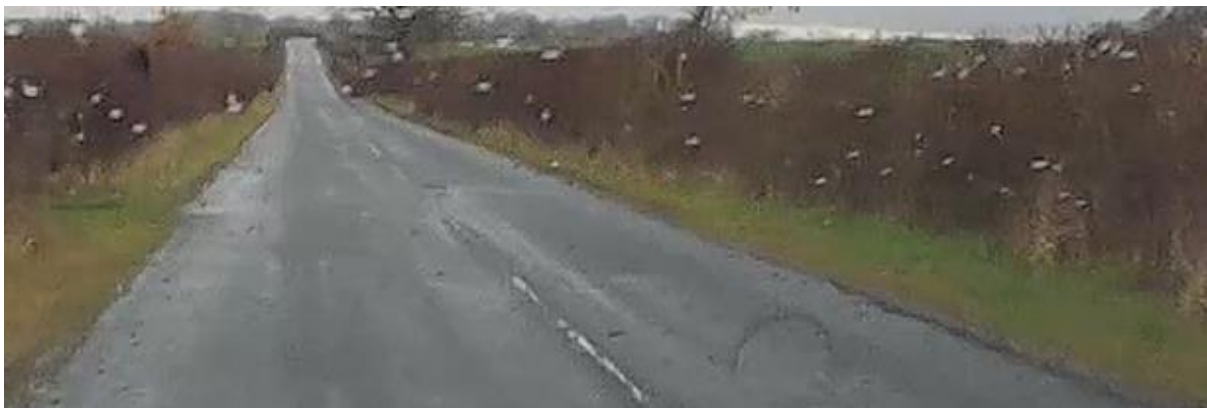
R4.20 Condition Score 0

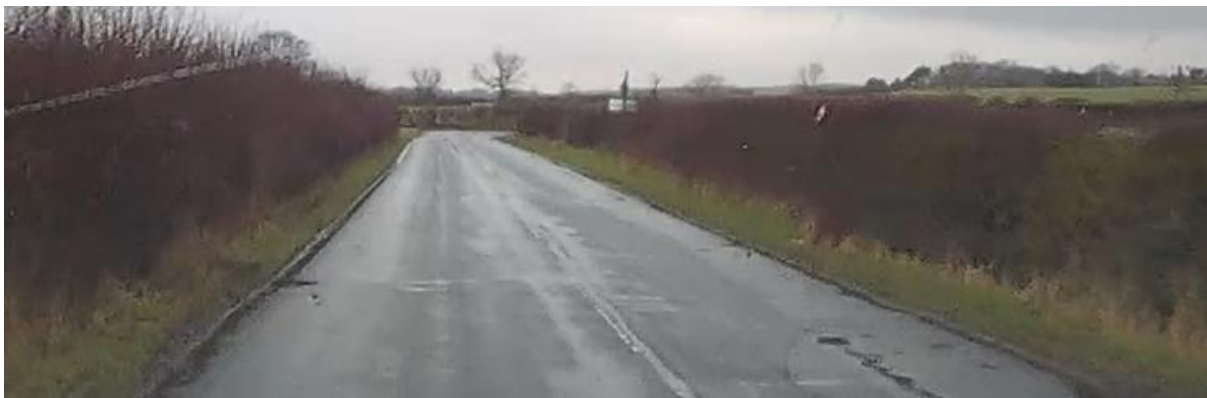
R4.27 Condition Score 0

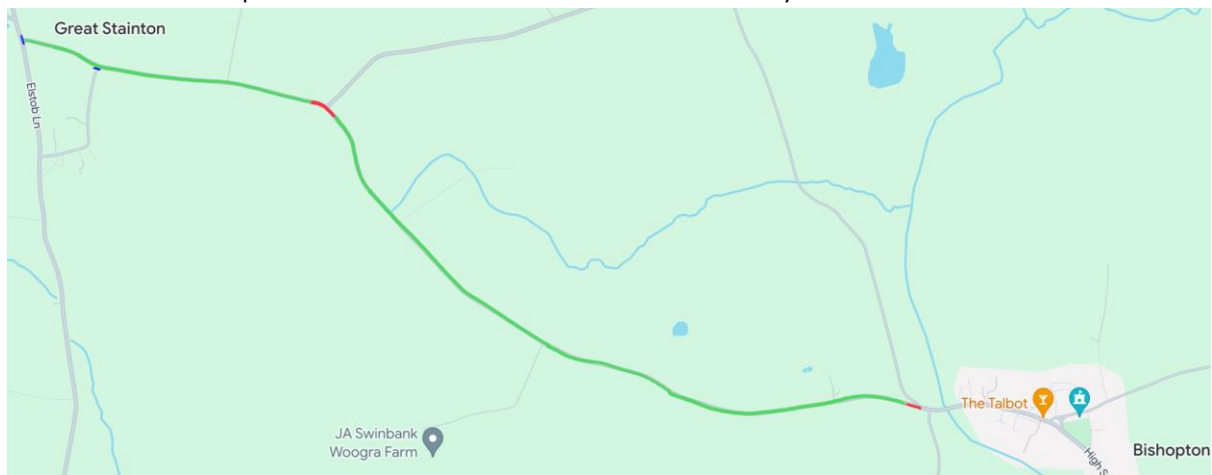
Summary Map – Line markings predominantly wear index Score 50 . Only very small sections have wear index score 0 (Critical defects) and require remedial action

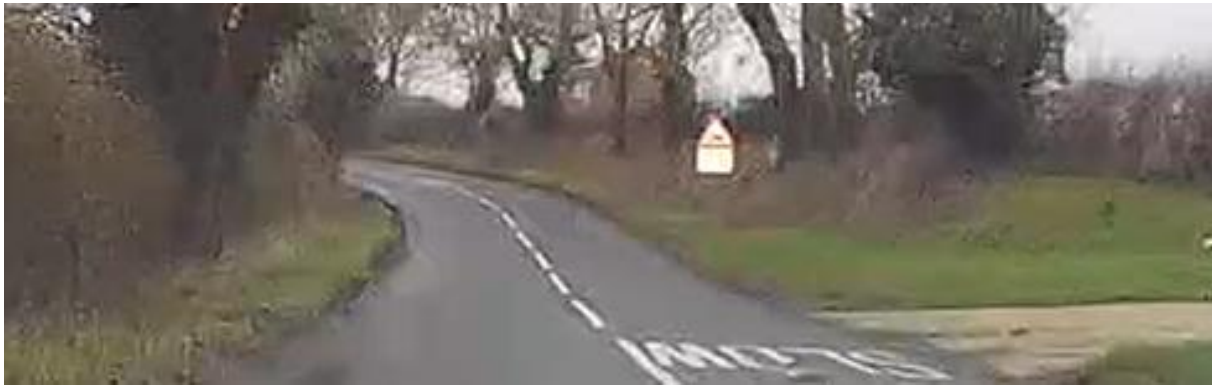
R5.3 - Condition Score 50

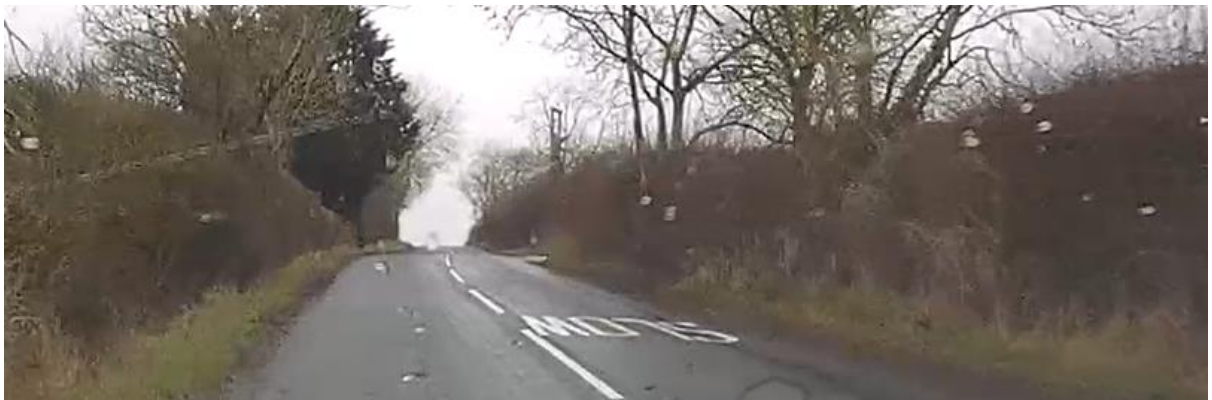
R5.4 - Condition Score 50

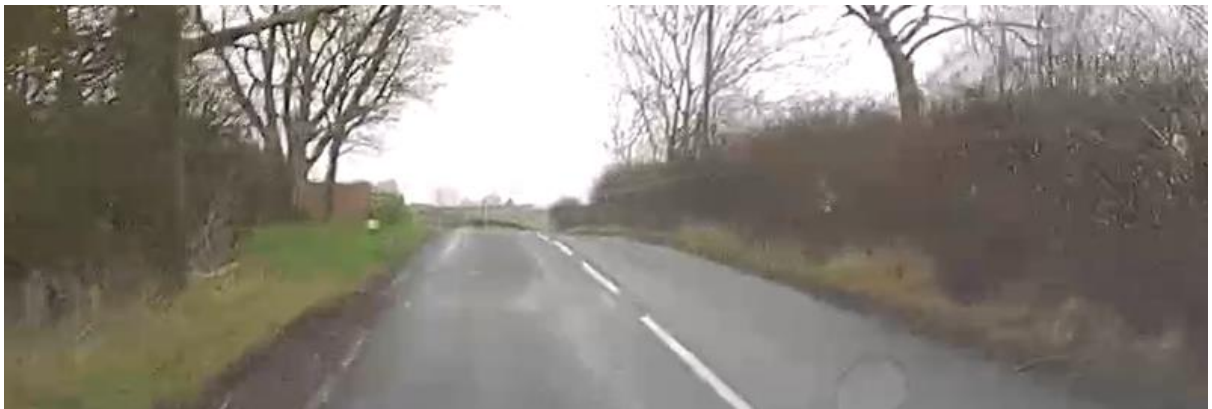
R5.5- Condition Score 50

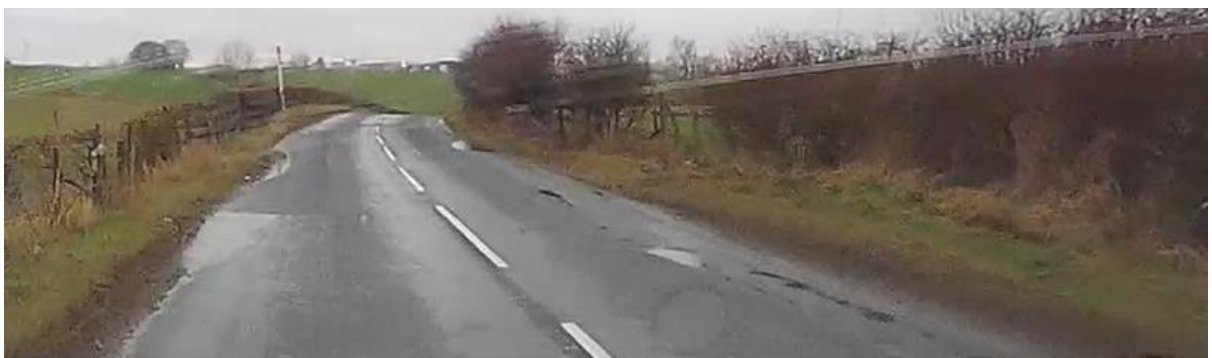
R5.6- Condition Score 50

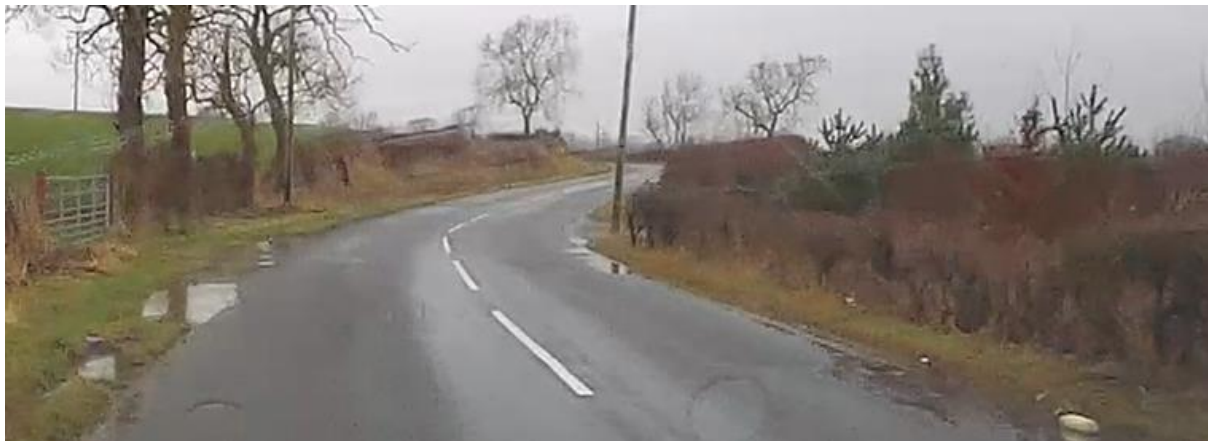
R5.7- Condition Score 50

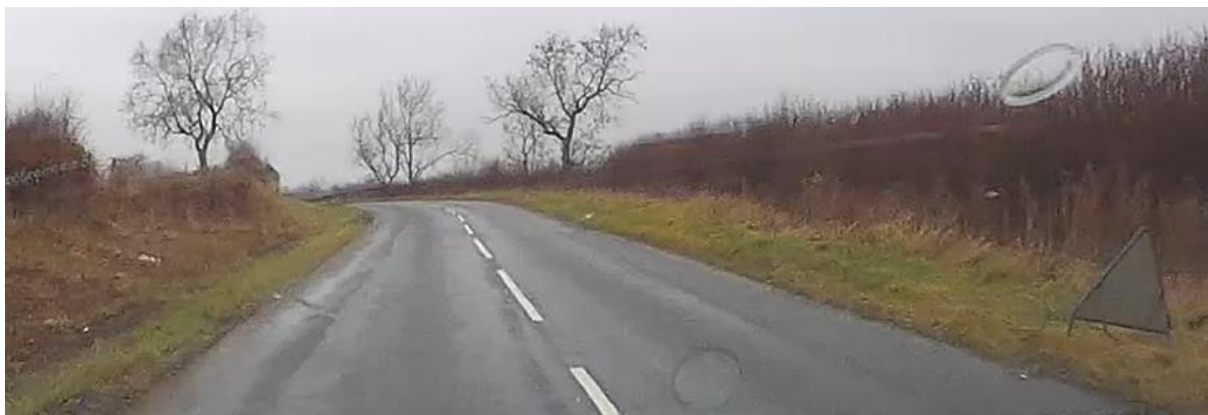
R5.8- Condition Score 50

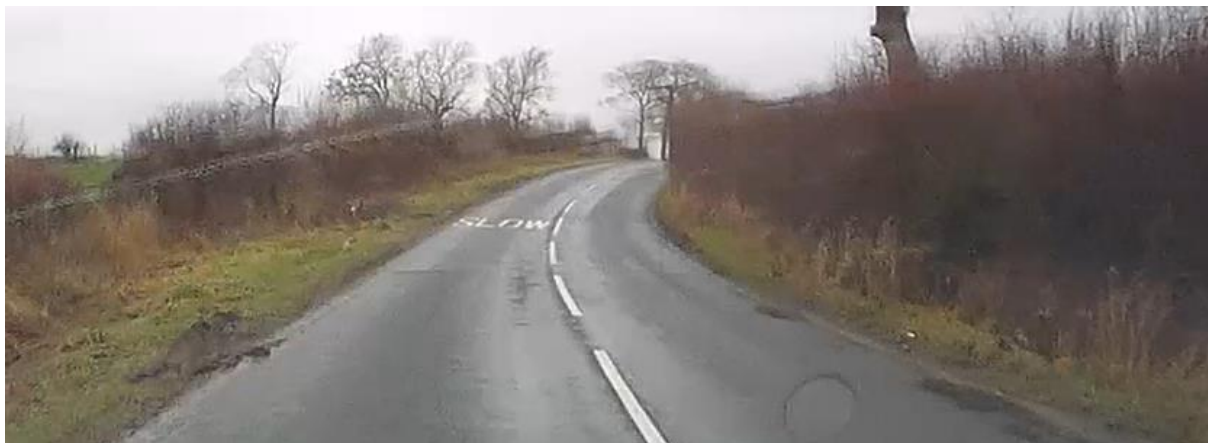
R5.9- Condition Score 50

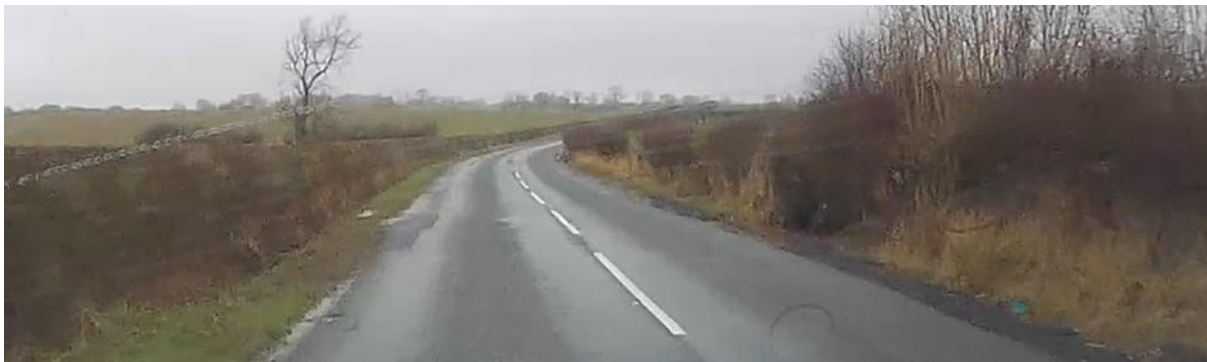
R5.11- Condition Score 50

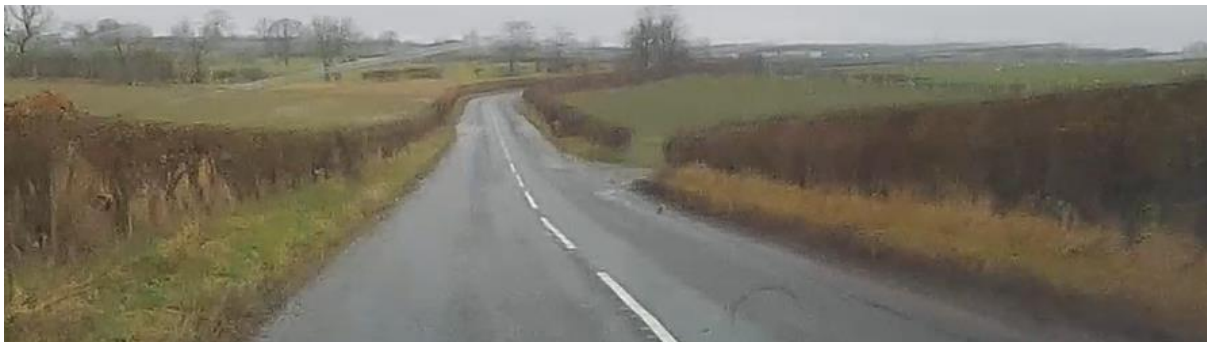
R5.12- Condition Score 50

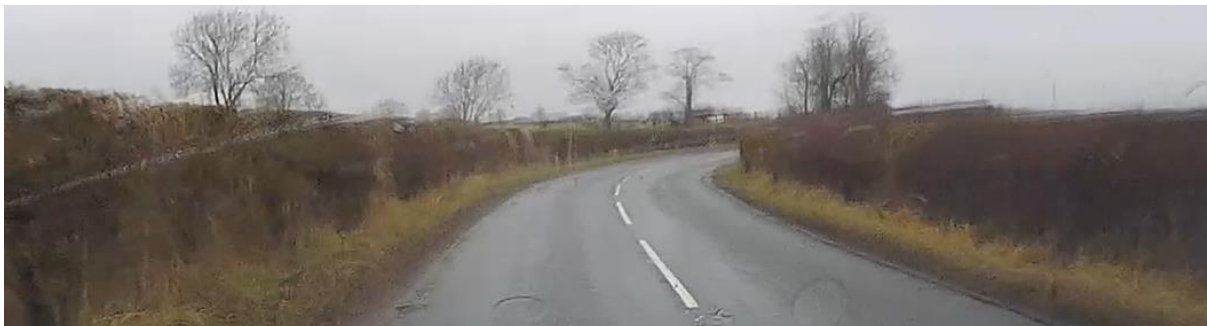
R5.13- Condition Score 50

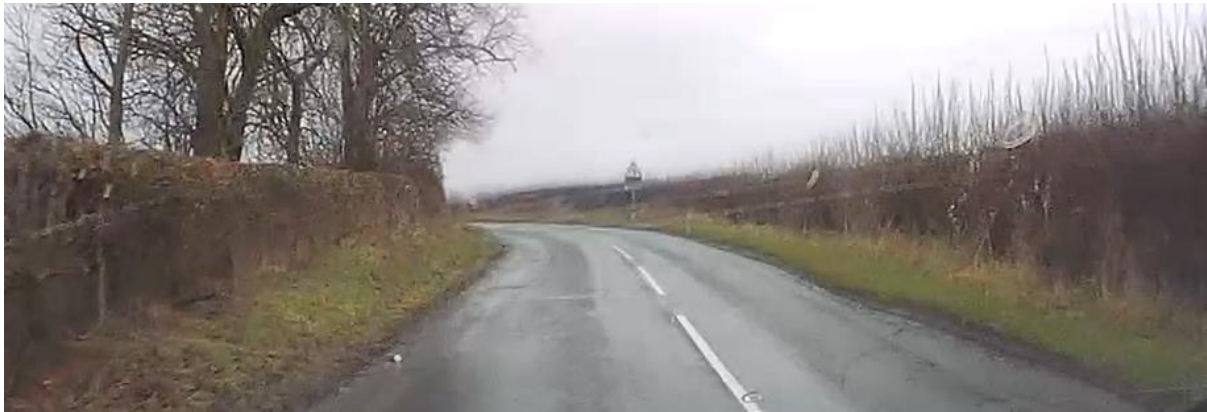
R5.14- Condition Score 50

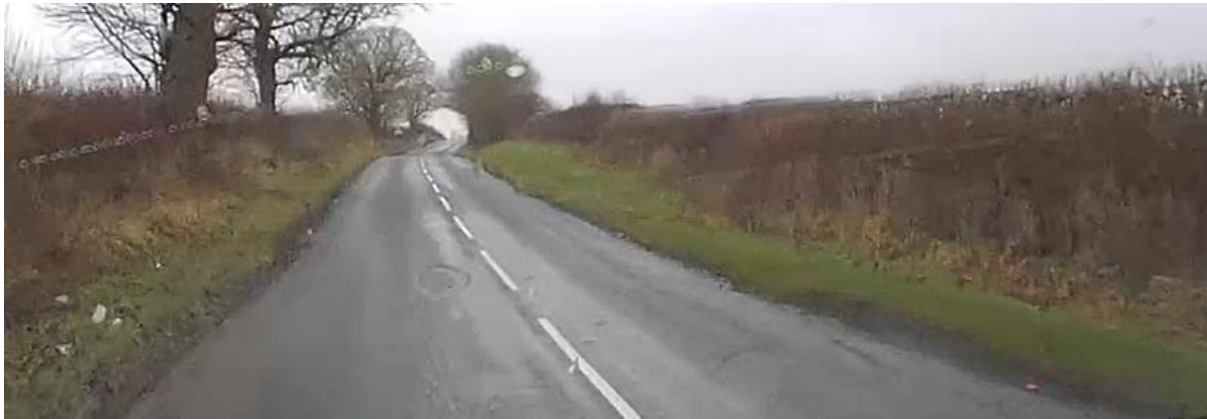
R5.21 - Condition Score 50

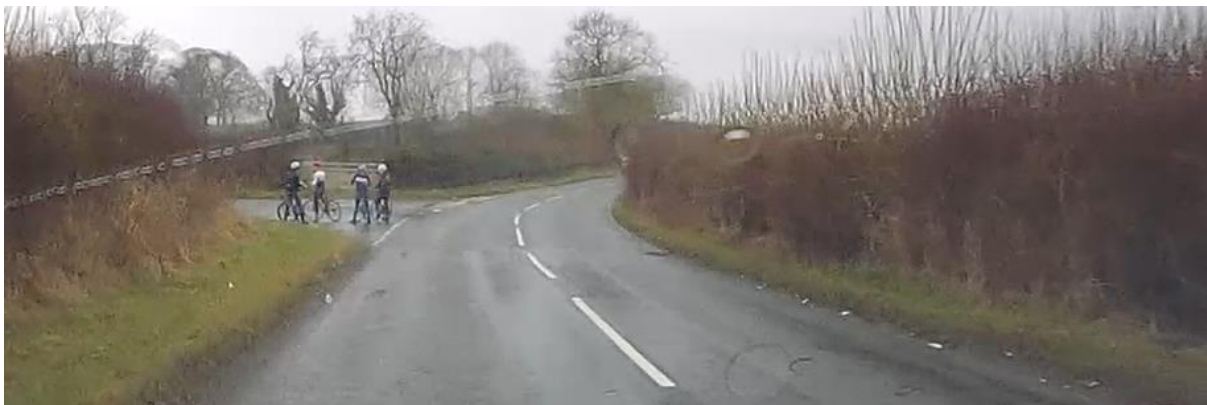
R5.23 - Condition Score 50

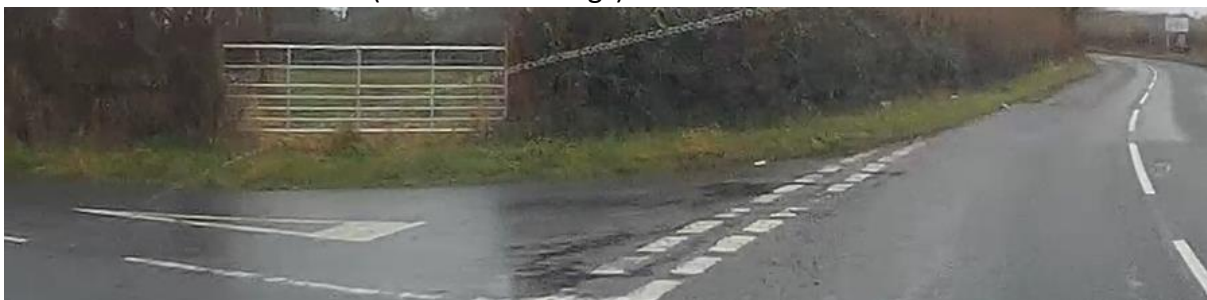
R5.23a - Condition Score 40 (Junction markings)

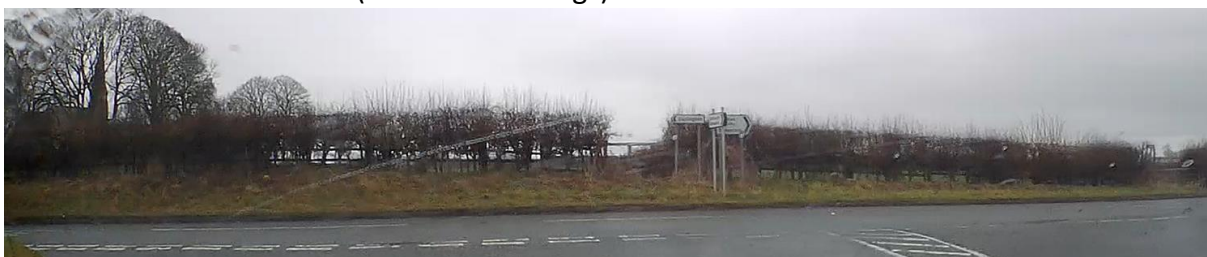
R5.27 - Condition Score 40 (Junction markings)

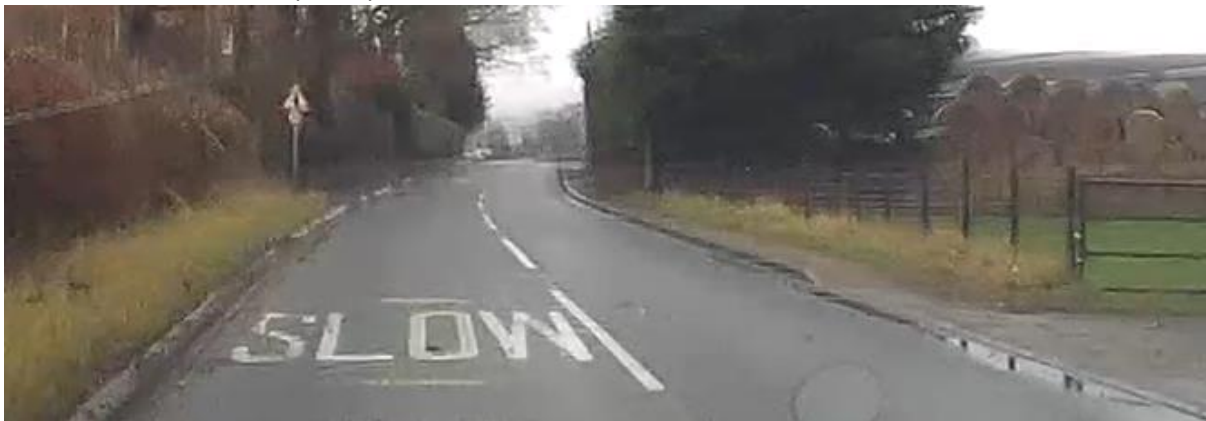
- R6.5 – Condition 0 (road shoulder ,markings))
Condition 30 (slow
Condition 40 (Lines)
