**Road Line Marking Assessment Report Covering Darlington
Borough Council Road Infrastructure Surrounding Bishopton
Parish Council Area.
Document Reference BPC/1/24/001**

This report has been written with reference to **CS 126 Inspection and assessment of road markings and road studs (formerly TD 26/17) Version 0.1.0**

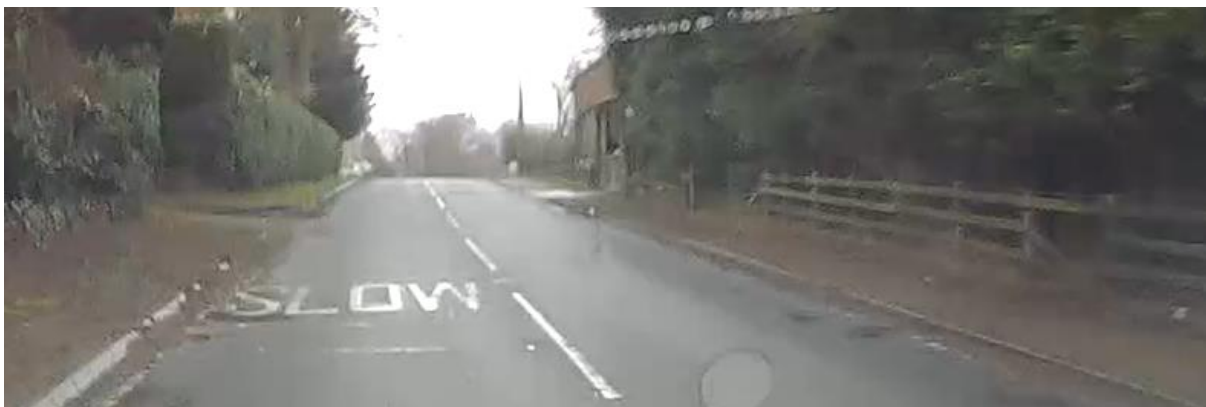
- R6.6 – Condition 0 (road shoulder ,markings))
Condition 40 (slow
Condition 40 (Lines)

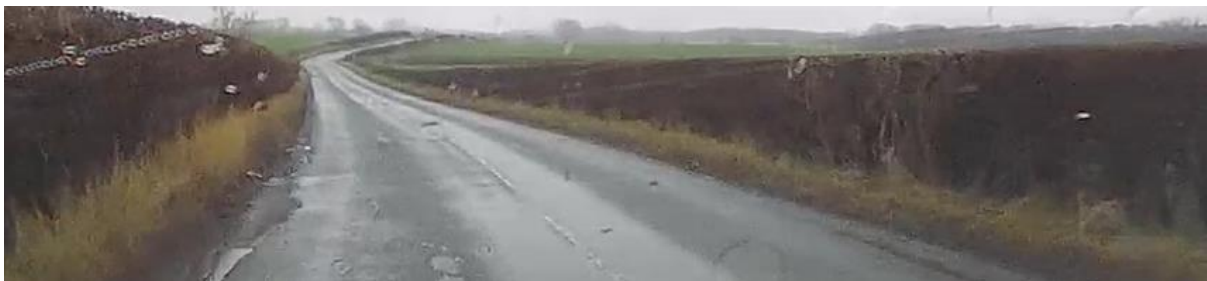
R6.17 – Condition 10

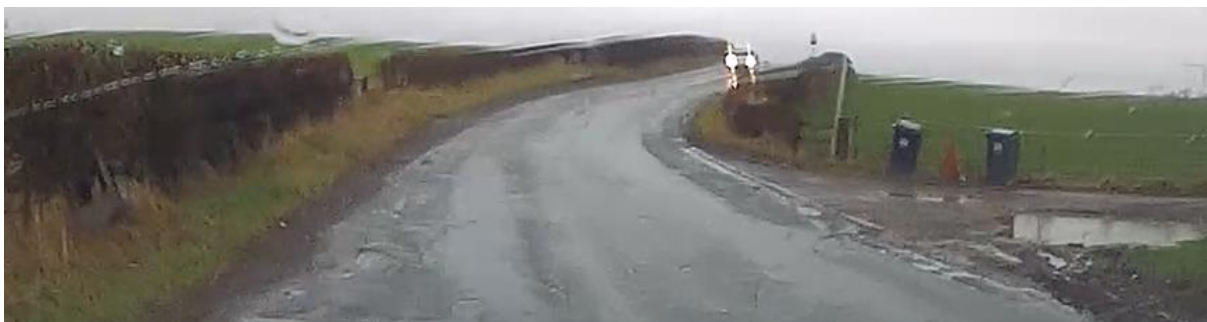
R6.19 – Condition 0

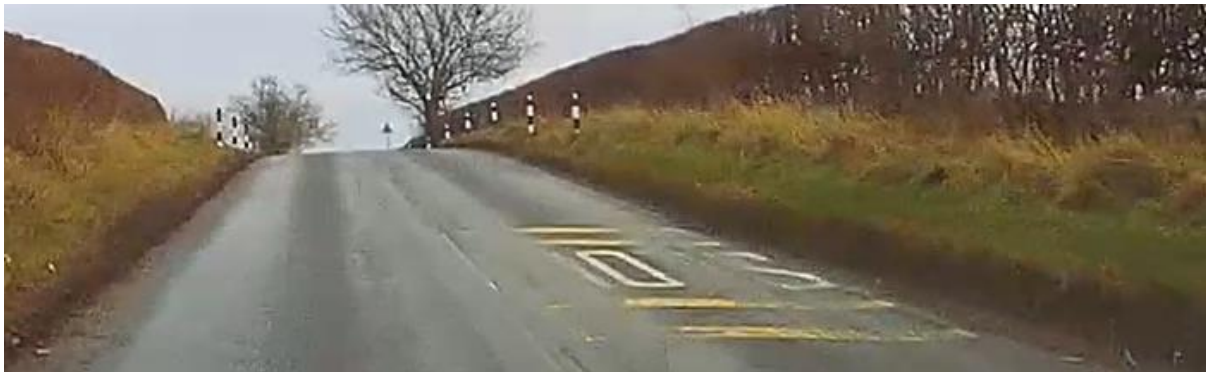
R7.9 – Condition 0 (line)
Condition 10 (slow)

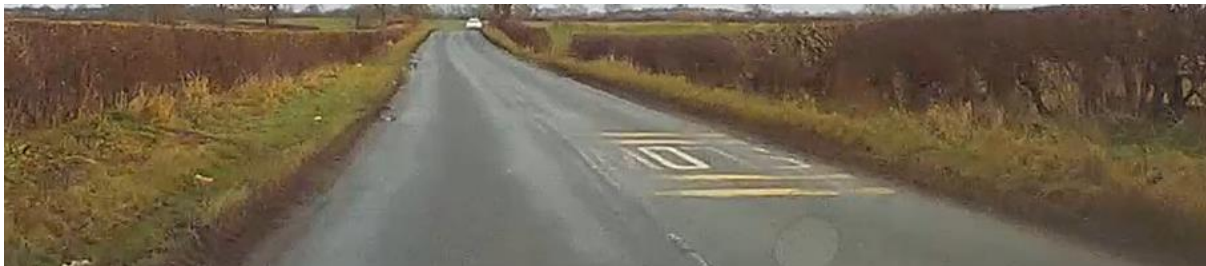
R7.10 – Condition 0 (line)
Condition 20 (slow)

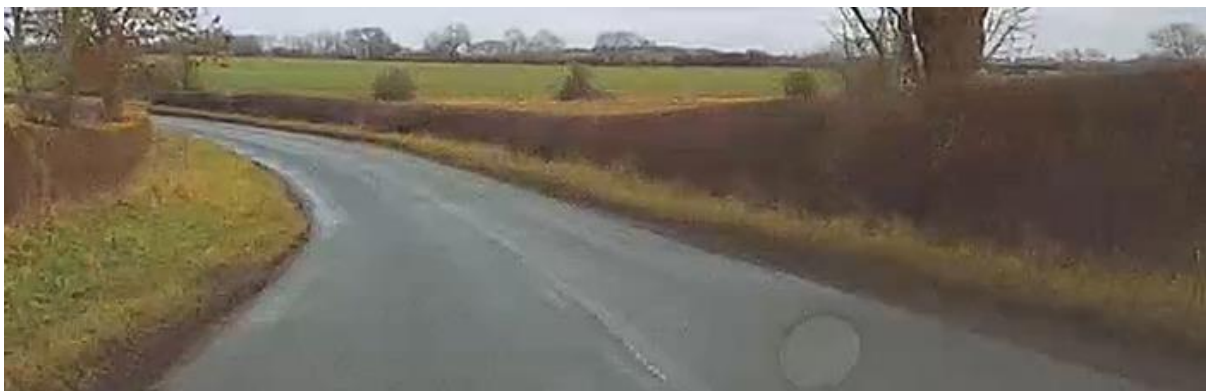
R7.11 – Condition 0

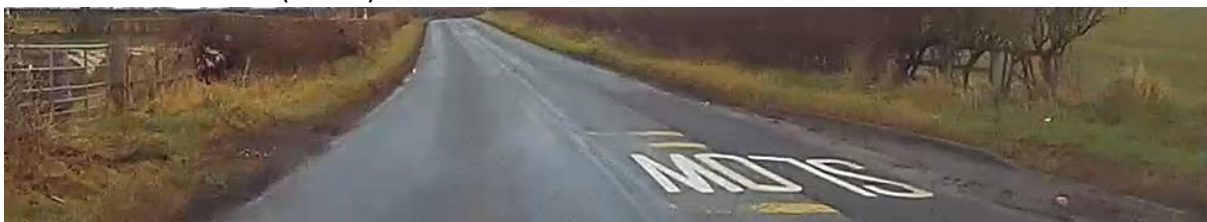
R7.15 – Condition 0 (LINE)
Condition 50 (SLOW)

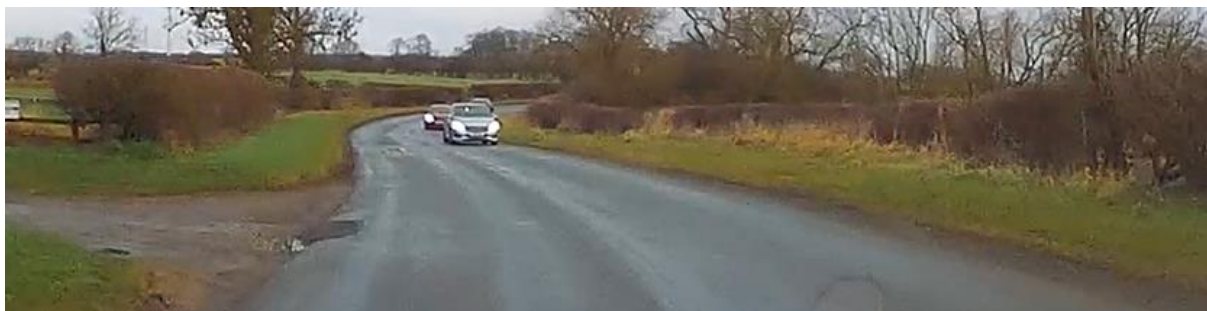
R7.17 – Condition 0

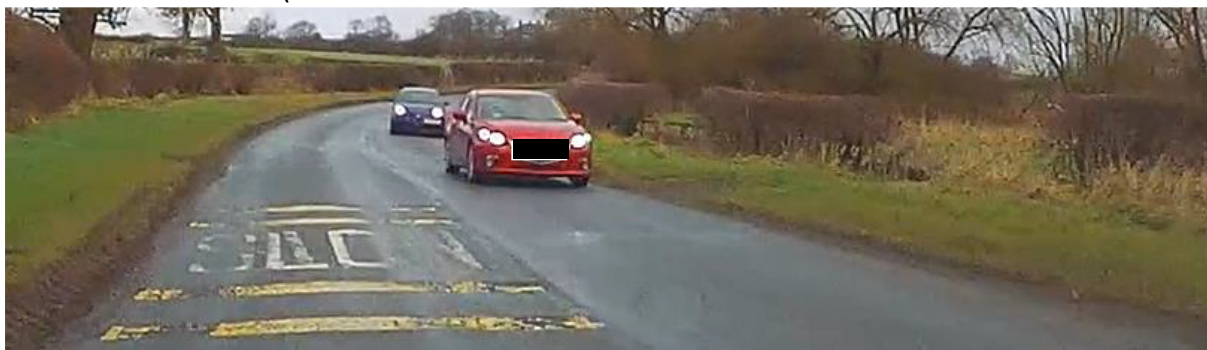
R7.18 – Condition 0 (LINE)
Condition 20 (SLOW)

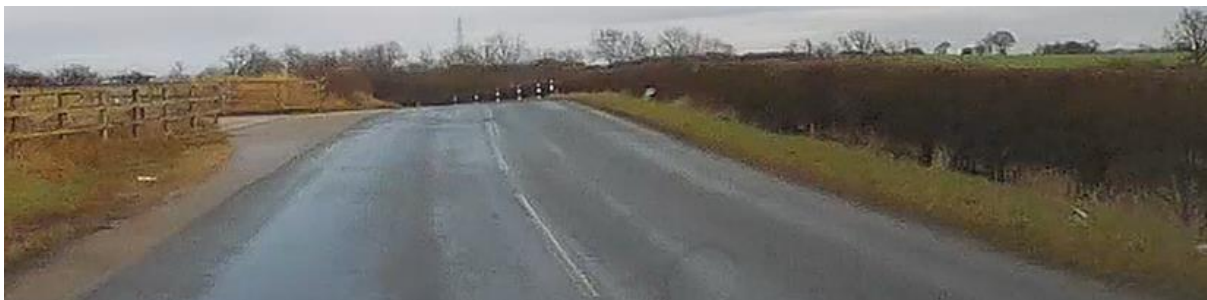
R7.39 – Condition 0

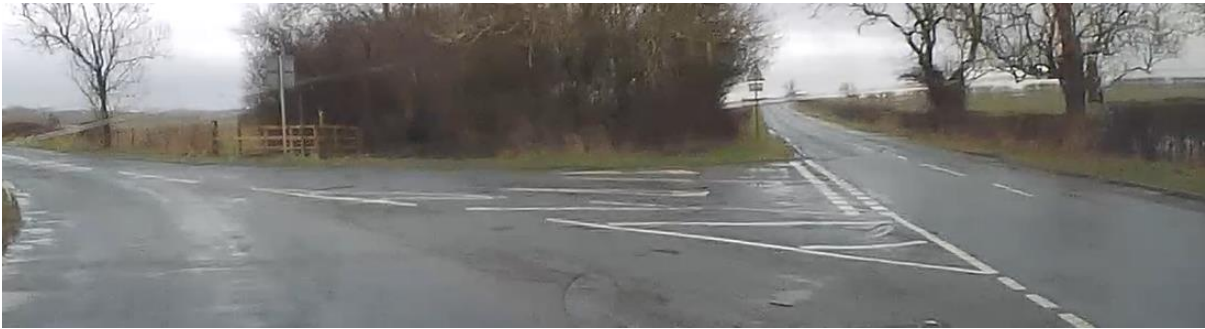
R8.1 – Condition 50 (Junction LINES)

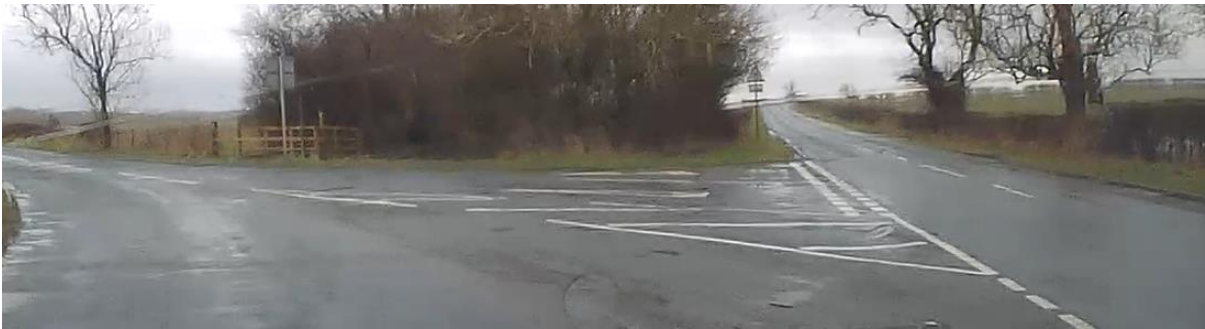
R8.2 – Condition 50 (Junction LINES)

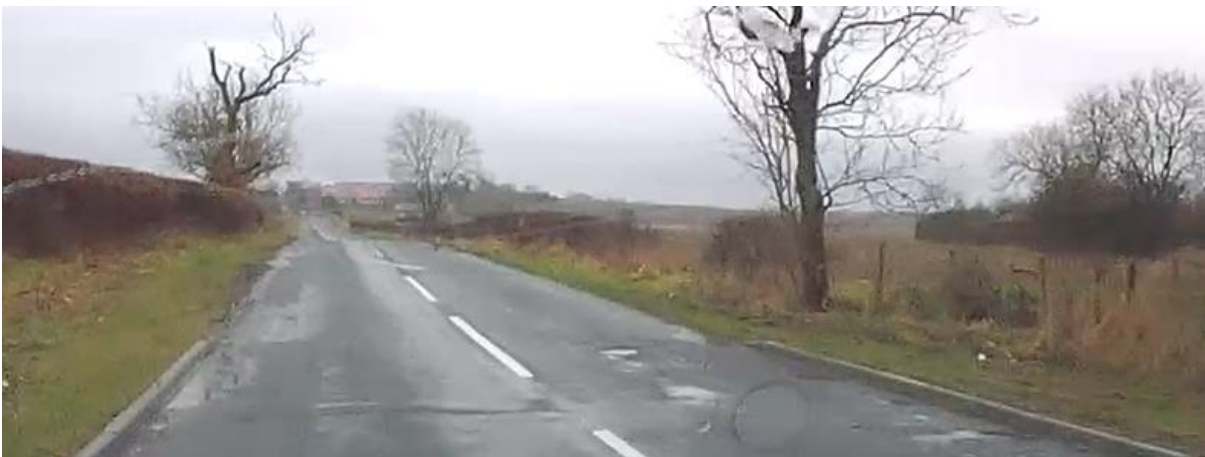
R8.3 – Condition 50

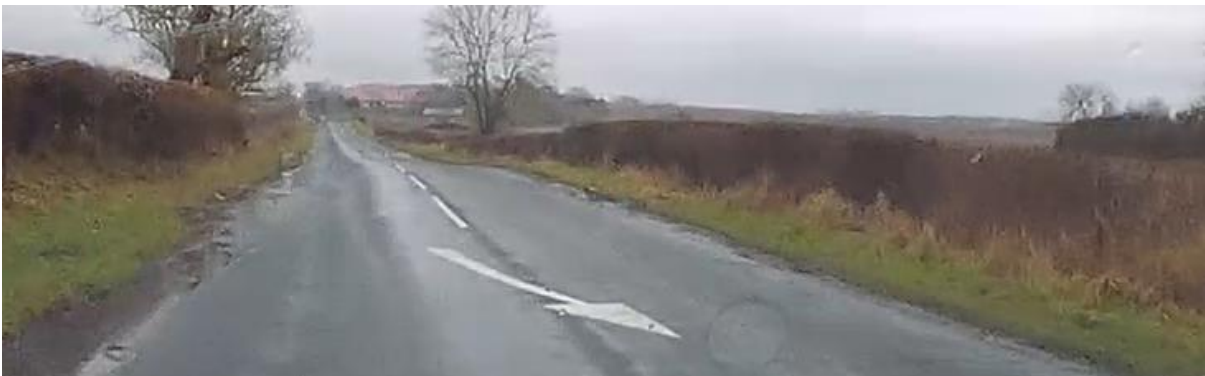
R8.4 – Condition 50

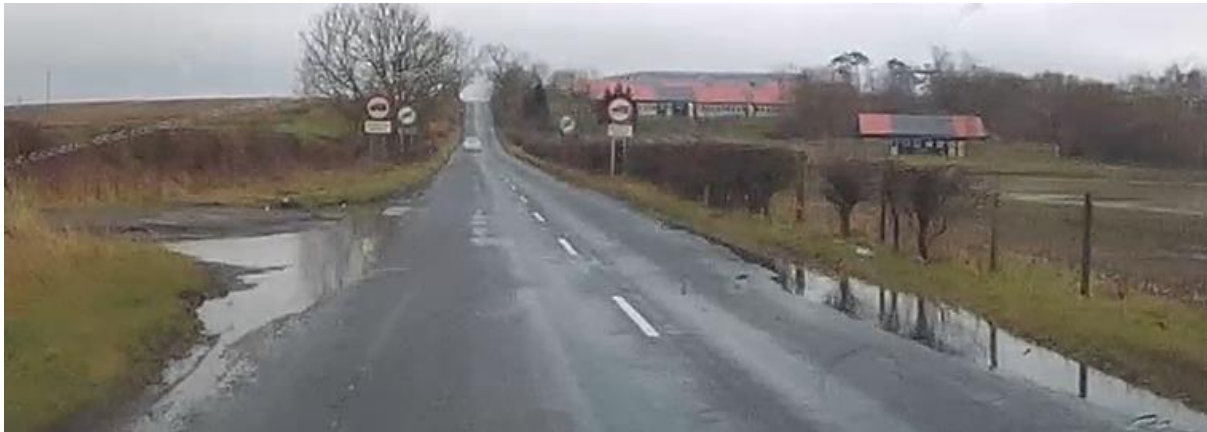
R8.8– Condition 50

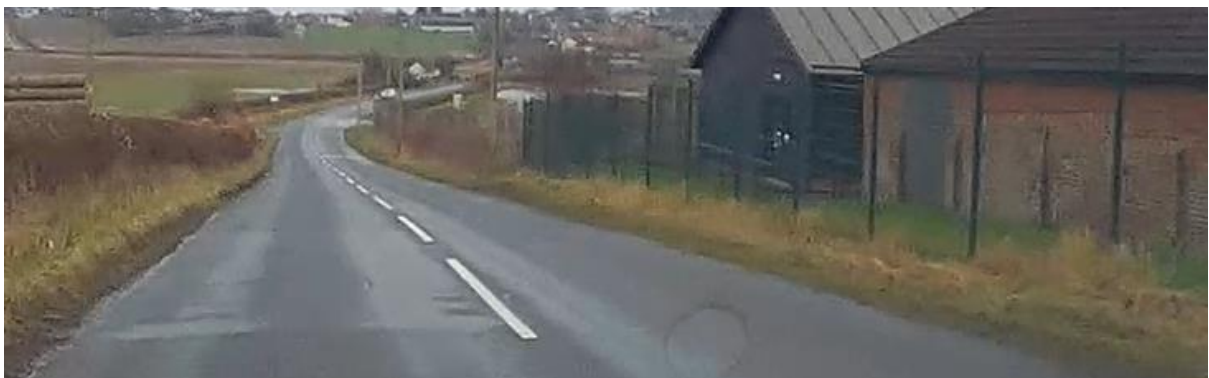
R8.12– Condition 50

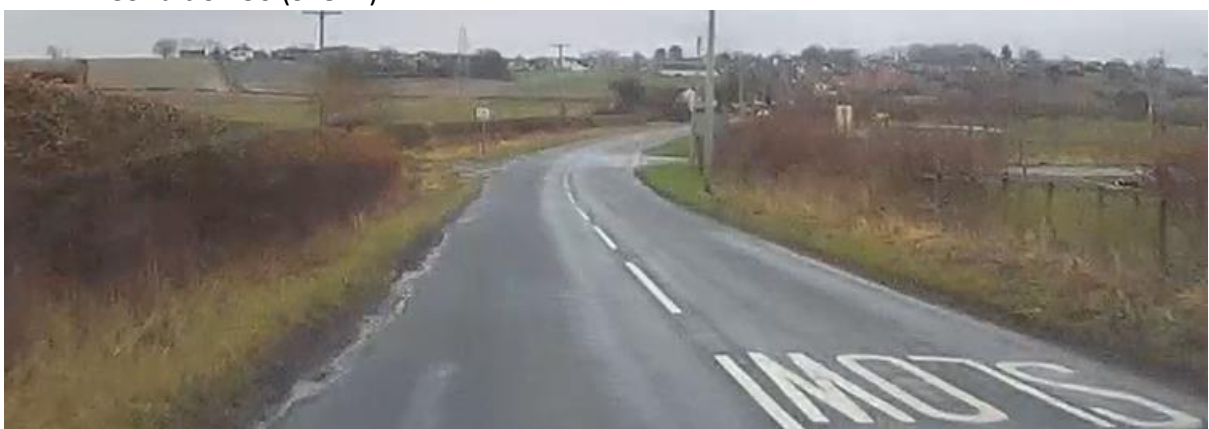
R8.13 – Condition 50 (LINES)
Condition 50 (SLOW)

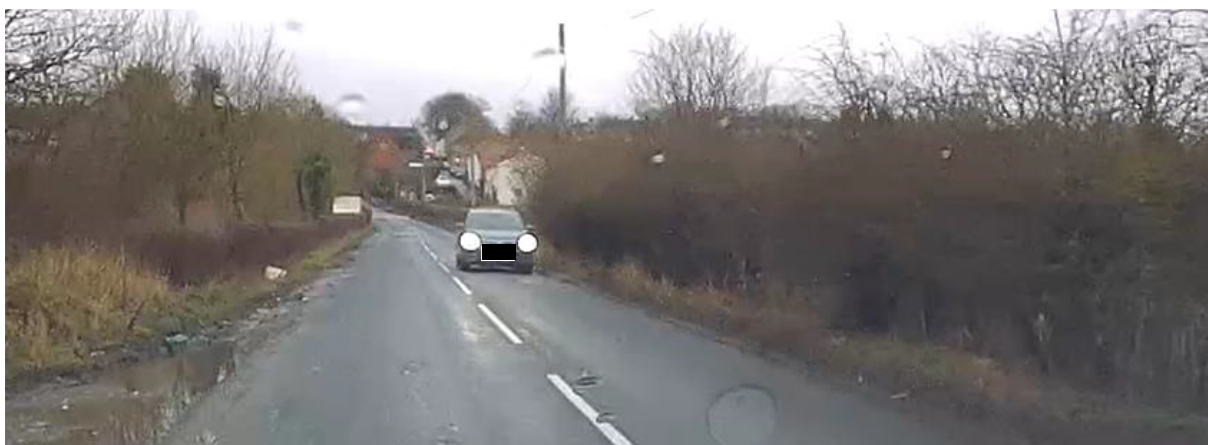
R8.22 – Condition 50

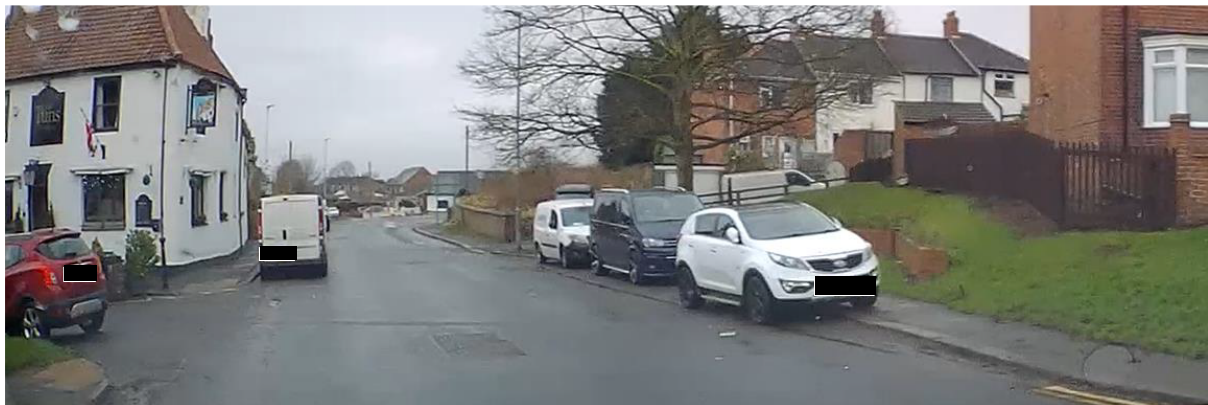
R9.1 - Condition 0

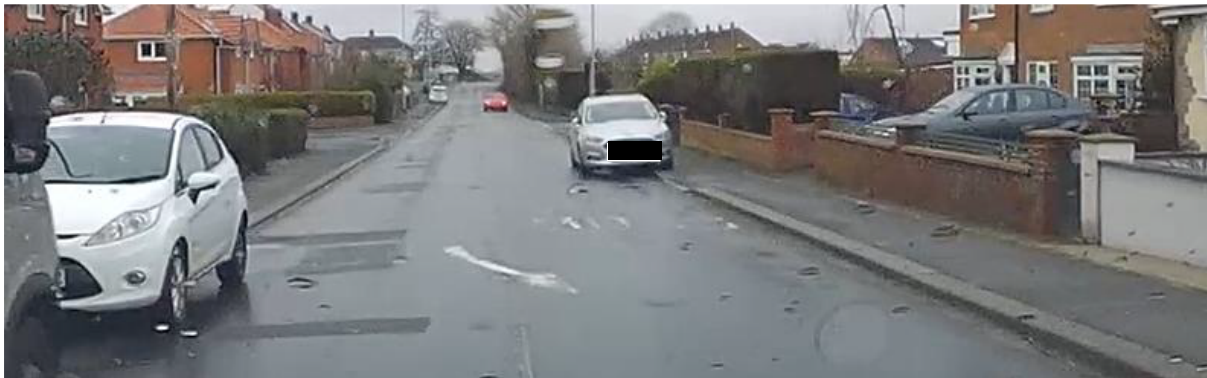
**R9.5 – Condition 0 (Lines)
Condition 10 (Arrow)
Condition 10 (SLOW)**

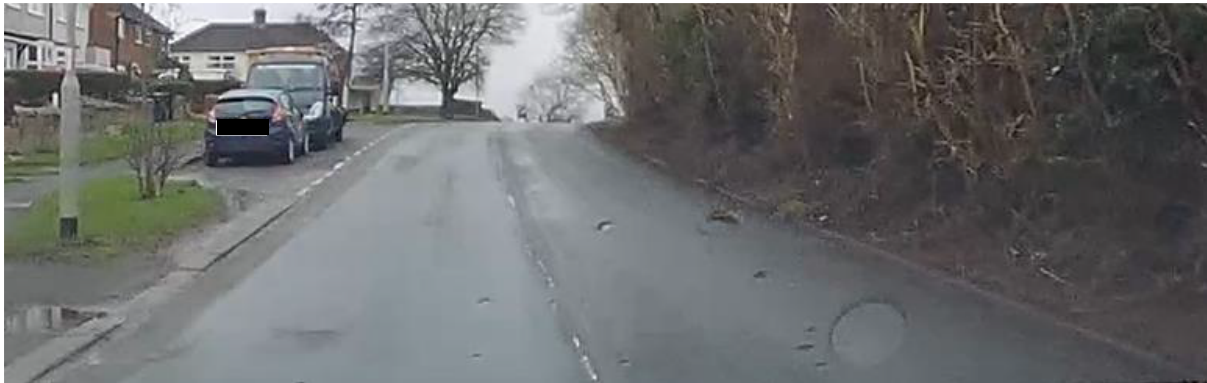
R9.8 – Condition 0

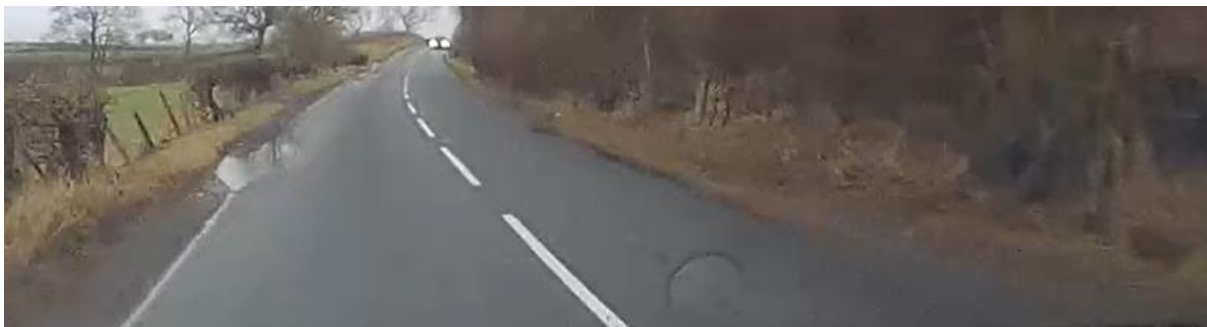
R9.17 – Condition 50

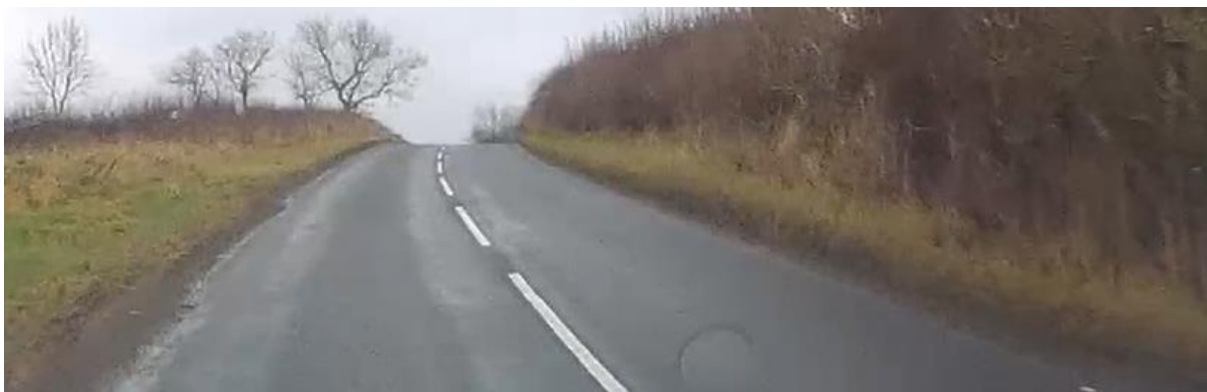
R9.18 – Condition 50

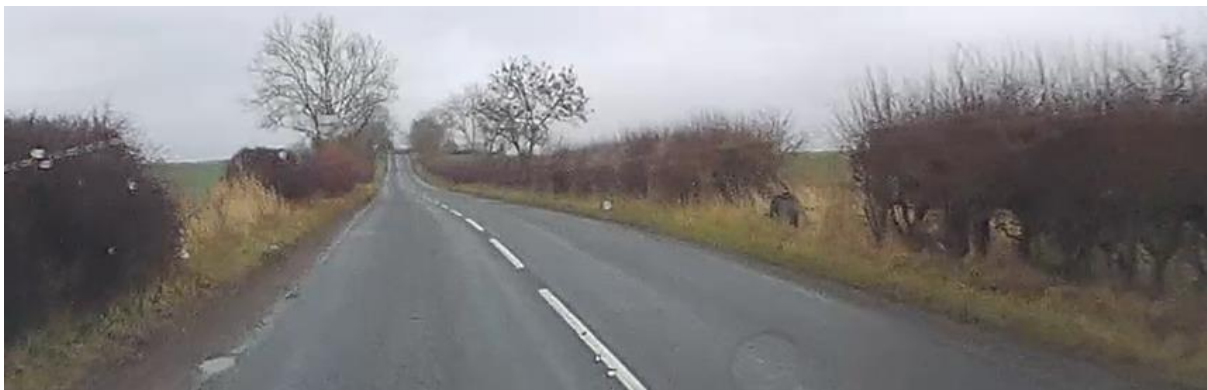
R9.19 – Condition 50

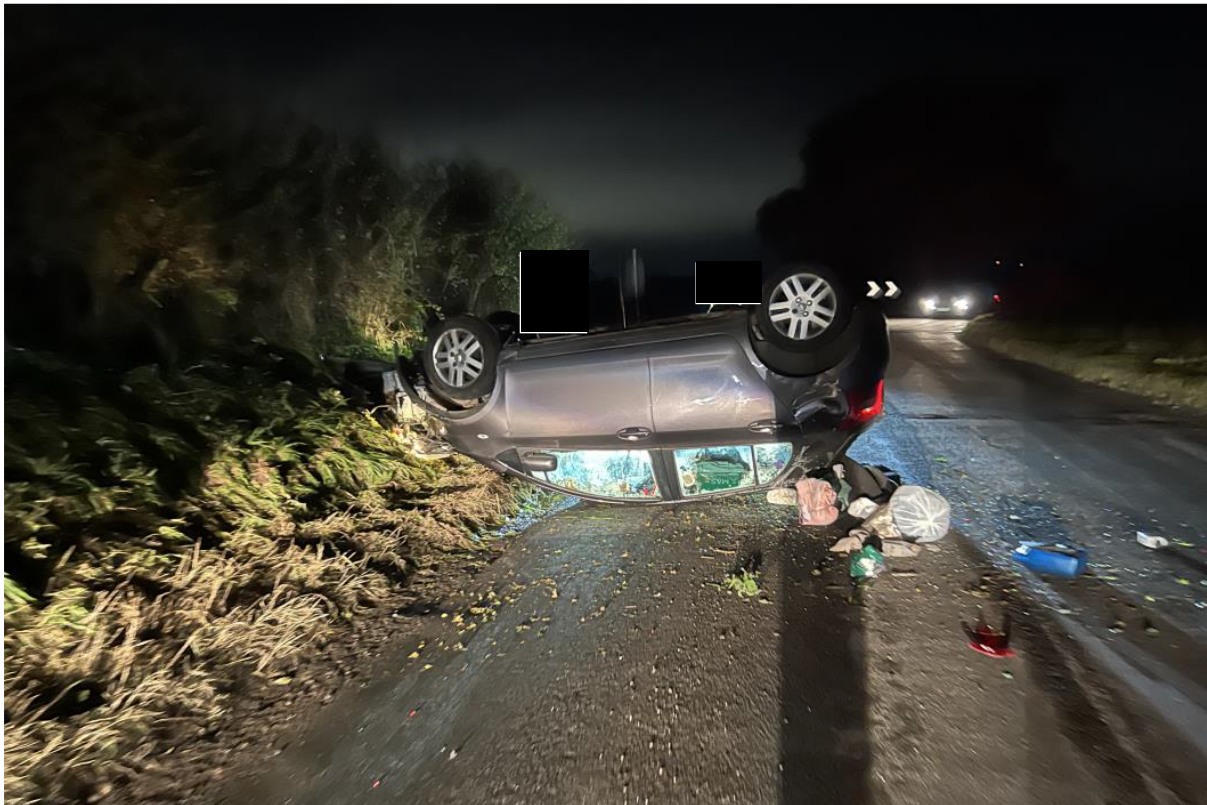
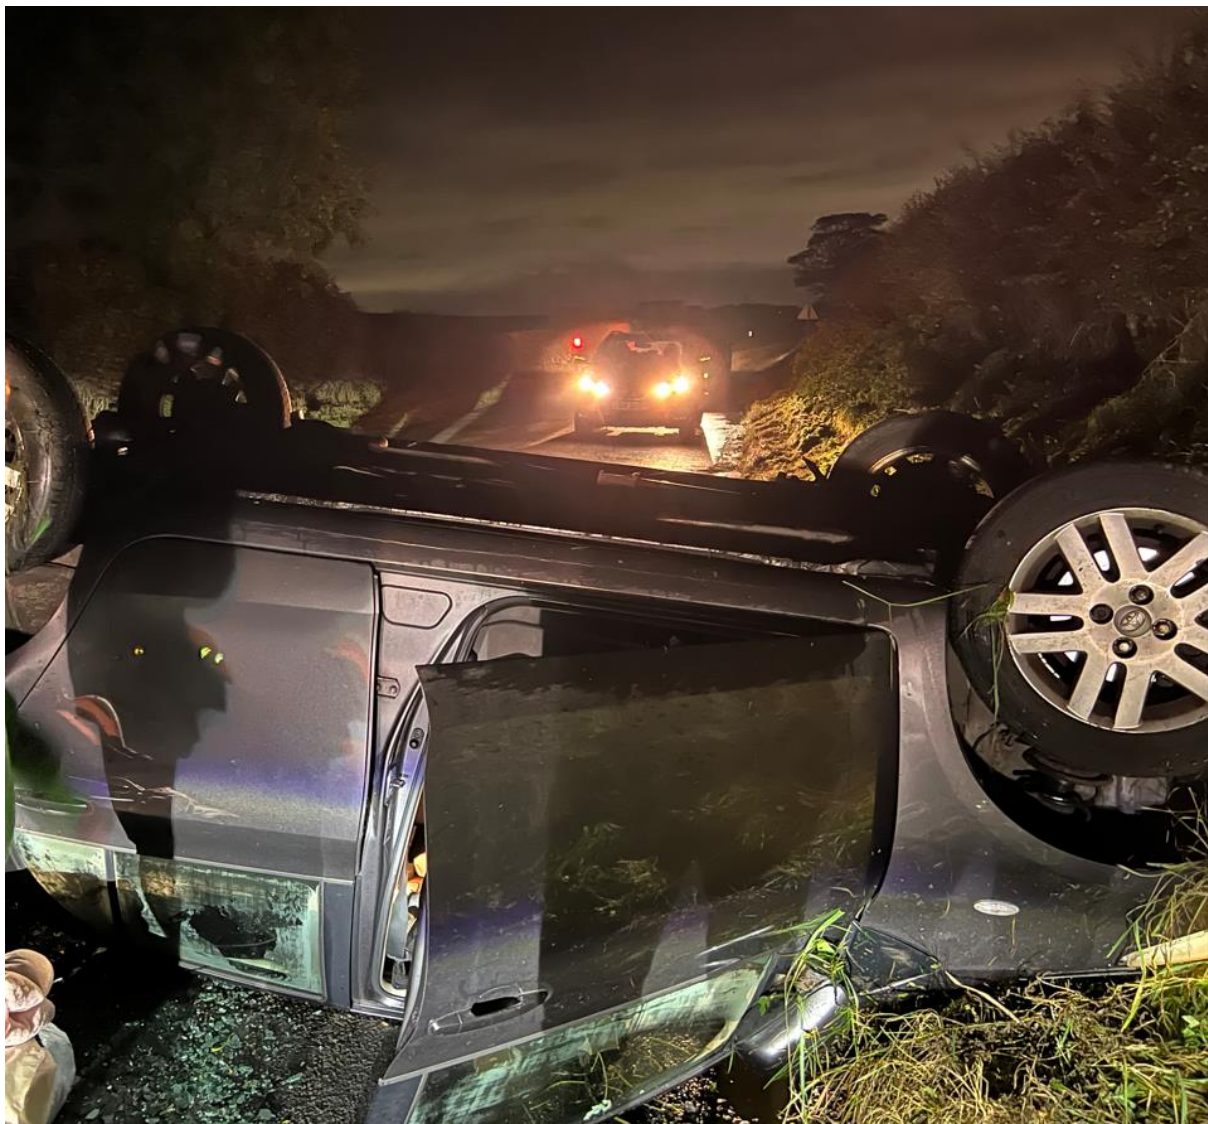
A Vehicle leaving Bishopton via Highstreet and failed to negotiate the bend onto Redmarshall Road On scene when questioned what happened the driver stated 'she couldn't see which way the road went'

RTI date 31.10.23 approx 1800hrs.

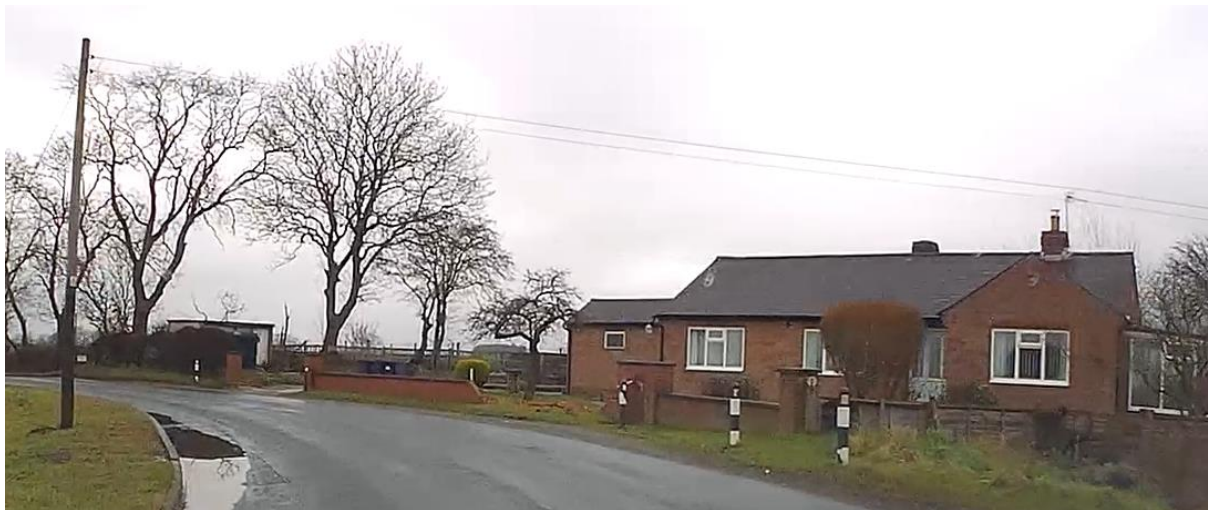
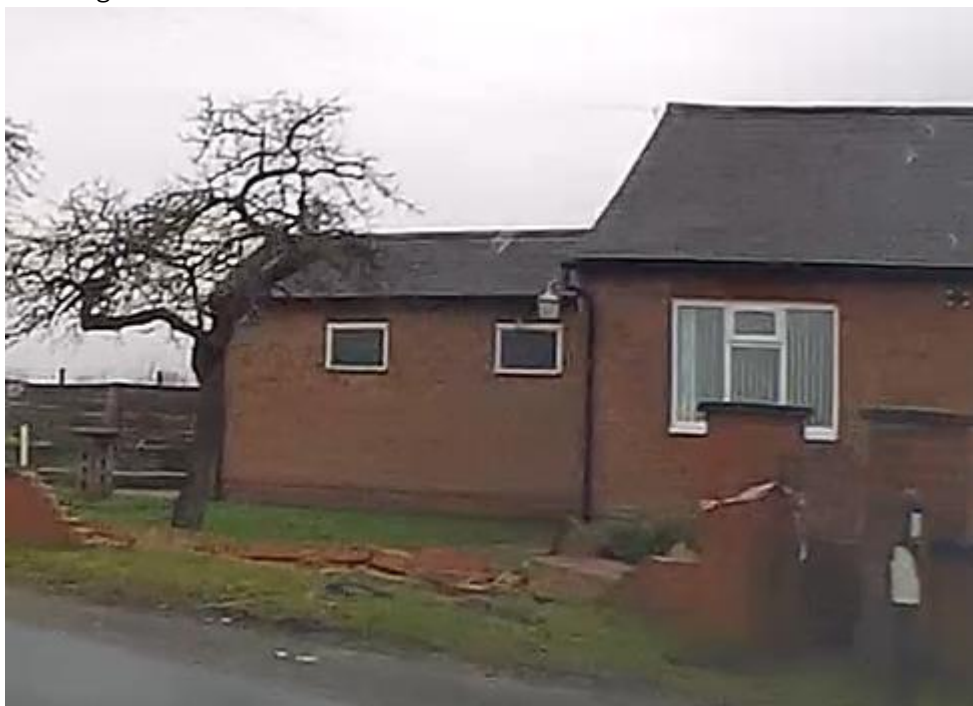
R1 image 7

This RTI is associated with (R1.18 road survey image)

Road markings categorised as Critical may well be a contributing factor to this RTI.

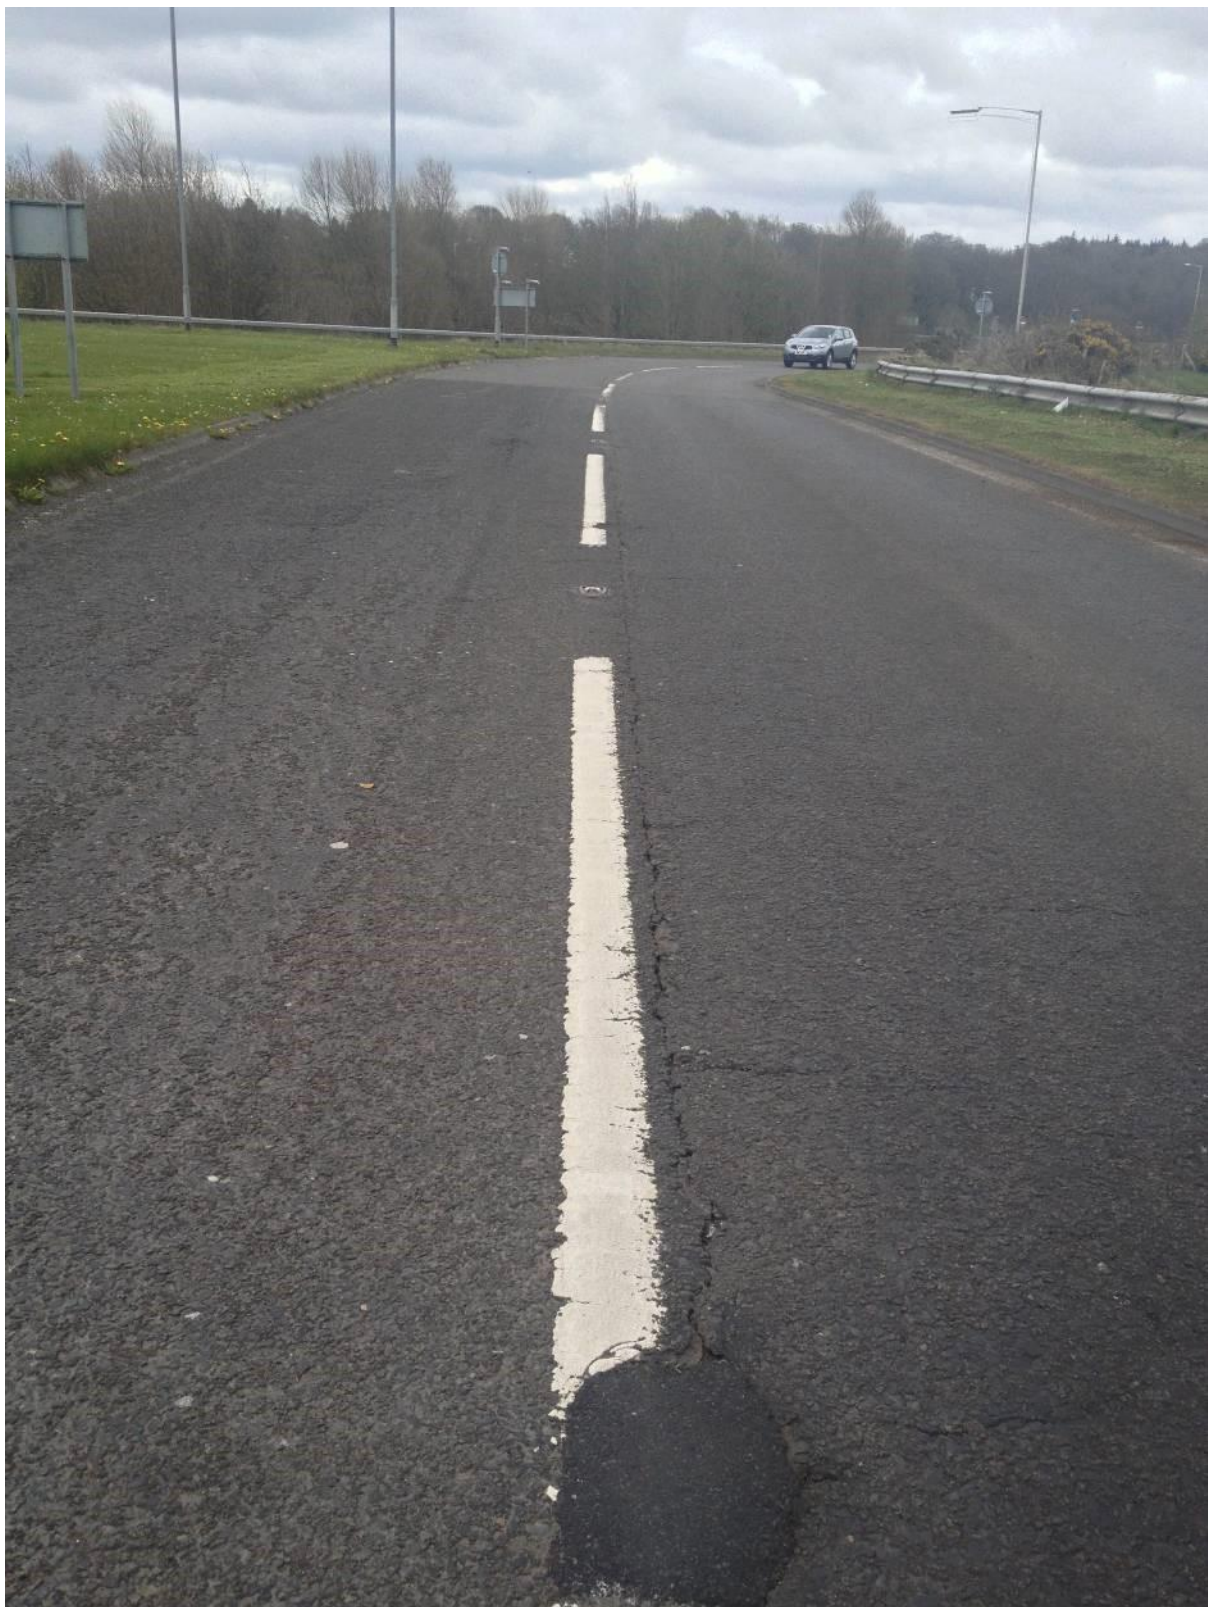
Figure C.5 Condition score 40 – long view

Note - although not ideal, the surface patch repair being at the end of the marking will be unlikely to have an effect on road user understanding, but may in time become a surfacing hazard, particularly for motorcyclists.
