**Road Line Marking Assessment Report Covering Darlington
Borough Council Road Infrastructure Surrounding Bishopton
Parish Council Area.
Document Reference BPC/1/24/001**

Document Reference	Revision	Date
BPC/1/24/001A	First issue Rev A (DRAFT internal Only)	14.01.2024
BPC/1/24/001B	Formal Issue Rev B	04.02.2024

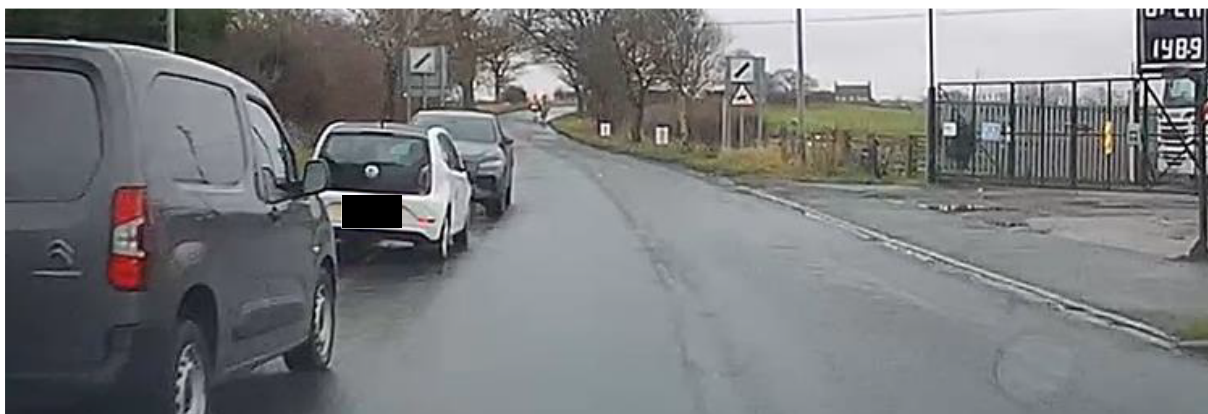
R1.4 – Condition score 0

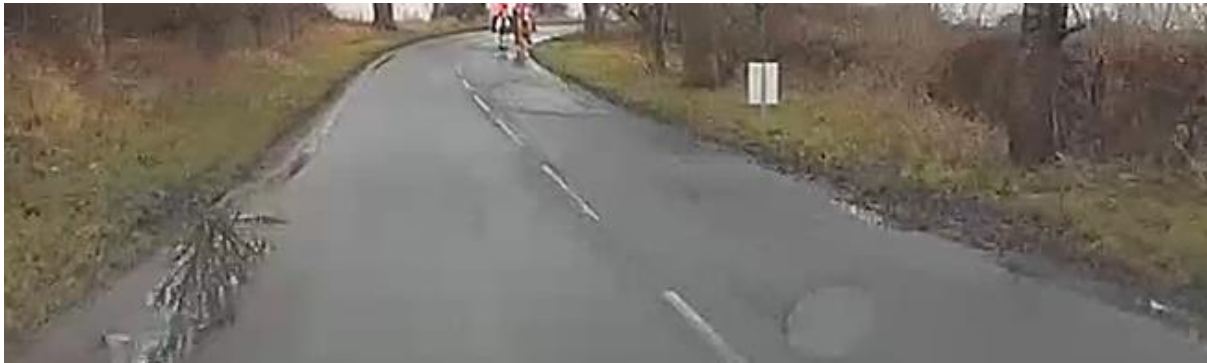
R1.5 – Condition score 10

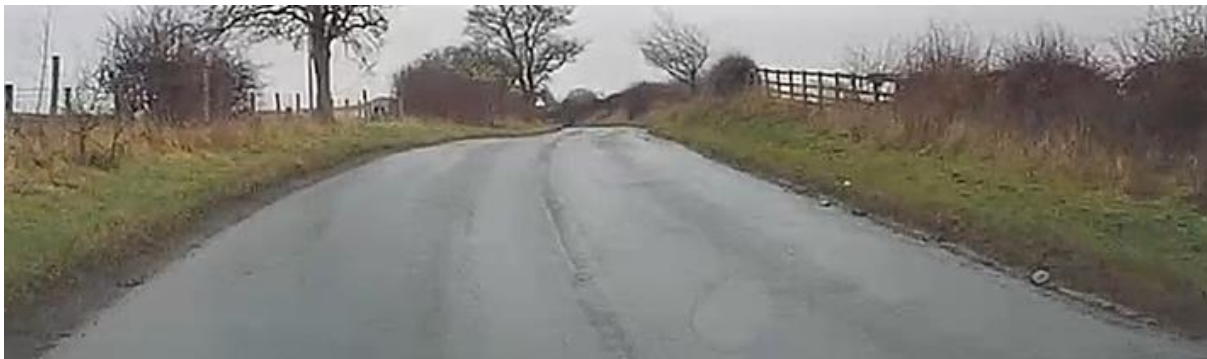
R1.5 – Condition score 0

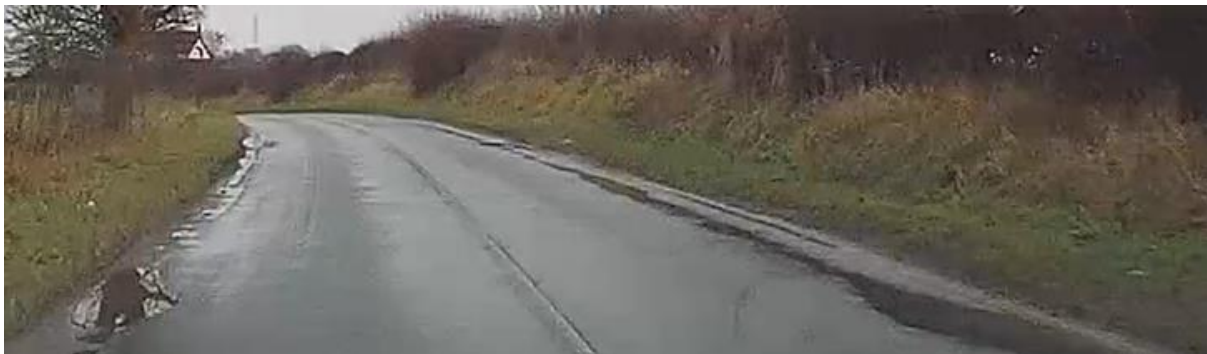
R1.6 – Condition score 0

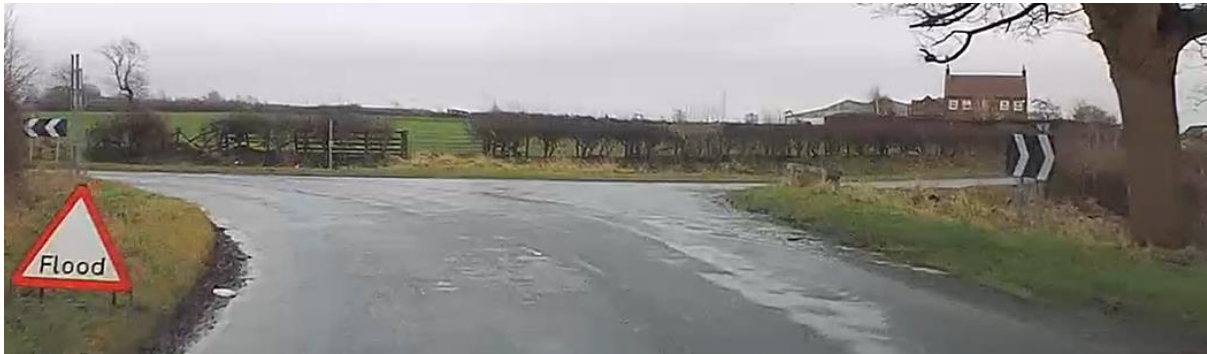
R1.7 – Condition score 0 (Junction lines also 0) **Location of recent RTI See Appendix B**

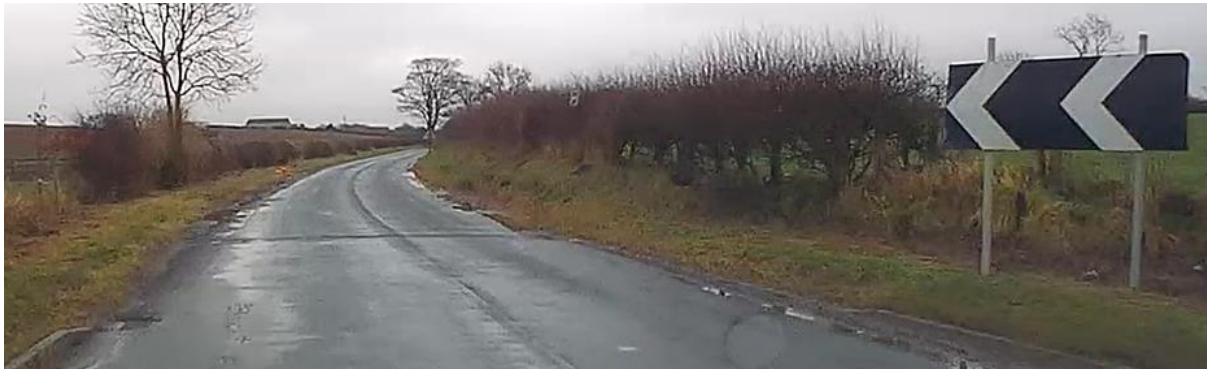
R1.8 – Condition score 0 **Location of recent RTI See Appendix B**

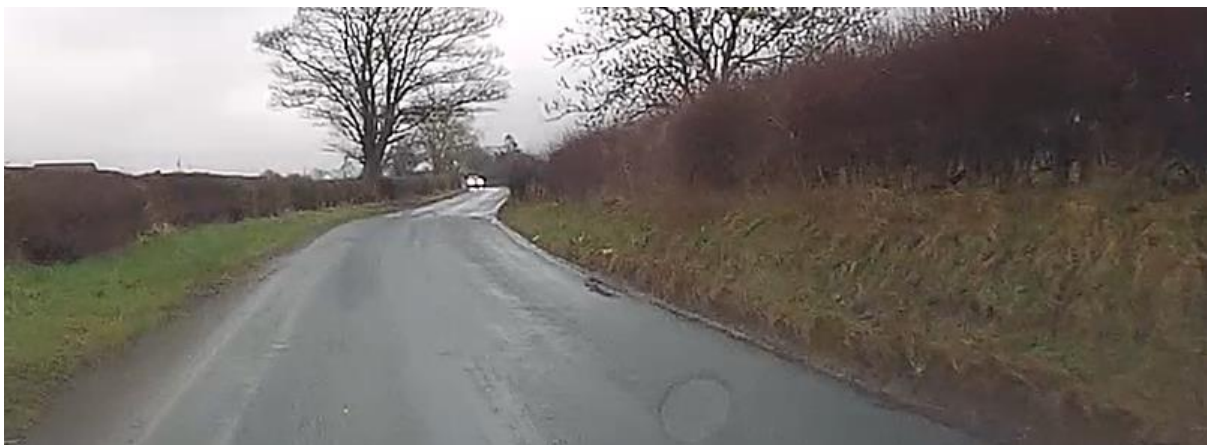
R1.9 – Condition score 0

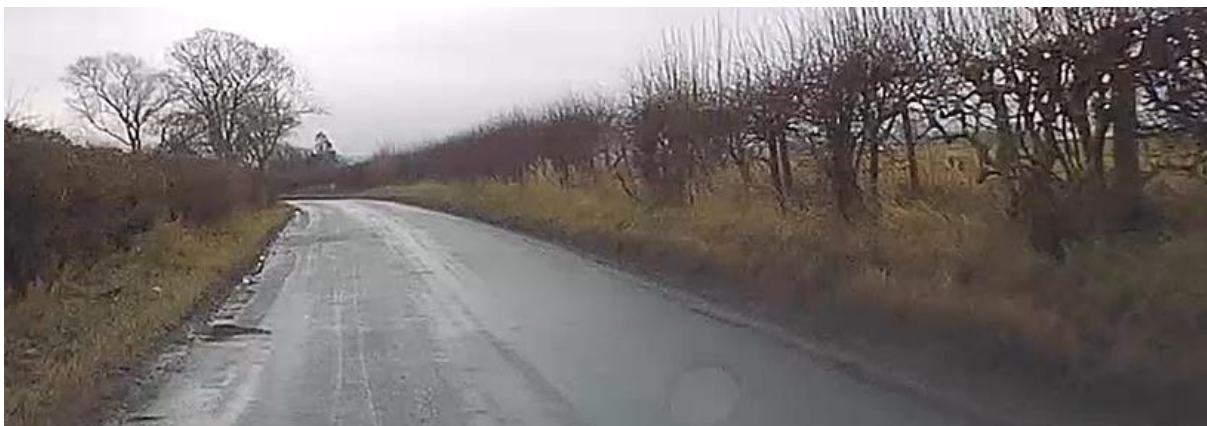
R1.10 – Condition score 0

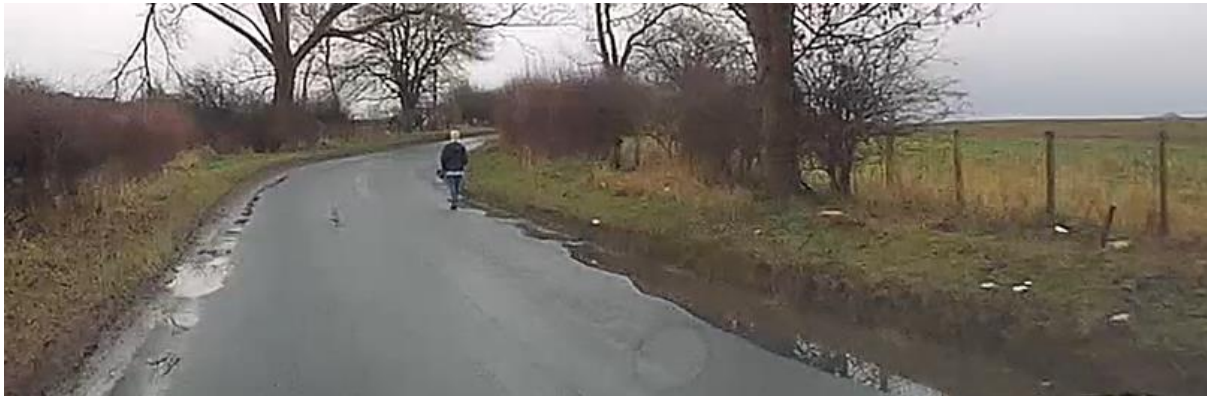
R1.11 – Condition score 0

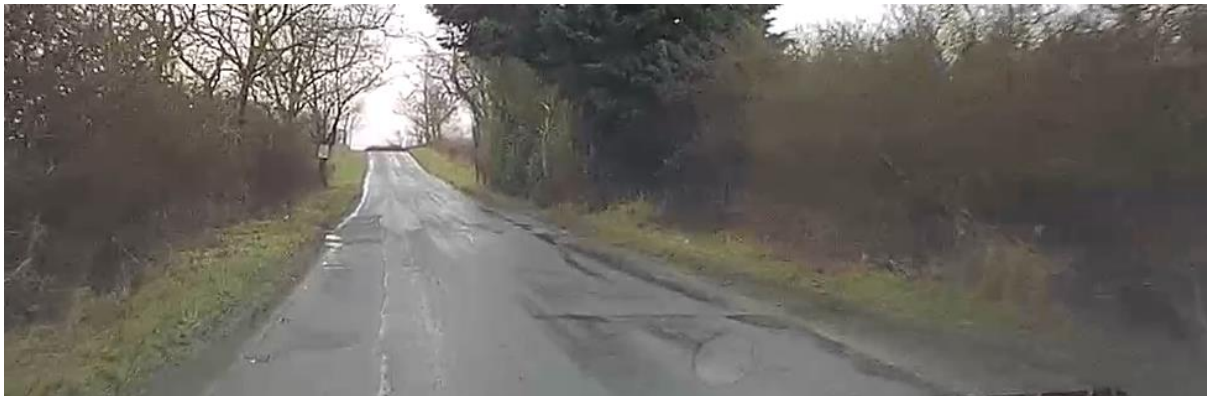
R1.12 – Condition score 0

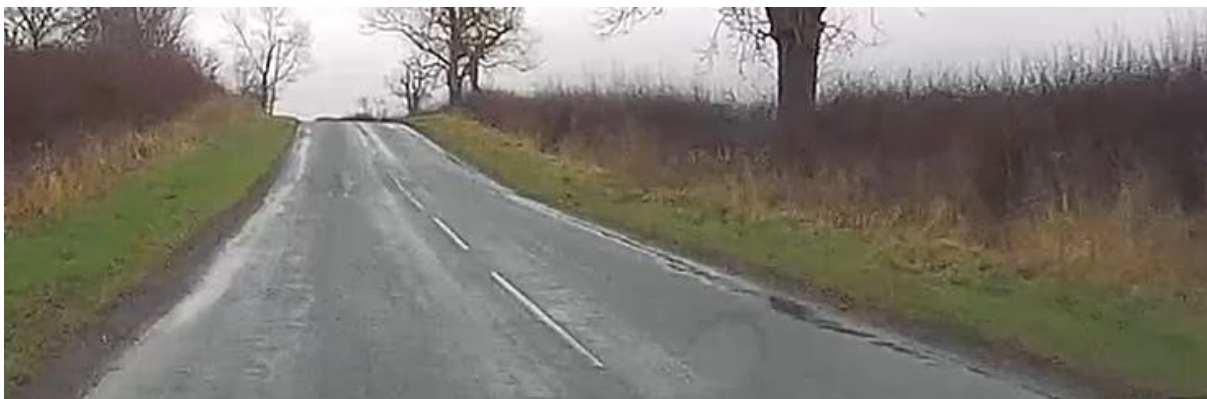
R1.13 – Condition score 10

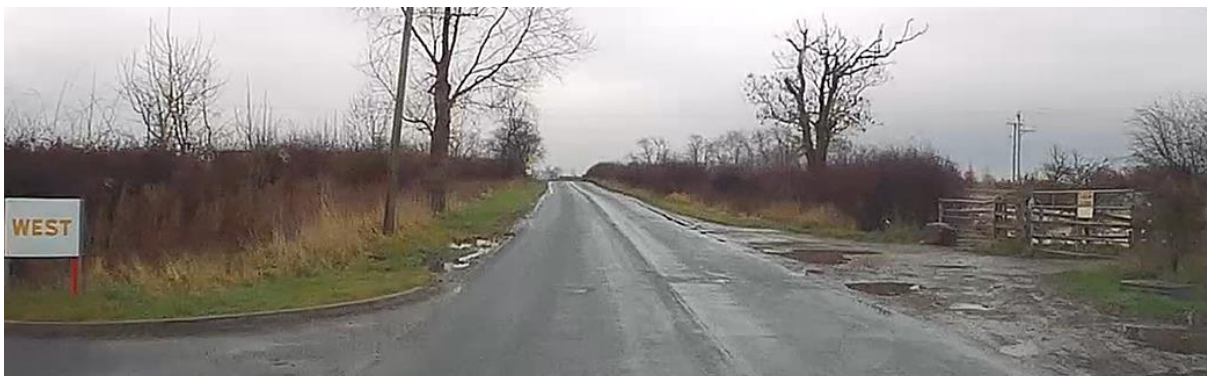
R1.14 – Condition score 0

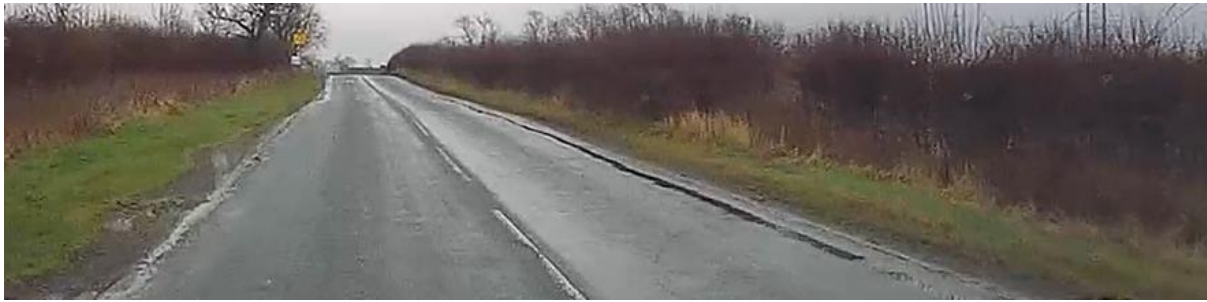
R1.15 – Condition score 10

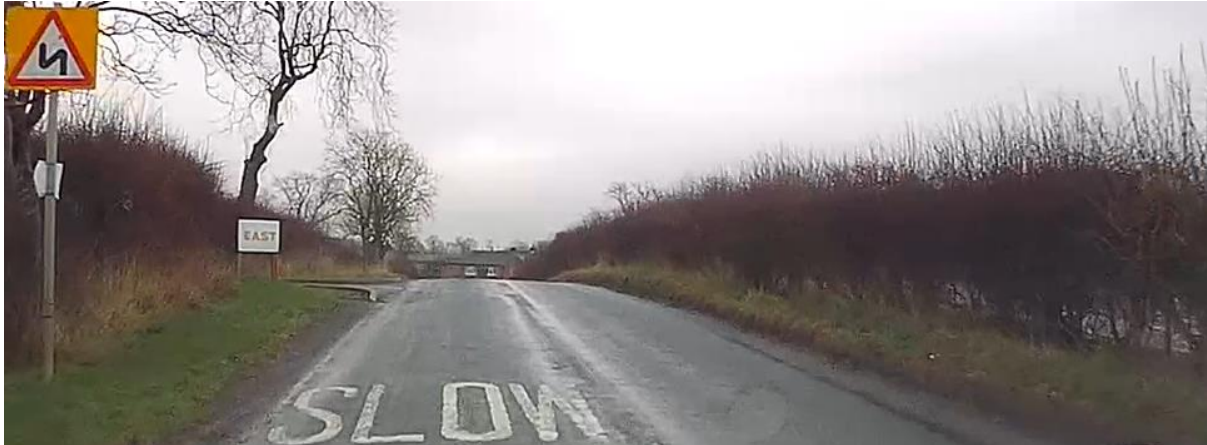
R1.16 – Condition score 0

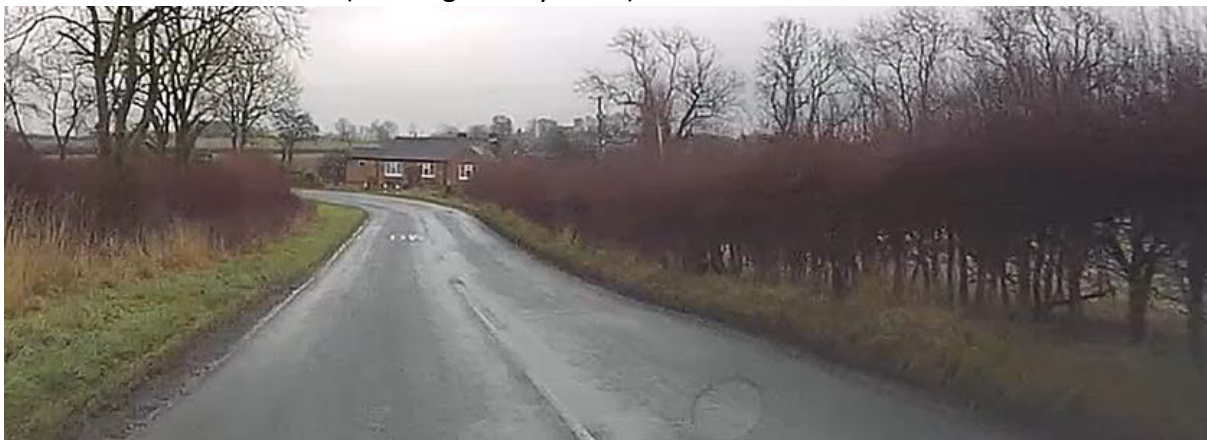
R1.17 – Condition score 0 (Slow sign badly worn)

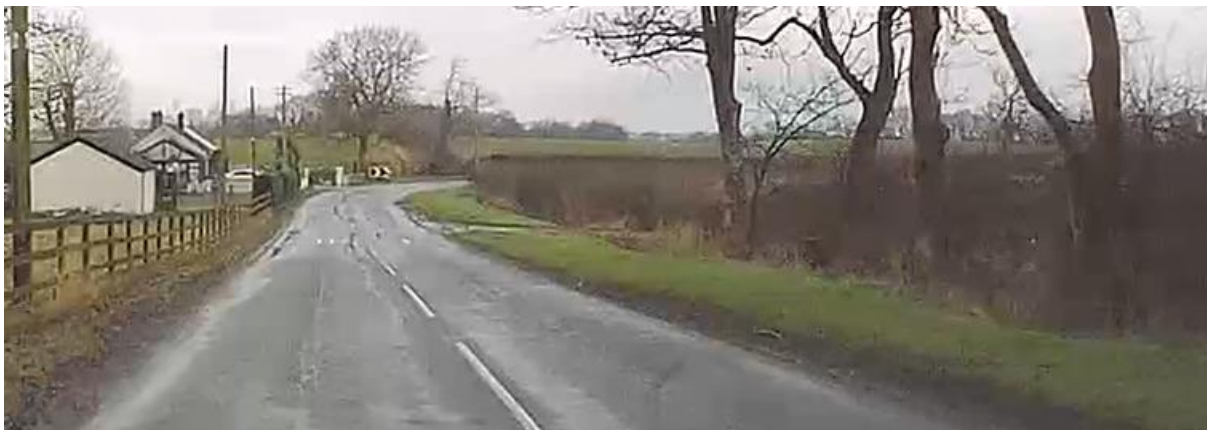
R1.19 – Condition score 20

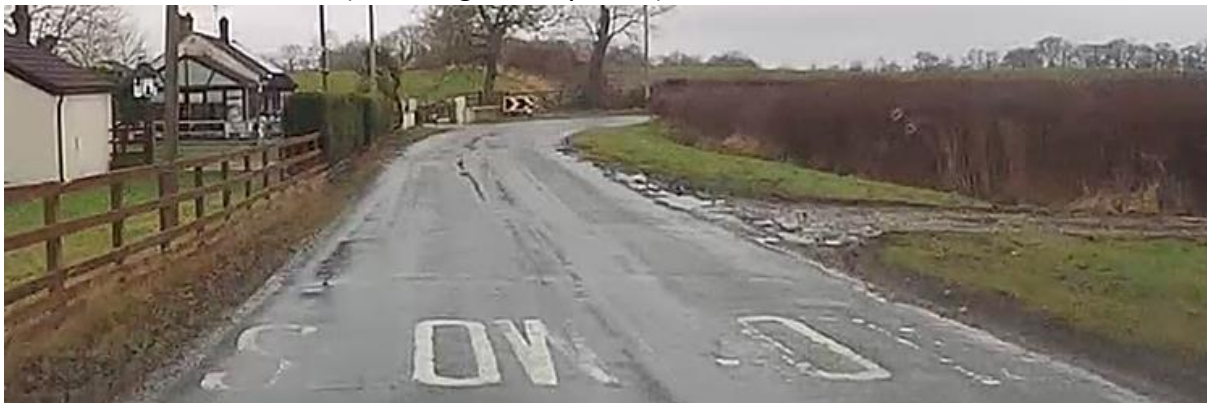
R1.20 – Condition score 0 (SLOW signs badly worn)

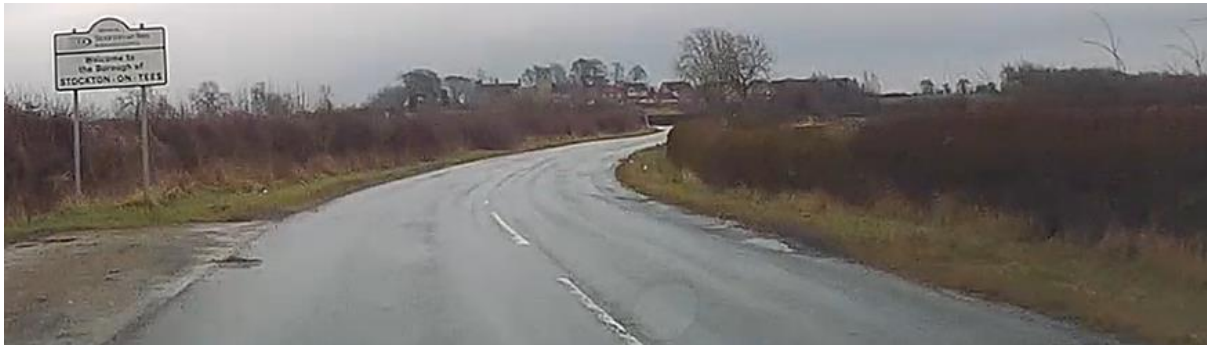
R1.22 – Condition score 10 (entering Stockton-on-Tees)

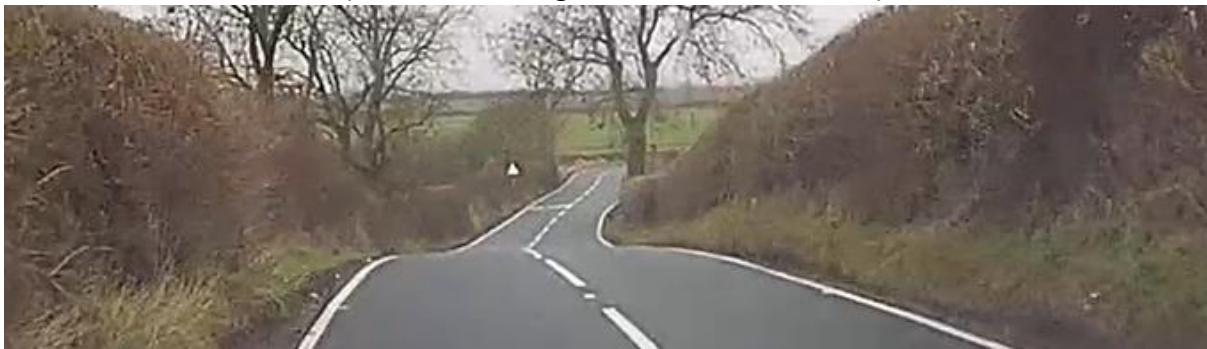
R2.2 – Condition score 50 (Stockton Borough Council infrastructure)

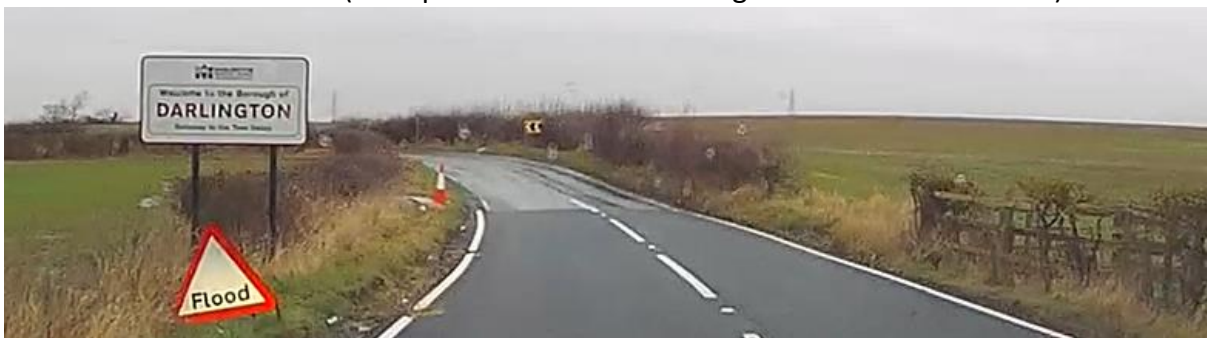
R2.3 – Condition score 50 (Final point of Stockton Borough Council infrastructure)

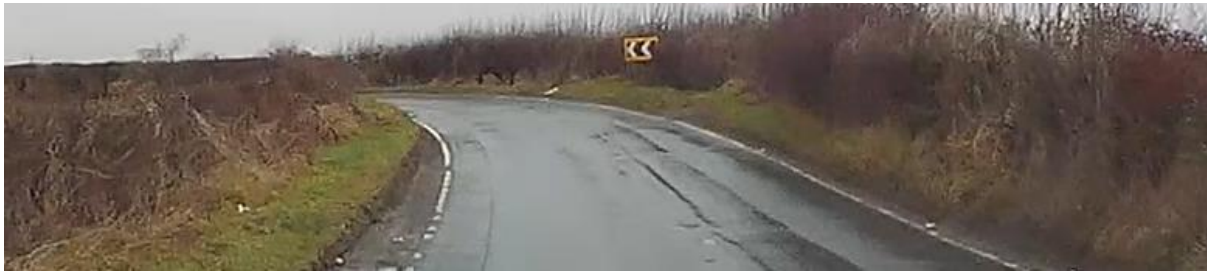
R2.4 – Condition score 0 Centre lines (crossing onto Darlington Borough council Infrastructure)

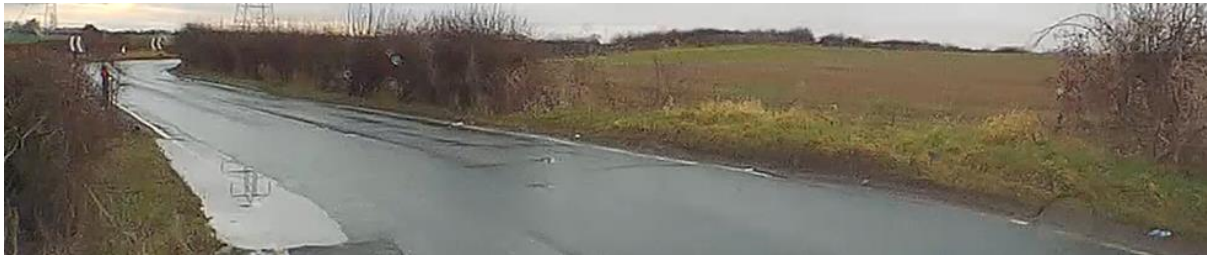
R2.5 – Condition score 0 Centre lines

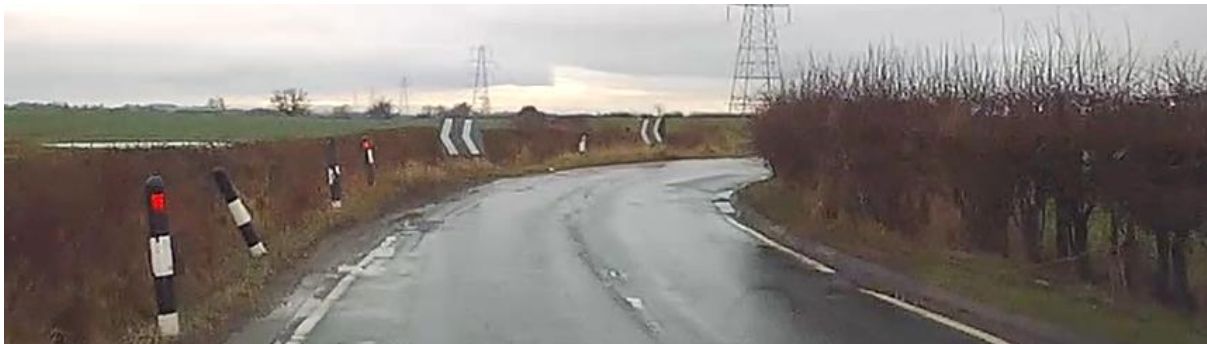
R2.5 – Condition score 0 Centre lines

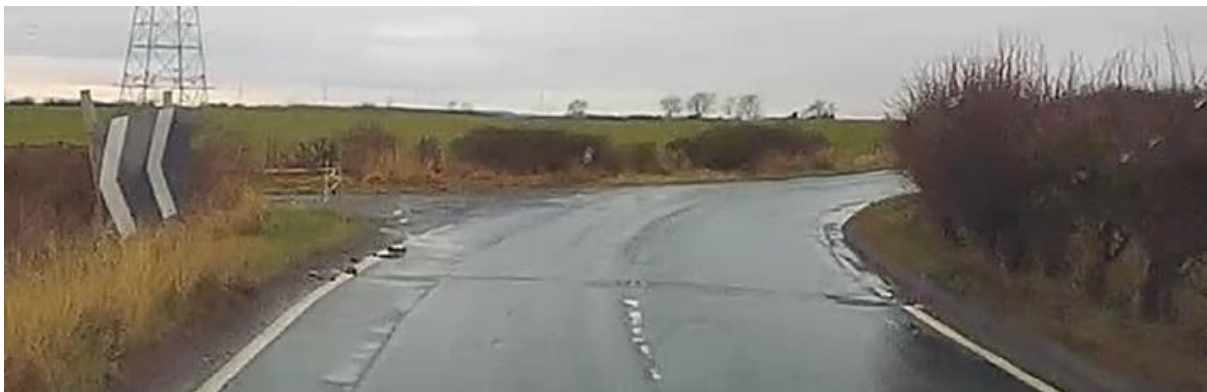
R2.6– Condition score 0 Centre lines

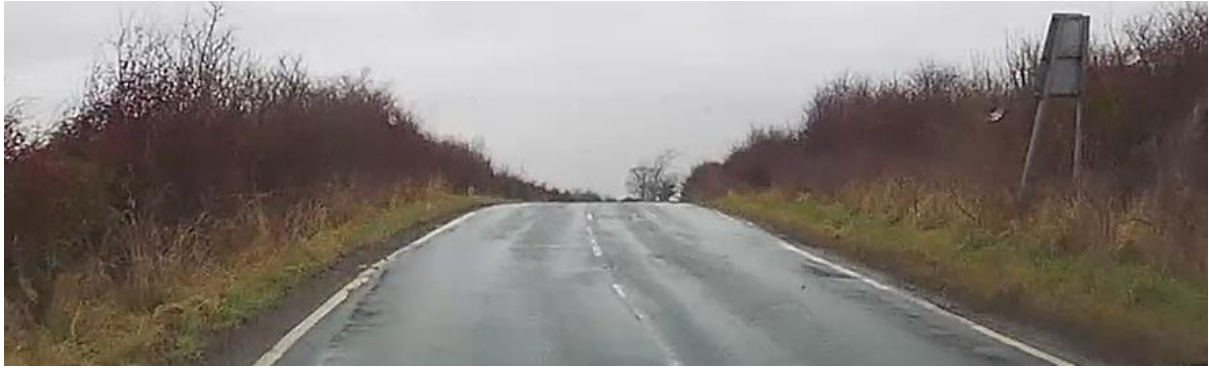
R2.6– Condition score 0 Centre lines

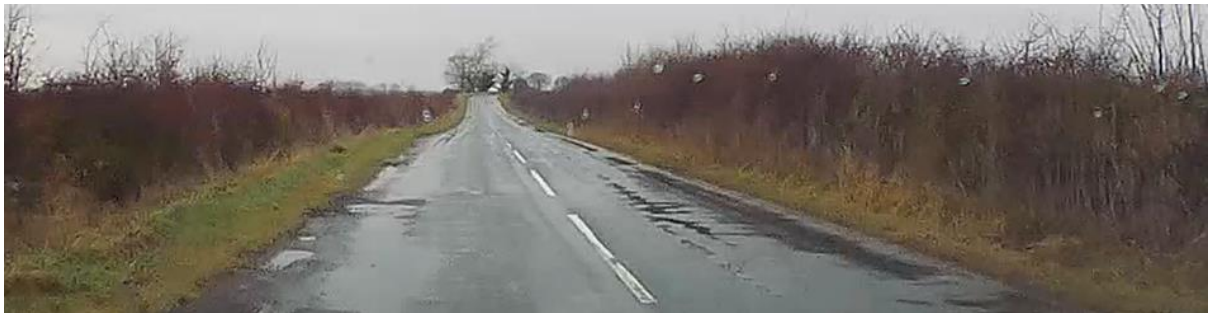
R2.6– Condition score 20

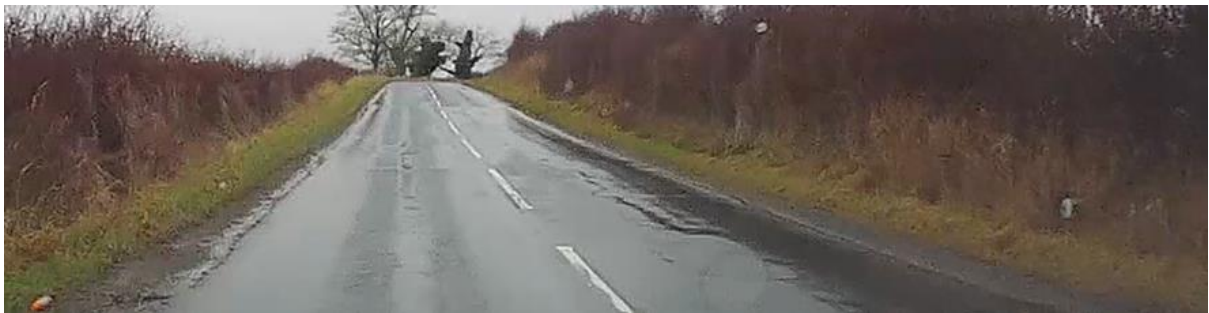
R2.7– Condition score 20

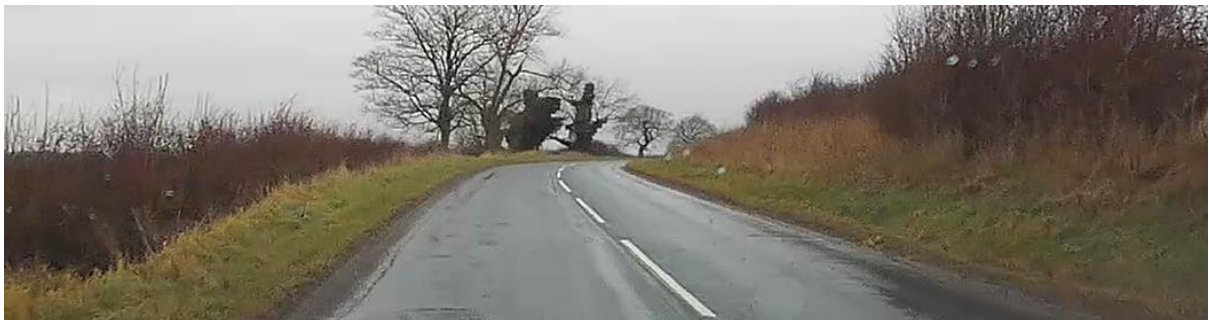
R2.8– Condition score 40

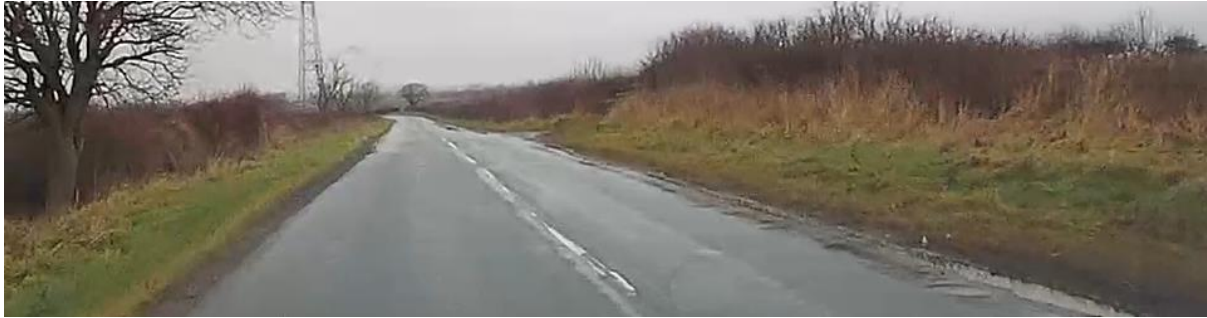
R2.9– Condition score 10

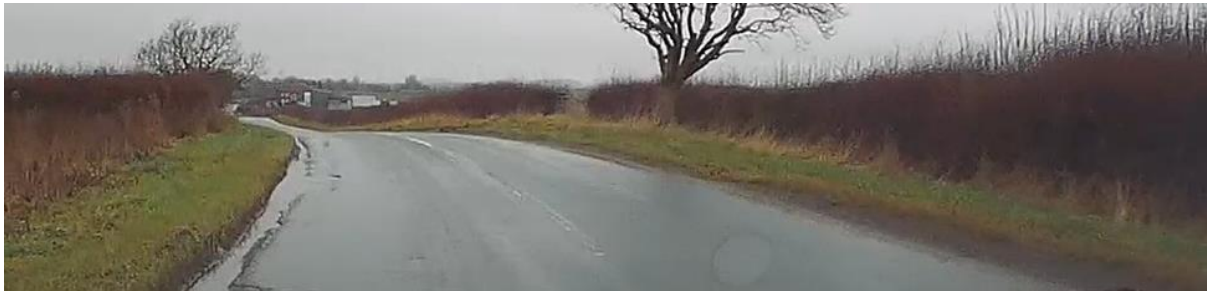
R2.10 - Condition score 0

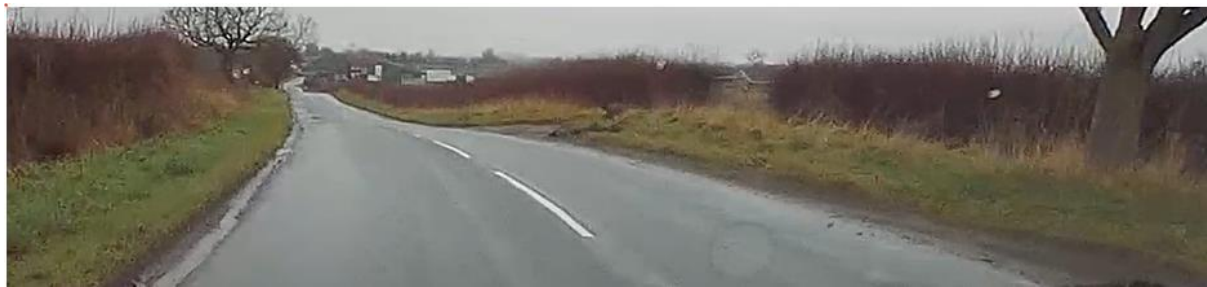
R2.11 - Condition score 0

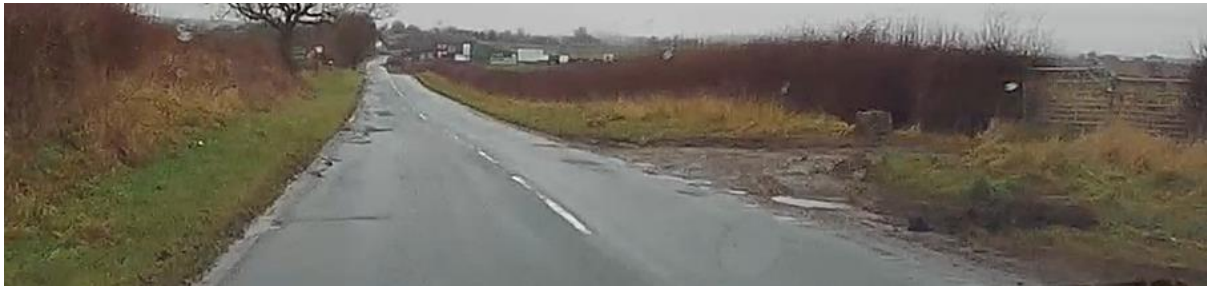
R2.12 - Condition score 10

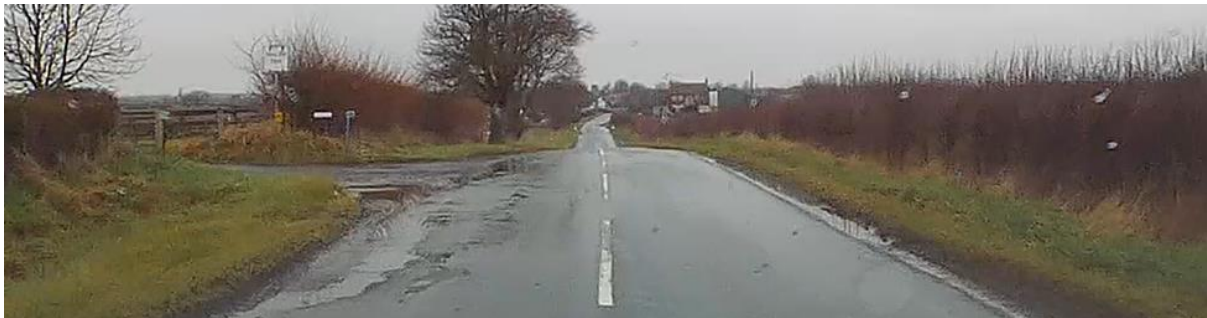
R2.13 - Condition score 10 (Note Lane surface extreme poor condition) forced to use centre of carriageway!

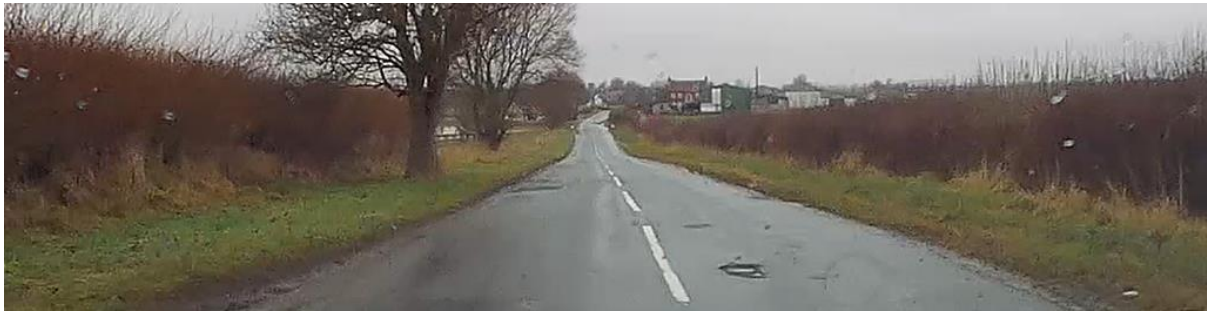
R2.14 - Condition score 30

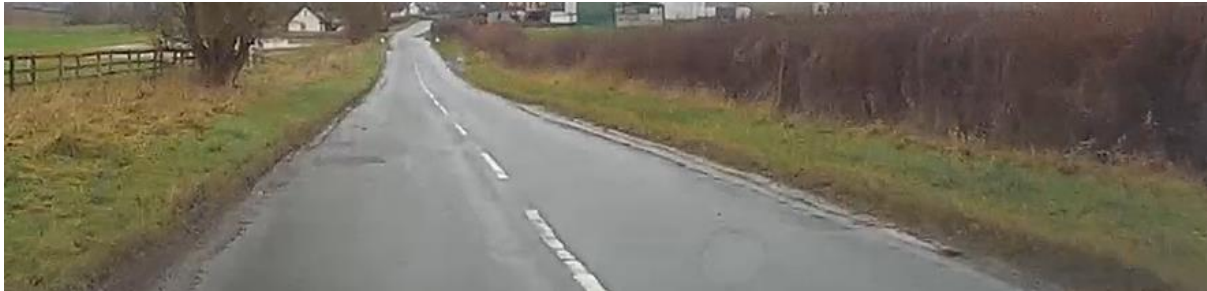
R2.15 - Condition score 20

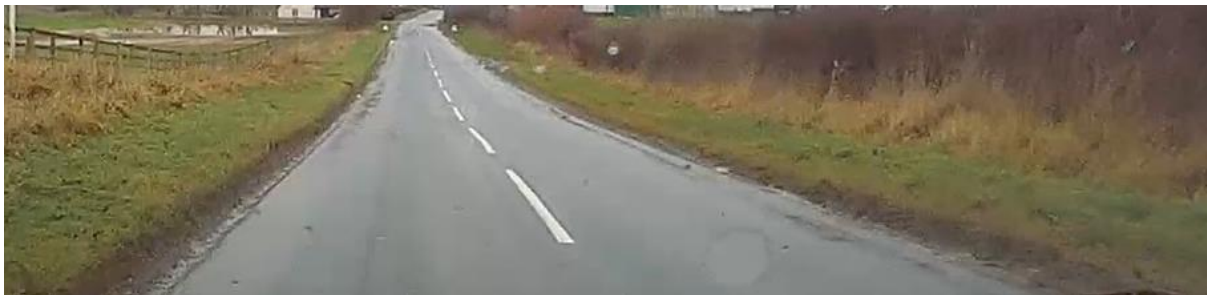
R2.16 - Condition score 30

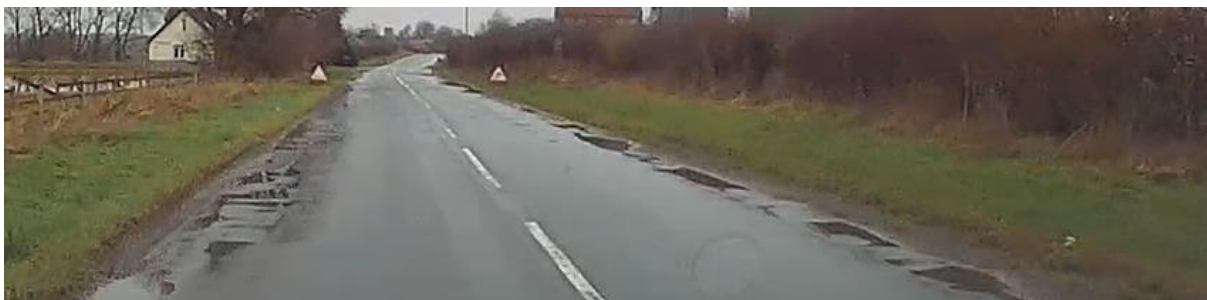
R2.17 - Condition score 10

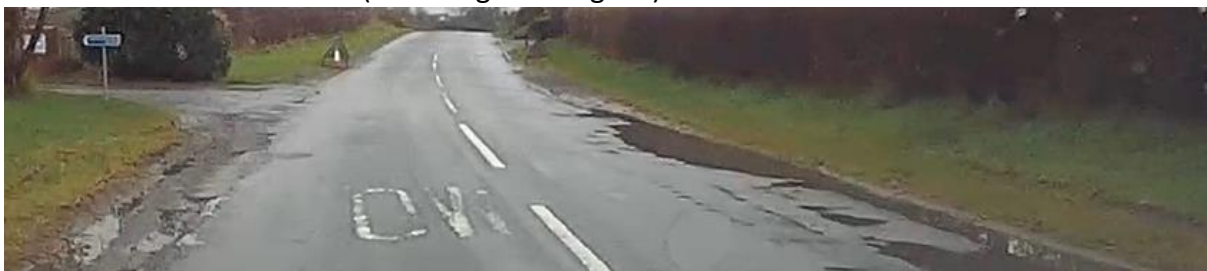
R2.18 - Condition score 10. (SLOW sign not legible)

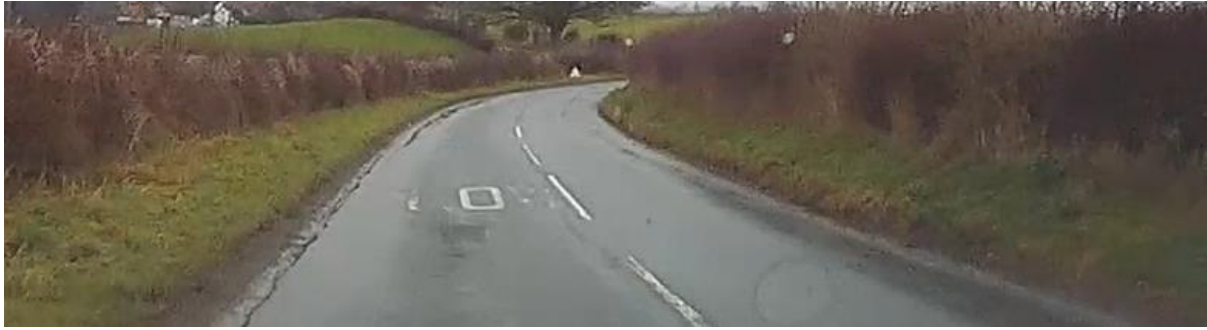
R2.19 - Condition score 10. (SLOW sign not legible)

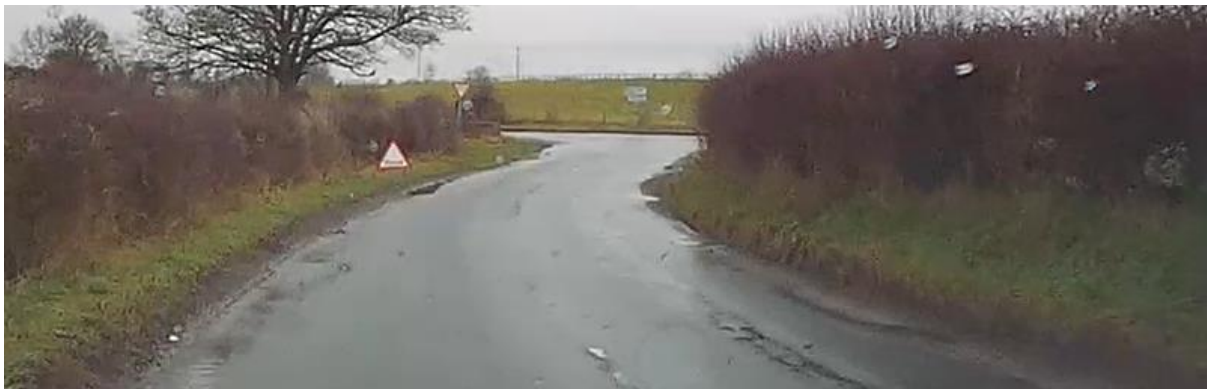
R2.20 - Condition score 0. (no marking approaching junction)

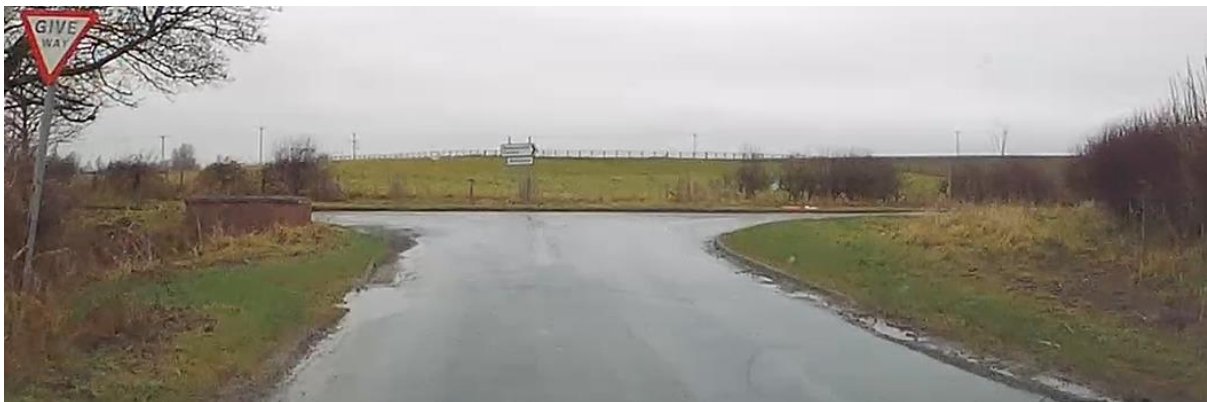
R2.22 - Condition score 0. (no markings approaching Junction)

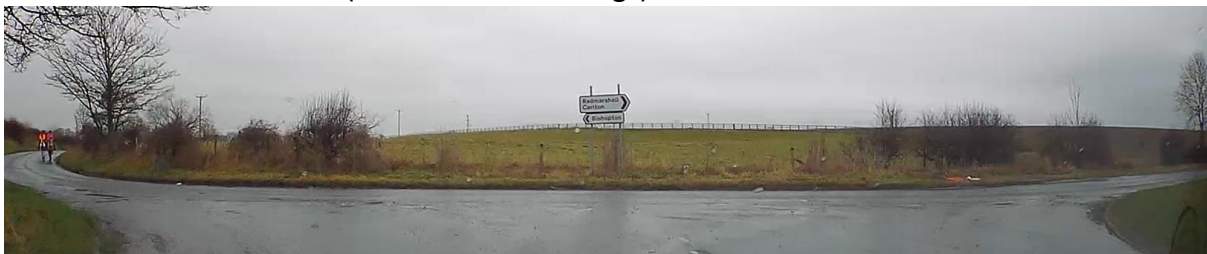
R2.22 - Condition score 0. (For Junction markings)

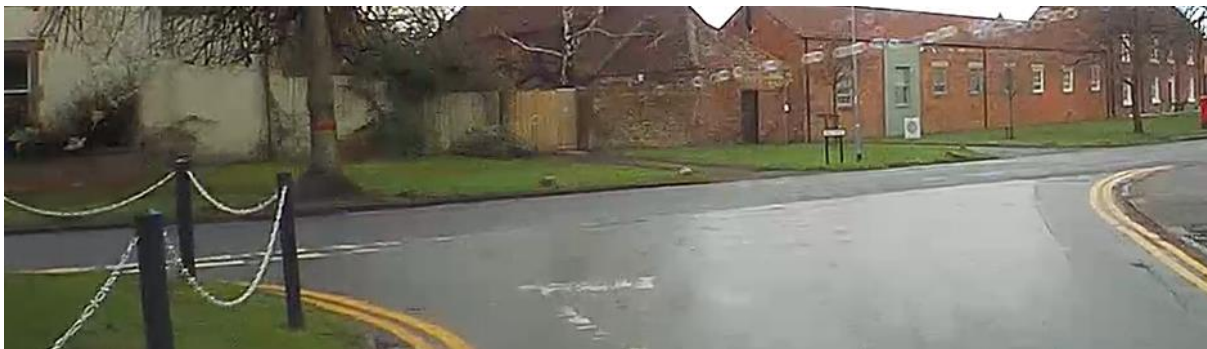
R3.1 - Condition score 0. Junction lines

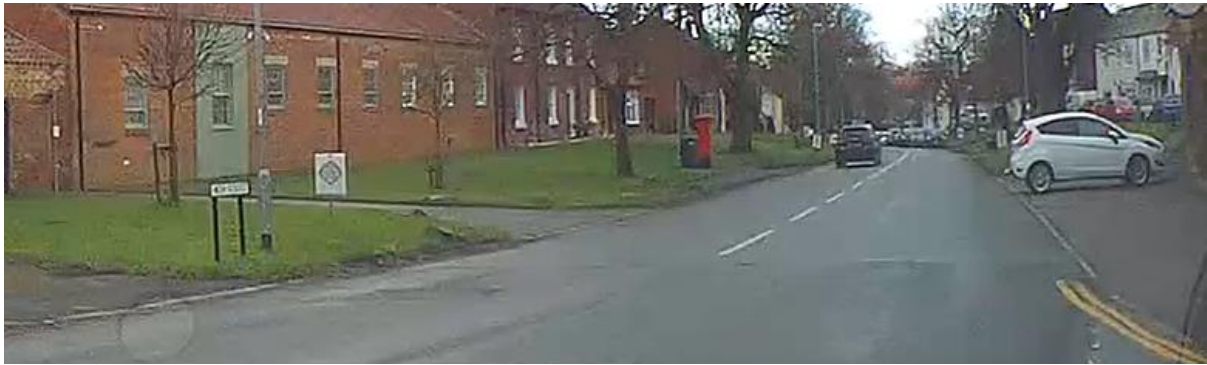
R3.2 - Condition score 0. (prior to resurfaced section)

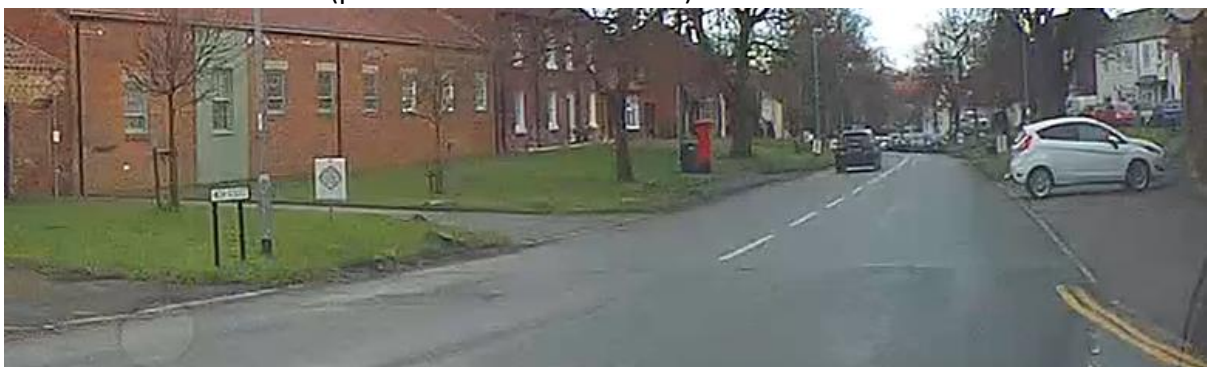
R3.3 - Condition score 0. (prior to resurfaced section)

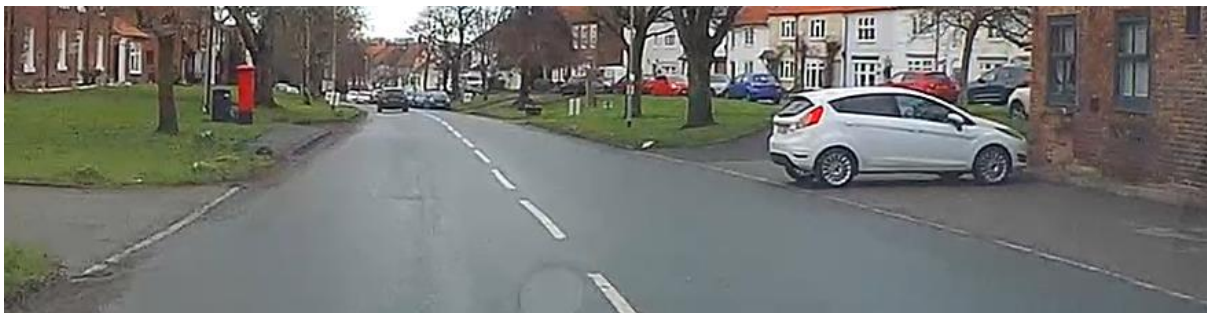
R3.4 - Condition score 40.

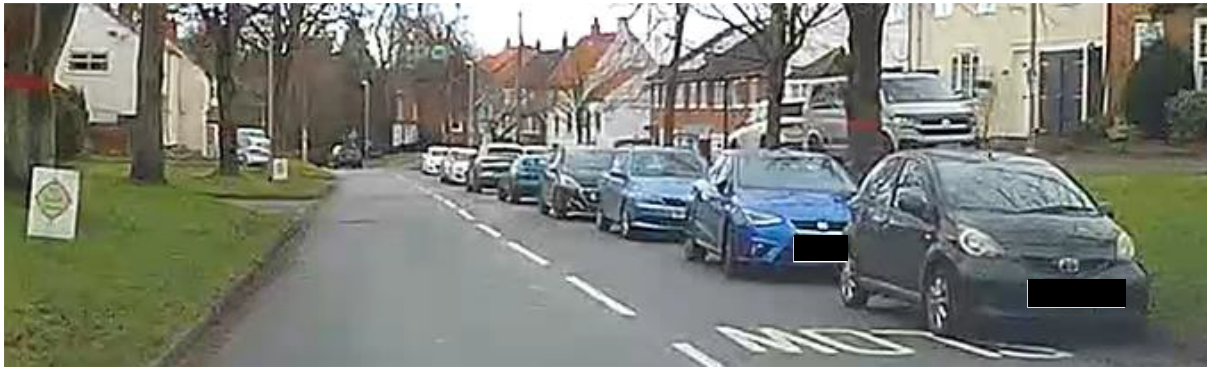
R3.5 - Condition score 40

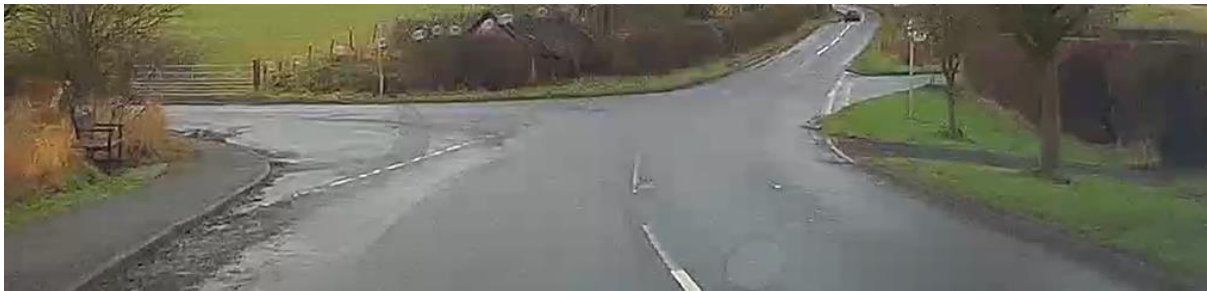
R3.7 - Condition score 0 - for centre Lines and Folly Bank Junction Markings

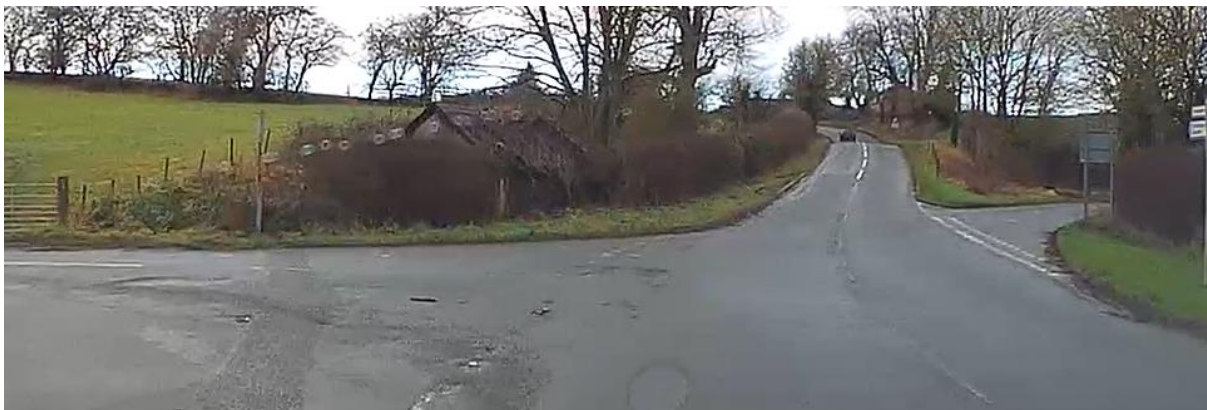
R3.7a Condition score 0

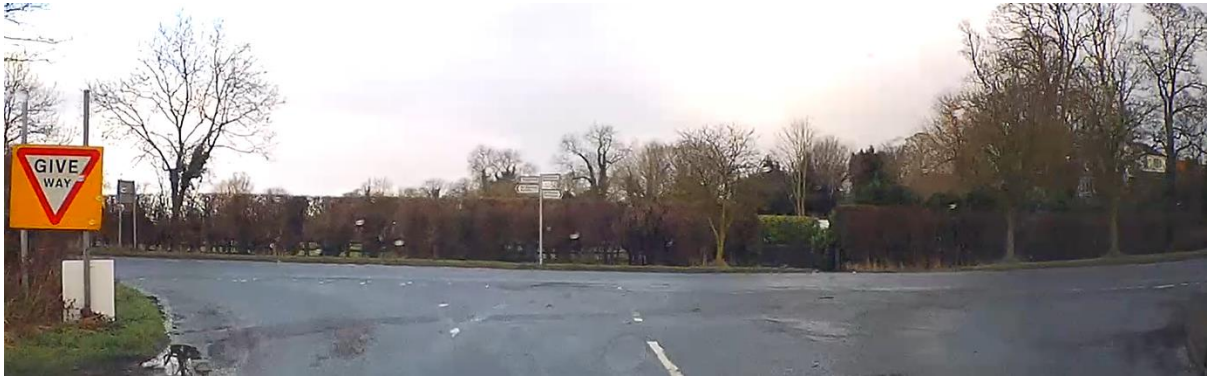
R3.7b Condition score 0 - Junction Markings. (alternate view opposite approach) **Location of recent Road Traffic Incident - See Appendix B**

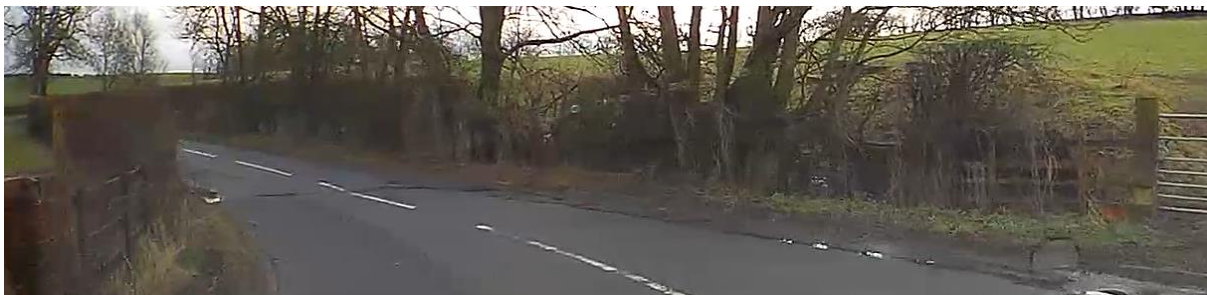
R3.8 Condition score 30

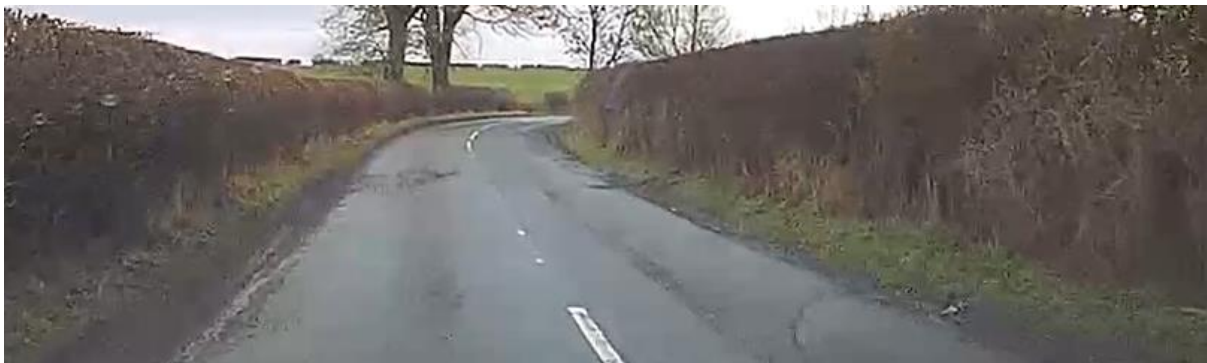
R3.9 Condition score 0

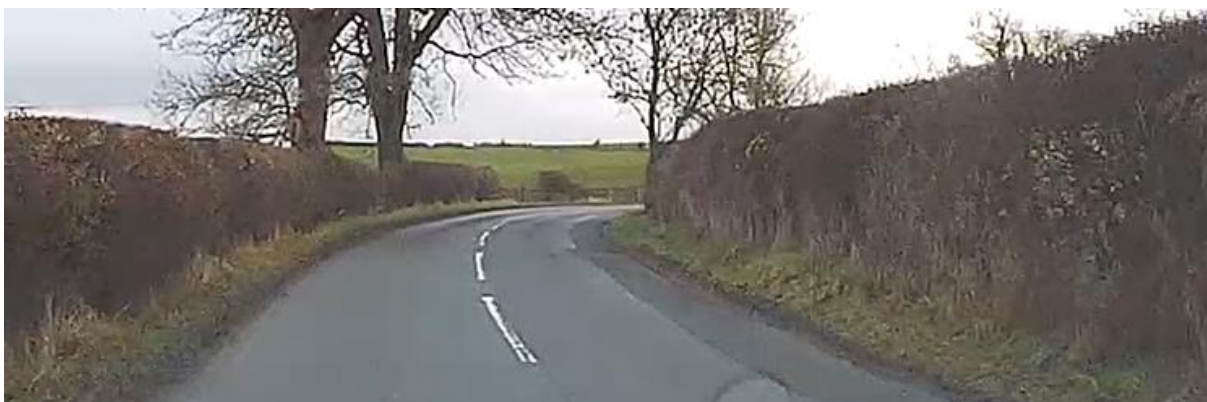
R3.10 Condition score 10
