**Road Line Marking Assessment Report Covering Darlington
Borough Council Road Infrastructure Surrounding Bishopton
Parish Council Area.
Document Reference BPC/1/24/001**

Document Reference	Revision	Date
BPC/1/24/001A	First issue Rev A (DRAFT internal Only)	14.01.2024
BPC/1/24/001B	Formal Issue Rev B	04.02.2024

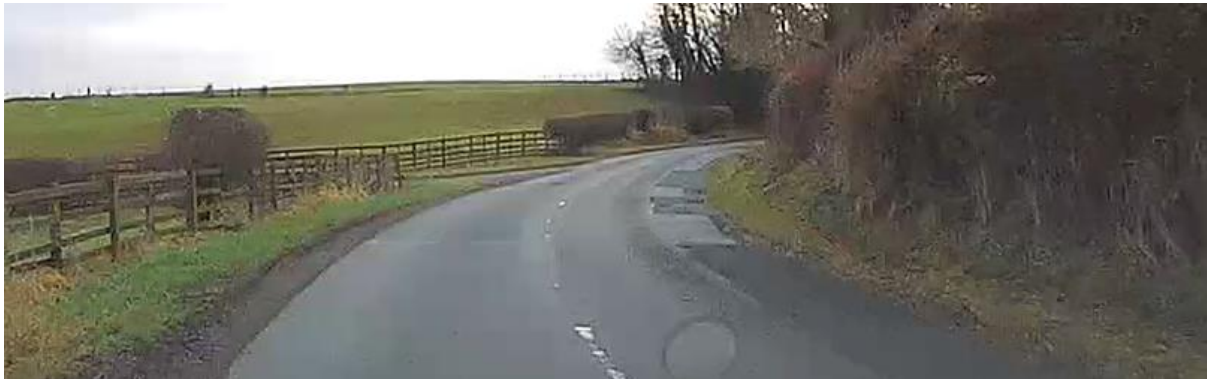
R3.11 Condition score 0 (very Poor road surface inside of bend)

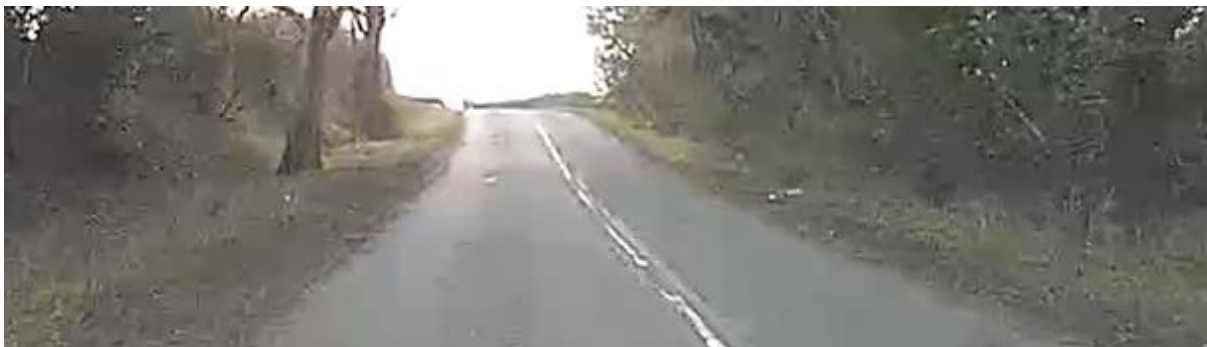
R3.12 Condition score 10

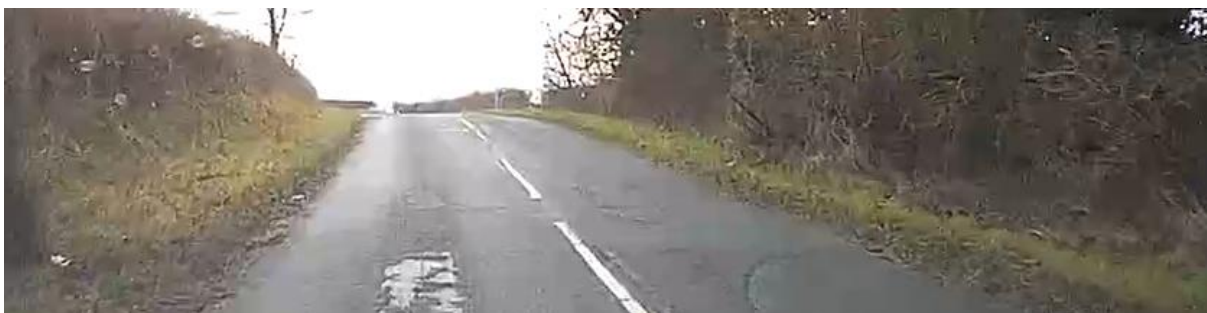
R3.13 Condition score 20

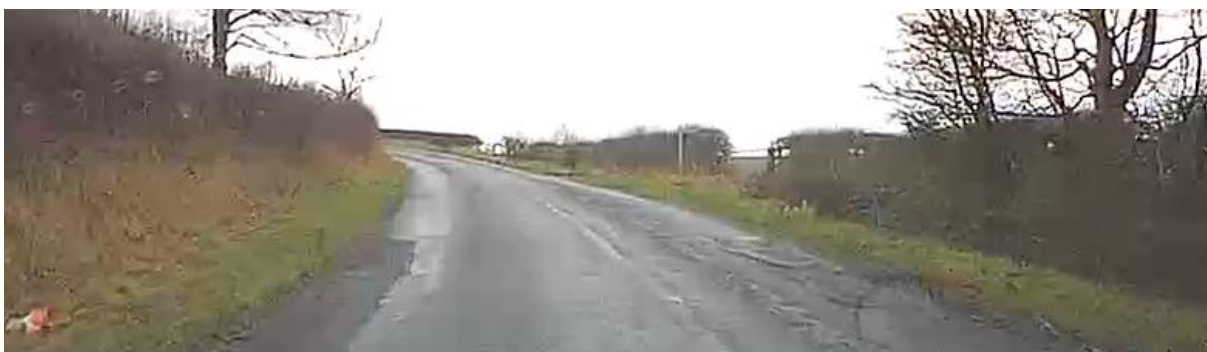
R3.14 Condition score 0

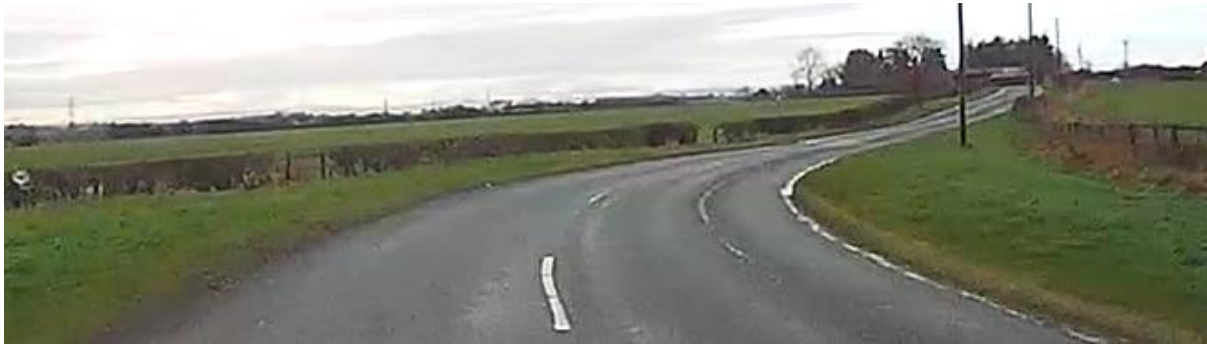
R3.15 Condition score 10

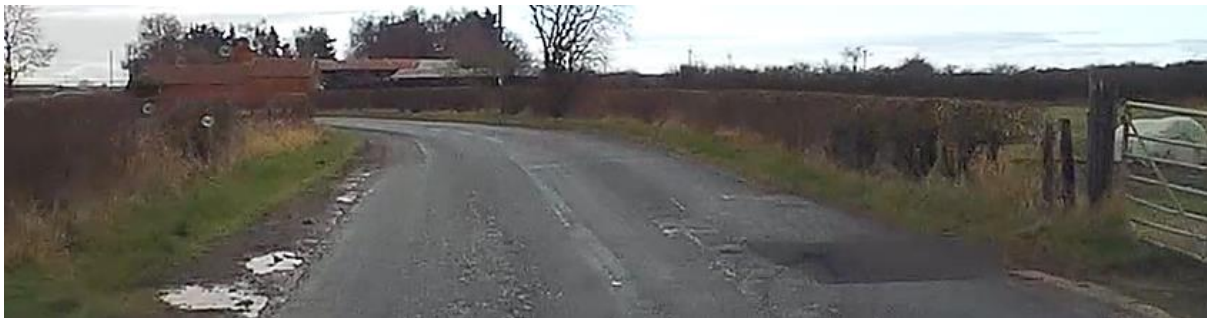
R3.16 Condition score 0

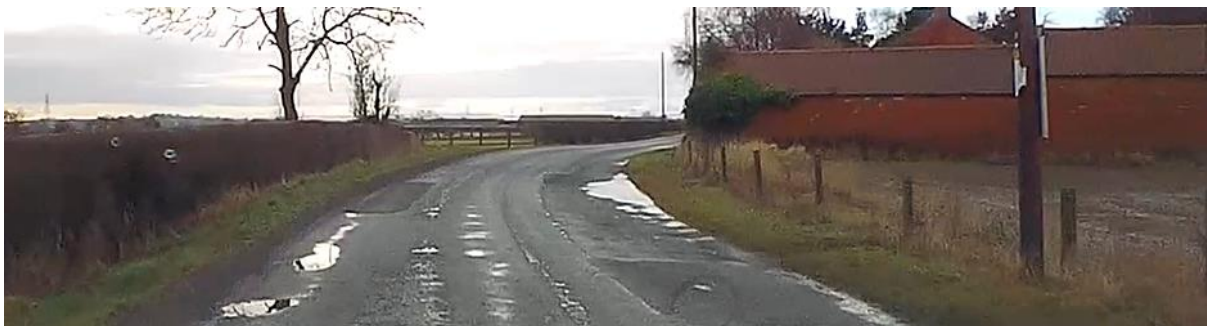
R3.17 Condition score 0

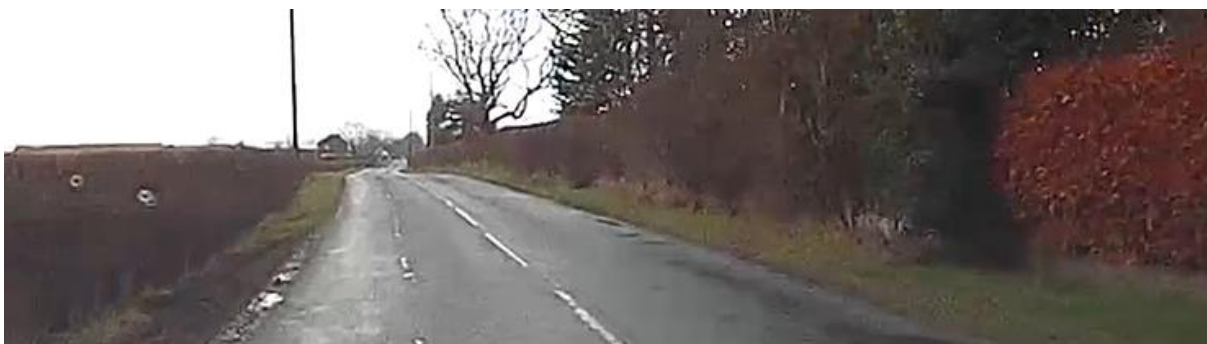
R3.18 Condition score 10

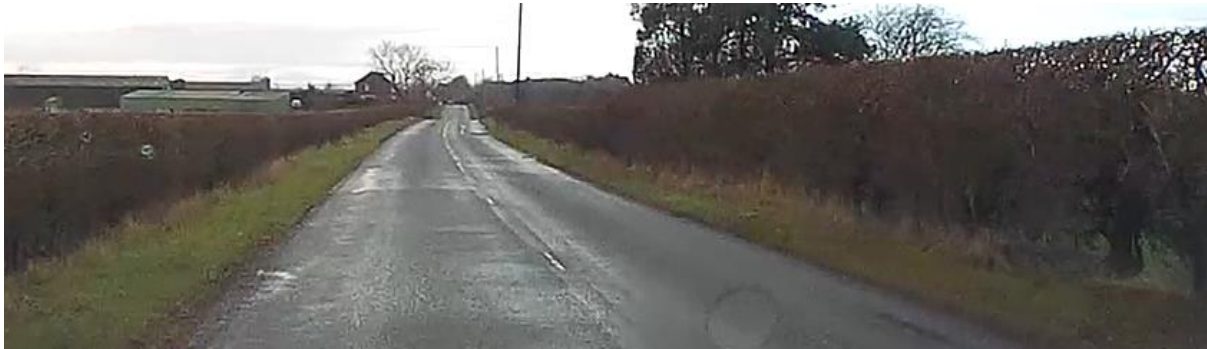
R3.19 Condition score 0

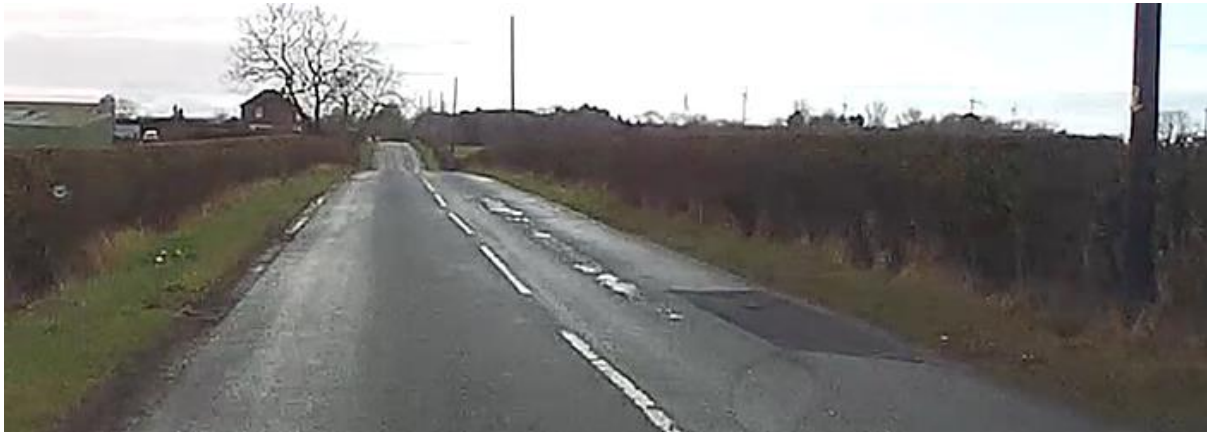
R3.20 Condition score 20

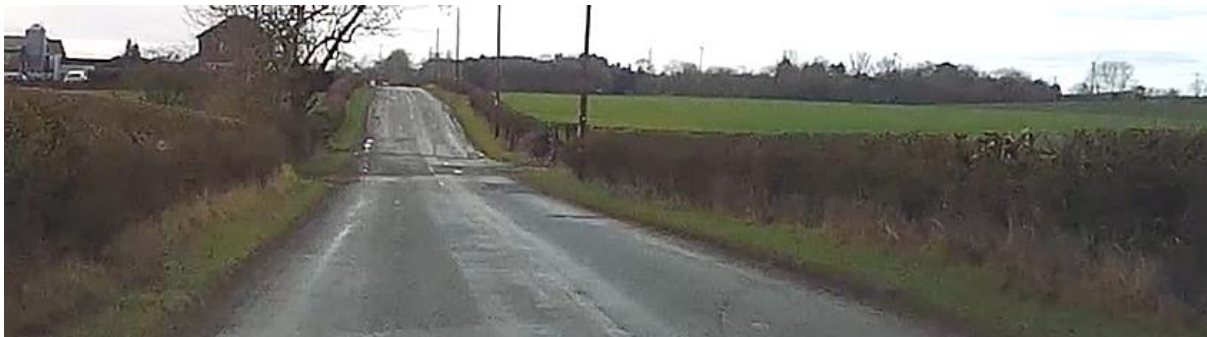
R3.21 Condition score 0

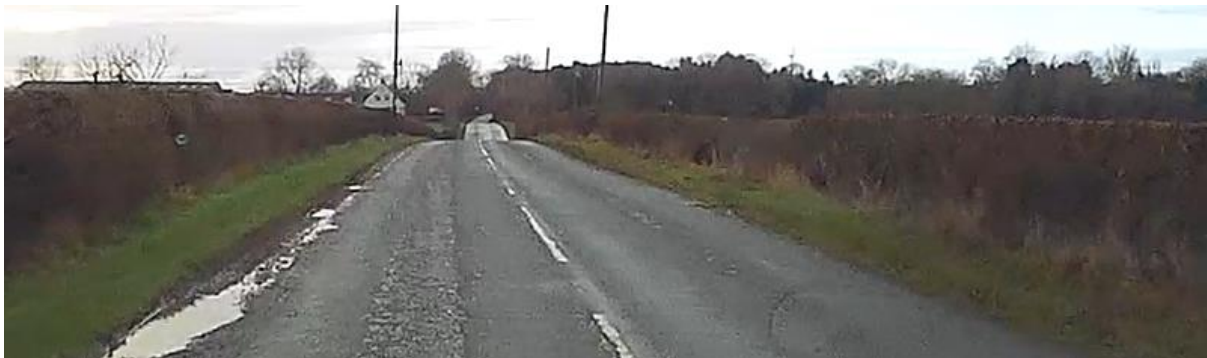
R3.22 Condition score 10

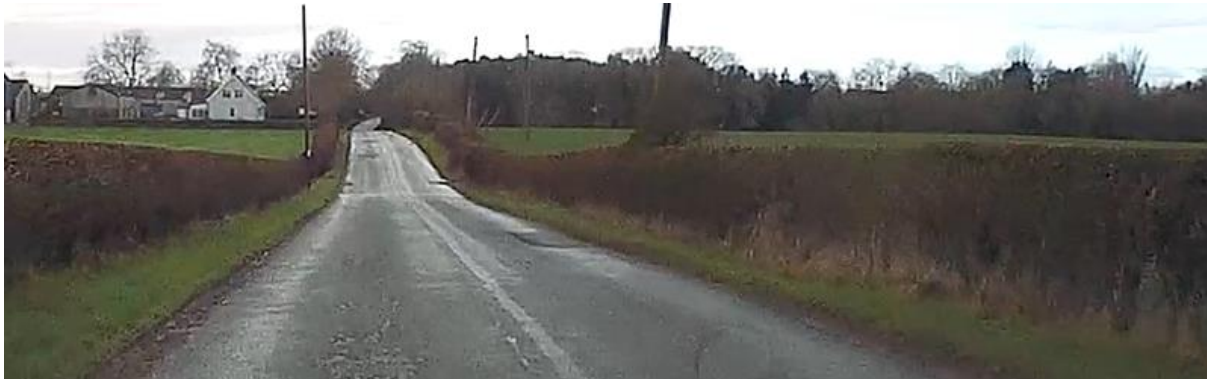
R3.23 Condition score 0

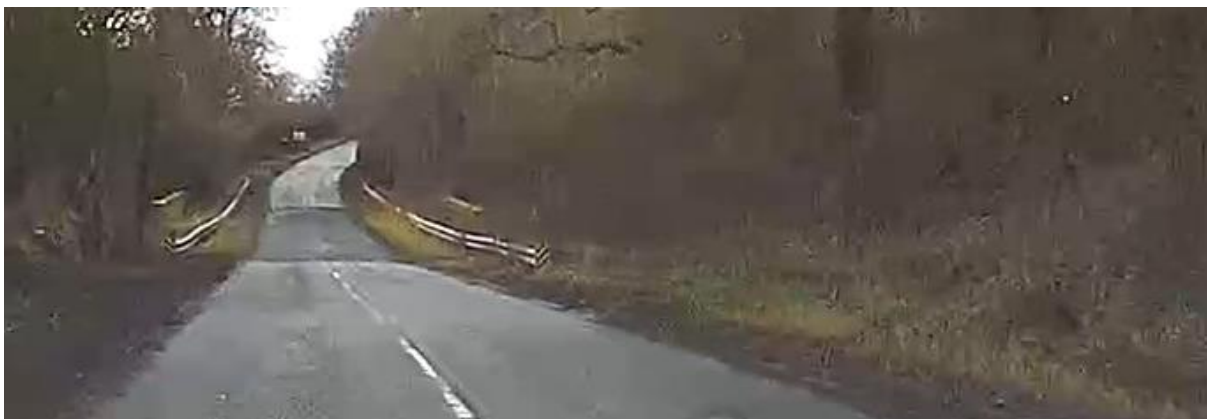
R3.23 Condition score 10

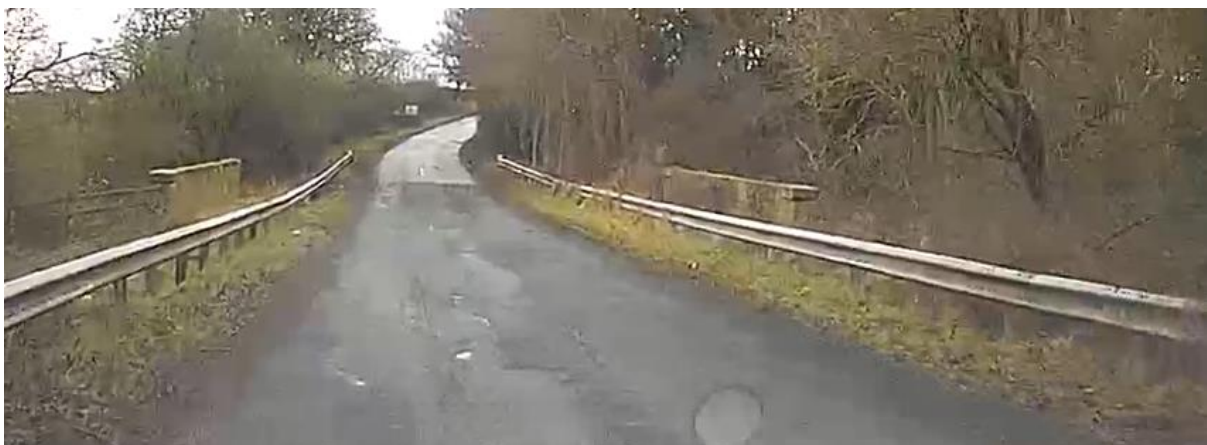
R3.24 Condition score 0 (very Poor road surface at water crossing)

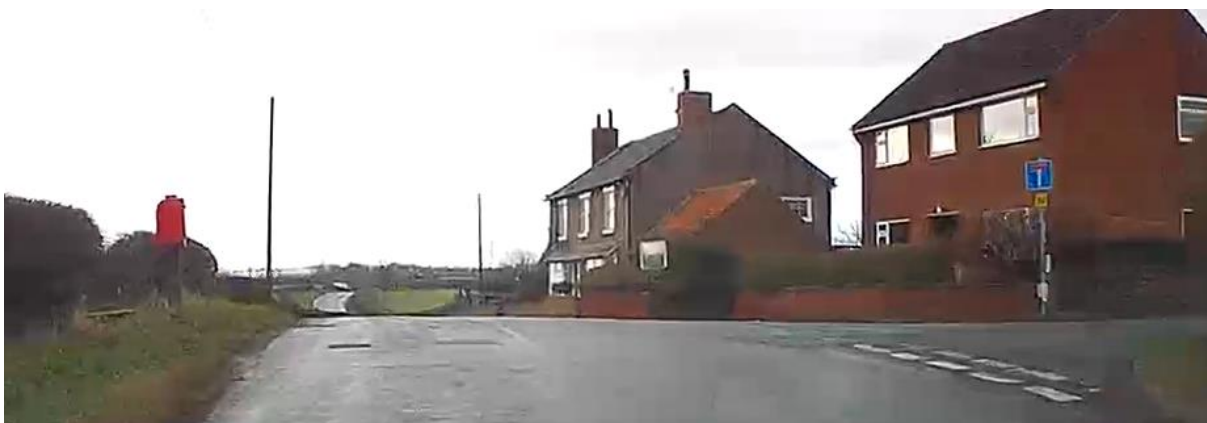
R3.27 Condition score 0

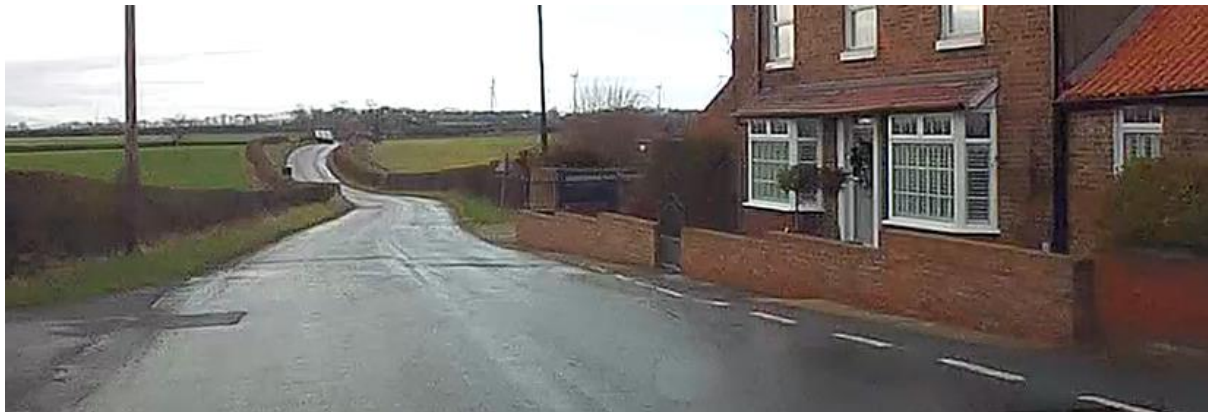
R3.28 Condition score 0

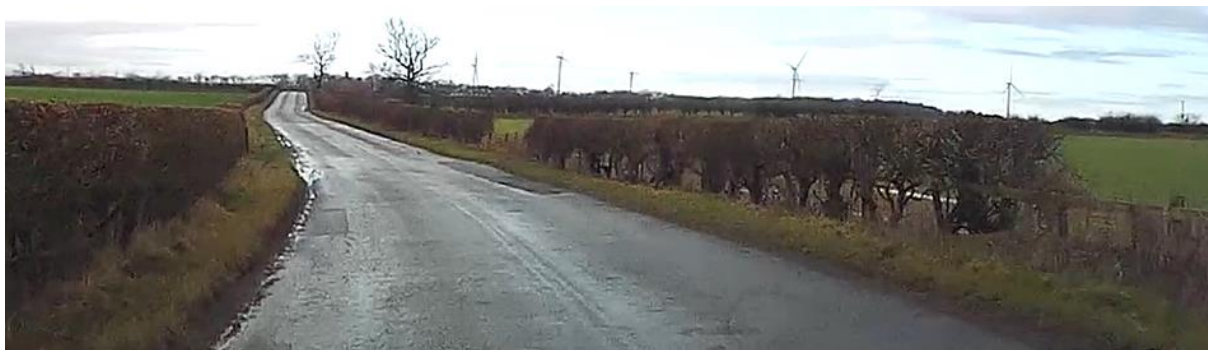
R3.29 Condition score 0

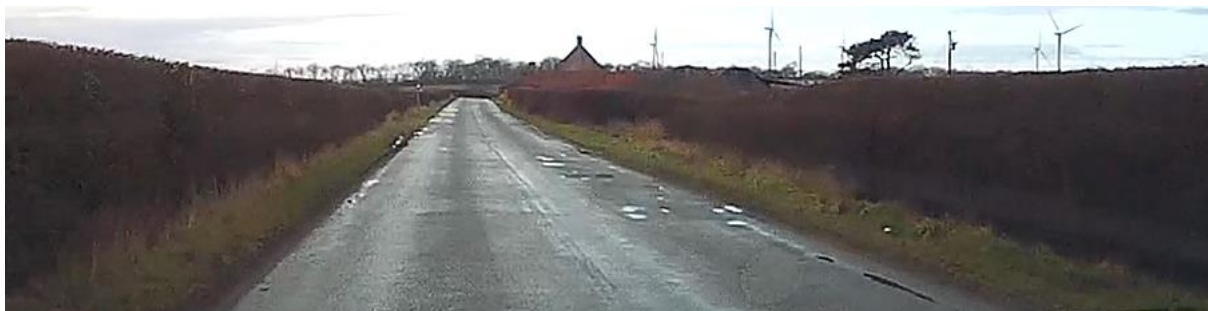
R3.30 Condition score 0

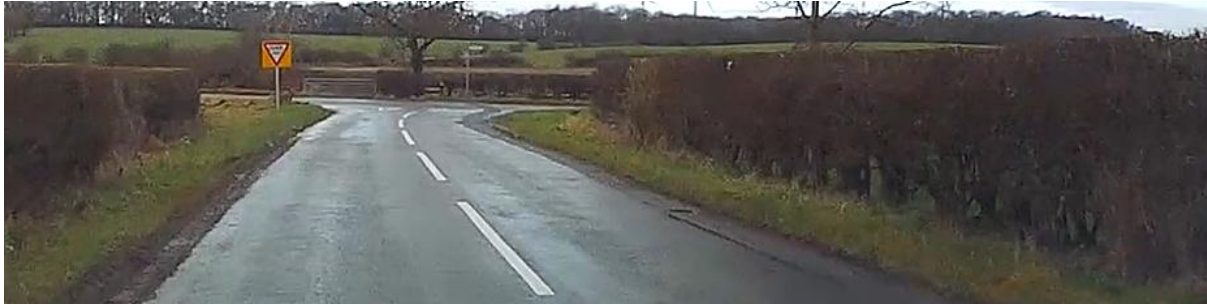
R3.26 Condition score 50 (Prior to Junction)

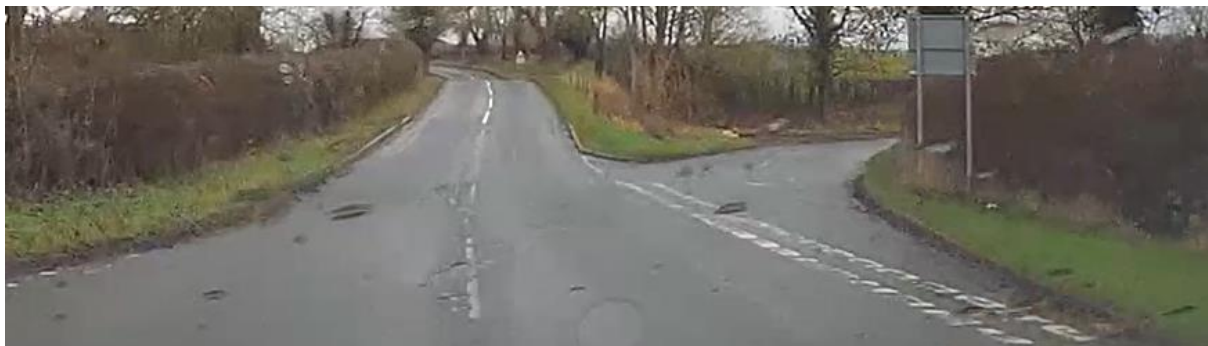
R4.1 Condition Score 0

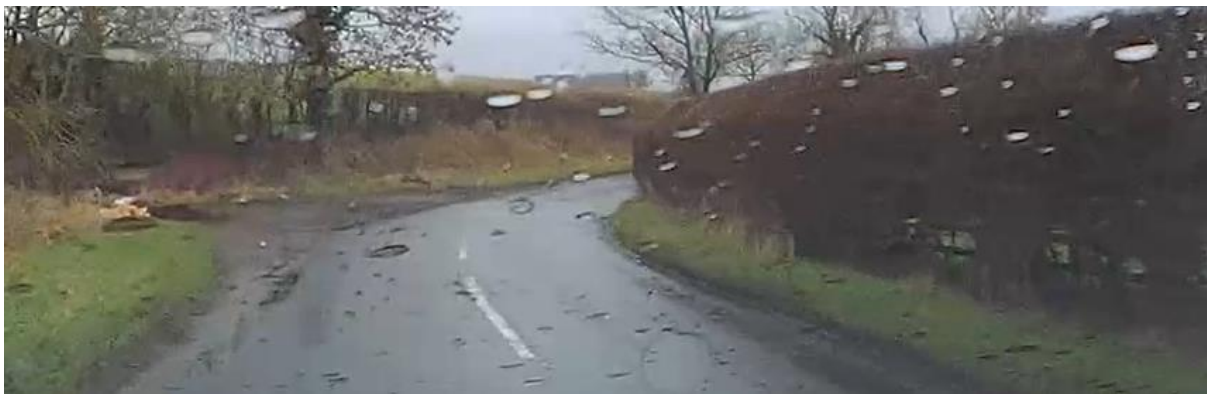
R4.3 Condition Score 10

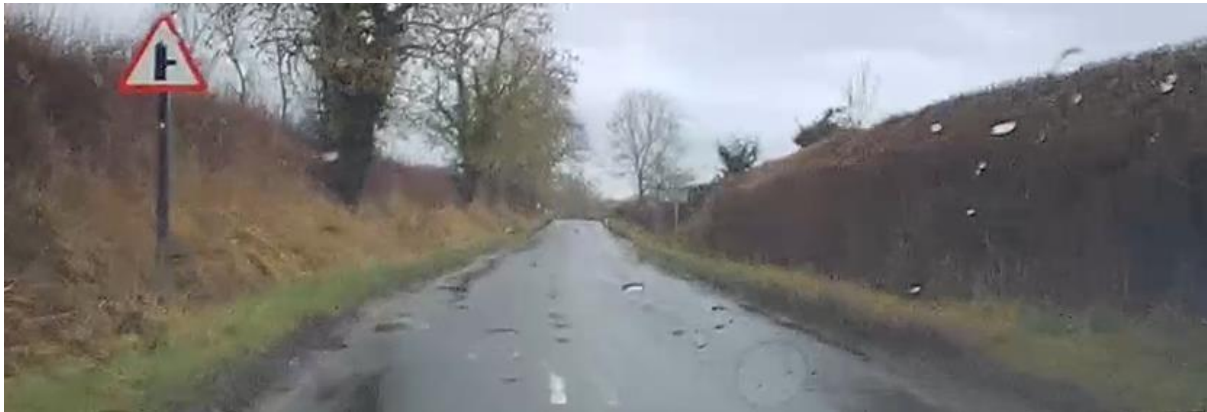
R4.5 Condition Score 0 (slow marking almost completely work away)

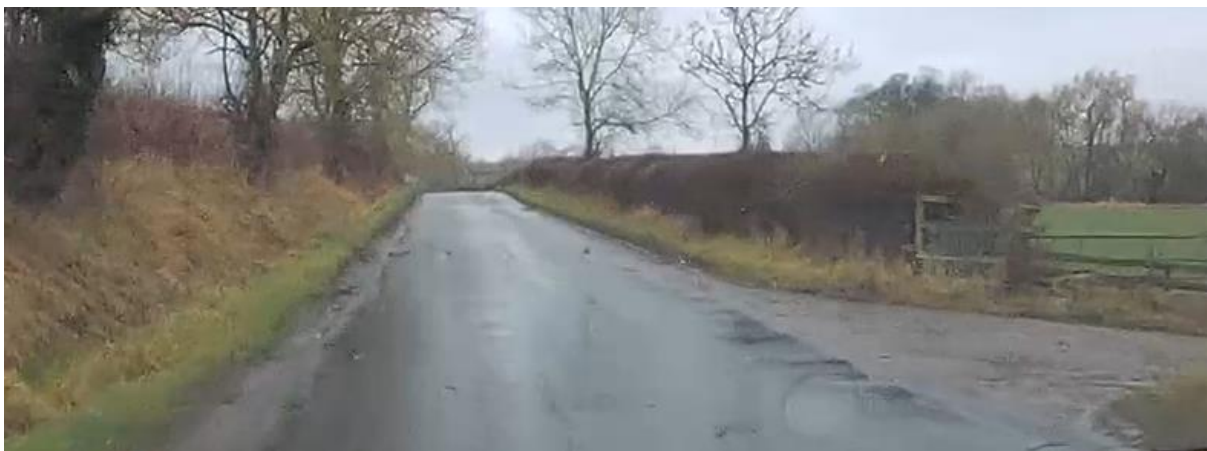
R4.6 Condition Score 0

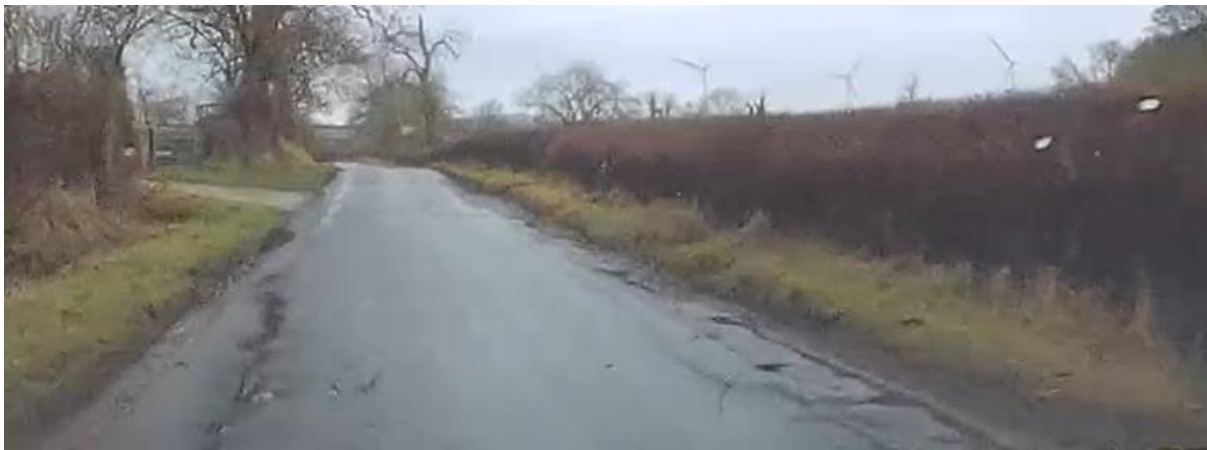
R4.7 Condition Score 0

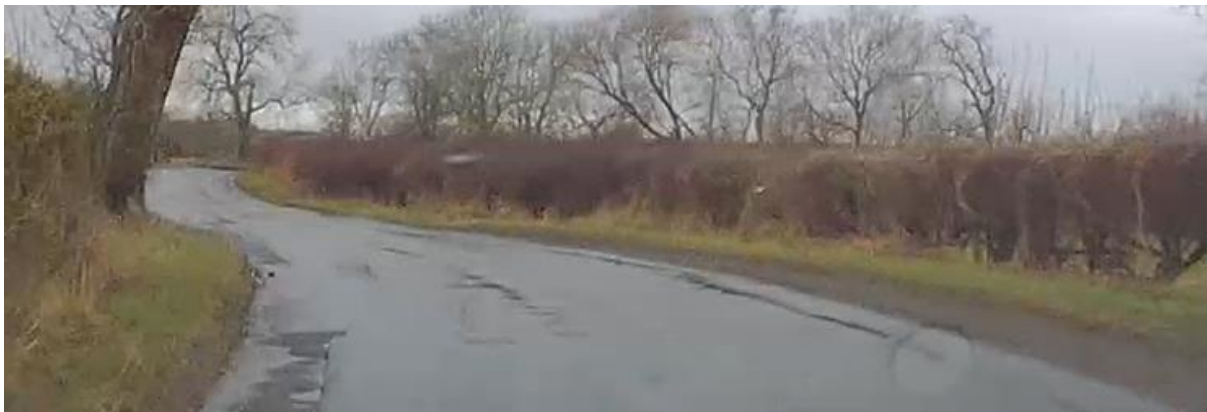
R4.9 Condition Score 0

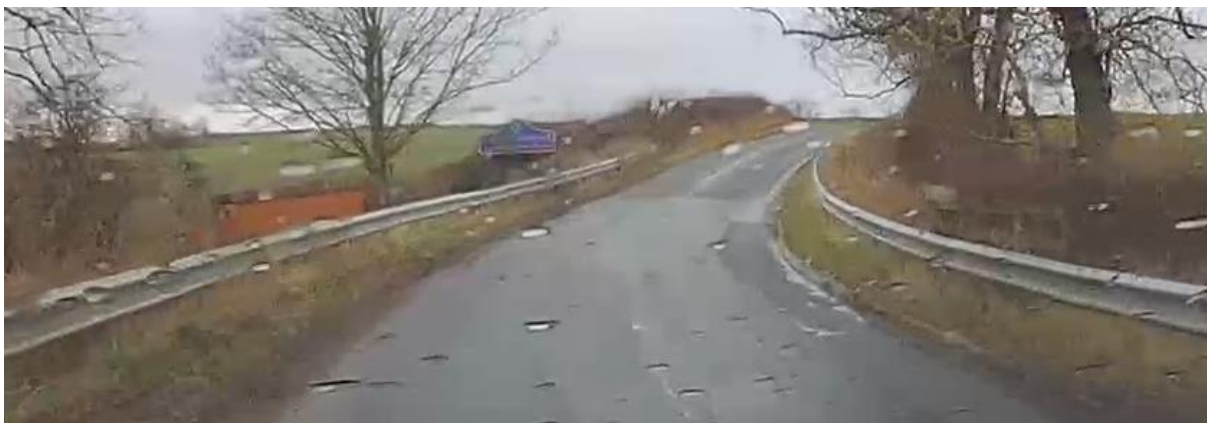
R4.10 Condition Score 0

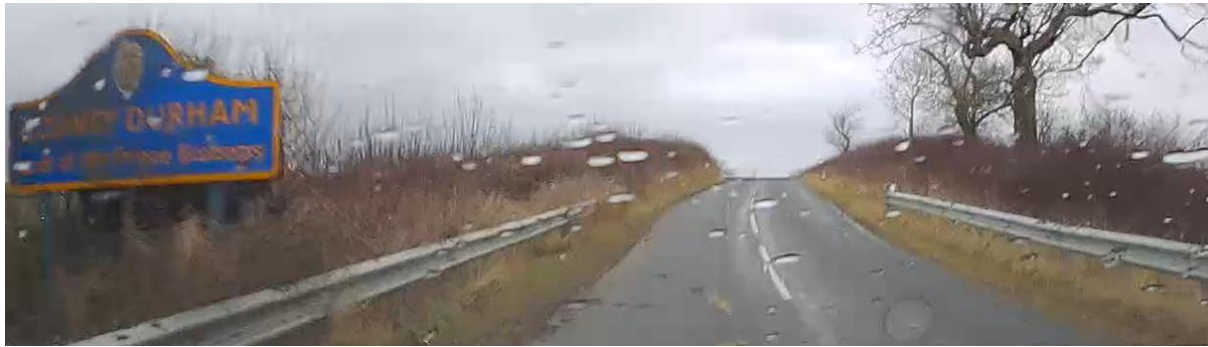
R4.11 Condition Score 30 (Crossing into Co Durham)

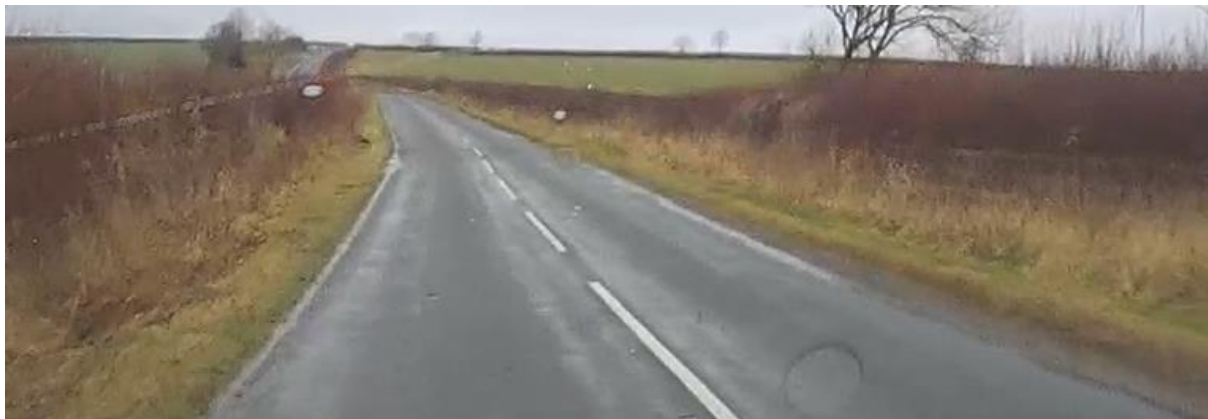
R4.13 Condition Score 40

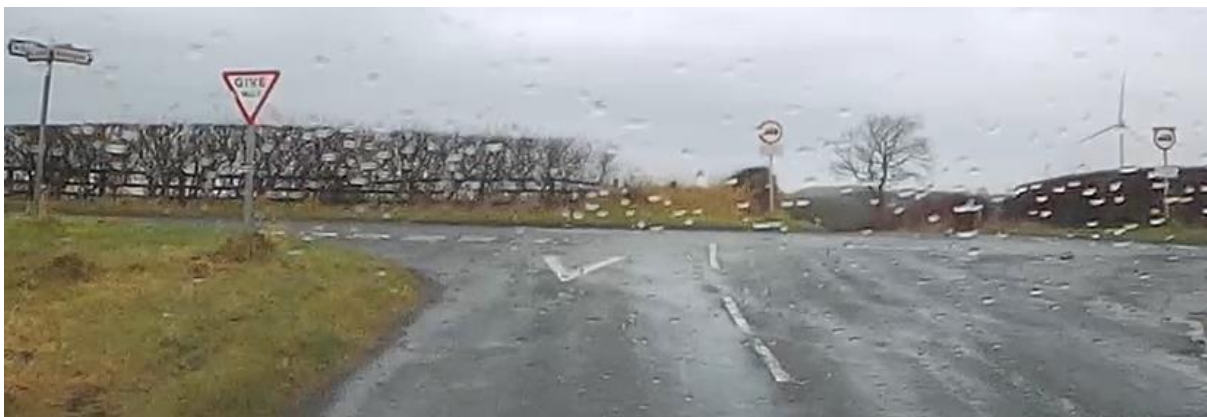
R4.15 Condition Score 30 (At Junction)

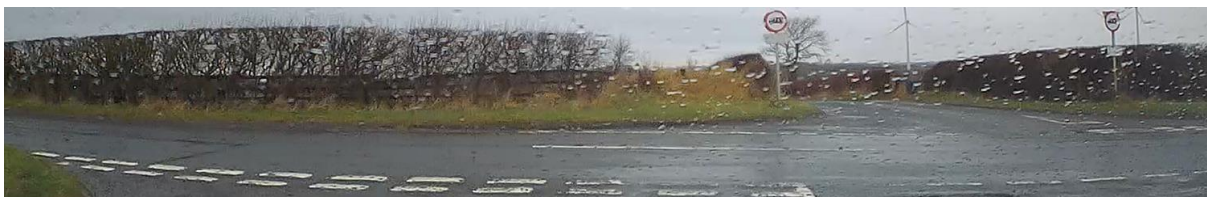
R4.16 Condition Score 30

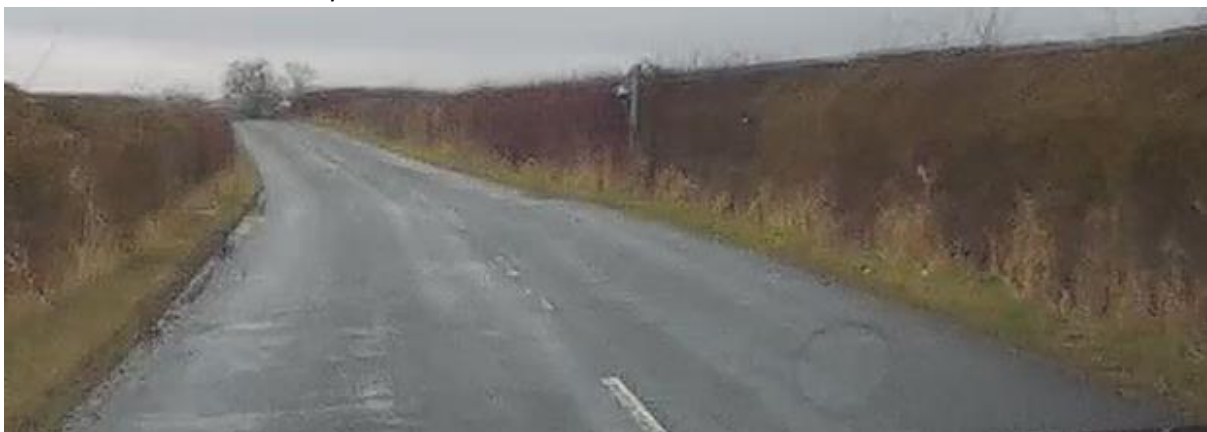
R4.17 Condition Score 10/0

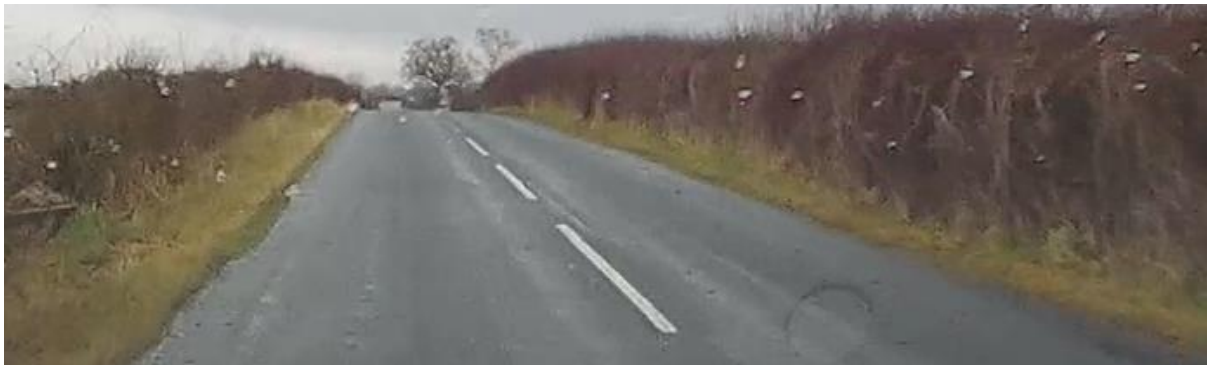
R4.18 Condition Score 20

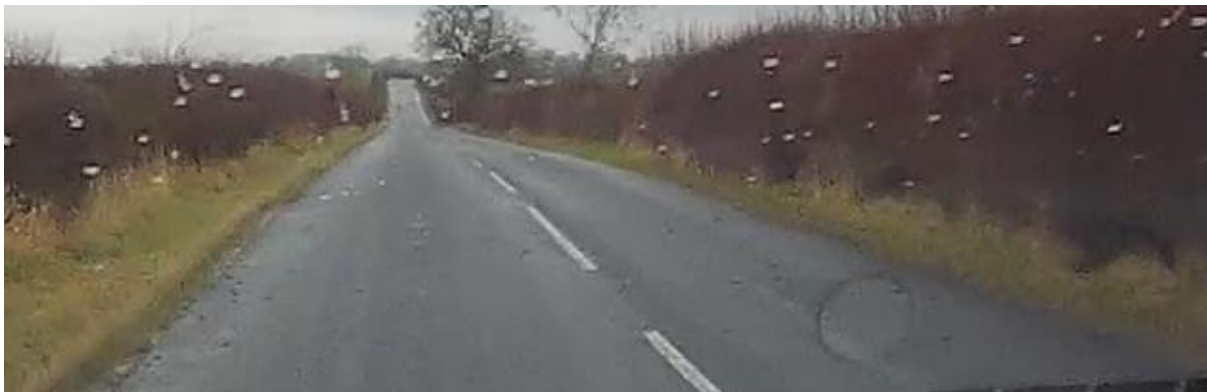
R4.19 Condition Score 20

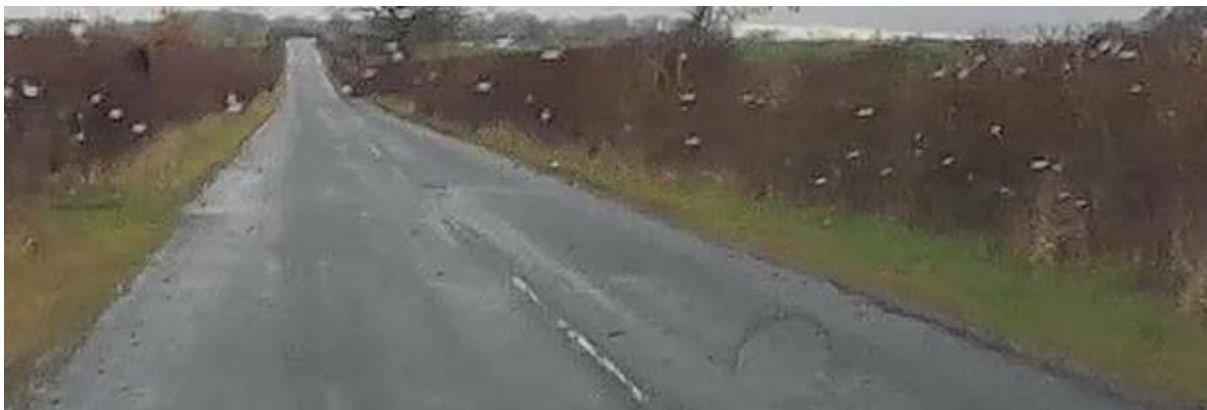
R4.20 Condition Score 0

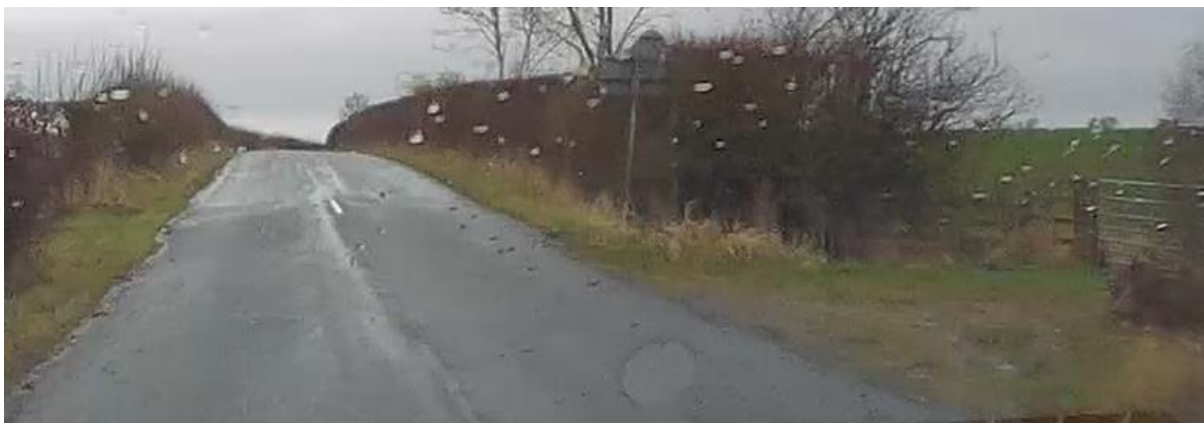
R4.22 Condition Score 0

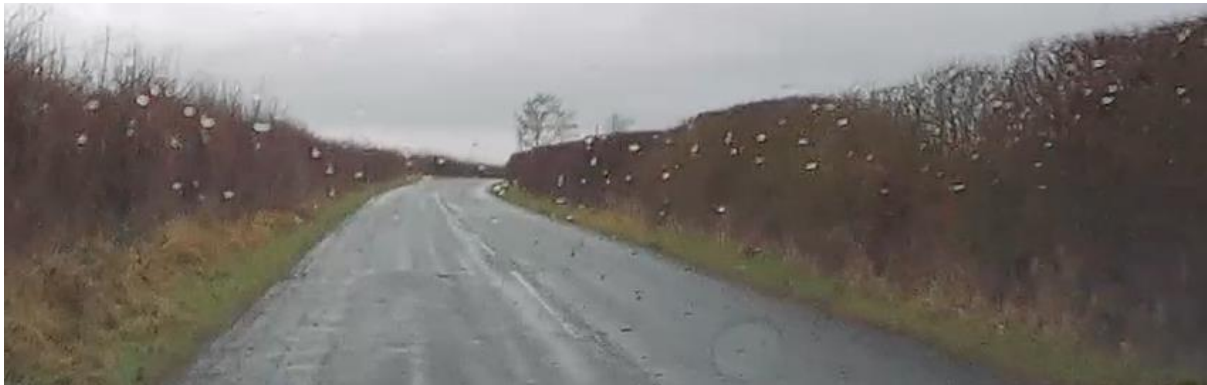
R4.23 Condition Score 0

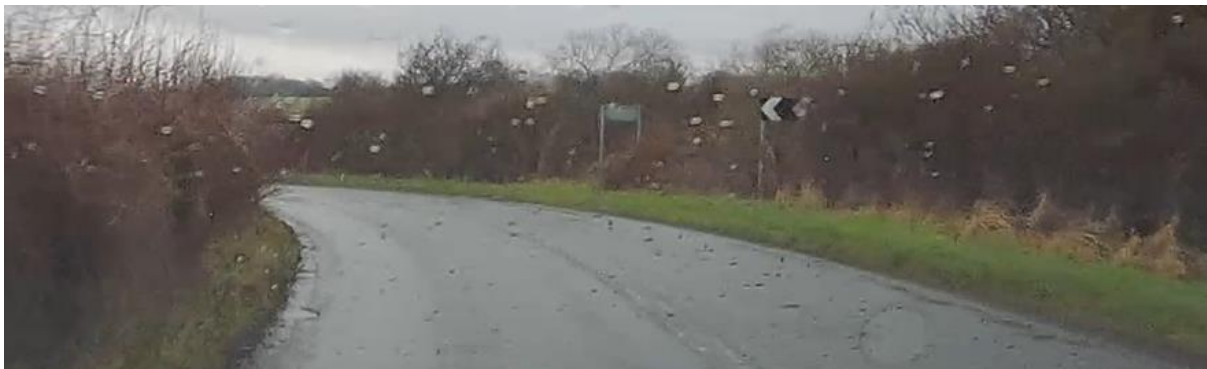
R4.25 Condition Score 0

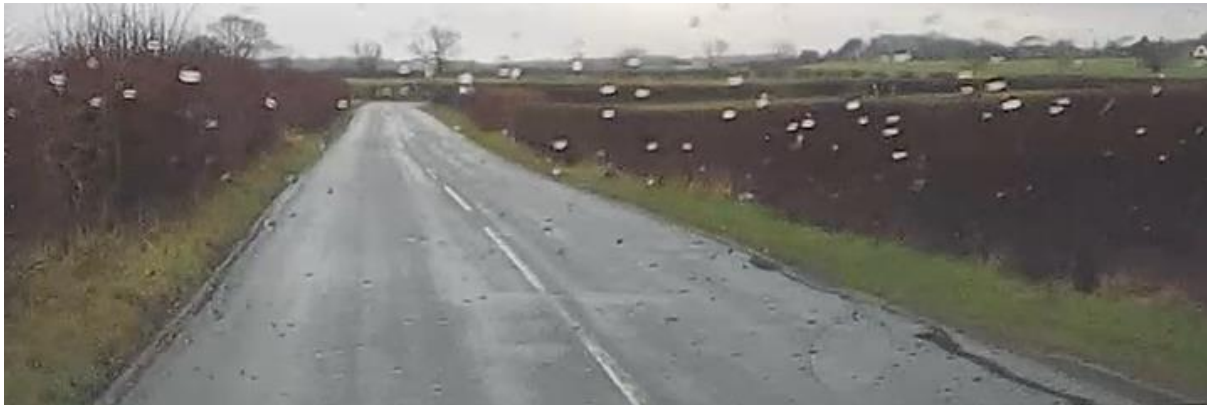
R4.26 Condition Score 10

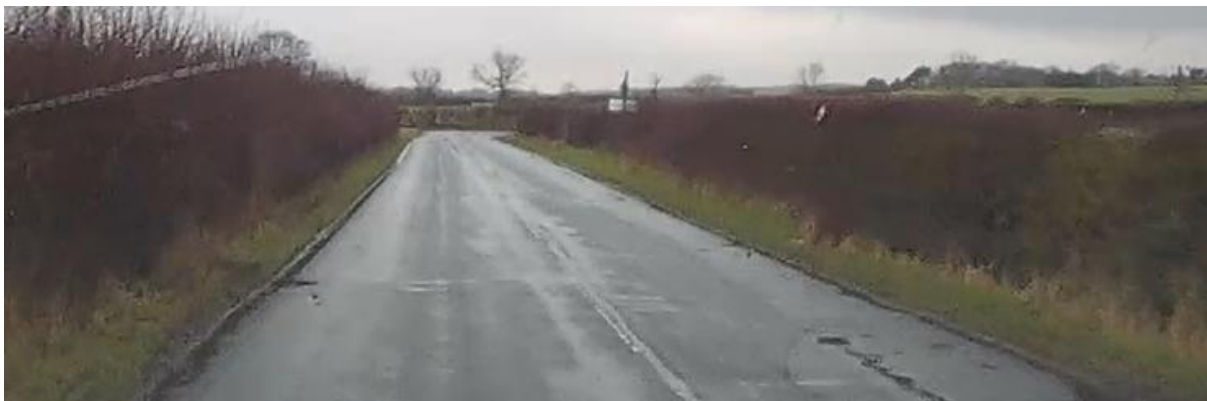
R4.27 Condition Score 0

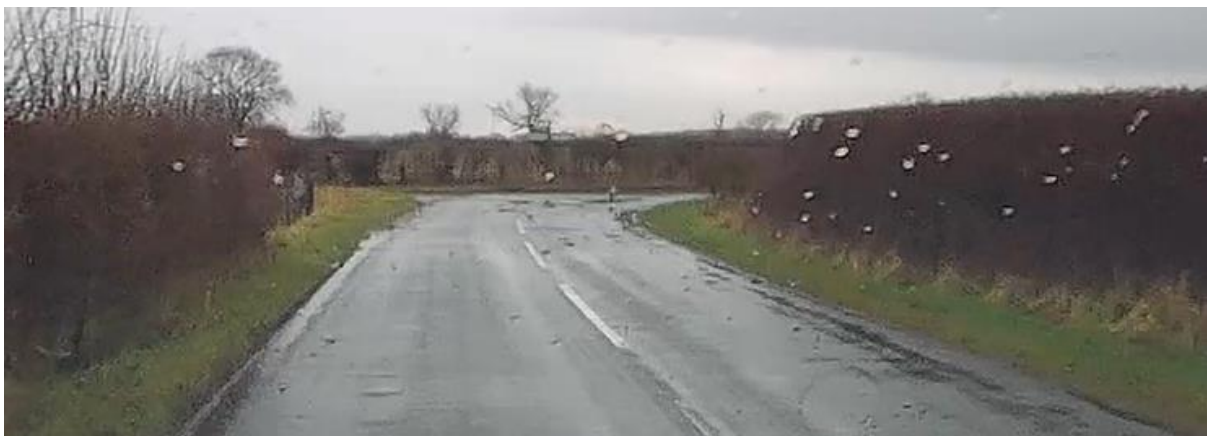
R4.28 Condition Score 0

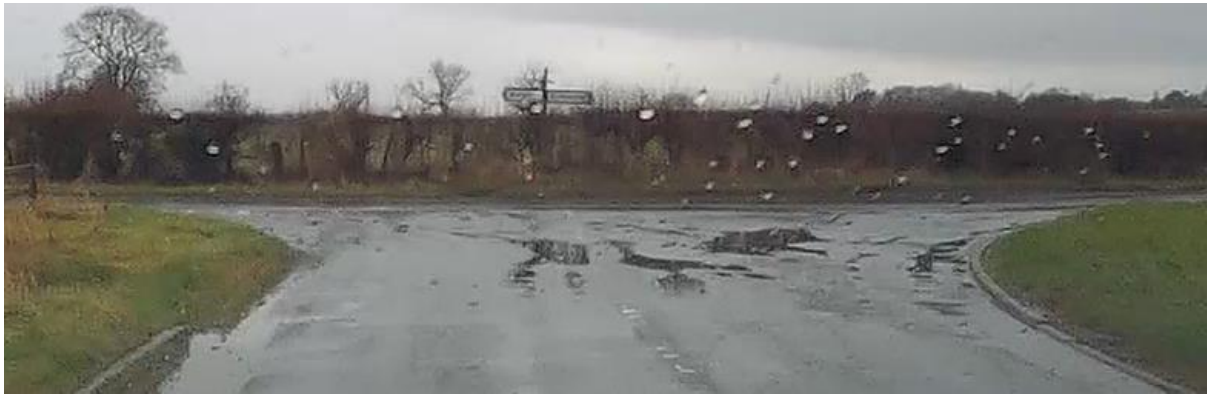
R4.29 Condition Score 0

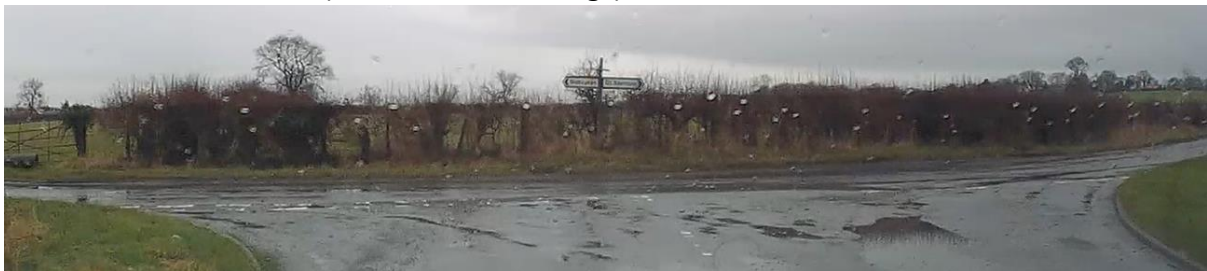
R4.30 Condition Score 0 (for Junction Markings)

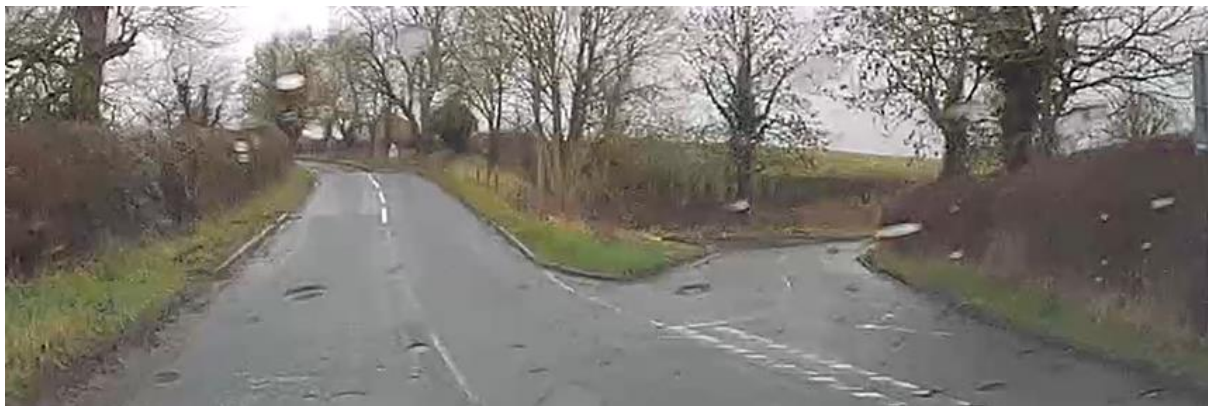
R5.1 - Condition Score 0

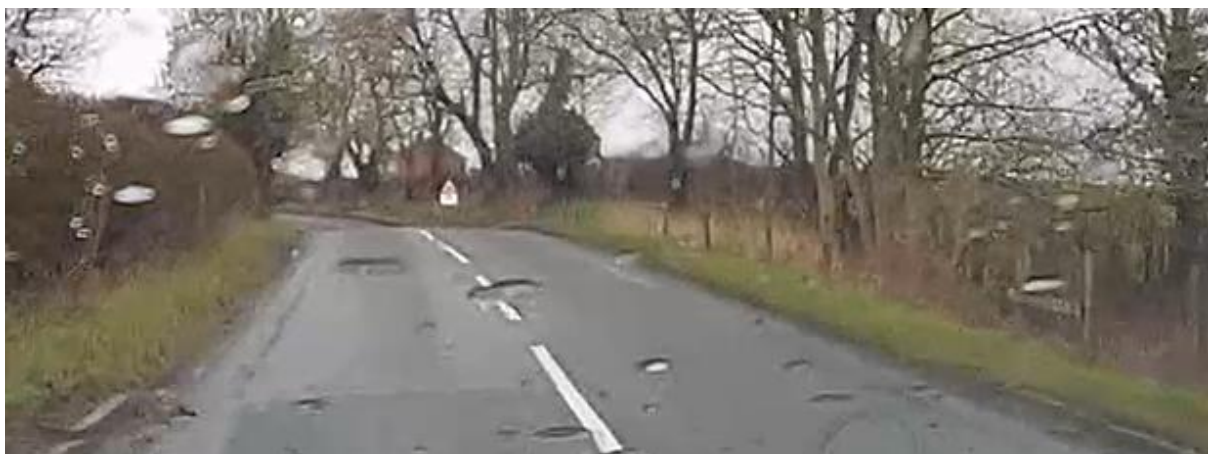
R5.2 - Condition Score 50

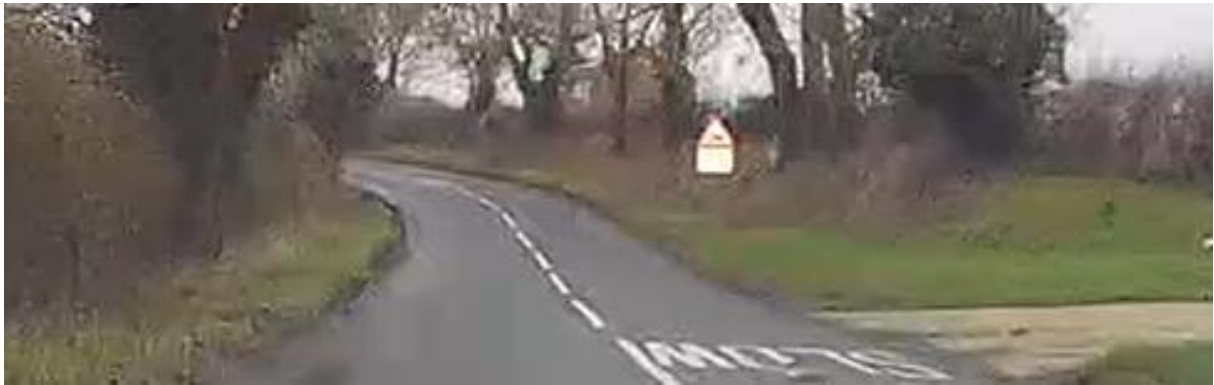
R5.3 - Condition Score 50

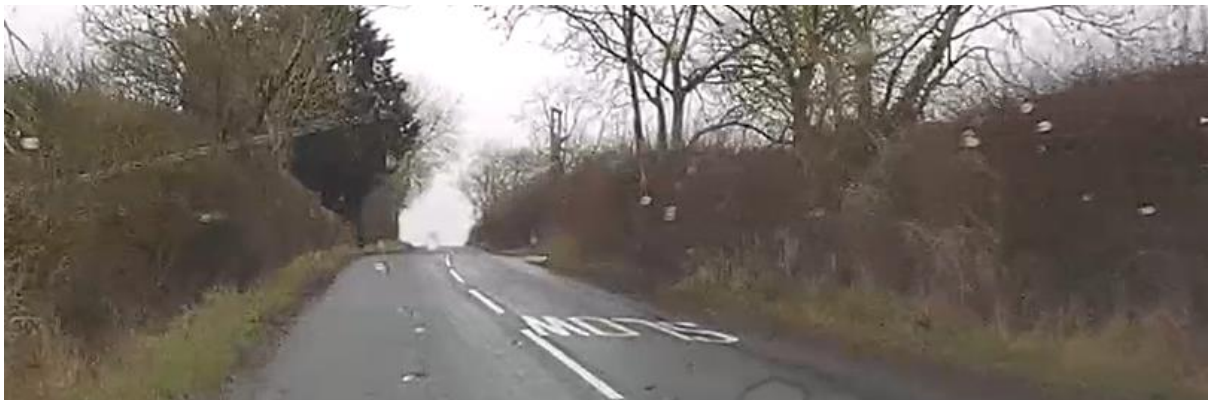
R5.4 - Condition Score 50

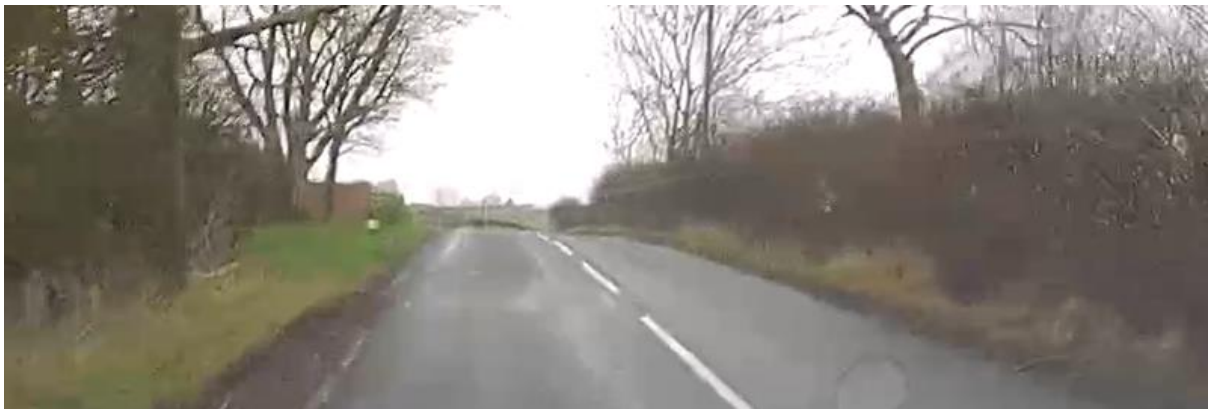
R5.5- Condition Score 50

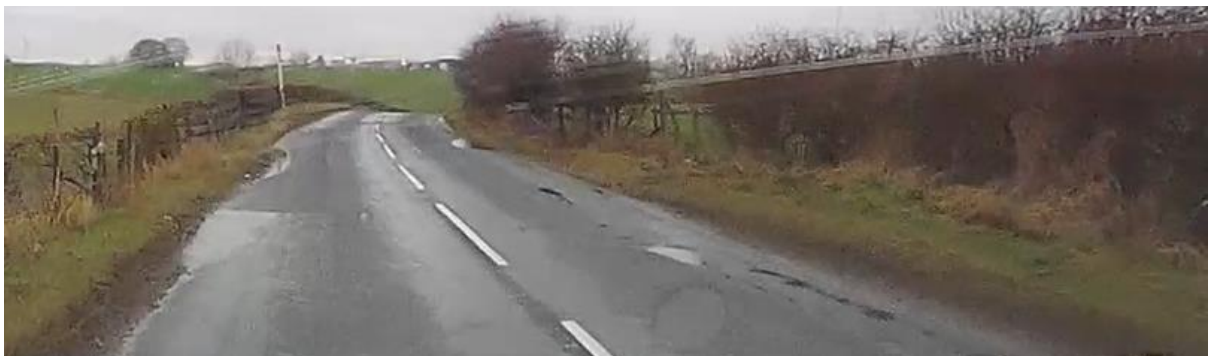
R5.6- Condition Score 50
