**Road Line Marking Assessment Report Covering Darlington
Borough Council Road Infrastructure Surrounding Bishopton
Parish Council Area.
Document Reference BPC/1/24/001**

Document Reference	Revision	Date
BPC/1/24/001A	First issue Rev A (DRAFT internal Only)	14.01.2024
BPC/1/24/001B	Formal Issue Rev B	04.02.2024

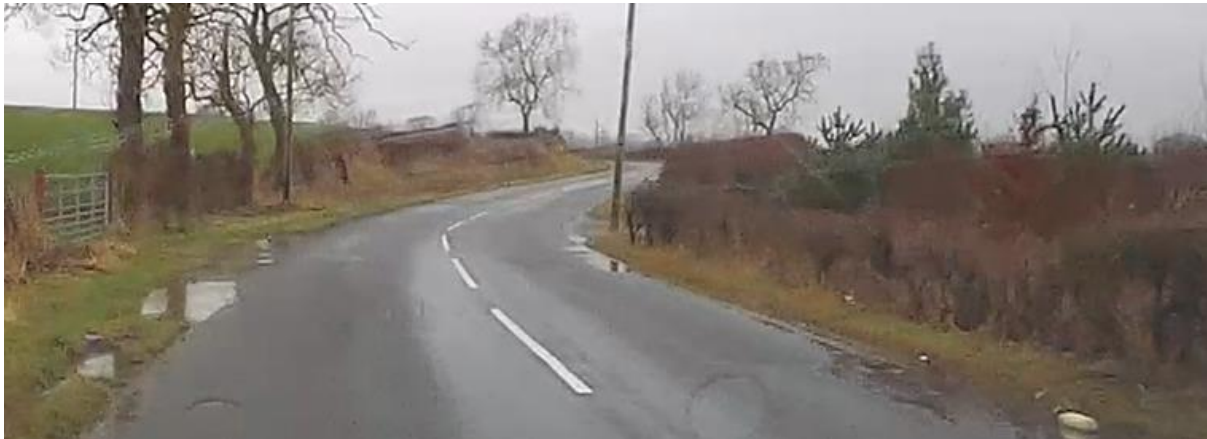
R5.7- Condition Score 50

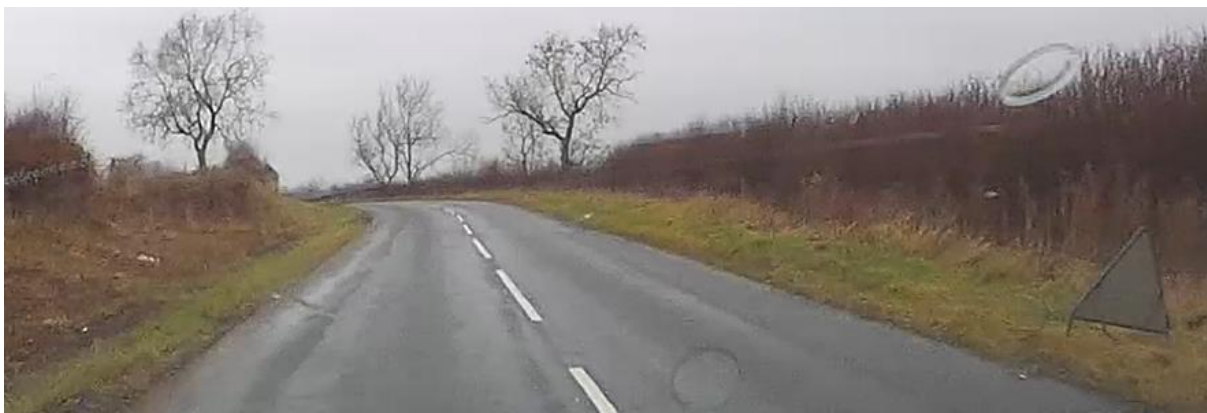
R5.8- Condition Score 50

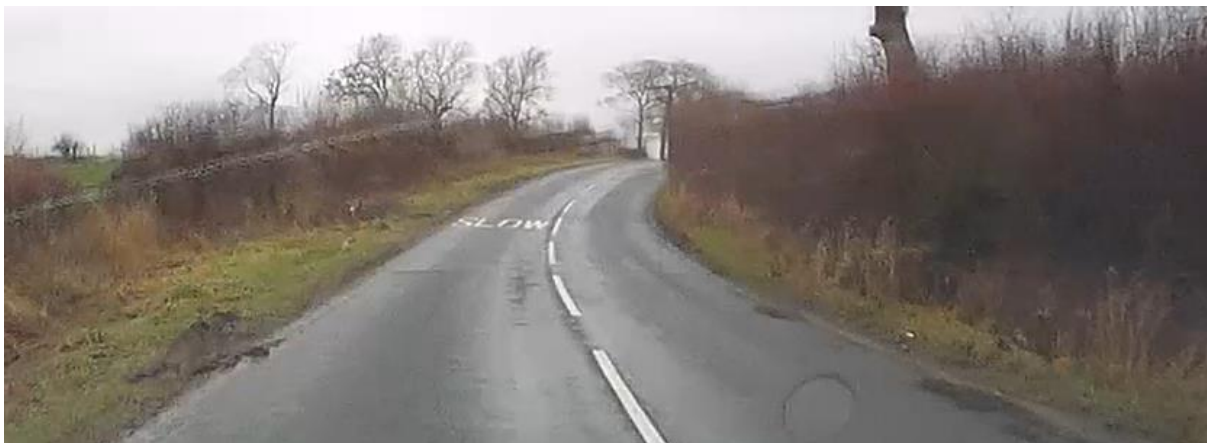
R5.9- Condition Score 50

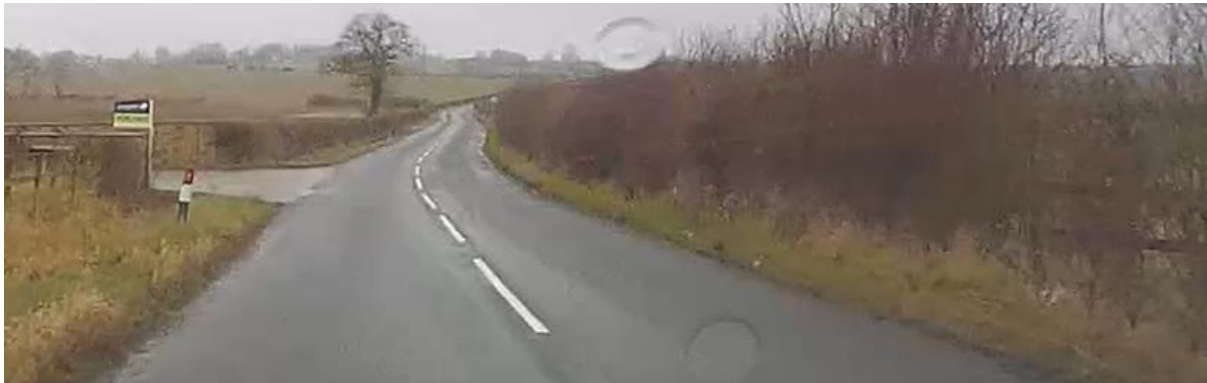
R5.10- Condition Score 50

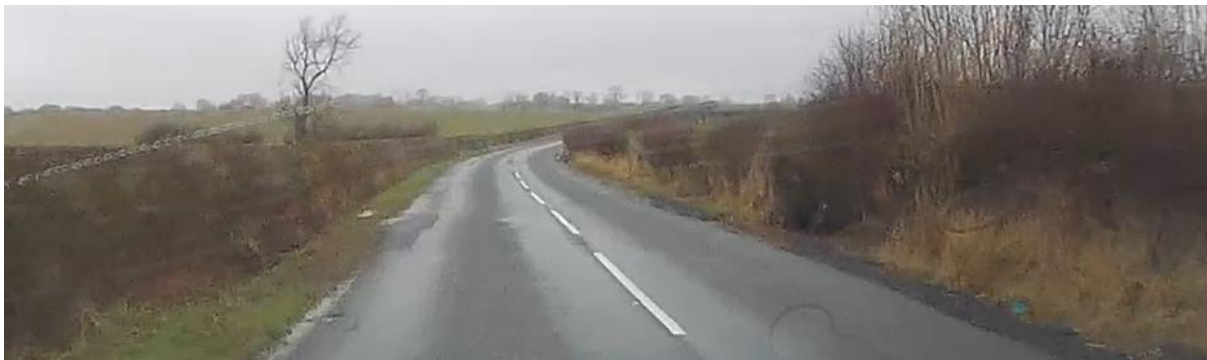
R5.11- Condition Score 50

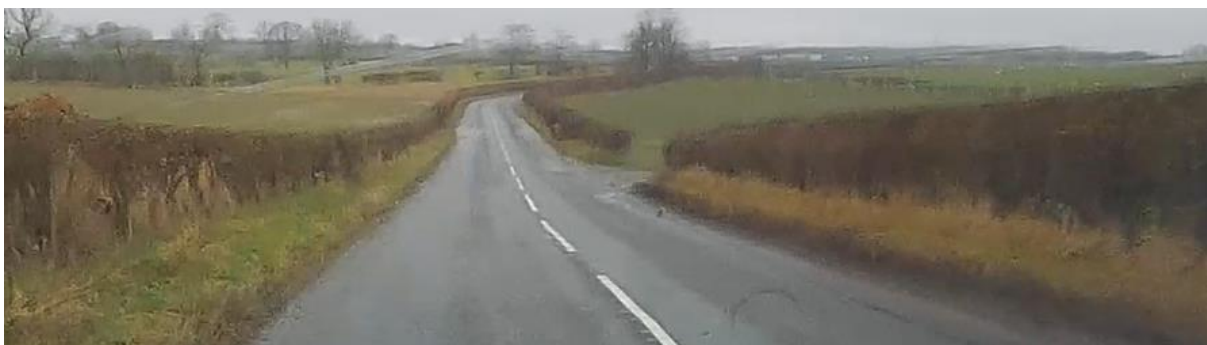
R5.12- Condition Score 50

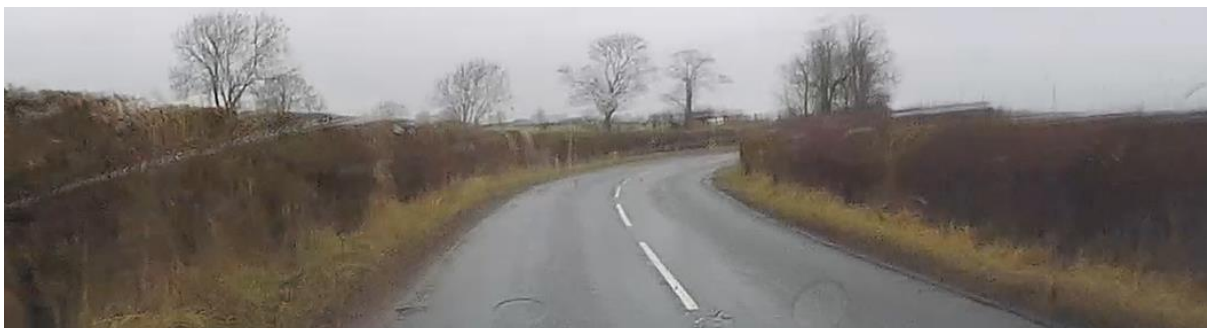
R5.13- Condition Score 50

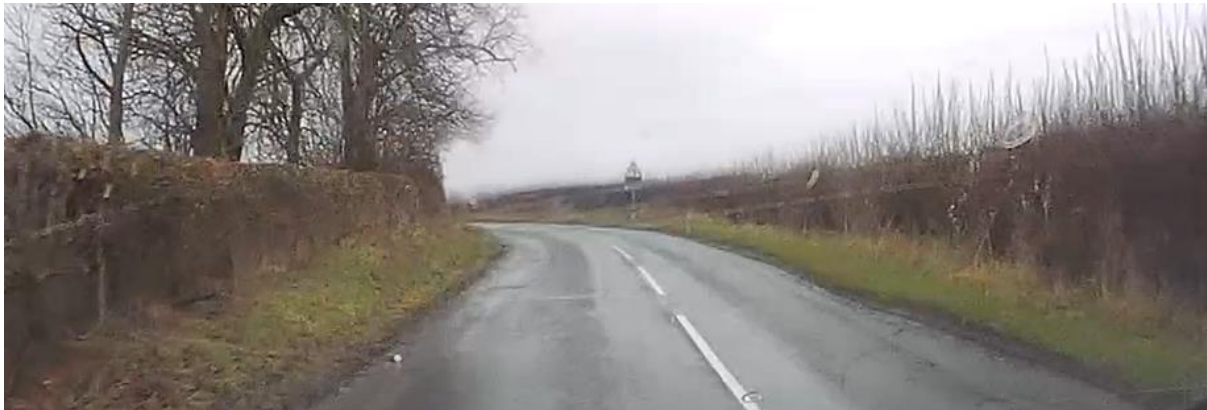
R5.14- Condition Score 50

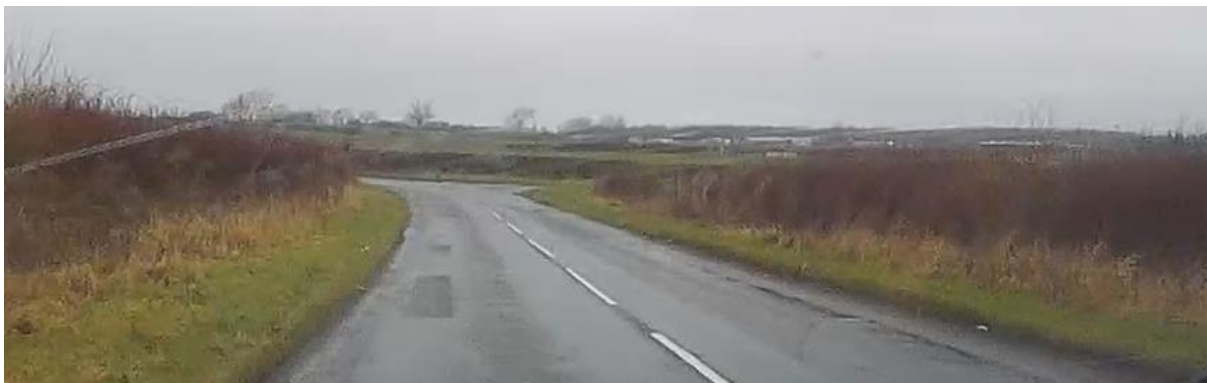
R5.15- Condition Score 50

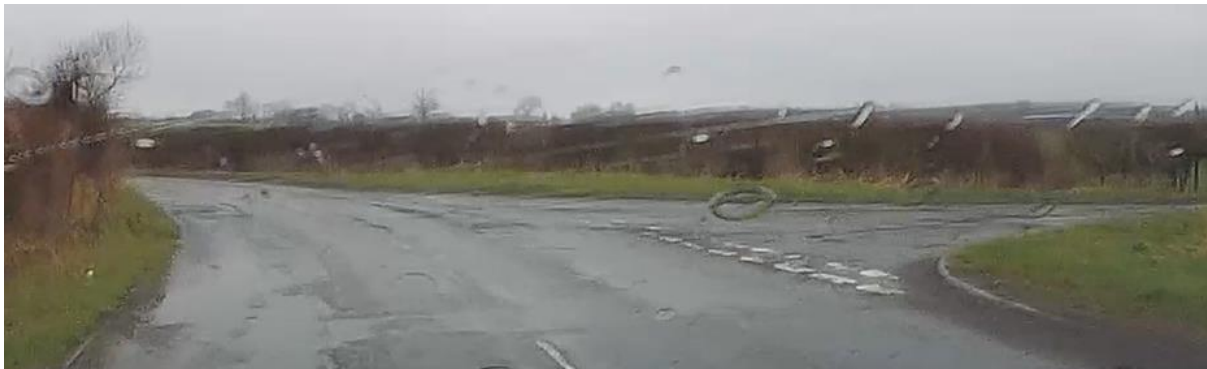
R5.16- Condition Score 0 (blind bend)

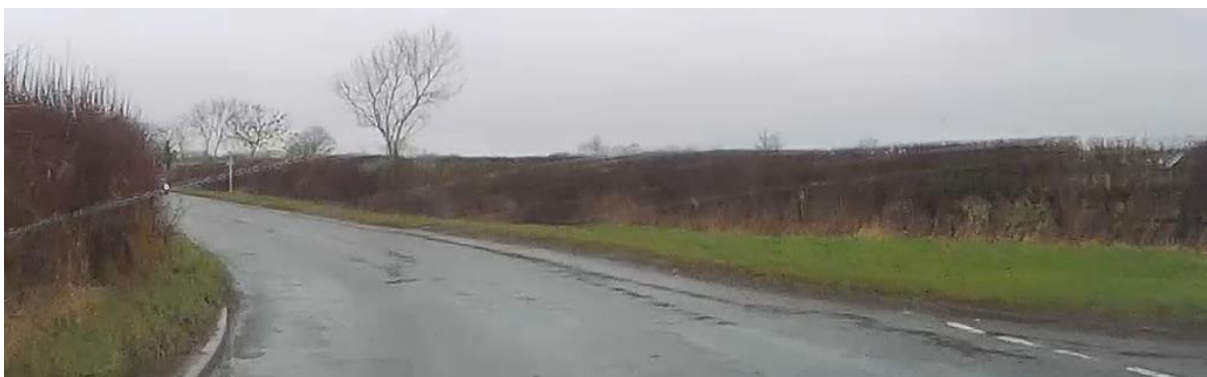
R5.17 - Condition Score 0

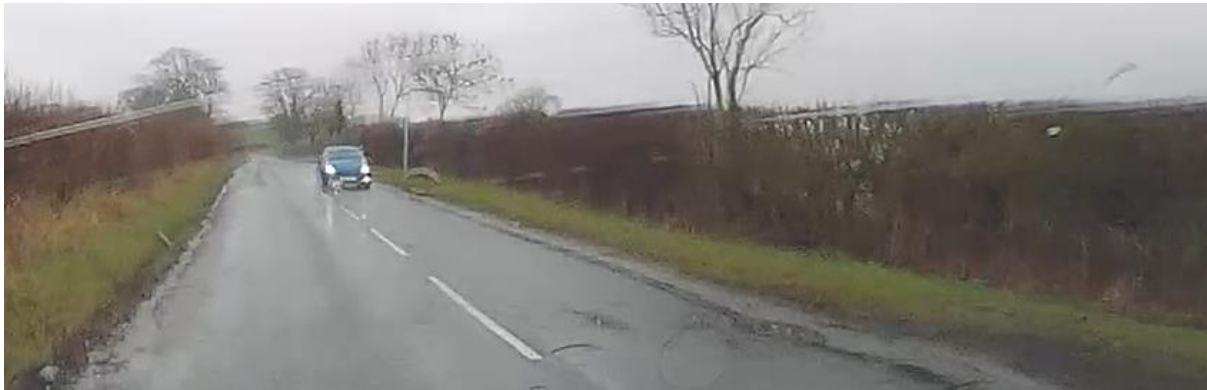
R5.18 - Condition Score 50

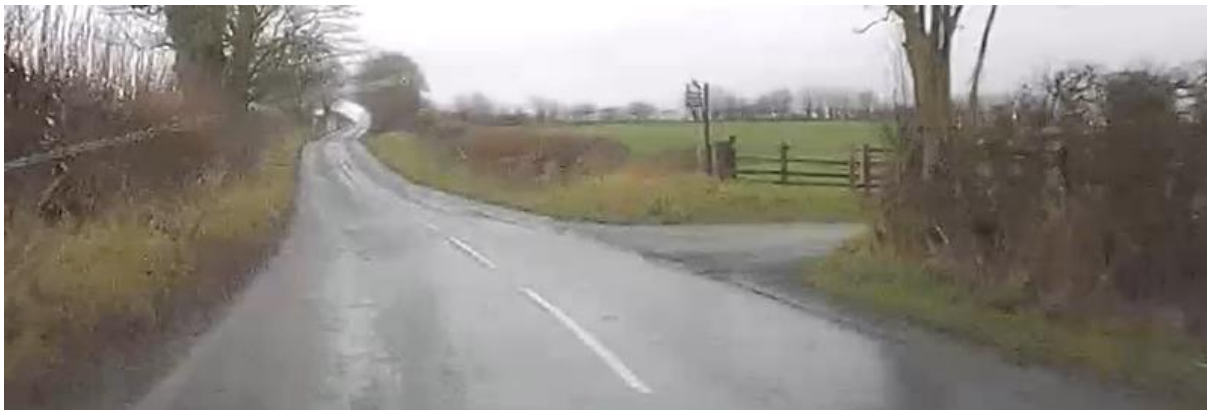
R5.20 - Condition Score 50

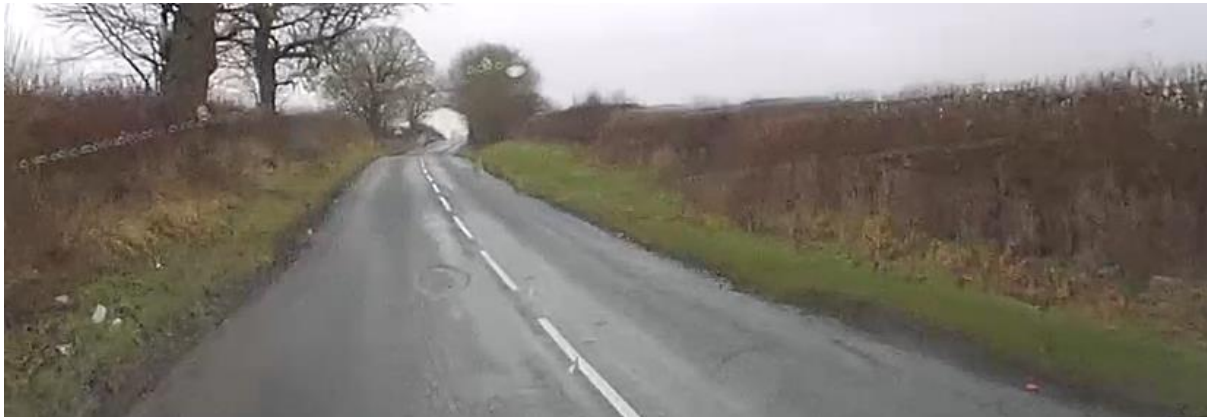
R5.21 - Condition Score 50

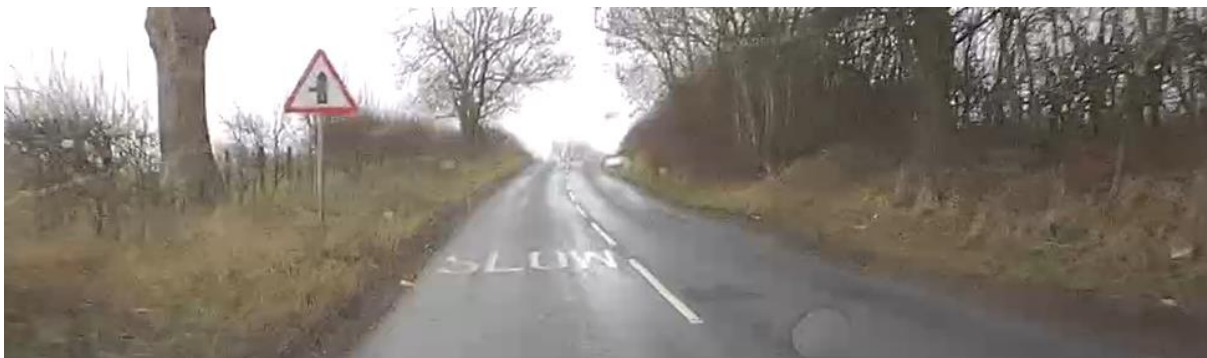
R5.22 - Condition Score 50

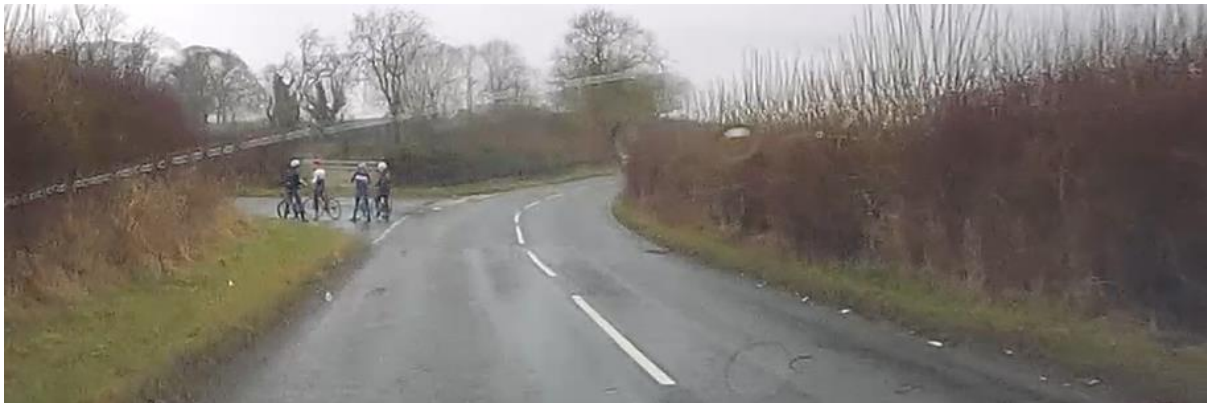
R5.23 - Condition Score 50

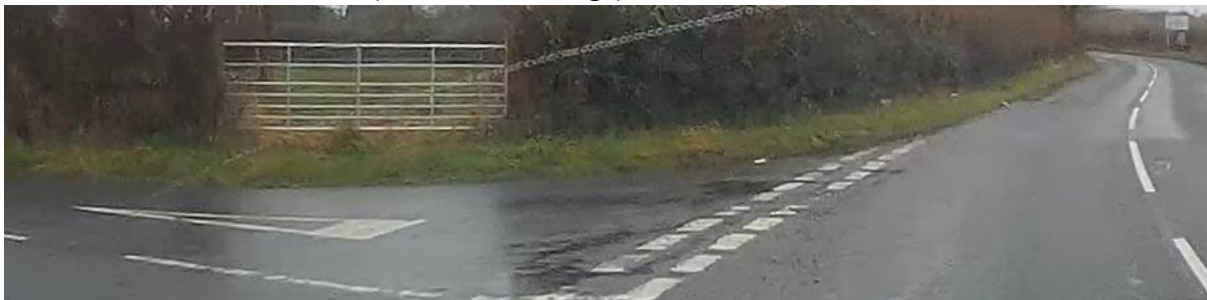
R5.23a - Condition Score 40 (Junction markings)

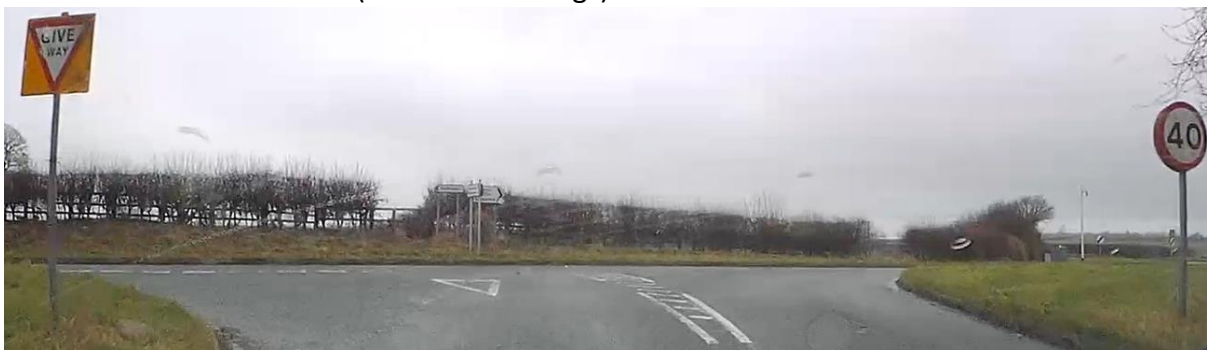
R5.26 - Condition Score 40 (Junction markings)

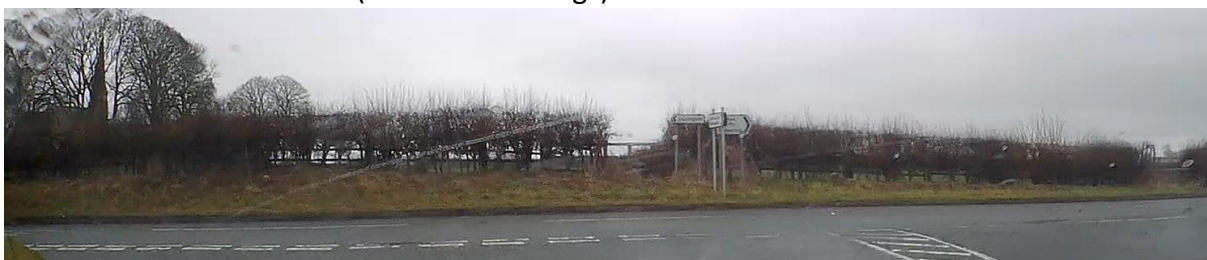
R5.27 - Condition Score 40 (Junction markings)

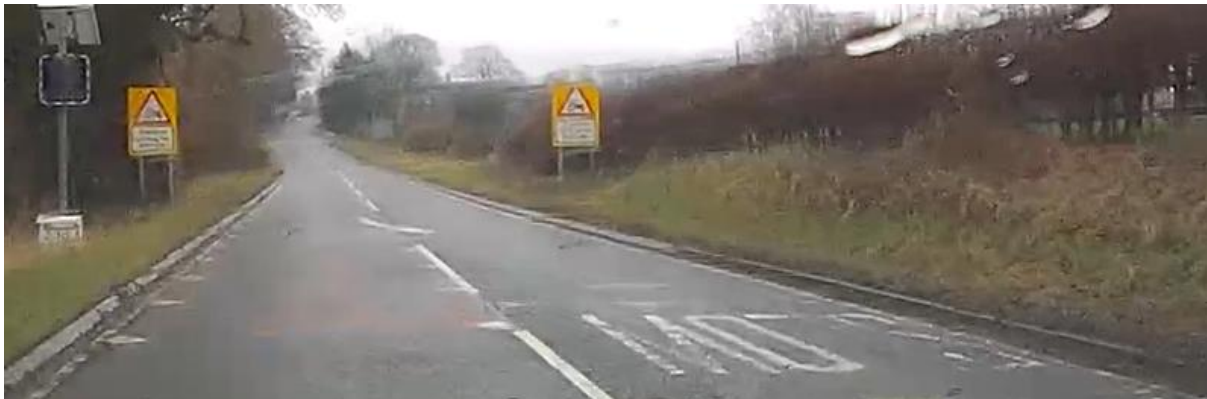
R6.2– Condition 20 (Slow Sign North)

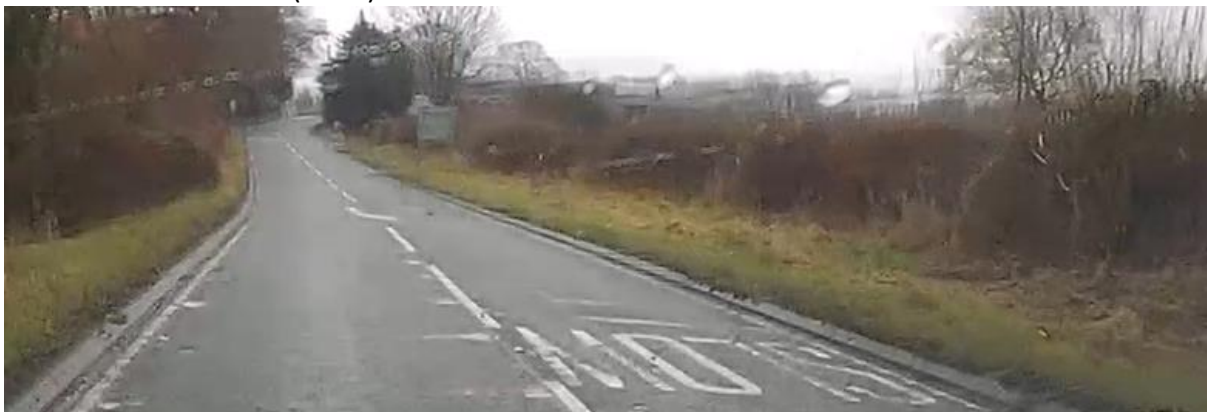
R6.3 – Condition 30 (Slow Sign North)
Condition 10 (Markers)
Condition 40 (Lines)

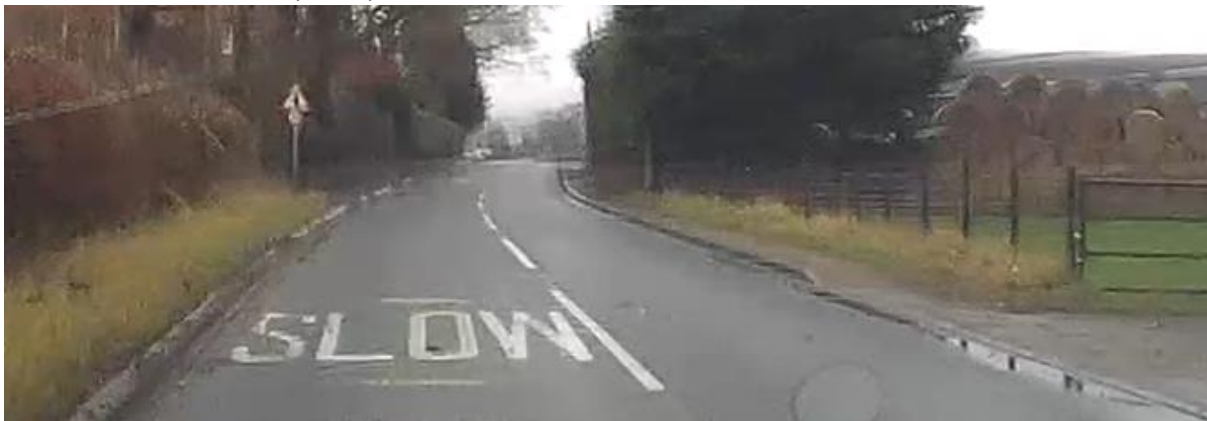
- R6.5 – Condition 0 (road shoulder ,markings))
Condition 30 (slow
Condition 40 (Lines)

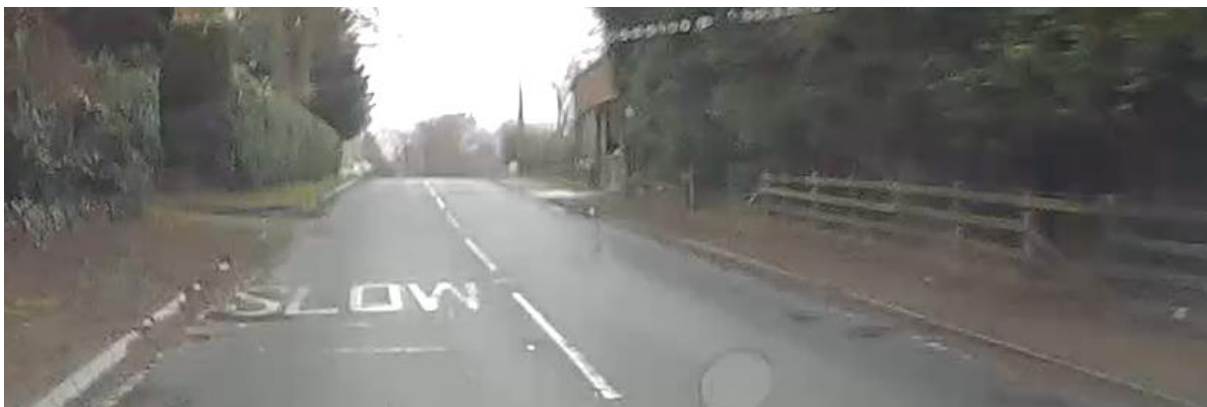
- R6.6 – Condition 0 (road shoulder ,markings))
Condition 40 (slow
Condition 40 (Lines)

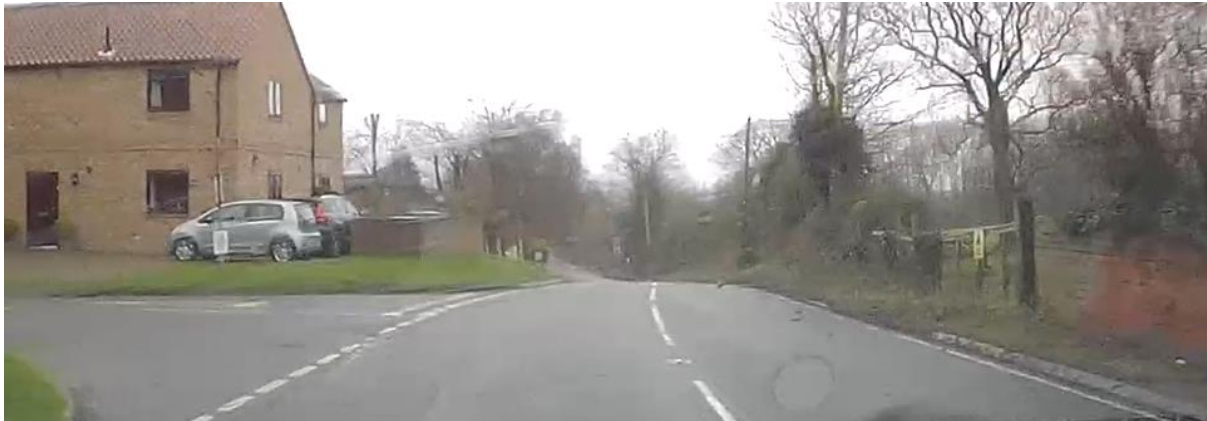
R6.7 – Condition 20 (road shoulder ,markings))
Condition 40 (junction markings)
Condition 30 (Lines)

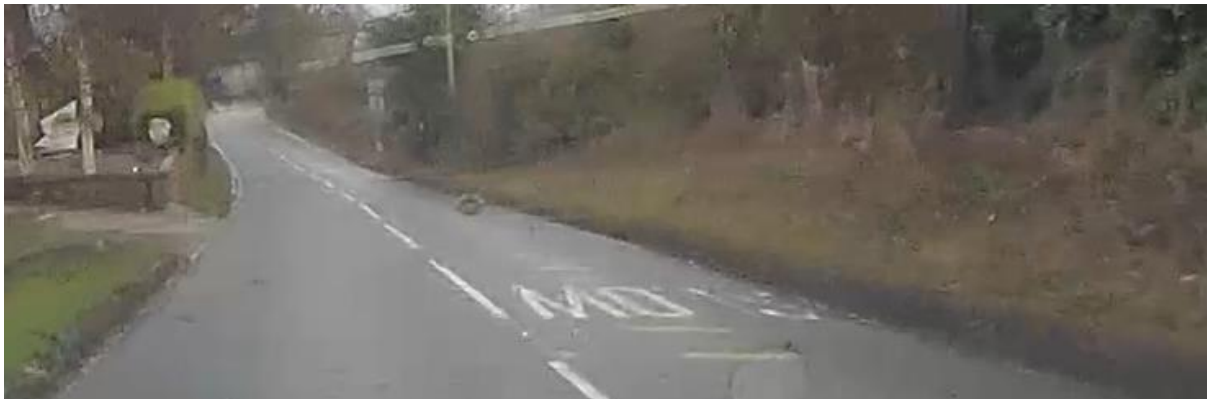
R6.8 – Condition 0 (road shoulder ,markings))
Condition 30 (slow sign)
Condition 30 (Lines)

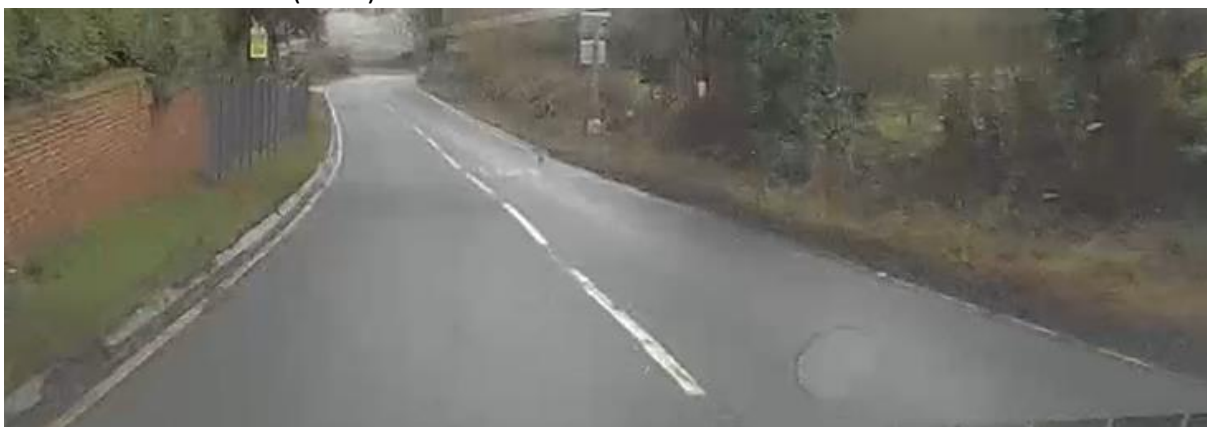
R6.9 – Condition 20 (road shoulder ,markings))
Condition 20 (Lines)

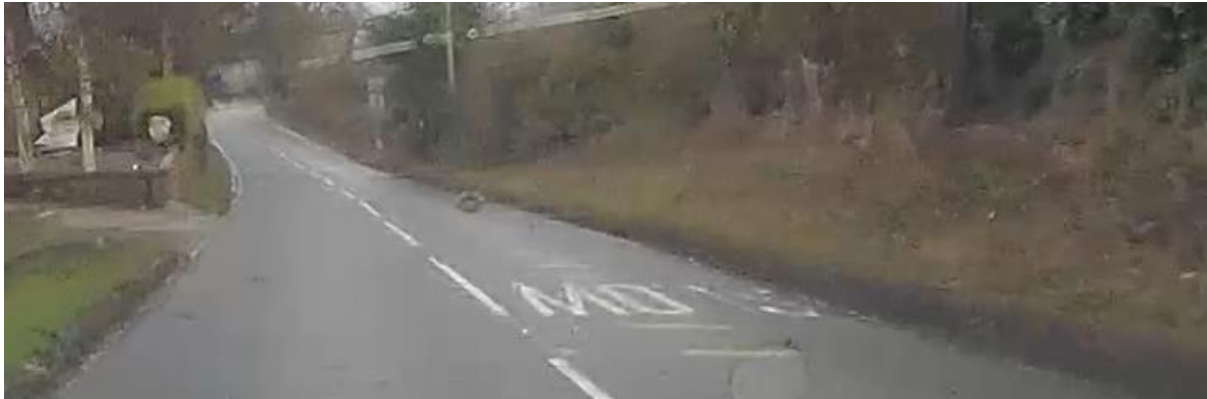
R6.10– Condition 0 (road shoulder ,markings))

Condition 30 (slow sign)

Condition 30 (Lines)

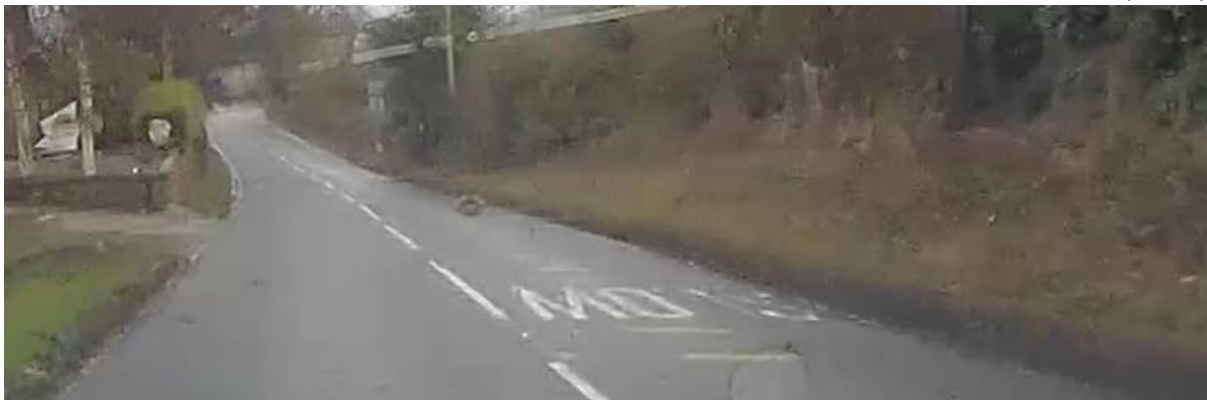
R6.11– Condition 0 (road shoulder ,markings))

Condition 20 (slow sign)

Condition

30

(Lines)

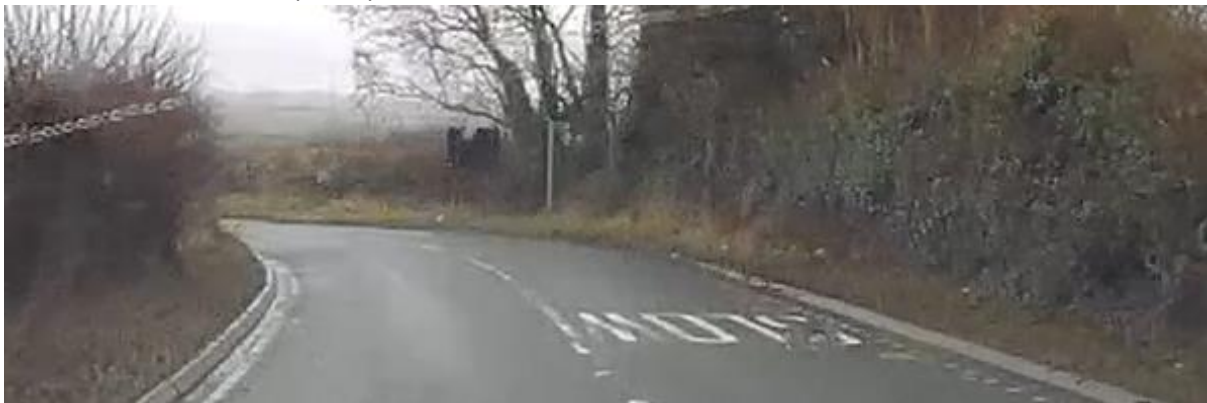
R6.14 – Condition 20 (road shoulder ,markings))

Condition 30 (slow sign)

Condition 30 (Lines)

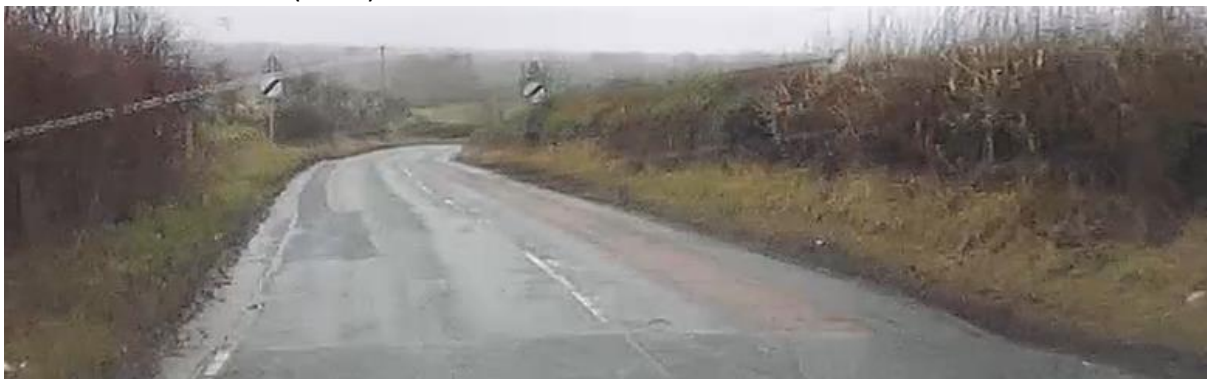
R6.15 – Condition 0 (road shoulder ,markings))

Condition 20 (Lines)

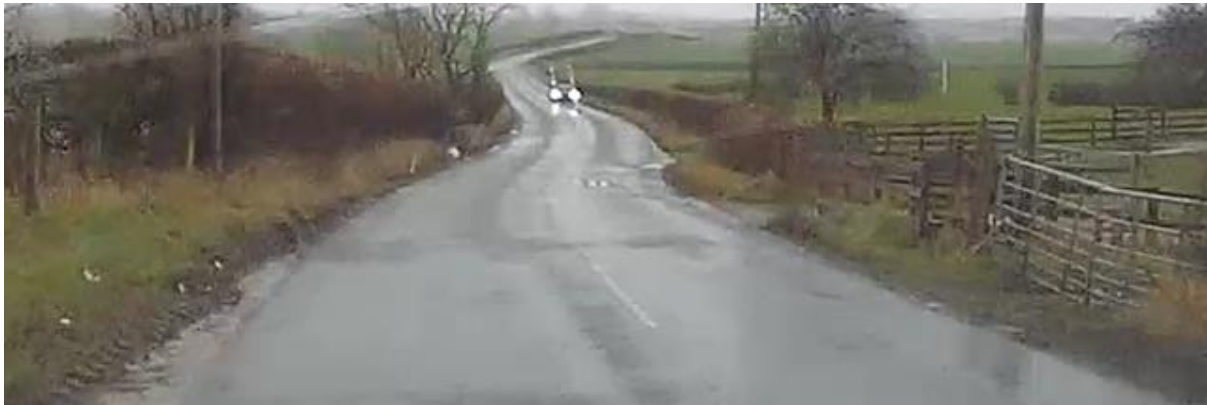
R6.16 – Condition

10

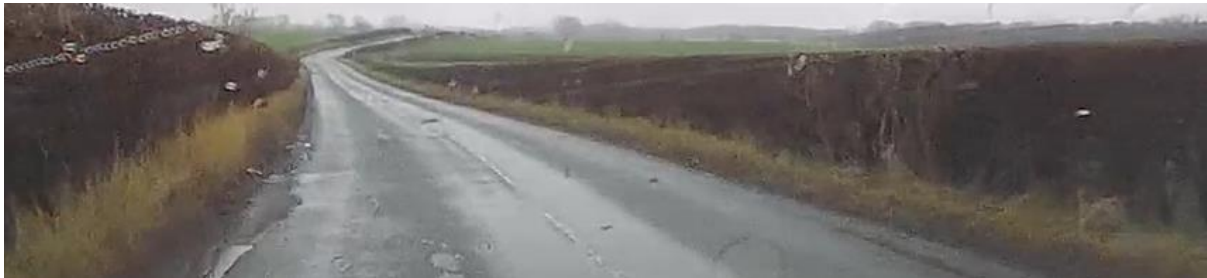
R6.17 – Condition 10

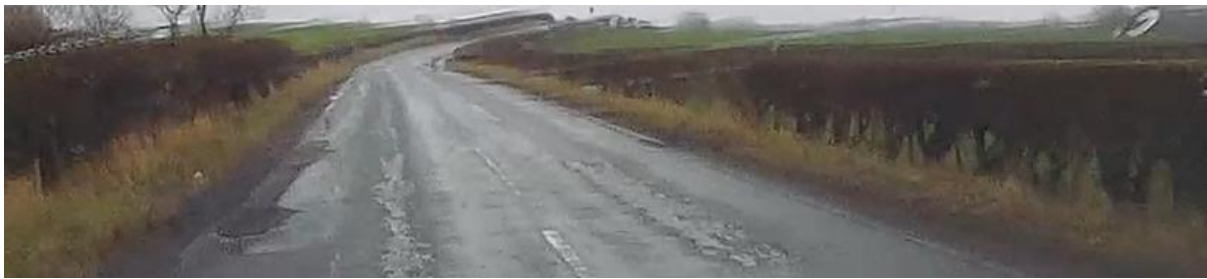
R6.18 – Condition 0

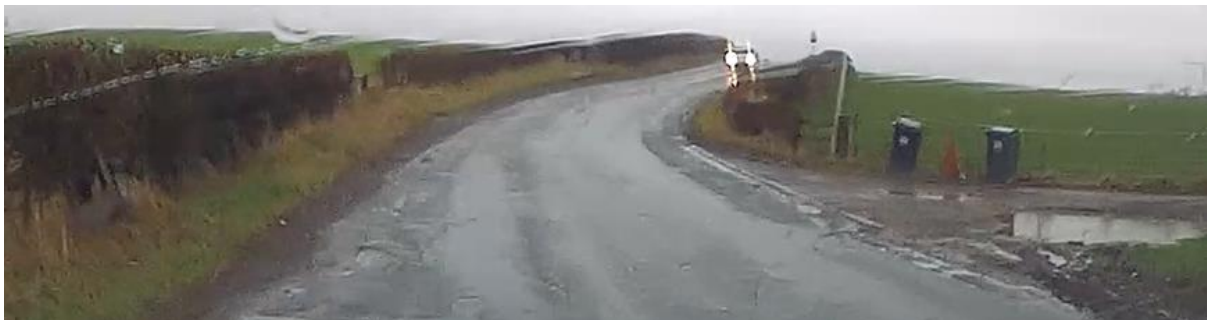
R6.19 – Condition 0

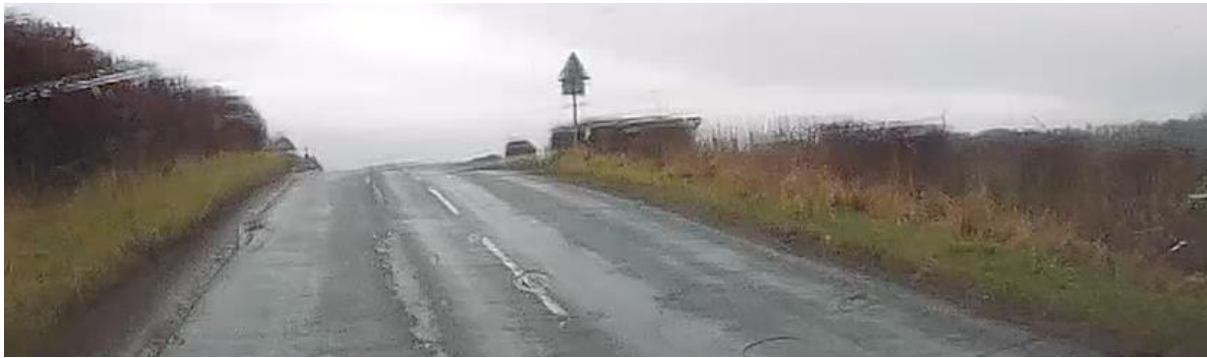
R6.20 – Condition 20

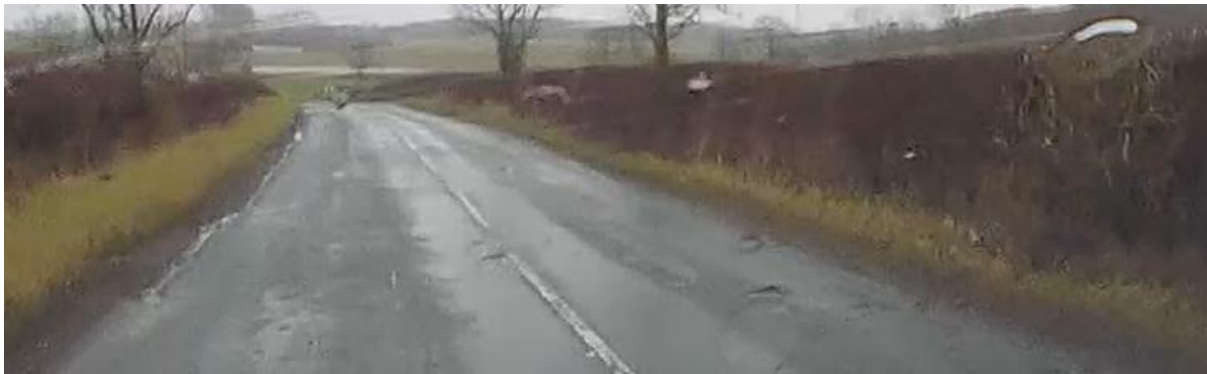
R6.21 – Condition 10

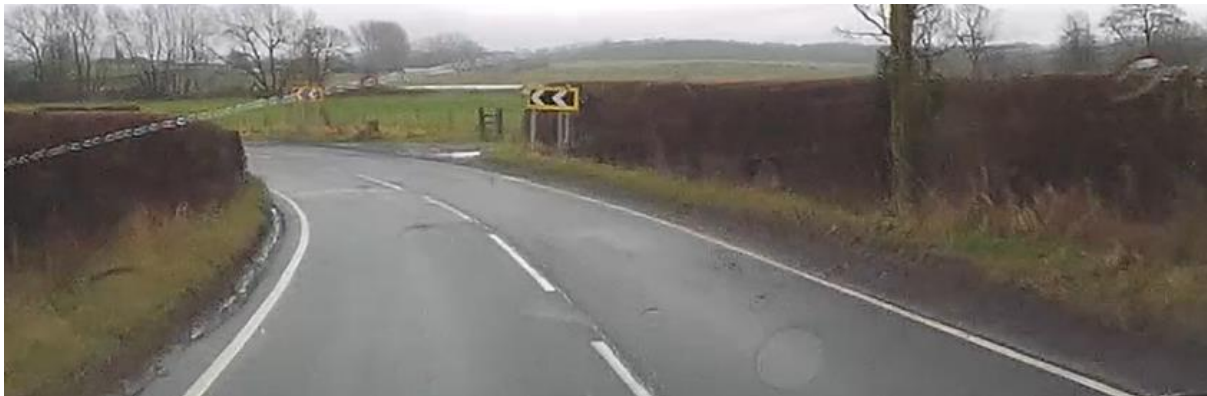
R6.22 – Condition 50 Shoulder markings
Condition 50 Lines

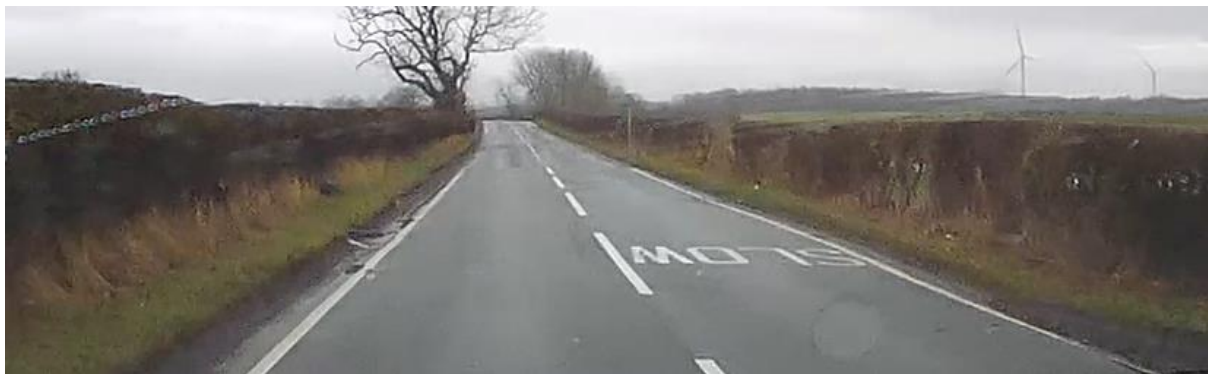
R6.23 – Condition 50 Shoulder markings
Condition 50 Lines

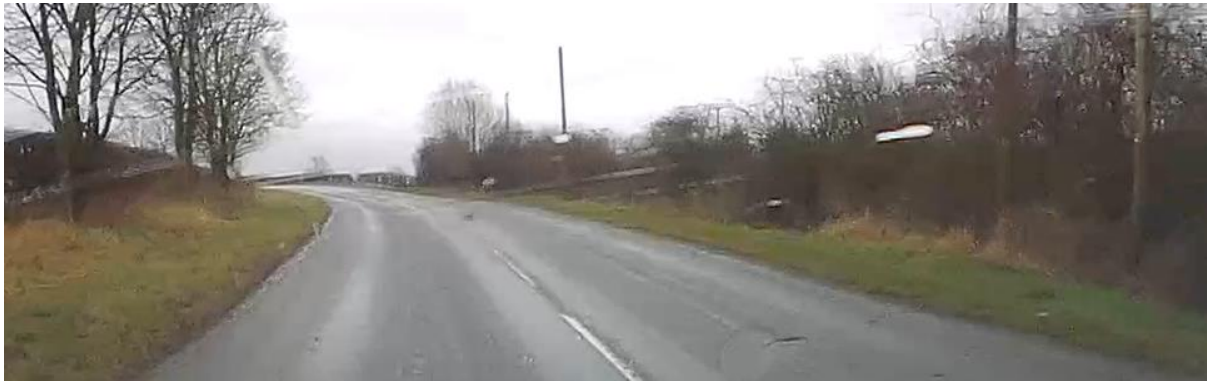
R6.26 Condition 20 Lines

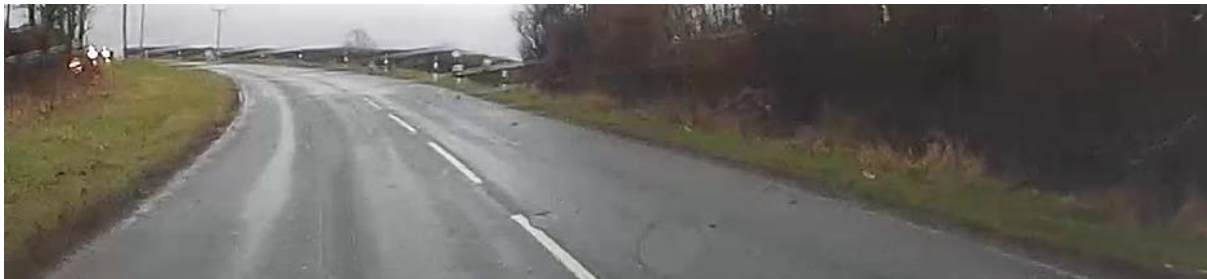
R6.27 Condition 30 Lines

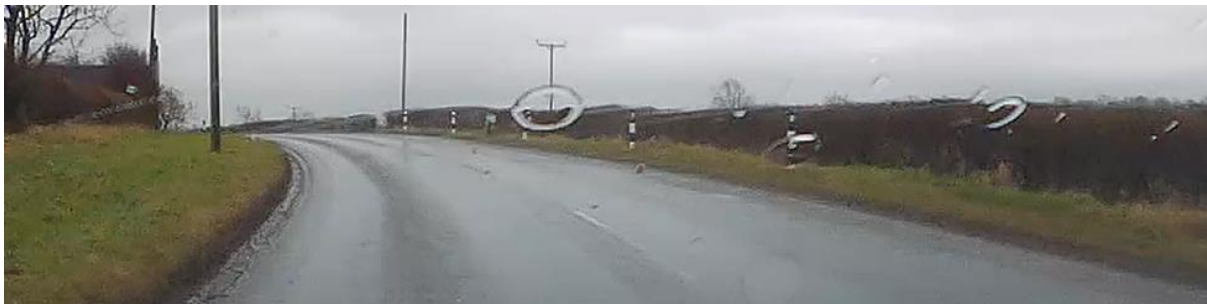
R6.28 Condition 10 Lines

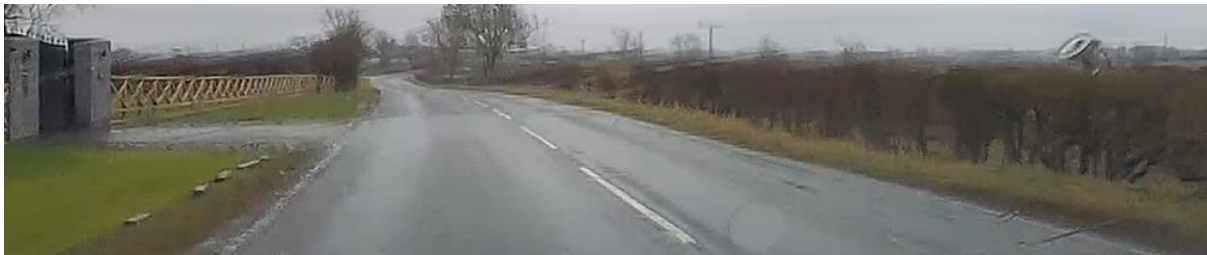
R6.29 Condition 40 Lines

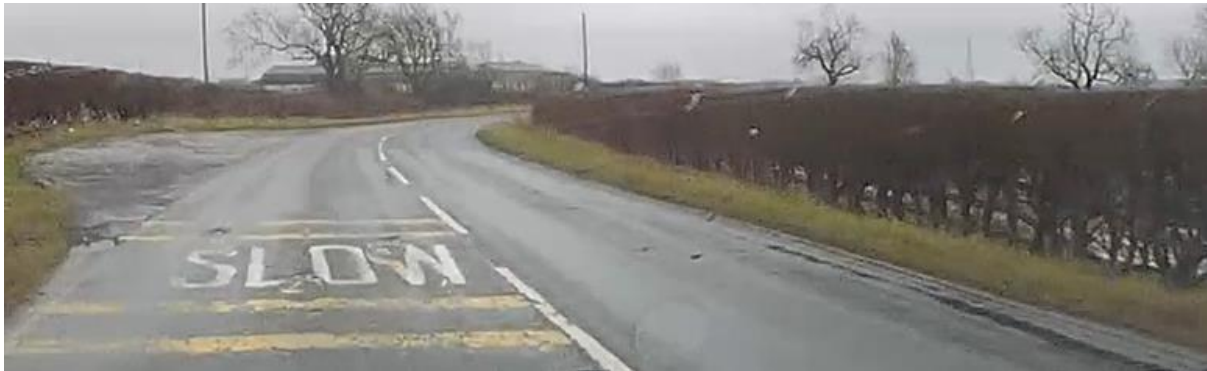
R6.30 Condition 40 (Lines)
40 (slow)

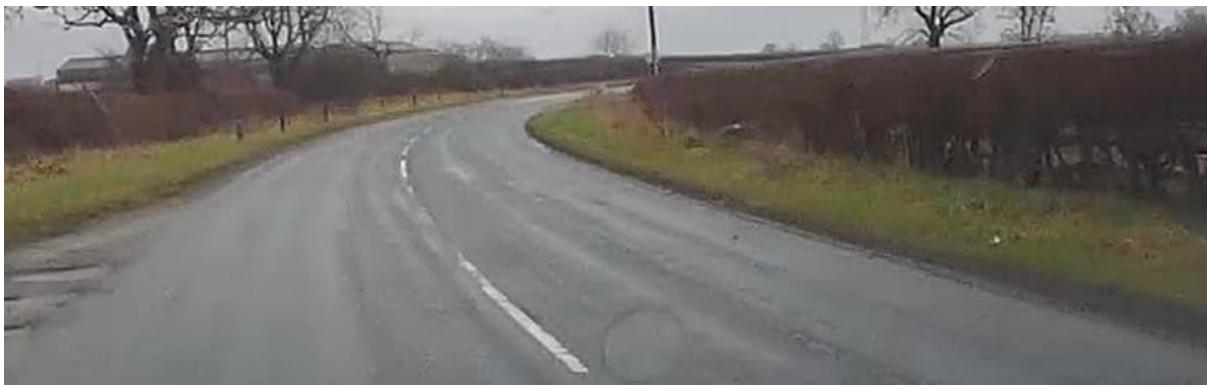
R6.31 Condition 20 Lines

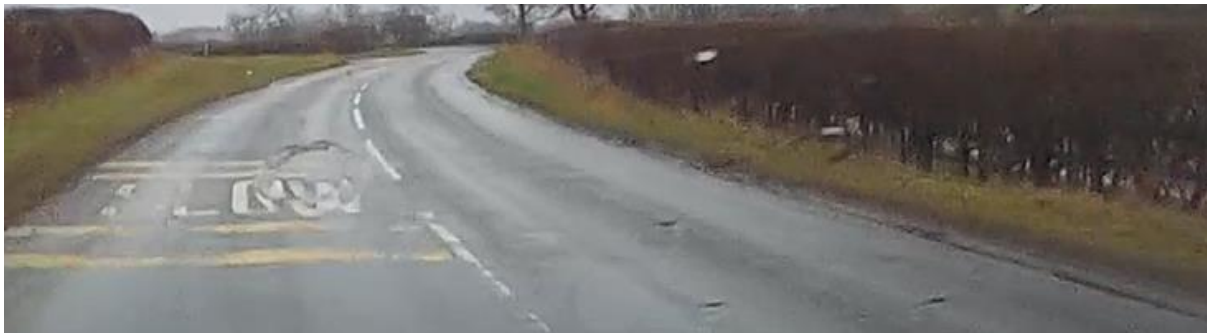
R6.32 Condition 20 Lines
30 (slow)

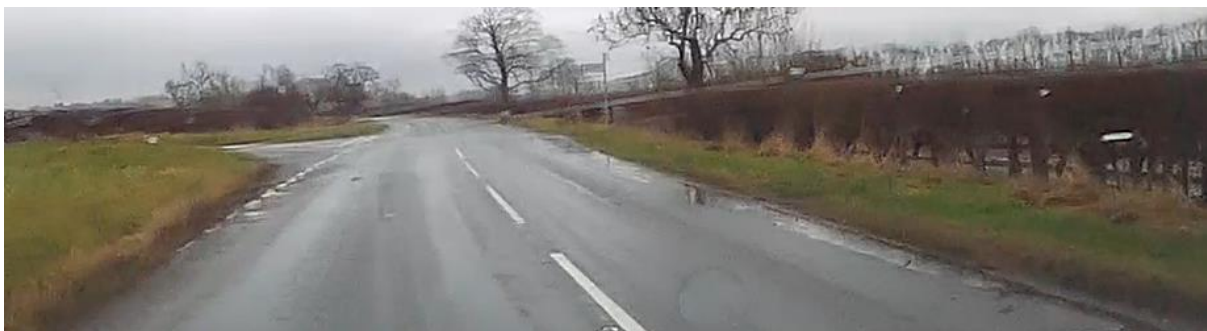
R6.33 Condition 30 Lines

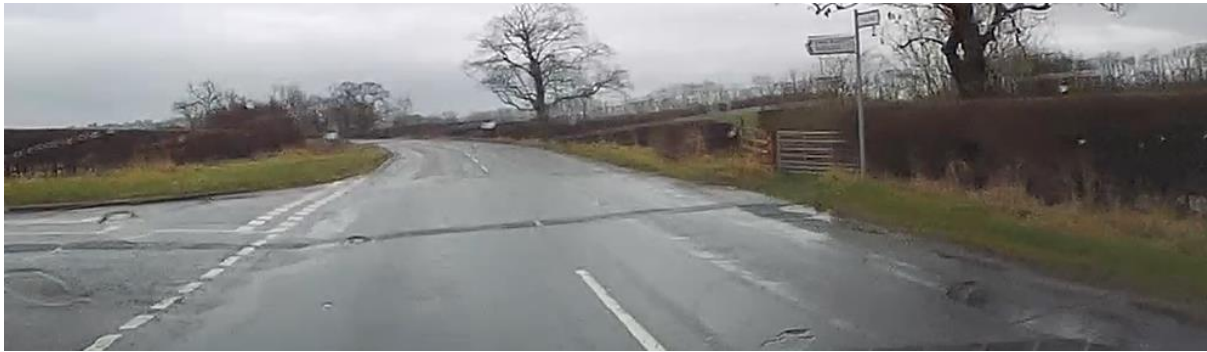
R6.34 Condition 0 Lines

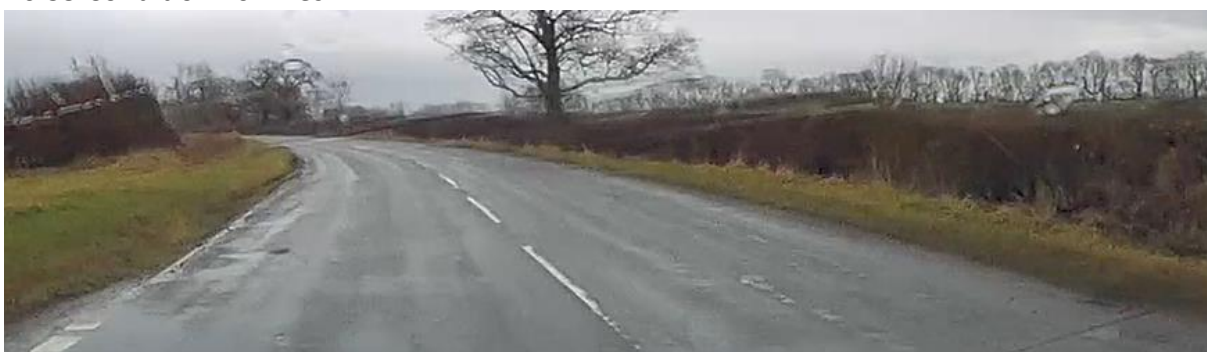
R6.35 Condition 20 Lines

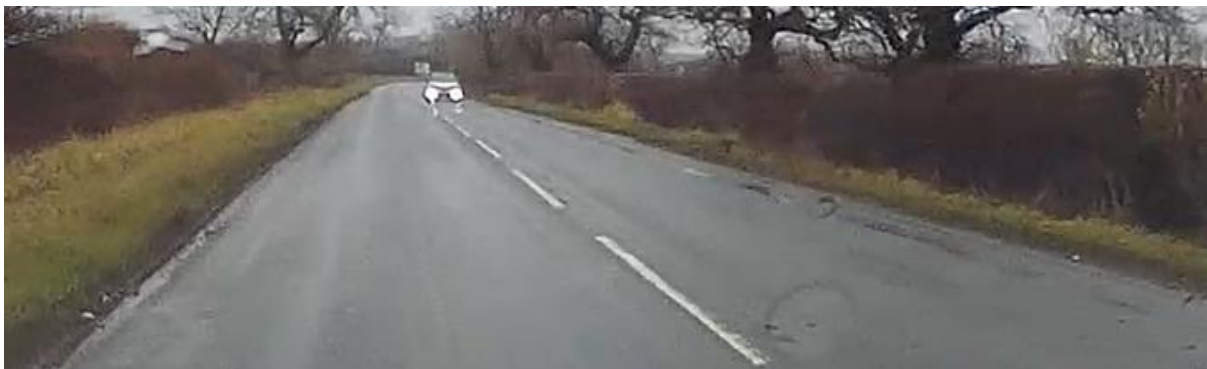
R6.36 Condition 20 Lines

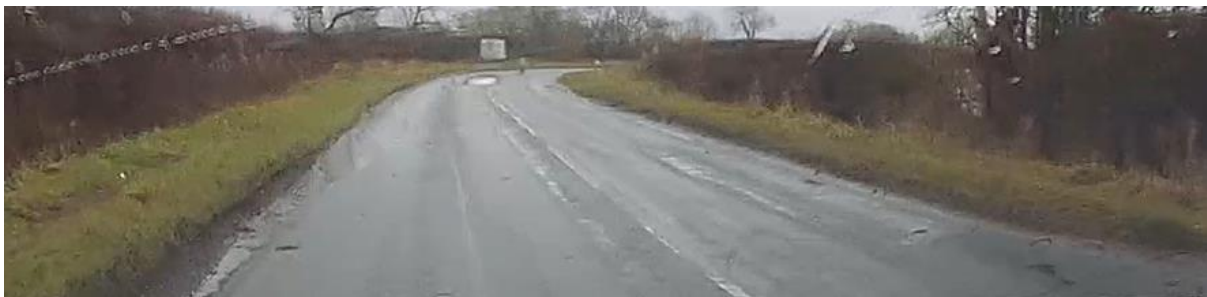
R6.37 Condition 0 Lines

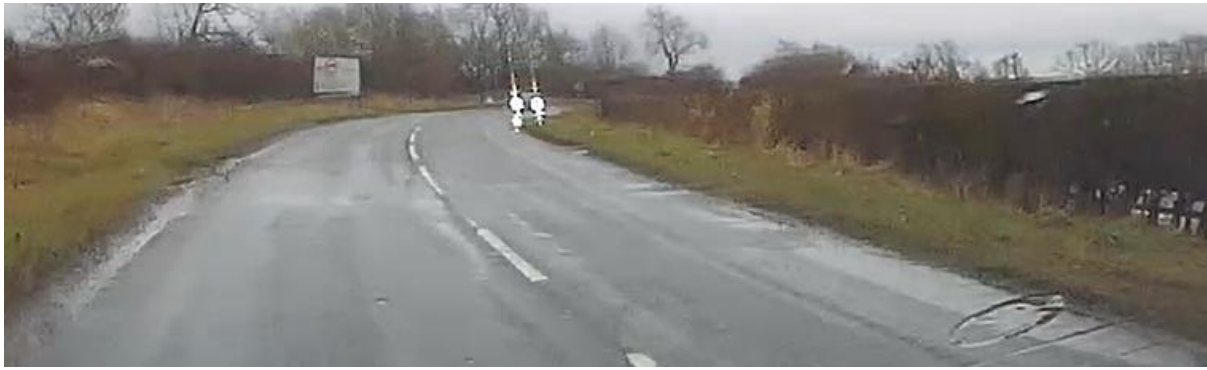
R6.38 Condition 20 Lines
