**Road Line Marking Assessment Report Covering Darlington
Borough Council Road Infrastructure Surrounding Bishopton
Parish Council Area.
Document Reference BPC/1/24/001**

Document Reference	Revision	Date
BPC/1/24/001A	First issue Rev A (DRAFT internal Only)	14.01.2024
BPC/1/24/001B	Formal Issue Rev B	04.02.2024

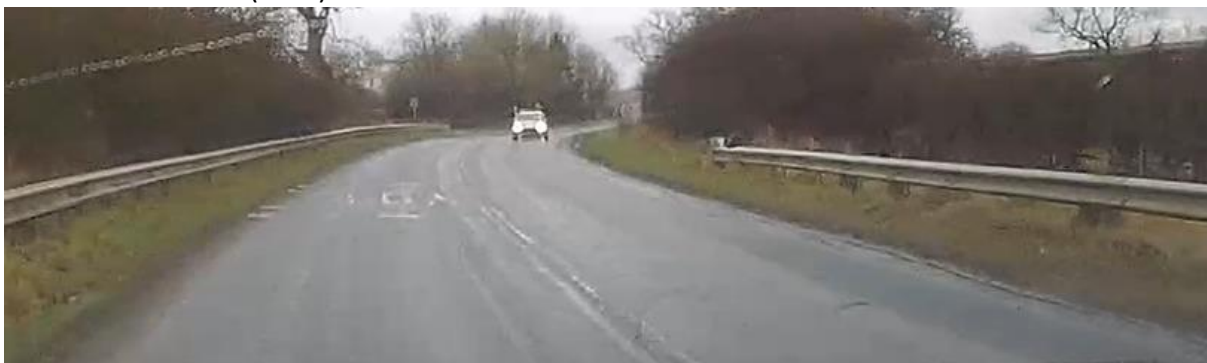
R6.39 Condition 0 (Lines)
0 (slow)

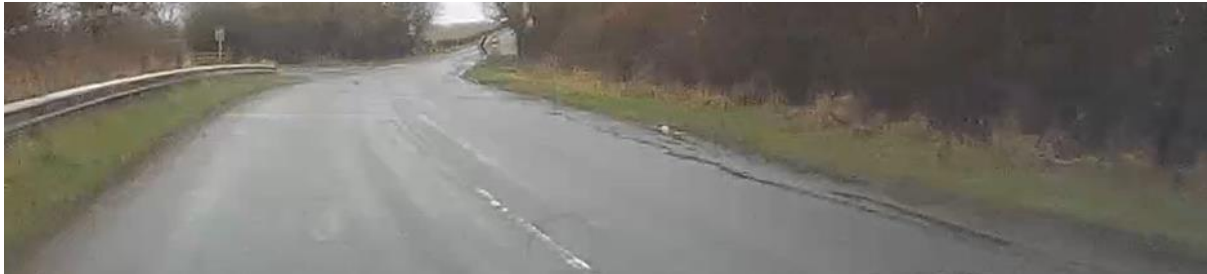
R6.40 Condition 0

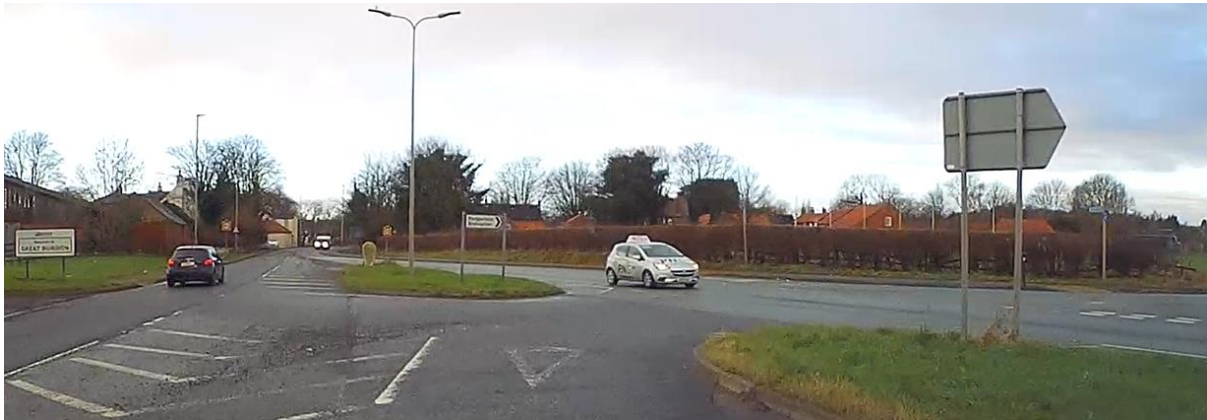
R7.1 – Condition 0 – Give Way Junction marking and lines (Confusing Junction and traffic priorities unclear!)

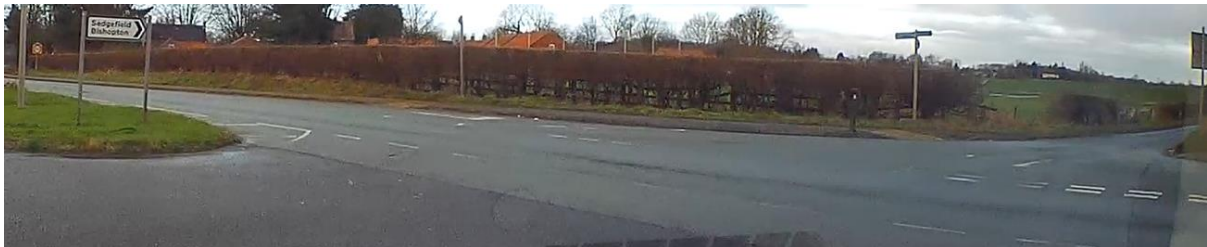
R7.2 – Condition 0 – Carraige way crossing lines. (priorities unclear)

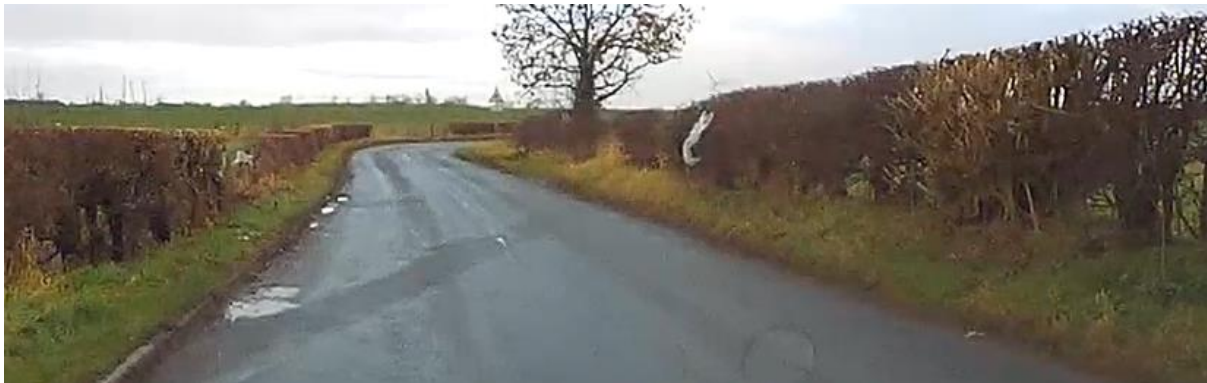
R7.3 – Condition 0

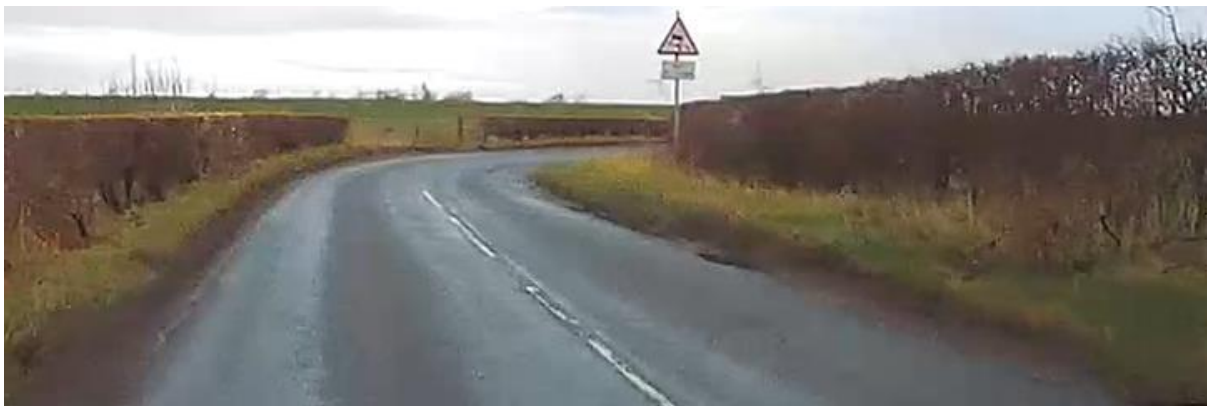
R7.4 – Condition 10

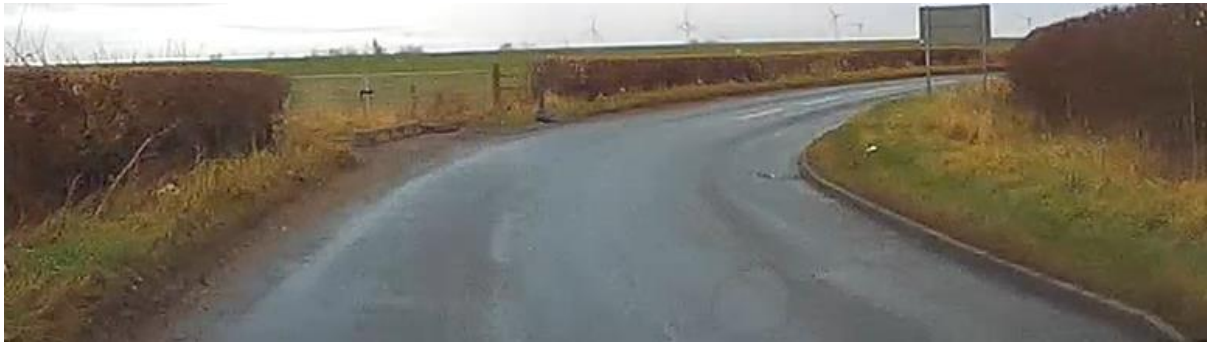
R7.5 – Condition 0

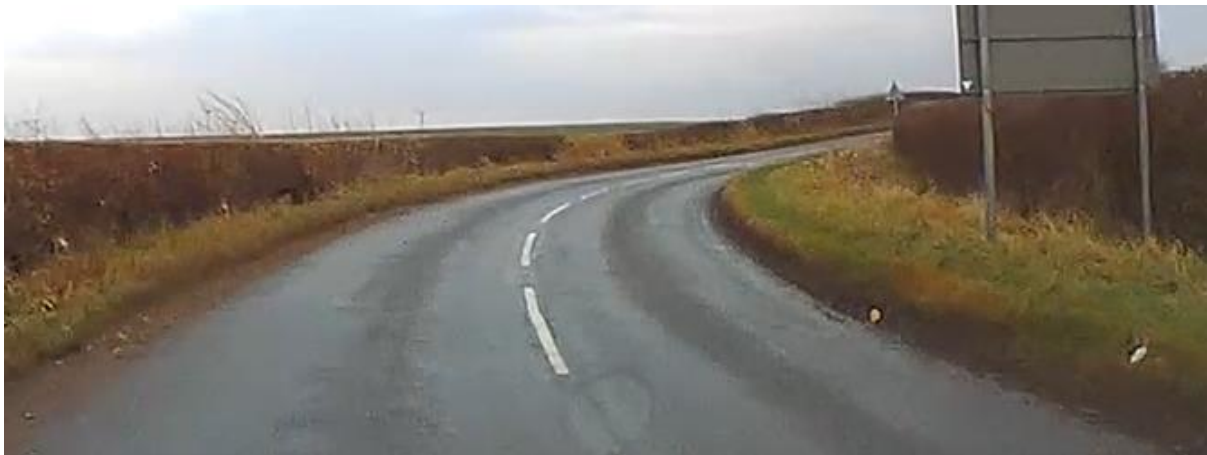
R7.6 – Condition 30

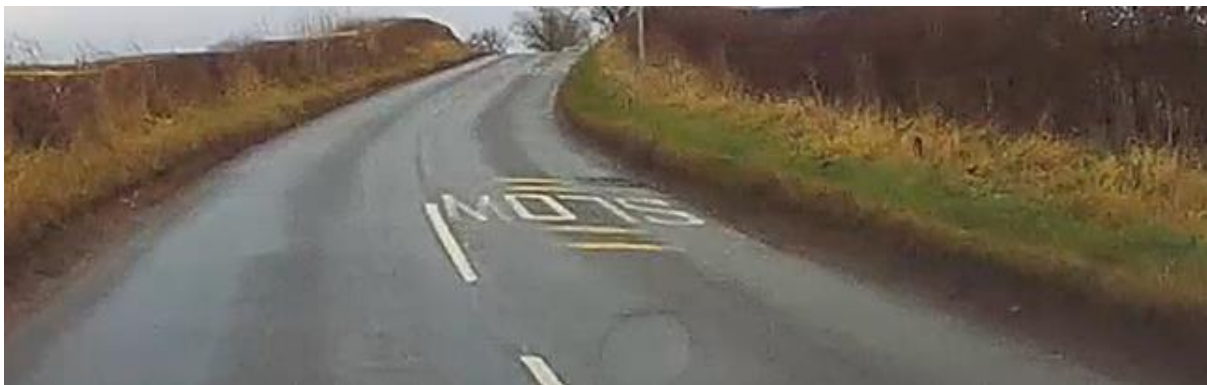
R7.7 – Condition 30

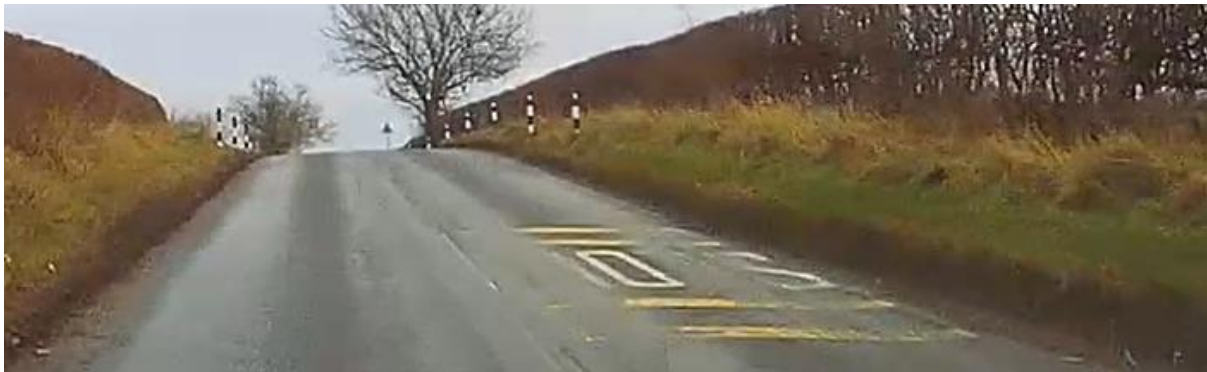
R7.9 – Condition 0 (line)
Condition 10 (slow)

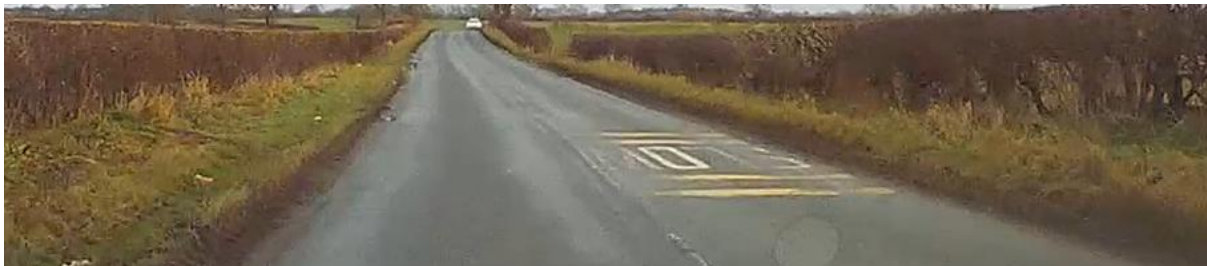
R7.10 – Condition 0 (line)
Condition 20 (slow)

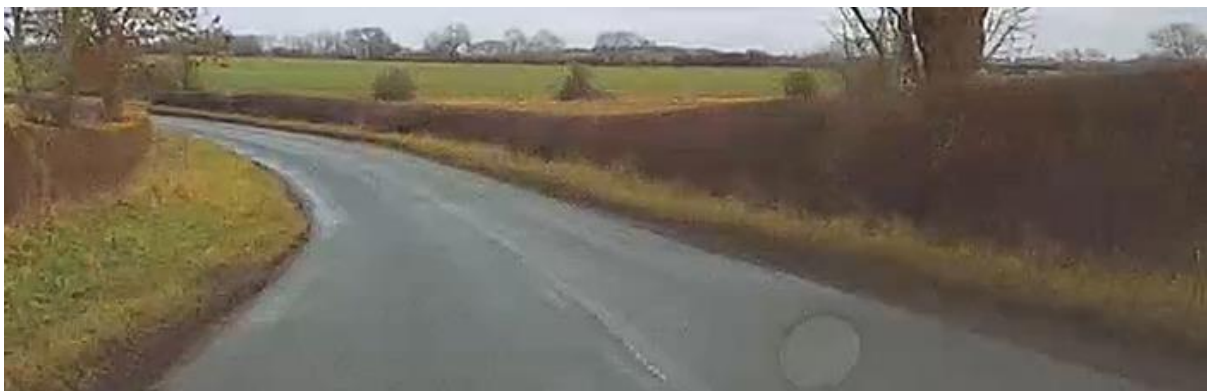
R7.11 – Condition 0

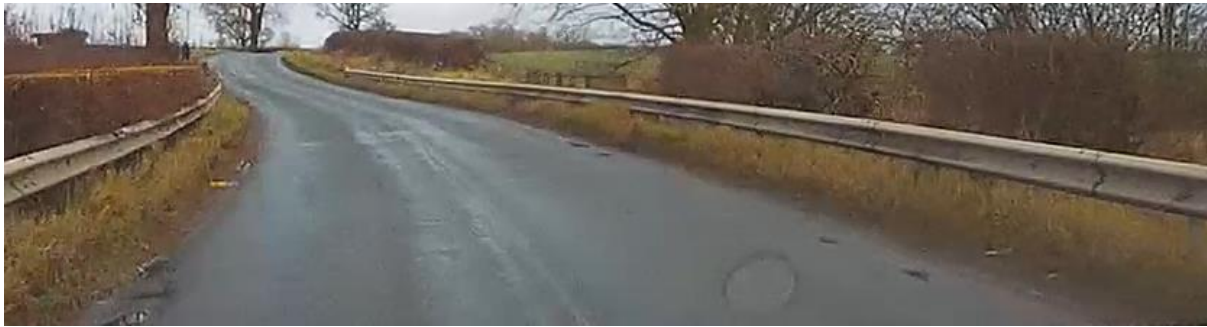
R7.12 – Condition 0

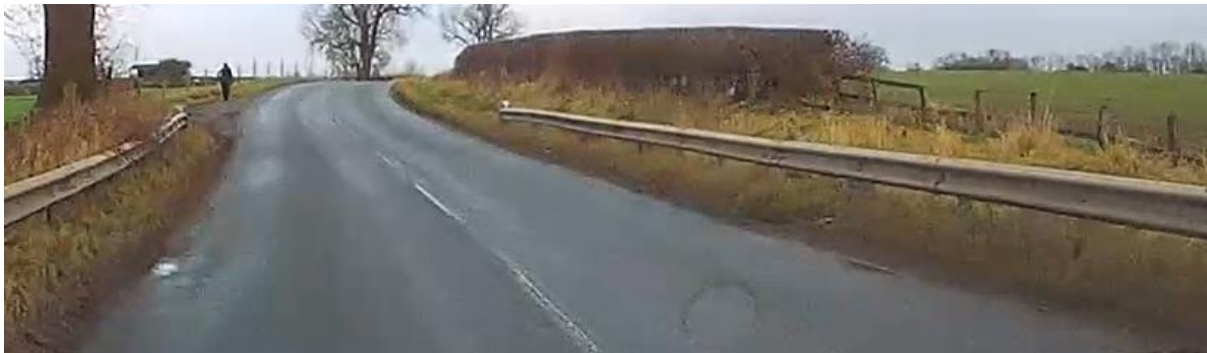
R7.13 – Condition 0

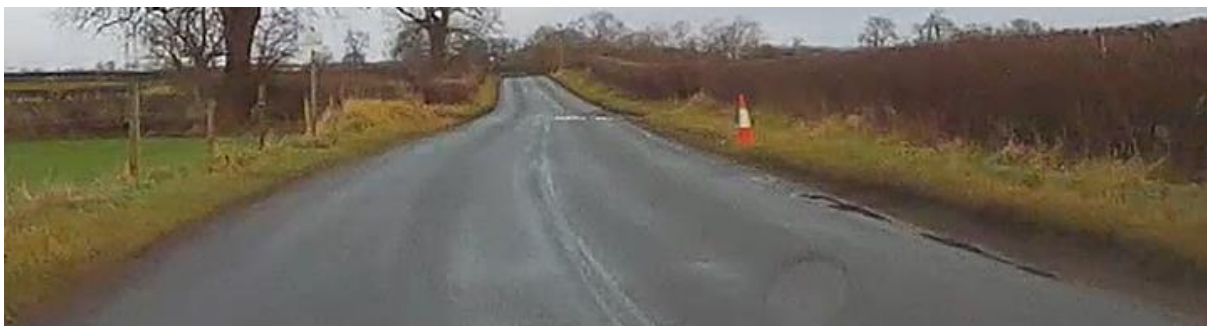
R7.14 – Condition 0

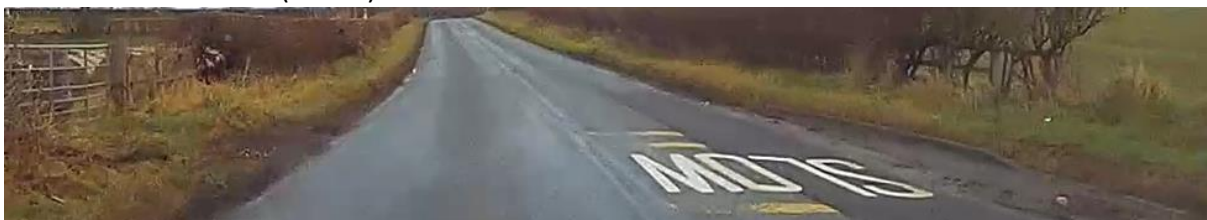
R7.15 – Condition 0 (LINE)
Condition 50 (SLOW)

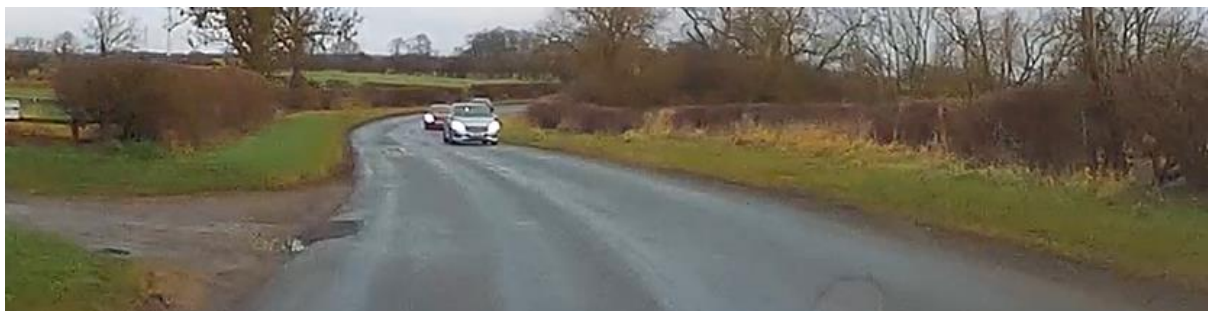
R7.17 – Condition 0

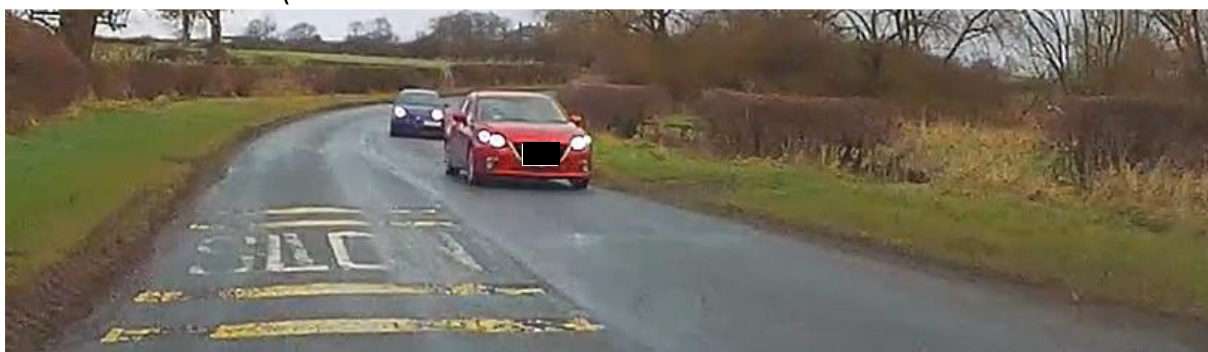
R7.18 – Condition 0 (LINE)
Condition 20 (SLOW)

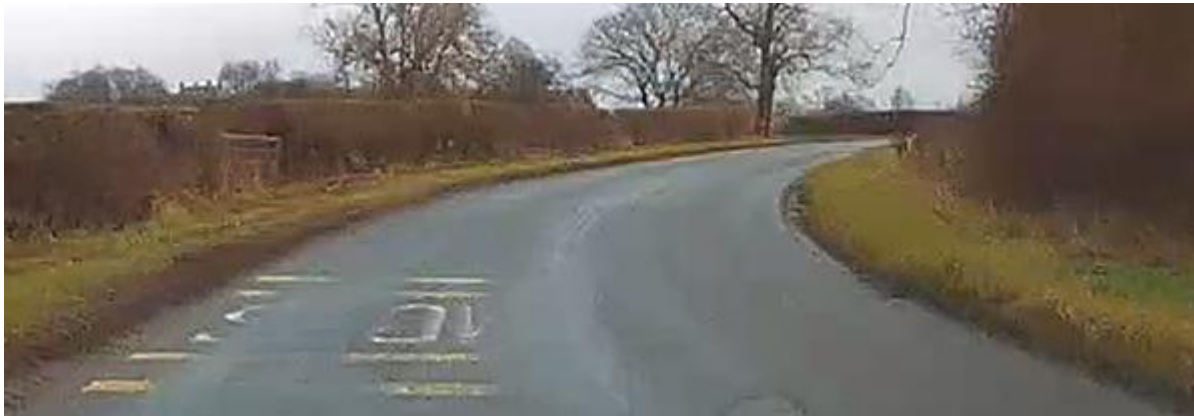
R7.19 – Condition 0 (LINE)
Condition 10 (SLOW)

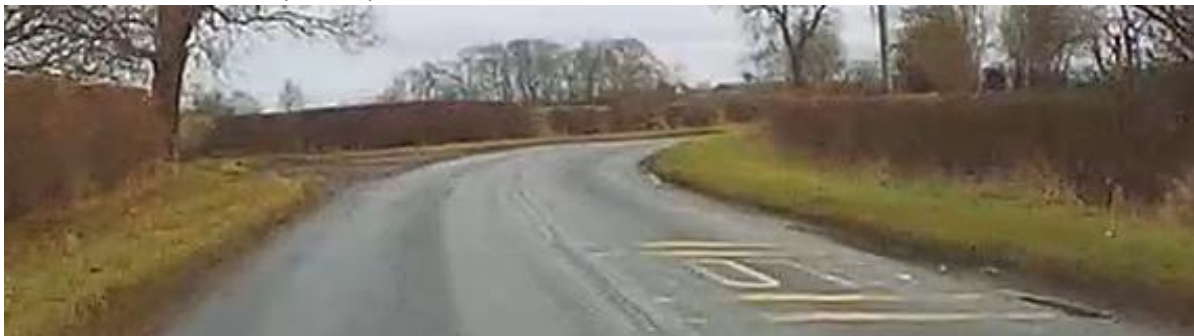
R7.20 – Condition 0 (LINE)
Condition 10 (SLOW)

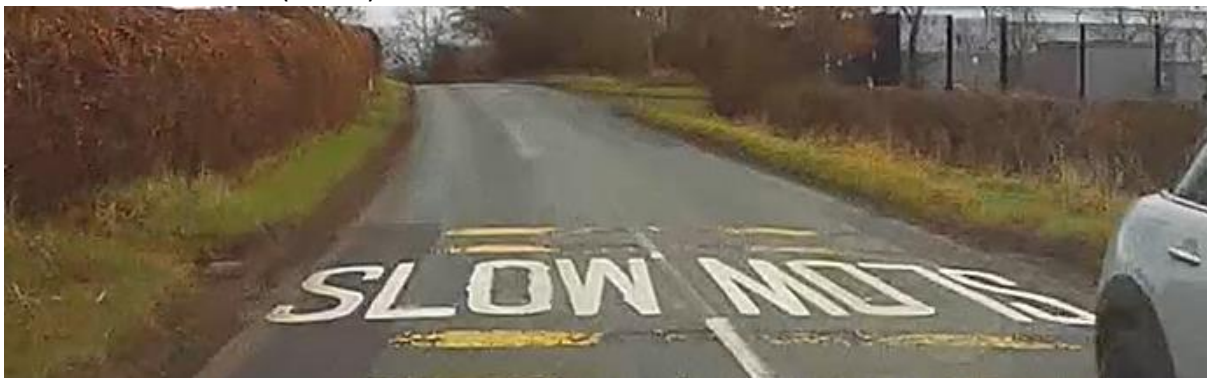
R7.21 – Condition 0 (LINE)
Condition 50 (SLOW)

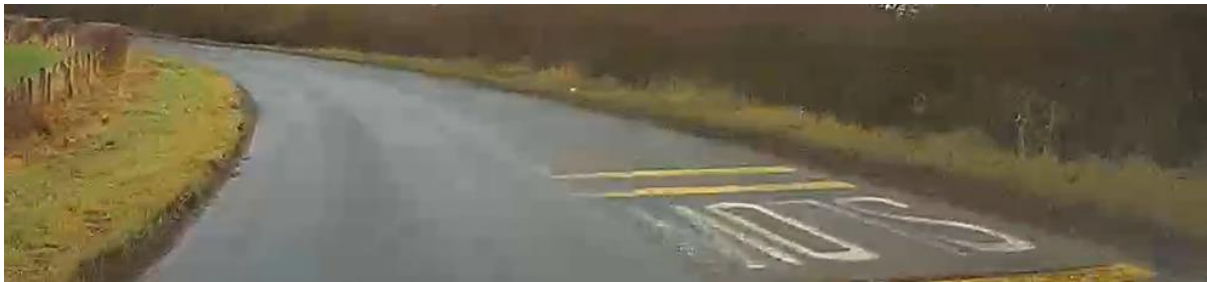
R7.22 – Condition 0 (LINE)
Condition 20 (SLOW)

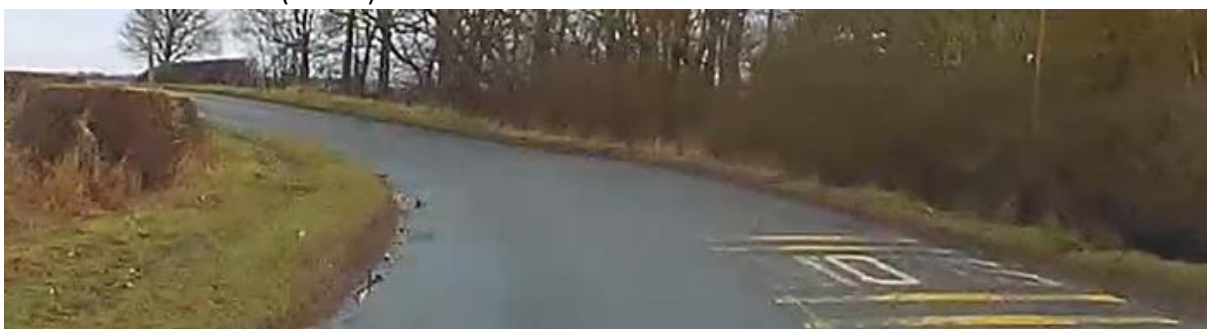
R7.23 – Condition 0 (LINE)
Condition 20 (SLOW)

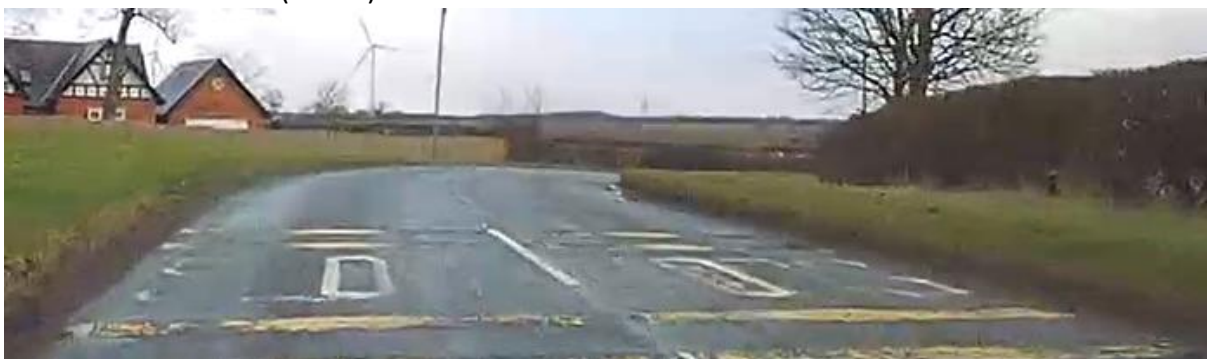
R7.24 – Condition 0 (LINE)
Condition 10 (SLOW)

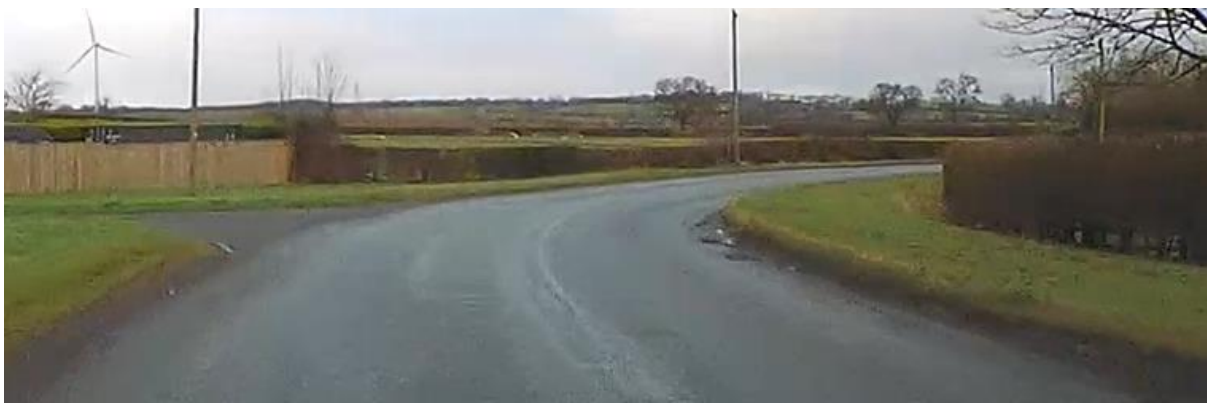
R7.25 – Condition 0

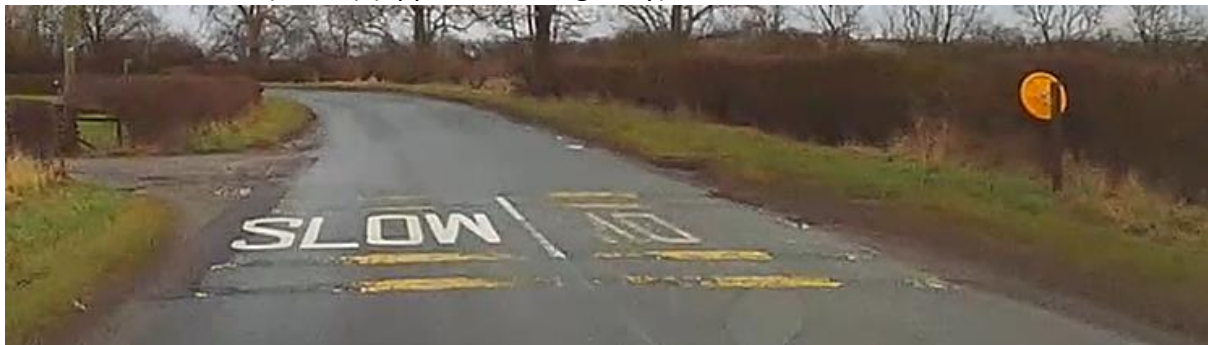
- R7.26 – Condition 0 (LINE)
- Condition 50 (SLOW)
- Condition 0 (SLOW) (opposite carriageway)

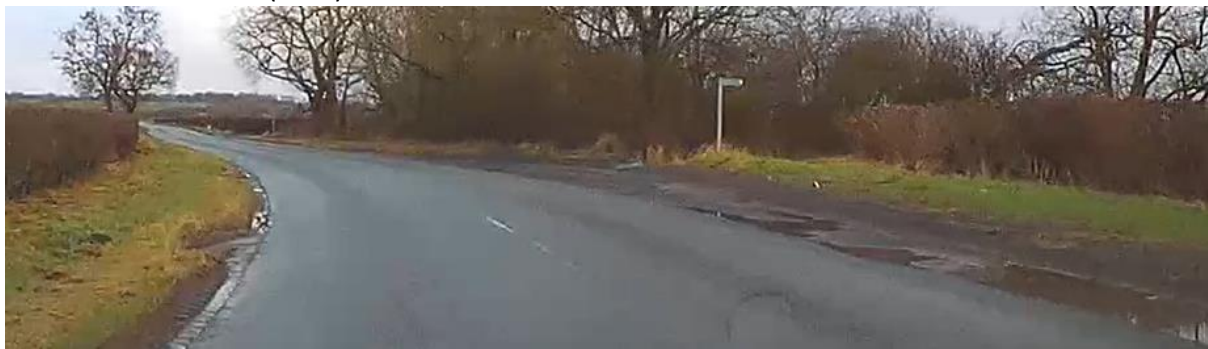
- R7.27 – Condition 0 (LINE)

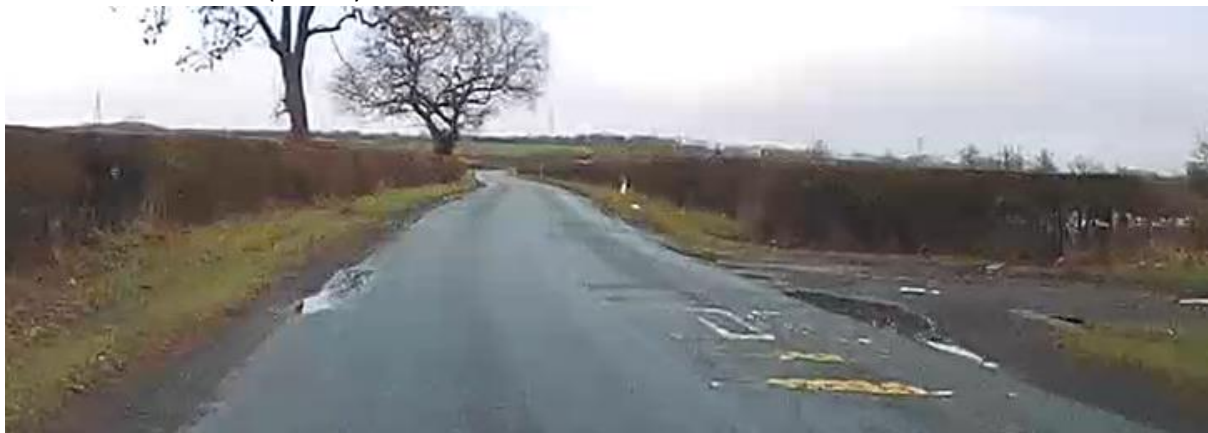
- R7.28 – Condition 0 (LINE)
- Condition 0 (SLOW)

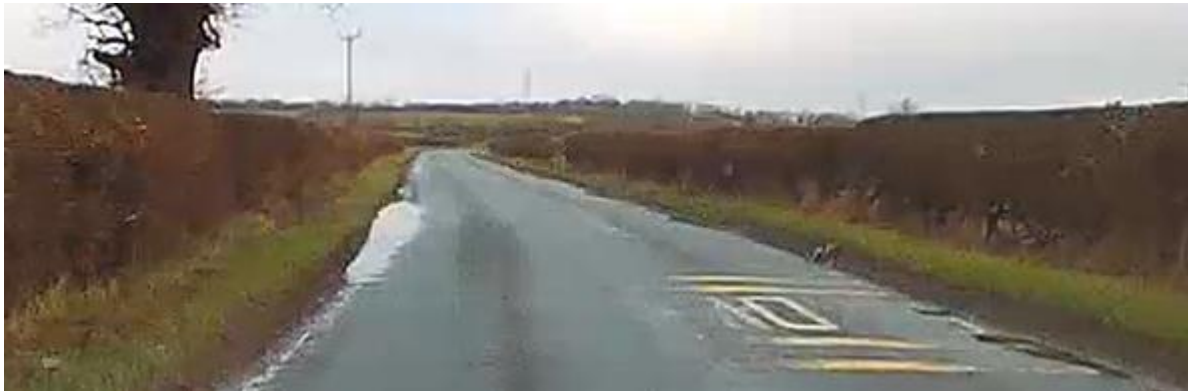
R7.29 – Condition 0 (LINE)
Condition 0 (SLOW)

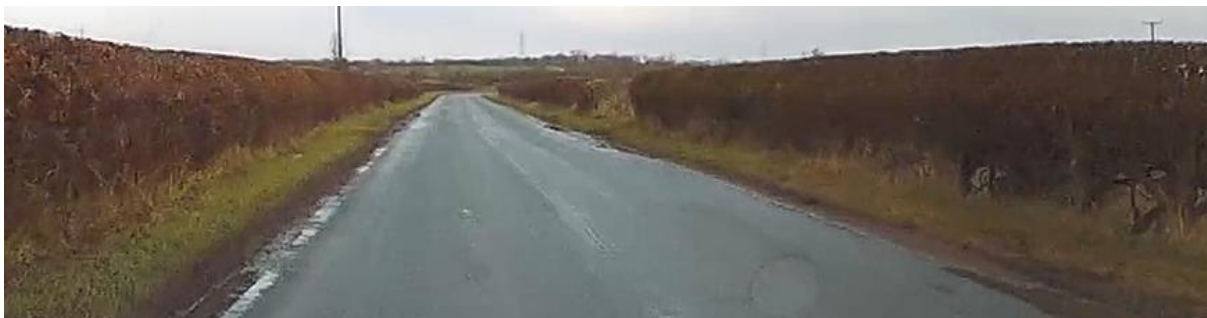
R7.30 – Condition 0

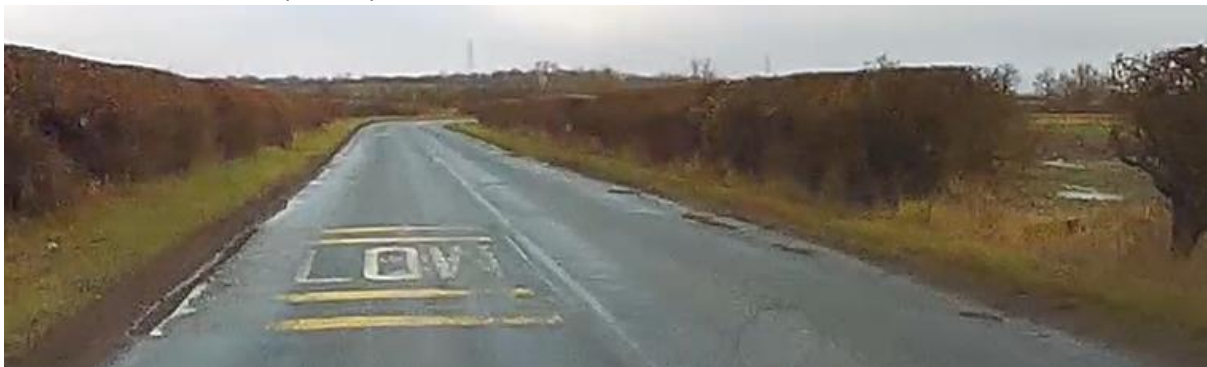
R7.31 – Condition 0 (LINE)
Condition 10 (SLOW)

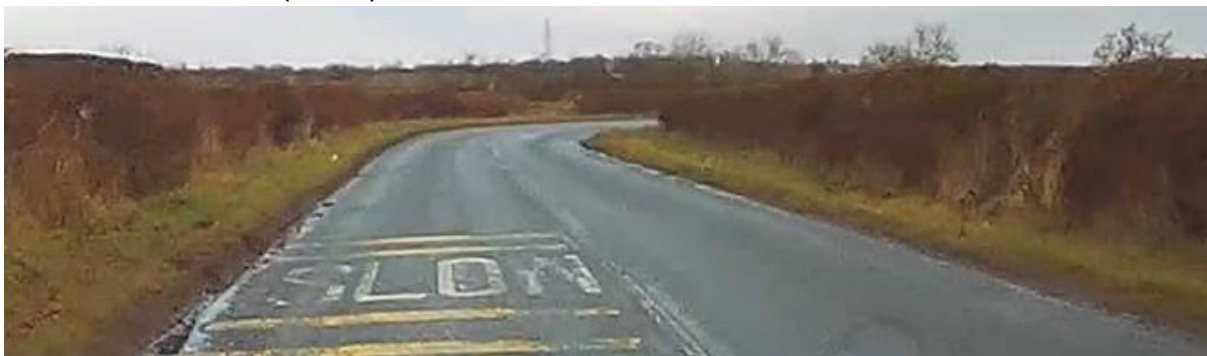
R7.32 – Condition 0 (LINE)
Condition 20 (SLOW)

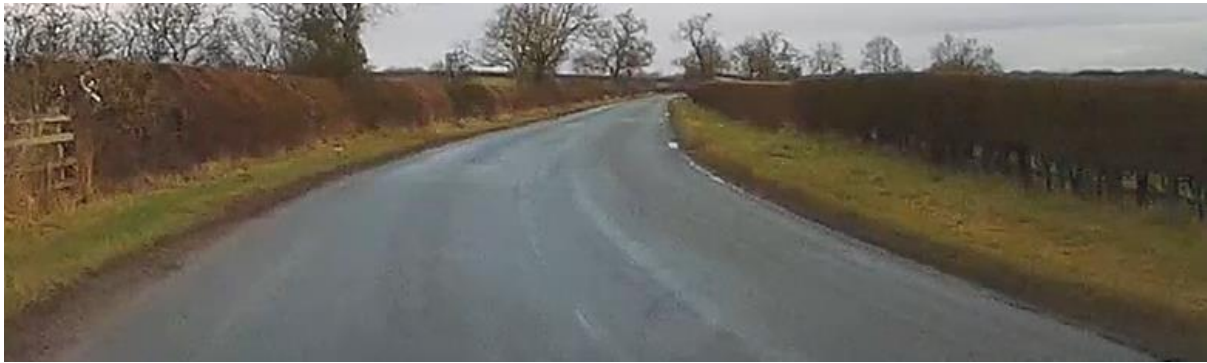
R7.33 – Condition 0 (LINE)

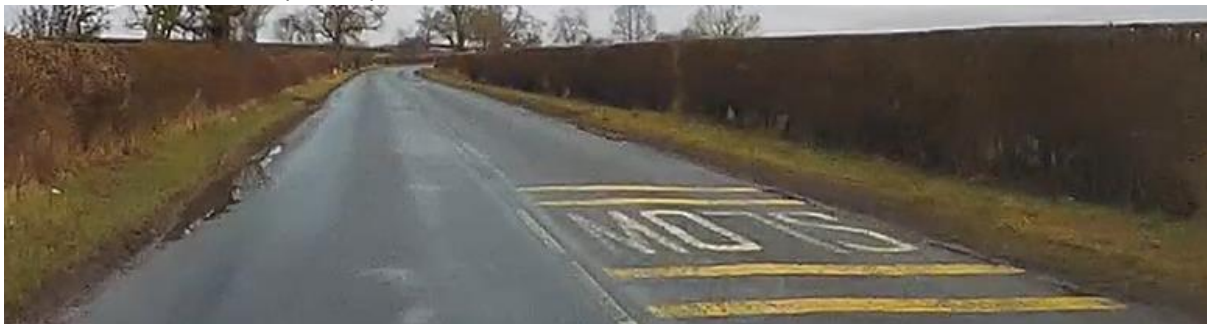
R7.34 – Condition 0 (LINE)
Condition 30 (SLOW)

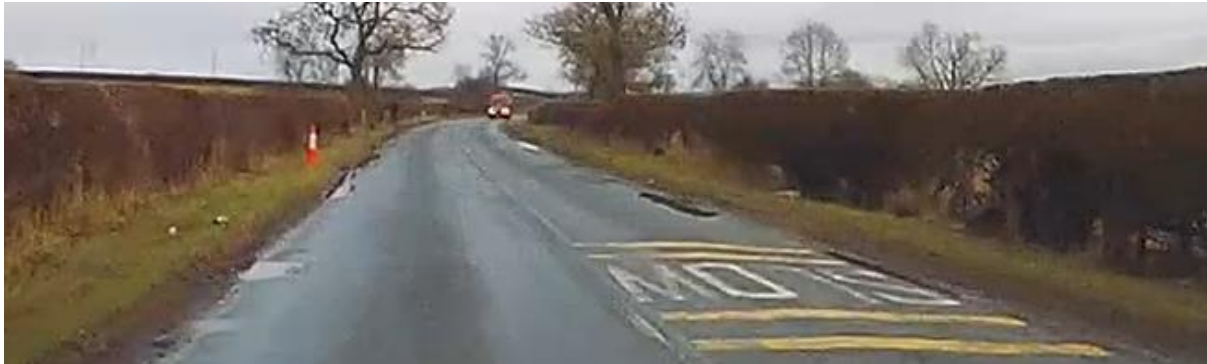
R7.35 – Condition 0 (LINE)
Condition 30 (SLOW)

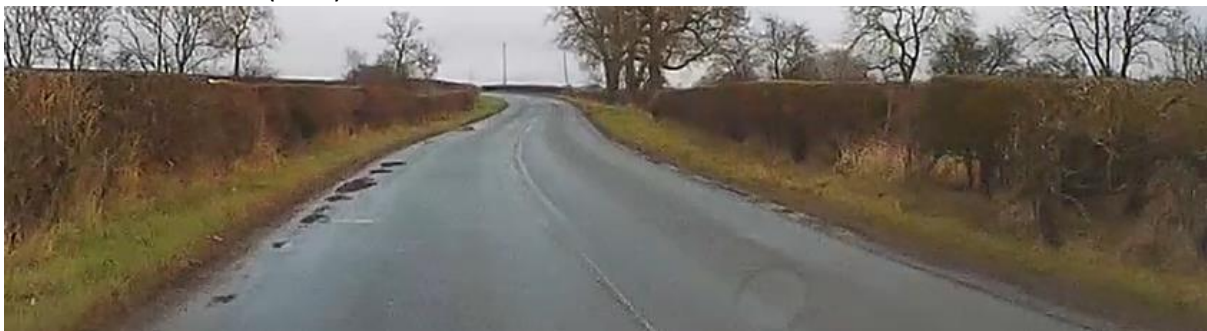
R7.36 – Condition 0 (LINE)

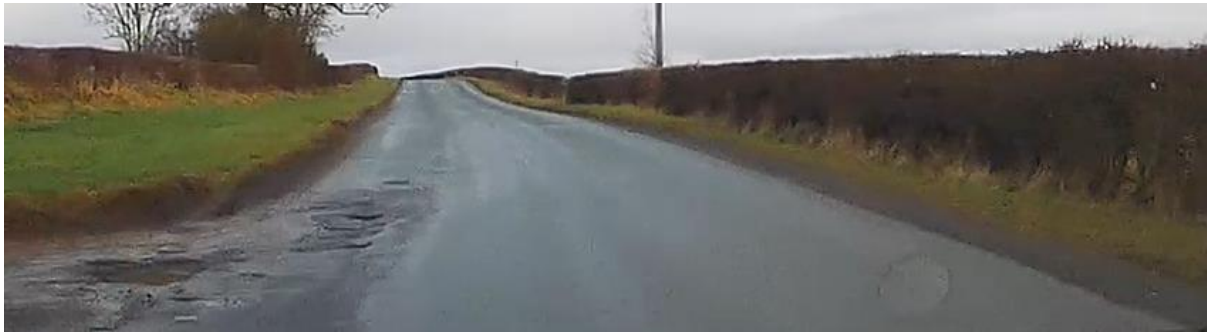
R7.37 – Condition 0

Poor Road surface forces drivers to centre of carriageway

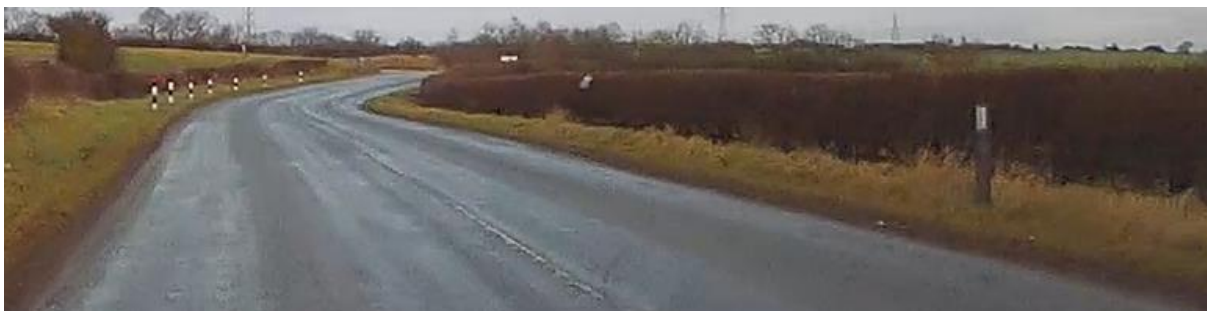
R7.38 – Condition 0

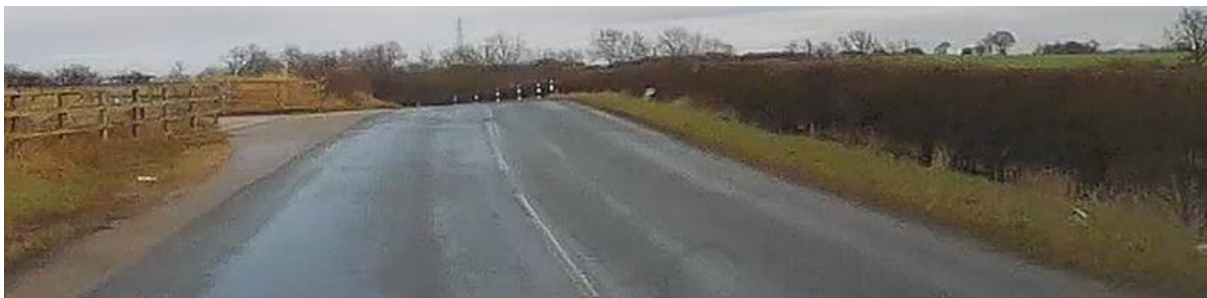
R7.39 – Condition 0

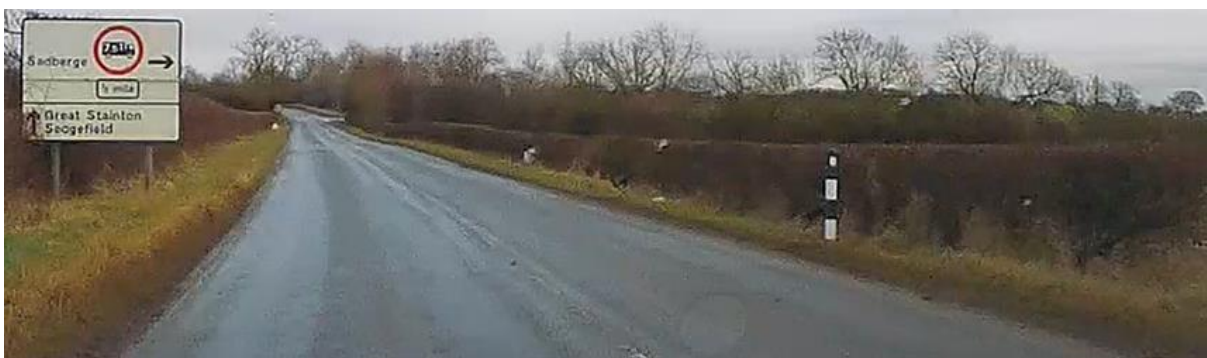
R7.40 – Condition 0

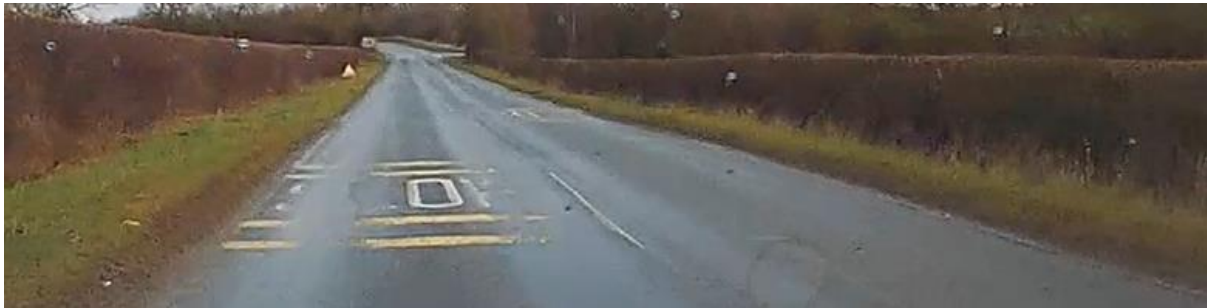
R7.41 – Condition 0 (LINE)
Condition 10 (SLOW)

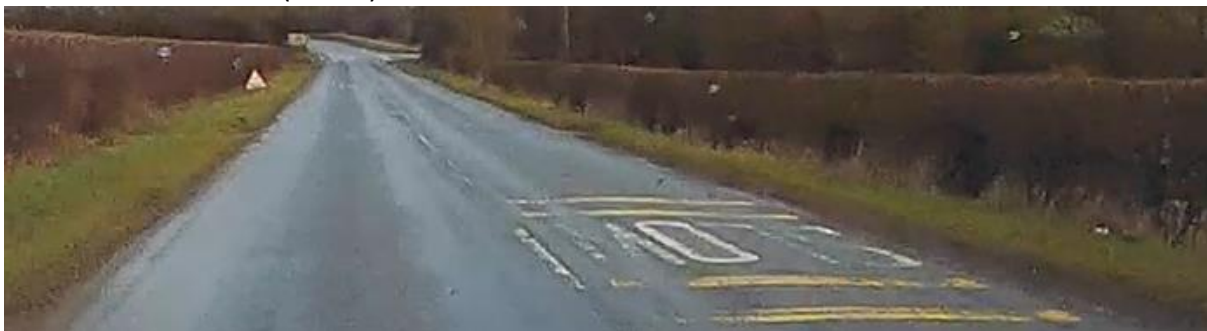
R7.42 – Condition 0 (LINE)
Condition 20 (SLOW)

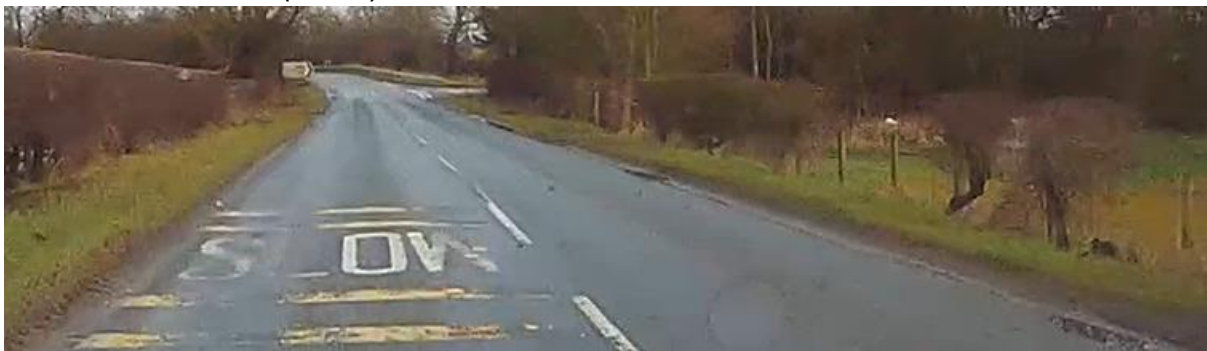
R7.43 – Condition 10 (LINE)
Condition 20 (SLOW)

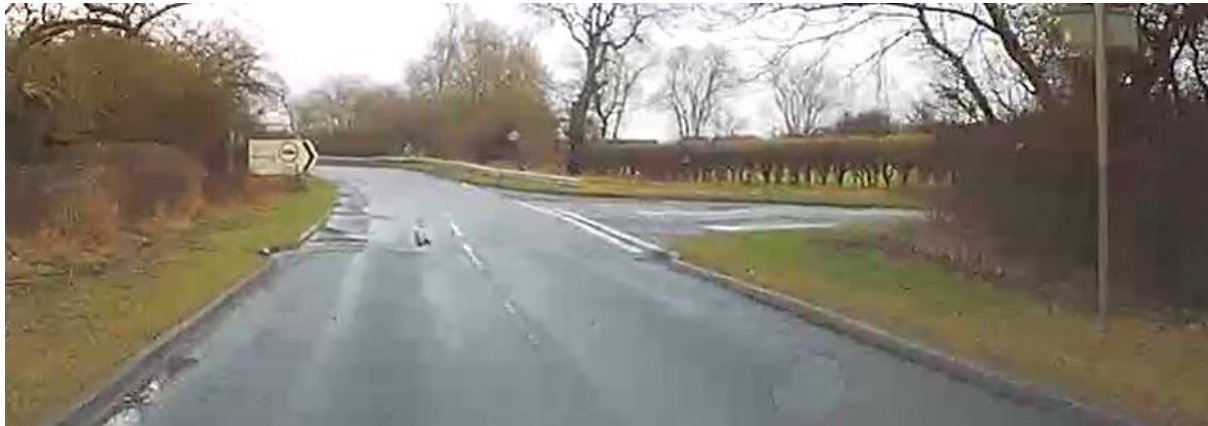
R7.44 – Condition 0

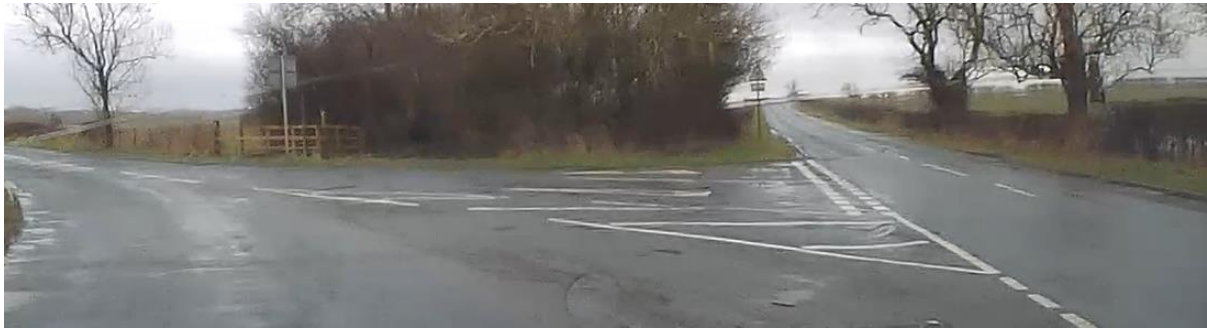
R8.1 – Condition 50 (Junction LINES)

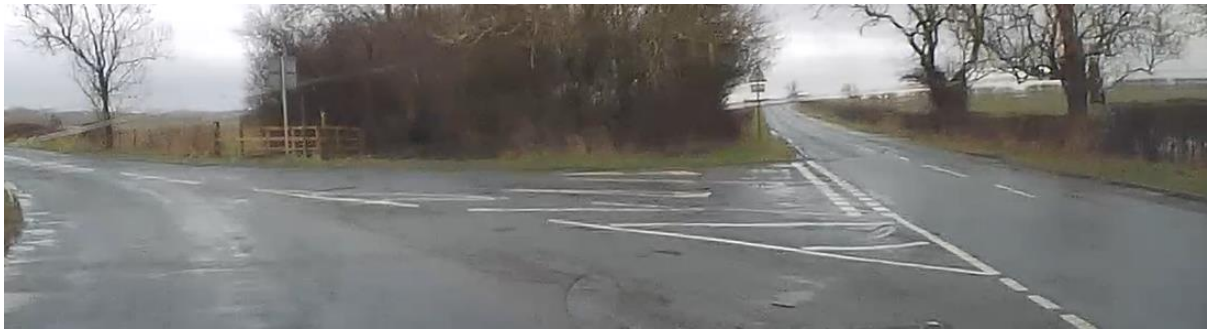
R8.2 – Condition 50 (Junction LINES)

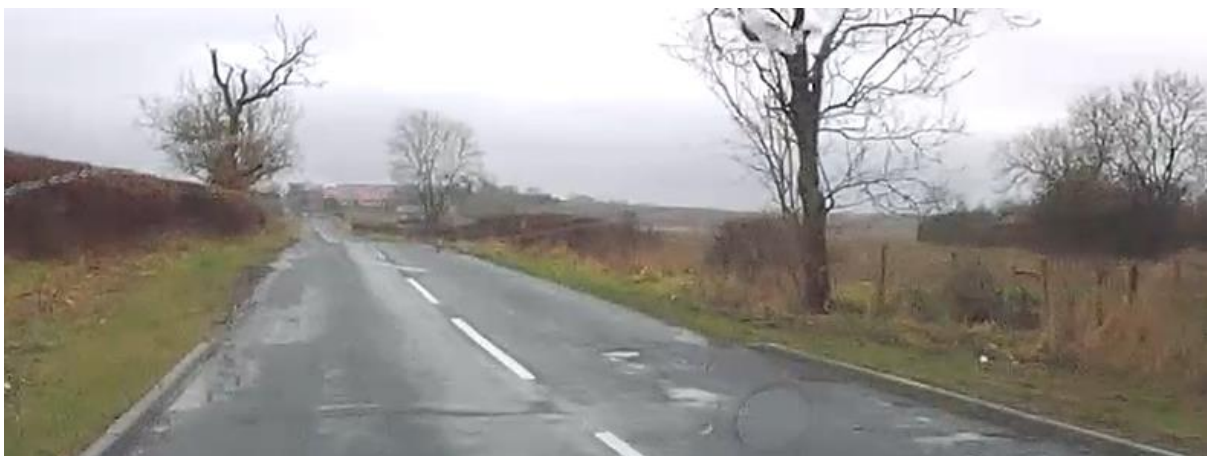
R8.3 – Condition 50

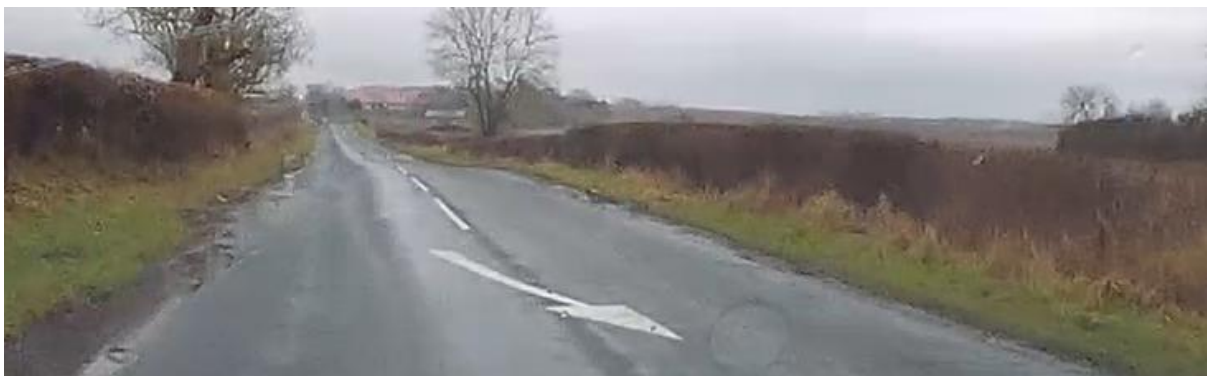
R8.4 – Condition 50

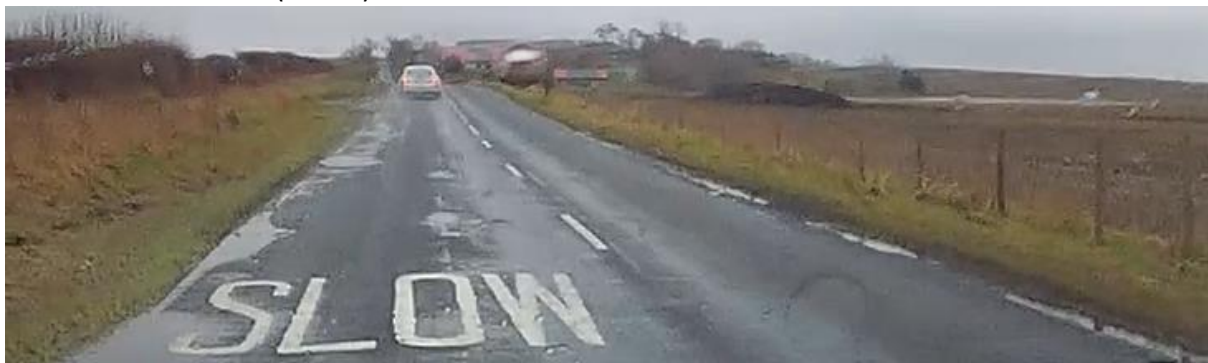
R8.5– Condition 50 (LINES)
Condition 50 (SLOW)

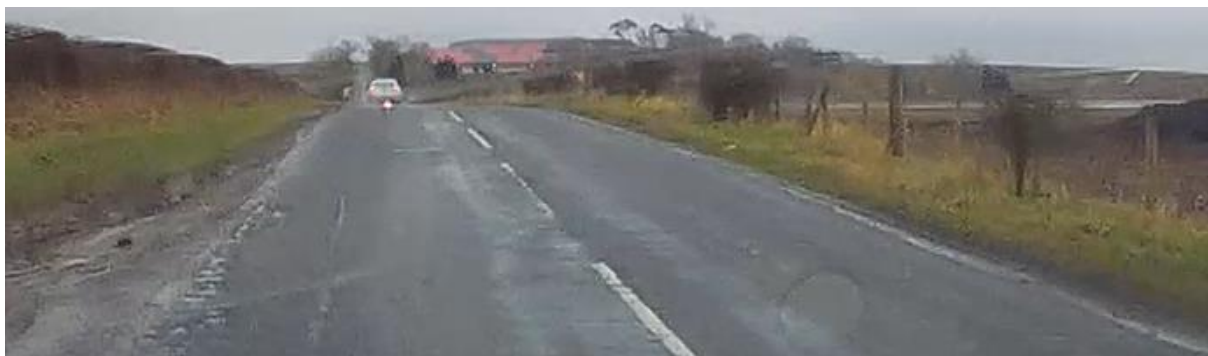
R8.6 – Condition 20

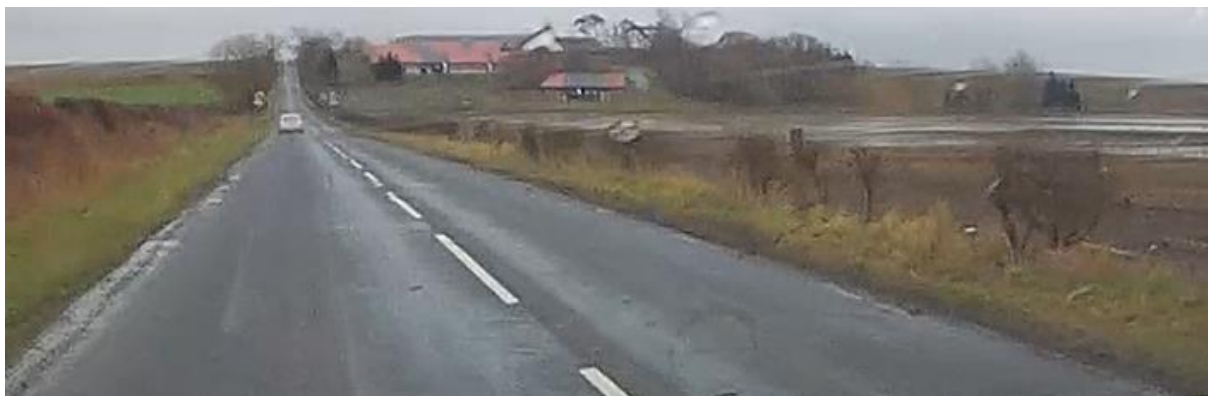
R8.7 – Condition 50

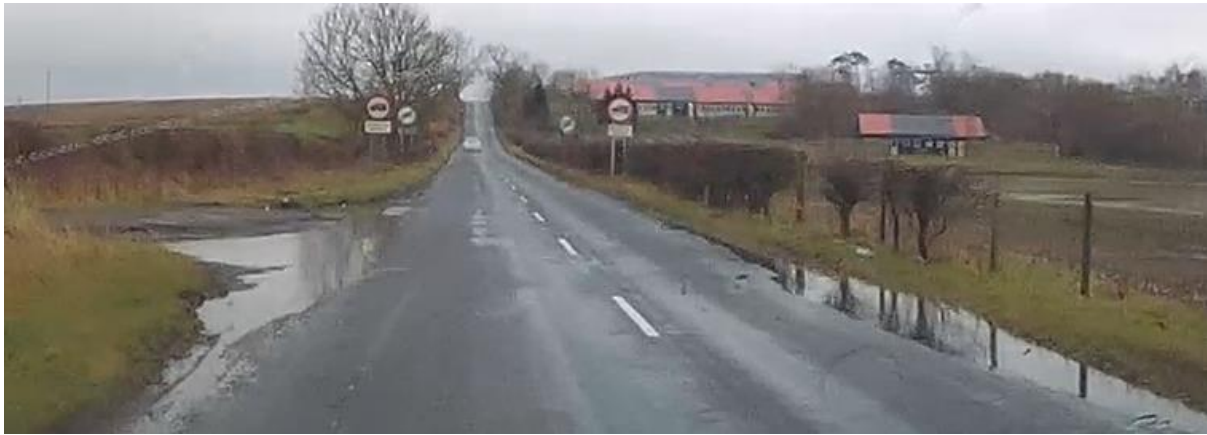
R8.8– Condition 50

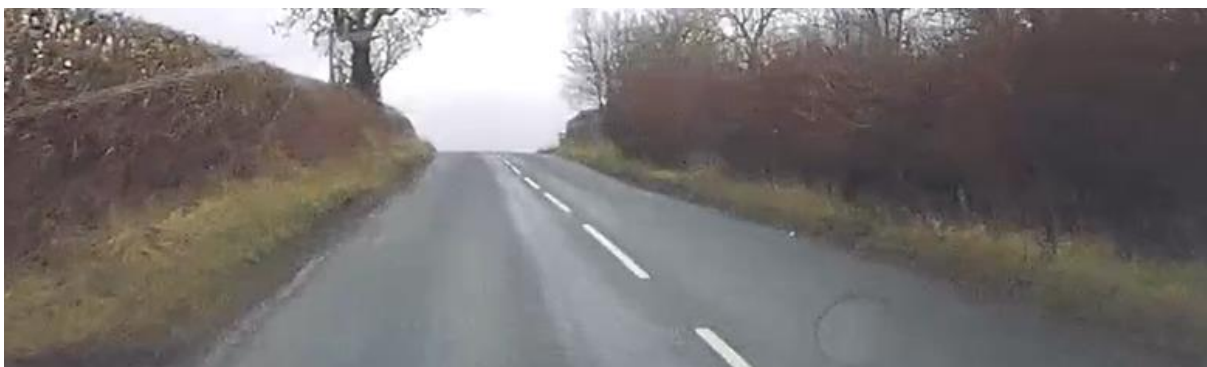
R8.10 – Condition 50
