**Road Line Marking Assessment Report Covering Darlington
Borough Council Road Infrastructure Surrounding Bishopton
Parish Council Area.
Document Reference BPC/1/24/001**

Document Reference	Revision	Date
BPC/1/24/001A	First issue Rev A (DRAFT internal Only)	14.01.2024
BPC/1/24/001B	Formal Issue Rev B	04.02.2024

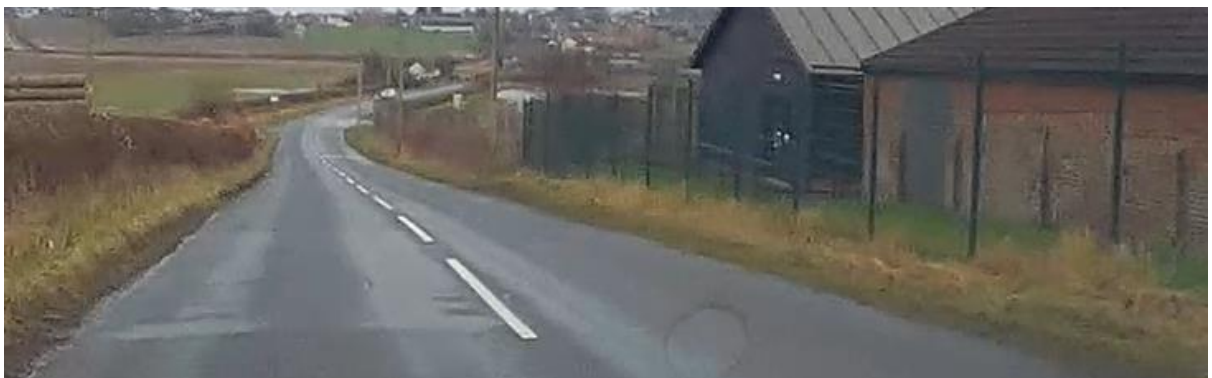
R8.12– Condition 50

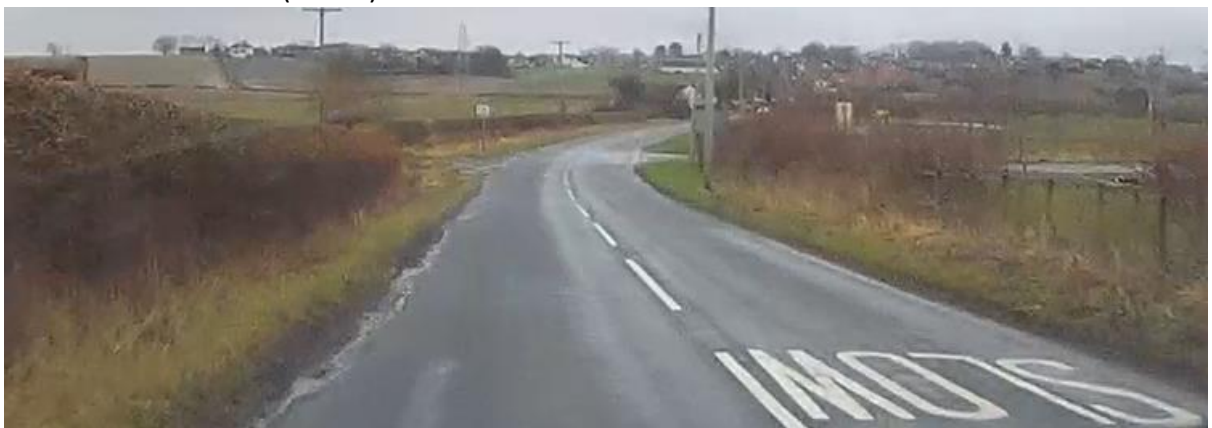
R8.13 – Condition 50 (LINES)
Condition 50 (SLOW)

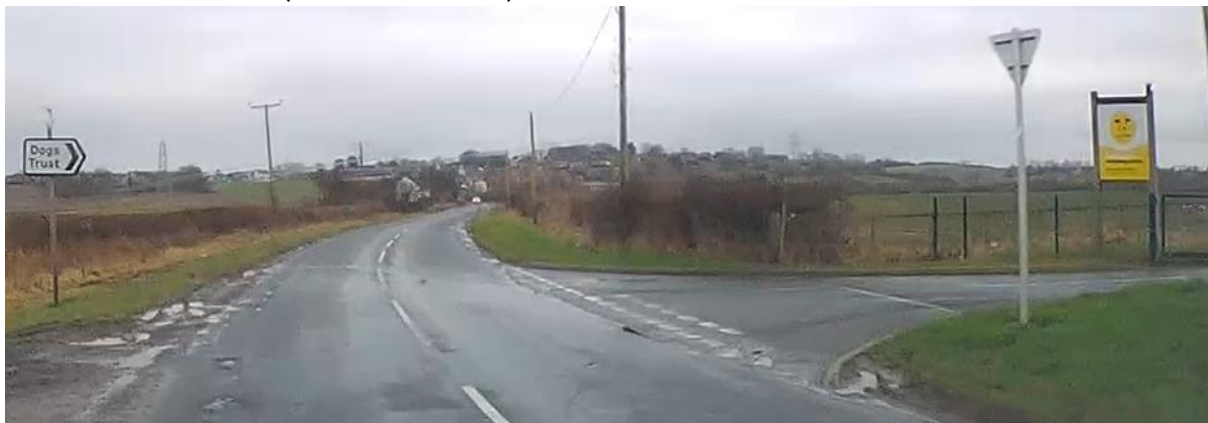
R8.14 – Condition 30 (LINES)
Condition 30 (JUNCTION LINES)

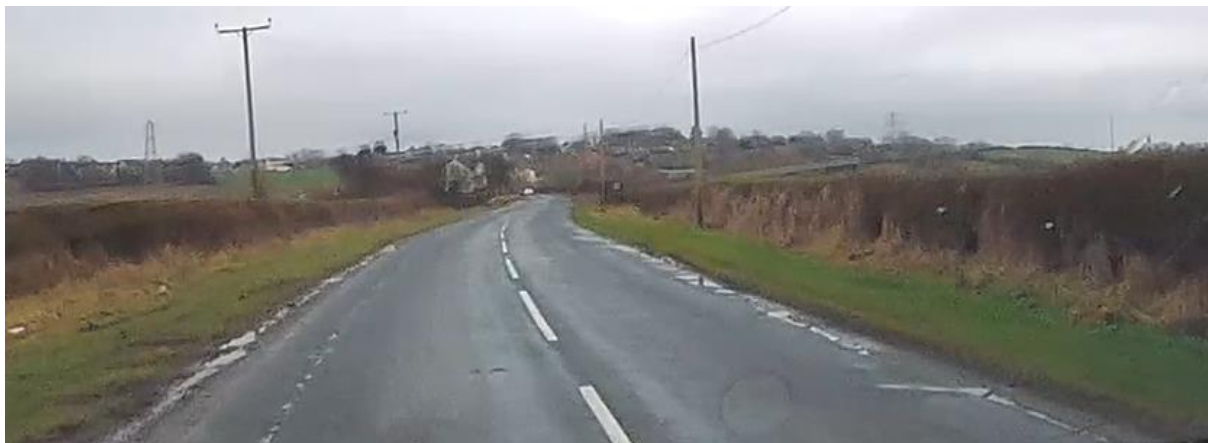
R8.15 – Condition 50

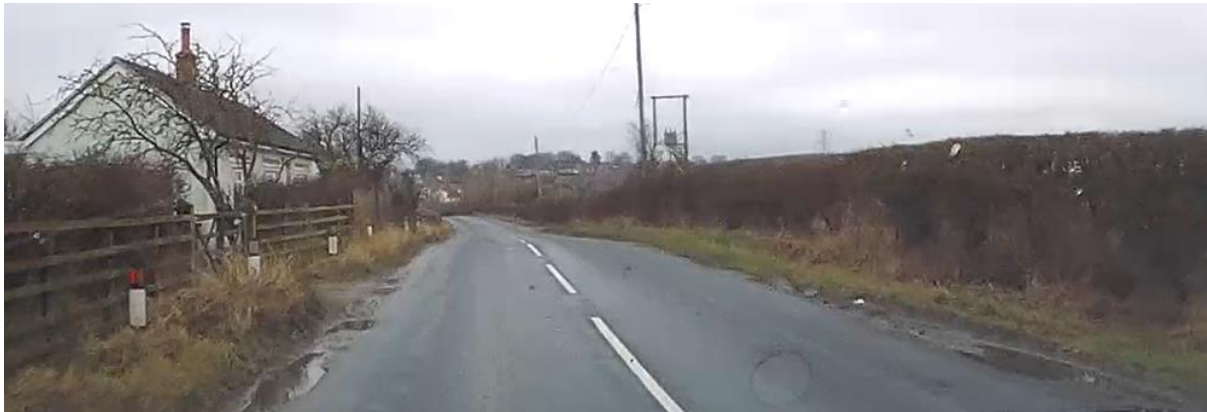
R8.17 – Condition 50

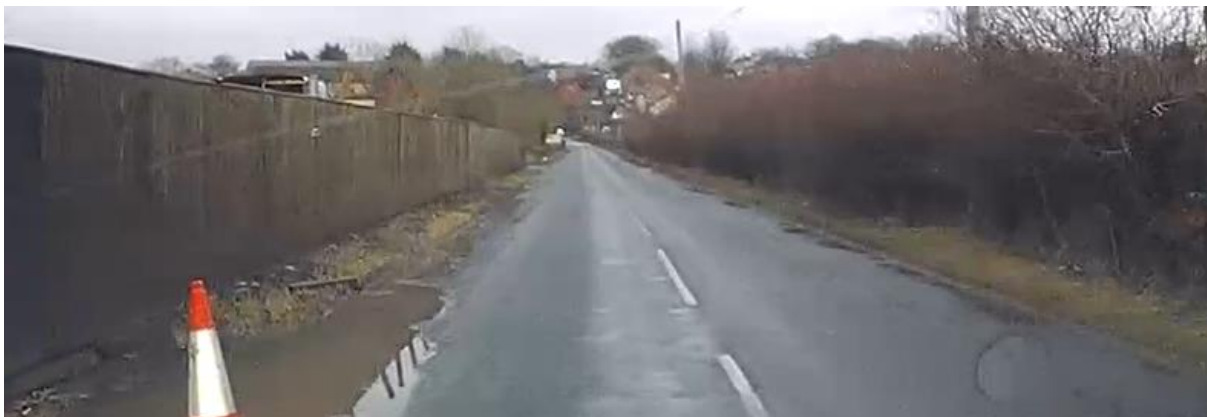
R8.19 – Condition 30

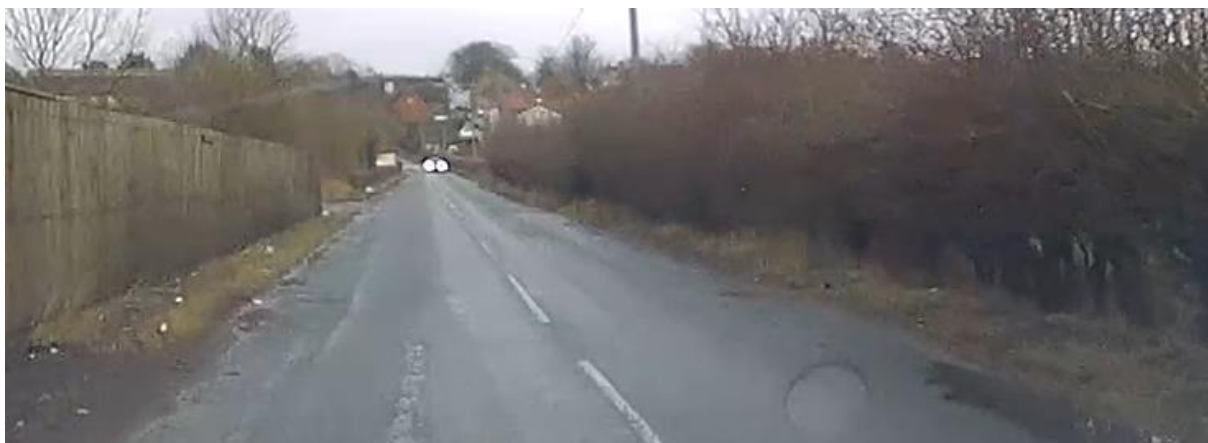
R8.20 – Condition 30

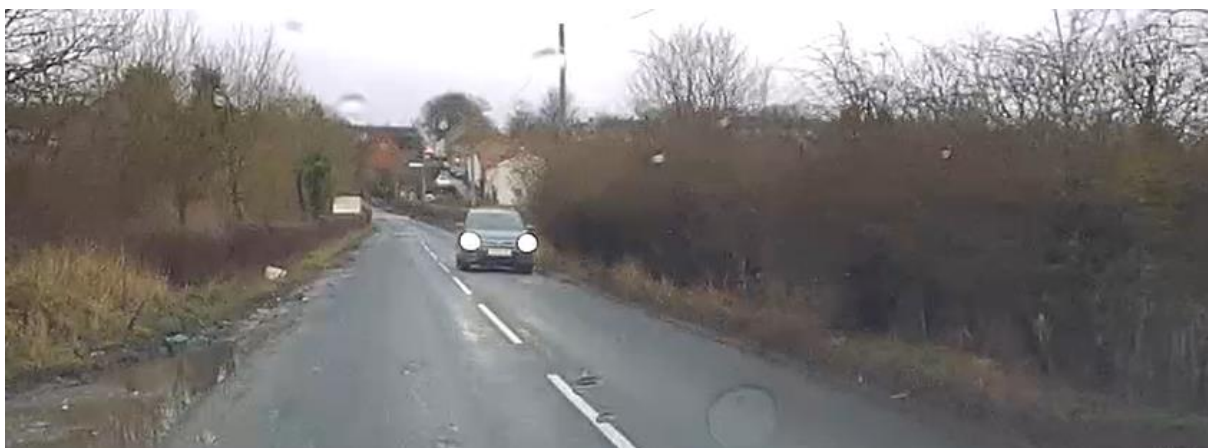
R8.22 – Condition 50

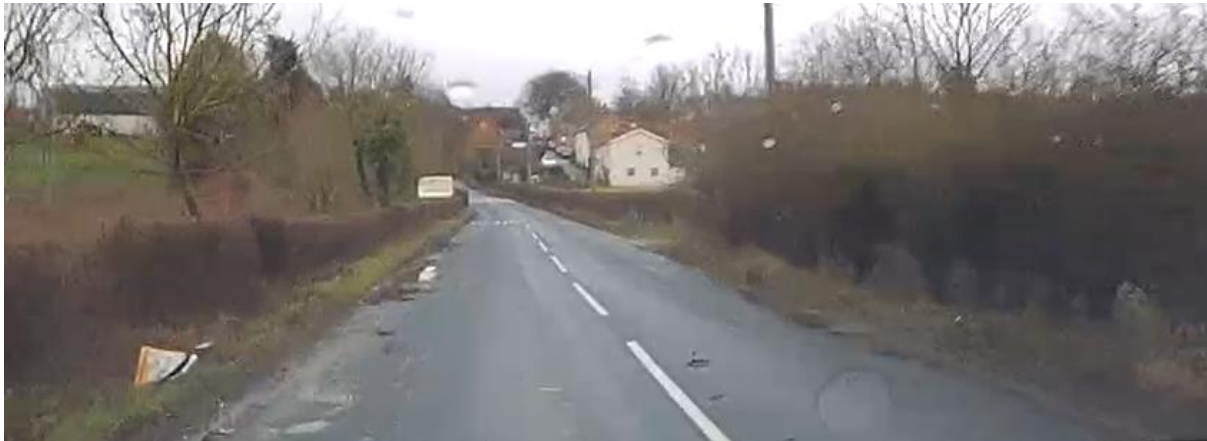
R8.23 – Condition 50

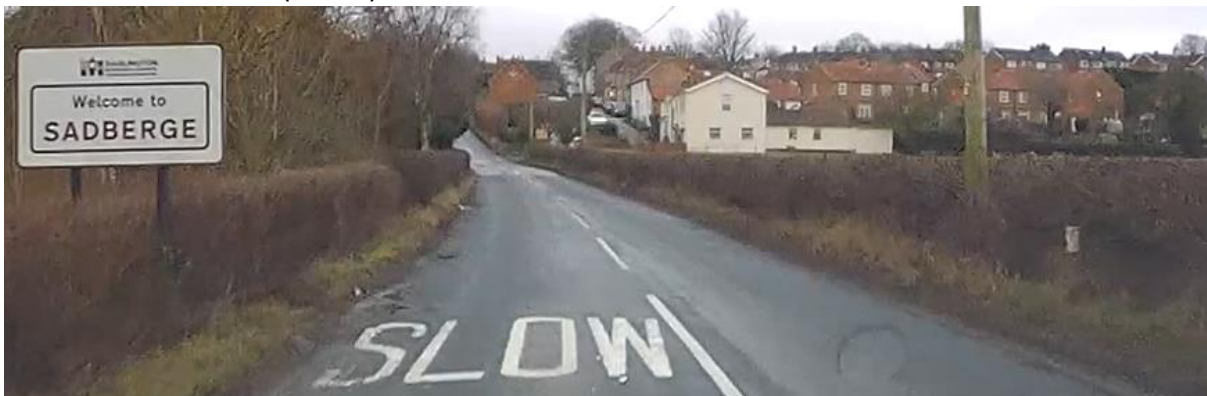
R8.24 – Condition 50 (LINES)
Condition 40 (SLOW)

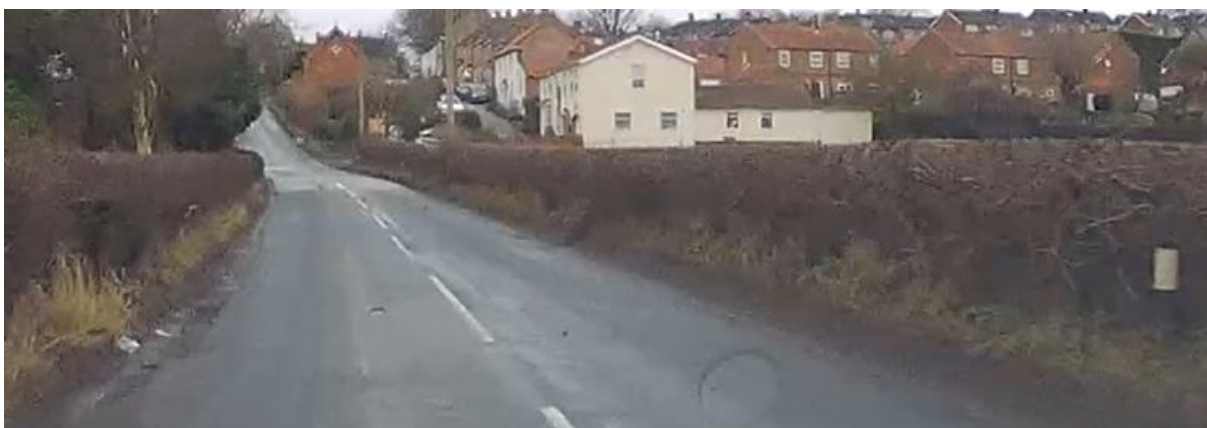
R8.25 – Condition 20

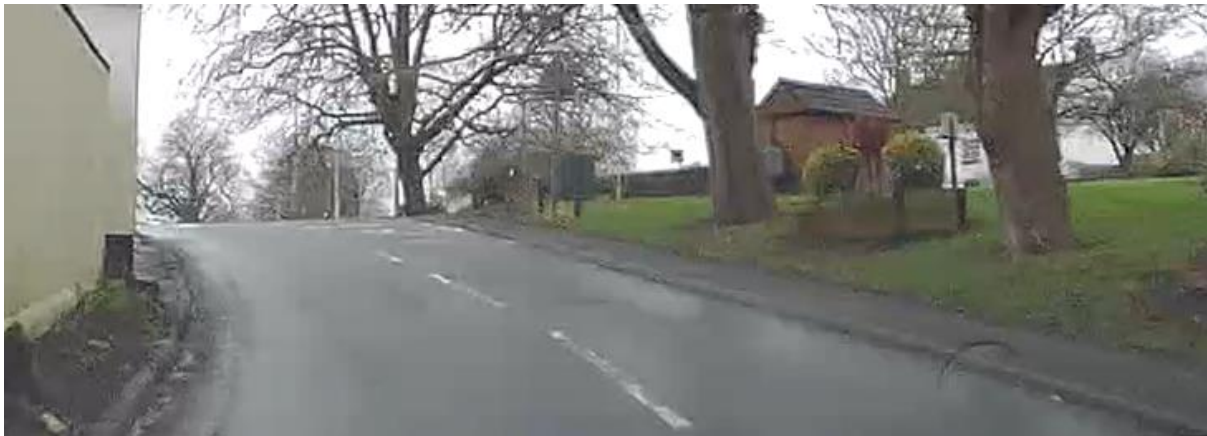
R8.33 – Condition 10

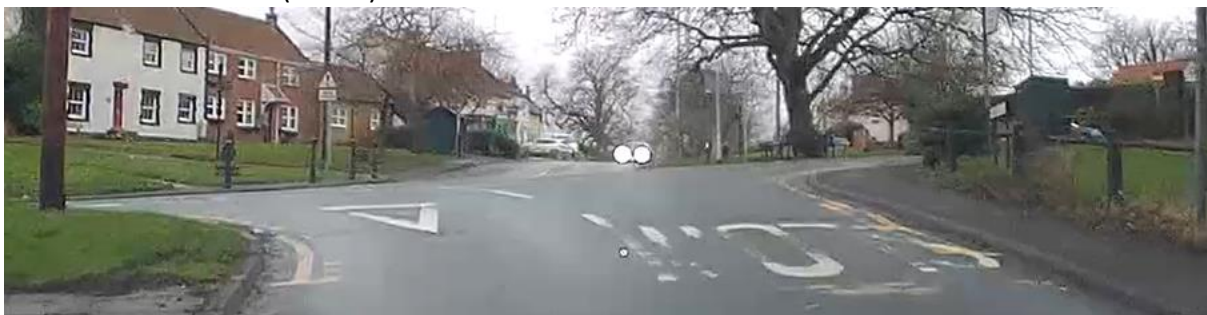
R8.34 – Condition 10 (LINES)
Condition 10 (SLOW)

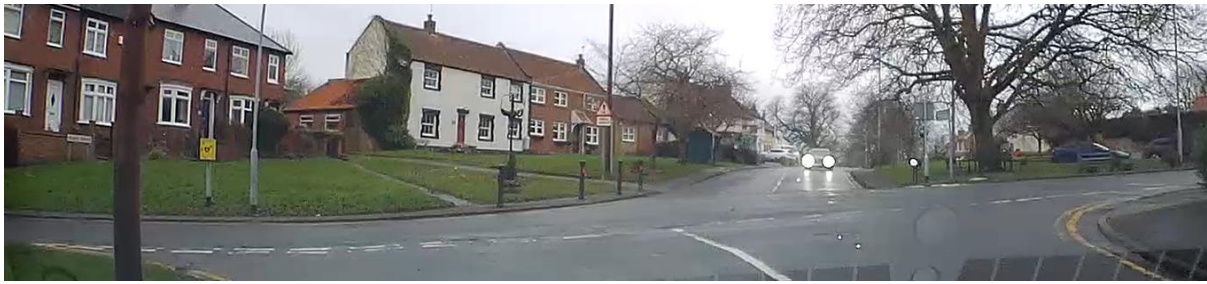
R8.35 – Condition 10 (LINES)

Condition 10 (JUNCTION MARKINGS)

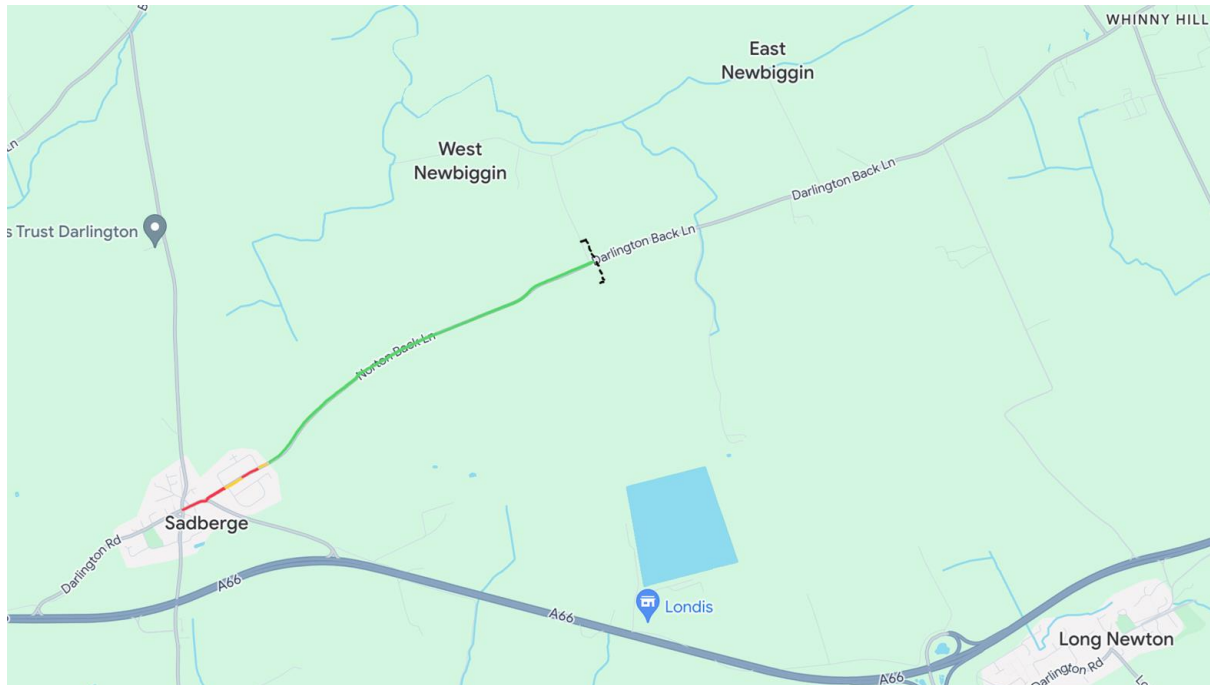
Summary Map – Line markings through Sadberge wear index score ranging from 0- 10 (Critical defects) require remedial Action. Remainder of Route wear index score 50

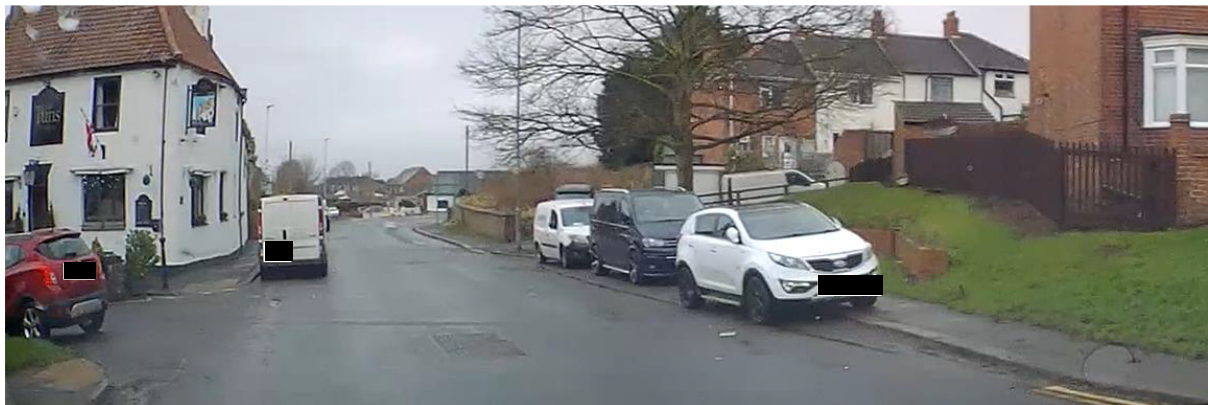
R9.1 - Condition 0

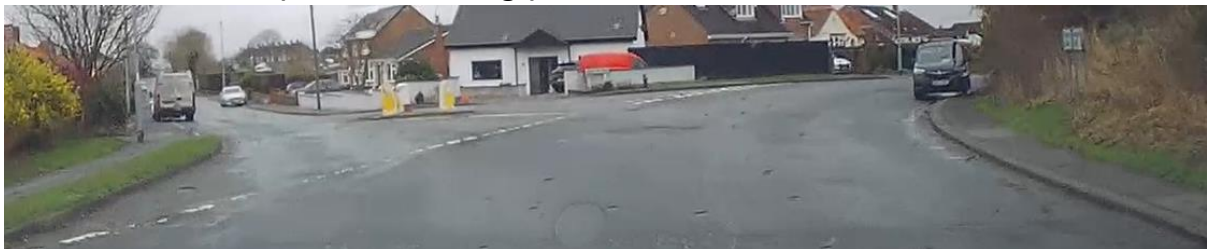
**R9.3 - Condition 0 (Lines)
Condition 20 (Junction Markings)**

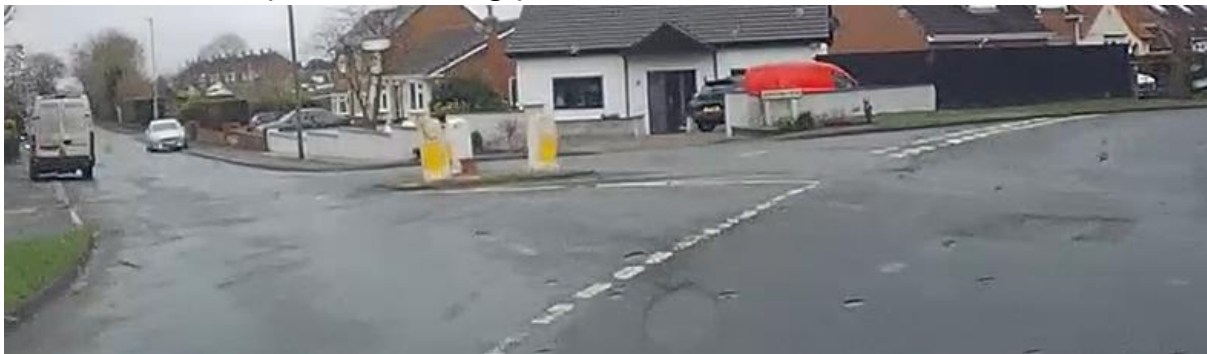
R9.4 - Condition 20 (Junction Markings)

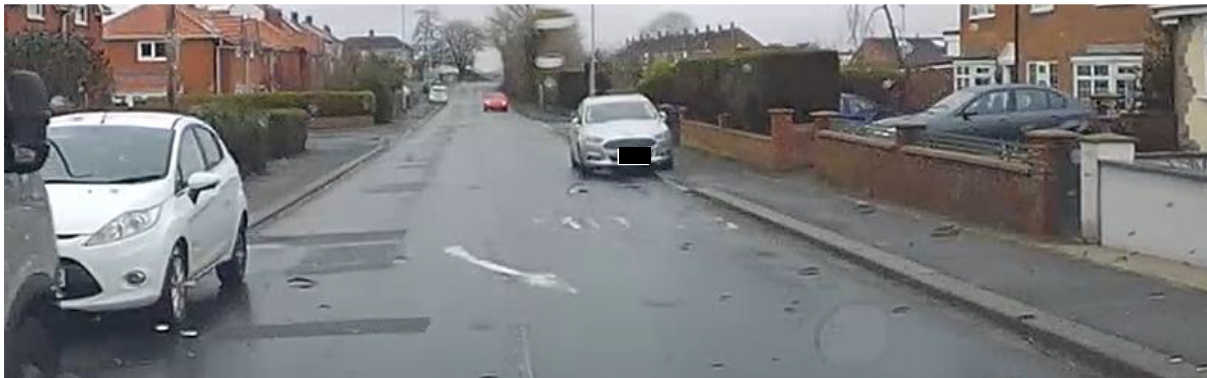
**R9.5 – Condition 0 (Lines)
Condition 10 (Arrow)
Condition 10 (SLOW)**

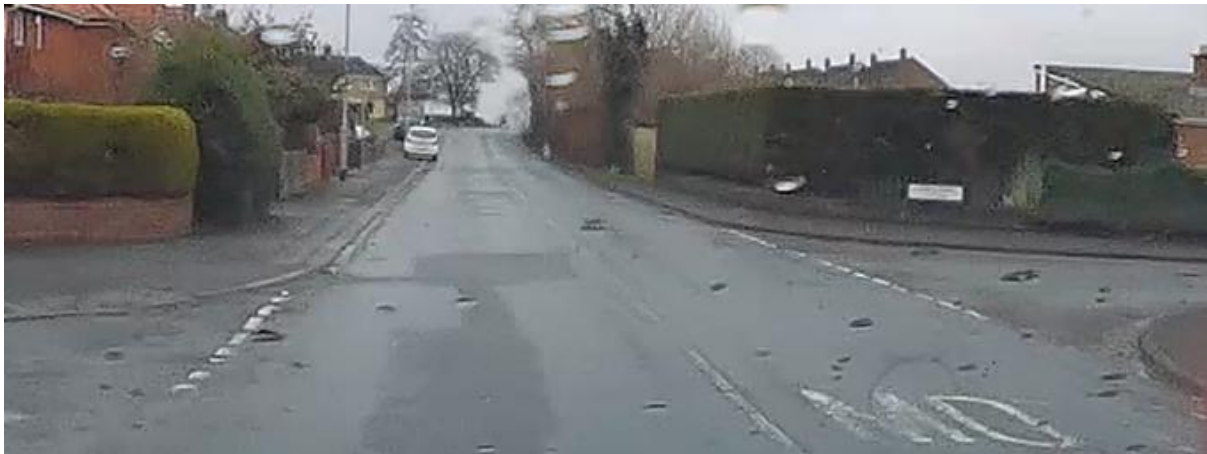
**R9.6 – Condition 0 (Lines)
Condition 10 / 20 (Junctions)
Condition 0 (SLOW)**

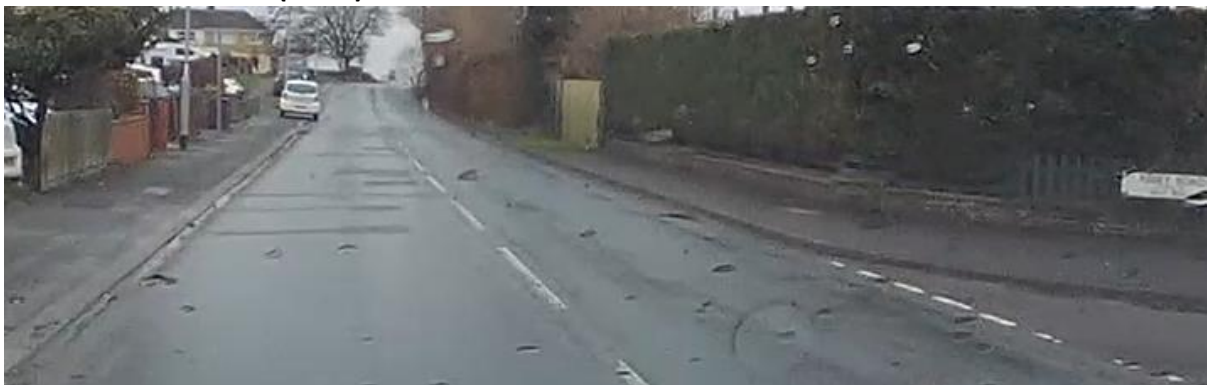
R9.7 – Condition 10 (Lines)

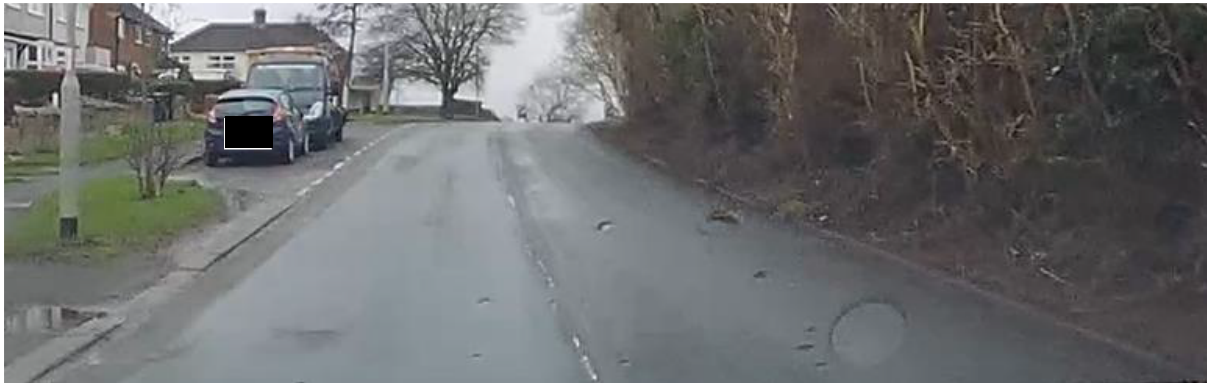
R9.8 – Condition 0

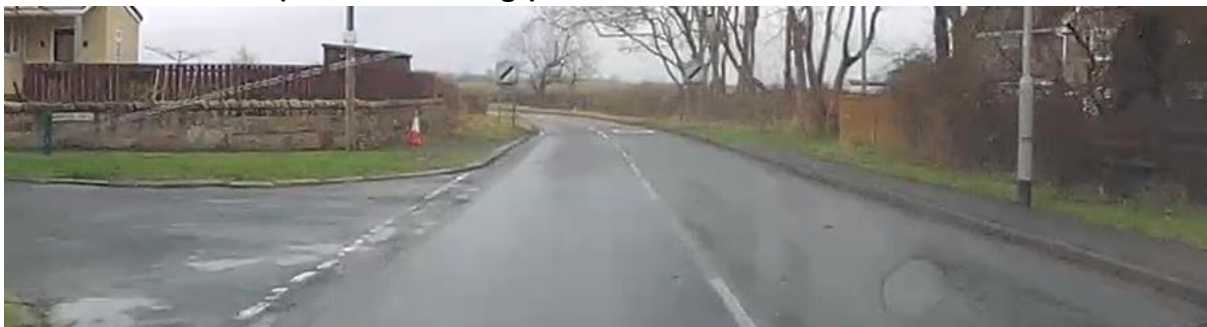
**R9.9 – Condition 10 (Lines)
Condition 10 (Junction Markings)**

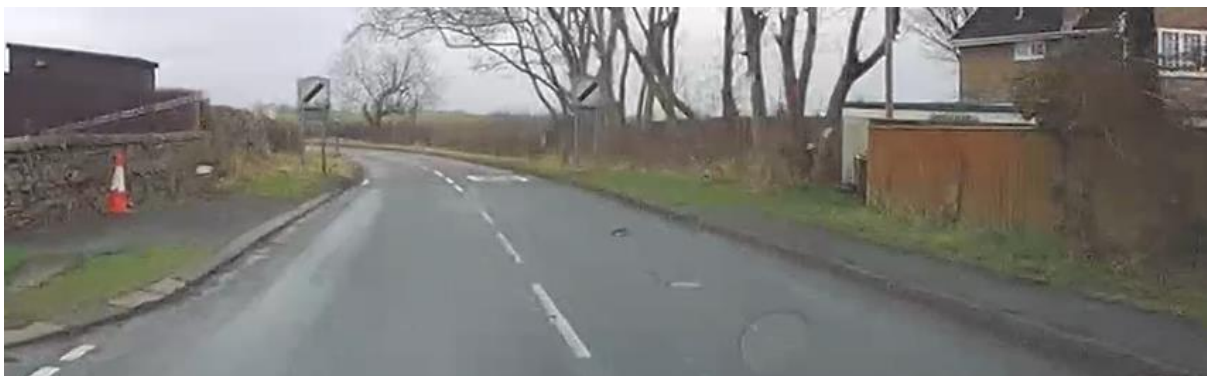
R9.10 – Condition 10

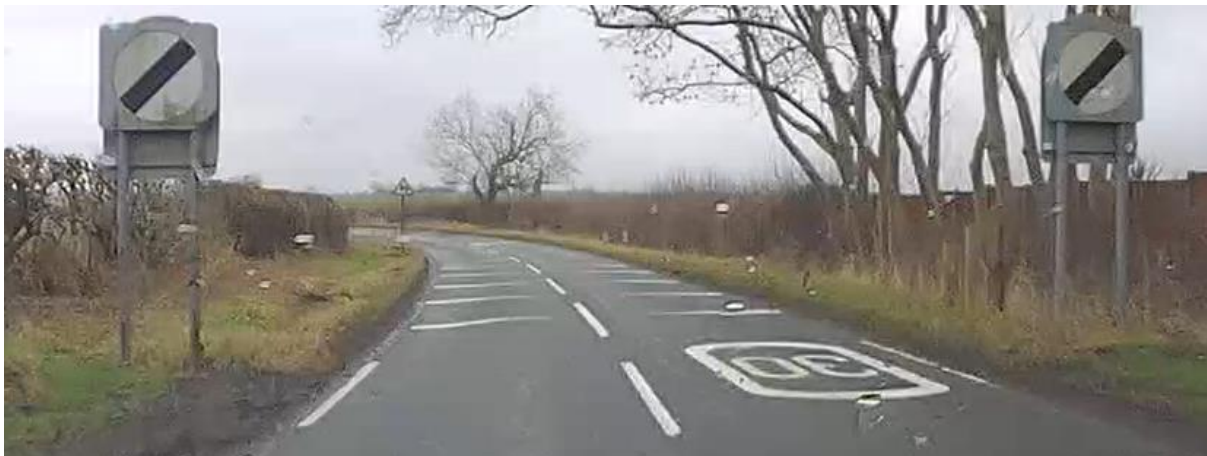
R9.11 – Condition 50

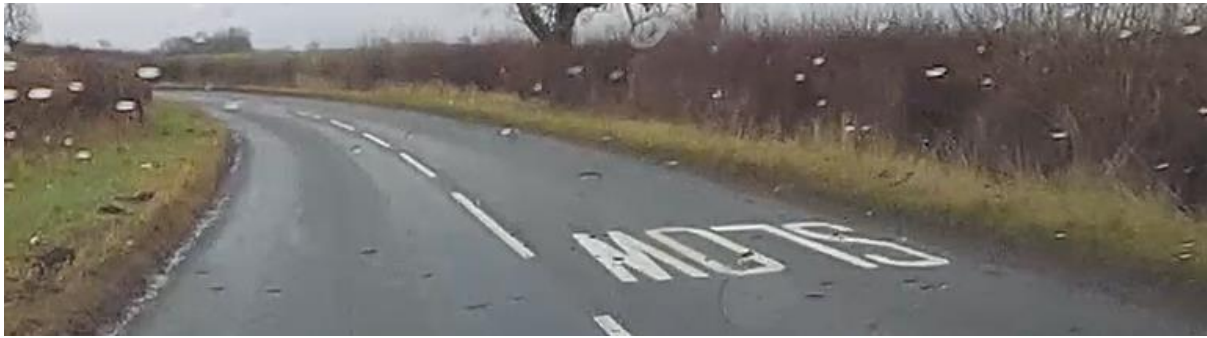
R9.12 – Condition 50

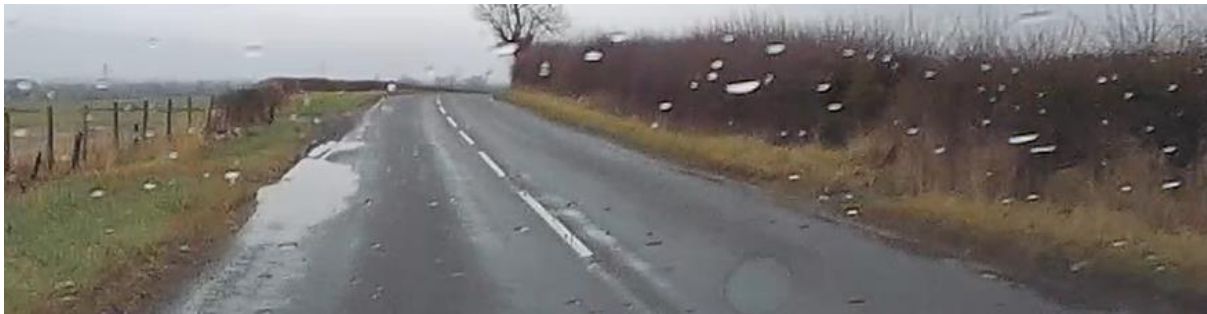
R9.13 – Condition 50

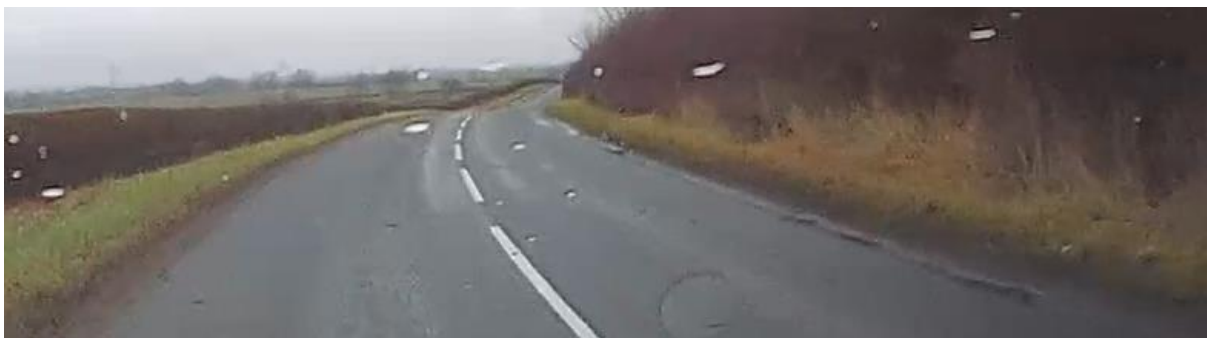
R9.14 – Condition 50

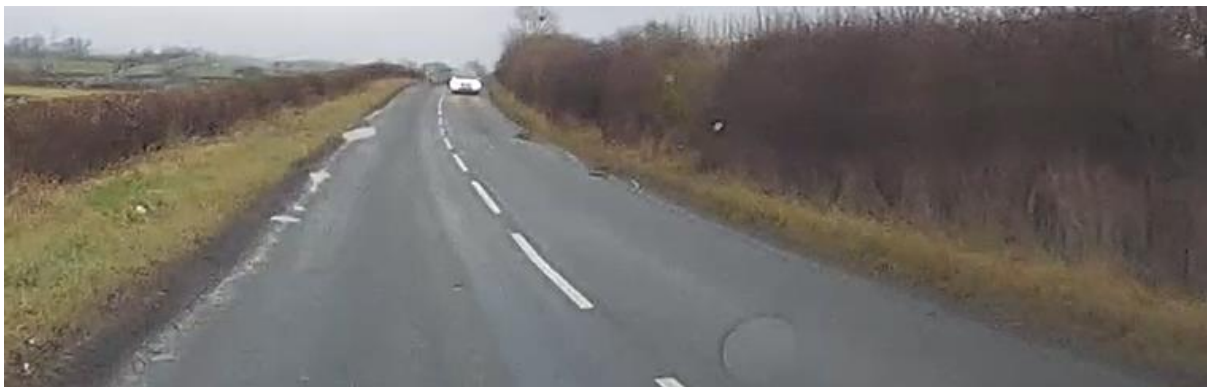
R9.15 – Condition 50

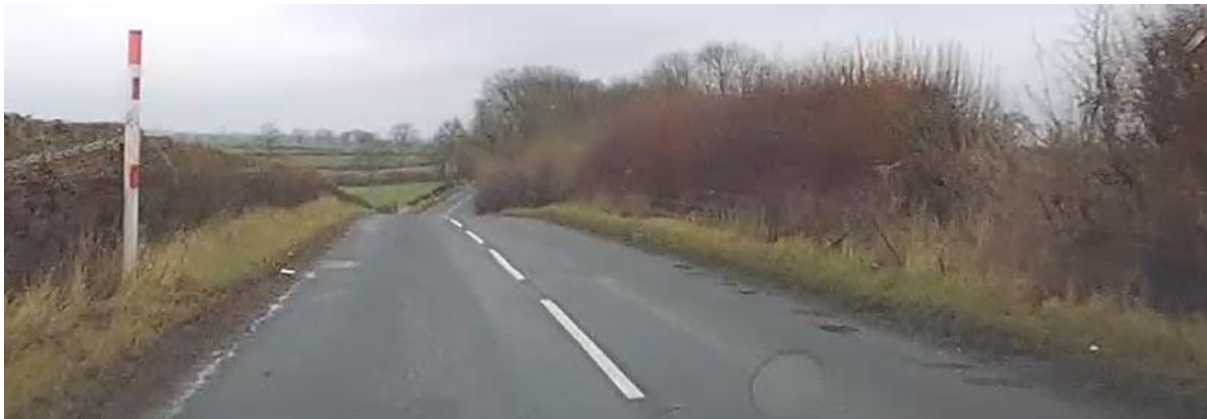
R9.16 – Condition 50

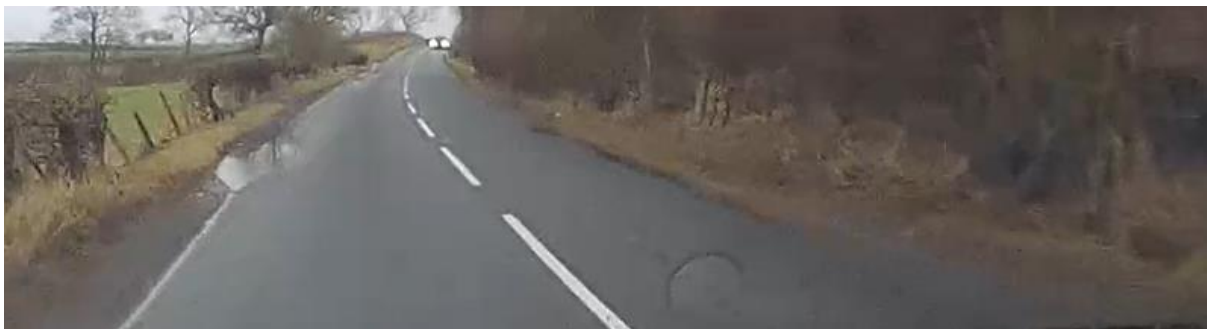
R9.17 – Condition 50

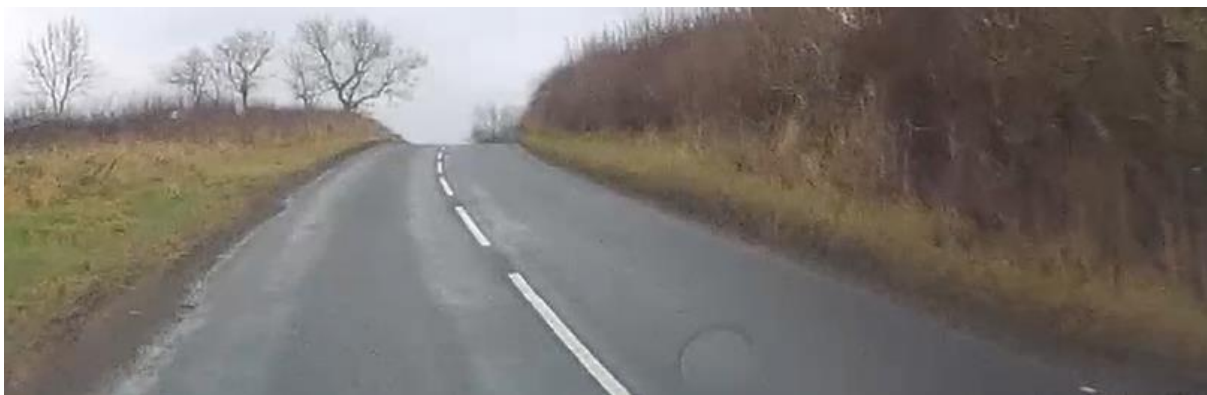
R9.18 – Condition 50

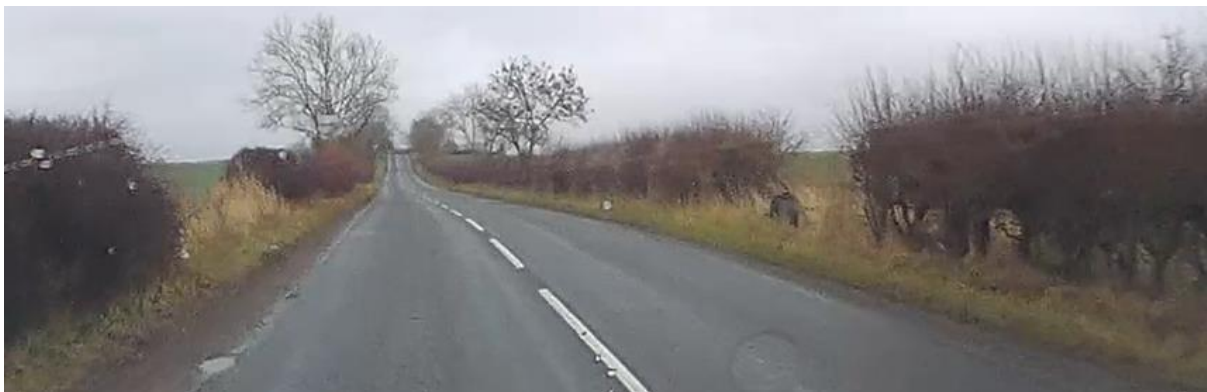
R9.19 – Condition 50

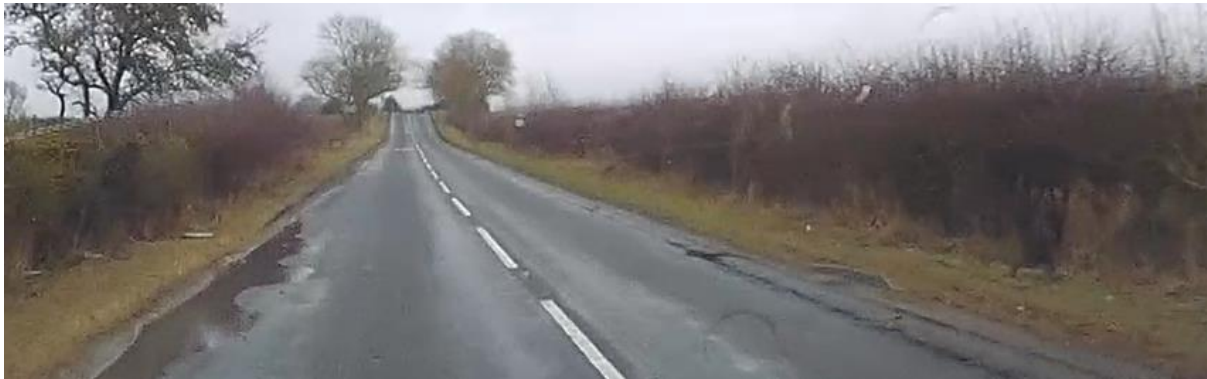
R9.20 – Condition 50

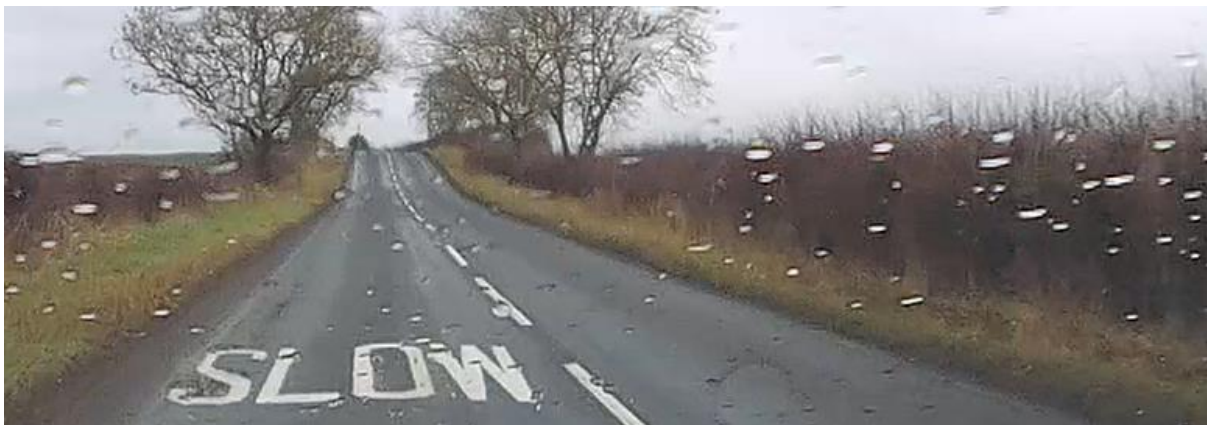
R9.21 – Condition 50

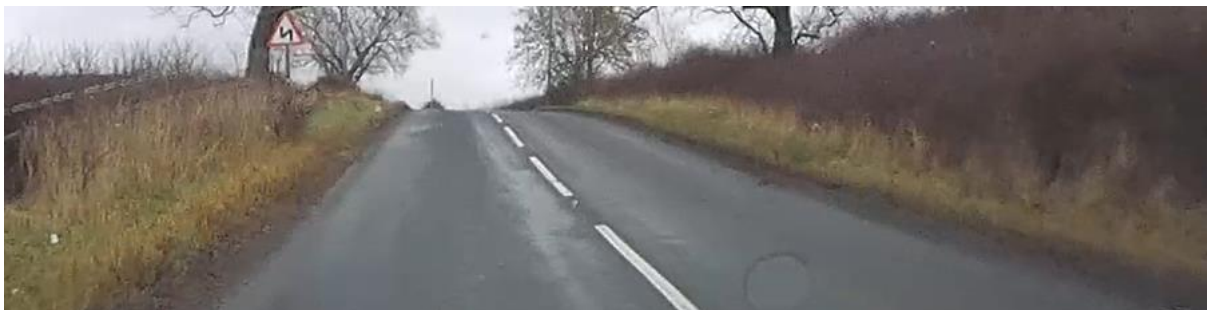
R9.22 – Condition 50

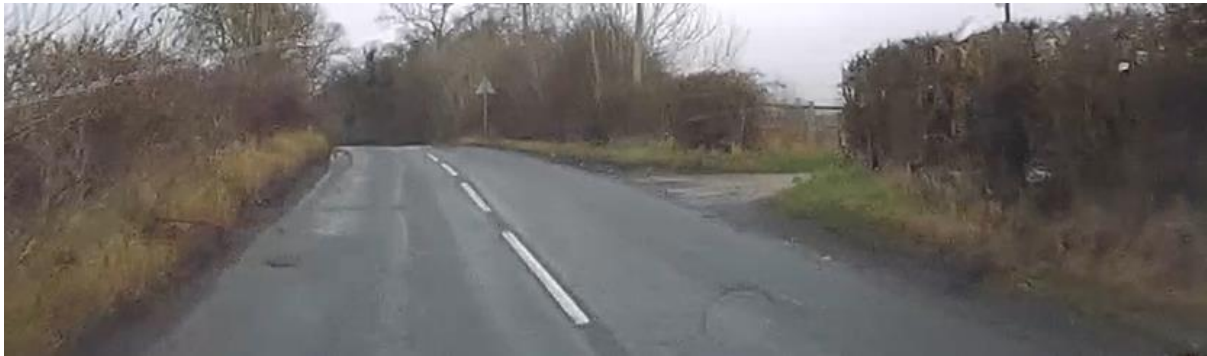
R9.24 – Condition 50

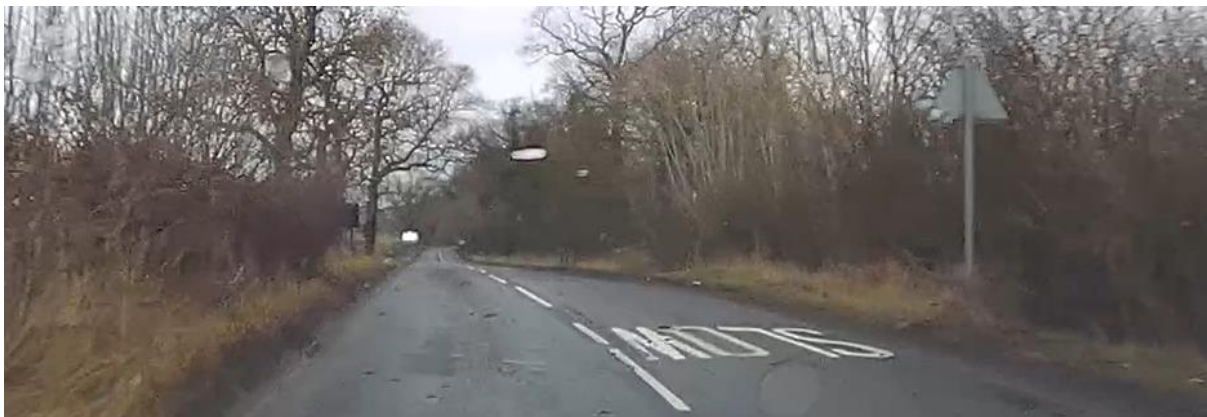
R9.25 – Condition 50

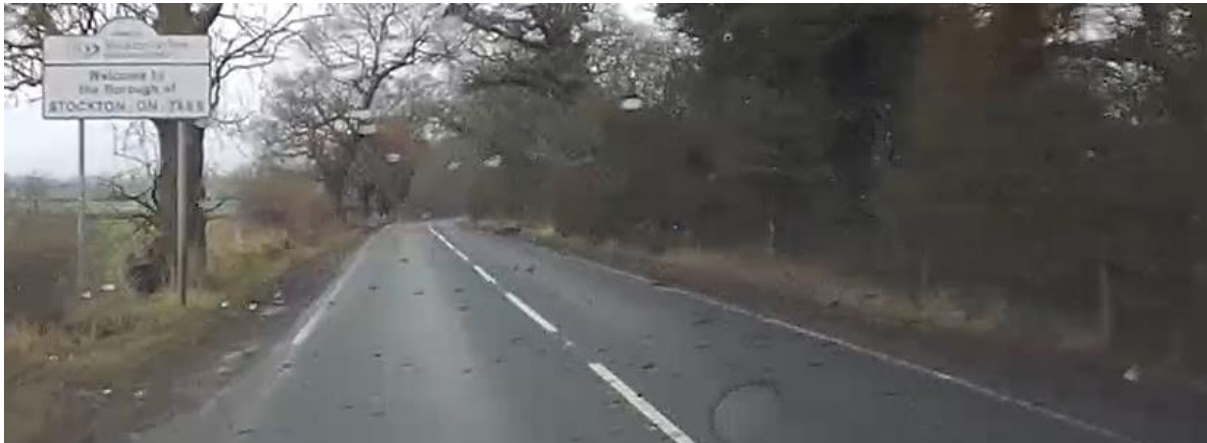
R9.26 – Condition 50 (Boundary with Stockton on Tees infrastructure.)

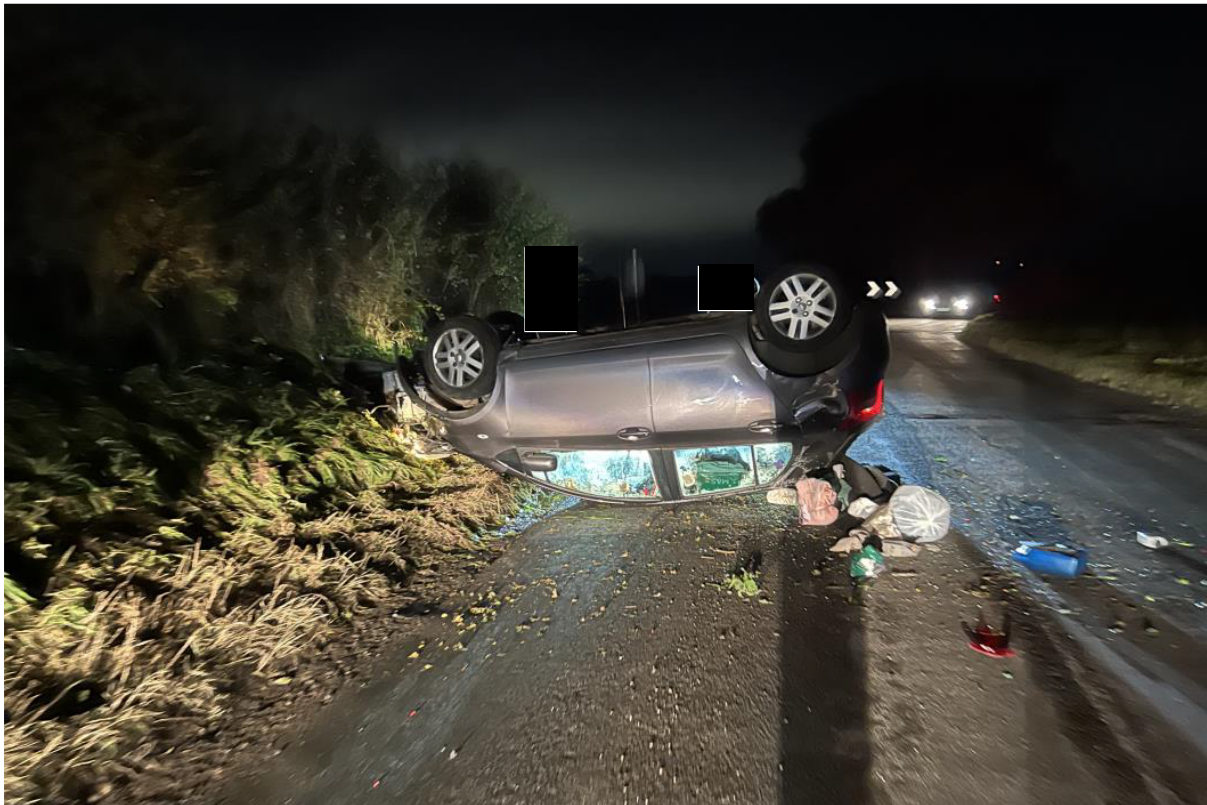
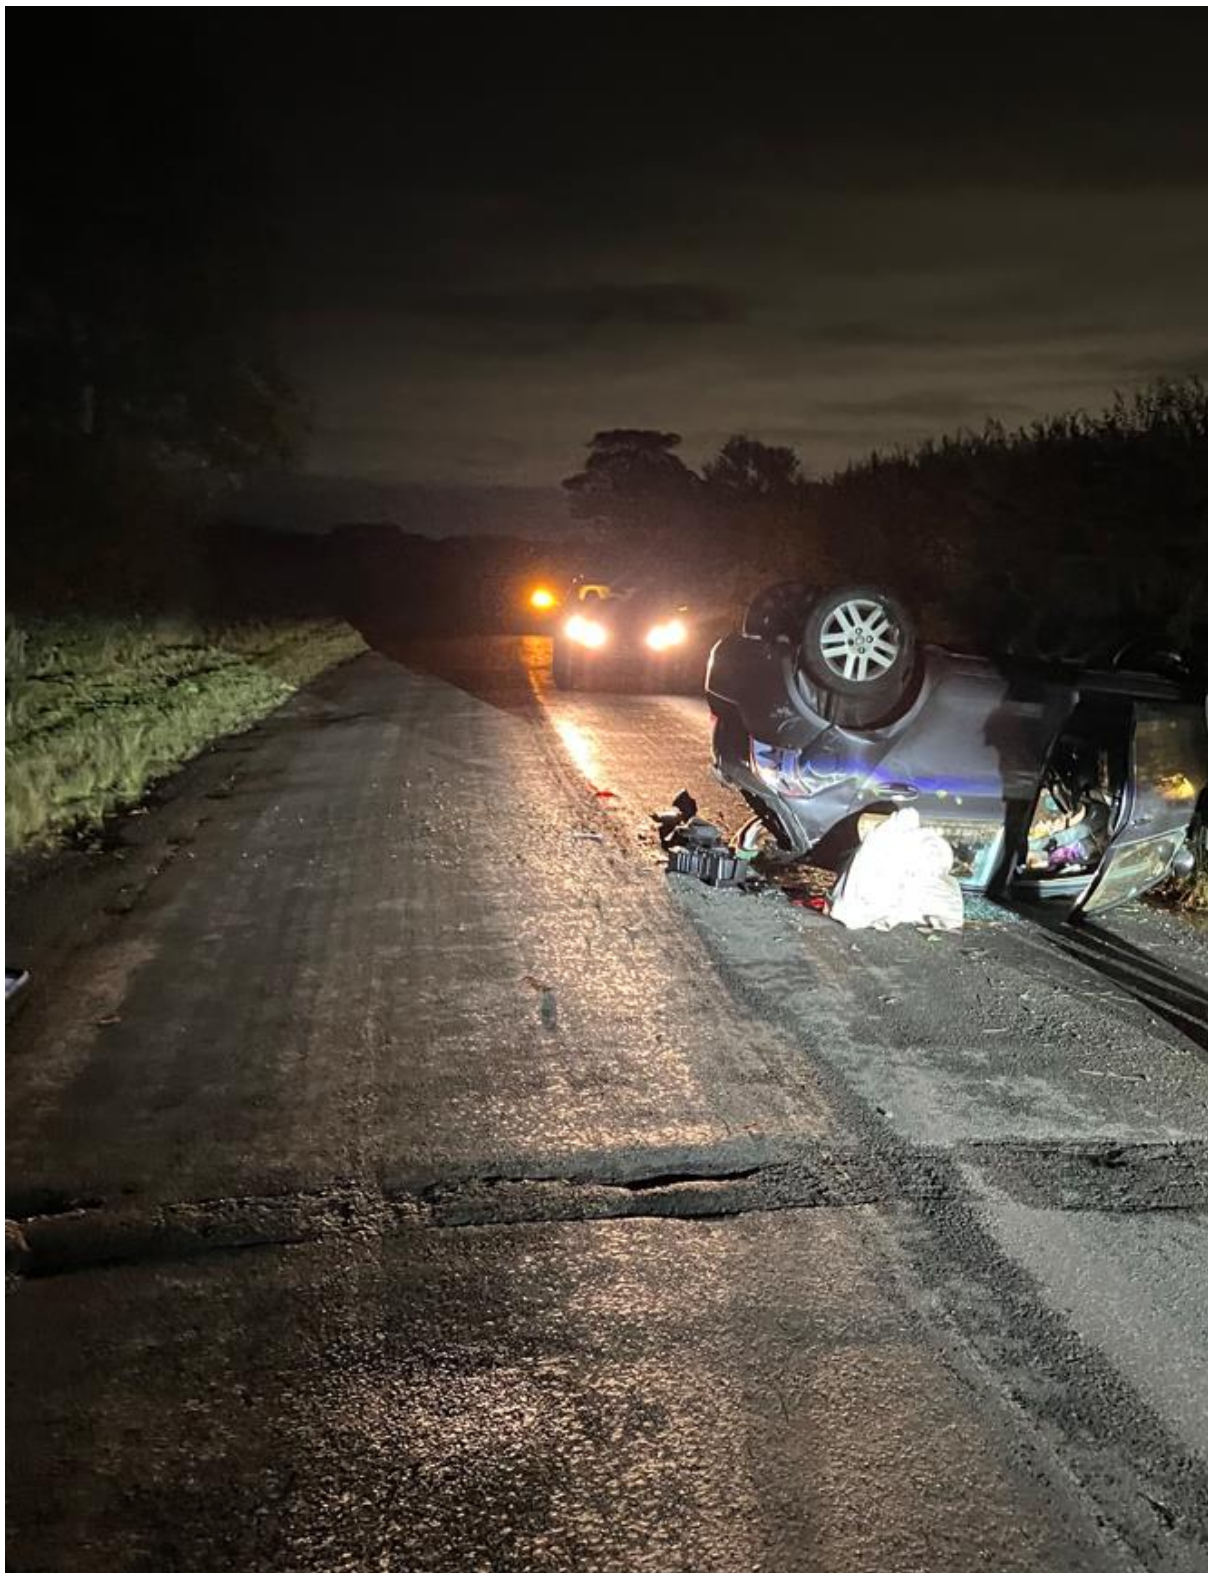
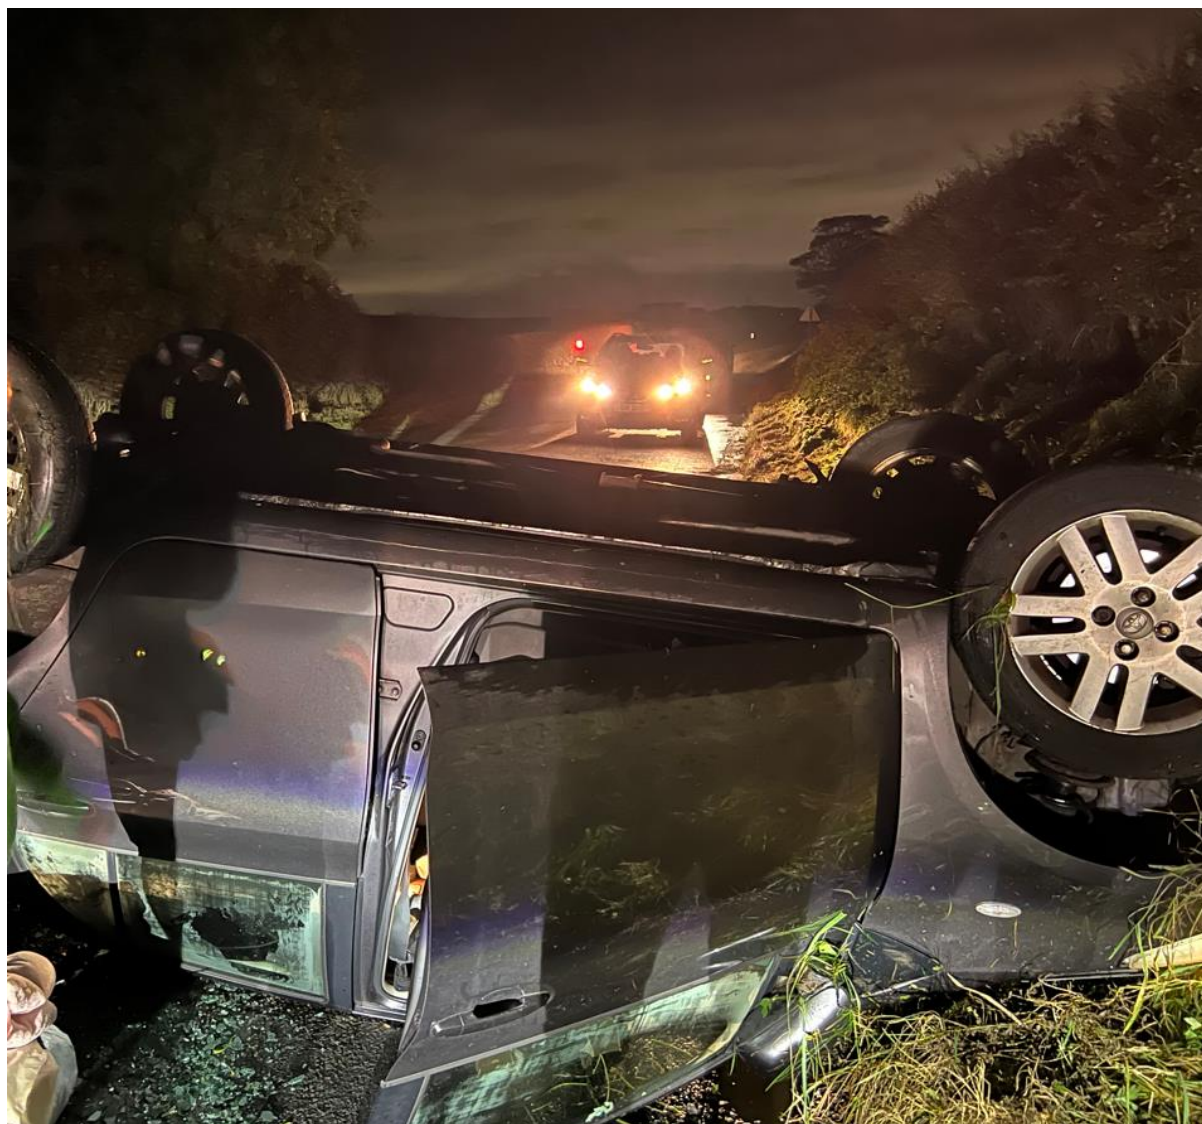
A Vehicle leaving Bishopton via Highstreet and failed to negotiate the bend onto Redmarshall Road On scene when questioned what happened the driver stated 'she couldn't see which way the road went'

RTI date 31.10.23 approx 1800hrs.
