**Road Line Marking Assessment Report Covering Darlington
Borough Council Road Infrastructure Surrounding Bishopton
Parish Council Area.
Document Reference BPC/1/24/001**

Document Reference	Revision	Date
BPC/1/24/001A	First issue Rev A (DRAFT internal Only)	14.01.2024
BPC/1/24/001B	Formal Issue Rev B	04.02.2024

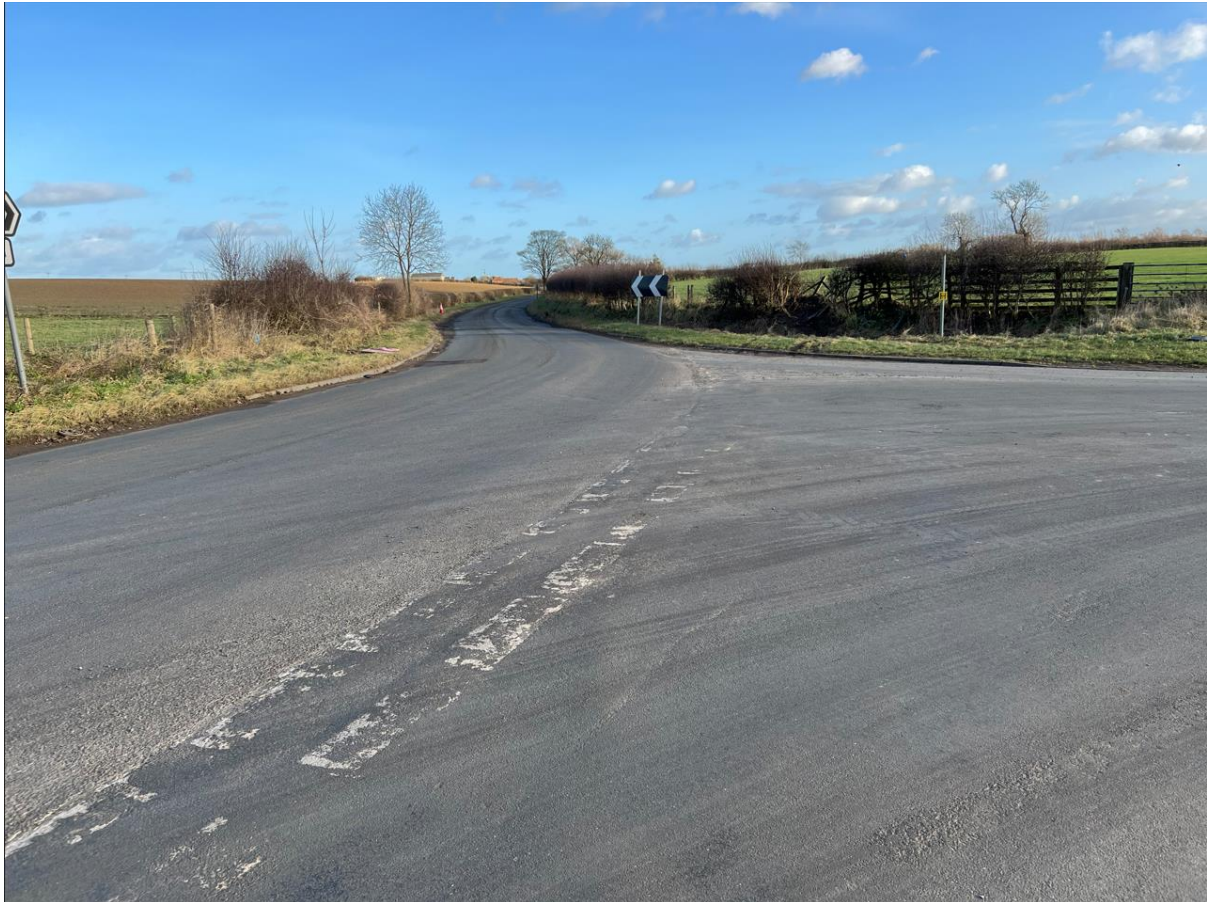
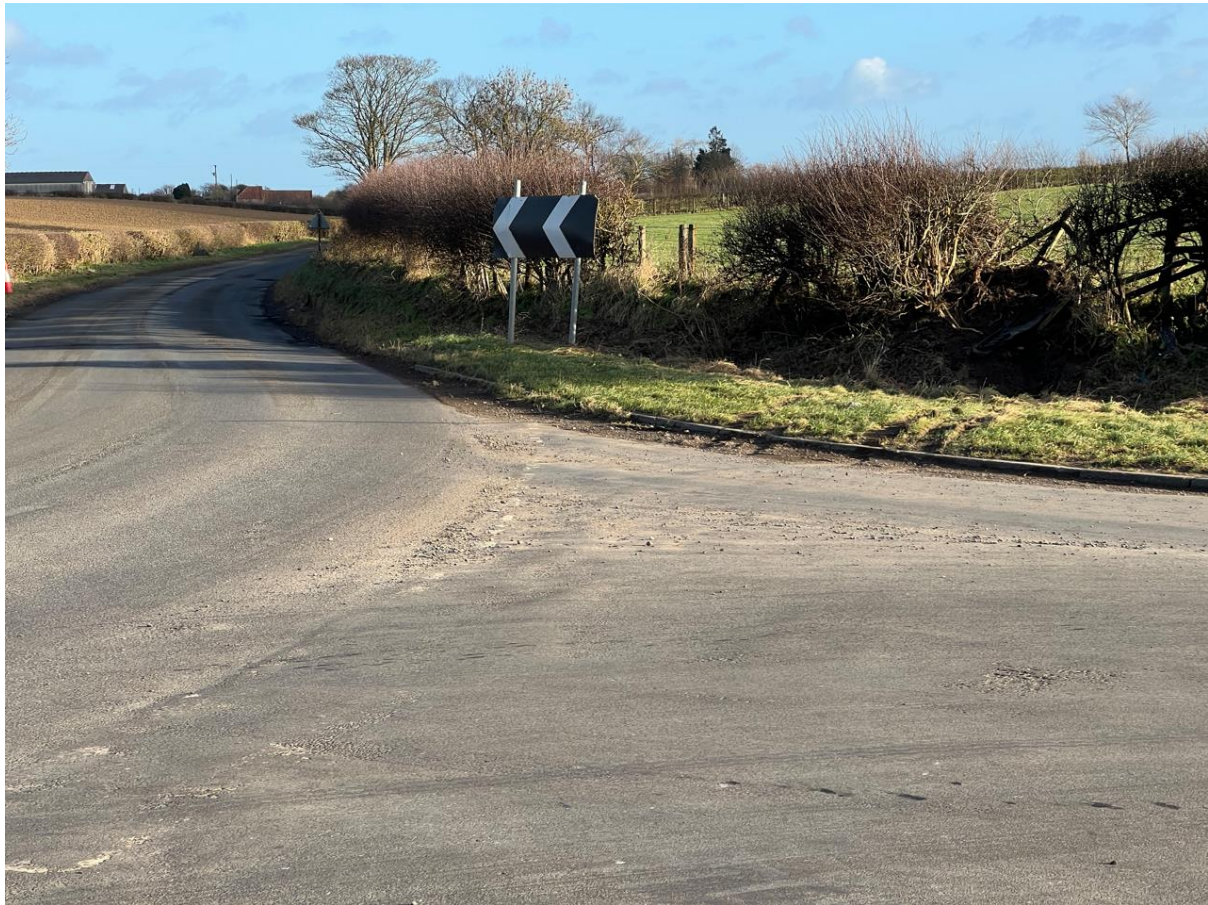
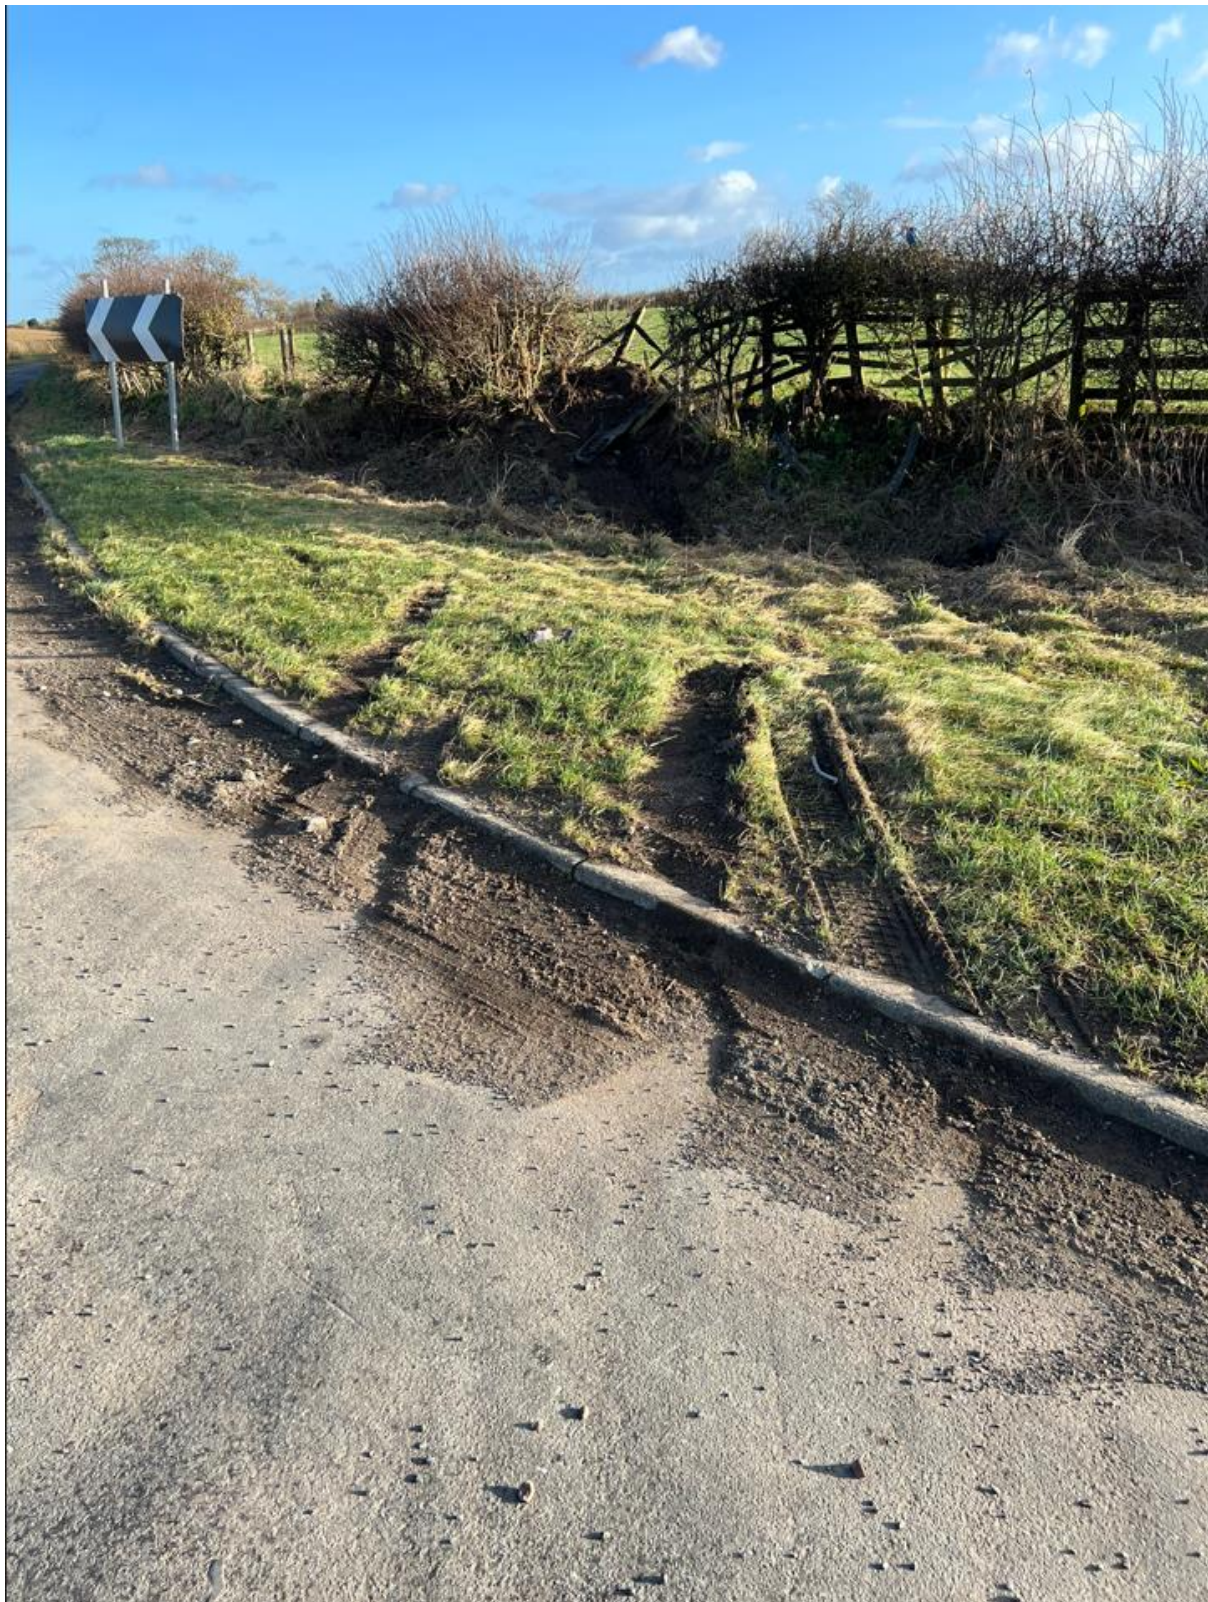
This RTI is associated with (R1.7 road survey image)

A Vehicle leaving Bishopton via Highstreet and failed to negotiate the bend onto Redmarshall Road left the road and came to rest on the embankment / ditch. RTI date 21.12.23 (approx.)

Road markings categorised as Critical may well be a contributing factor to this RTI

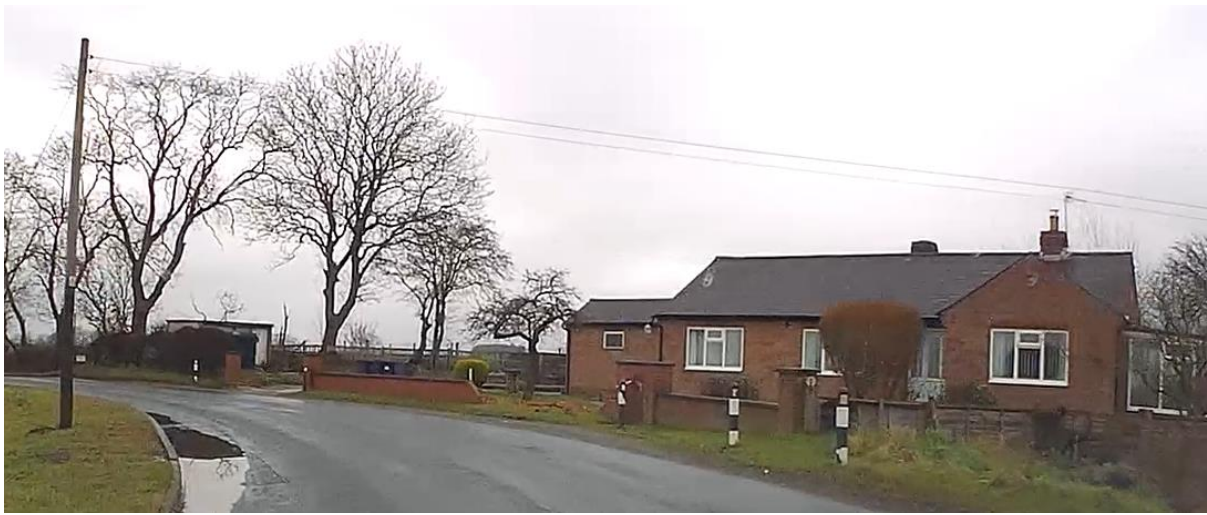
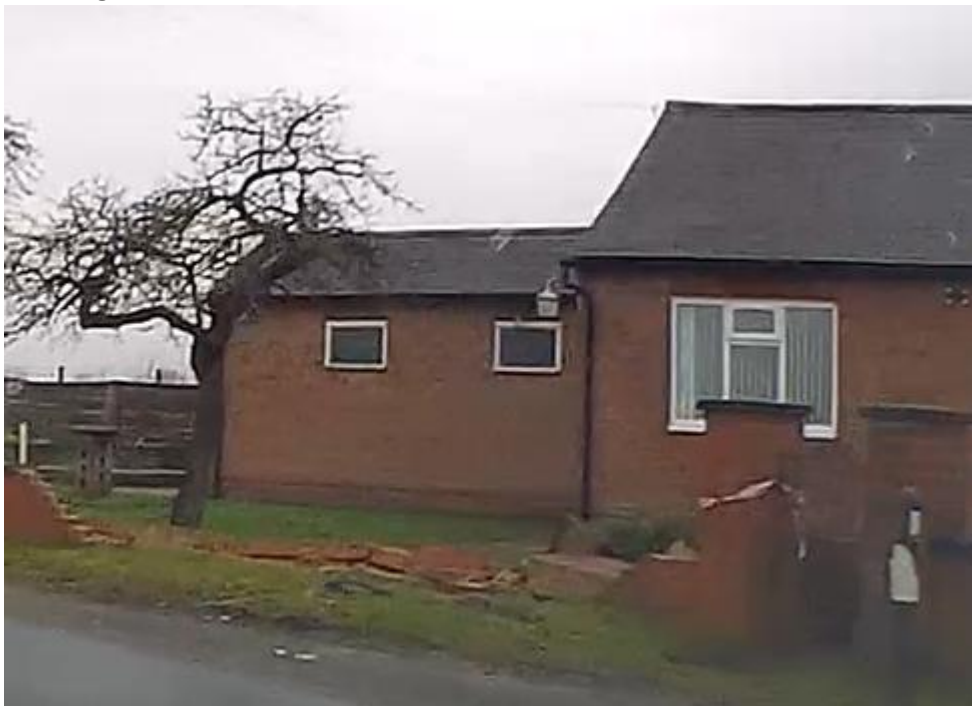
R1 image 7

This RTI is associated with (R1.18 road survey image)

Road markings categorised as Critical may well be a contributing factor to this RTI.

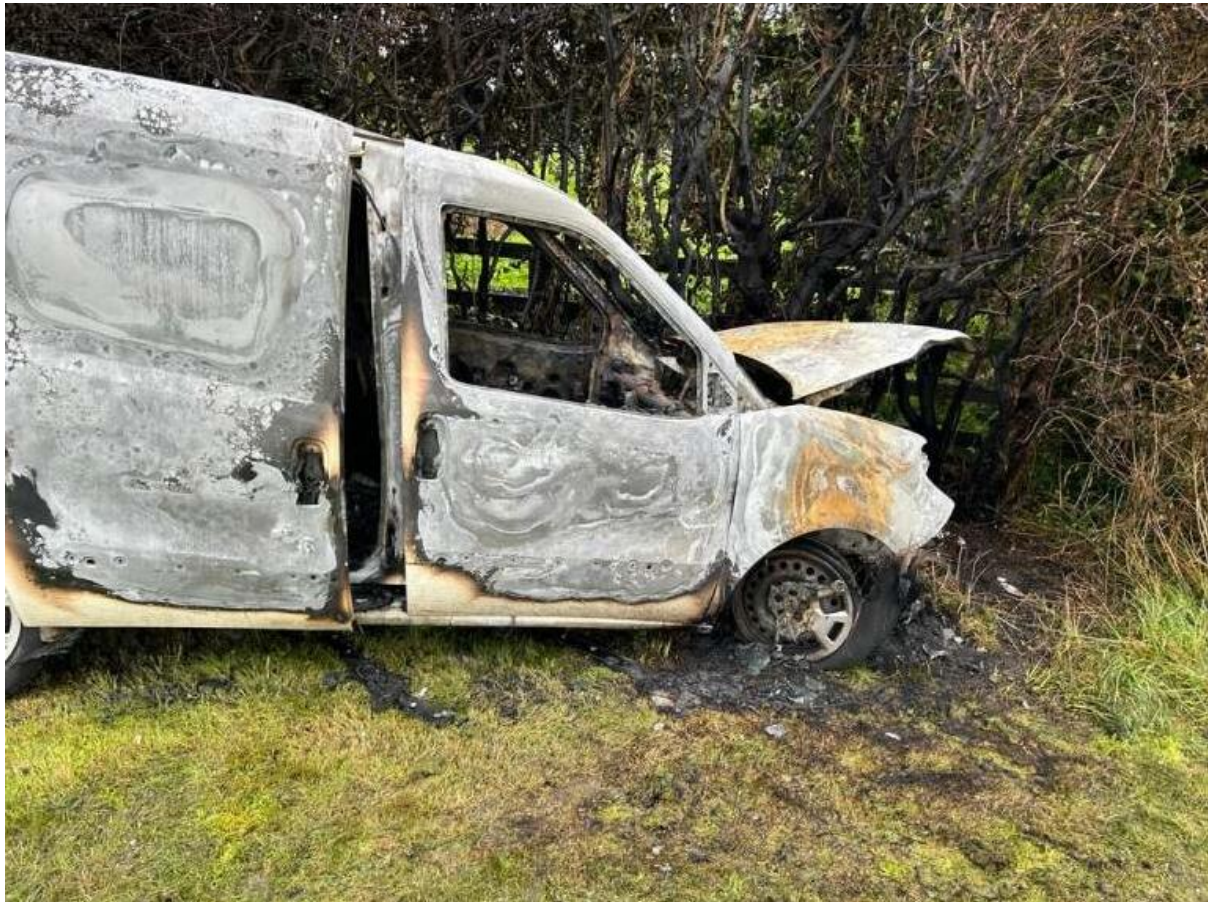
R3 Image 2

A vehicle descending Folly Bank approaching Bishopton failed to stop at the Junction and left the road and crashed into trees knocking down street furniture. A vehicle fire ensued.
