# **XLINKS' MOROCCO-UK POWER PROJECT**

**Volume 2, Appendix 1.5: Preliminary Ground Level Bat Tree Roost Assessment**

**Xlinks – Cable Route  
Bideford  
Devon**

**Preliminary Ground Level Bat Tree Roost Assessment**

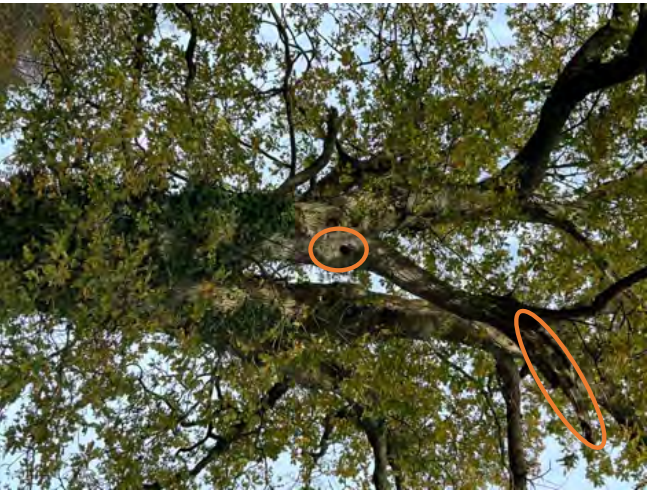
T3 – Tear-out, likely extending

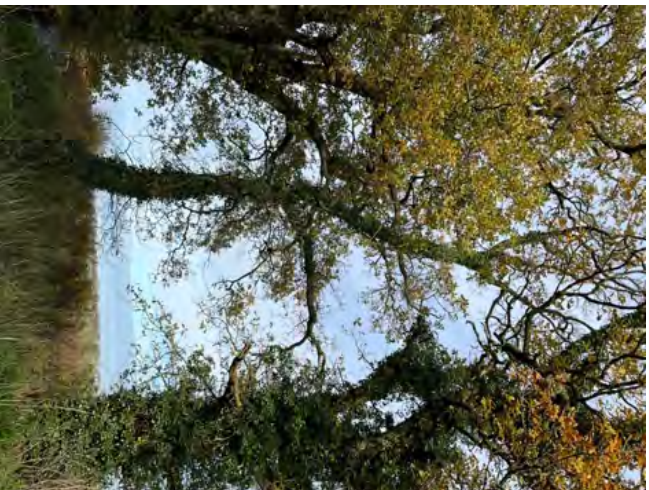
T4 – Knothole

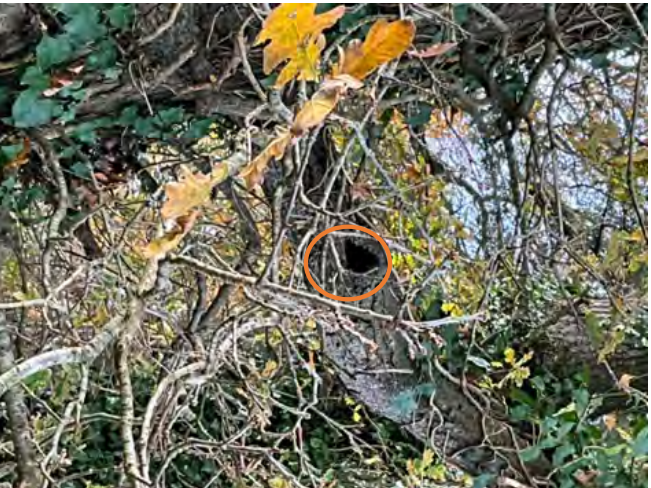
T4 – Knothole

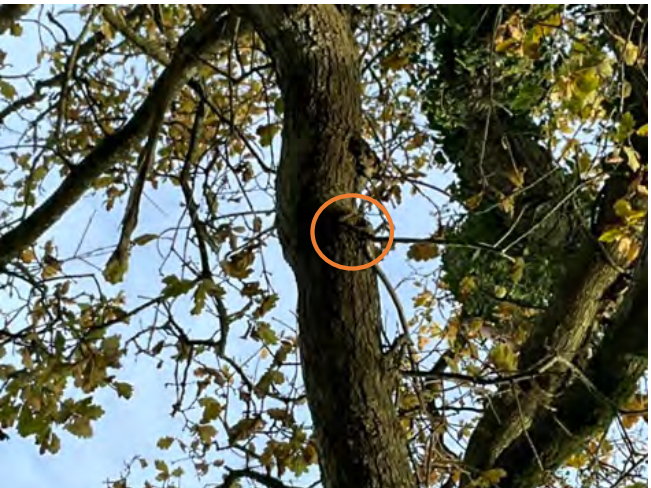
T5 – Tear-out/knothole

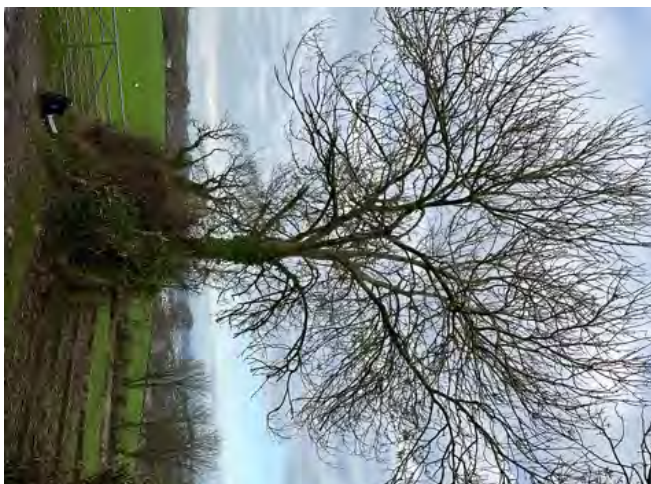
T7 – Tear-out

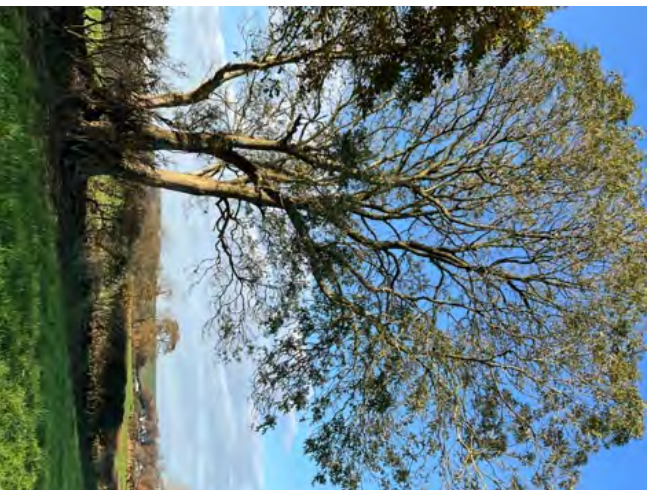
T9 – Canker with cavity extending upwards and lifting bark

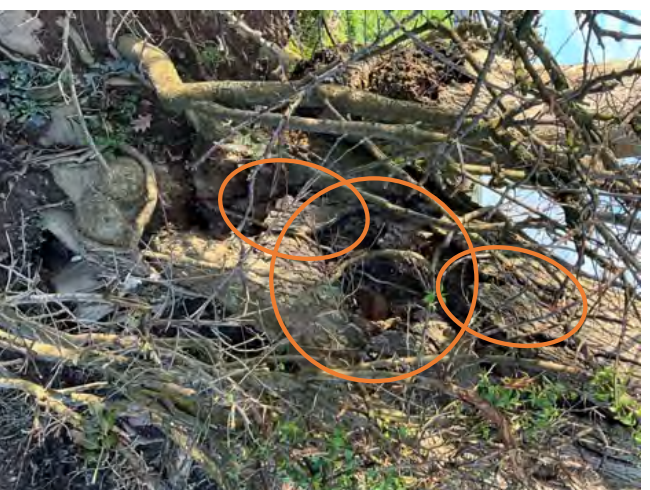
T9 – Wound, may extend

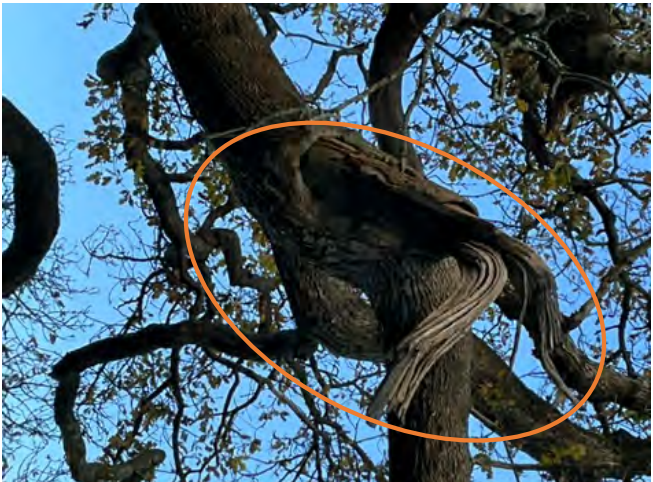
T14 – Knot-hole

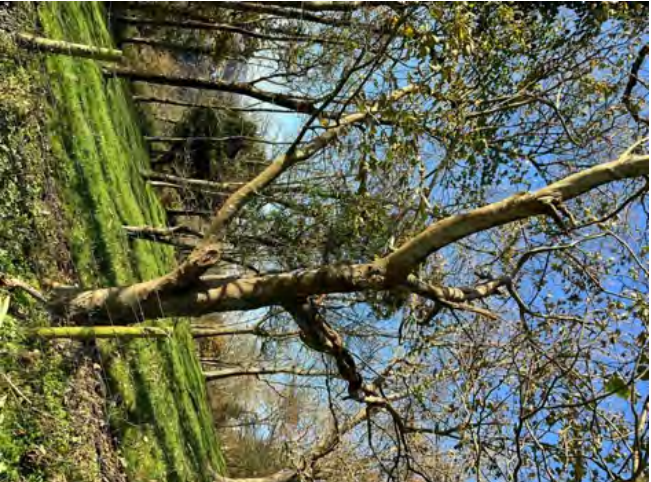
T17 – Knothole that extends to open cavity

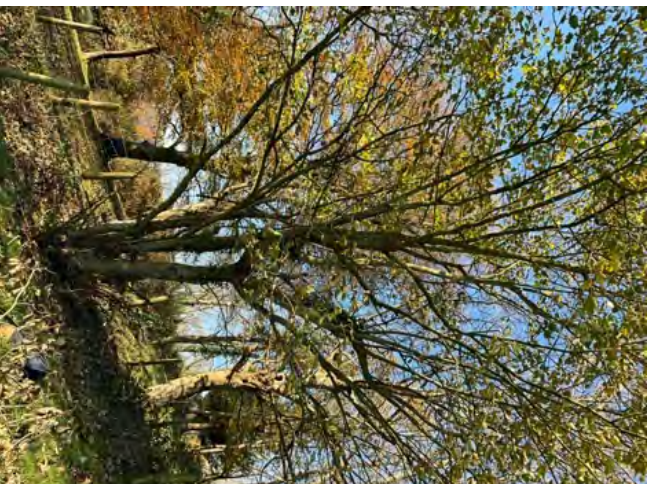
T19 – Wound that does not extend

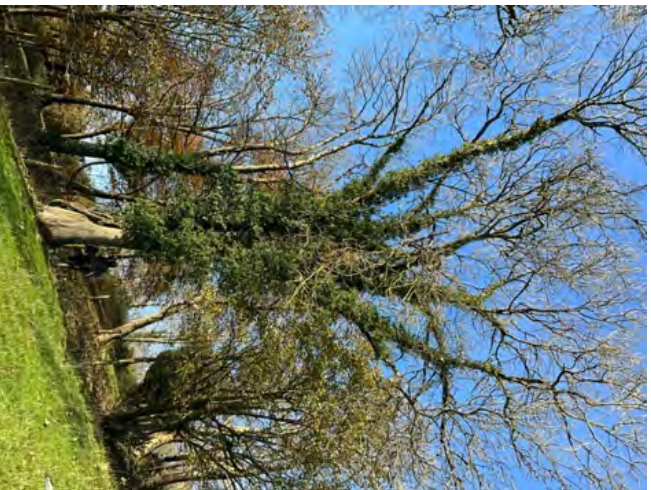
T20 – Double-leader without extending cavity

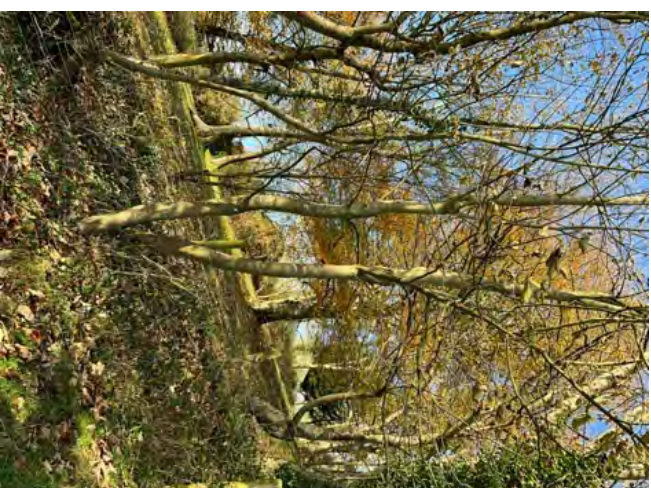
T21 – Wound, extending

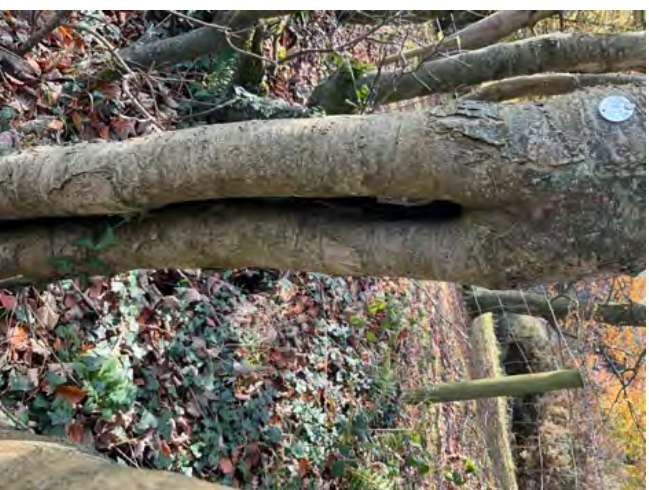
T21 – Wound that does not extend

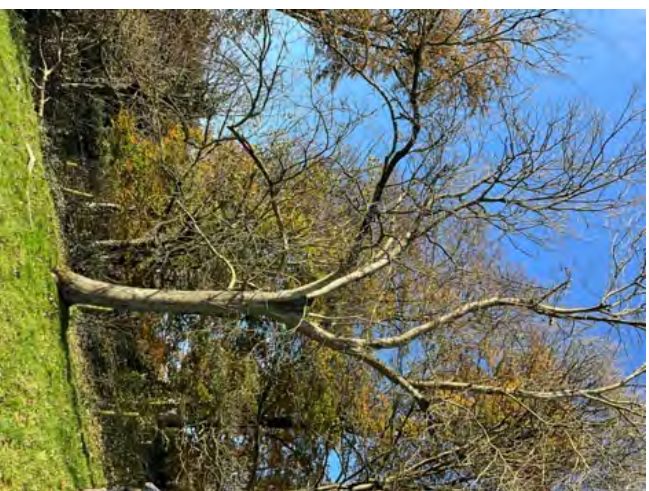
T22 – Wound

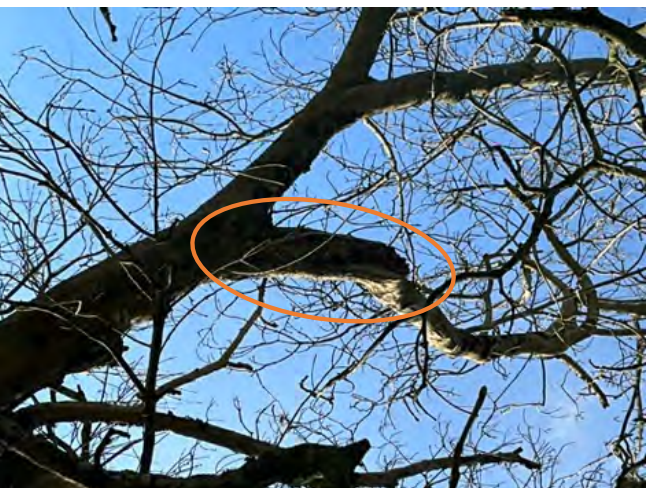
T22 – Knothole; facing upward and may extend

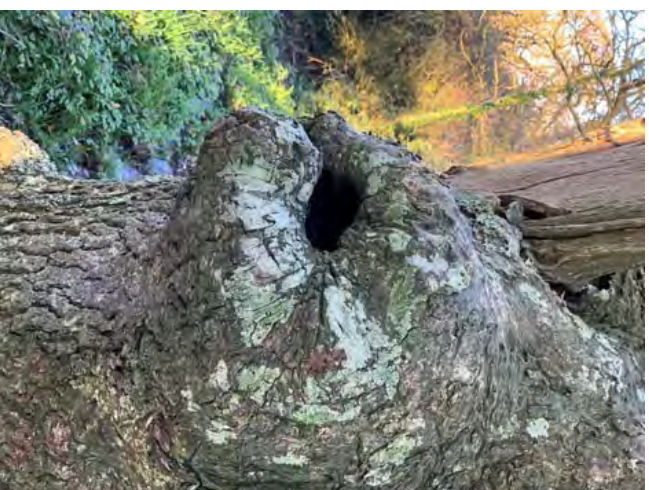
T28 – Wound, extending upwards
