A417 Missing Link
TR010056

6.4 Environmental Statement
Appendix 13.11 Water Features Survey
(Part 1 of 2)

**6.4 Environmental Statement
Appendix 13.11 Water Features Survey
(Part 1 of 2)**

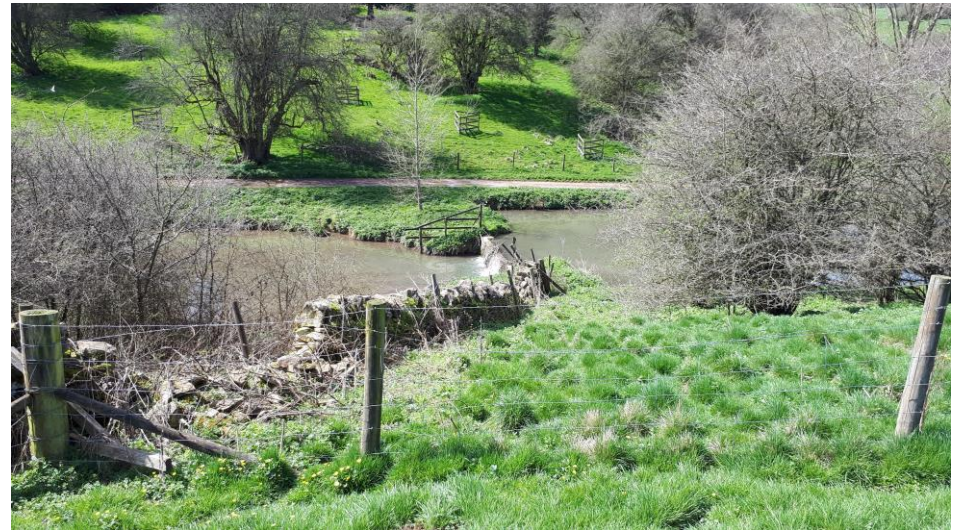
22_looking W at weir between upper and middle pond_180418

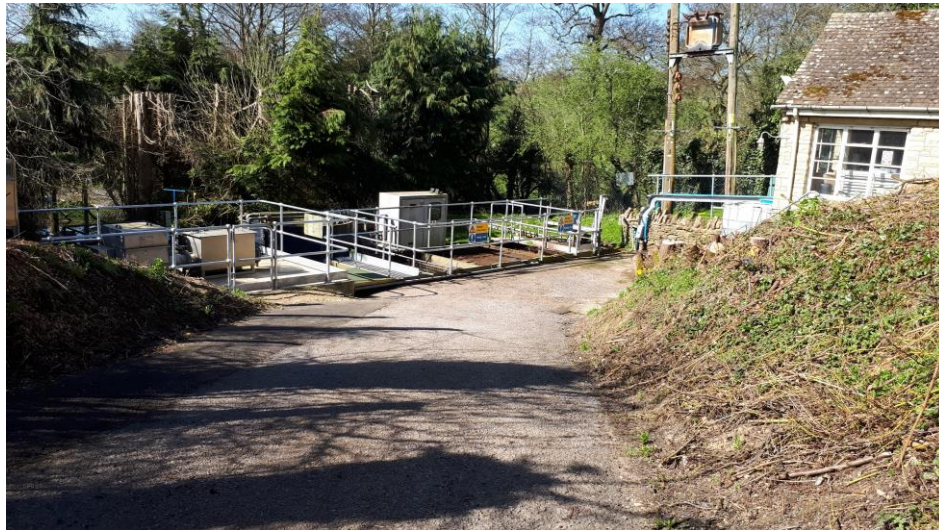
41_looking SW at STW_190418

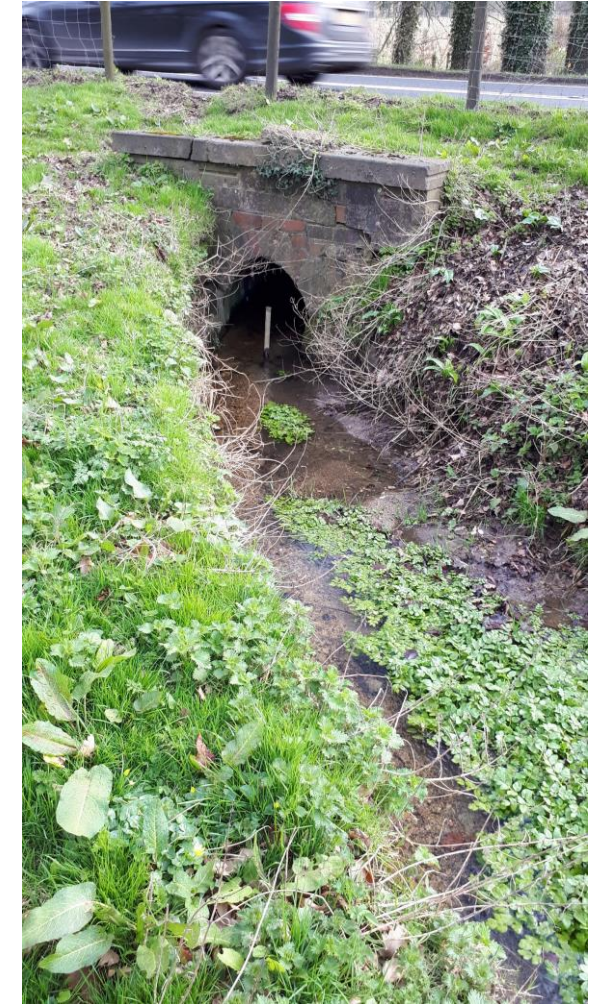
91_culverted flows of churn
tributary headwaters_looking S DS

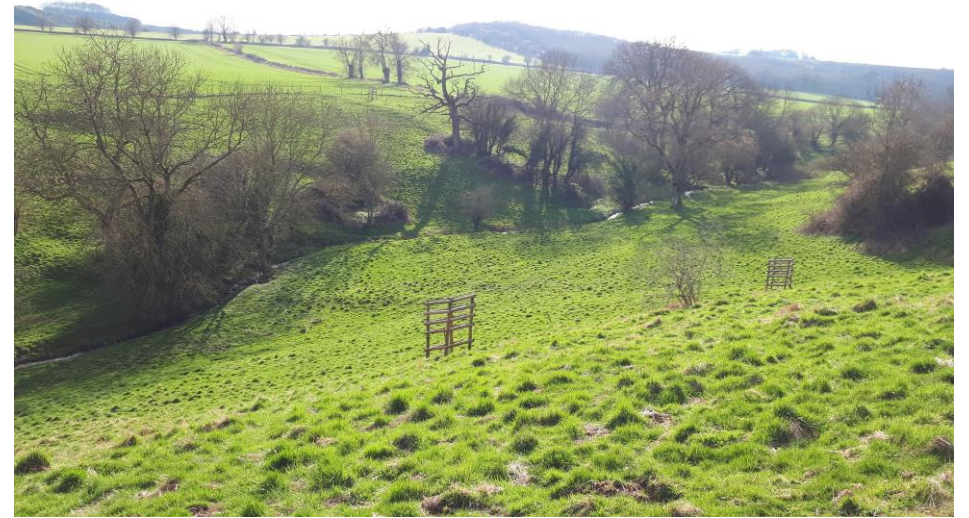
94_Looking S towards River Churn tributary

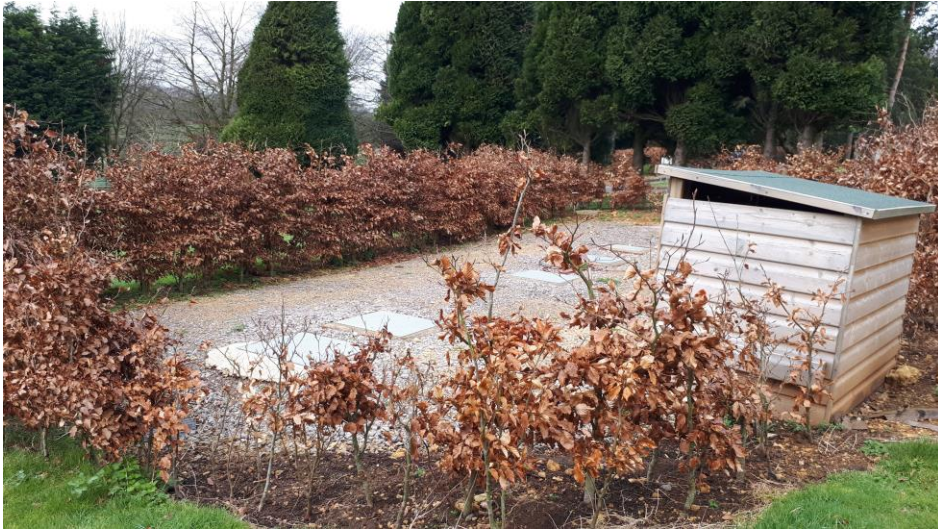
95_waste treatment at golf course

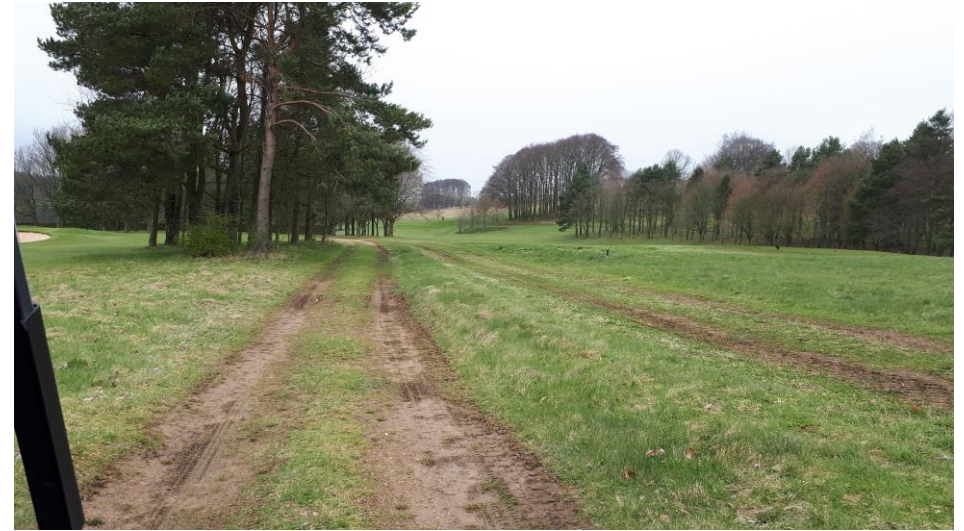
98_location of proposed lake approved for construction

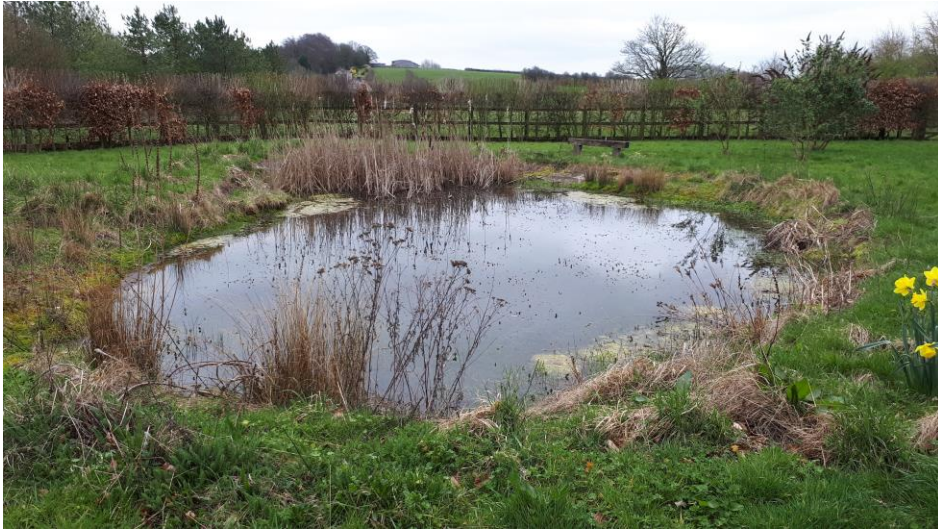
99_lined pond

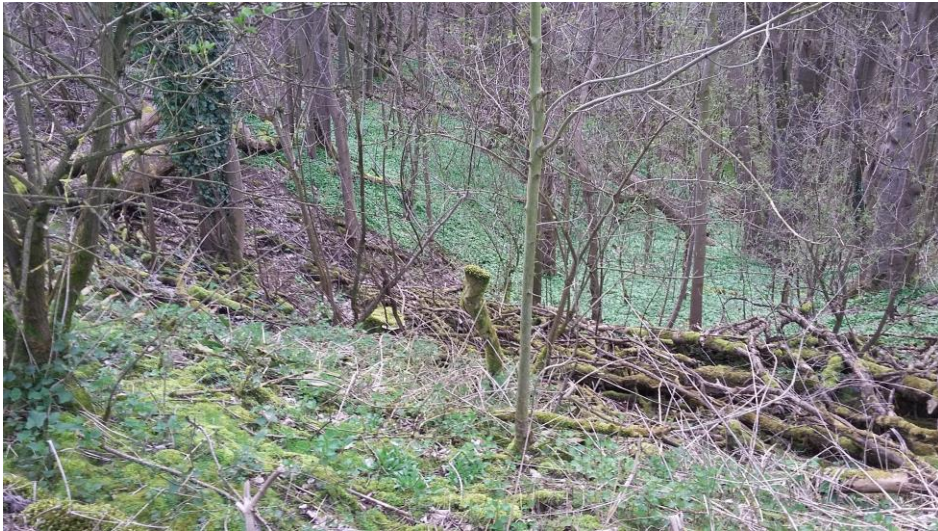
G3_dry valley where spring marked on OS map_looking W

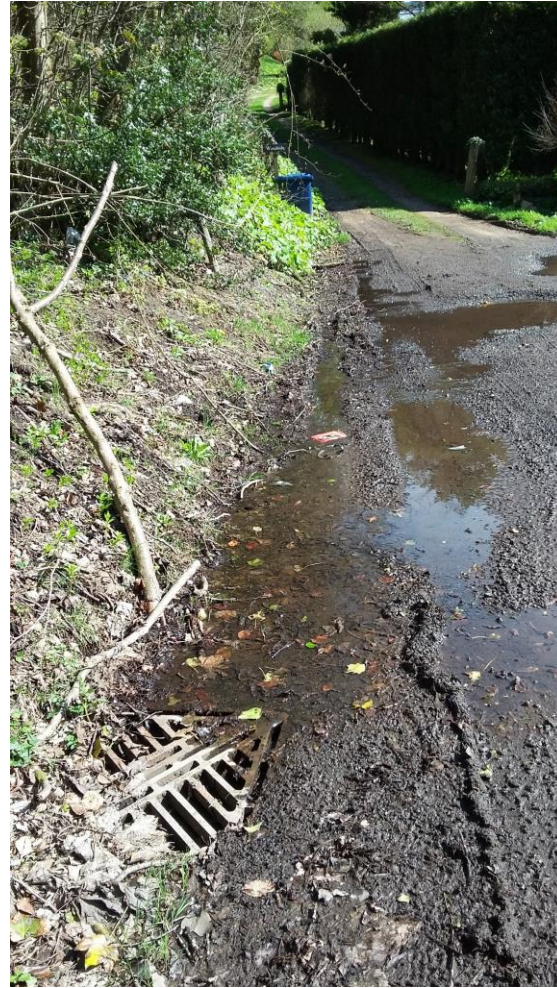
G2_Spring at start of drive of Woodside House_looking E

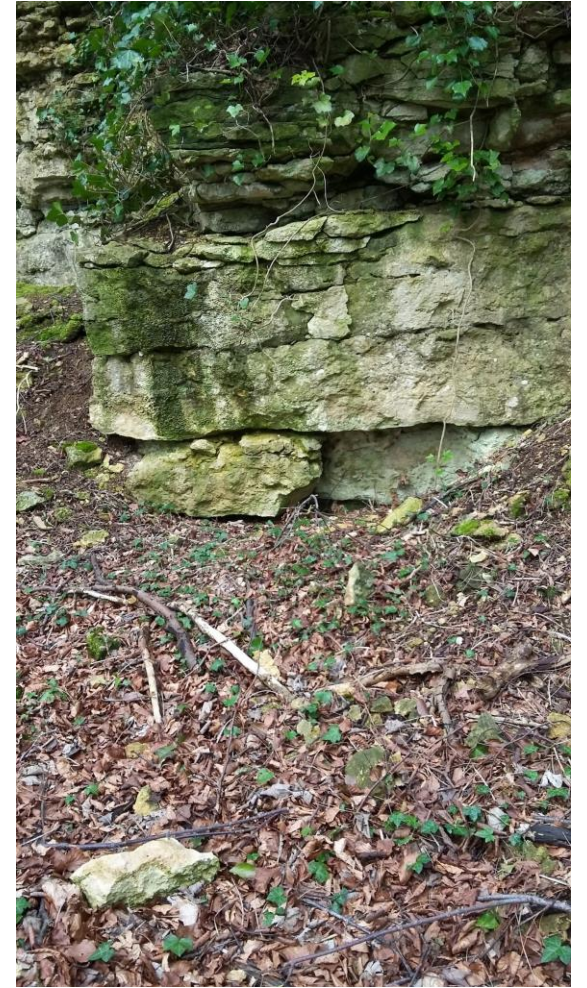
G1_Solution features on Imst outcrop barrow wake

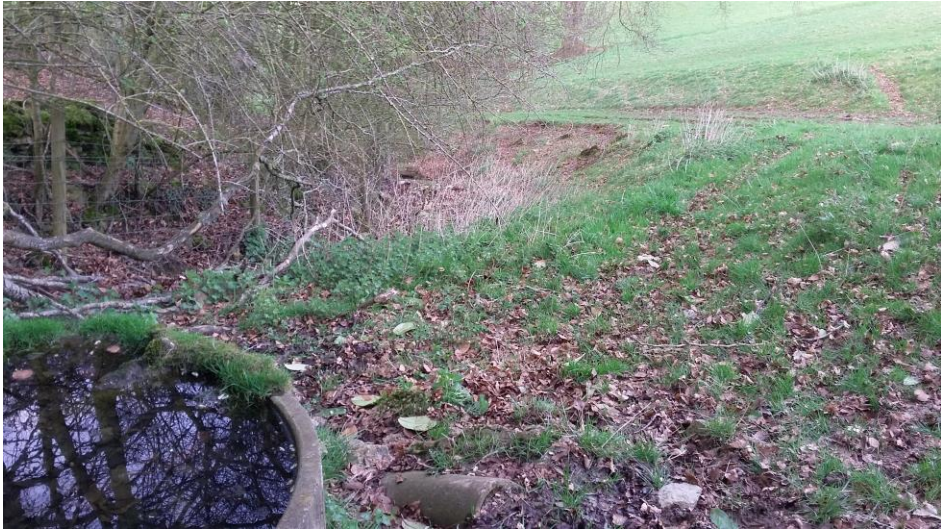
G4_spring_collects_looking NE

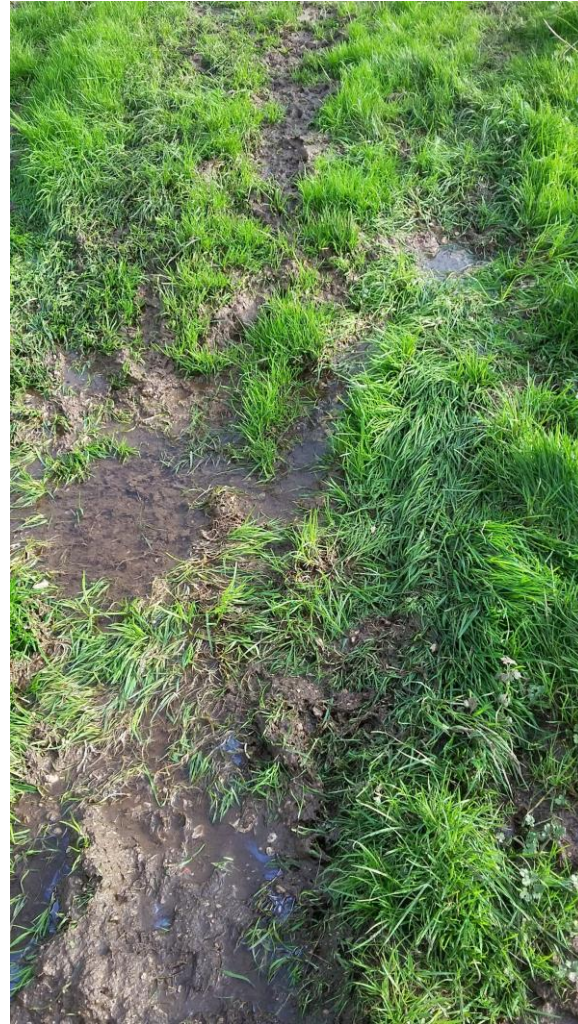
G6_spring_facing SW

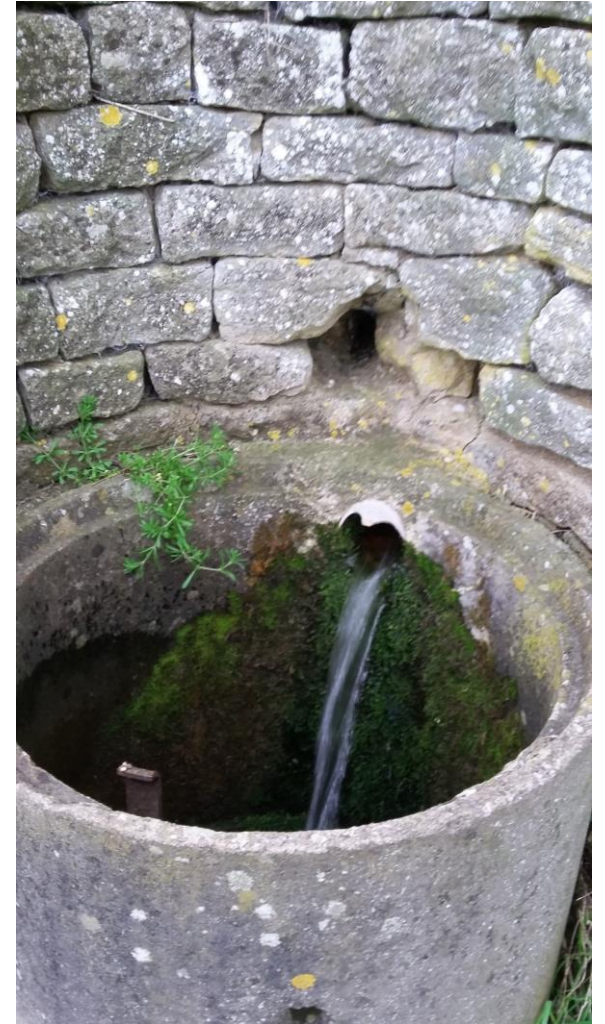
G8_possible spring collects or well
Facing WNW

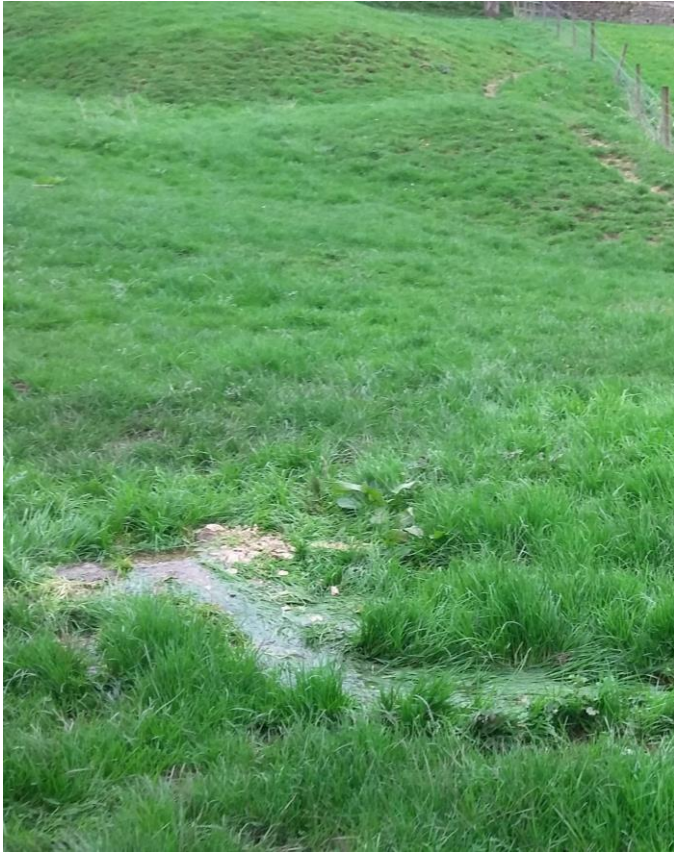
G9_spring with tufa facing WNW

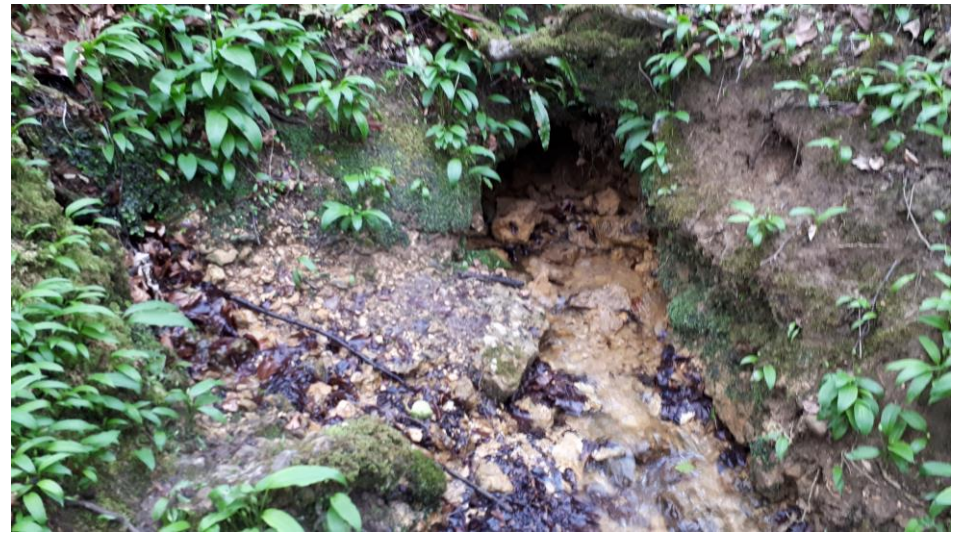
G10_Looking US_170418

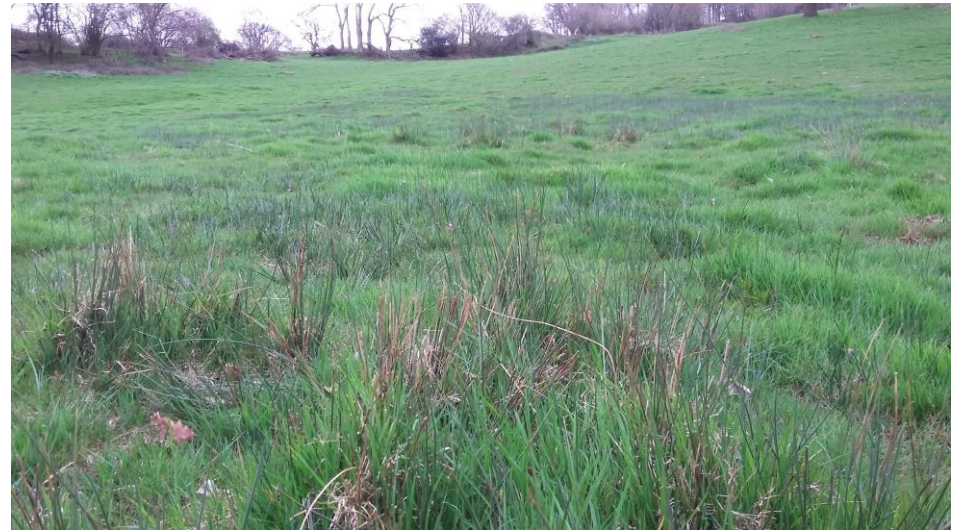
G13_rushes in depression in field Facing E

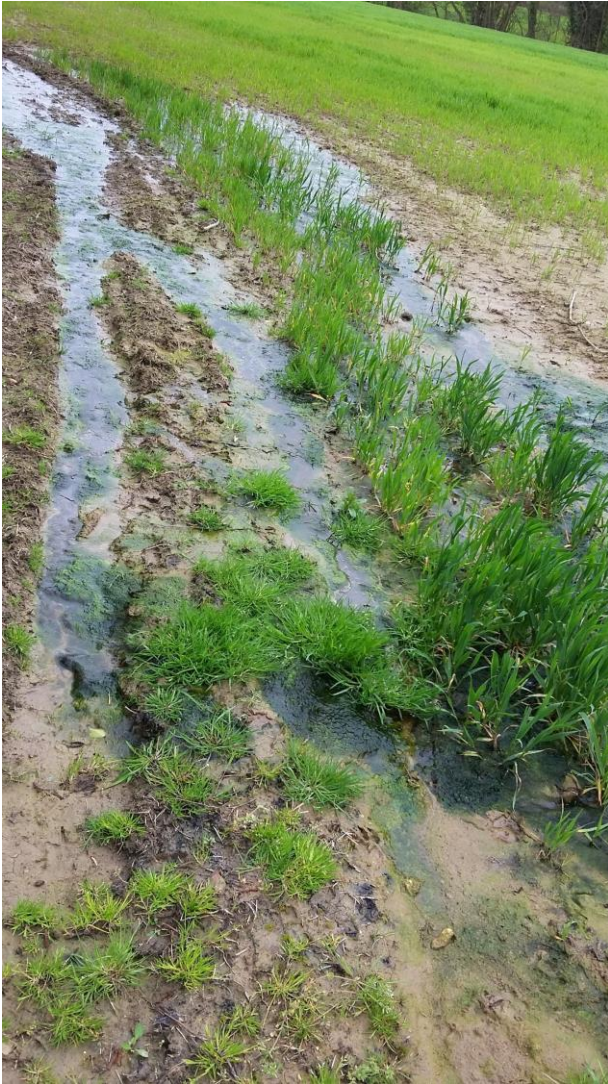
G14_spring flow in field facing ENE

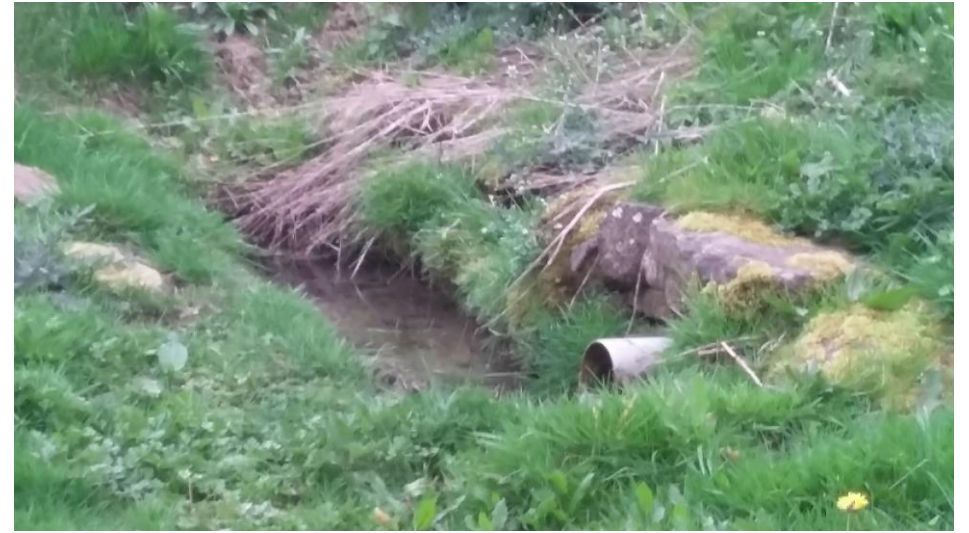
G16_piped spring facing E

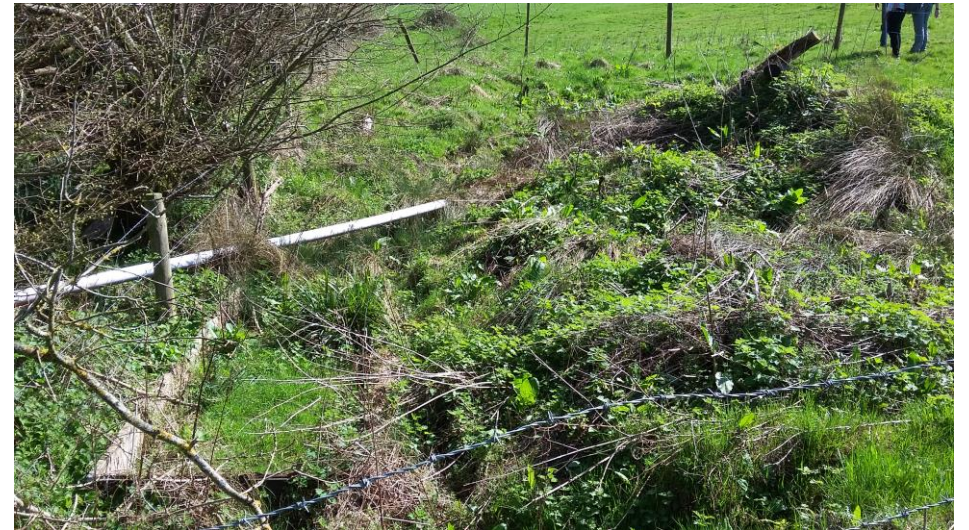
G17_fenced off spring in field facing E

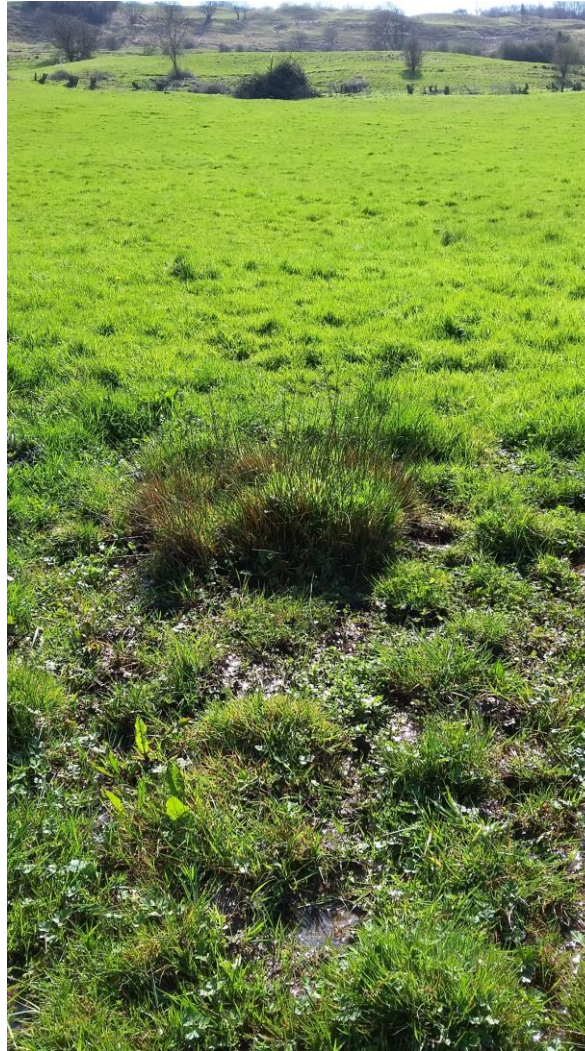
G20_rushes in field facing S

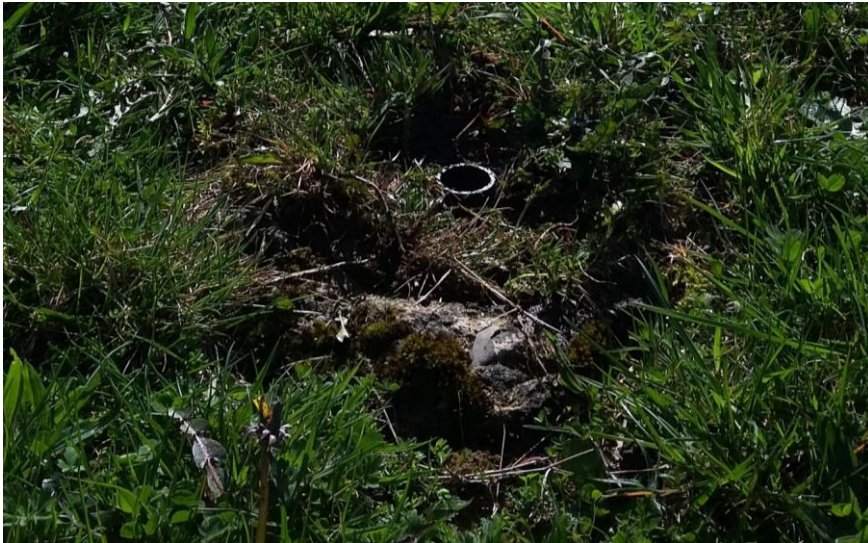
G21_old GI borehole in field facing S

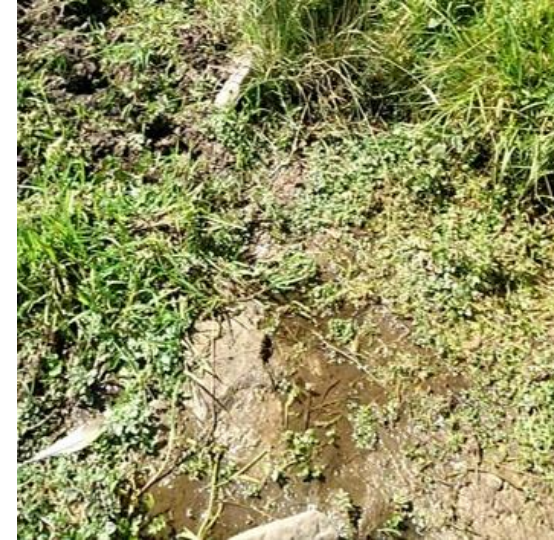
G25_springs at Bushley Muzzard facing N_230718

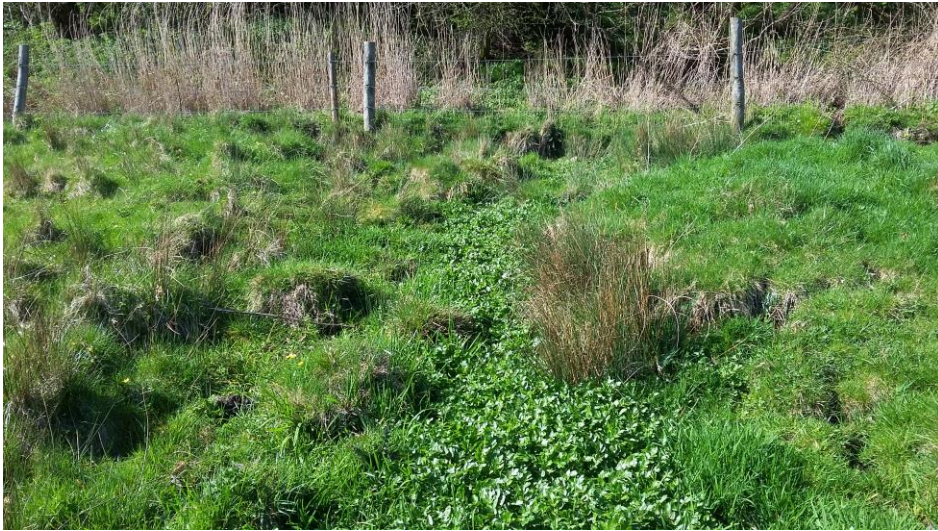
G25_Bushley Muzzard facing N

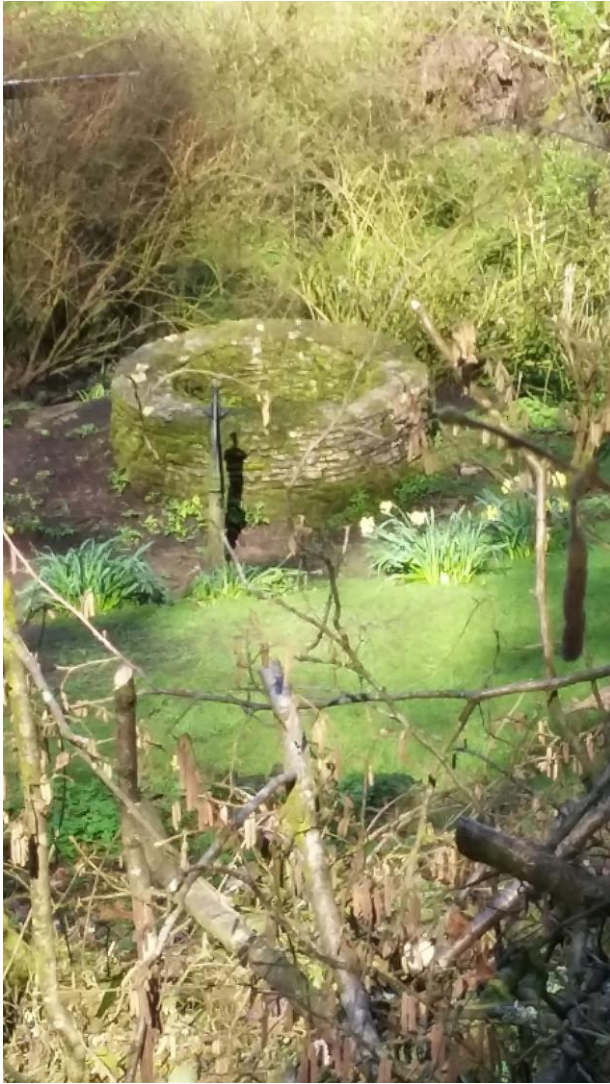
G27_well at Ivy Cottage facing N

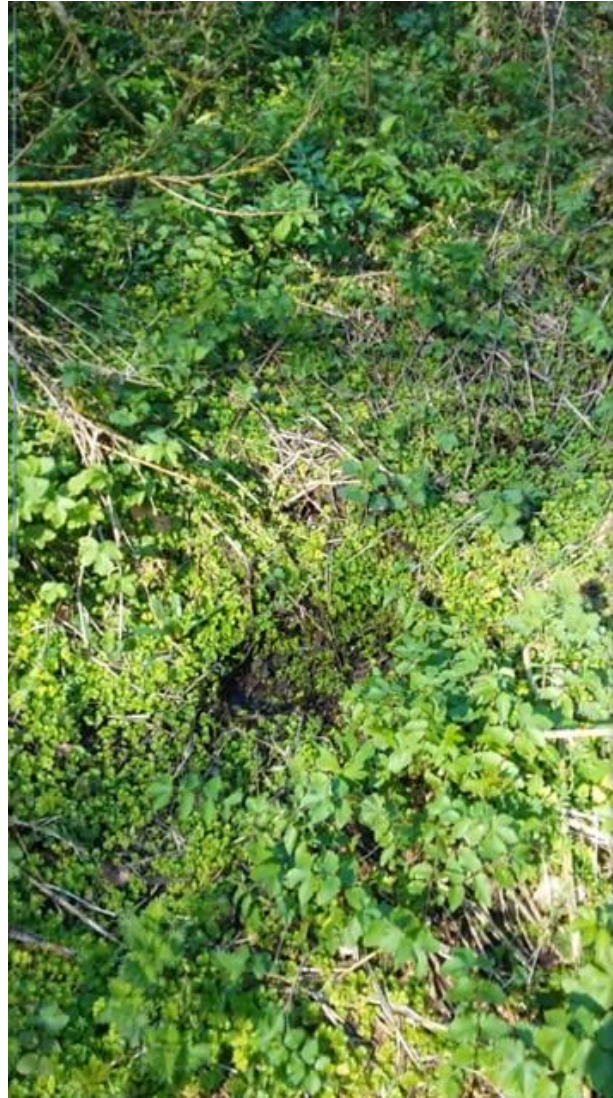
G28_seepage on banks of River Frome trib

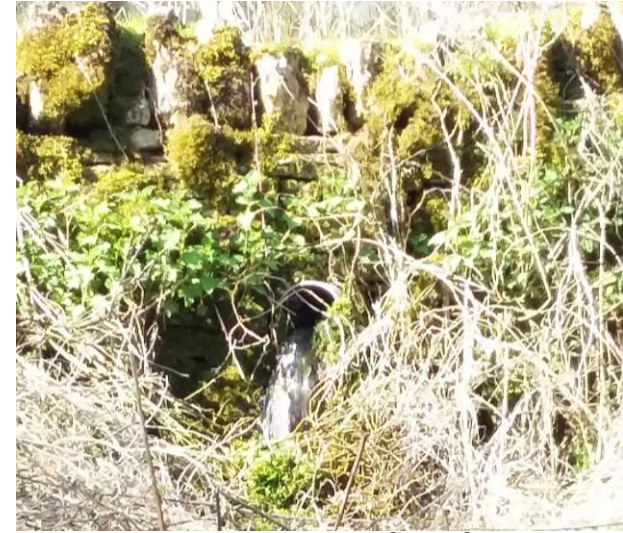
G30_piped spring flow from Watercombe Farm

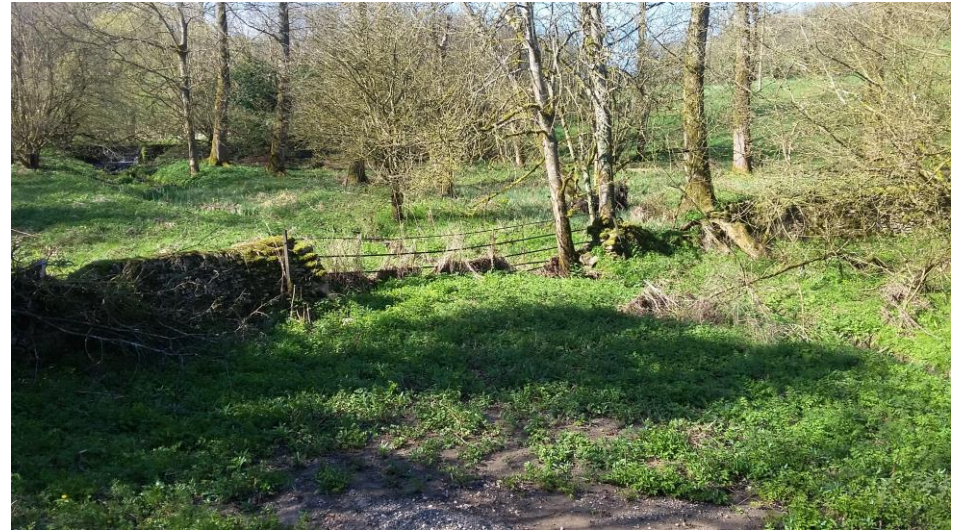
G31_seepage on banks of River Frome trib

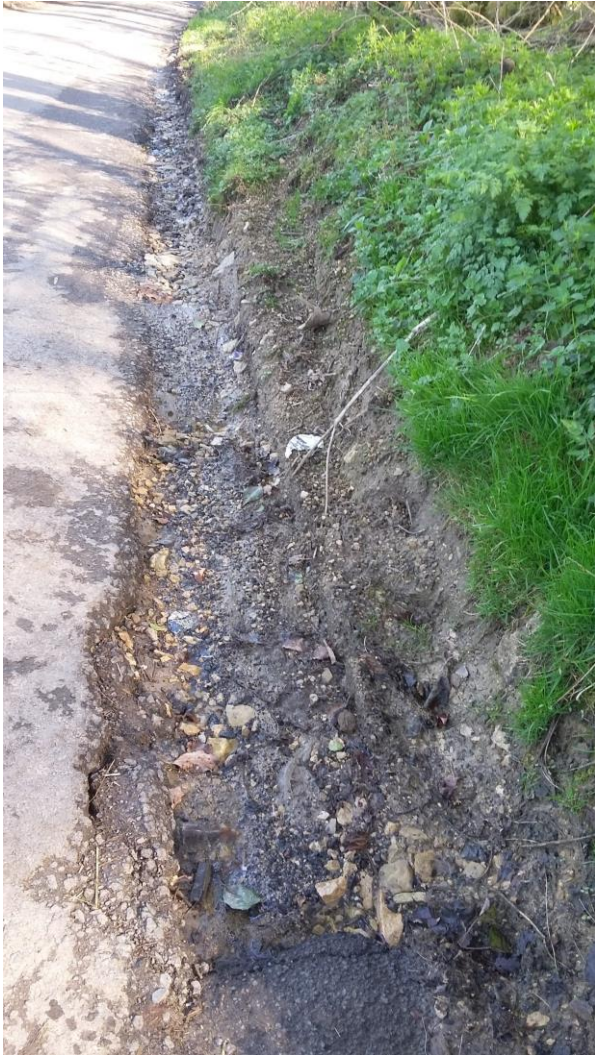
G32_spring on roadside facing E

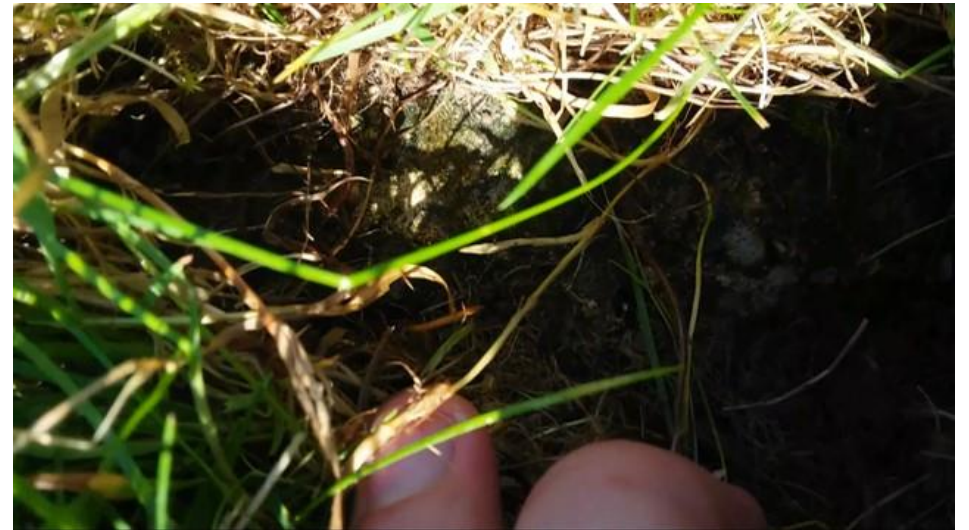
G40_seepage upgradient of River Churn trib starts facing N

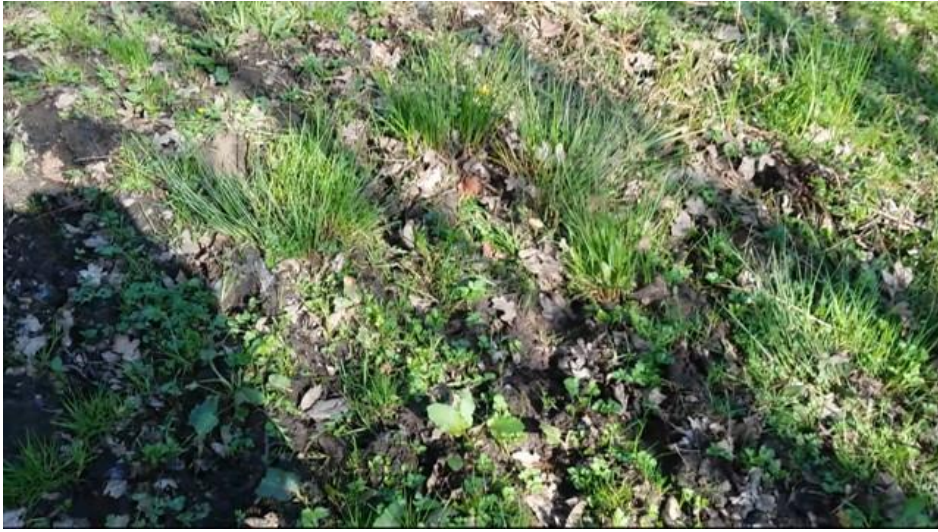
G41_spring upgradient of River Churn trib starts facing W

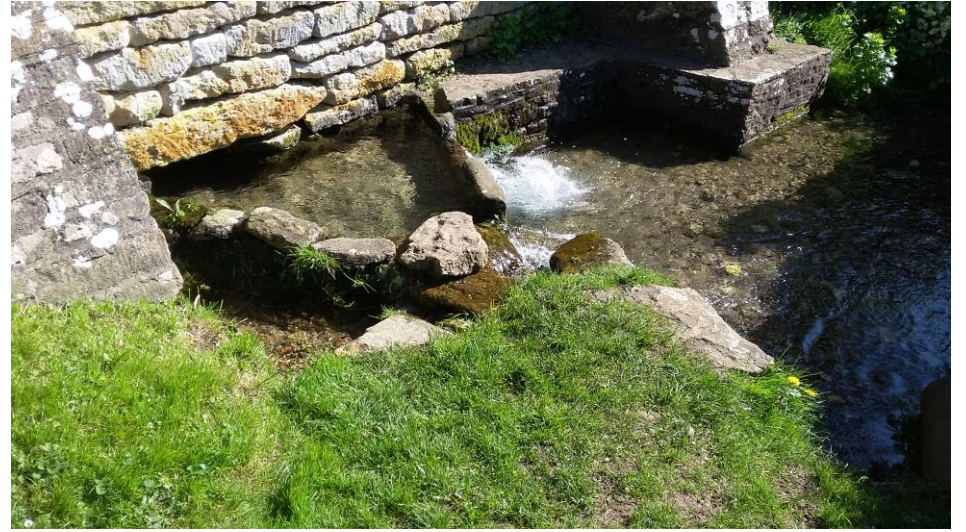
G42_seepage on banks of River Churn trib facing N E

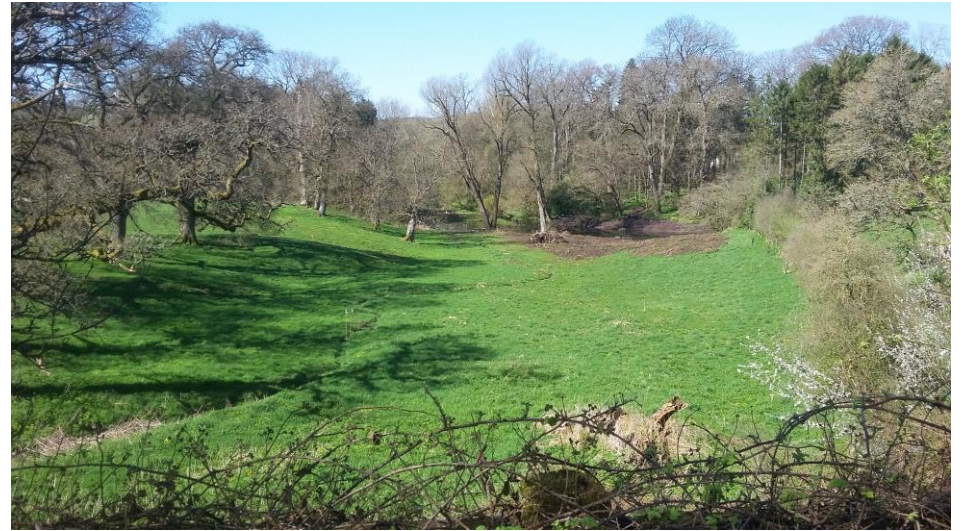
G44_seepage on banks of River Churn trib facing N E

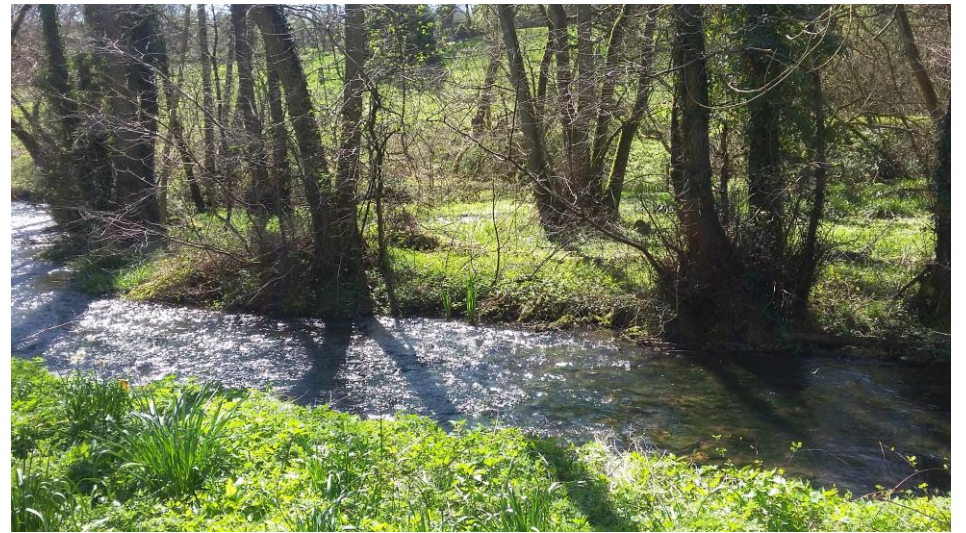
G50_River Churn culverted under road
facing NW

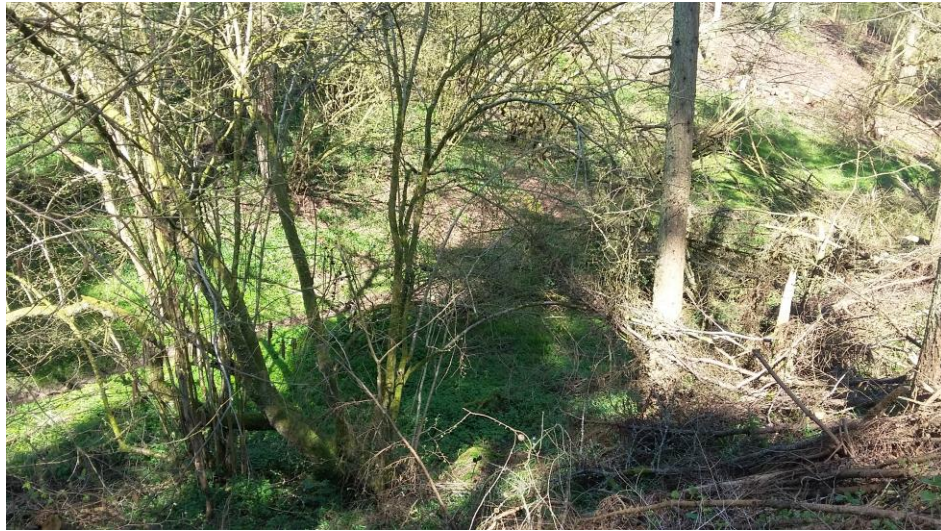
G51_River Churn facing S

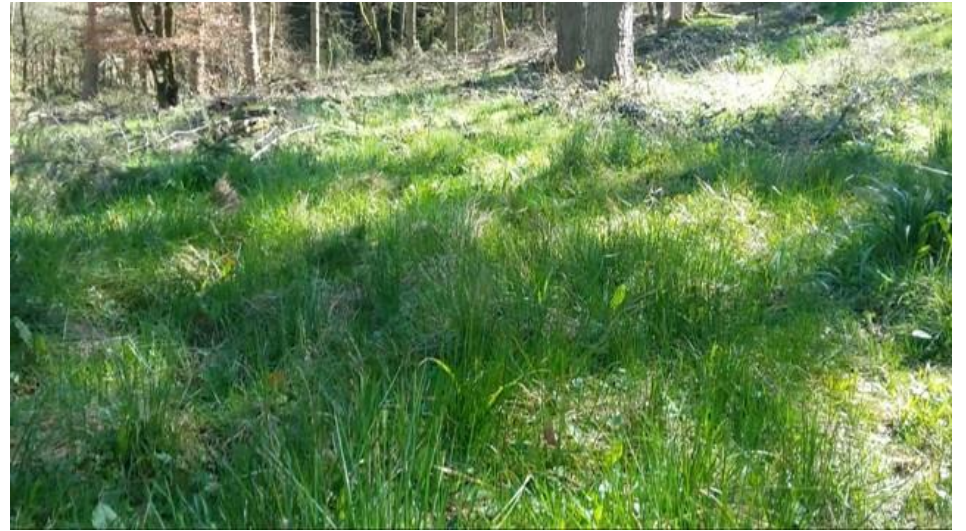
G52_trib of River Churn viewed from path facing N

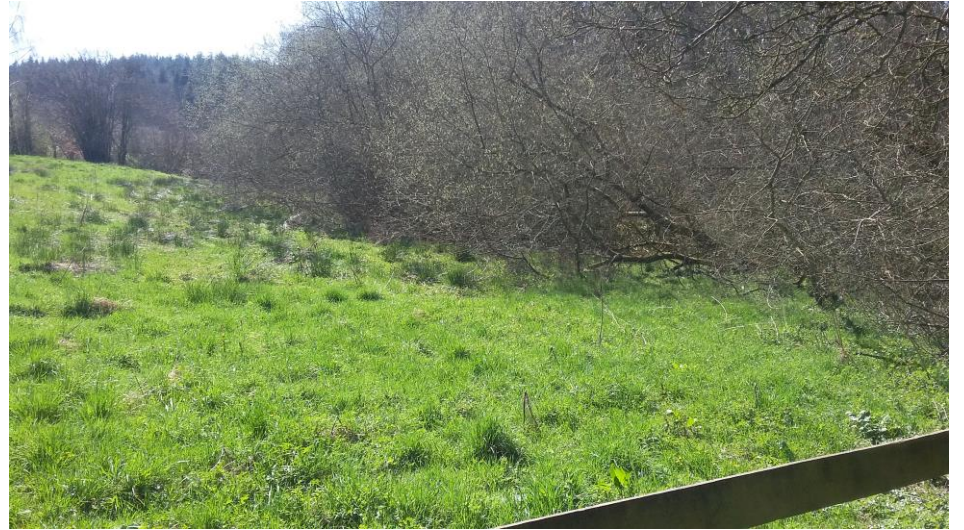
G54_spring fed lake that feeds trib of River Churn starts facing SW

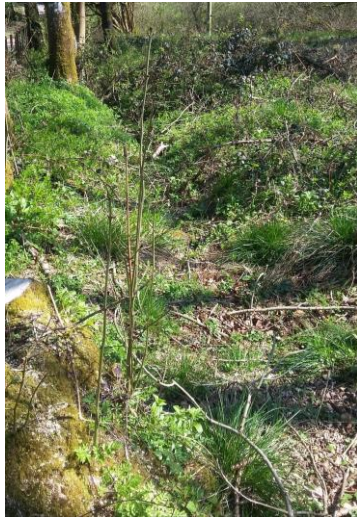
G55_rushes on slope facing SW

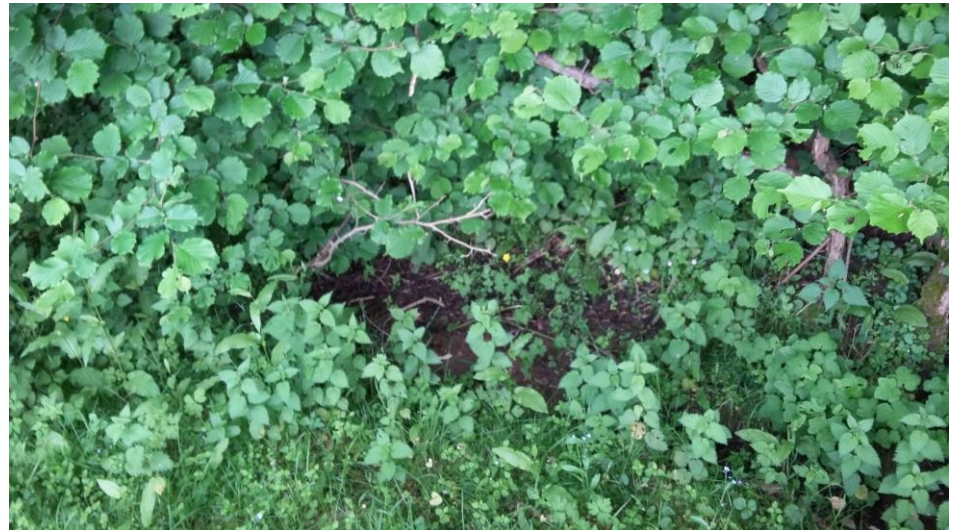
G56_spring facing SE

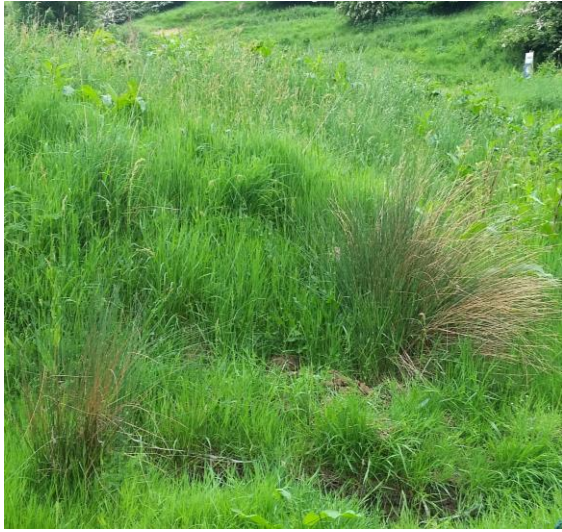
G61_seepage on slope facing S

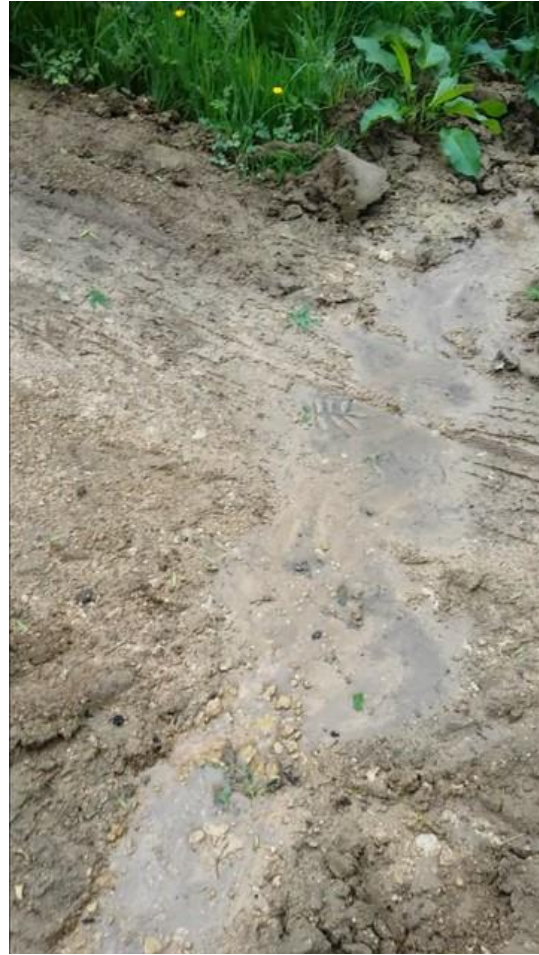
G62_seepage on slope facing S

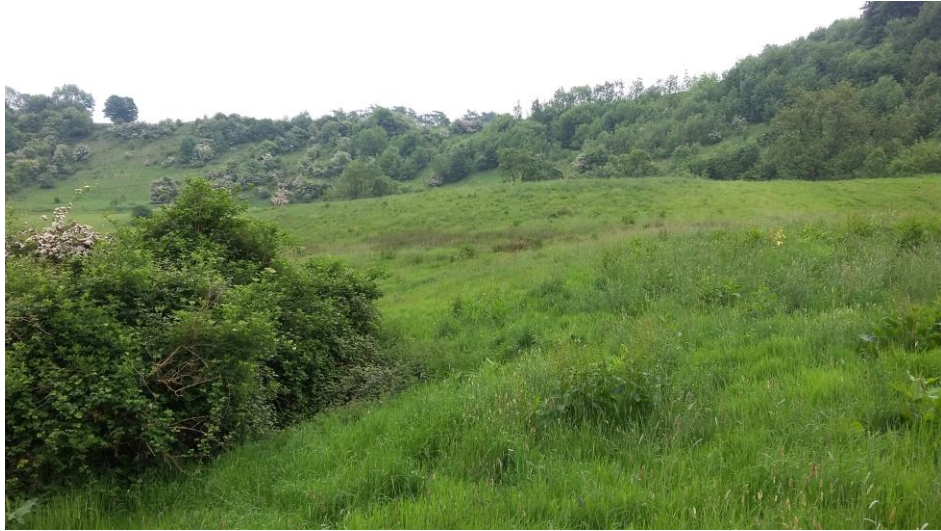
G65_piped spring facing S

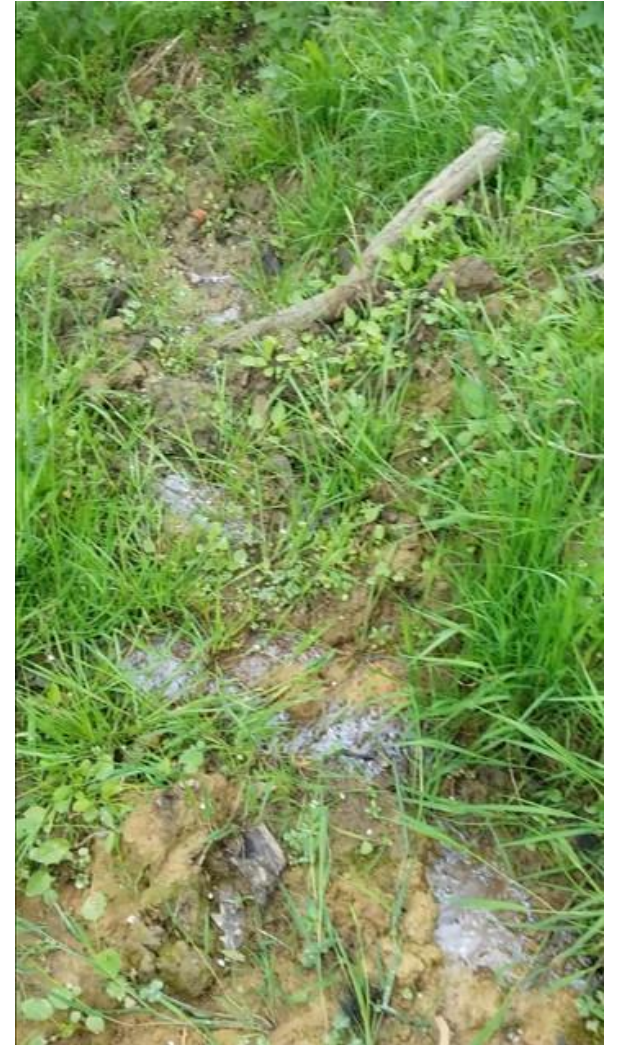
G67_hidden watercourse and seepage patches on slope facing E

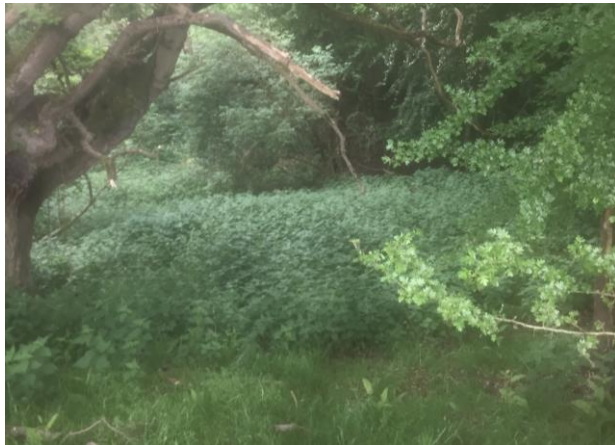
G68_spring marked by tree facing W

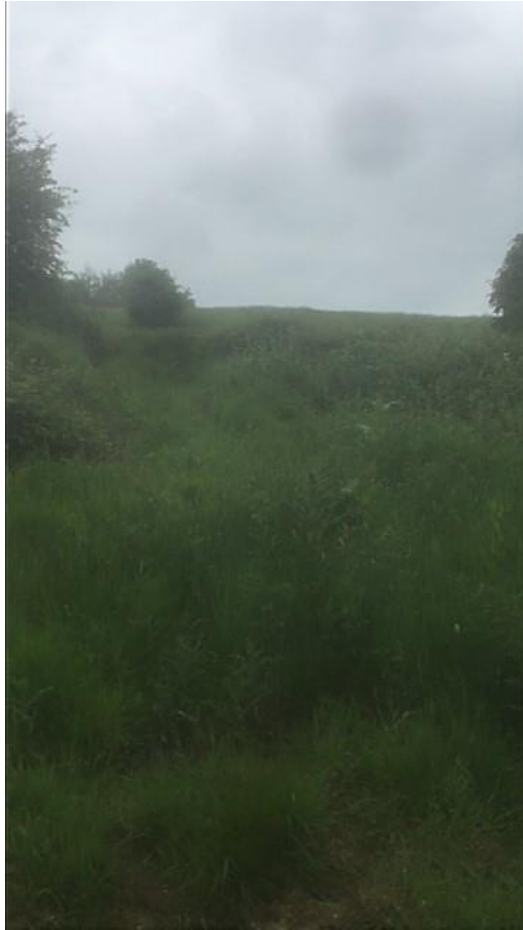
G69_overgrown watercourse facing E
