A417 Missing Link
TR010056

6.4 Environmental Statement
Appendix 13.11 Water Features Survey
(Part 1 of 2)

**6.4 Environmental Statement
Appendix 13.11 Water Features Survey
(Part 1 of 2)**

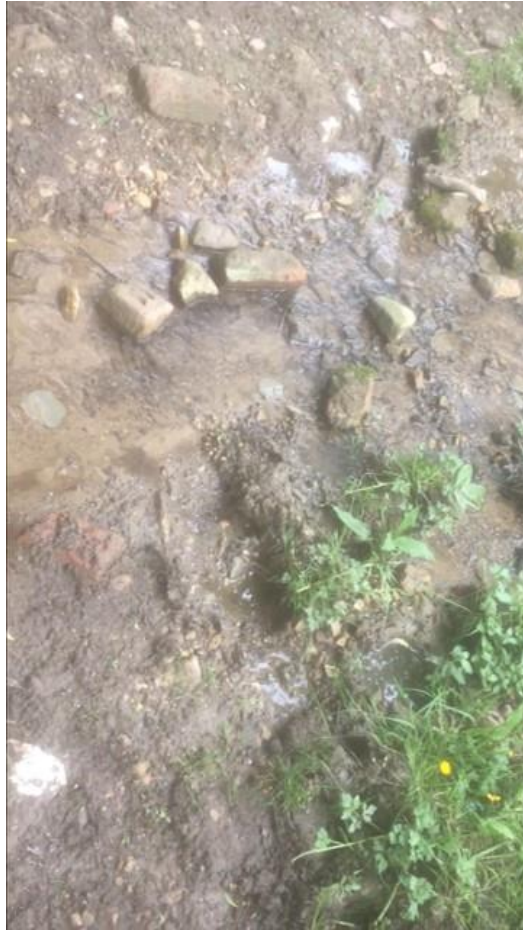
G70_rushes on slope starts facing W

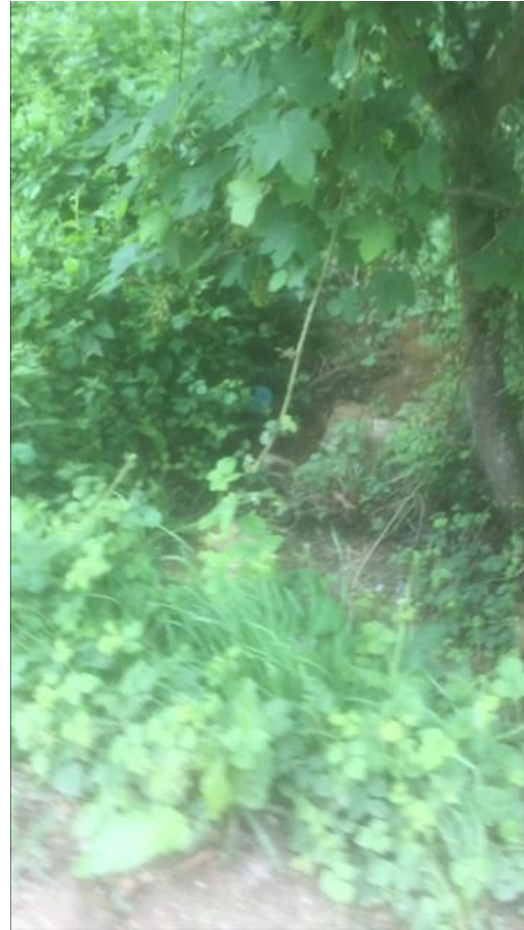
G71_watercourse flowing to Norman's Brook flowing over path facing SE

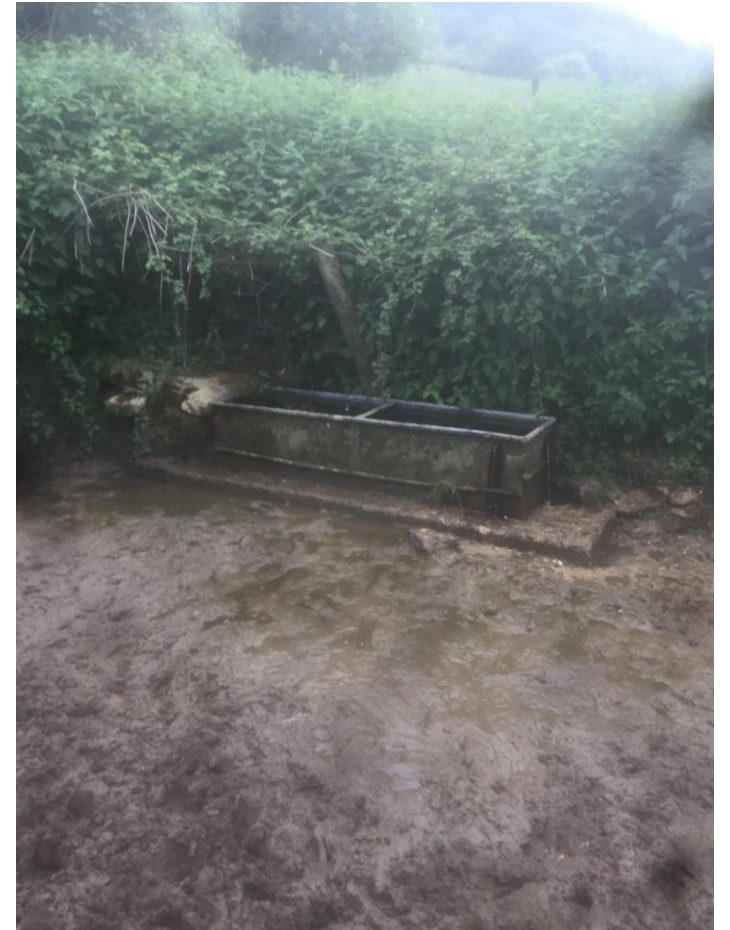
G72_watercourse flowing under path to Norman's Brook facing N

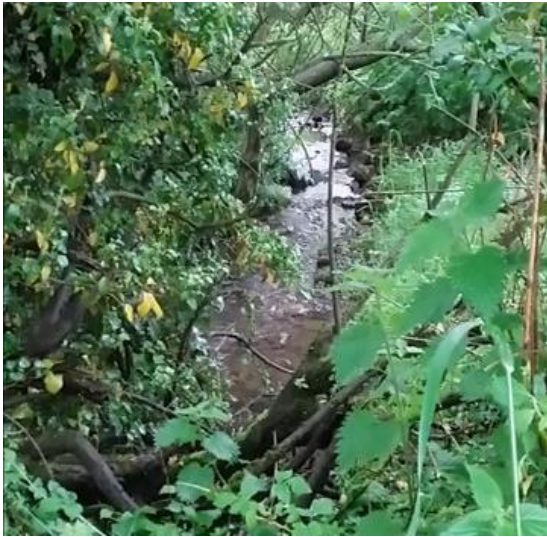
G77_watercourse seeps to ground marked as culvert but overgrown so not proved facing N W

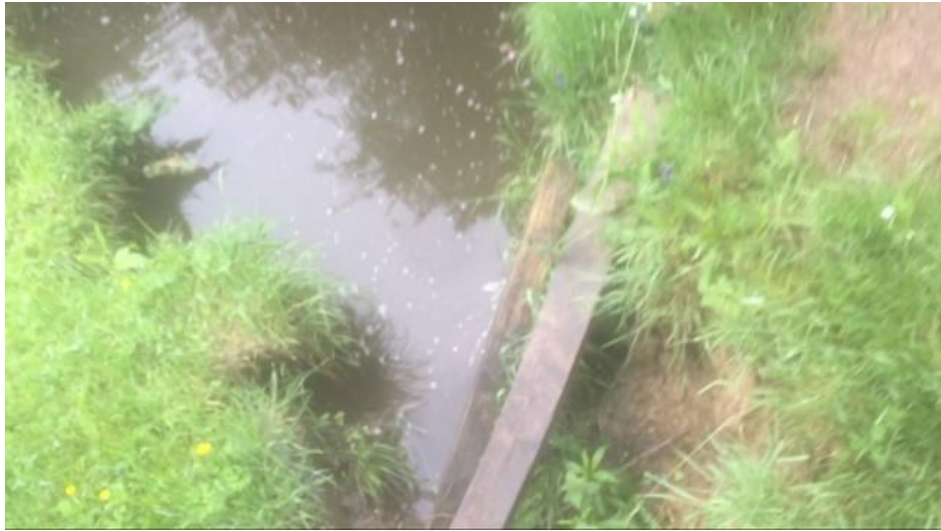
G79_culvert exposed in ground flowing S possible road drainage

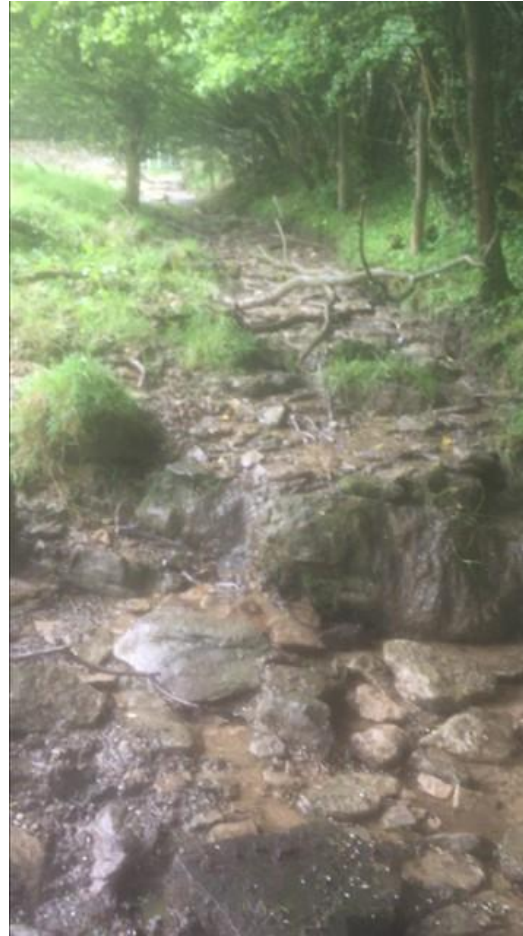
G81-spring flowing over ground facing S

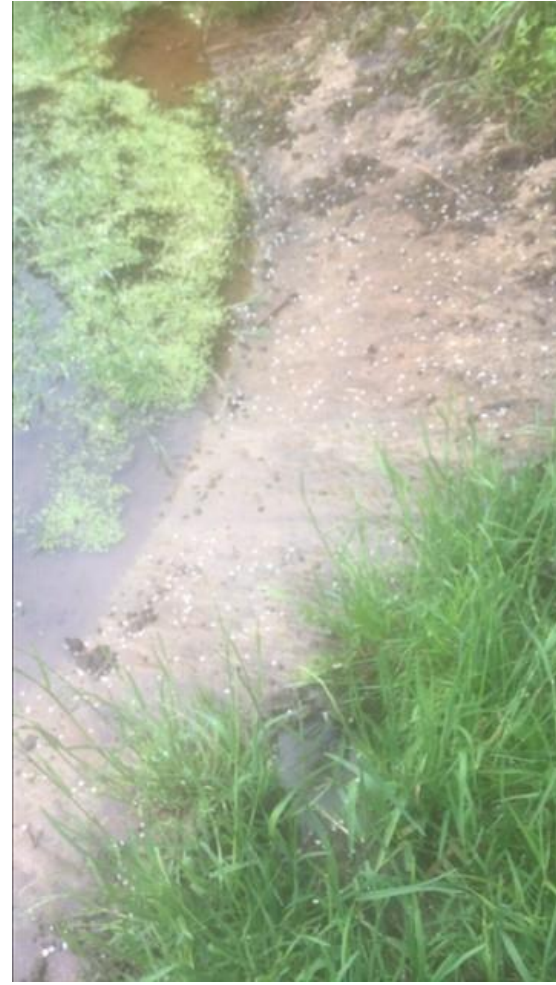
G86_spring collects flowing N facing E

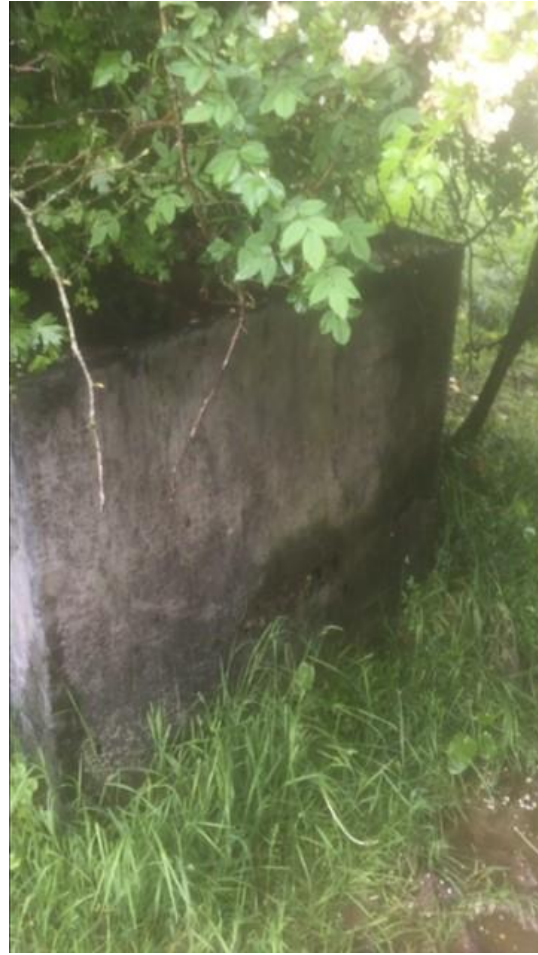
G89	393401 213495	Well					30/05/2018 15:17 Broken well/collects, overflowing to south. Source from north on private land which is not yet accessible.
G90	393620 213386	Seepage					30/05/2018 15:25 Seepage area marked by rushes, viewed from public right of way.
G91	392283 214111	Spring					30/05/2018 16:34 Spring at Bittom Barn, which flows into manmade pond. Used to control flow and turned into a feature. No visible flows. Not accessible as fenced off by owner.
G92	392728 214153	Pond					30/05/2018 16:48 Pond, unlikely groundwater fed (dew pond). Viewed from public footpath.

G89_well facing N

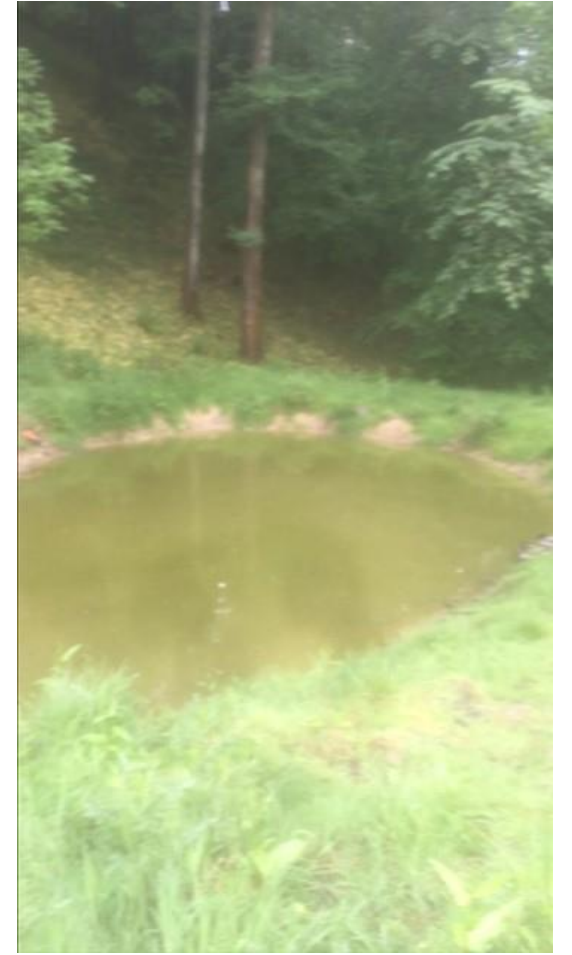
G91_spring fed pond facing S

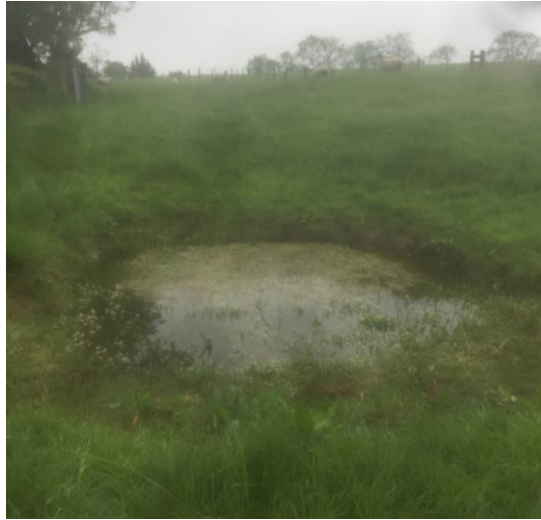
G92_pond facing S

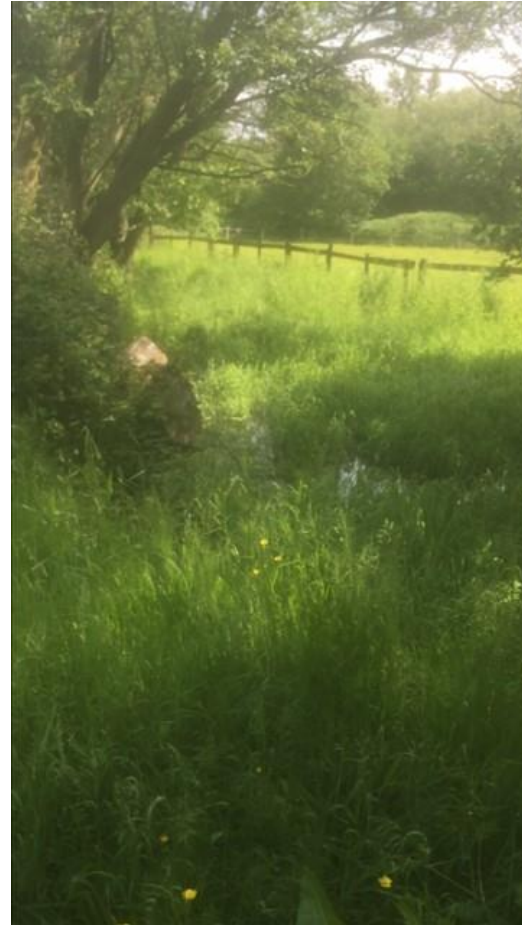
G94_spring facing N

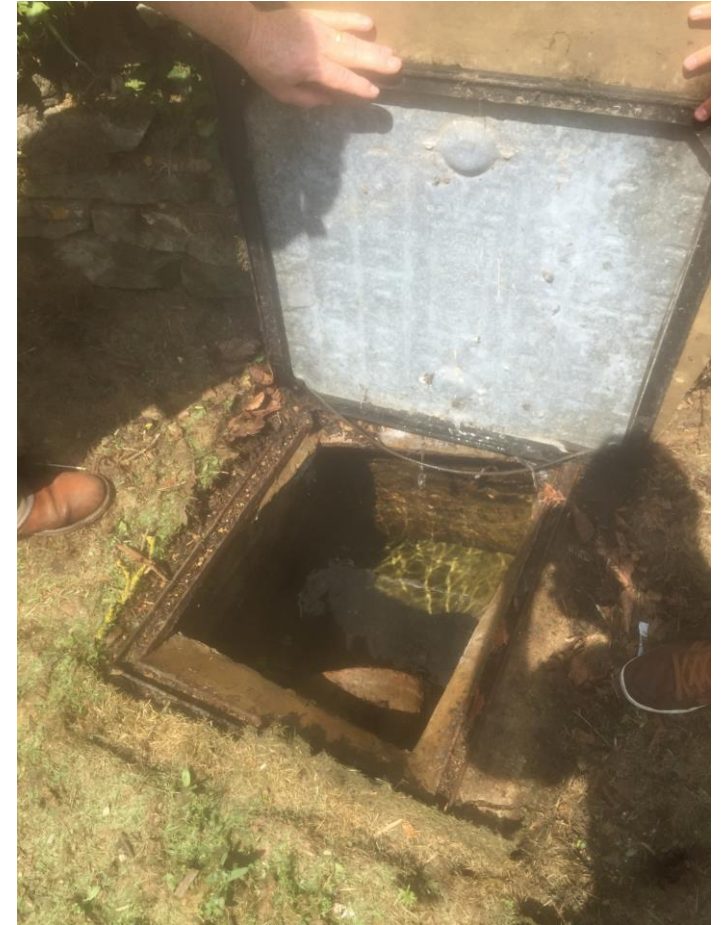
G95_spring managed by college,
discharged to lake

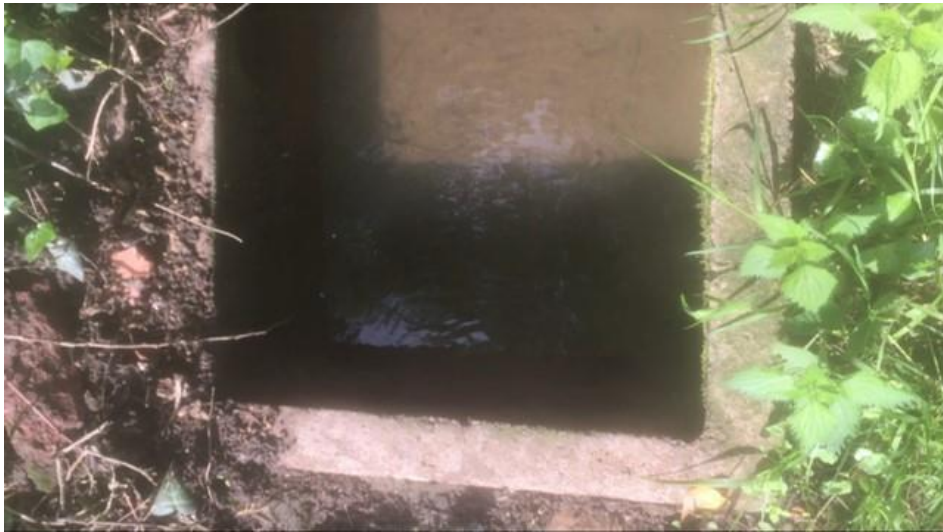
G93_spring collects

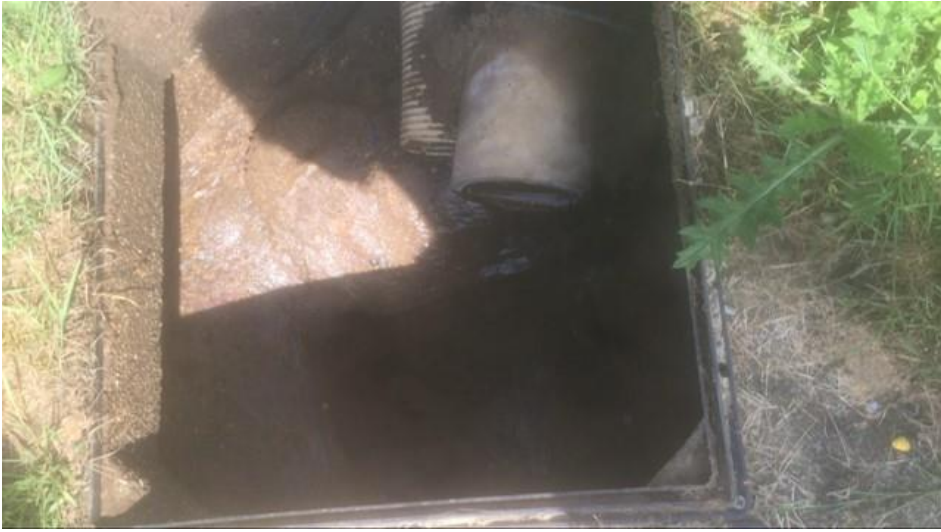
G96_lake and effluent discharge

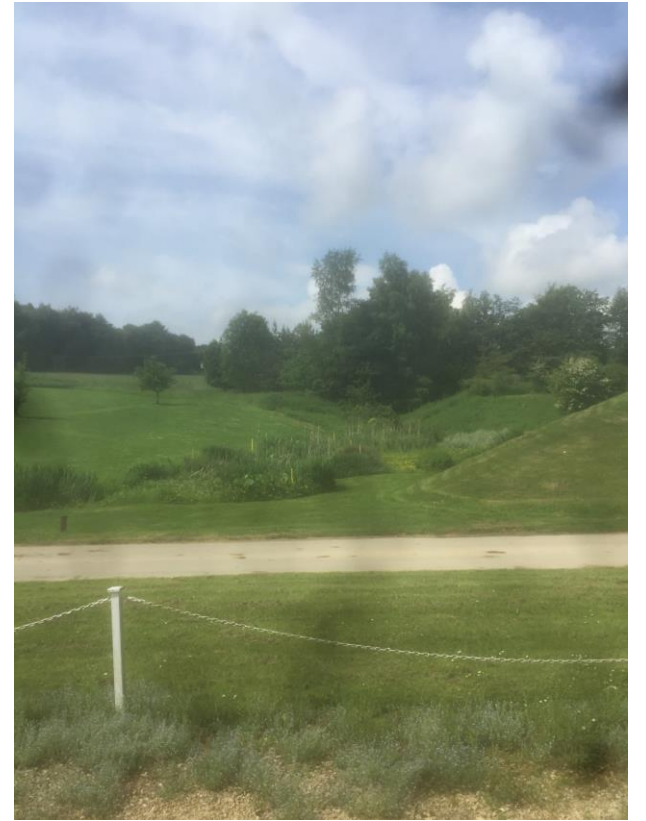
G98_spring fed pond facing W

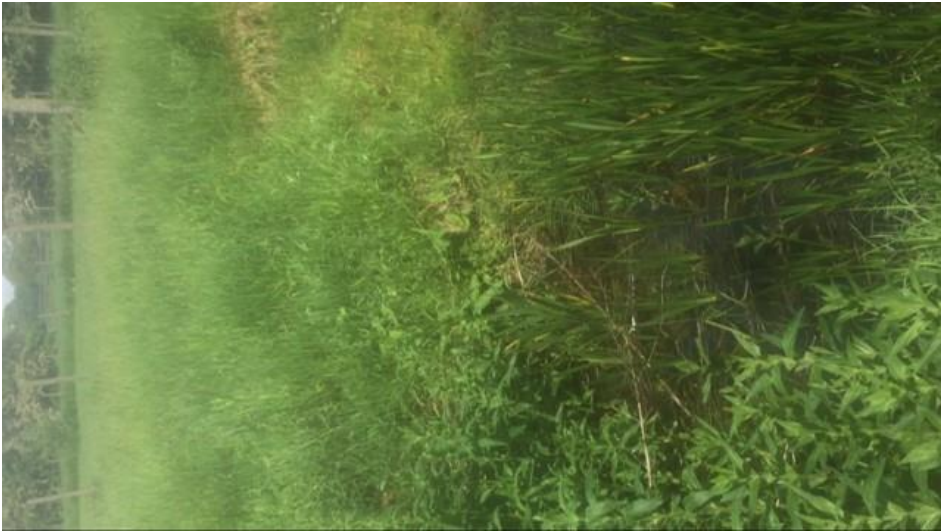
G99_spring facing W

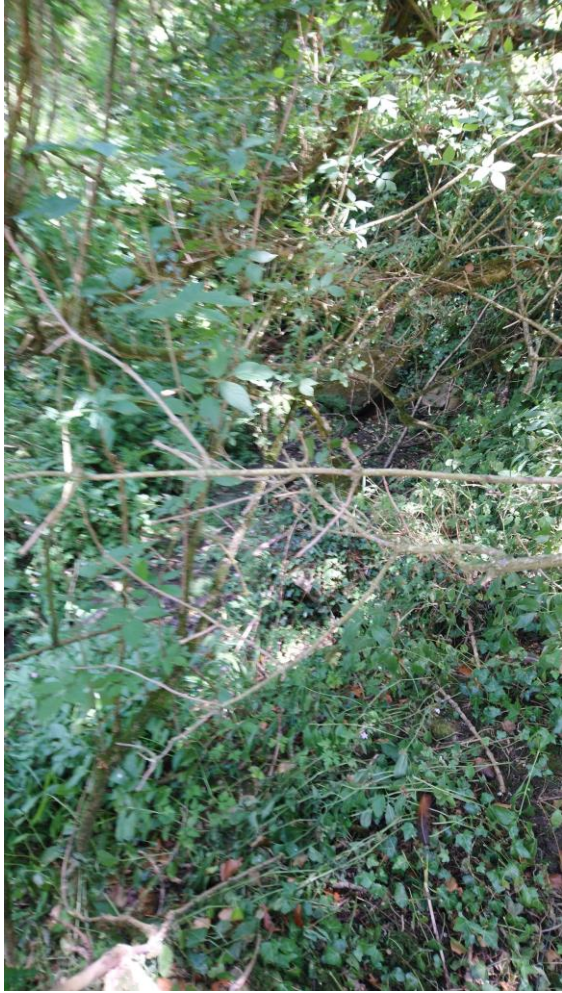
G100_spring facing N

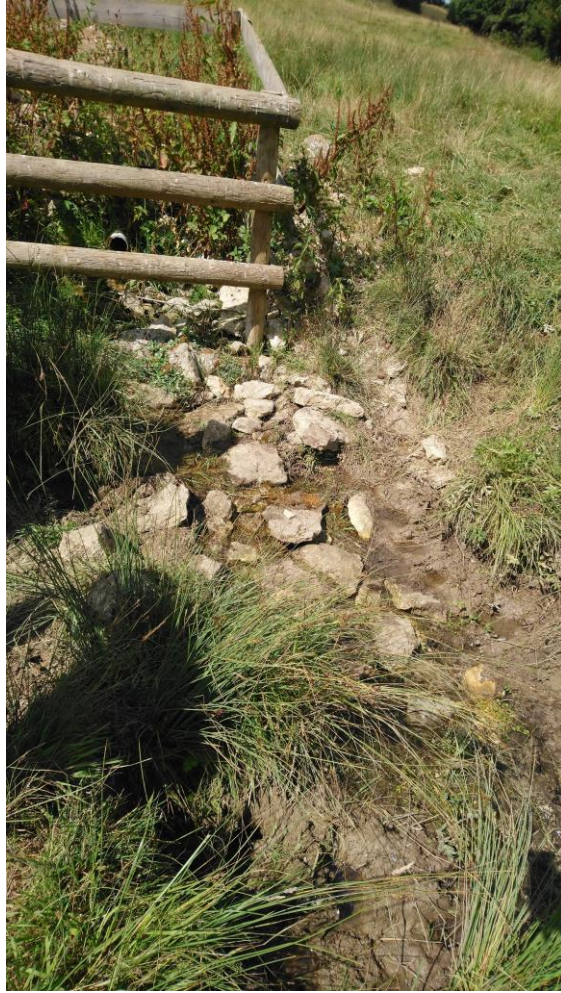
G101_piped spring facing W

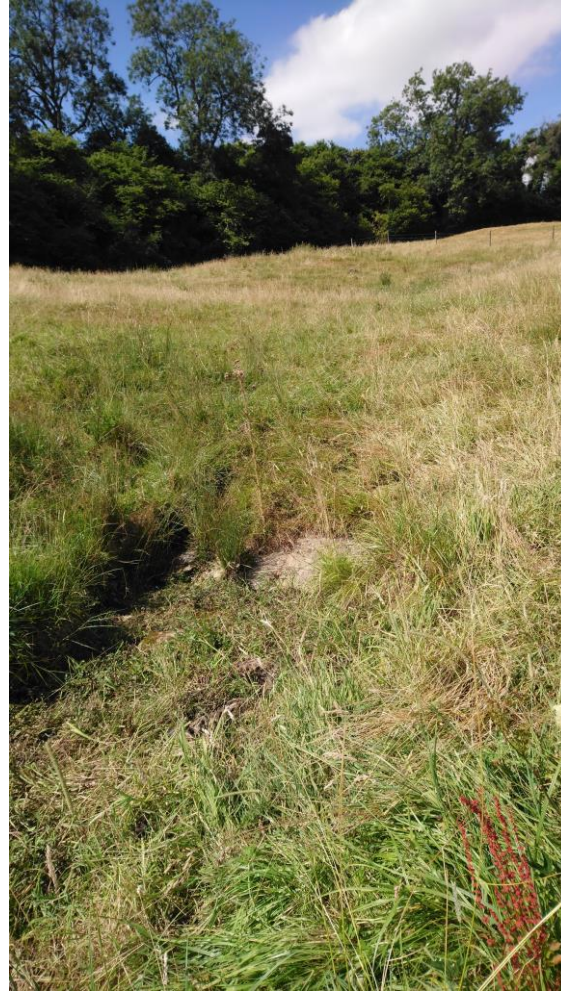
G102_spring facing N W

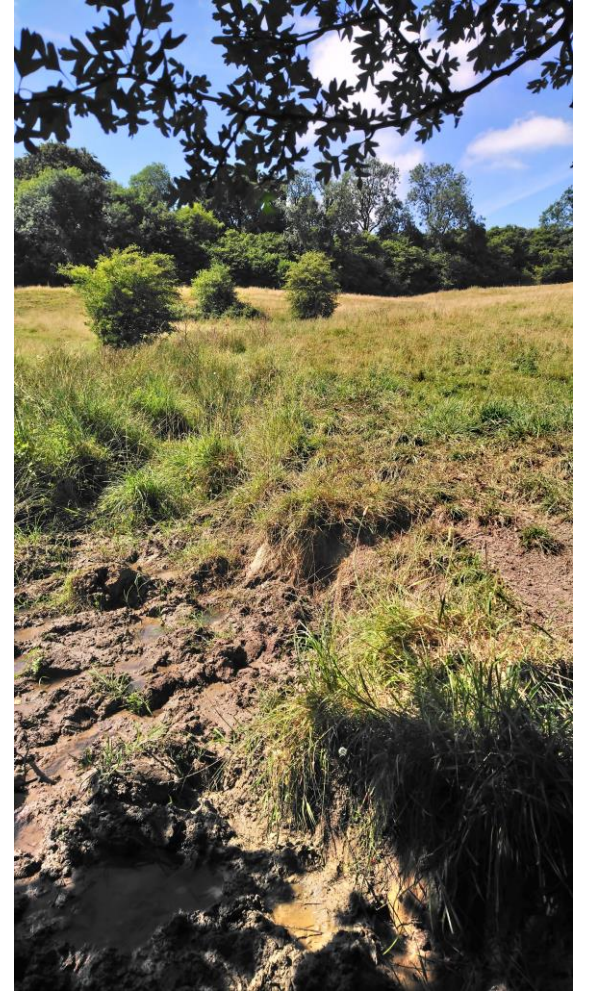
G103_spring issues facing N W

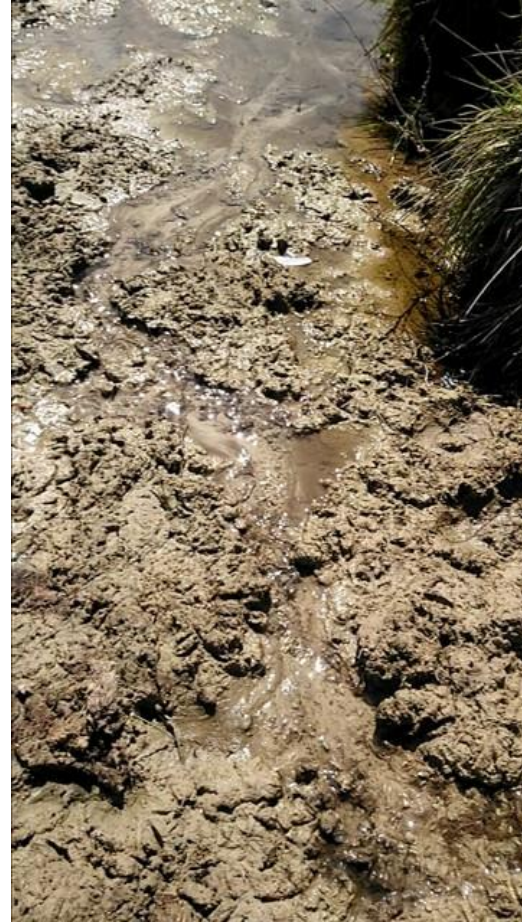
G105_spring flow facing N

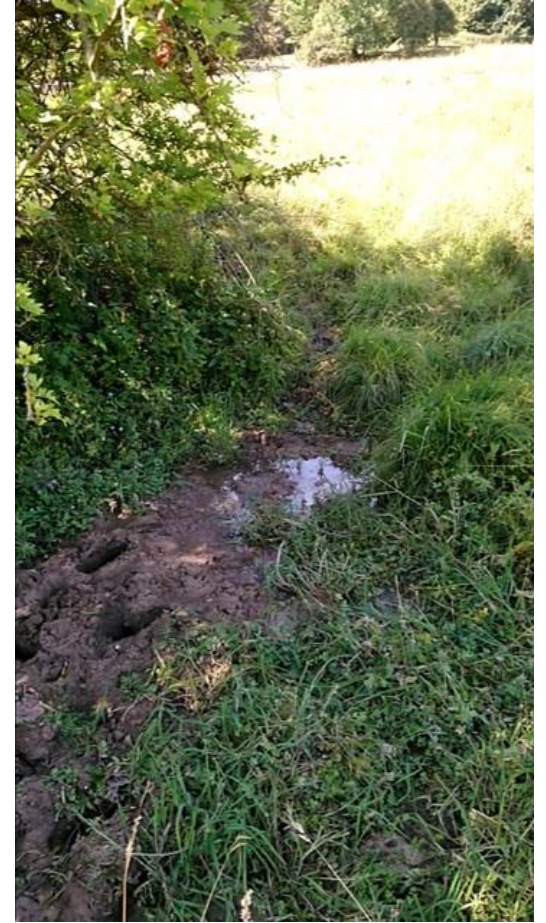
G108_confluence of spring fed
watercourse facing N

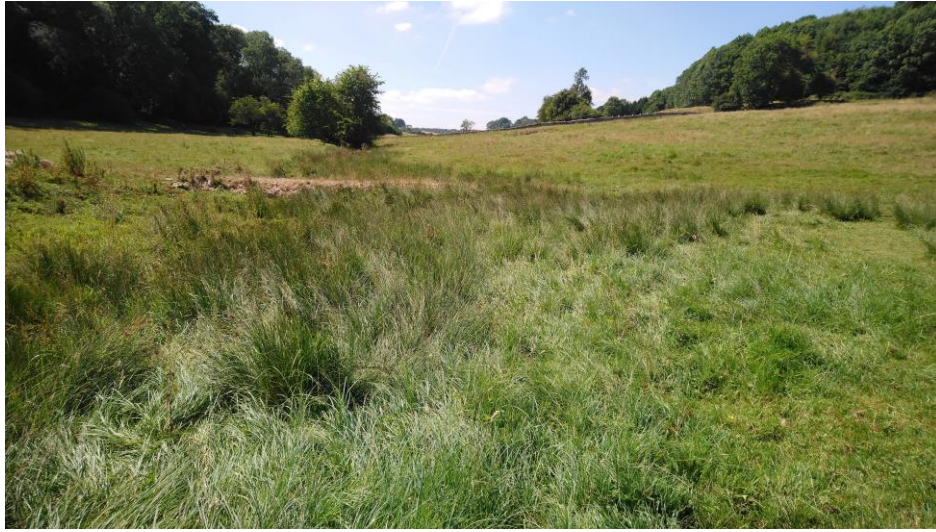
G109_spring fed watercourse facing W

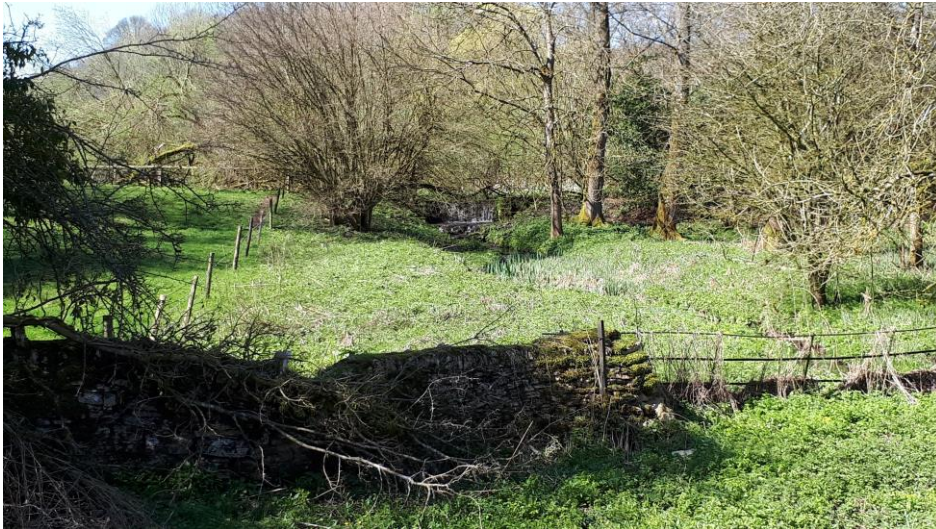
G111_overflow from pond possible tufa precipitation
Looking NW from 27_180418

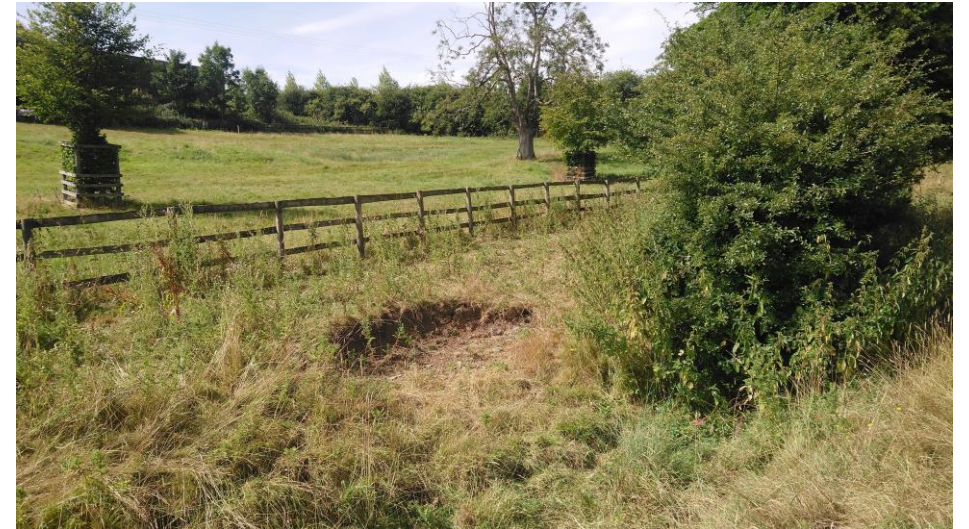
G112_seepage and dry watercourse facing S

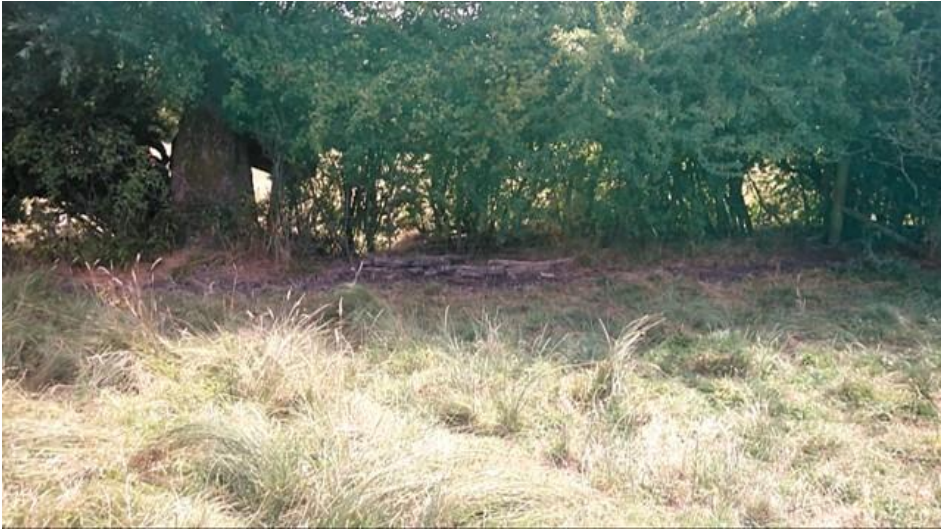
G113_spring facing N

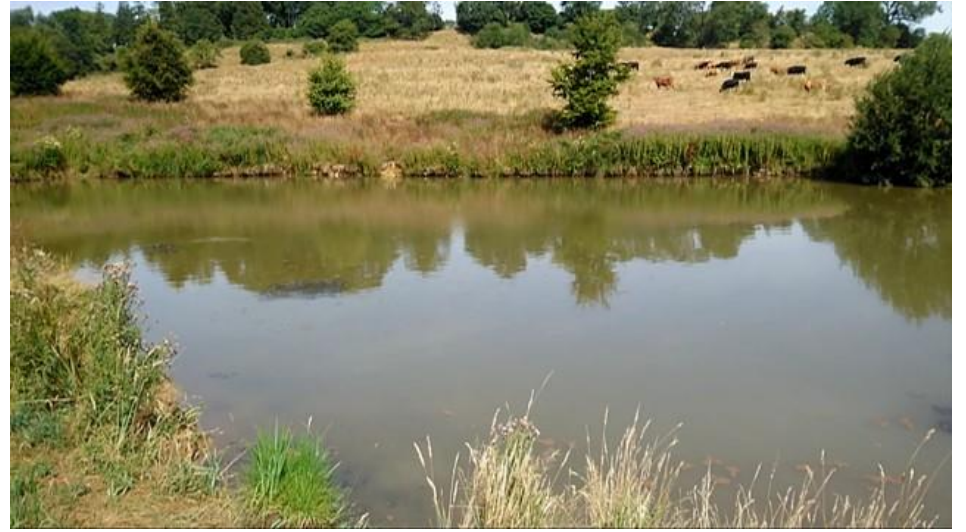
G114_pond facing N

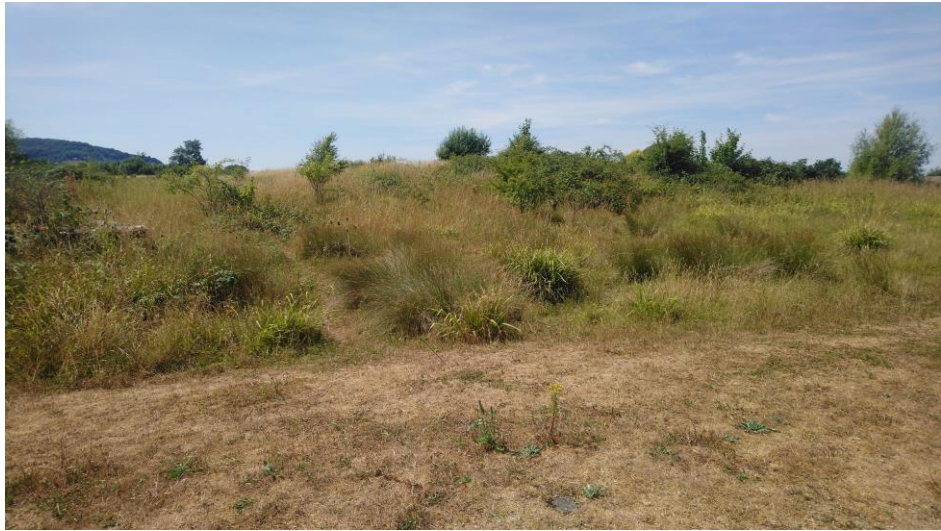
G115_rushes in location of well facing S

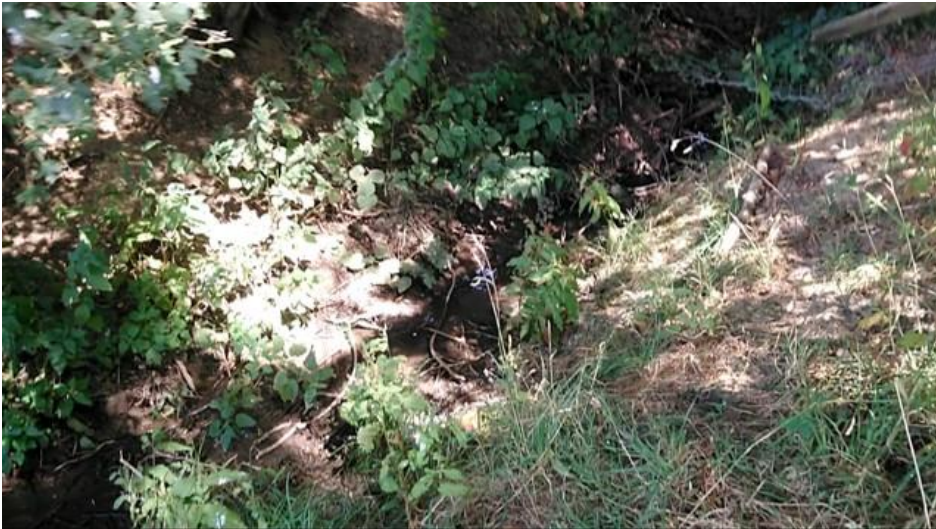
G119_dry spring fed watercourse facing N

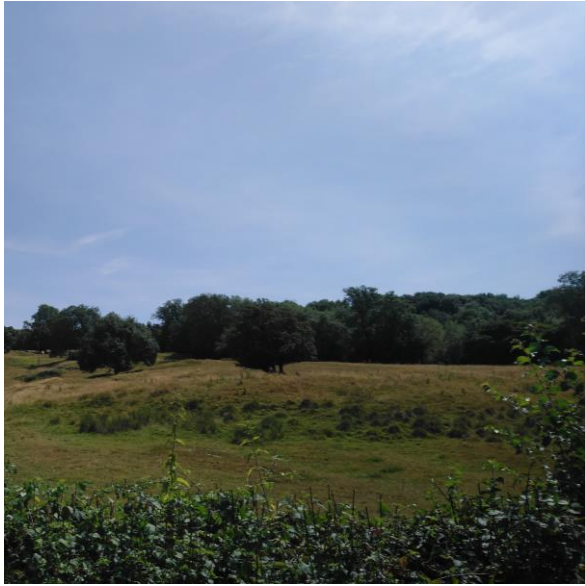
G121_rushes on slope facing E

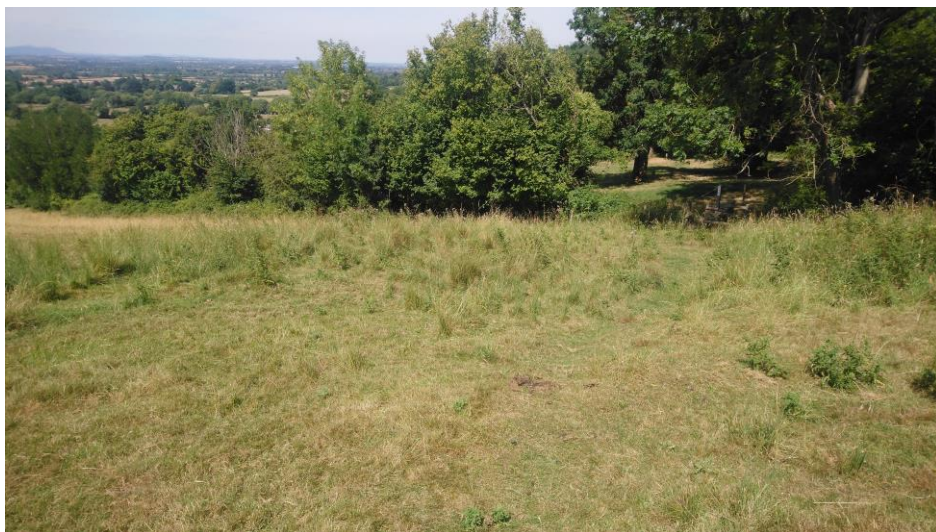
G124_dry spring facing E

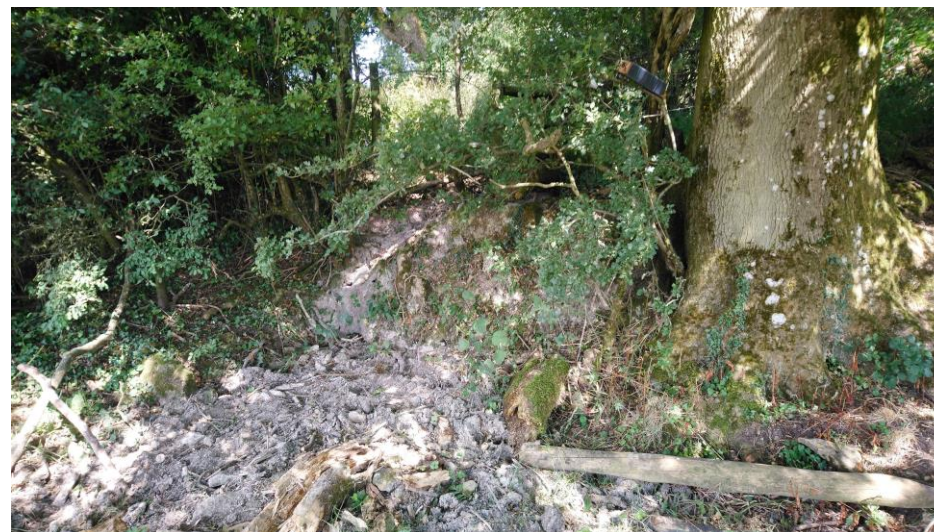
G125_rushes on slope facing N

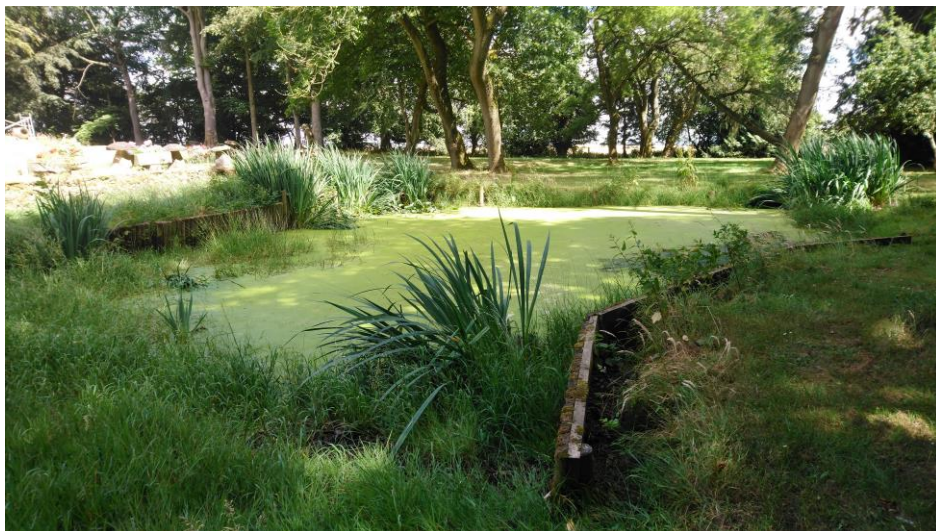
G127_dry spring fed pond facing N

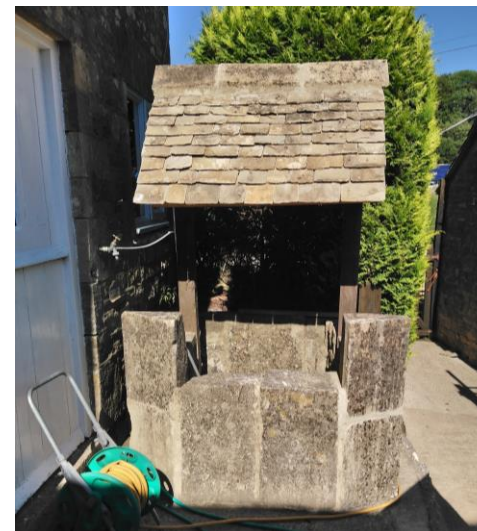
G128_pond possibly dew pond facing E

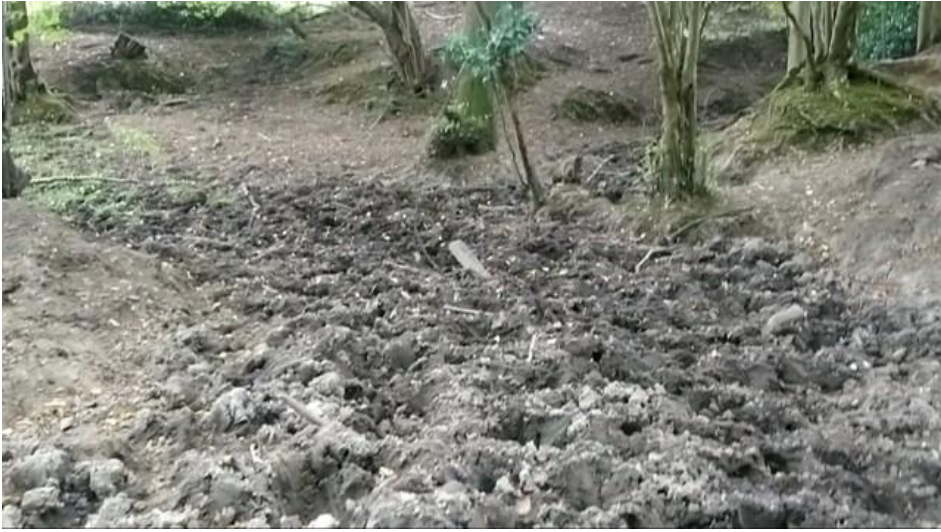
G129_well facing E

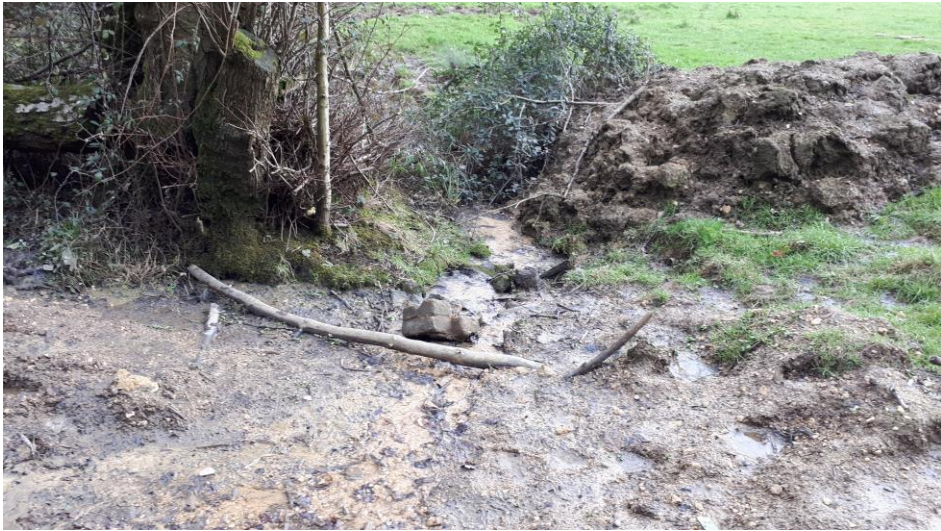
G131_seepage from woodland facing W

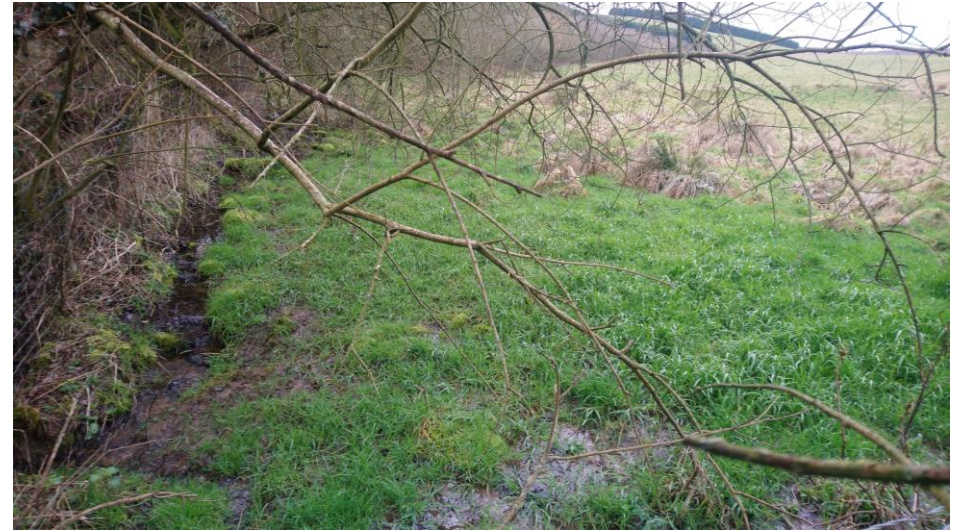
G140 _ confluence of spring on northern slope with Coldwell Bottom facing W

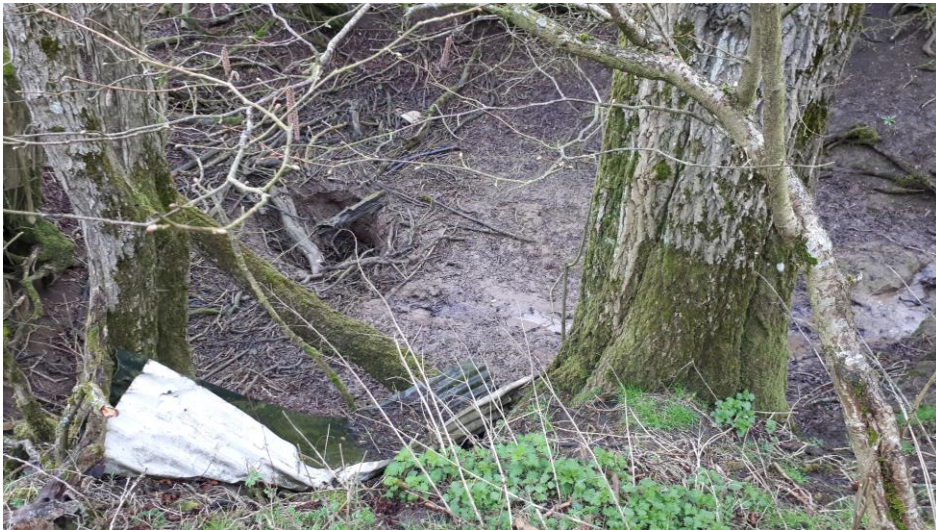
G141 _ spring N of Coldwell Bottom facing W

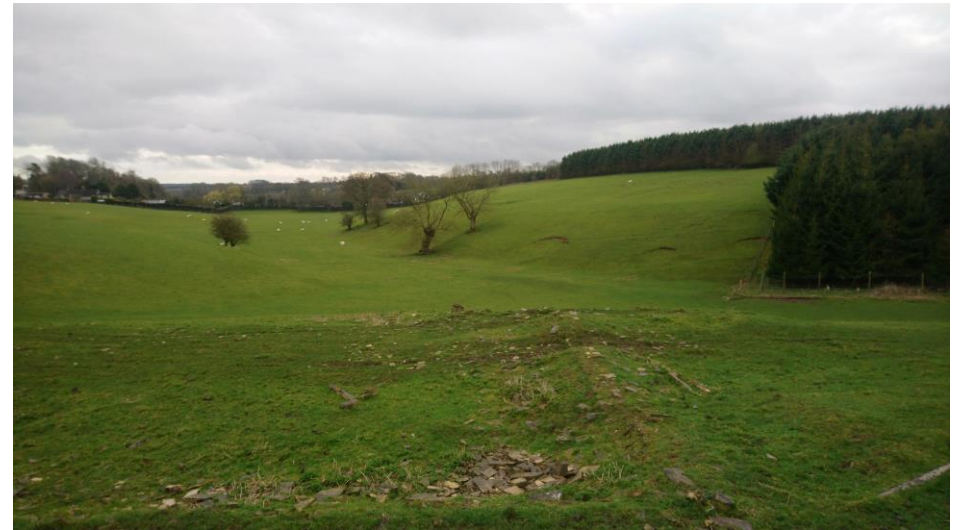
G142 _ flow into ground depression from G177
