# London Luton Airport Expansion

Volume 5 Environmental Statement and Related Documents  
**5.02 Appendix 17.1 Preliminary Risk Assessment of Land  
Contamination - Part G**

## SITE WALKOVER PROFORMA

**PROJECT:** London Luton Airport Expansion Development Consent Order Project No:261327-05

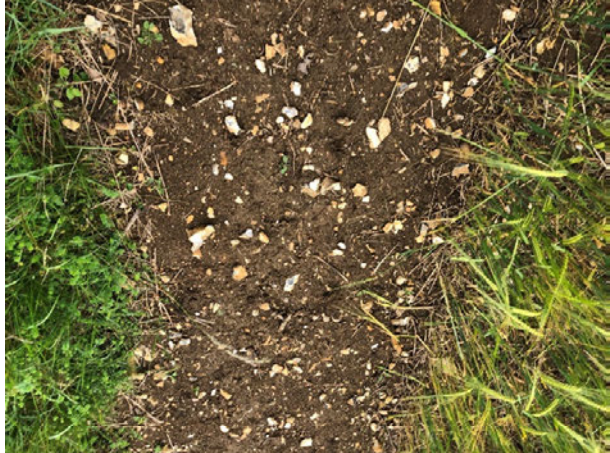
Northern land parcel, topsoil.
6

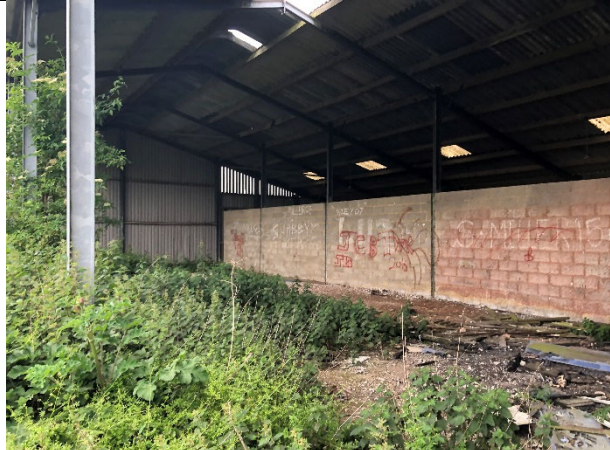
<p>Agricultural shed, broken roofing sheets, looking east.</p>

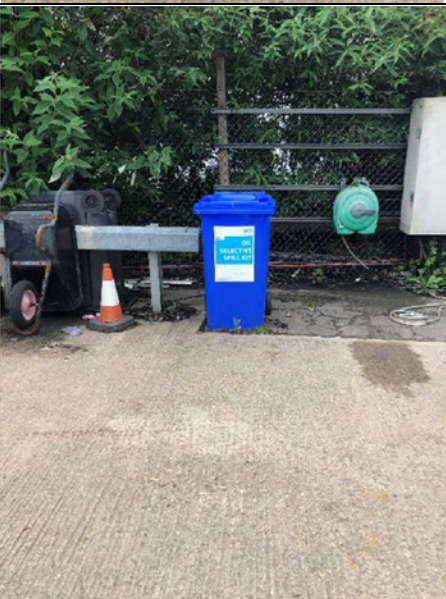
Oil spill kit at western boundary, looking west.
3

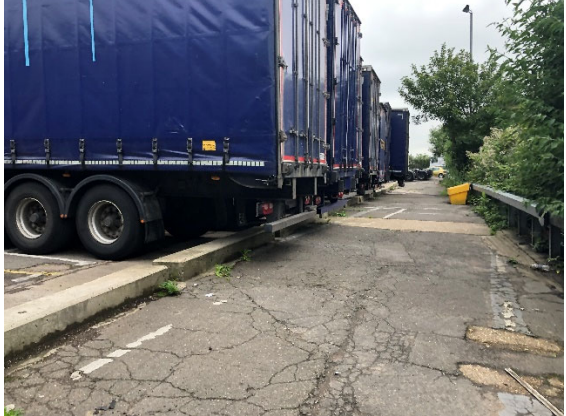
<p>Western boundary looking south, showing former white lines close to the edge.</p>
5

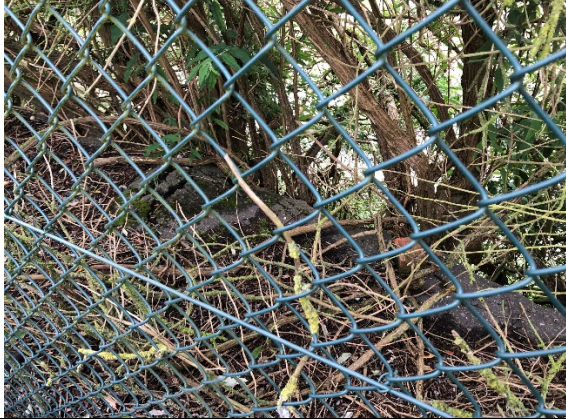
<p>Southern boundary beyond fenceline showing former edge of asphalt.</p>
7

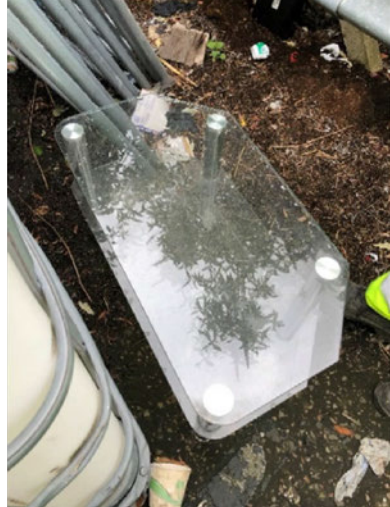
Glass TV Stand
10

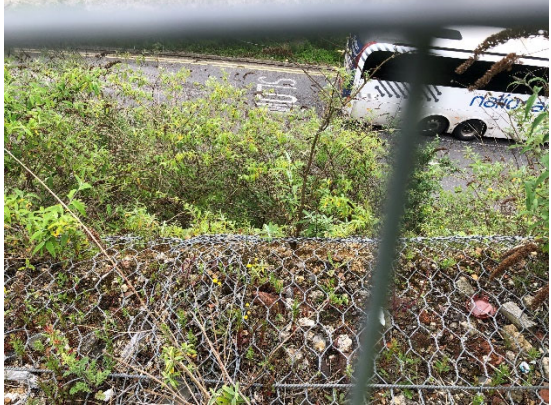
Evidence of embankment reinforcement.
13

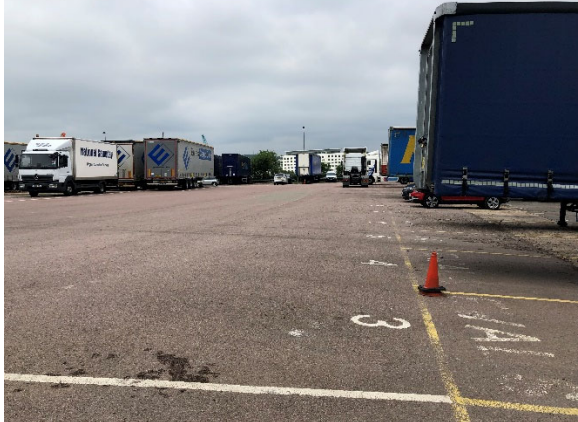
View across northern area looking west.
22

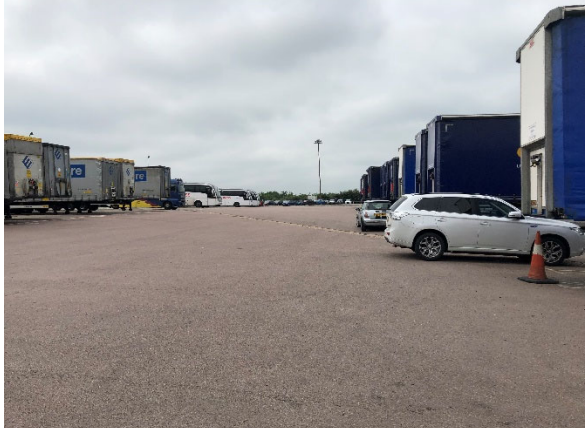
View looking south from northern boundary.

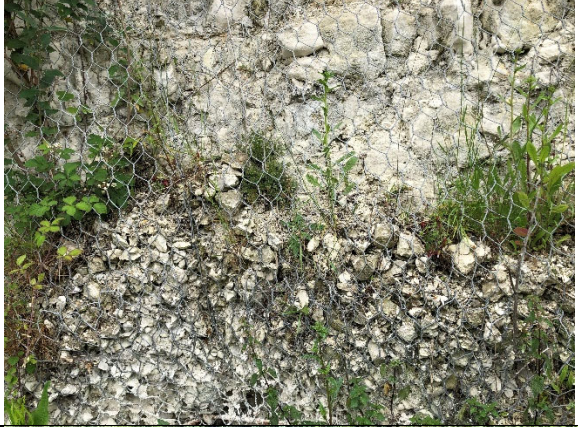
Chalk in face of eastern embankment
29

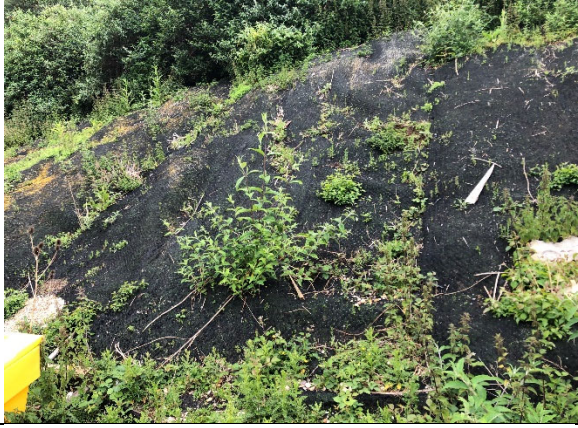
Protective netting to southern embankment
30

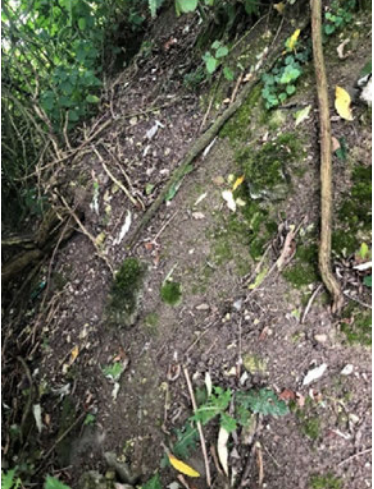
Earth exposed on surface of northern embankment.
<b>Area E2</b>		
36

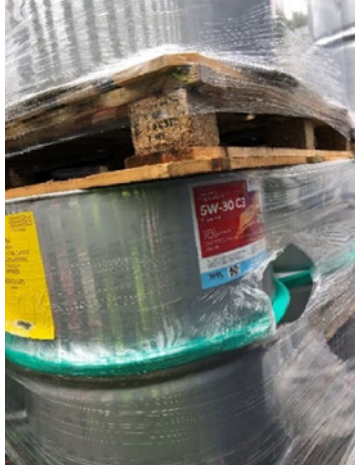
Drums of lubricant oil
44

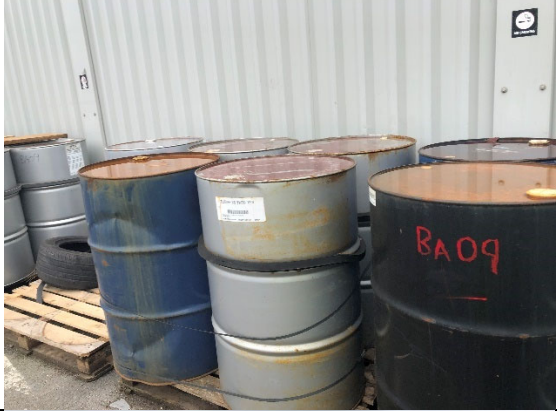
Storage of lubricant oil
45

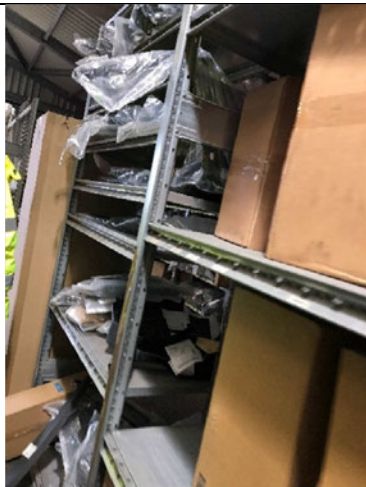
Car Parts inside shed
48

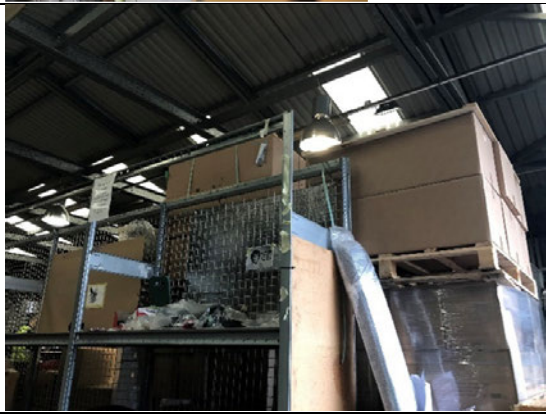
Stored car parts
49

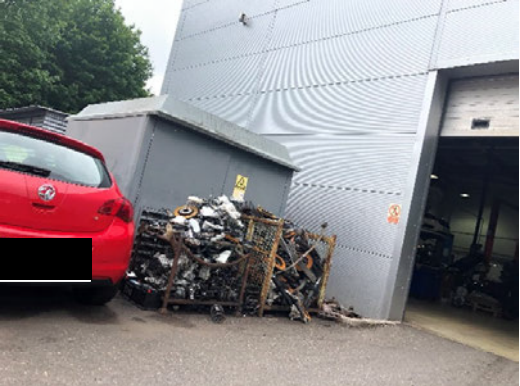
Used car parts and batteries to front of substation.
